Rapid Repair of Seismically Vulnerable Bridge Columns Following Earthquake Induced Damage

RAPID REPAIR OF SEISMICALLY VULNERABLE BRIDGE COLUMNS FOLLOWING
EARTHQUAKE INDUCED DAMAGE

MASTER OF SCIENCE
IN
CIVIL AND ENVIRONMENTAL ENGINEERING

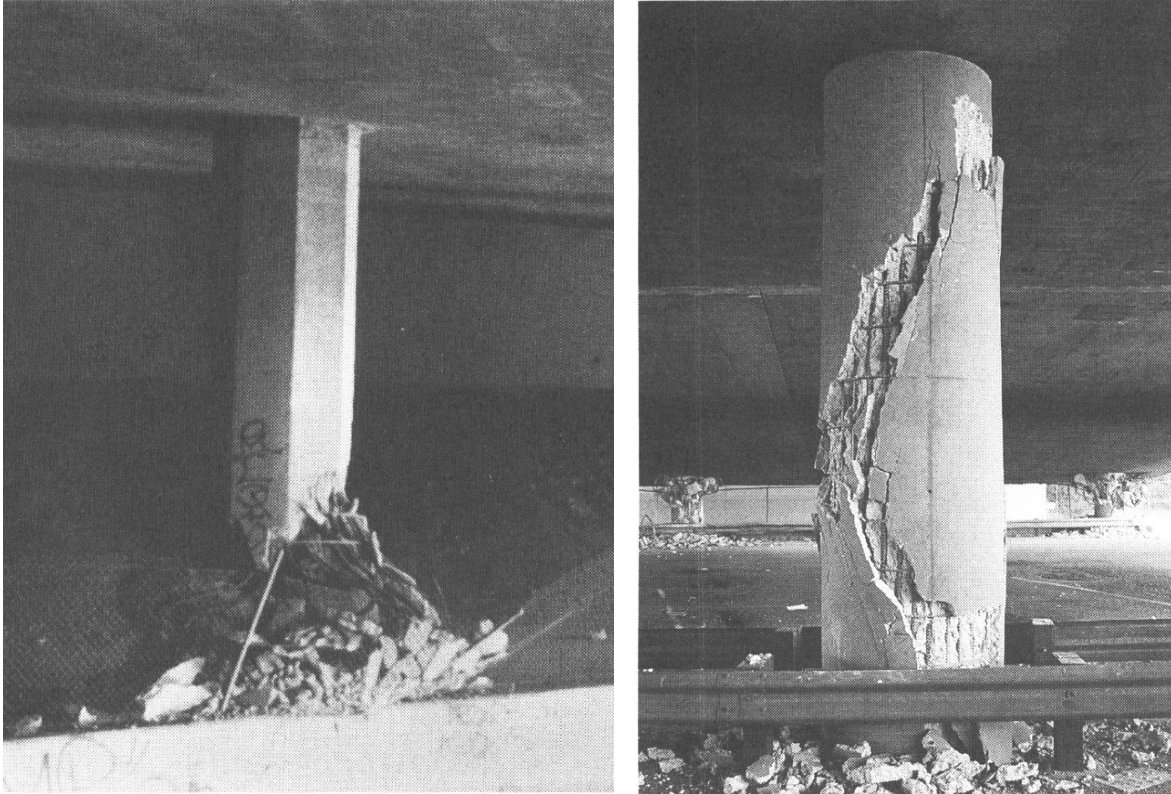
Figure 2.1: (a) Column shear failure, (b) Column flexural failure and collapse, 1994 Northridge earthquake (Priestley, Seible, & Calvi, 1996)

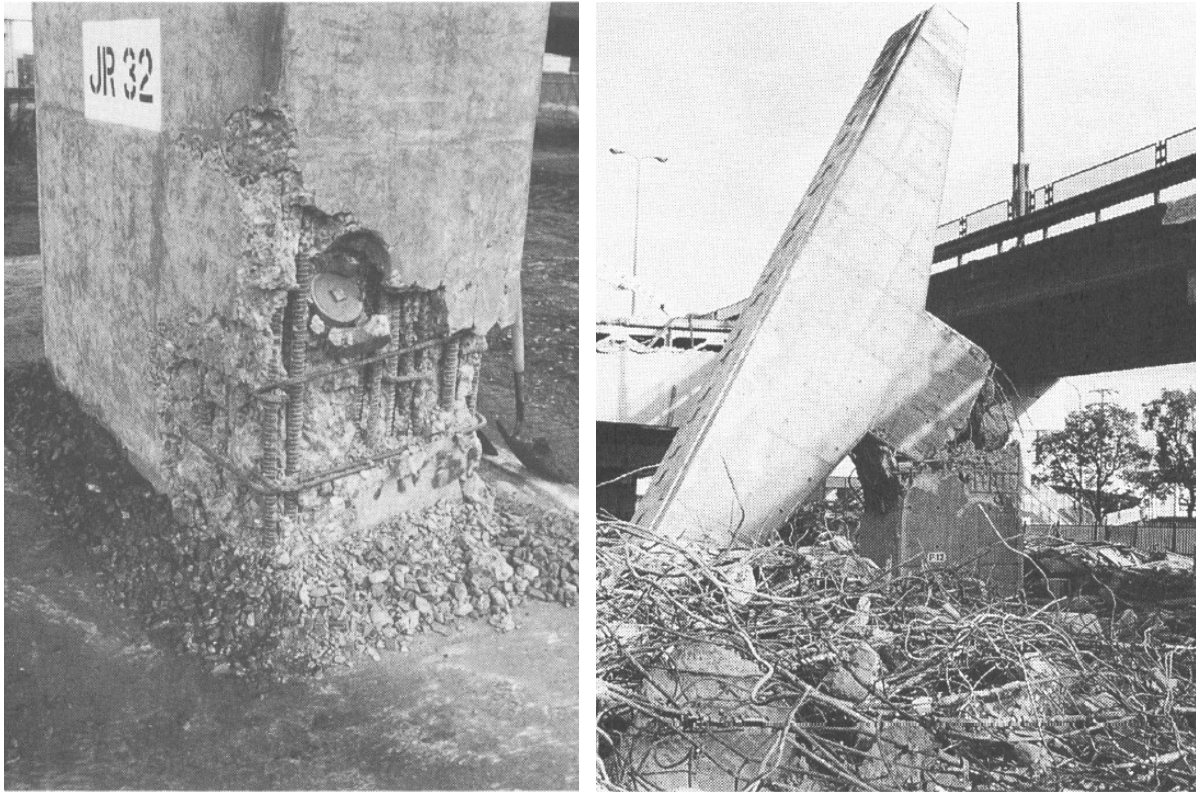
(2) Undependable Column Flexural Strength – Inadequate development length of lap splices is commonly found in reinforced concrete bridge columns. Furthermore, these lap splices often reside at the top and bottom of the column, where seismic loading produces large flexural forces. Priestley et al. (1966) has found lap splice lengths as short as 20 bar diameters to be common in California. Inadequate development length prevents reinforcing bars from reaching their design levels, causing the column flexural design strength to be undependable. An example of lap splice failure from the 1989 Loma Prieta earthquake is shown in Figure 2.2(a).

(4) Premature Termination of Column Reinforcement – Mid-height flexural failures have been attributed to premature termination of the longitudinal reinforcing bars. Priestley et al. (1996) found that a series of columns that failed in the 1995 Kobe earthquake had 33% of the longitudinal rebar terminate at 20% of the column height. The plastic hinge formed above this termination, where the flexural strength was less, causing a flexural-shear failure at mid-height. The failed column is shown in Figure 2.2(b).

Figure 2.2: (a) Lap splice failure, 1989 Loma Prieta earthquake, (b) Mid-height failure, 1995 Kobe earthquake (Priestley, Seible, & Calvi, 1996)

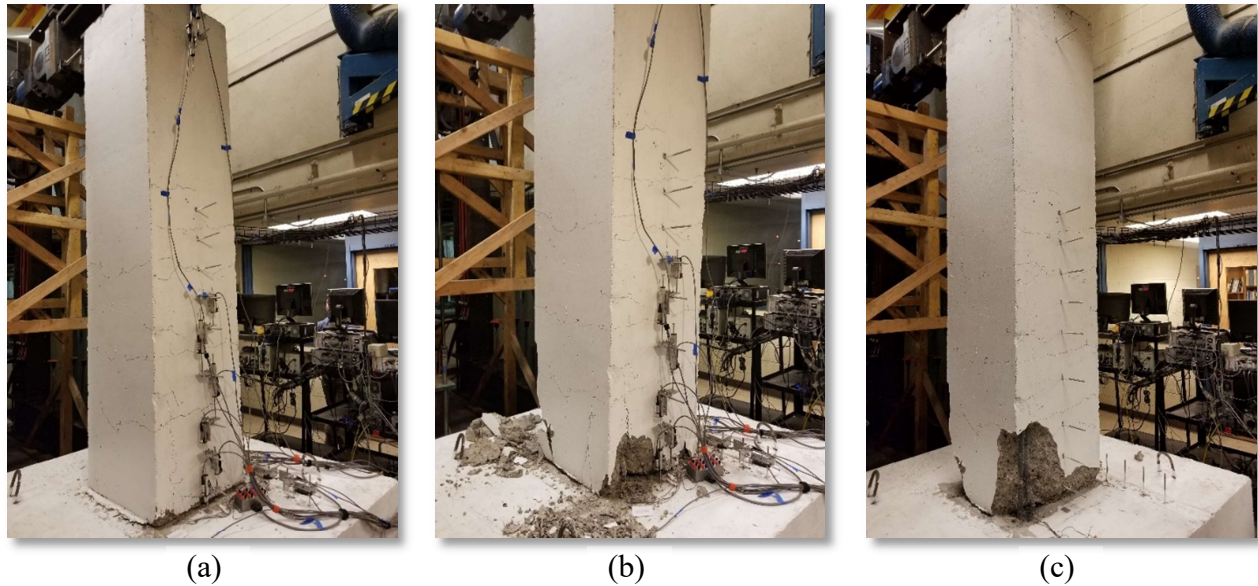
of the longitudinal rebar occurred at the base of the column after a 12-inch section of cover spalled from the corner. The final damage state is pictured in Figure 3.5 (c).

Figure 3.5: As-built damage progression (specimen SVF#8)

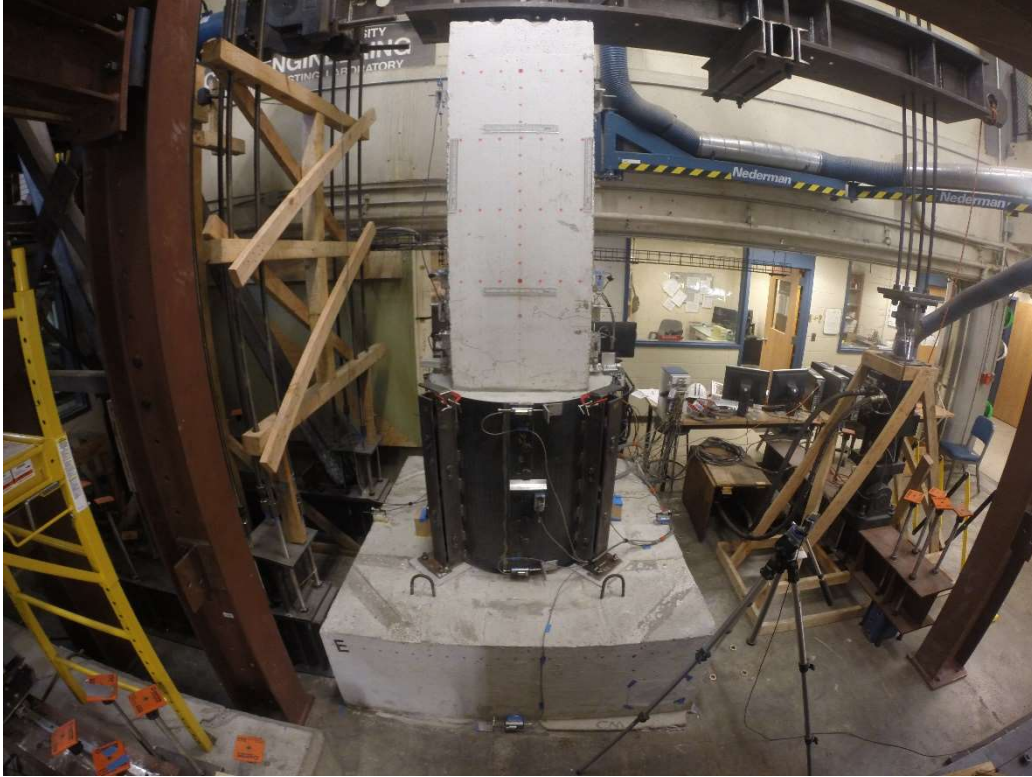
At the final target displacement of 5.4 inches, the axial load actuator stroked out and axial load on the column was lost. The column was returned to its unloaded state while the test set-up was adjusted. The test was resumed, but after three more cycles at the same target displacement of 5.4 inches, the test was terminated when the south east hold-down failed while in tension. The weld between the L4X4X1/2 and the base plate ruptured. The ruptured weld is pictured in Figure 5.12. The weld was a 5/16-inch fillet weld around the perimeter of the angle. While the weld was sufficient to resist the axial capacity of the hold down, it was not designed for combination axial plus flexural forces.

Figure 5.9: Test 1 initial state

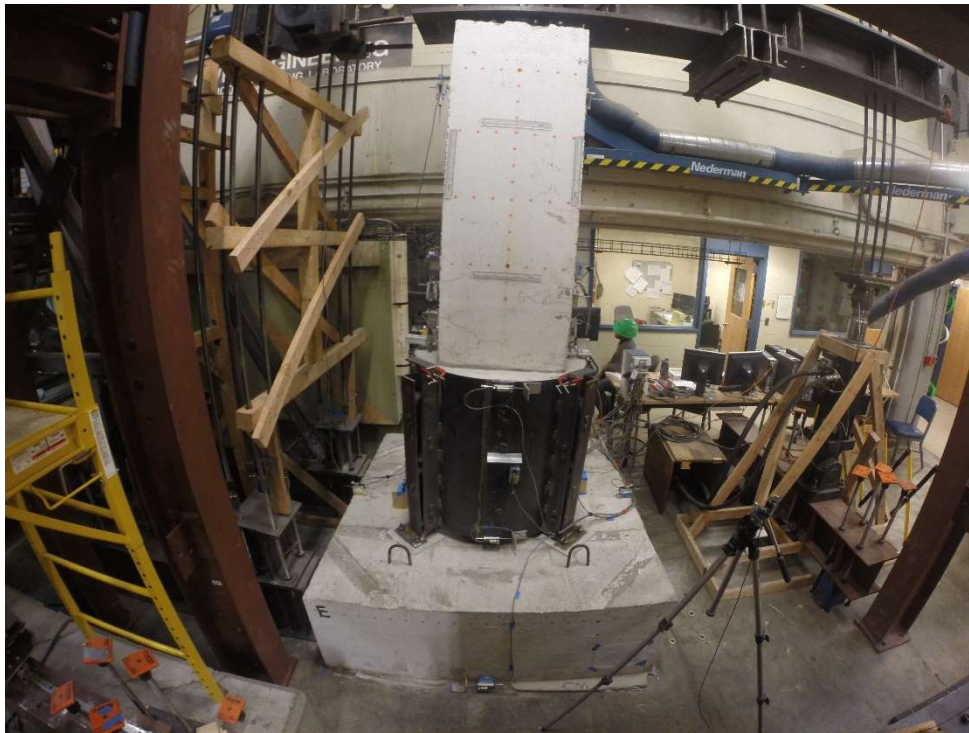
Figure 5.10: Test 1 displacement = 2.5 inches

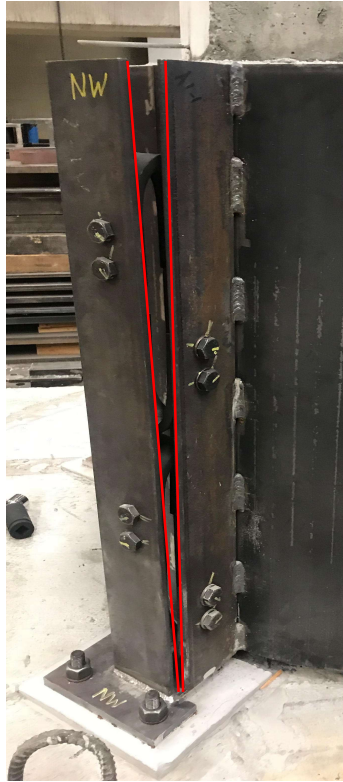
Figure 5.11: Residual hold-down deformation

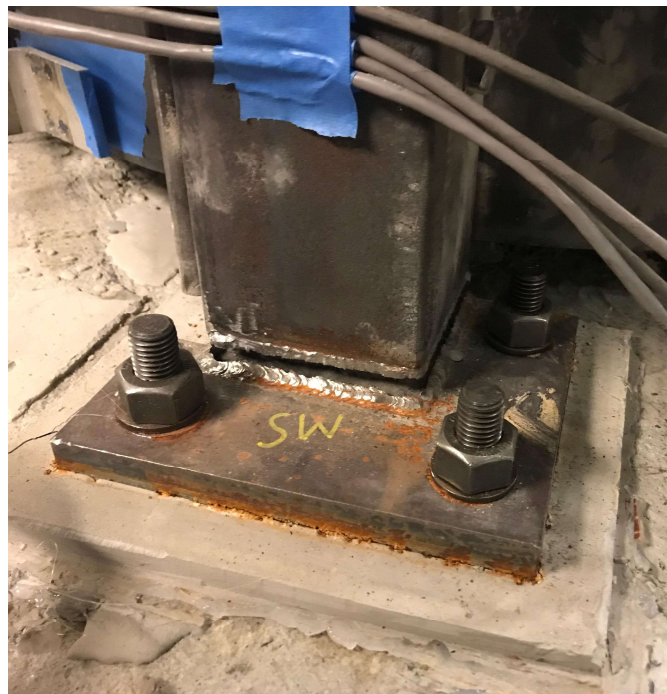
Figure 5.12: Hold-down weld failure

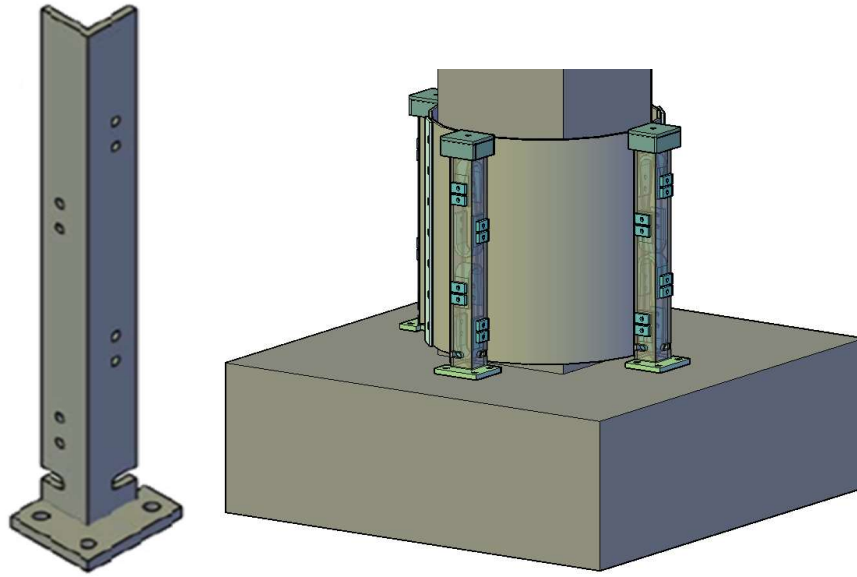
Figure 5.13: Test 2 design modifications

- (3) Hold-down caps – Each hold-down was equipped with a cap. The cap was attached via an angle bracket that was welded to the interior hold-down on the inside of the hold-down. This cap serves two purposes. First, it prevents separation of the exterior leg while allowing the leg to slide within, displacing vertically. Secondly, the cap serves as an encapsulation for subgrade applications.

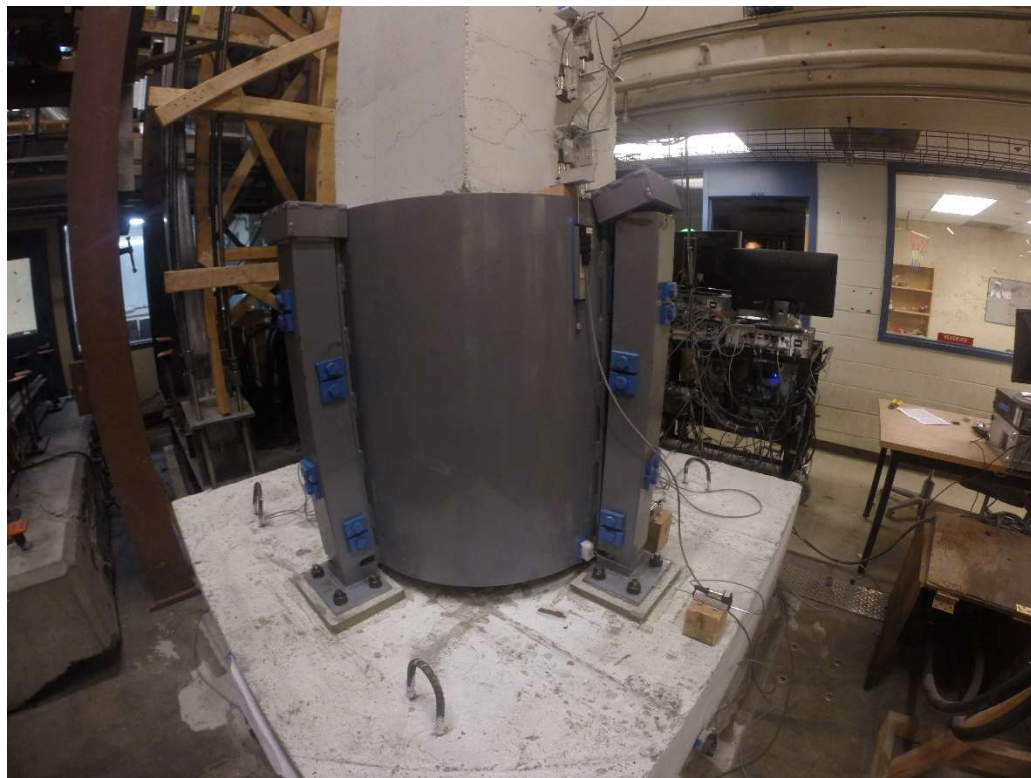
The hold-down caps did not function as intended. With each cycle, the cap was slowly pushed up as the angle bracket yielded. Figure 5.15 show the final state of the test specimen. The cap bracket has yielded and no longer engages the exterior leg of the hold-down. Following this test, the hold-down cap was abandoned and replaced by hold-down rollers which are discussed in the following section.

Figure 5.15: Test 2 final state

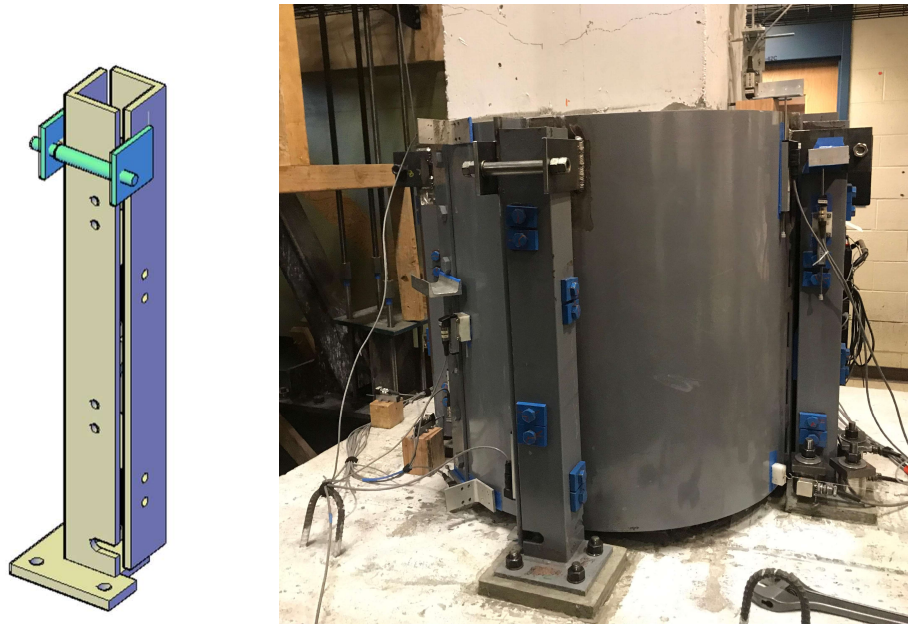
Figure 5.16: Test 3 modification - hold-down roller

For the third test, the hold-down caps were removed, and new hold-down rollers were installed. The hold down roller is shown in Figure 5.16. The roller was made from a ½ inch threaded rod and a hollow pipe which were mounted using ¼ inch plate welded to the shell. The rollers prevent hold-down separation while allowing vertical displacement.

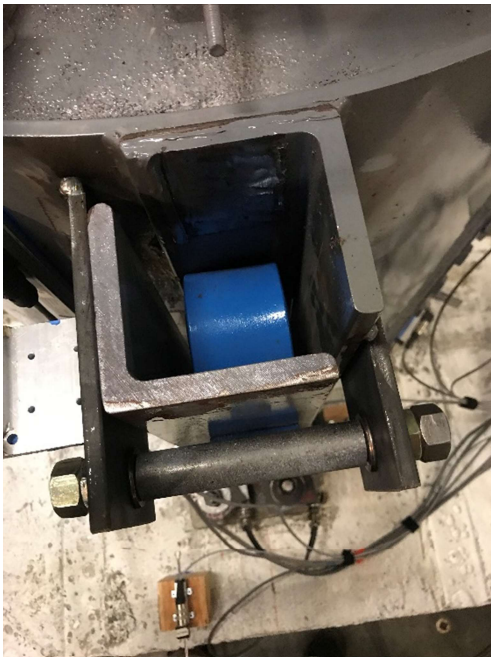
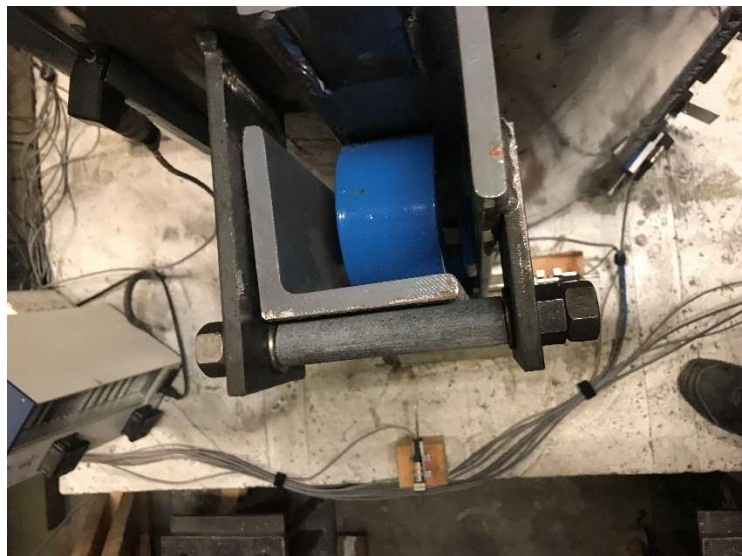
Figure 5.18 shows the hold down rollers before and after the test. They were designed and installed with a ¼” gap between the roller and the hold-down leg. During the test, the gap opened and closed on push and pull cycles.

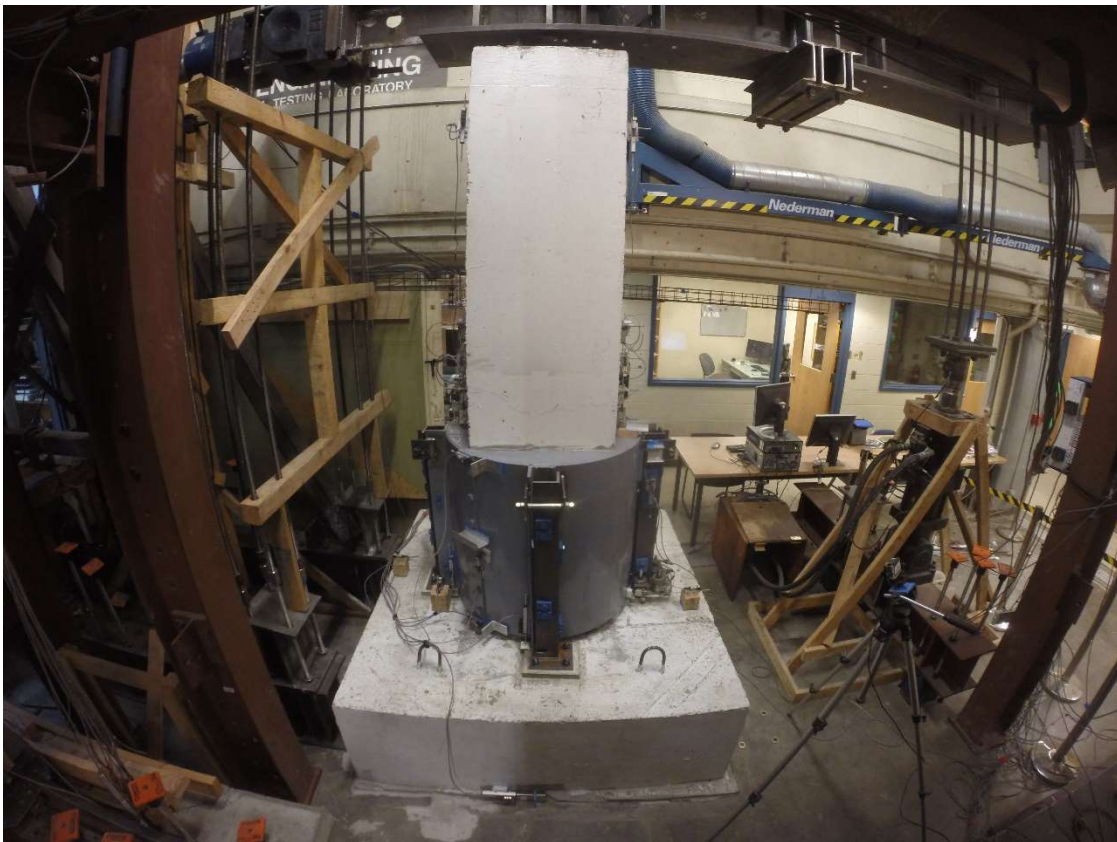
Figure 5.19: Test 4 initial state

The fourth test was also a repeated repair on specimen LVF#8. New exterior legs were installed. The previous legs were permanently distorted and fatigued from cyclic loading over the first three tests. For this test, the objective was to design the hold-downs such that the lateral capacity of the repaired column would be greater than the as-built column. To increase capacity, the UFP thickness was increased by 1/8 inch and the bend diameter was decreased such that the outside diameter remained constant. This results in a 63% increase in maximum hold-down force and a 27% increase in expected lateral load. The fourth test is shown in its initial state in Figure 5.19.
