Factors for Improved Fish Passage Waterway Construction

**FACTORS FOR IMPROVED FISH
PASSAGE WATERWAY
CONSTRUCTION**

Final Report

**SPR 654
OTREC-RR-11-19**

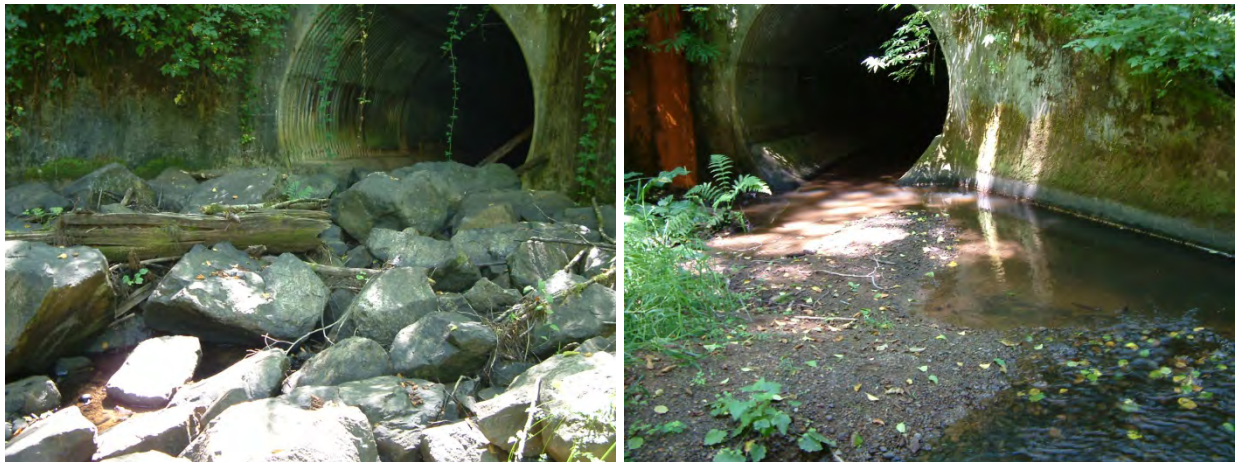
Figure 4.5: Site 02 – Mill Creek downstream and upstream

The upstream side was only accessible after walking through the culvert. There was an accumulation of sand and gravel at the upstream channel.

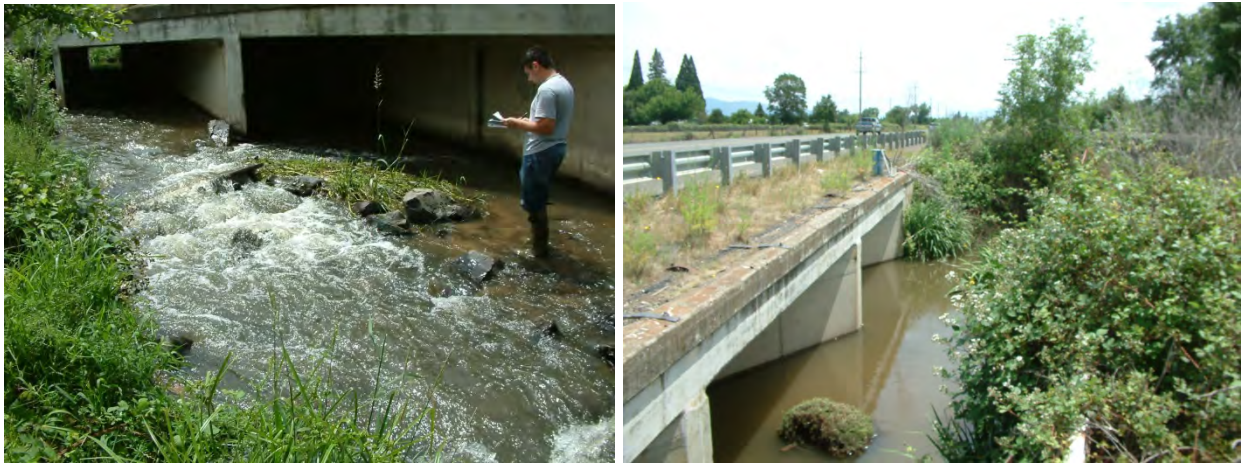
Figure 4.9: Site 07 - Jackson Creek (1) downstream and upstream

There are three culverts in parallel at the site. There was a lot of gravel accumulation and in all three culverts. All the weirs in the middle culvert were covered by this accumulation.

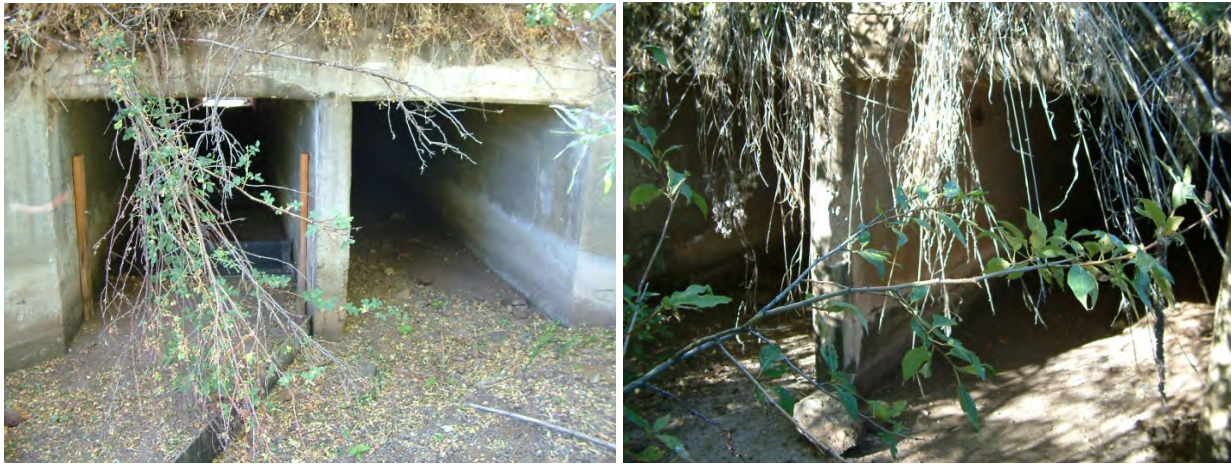
Figure 4.11: Site 09 - Wiley Creek downstream and upstream

Wiley Creek is located in Grant County and crosses Highway 395 at MP 101.8. The culvert is easily accessible from both sides of the road and the investigators had no problem performing measurements, except for cross-sections of the river could not be performed due to heavy bank vegetation. As can be seen in Figure 4.11, the river was dry.

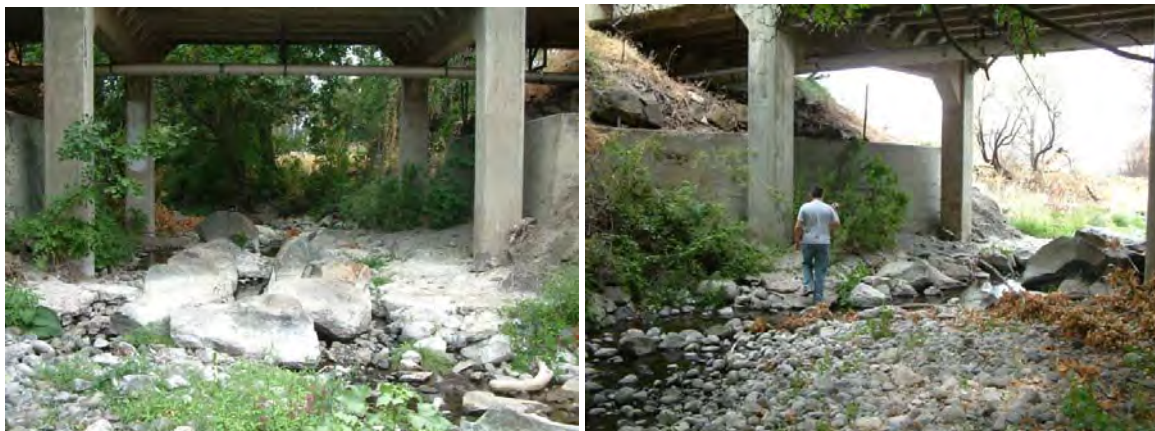
Figure 4.12: Site 10 - Chenoweth Creek downstream and upstream

Some history was available for this structure: Repairs to the channel located under the remnant bridge were performed in September of 2006 by applying concrete to the eroded streambed and placement of compacted streambed materials over the concrete base to provide fish passage to steelhead and salmon. Chenoweth Creek had exceptional winter flows in 2006 just after the concrete bed was installed. This resulted in structural failure of the concrete, extensive streambed material movement and loss of fines. In August 2007, subsurface flow was observed under the concrete channel liner and remaining streambed material immediately downstream of the structure as shown in Figure 4.13. Large boulders served to concentrate stream flow, created backwater and flow vortexes in the channel. In September 2007, ODOT made further repairs to this passage by removing the mid portion of the concrete bed and replacing streambed materials (NMFS Washington 2008).

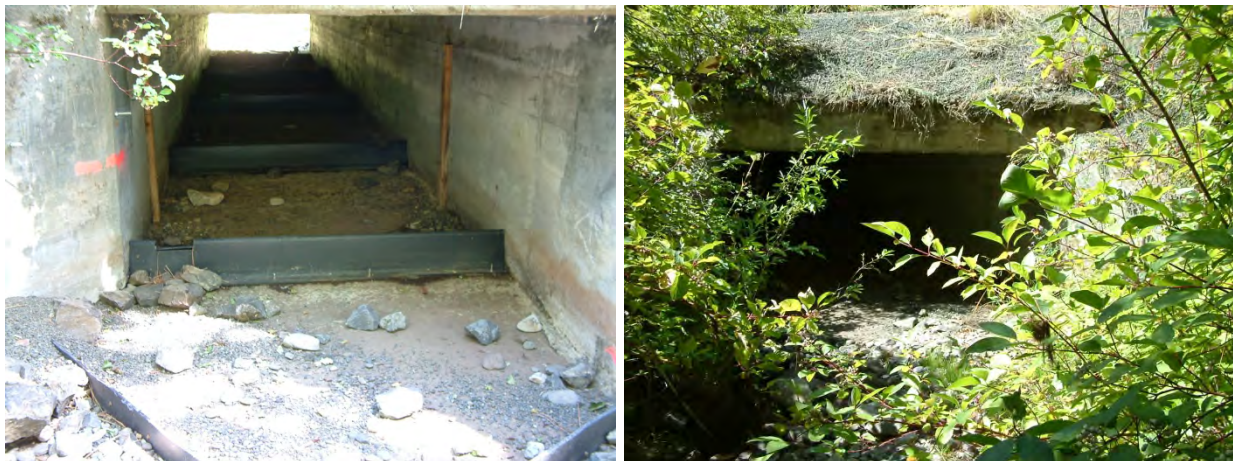
Figure 4.14: Site 11 - Cottonwood Creek upstream and downstream

The structure consisted of one culvert, which had baffles and weirs. There was no water flowing in the creek. Photos of Cottonwood Creek are shown in Figure 4.14 below.

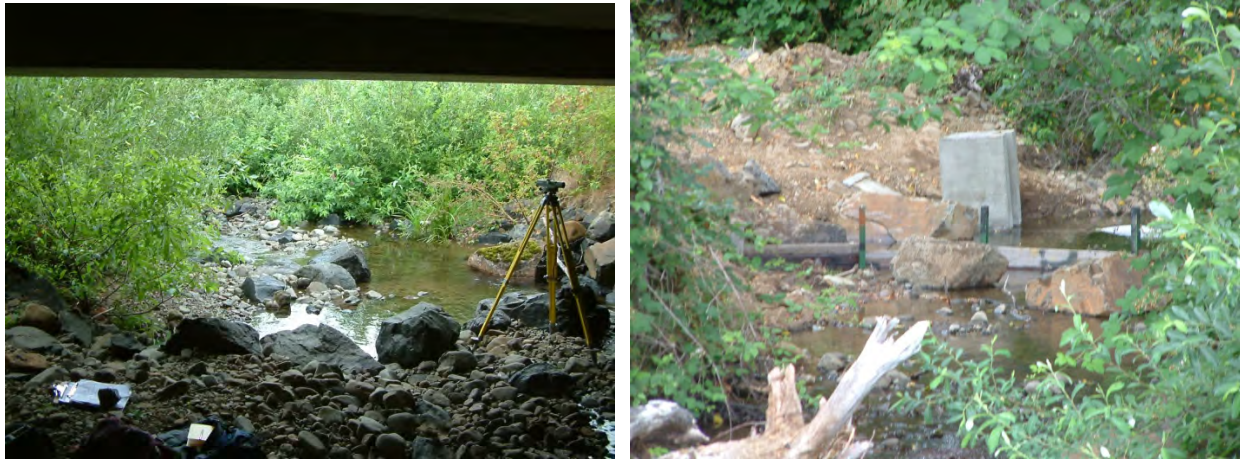
Figure 4.18: Site 16 - Jackass Creek downstream and upstream

Jackass Creek is located in Polk County and crosses highway 18 at MP 19.16. Access to the creek was from the downstream side (Figure 4.18 left) and was not particularly difficult. There were no problems in gathering any of the information and slopes and cross-sections were obtained easily. The upstream side of the creek (Figure 4.18 right) had an artificial block that created a small pool. In addition, the upstream channel had several high jumps (greater than 12 inches (30 cm)).
