# The Engineering Geology of the Fountain Landslide, Hood River County, Oregon

Susanne L. D'Agnese  
*Portland State University*

Title: The Engineering Geology of the Fountain Landslide  
Hood River County, Oregon.

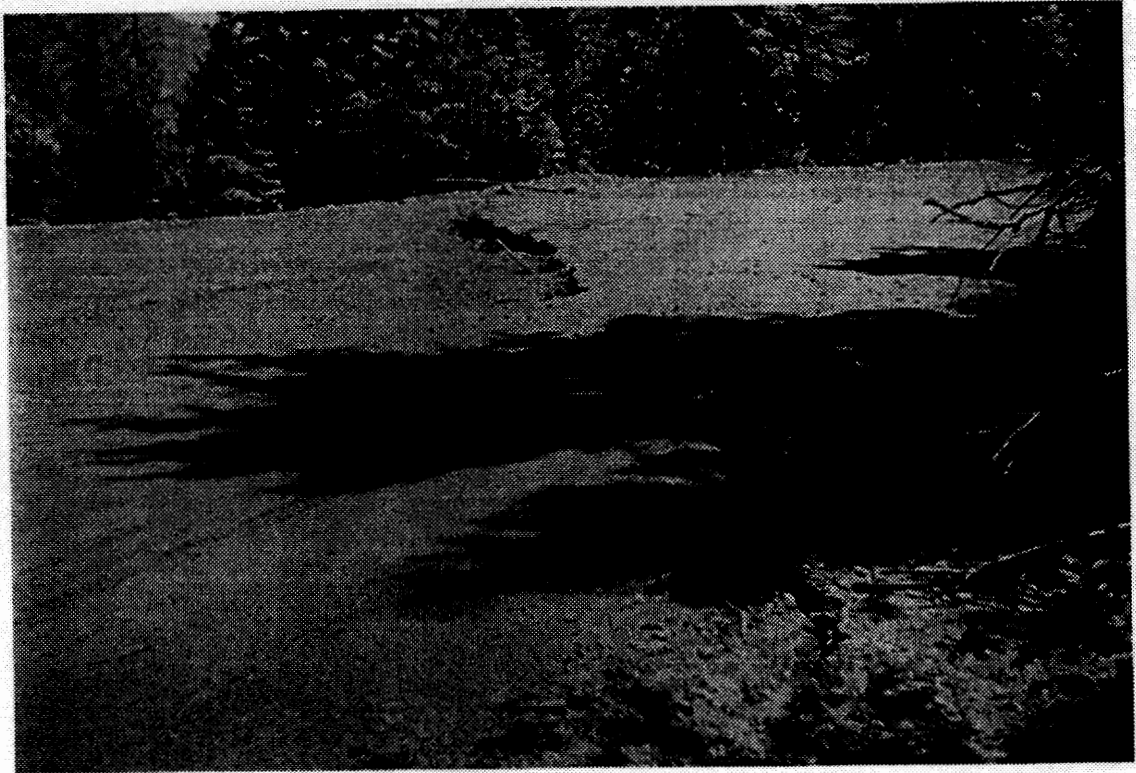
The length of highway affected by slide movement enlarged to the east beginning in January 1971 (Gano, 1971a). After examining the area the Oregon State Highway Division found the boundary to be enlarged to the south and the east (see Figure 15). The enlarged boundaries were defined by the presence of 0.3 to 0.65 meter (1 to 2 foot) scarps across the haul roads constructed for the unloading process. A photograph of the the scarp on the upper haul road is shown in Figure 17.

Figure 17. Photograph of scarp in upper haul road. (1971)  
(from OSHD files)

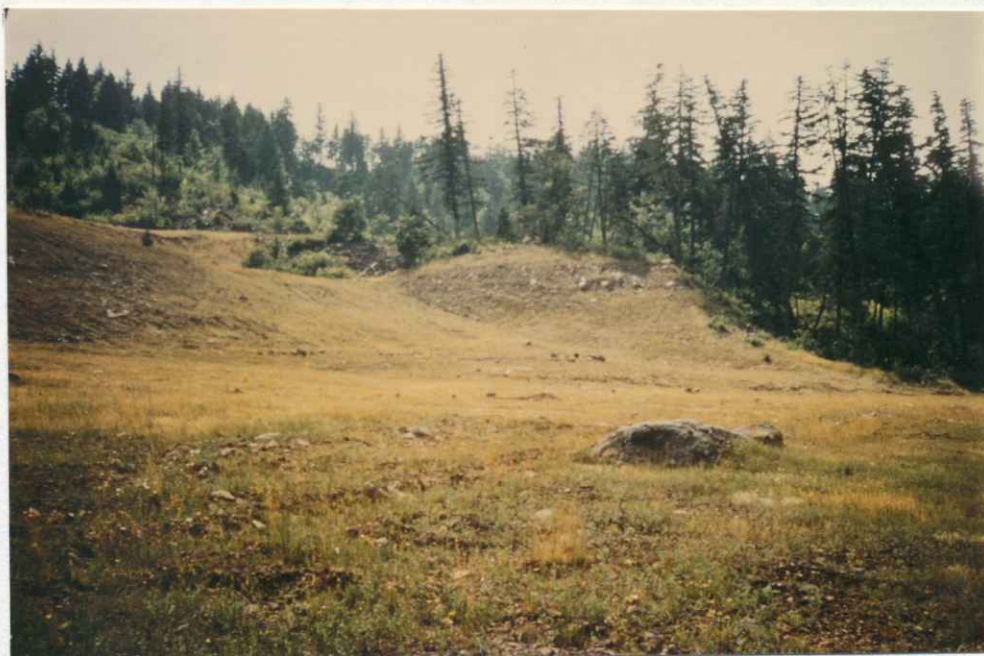
Figure 23. Photograph of the surface condition of the Wind River Lava. Looking west at the western boundary.

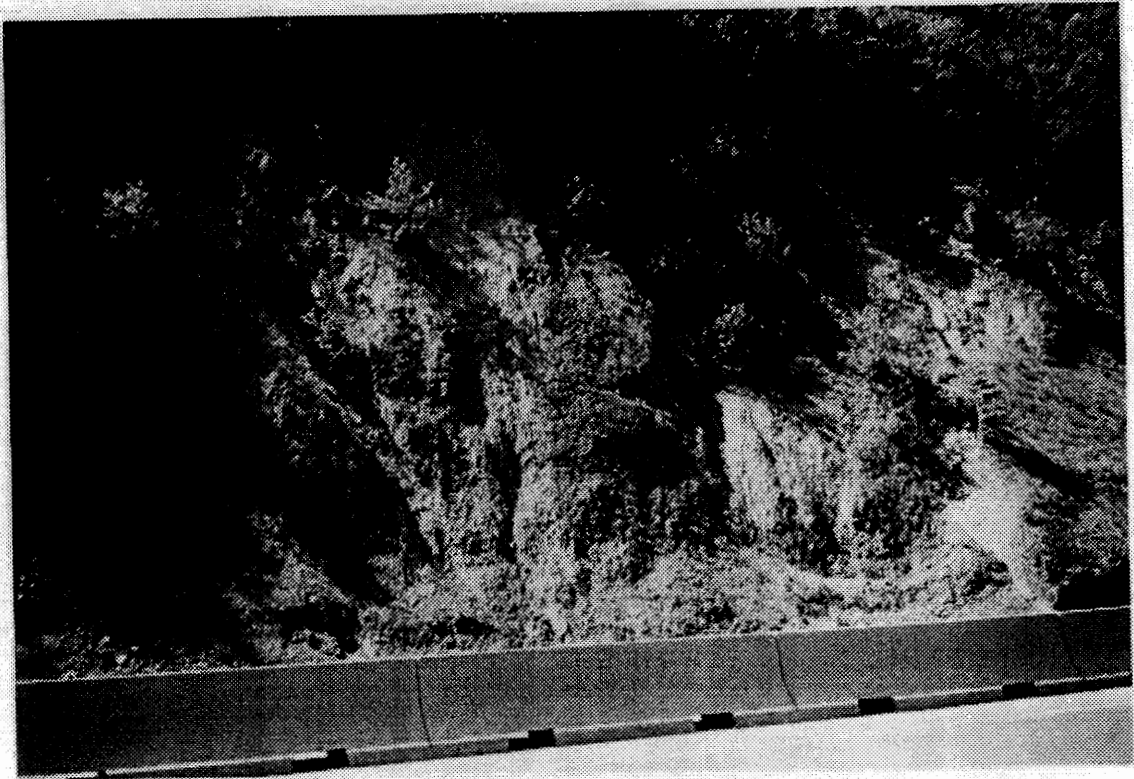
Figure 27. Photograph of fracture zone east of the weigh station. The zone is approximately 15 meters wide.

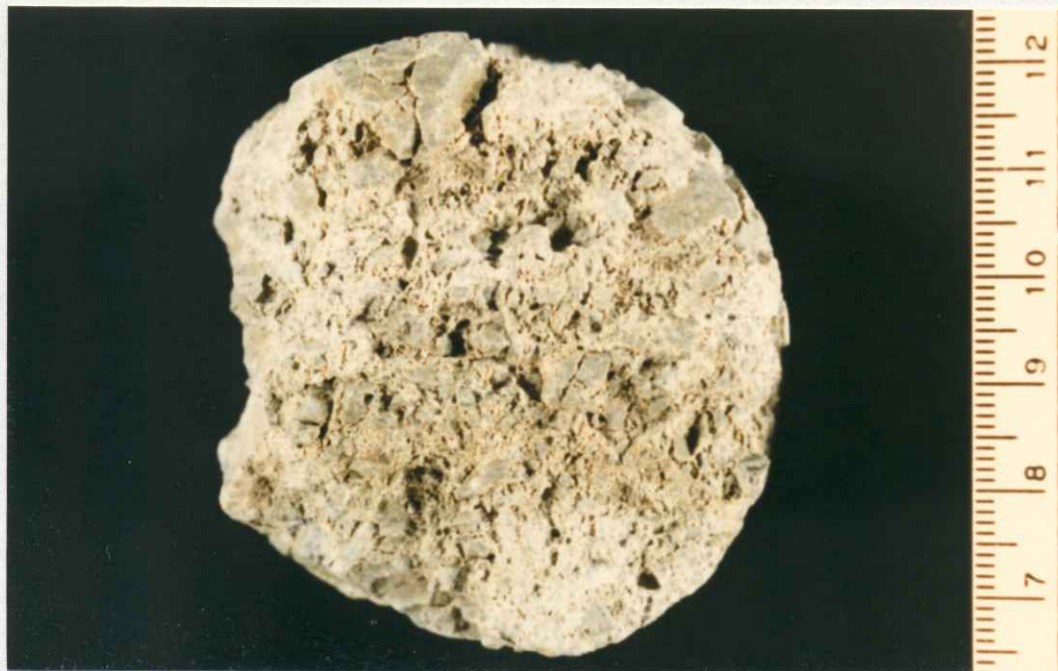
Figure 28. Photograph of core sample of the tectonic breccia. Sample taken from SM24. See Table I.

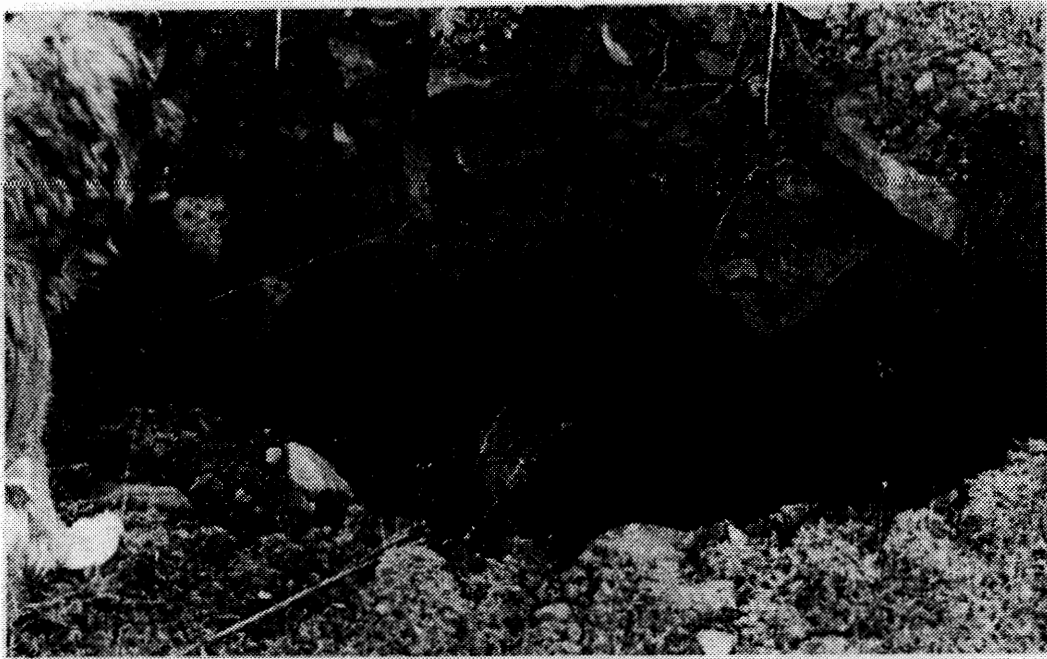
Most of the cracks and scarps are rounded and have vegetation covering them as shown in Figure 33. Except crack A1, (Figure 32) which has angular rims and no vegetation on it. Those features which are angular and not vegetated indicate recent activity, the others are older features. Two other recent cracks are, 1) the long crack along the lower haul road (F on Plate 1), and 2) the small

Figure 32. Photograph of crack A1. Located along the western edge of the landslide.

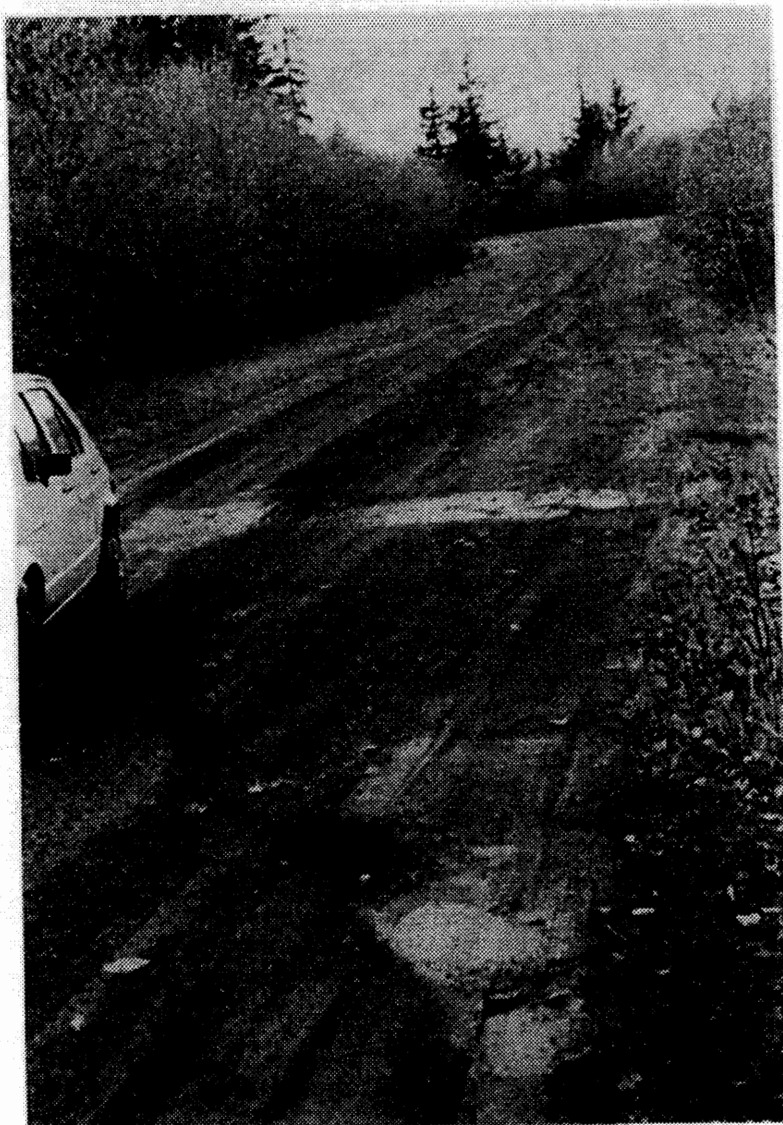
Figure 34. Photograph of arc-shaped crack in the lower haul road. Located near the intersection with Herman Creek Road.

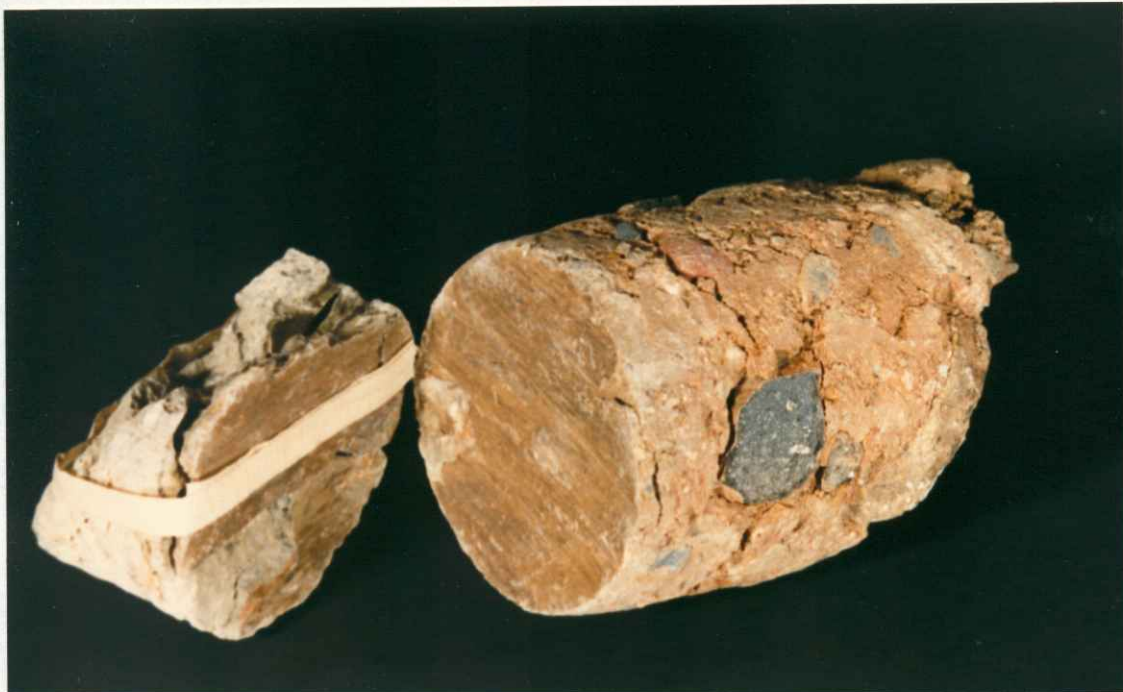
Figure 37. Photograph of the slip plane material.  $2\frac{1}{2}$ " core sample taken from SM36, see Table I.
