10-17-1994

Landslide Inventory and Susceptibility Mapping of the Upper Canyon Creek Basin, Cascade Range, Skamania County, Washington

Lawrence P. Growney
Portland State University

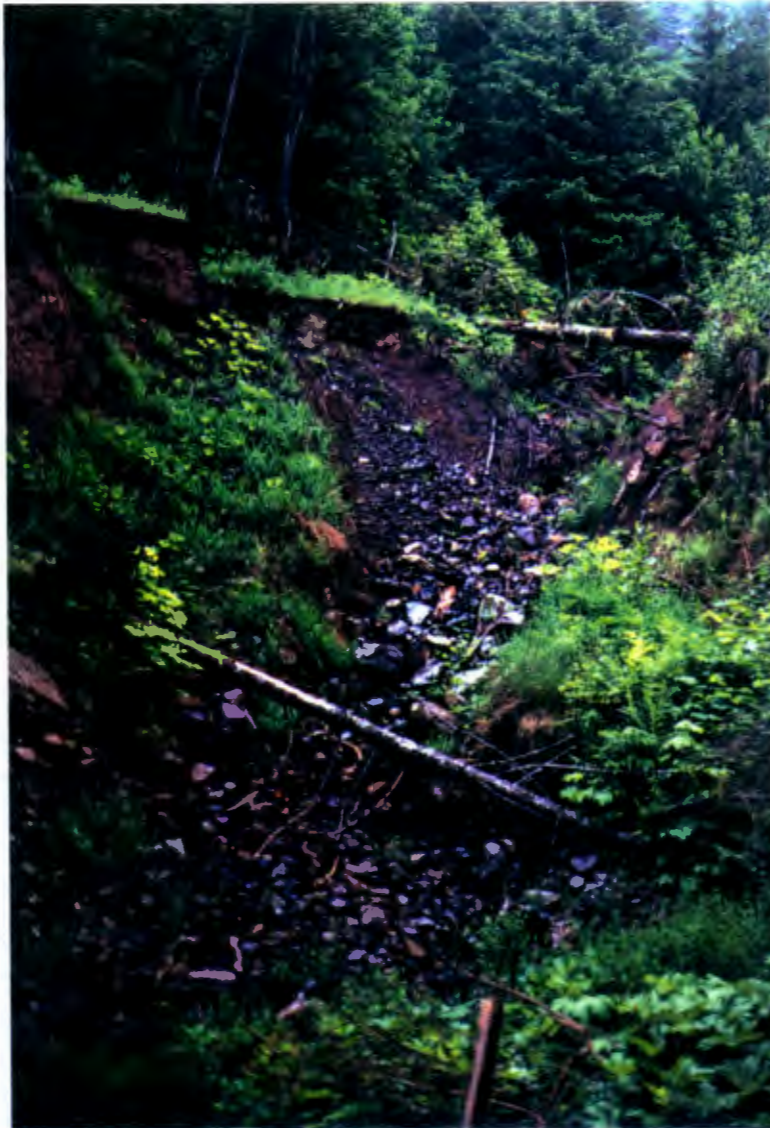
Figure 17. Slump-flow failure in thick glacial deposit - Big Rock Creek, sec. 29, T.5 N. R.5 E. Road failure has occurred where thick till has become oversaturated due to the presence of a perched water table just below the roadbed at the top of the gravel in the left center. The fallen tree at the top of the failure lies in the position of the former roadbed. The stream is flowing from right to left across the bottom of the photo below the green ridge in the foreground, not through the cut below the log.

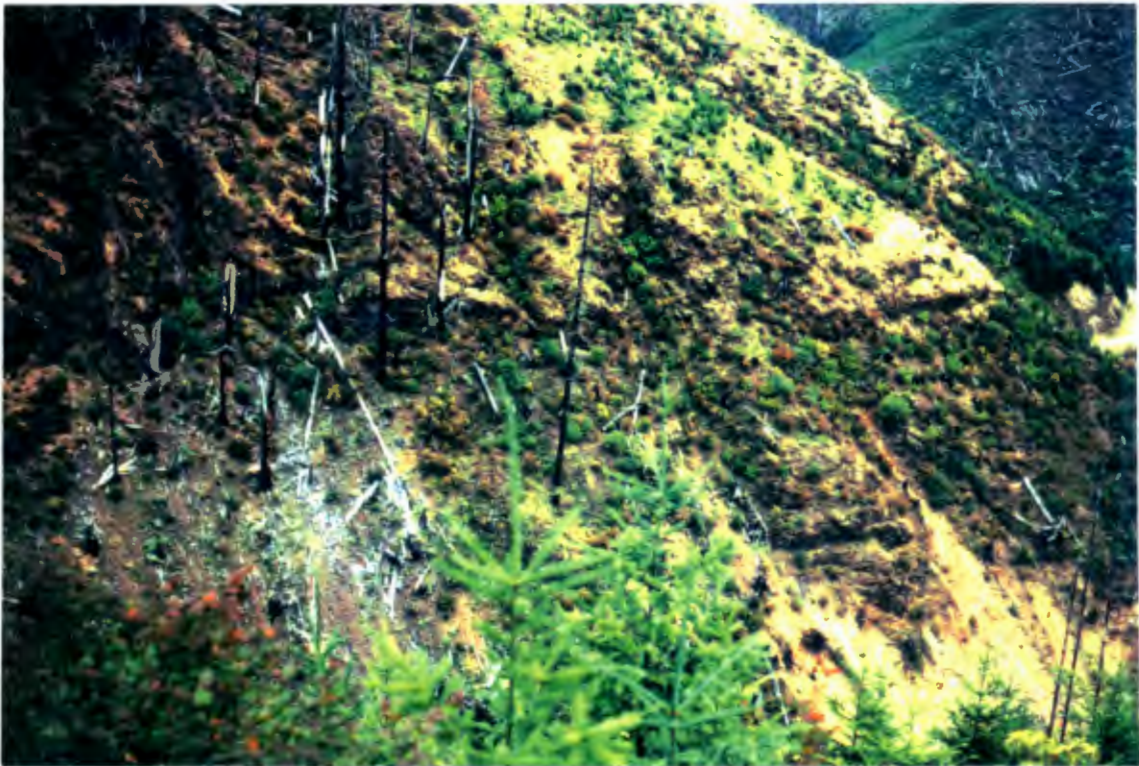
Figure 18. Debris slip at the bedrock/overburden contact - Sorehead Creek, sec. 15, T.5 N. R.5 E. Shallow debris slips are common throughout the area where thin overburden or residuum overlies bedrock. Steep, smooth slopes and oversaturation are the primary instigators of failure. Numerous, small debris slips are visible in the lower right of the photo.

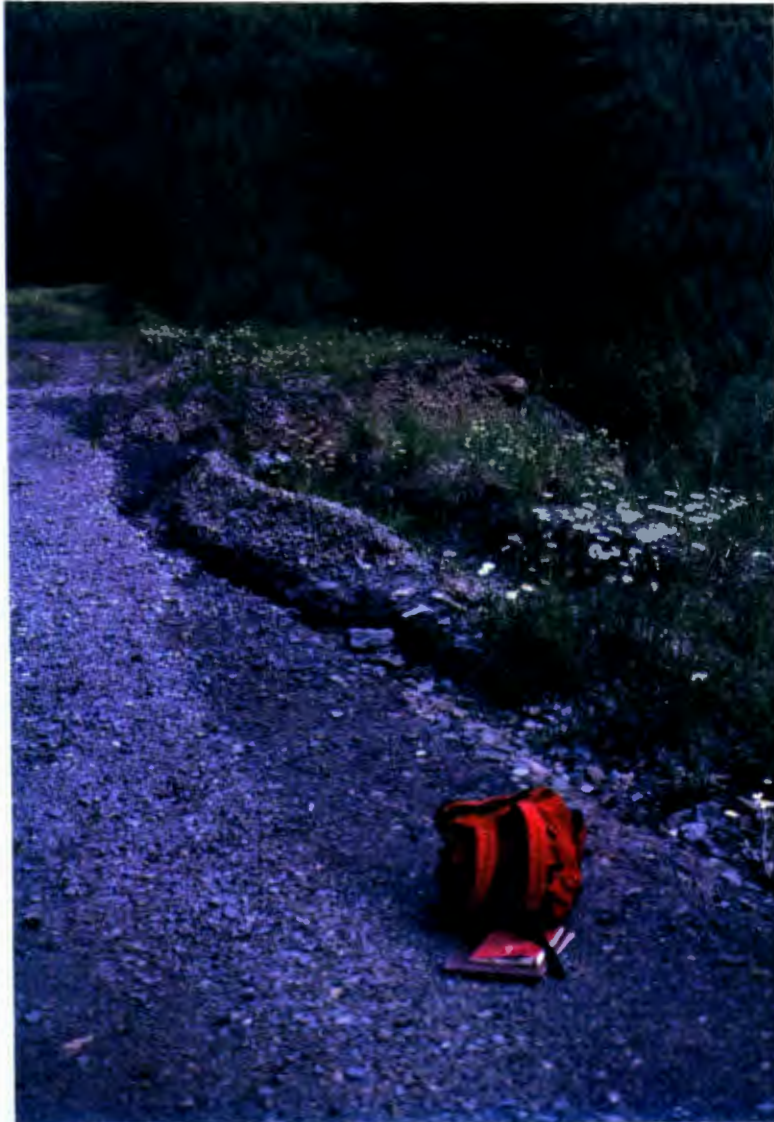
Figure 19. Roadbed destruction due to unconfined surface runoff - Jake's Creek, sec. 27, T.5 N. R.5 E. The two gullies in the photo are over .3 m deep. The boulder sticking out of the hillside in the background is part of the fill material and is exposed due to failure of the hillside resulting from surface runoff. This roadfill failure is occurring over strata dipping into the stream. The outermost gully is now a failure crack.

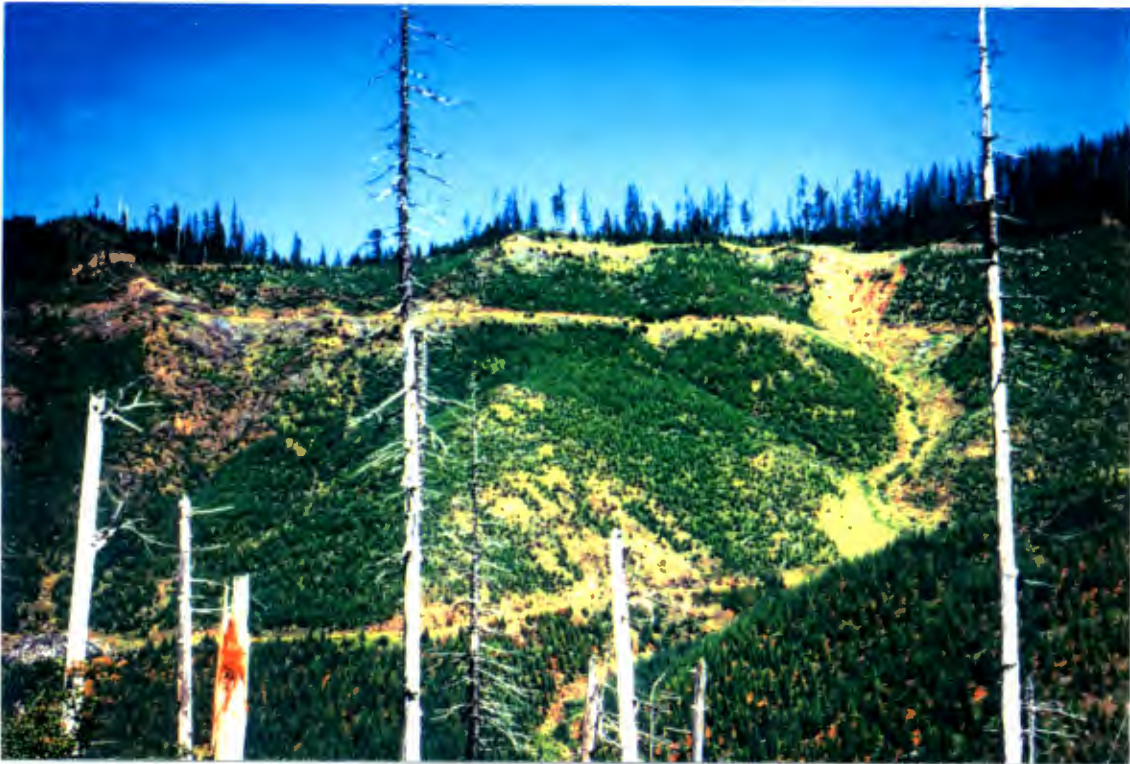
The development of a debris chute in the SW NE SW 1/4 Sec.10, T.5 N. R.5 E., on the southwest side of West Point, is occurring in tuff breccias, lapilli tuffs and lahars. To date, approximately 700 m³ of material have failed. Numerous ephemeral seep locations occur vertically up this hillside for its entire length. In addition, the regional dip direction is out of the hillside. The presence of even larger fan-shaped, concave features along the ridge adjacent to the current debris chute (Fig. 20), suggests the possibility of continued failure at this site. Keough (1992) found that potentially large debris flows (> 914 m³) may have occurred just over the ridge on the northwest side of West Point, in the Siouxon Creek drainage, in the same lithologic and topographic setting.

Figure 20. Active and ancient debris chute morphology - West Point, sec. 14, T. 5 N. R.5 E. A recent landslide has created a debris chute nearly 30 m across, visible in the upper right. Behind the tall, dead tree on the left is the scalloped-shaped scarp of an ancient slide which stabilized after encountering a dike on both sides. If dikes are the stabilizing factor, the younger feature may grow to nearly twice its present width, based on the location of the nearest dikes. The dip in this location is out of the hillside toward the viewer.

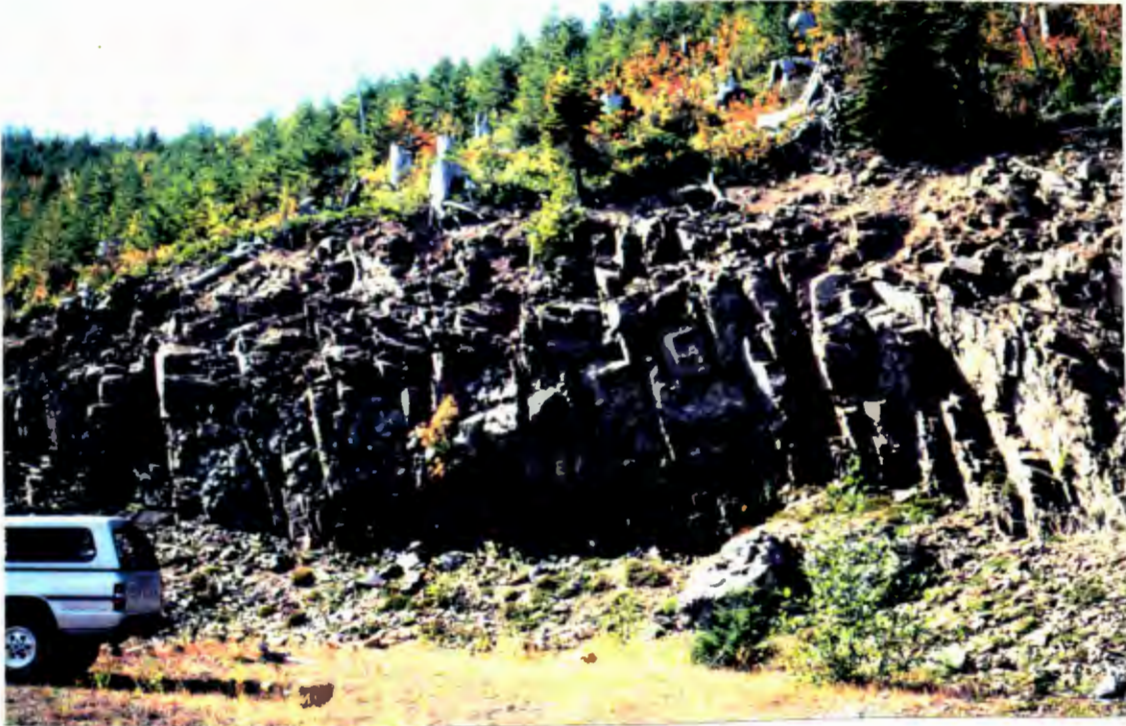
One concern to slope stability in the basin, is the presence, in many rock masses, of a continuous, near vertical joint orientation which reduces the friction and cohesion of the whole rock mass without affecting the strength of the individual blocks. When viewed parallel to the strike of these joints, the rock mass is similar in appearance to a stack of cards viewed from the side (Fig. 21).

Figure 21. Vertically oriented jointing - FS Rd. 53, SE 1/4 sec. 28, T.5 N. R..5 E. Many bedrock units display a pronounced near vertical joint habit. Lack of a continuous, normal joint direction results in the unexpected degree of stability. Minor rockfall occurs but is very limited.

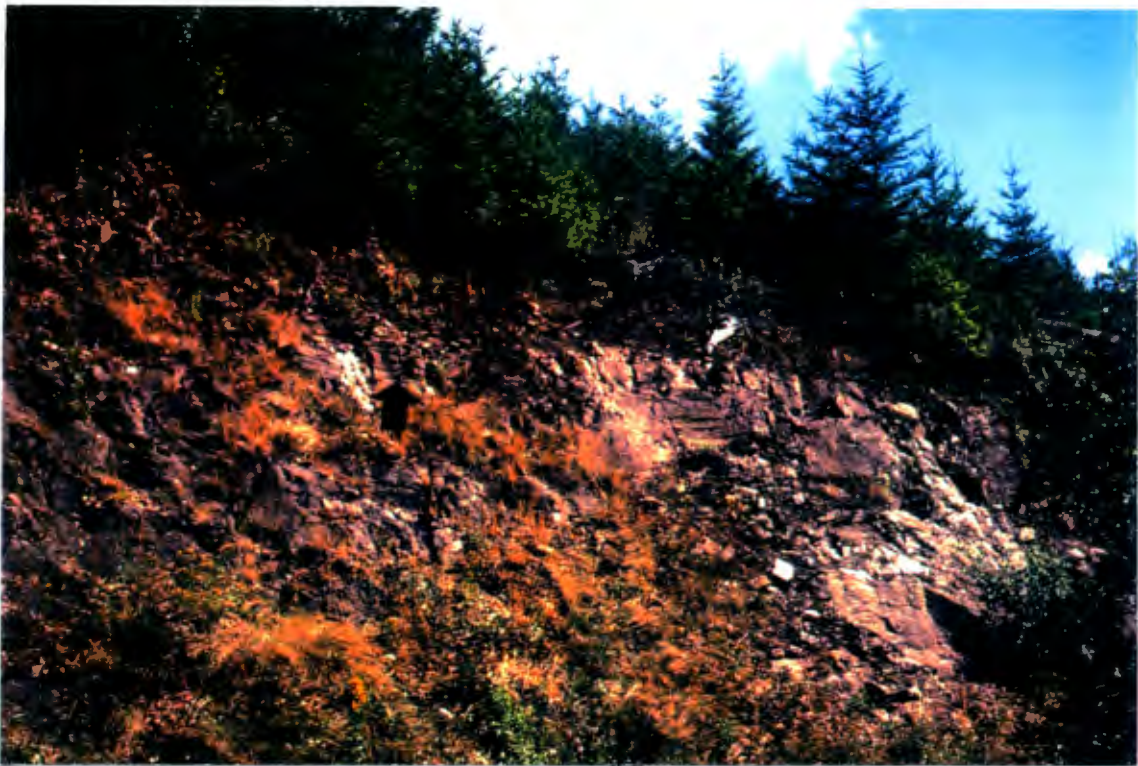
In many cases where platy jointing occurs, the concentration and dilation of discontinuities decreases moving toward the center of the rock mass from the top surface. As a result, rockmass discontinuities grade from open planes of separation (dilated), with high block strength but lower rock mass strength, to latent planes of separation (visible but not dilated) to a massive-looking exposure characterized by preferred or random breakage with high rock mass strength (Fig. 22).

Figure 22. Variation in fracture dilation with depth - FS Rd. 310, NE 1/4 sec. 19, T.5 N. R..5 E. Typical compact igneous bedrock joint dilation habit. Rock mass joints are characteristically platy at the overburden contact (arrow), become more closed and latent with depth and nearly nonexistent furthest away from the contact.

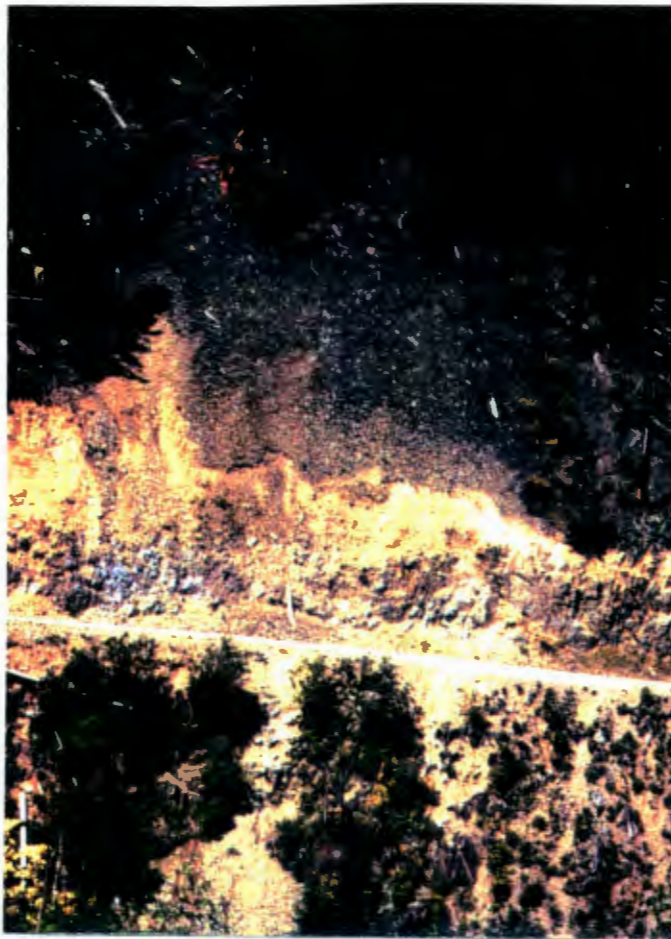
Figure 23. Effect of anthropogenic oversteepening. FS Road 37 in the NE SE 1/4 of sec 36, T.5 N. R.5 E. This roadcut has oversteepened the till and talus overlying basaltic andesite bedrock. Oversaturation has resulted in the progressive failure of the overburden which has blocked the road at times. The largest failure, on the left, is 30 m long. Note that the overburden is failing progressively uphill as highlighted by the overburden color changes.

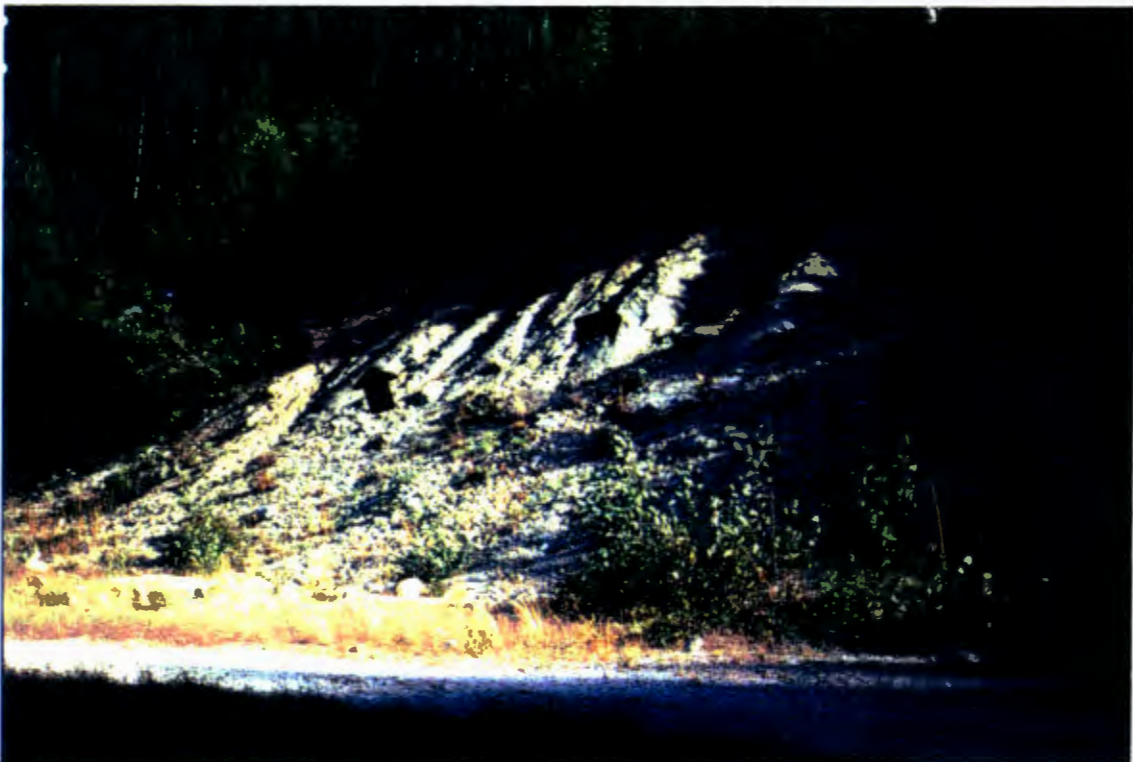
Figure 24. Concavity and rill development in till - SE NE 1/4 sec. 34, T.5 N. R.5 E. The formation of rills and concavities in till deposits may be a reflection of the thickness of the deposits. Concavities (arrows) appear to form in thicker deposits as a result of failure along a critical circle, whereas, rills develop in response to surface wash. Note that the concavities have developed rill overprints due to the thinning of the deposits as a result of prior concave failure.

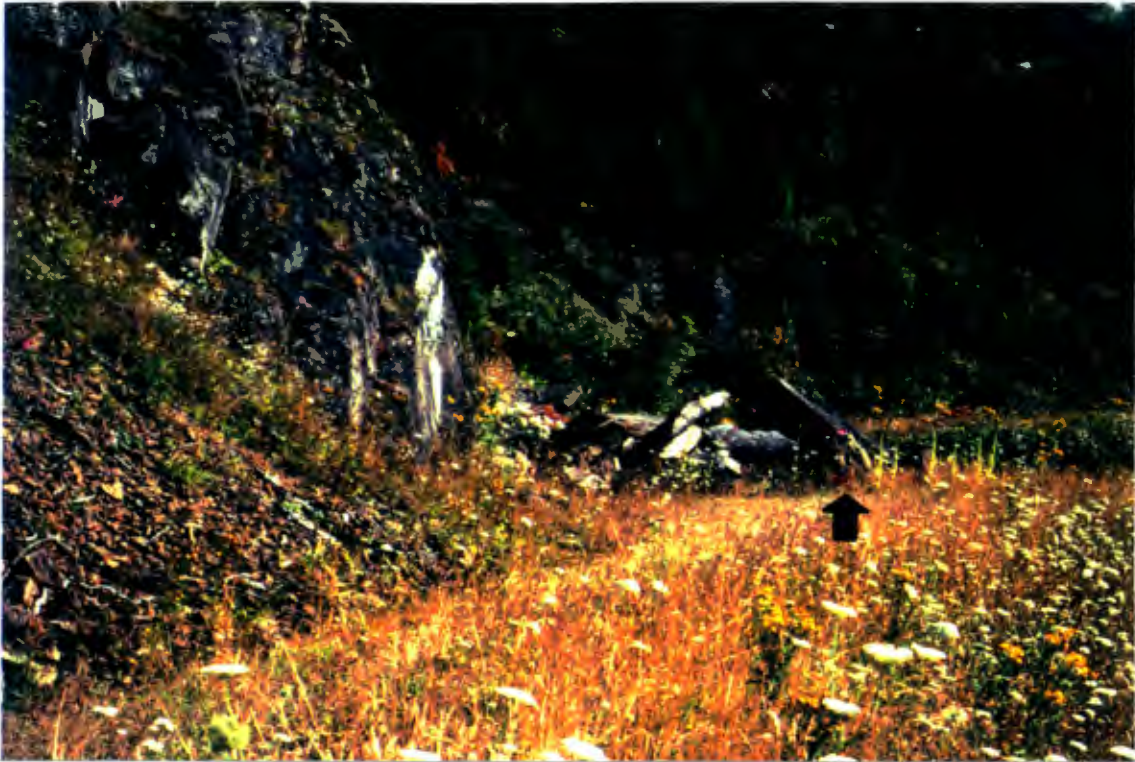
Figure 25. Slab block failure in a fragmental igneous unit - FS Rd. 310, ctr. sec. 16, T.5 N. R.5 E. Large failure blocks are common in the more welded ashflow units, which have jointing habits more similar to compact igneous bedrock. These slabs are as much as 4.7 m in length. Backpack (arrow) is .3 m for scale.

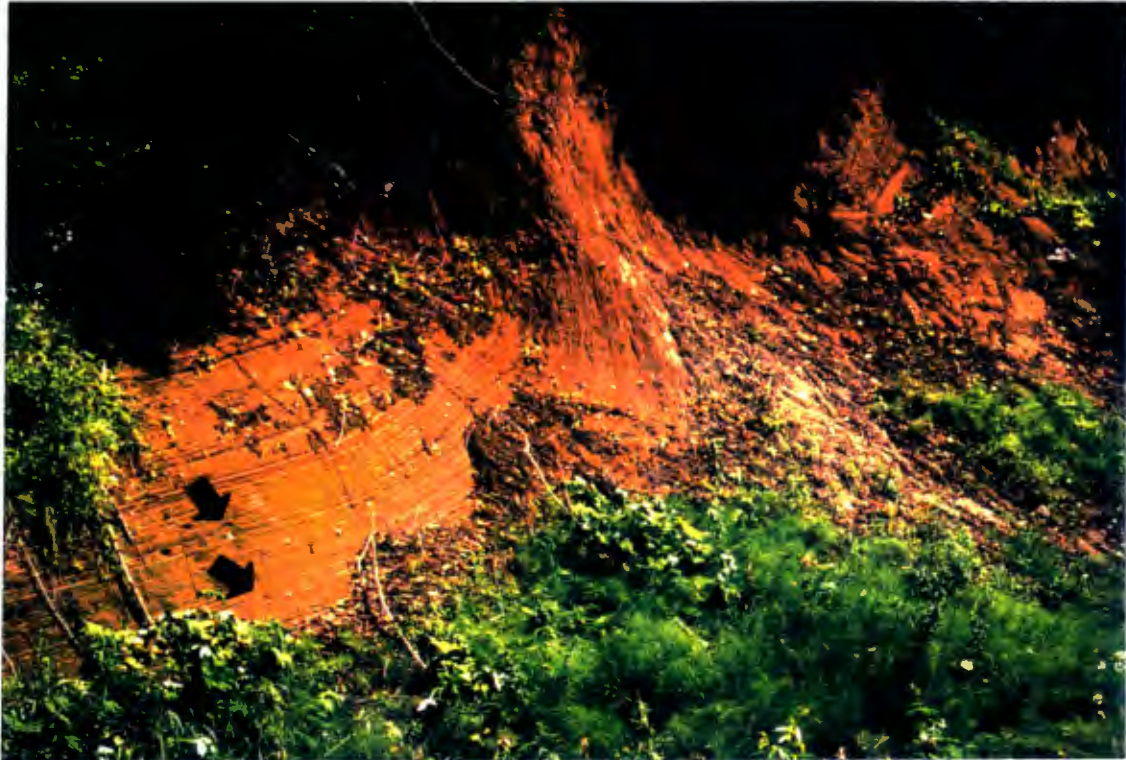
Figure 28. Disrupted varves - FS Rd. 54, SE 1/4 sec. 8, T.5 N. R.5 E. The disruption in this varve sequence along lower Canyon Creek is interpreted to have occurred as a result of overriding by glacial ice. Cobble/boulder till (out of picture) forms the superjacent deposit. Dropstones up to 0.7 m can be found in this sequence above the level of the disruption. Note bowing of varves over small dropstones (arrows).
