ROAD FAILURE LOCATION MAP  
PLATE 6  
UPPER CANYON CREEK  
DRAINAGE BASIN

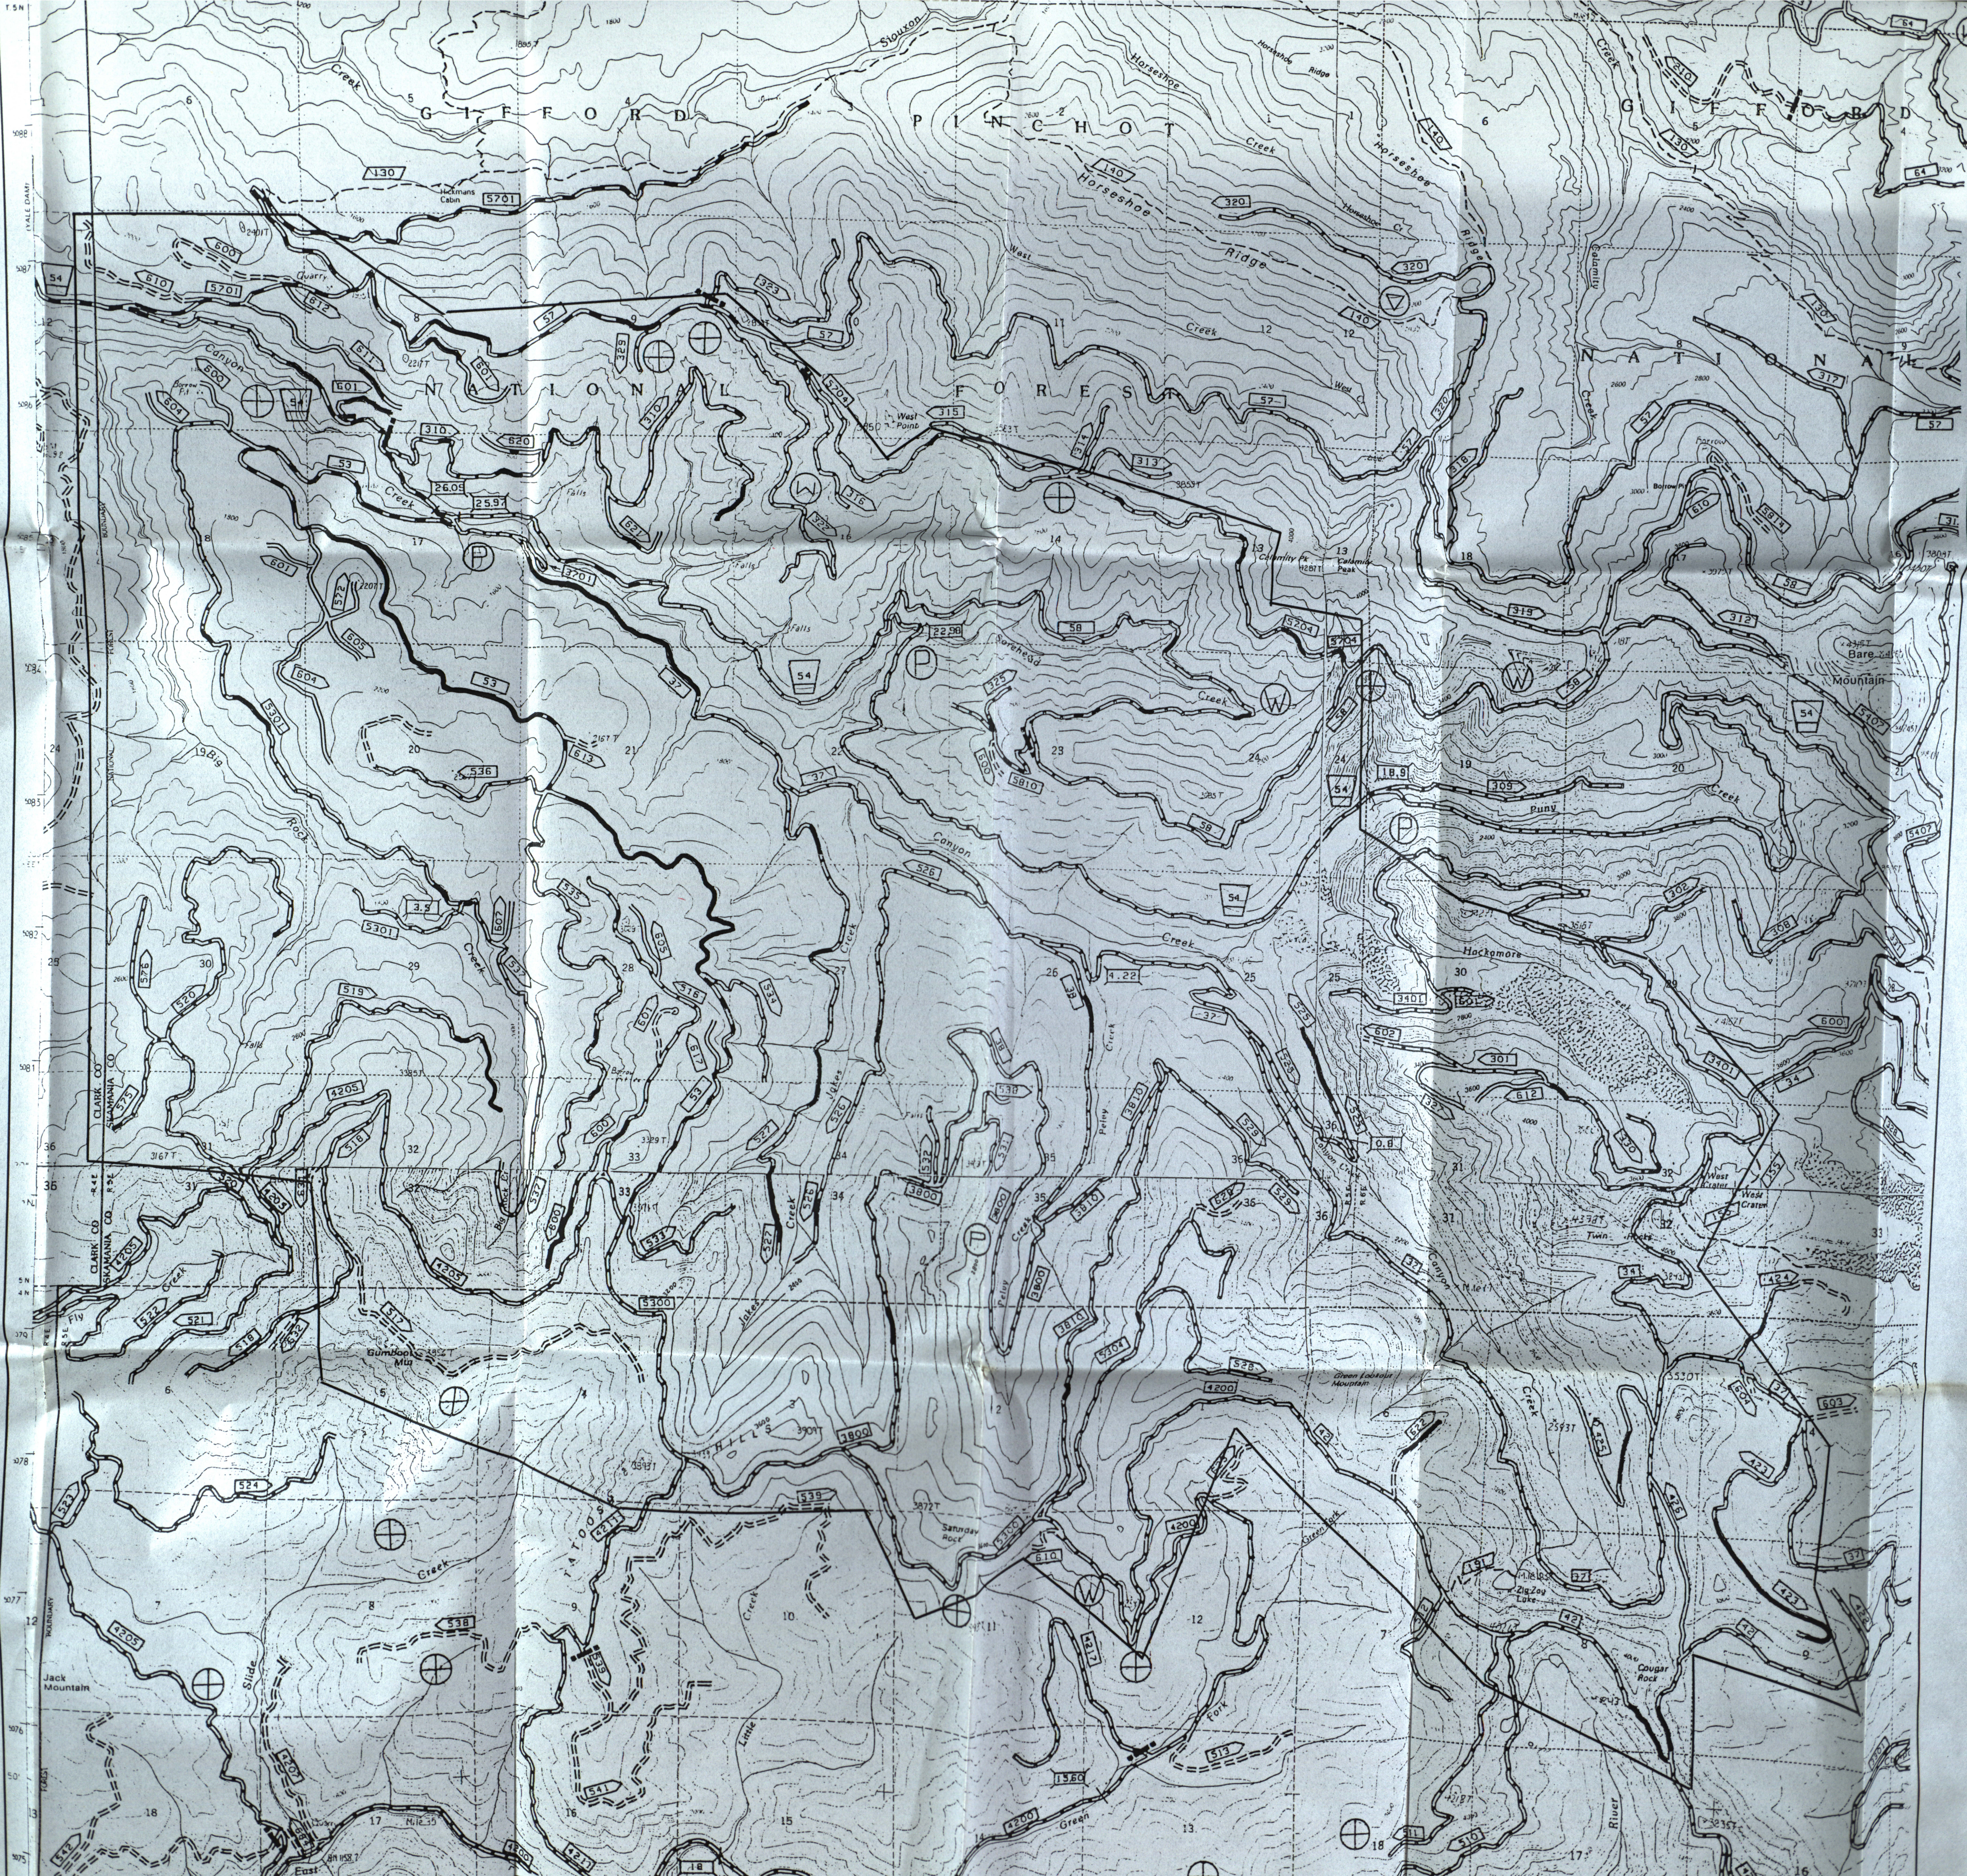
Evidence of roadbed failure is manifest as slumps, cracks, offset and a collection of potholes on the road surface. Slides and gully formation occur infrequently in the exposed roadfill. The effect of gully formation can be severe where water is channelled onto gravel roadbeds.

Failure slivers parallel to the road and extending less than one meter into the roadway are common along many segments of paved road. This type of failure is the result of a poorly engineered roadfill prism.

The more serious roadfill failure problems are expressed as concave fractures and slumps extending into and across the road surface. These suggest instability within the roadfill, or underlying subgrade, which will eventually result in the loss of the affected road segment.

The most serious indications of imminent failure are fractures with actual displacement which extend entirely across the roadway and into the hillside. In these cases, the road has been built across an unstable block, resulting in the displacement of the road as part of a larger failure.
