## Oregon Lake Watch, 2014 Annual Report

## **Oregon Lake Watch, 2014 Annual Report**

Final report submitted to the Oregon State Marine Board  
Meredith Jordan, Rich Miller, and Angela Strecker  
Portland State University, Center for Lakes and Reservoirs  
March 2015

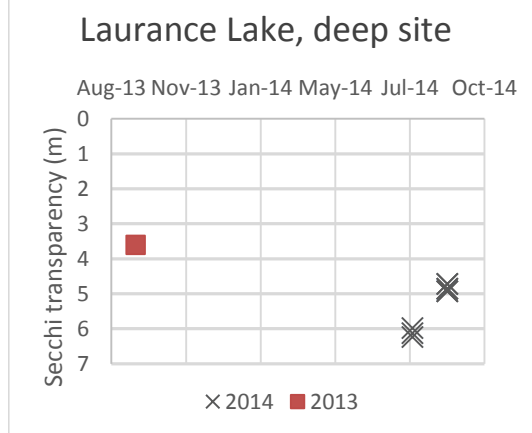
**Figure 5. Laurance Lake location, Secchi transparency, and temperature profiles.**

Laurance Lake is a small irrigation supply and recreation reservoir located north of Mount Hood in the Mount Hood National Forest (Figure 5). The reservoir was surveyed for AIS, temperature profiles and Secchi transparency at two points during the summer of 2014. AIS surveys were conducted using rake toss and shoreline zig-zag methods. No AIS were detected during the surveys.

Surface temperature in the lake was above 23°C in August of 2014, and had dropped to 19 °C by mid-September, where temperatures were mostly mixed below 1.5 meters. The 2014 averages of multiple Secchi transparency measurements ranged from 4.8 to 6. meters 1 (July and August respectively) which is a marked increase in water clarity from the 2013 measurement of 3.6 meters.

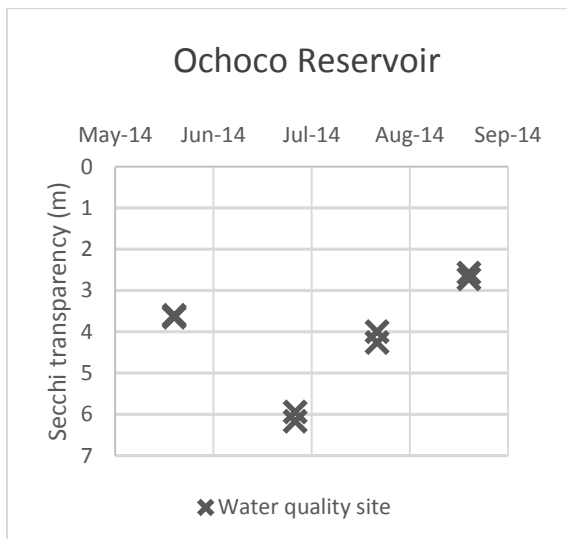
Figure 13. Ochocho Reservoir Secchi measurements.

Temperature profiles and Secchi transparency (Figure 13) were measured at one site at all four sampling events. Temperature profiles showed similar trends across the summer sampling dates, with surface water mixing to approximately 7 meters. Surface temperatures ranged from 17 °C in June to a high of 22 °C in August. Water clarity ranged from 2.6 meters to 6.2 meters.

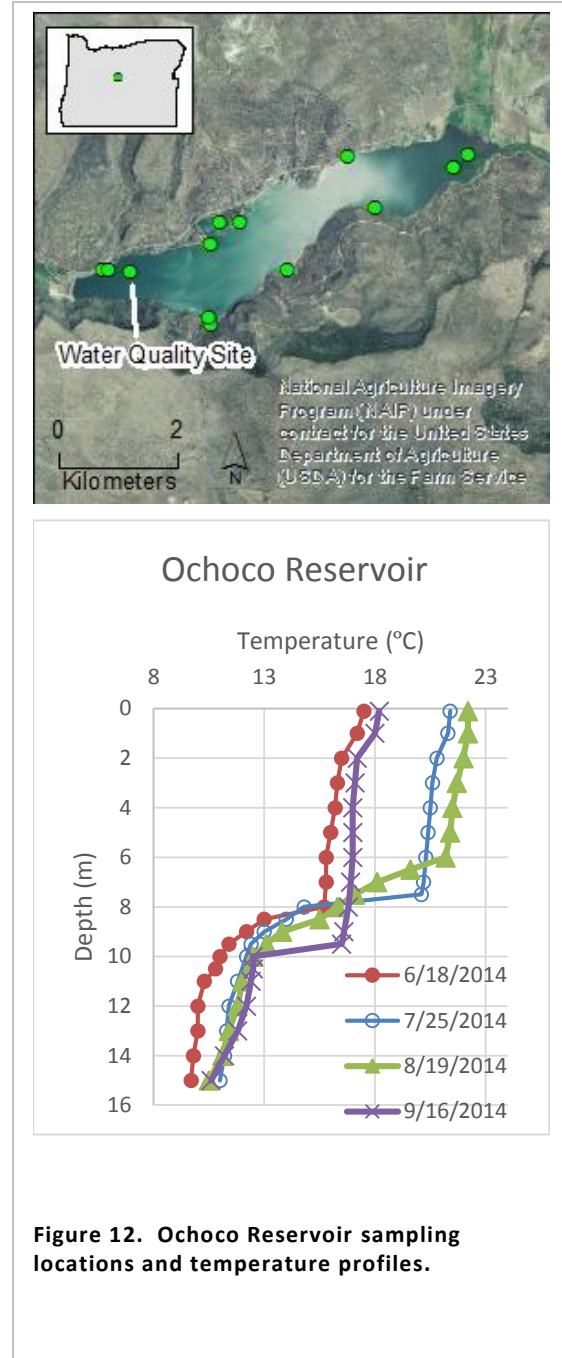
Figure 12. Ochoco Reservoir sampling locations and temperature profiles.

Ochoco Reservoir in Crook County lies in Central Oregon on the western slope of the Ochoco Mountains (Figure 12). It began as an irrigation impoundment that was later stocked with fish for recreational use. Water levels continue to fluctuate greatly for irrigation withdrawals for surrounding agricultural uses. OLW volunteers surveyed for AIS at eleven locations and four sampling dates across the reservoir, and no AIS were observed. The native signal crayfish (*Pacifastacus leniusculus*) was present in three of the survey sites.

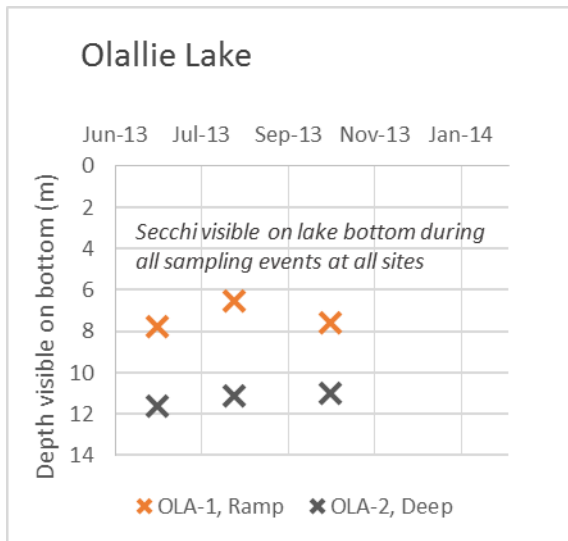
Figure 15. 2013 Olallie Lake Secchi measurements.

Temperature profiles were measured at two sites during each sampling event. Surface temperatures at both the “Deep” site and the “Peninsula Ramp” site ranged up to 28°C. The lake was thermally mixed through the water column at the Peninsula Ramp site during July and October. Surface waters were mixed down to 4 m at the “Deep” site during the July sampling event (Figure 15). Secchi transparency measurements were not taken in 2014. In 2013, water clarity was greater than the depth at each sampling site, and since the Secchi was visible to a minimum of 12 m, the lake is considered oligotrophic.

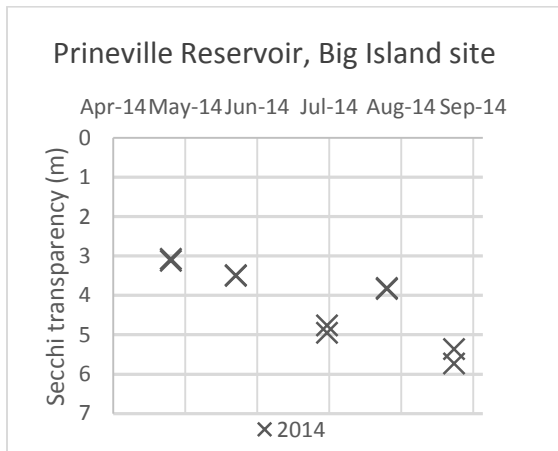
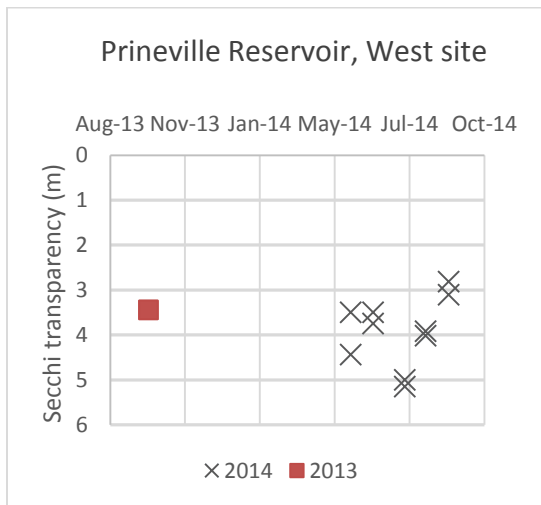
Figure 16. Prineville Reservoir location and temperature profiles.

Temperature profiles were measured on five dates at two sites. Surface water temperatures ranged up to nearly 24°C (76°F) and were well mixed to six meters during July and increased to near ten meters in September 2013 (Figure 17).

Figure 17. Prineville Reservoir Secchi transparency.

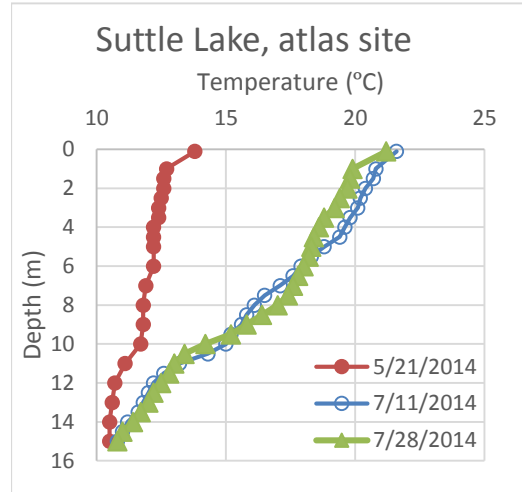
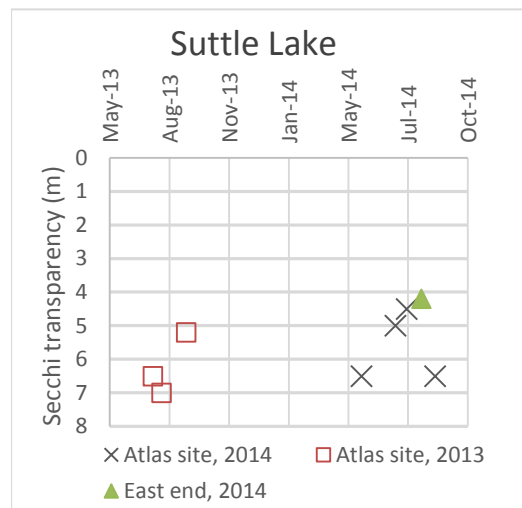
Figure 19. Suttle Lake location, temperature profile, and Secchi transparency.

Suttle Lake is a popular recreation lake located in the Deschutes National Forest on the east side of the Cascade Range (Figure 19). A Zebra/Quagga mussel substrate deployed at the Suttle Lake Lodge dock was checked by volunteers on two dates during 2013 and no mussels were found. Rake toss sampling was conducted on two dates and shoreline zig-zag sampling was conducted one of the days. A *Myriophyllum* species was collected that had more than 14 leaflet pairs and may be the AIS *M. spicatum* or a hybrid of *M. spicatum* and the native *M. sibiricum*. *M. spicatum* has been noted in the lake in the past. No other AIS were detected. A crayfish trap was deployed on one of the sampling dates near the Link Creek inlet and no crayfish were captured.

Temperature profiles and Secchi transparency measurements were collected at the Suttle Lake “Atlas Site” (Figure 19) on three dates. The lake was well-mixed below 1.5 m on the first sampling date in May but had stratified by July sampling dates. One temperature profile taken at the east end site in August showed mixing below 1m.

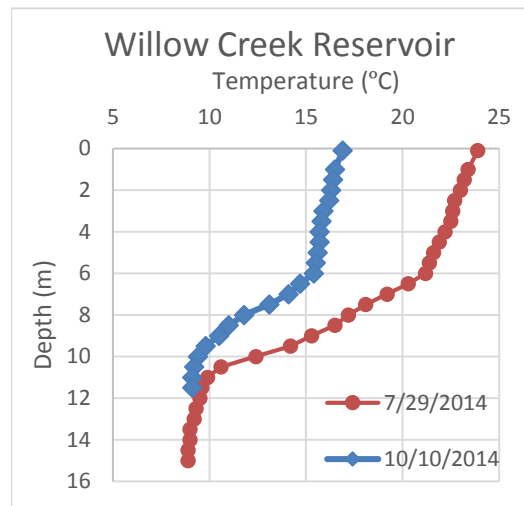
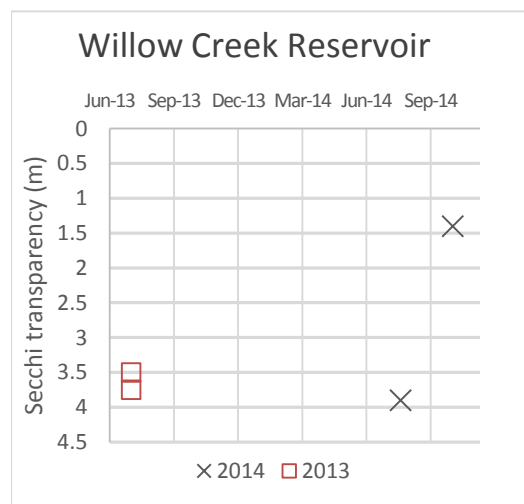
Figure 21. Willow Creek Reservoir location, temperature profile, and Secchi transparency.

Temperature profiles and Secchi transparency were measured twice at the same location in 2014. Surface waters were quite warm on July 29, 2014 at nearly 24°C and well mixed to a depth of 6 m. Secchi transparency measurements varied greatly between sampling dates, with transparency at 3.9 meters in July, and only 1.4 meters in October 2014. This clarity borders on eutrophic conditions.
