Exploring mitigation options to reduce vehicle-caused
mortality for the Oregon Silverspot Butterfly,
Speyeria zerene hippolyta, along Highway 101 at the
Siuslaw National Forest

Prepared by: Sara B. Zielin, Master of
Environmental Management Student,
Portland State University

May 2010

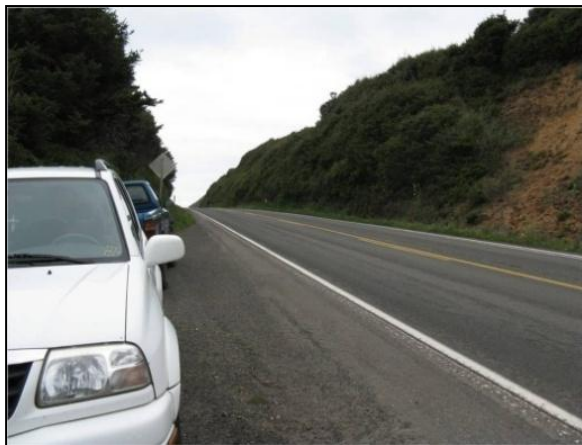
Figure 2. Road-cut area at Rock Creek – Big Creek Site, photo taken observing north from plot 8. Photo credit: Sara Zielin.

In some locations along Highway 101 the road surface is significantly lower than the adjacent meadows creating a walled corridor (road-cut) made of earth and vegetation reaching well over 5 m in height relative to the road surface (Figure 2). Plot 7 and the southern section of plot 8 were immediately south of the longest walled corridor at this site and north of the Big Creek Bridge. These same plots are also a location in which the road surface of Highway 101 slopes. The road begins to drop in elevation at the southerly end of the walled corridor (plot 8) and continues to slope downward toward the south at a moderate grade to the north-side of the Big Creek Bridge where the road levels again (plots 5 and 6) (Appendix 1).

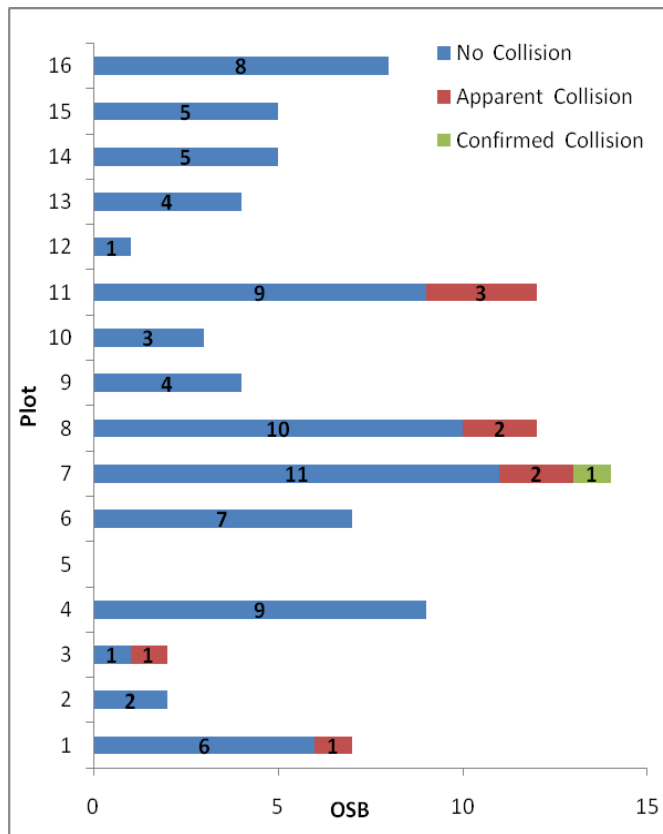
Figure 7. Vehicle and OSB interactions (no collision, apparent collision, confirmed collision) by plot for all accounts of detection either during surveys (scan or all occurrence) or opportunistic sightings. Across plots, 49 observations were from Instantaneous scan sampling, 24 were from all-occurrence surveys, and 22 were from opportunistic sampling.

There was one confirmed account of an OSB-vehicle collision: it occurred on August 19th at 11:02 am in plot 7 (subplot 34) (Figure 7). The road-killed OSB, which was sexed as a female, entered the road from the west and crossed both lanes of Highway 101 to the east-side of the road, flew north, then when it attempted to cross back to the west it collided with a southbound

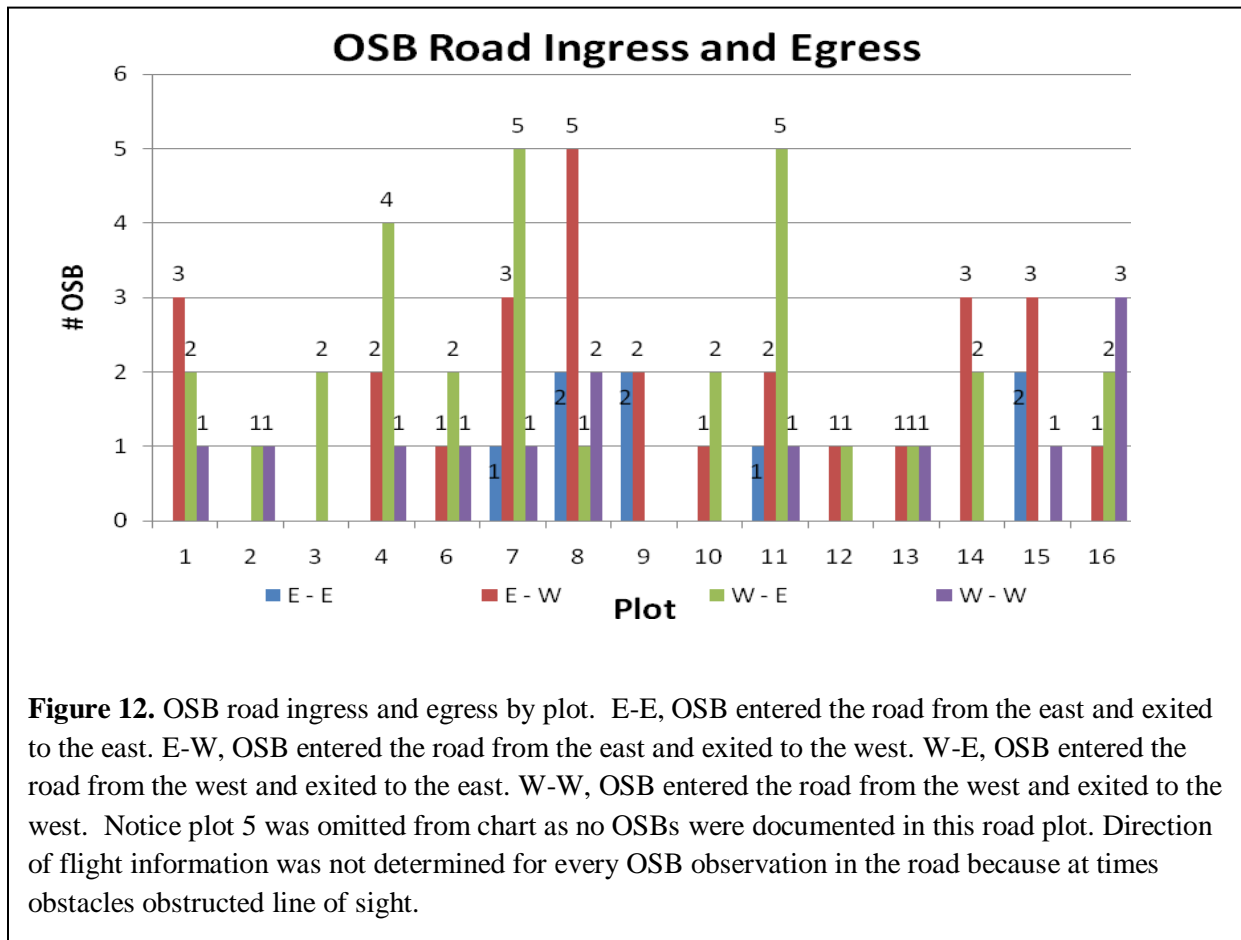
Figure 12. OSB road ingress and egress by plot. E-E, OSB entered the road from the east and exited to the east. E-W, OSB entered the road from the east and exited to the west. W-E, OSB entered the road from the west and exited to the east. W-W, OSB entered the road from the west and exited to the west. Notice plot 5 was omitted from chart as no OSBs were documented in this road plot. Direction of flight information was not determined for every OSB observation in the road because at times obstacles obstructed line of sight.

OSBs were observed entering and exiting the road from both the west and east sides with an overall even pattern (Table 4) (Figure 12).

contrast, for example, two adjacent plots, 7 and 8, showed a circular pattern of movement wherein OSBs entered the road at plot 7 from the west and exited the road to the east, whereas they were primarily heading west when crossing the road in plot 8 (entering from east and exiting west) (Appendix 6).

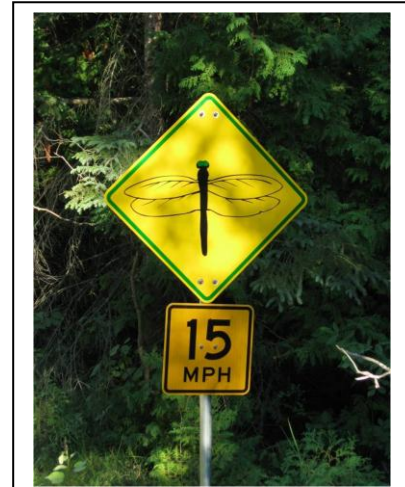
Figure 22. Photo of speed reduction traffic sign for the endangered Hine’s emerald dragonfly (*Somatochlora hineana*). Photo credit: Dan Soluk

Although the effect (or exact relationship) of vehicle speed reduction on vehicle-caused mortality of the Hine’s emerald dragonfly has not been studied, managers were asked to suggest

an ideal speed limit for vehicles traveling on a road adjacent to dragonfly habitat (to essentially avoid any dragonfly “take” caused by vehicle collisions) (D. Soluk, personal communication, April 10, 2009). Managers of the dragonfly recommended a speed limit of 15 mph based on their expertise related to the species and overall sense of how the dragonfly interacts with vehicles from observations (Figure 22). Although no follow up research observing the relationship between vehicle speed and mortality has been performed with the Hine’s emerald dragonfly, future research of this sort related to butterflies and other invertebrates should be performed to better understand if there is in fact a predictable relationship between vehicle speed and collisions with flying organisms and how it varies with flight speed.
