Behavior of Concrete Beams with Corroded Reinforcement Retrofitted with Carbon Fiber Reinforced Polymer

A research project submitted in partial fulfillment of the
requirements for the degree of

MASTER OF SCIENCE
IN
CIVIL & ENVIRONMENTAL ENGINEERING

Portland State University
©2016

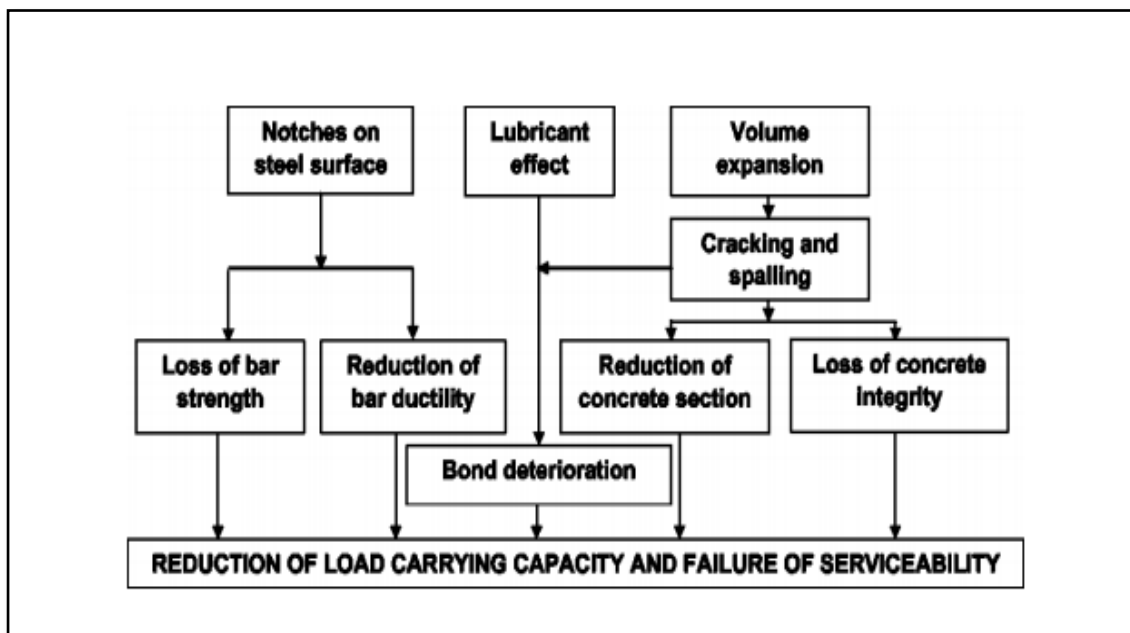
Figure 1: Effect of corrosion on structures [28]

[3]. This protects the steel against corrosion. Concrete also provides a physical barrier that prevents the steel from coming in contact with the external environment. This prevents substances such as water, salt, or other damaging ions from reaching the iron atoms that make up the steel. However, corrosion will still result in structures that experience poor concrete quality, poor design, or construction, and/or harsh environmental conditions, especially structures located in the coastal marine environment [4]. Figure 1 summarizes the effect of corrosion on concrete structures.

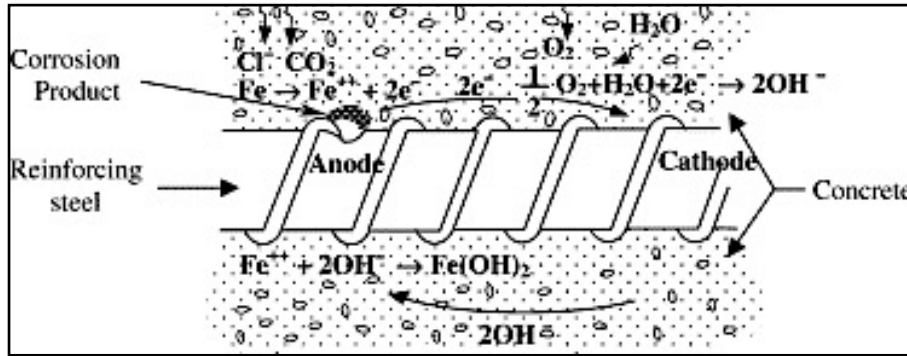
Figure 2: Illustrates a mechanism of corrosion process in steel bar [5].

well. According to the ACI Committee 222, steel corrosion in concrete is an electrochemical process where corrosion cells are generated due to differences in electrochemical potentials. Some areas of the steel bar become anodes, and some cathodes, as shown in Figure 2 [4].

The anodic reaction is the oxidation process, which results in the loss of metal. The cathodic reaction is the reduction of dissolved oxygen creating hydroxyl ions. The released hydroxyl ions at the cathode travel through the electrolyte to react with the ions at the anode, producing rust. The common anodic and cathodic reactions of steel in concrete are iron dissolution (equation 1) and oxygen reduction (equation 2) reactions.

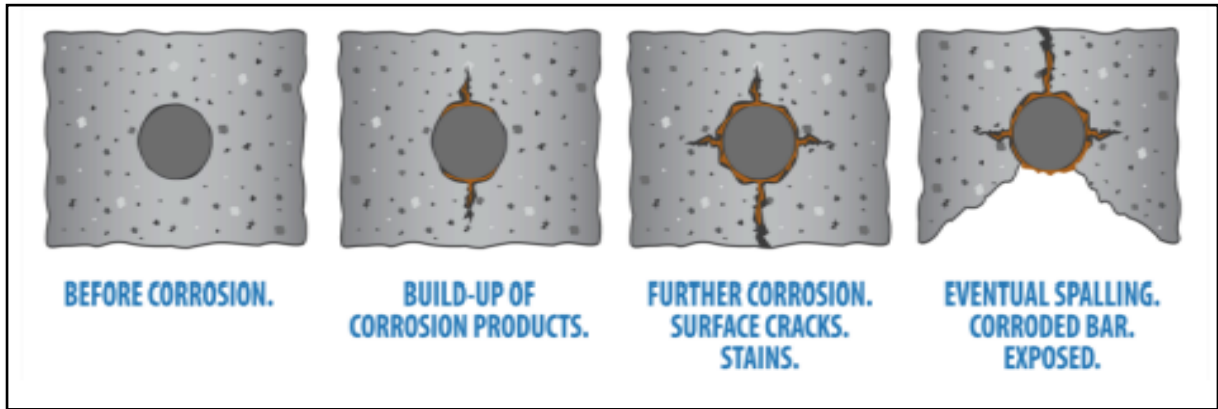
Figure 3: Progress of corrosion in concrete and eventual spalling [3]

corrosion with low cover thickness. However, once the corrosion starts, the rate of corrosion is independent of the cover thickness as shown in Figure 3. The service life of reinforced concrete structures can be extended greatly by simply increasing the thickness of the concrete cover.

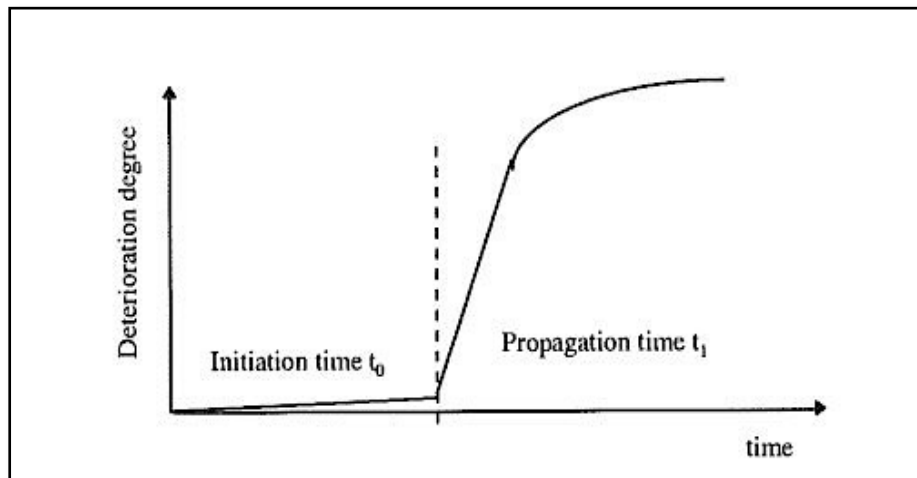
Figure 4: Deterioration degree of reinforced concrete vs. time [11].

Generally, the deterioration of reinforced concrete structures can be defined as a two-phase process: initiation and propagation. The deterioration of reinforced concrete versus time is illustrated in Figure 4.

As shown in Figure 4, the initiation period represents the time required for CO₂ or chloride ion to diffuse to the steel and activate corrosion. The propagation period represents the time between corrosion initiation and corrosion cracking. If the corrosion cracking can be delayed or prevented, structural strength is maintained for a longer period.

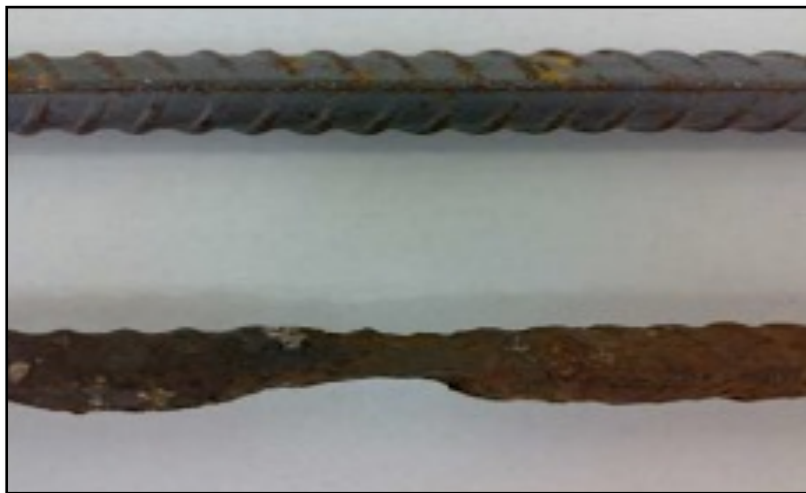
Figure 5: Corroded steel bar in comparison with noncorroded steel bar [14]

Reinforced concrete uses steel to provide the tensile properties that are needed in structural concrete. It prevents failure of concrete structures that are subjected to tensile and flexural stress due to dead and live loads, wind, snow, or traffic. However, when the reinforcement corrodes, the formation of rust will cause a loss in the bond between the steel and the concrete resulting in delamination and spalling. Al-saidy [14] concludes in his study that as steel corrodes, there is a corresponding loss in cross sectional area and as a result, a reduction in the flexural strength capacity of concrete as shown in Figure 5.

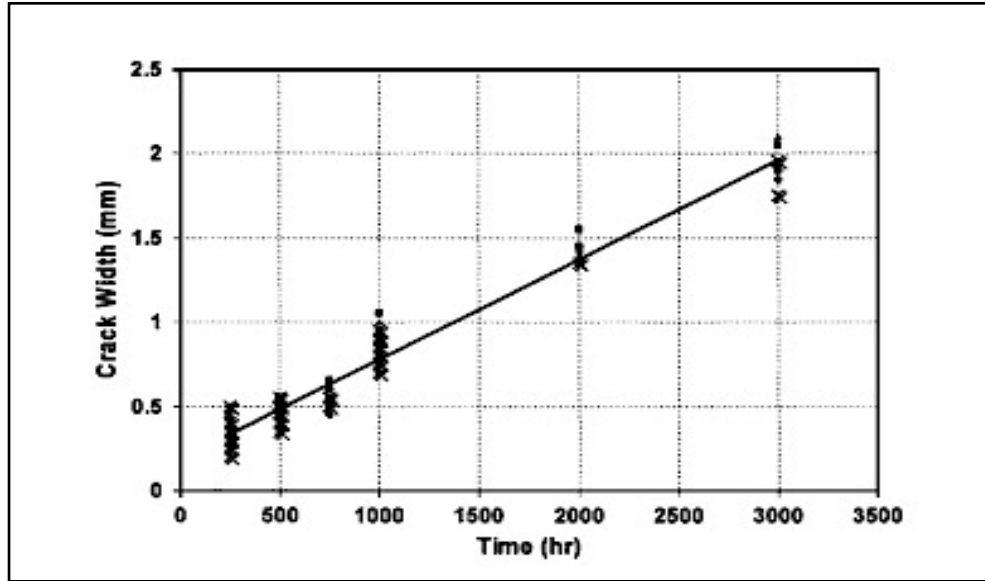
Figure 6: Corrosion crack width vs. time [16]

The accumulated corrosion products on the bar surface cause longitudinal cracking of the concrete cover. Loss of concrete cover implies a loss of confinement and a reduction in bond strength at the interfacial zone between the steel and concrete. As a result, the bond strength is significantly reduced and becomes negligible. A number of researchers have attempted to study the corrosion-induced crack width and corrosion crack patterns using accelerated corrosion techniques. A study by Badawi and Soudki [18], investigated different corrosion configuration in eight specimens at three different degrees of corrosion (5%, 10%, and 15%). One of their conclusions was that corrosion-induced crack width increases with time as corrosion activity progresses. A larger crack width is presented at a higher rate of corrosion assuming uniform corrosion as shown in Figure 6.

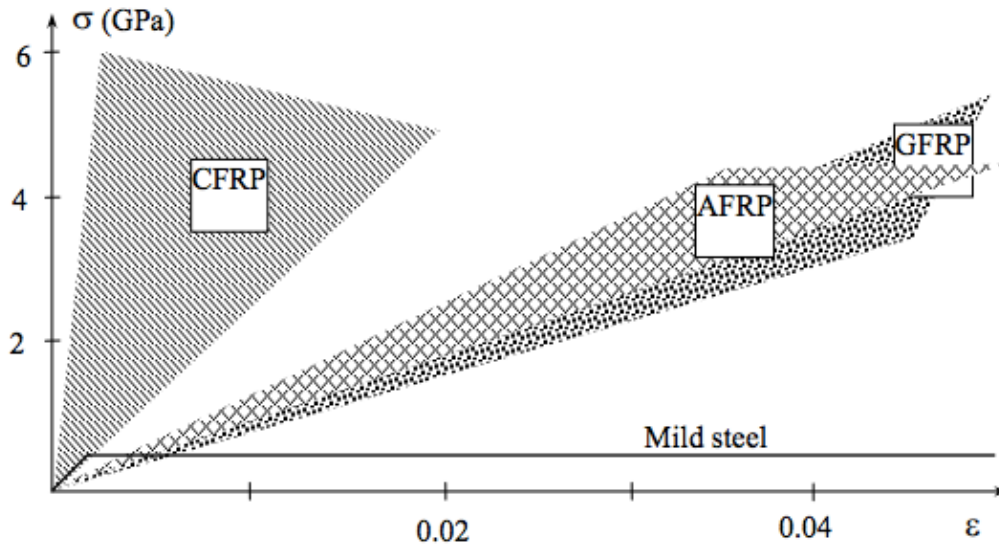
Figure 7: Stress-strain diagrams for different unidirectional FRPs and steel [22]

Over the past few years, external strengthening using CFRP composites gained popularity over steel for several reasons, including material cost, lower weight, corrosion resistance, and ease of application (Figure7).

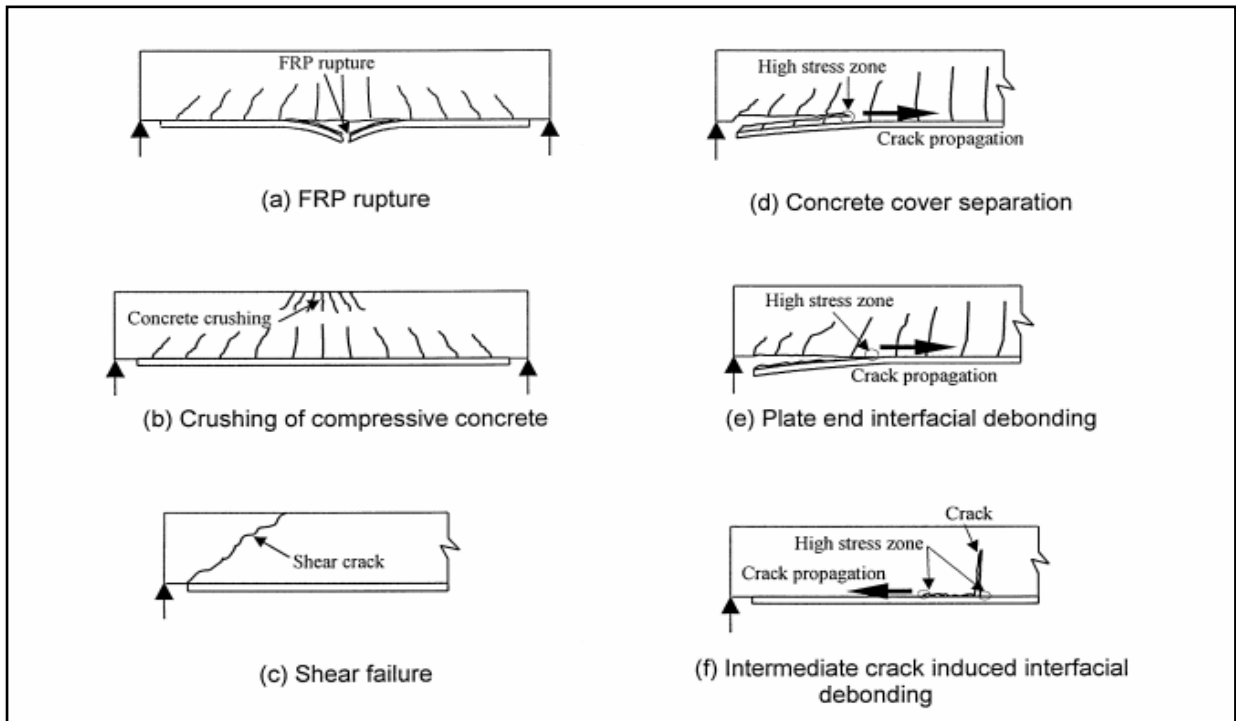
Figure 8: Failure modes of FRP wrapped RC beams

The debonding of an externally bonded CFRP sheet/ strip can be predicted by considering the different bond failure modes, which can occur under any of the following occurrences: bond-critical failure modes (end debonding or intermediate crack debonding); cohesive and adhesive strengths of the concrete; ultimate strength for end debonding (concrete rip-off); ultimate strength for intermediate rip-off; and, interfacial stresses for the serviceability limit state [22] as shown in Figure 8. Failure in the case of RC beams may take place through concrete crushing before yielding of the reinforcing steel, steel yielding followed by FRP rupture; steel yielding followed by concrete crushing, cover delamination; and/or FRP debonding.

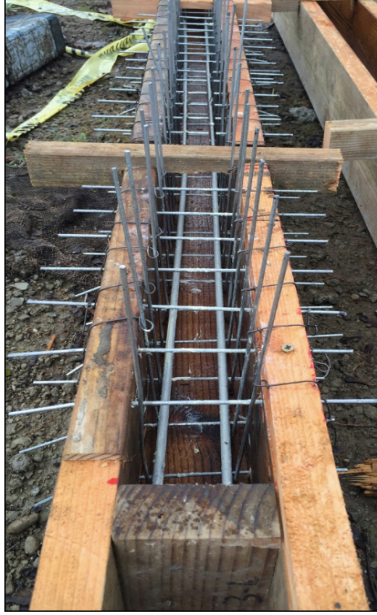
Figure 9: Deteriorated beam mold

Beam #1 is used to represent an extremely corroded and deteriorated concrete beam. The deterioration was represented by pulling out the temporary reinforcement shortly after the beams were set to cure. The voids represent the loss in bond to the concrete and the loss in steel cross section. Figure 9 shows the mold for Beam #1.

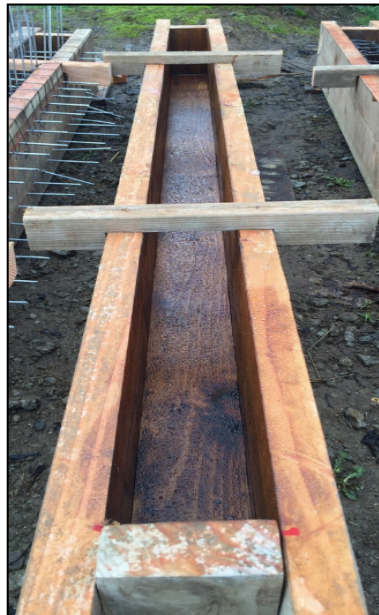
Figure 10: Plain concrete mold

The purpose of Beam #2 is to compare the load carrying capacity of a plain concrete beam to a deteriorated concrete beam (Beam #1). Figure 10 shows the mold for Beam #1.

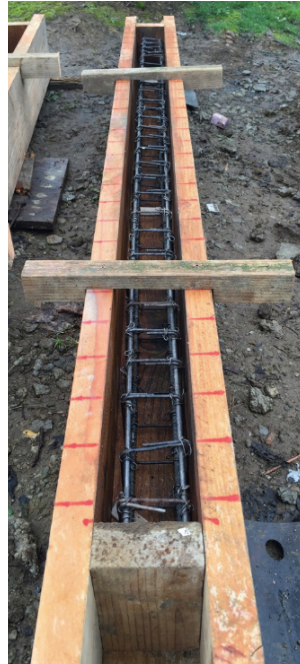
Figure 11: Reinforced concrete beam mold

The mold and reinforcements of control (un-corroded) Beam #3 are shown in Figure 11. Beams #4 and #5 are the same as Beam #3 and are externally bonded and wrapped with one and two layers of CFRP sheets.

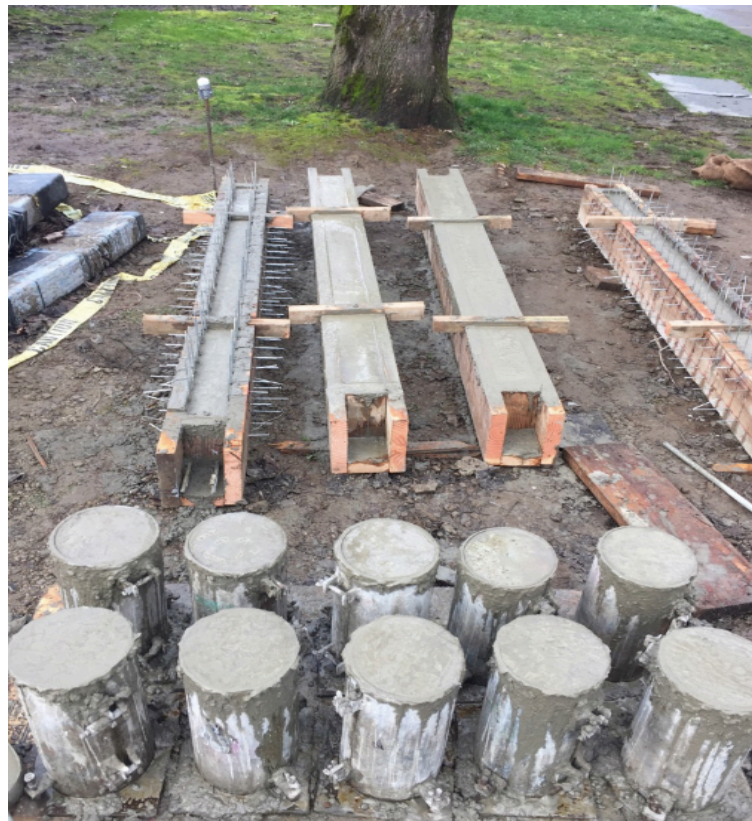
Figure 12: Concrete beams and cylinders

The formwork consisted of plywood to provide good finishing of substrates. Two beams were cast at a time, and ten cylinders 6in. x 12in. were retained as samples for compressive strength testing (Figure 12). The concrete was mixed using a small rotary mixer and shoveled into the formwork, and a steel rod was used to minimize air voids in concrete members as in Figure 13.

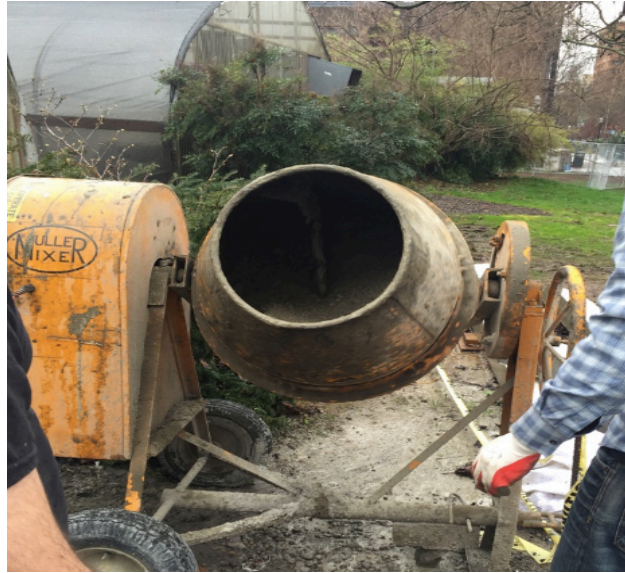
Figure 13: Mixing concrete on sit

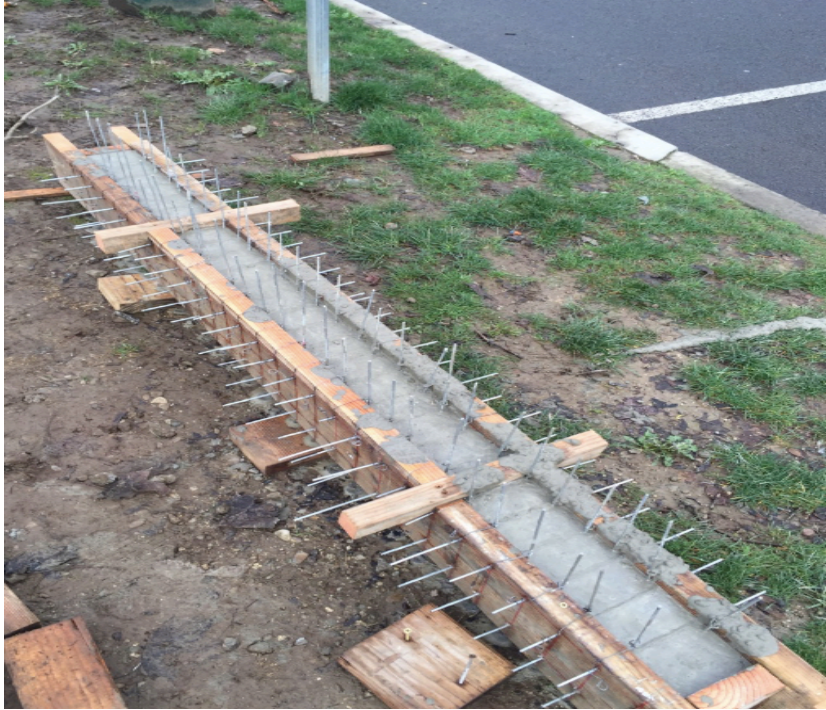
Figure 14: Temporary reinforcement in deteriorated Beam #4 &5

A single beam was fully reinforced in shear and flexure. The steel reinforcements were cut on-site to the required length and assembled in the cage ready for concrete casting. Plastic spacers were used in formwork as well as corner chamfers to provide beam specimens typical of those used in construction. For the deteriorated beams (Beams #2, #4, and #5), small sizes of reinforcements were cut and inserted after they were greased in the formwork as shown in Figure14. All five beams were cast and cured under similar conditions. After six hours of concrete curing, reinforcements were safely pulled out of three beams (#2, #4, and #5) leaving voids. The voids represent the area of the steel reinforcement after it has been completely corroded (Figure 15, 16 & 17).

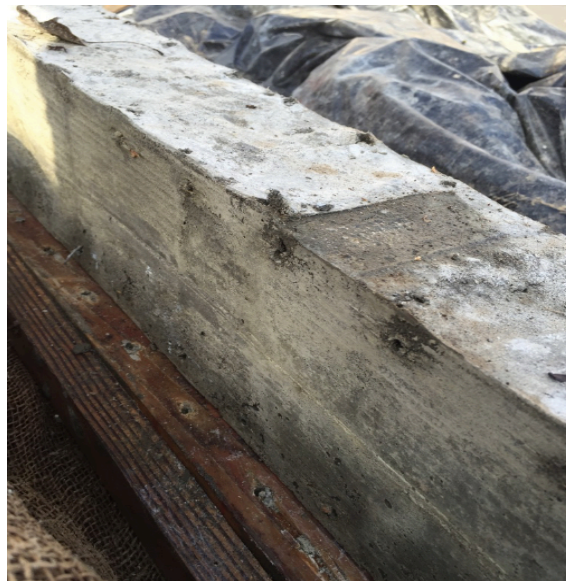
Figure 15: Shear voids in the deteriorated beam

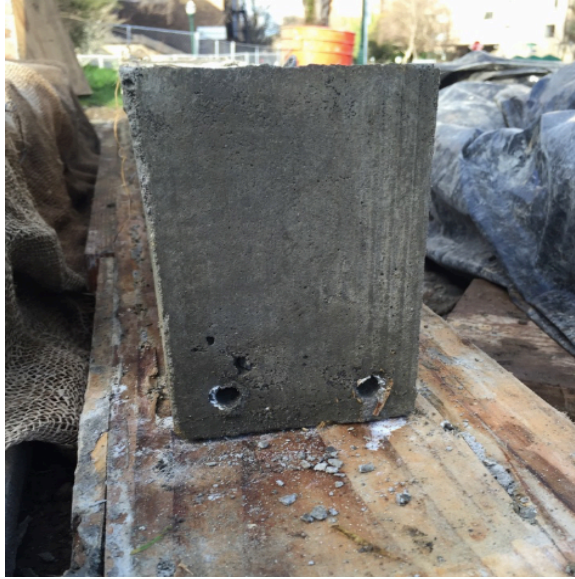
Figure 16: Voids representing deteriorated flexural reinforcement

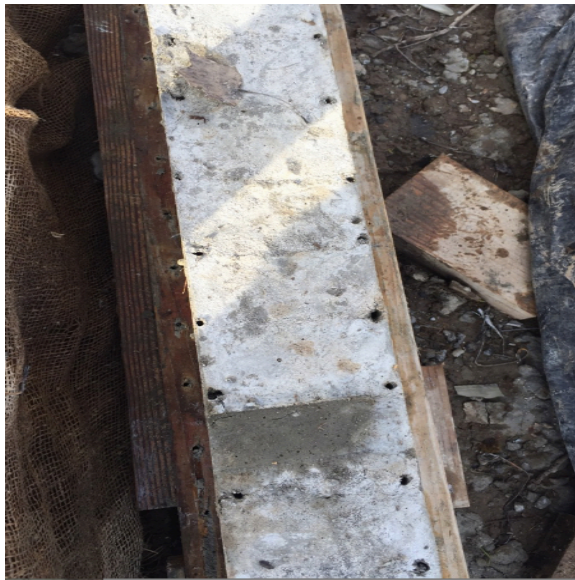
Figure 17: Voids representing deteriorated shear reinforcement

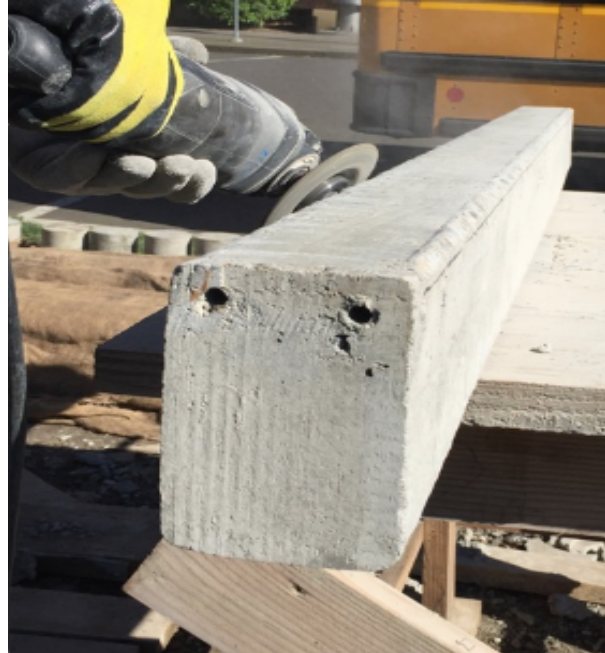
Figure 18: Beam surface and corner preparation

Special consideration was given to surface preparation before bonding the CFRP sheets to the concrete surface. Sandblasting was employed to remove the weak layer from the surface of the beam, and then the surface was cleaned with a high-pressure air jet. The beam corners were grinded and smoothed per ACI 440.2R-08 as in Figure18.

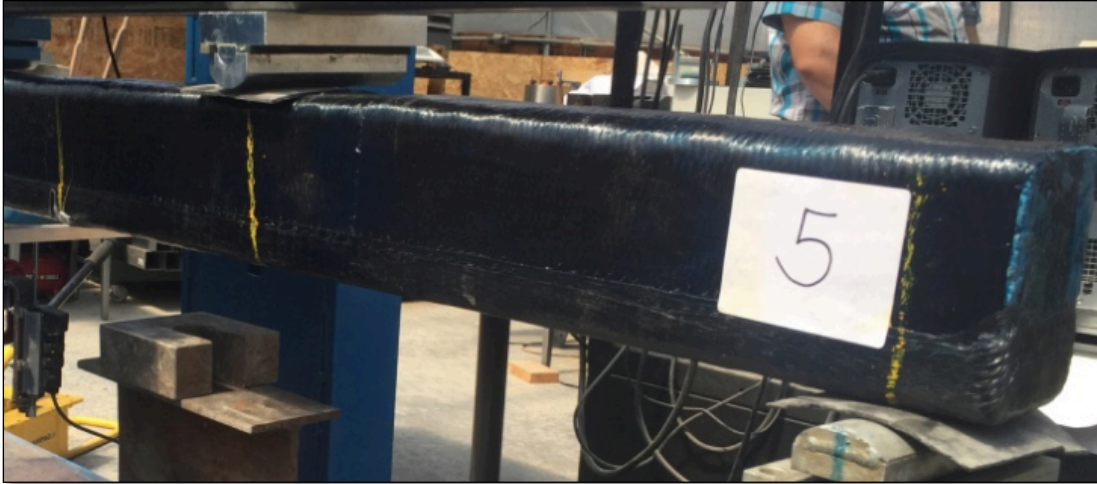
Figure 19: CFRP wrapped Beam #5

Strips of carbon fiber reinforced polymer sheets (CFRP) were cut to the proper dimension and bonded to the tension side (longitudinally) over the length of Beam # 4 and Beam #5. The strips were extended few inches at both ends as well as along the sides of the beams to reduce the risk of de-bonding failure. Also, a continuous sheet of CFRP was wrapped around the entire cross section of the beams. The deteriorated beams (Beam #4 &5) were wrapped with CFRP around the circumferential of the beams first, and then were strengthened in tension. The layout of CFRP strips and CFRP wrap will typically be as indicated in the application procedure. Figure 19 presents a better view for the actual application.

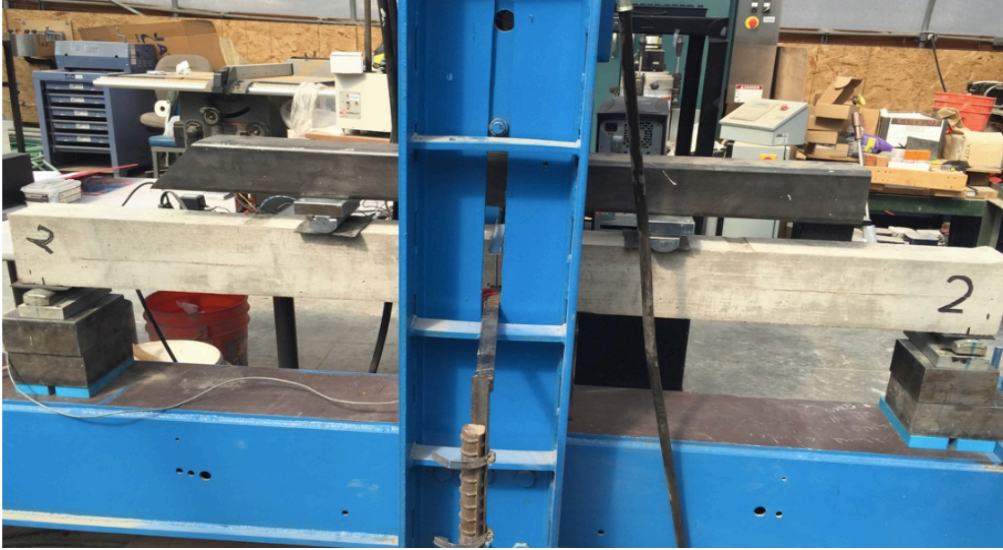
Figure 20: Testing beams using two-point loading

All beams were tested to failure under two-point loading as shown in Figure 20. Prior to testing, beams were checked dimensionally, and a detailed visual inspection made with all information carefully recorded. The load was applied to the concrete beams through a steel plate and half rollers with a flat side. The rollers consisted of 1 in. radius steel rods on a flat steel plate that extended across the entire width of the beams. All load points in contact with concrete surfaces were distributed with steel plates to avoid stress concentration problems. Since the non-reinforced beams have a low tensile strength, the load was manually applied at a constant rate. A strengthened modulus beam in the testing machine is presented in Figure 21. Two channels of data were collected during the tests, the applied load and centerline displacement (measured with a National Instrument Data Logger), Figure 22.

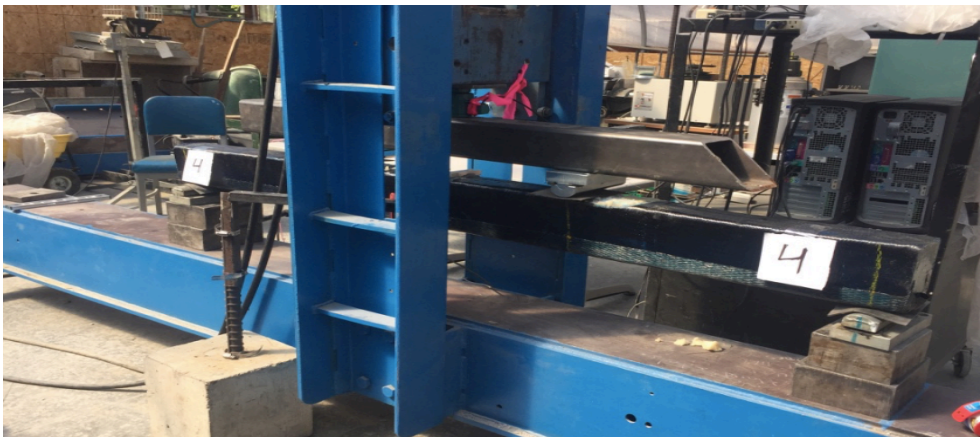
Figure 21 : Retrofeted beam test setup in the Greenhouse lab.

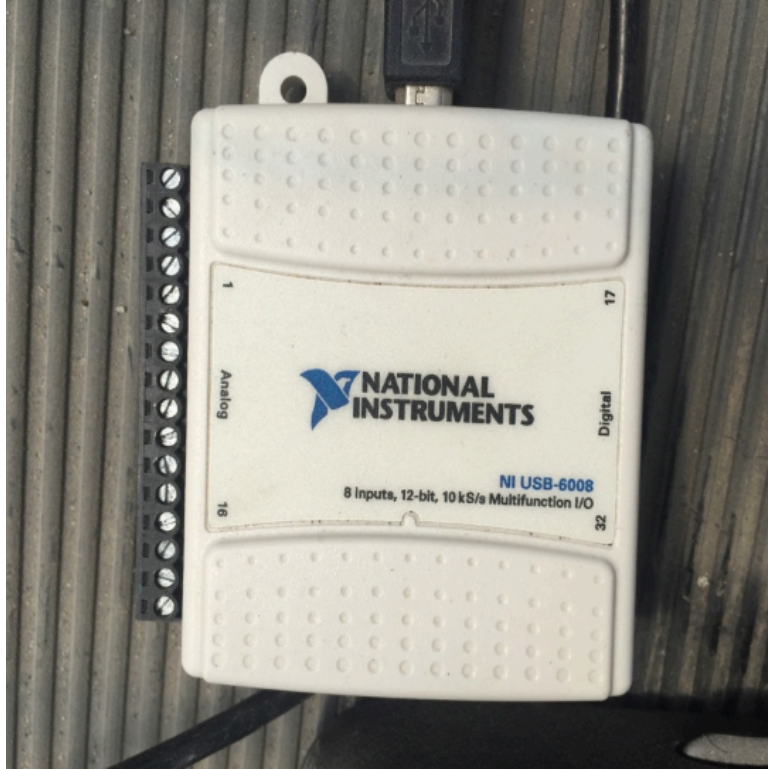
Figure 22: Data logger

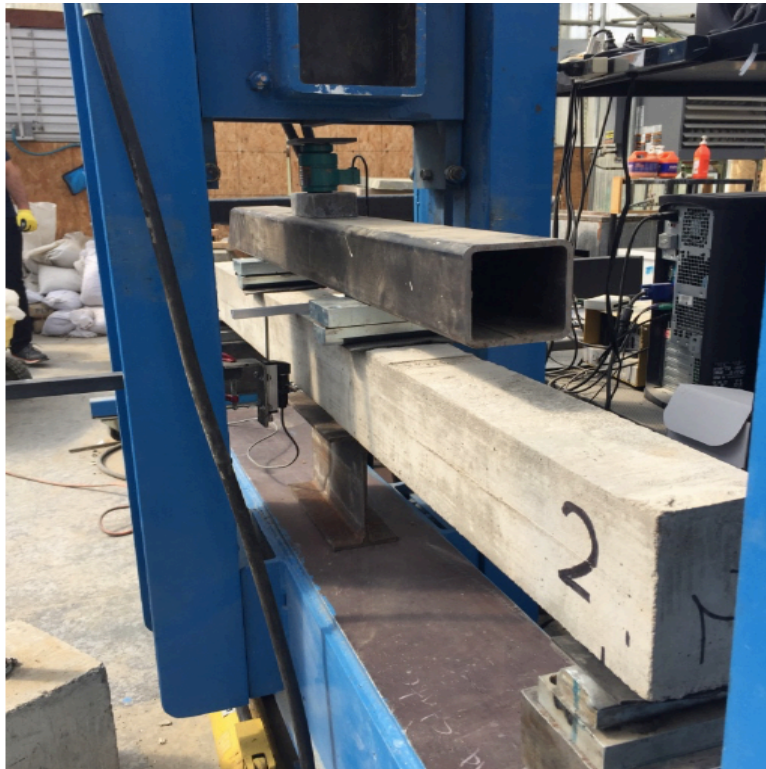
Figure 23: Beam test set-up

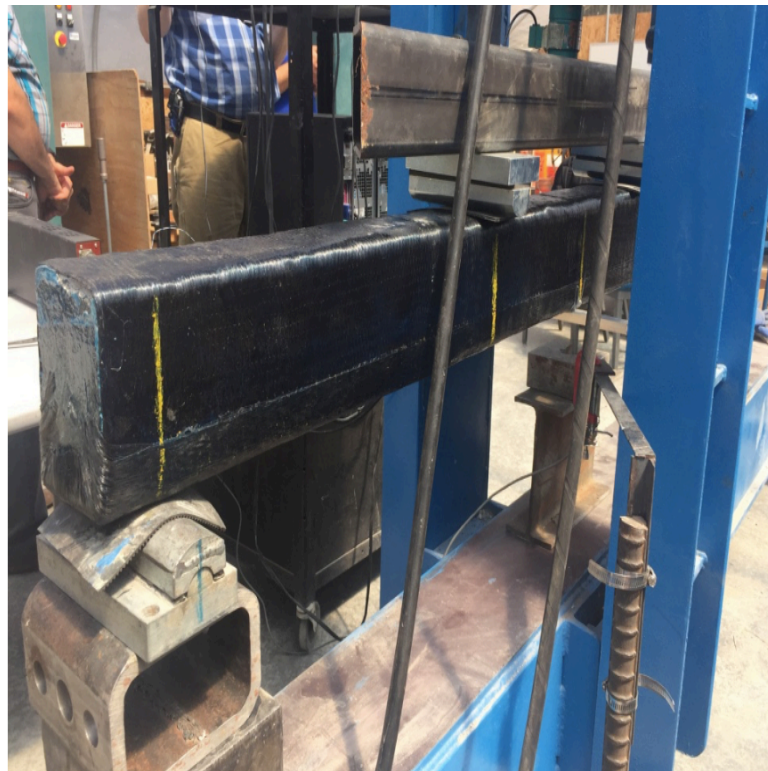
Figure 25: Testing CFRP-wrapped beam

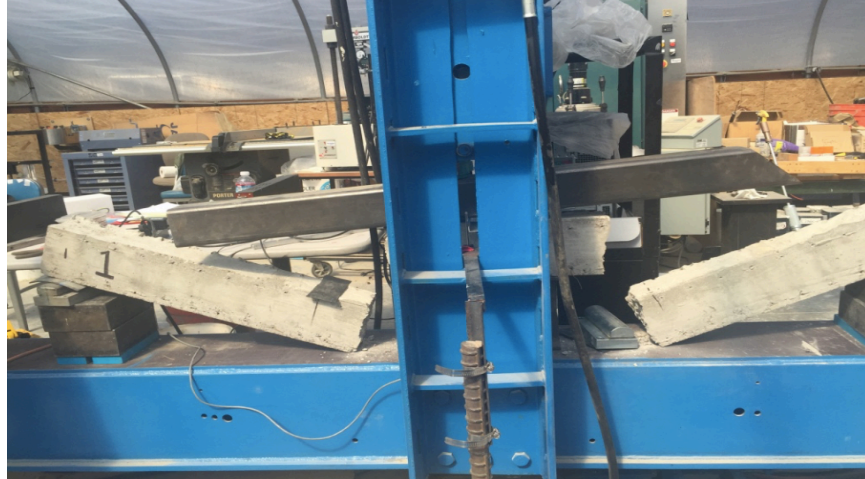
Figure 26: Failure mode of beam #1

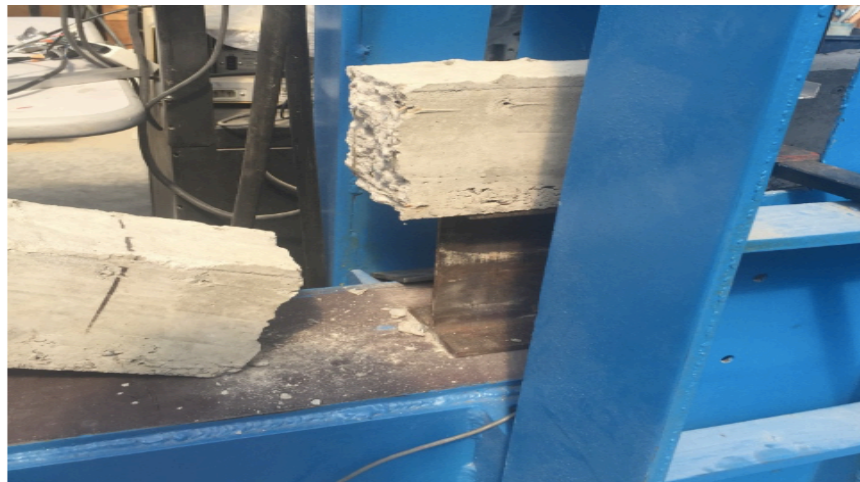
Figure 27: Beam #1 brittle failure

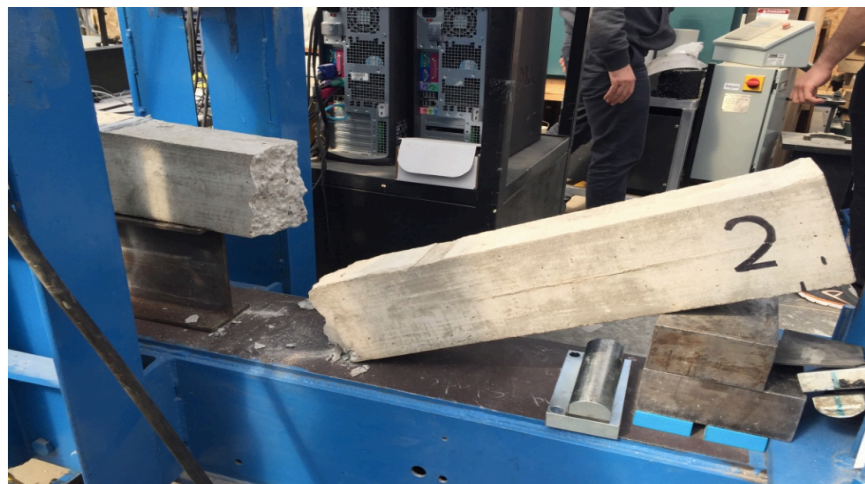
Figure 28: Beam #2 brittle failure

This beam experienced a very similar brittle failure mode as beam #1 as shown in Figure 28. The load capacity was slightly higher than that of Beam #1 due to the full concrete cross section without voids. Beam #2 failed at a higher load of 0.54 kips and it had a slightly larger deflection value of 0.015 in.

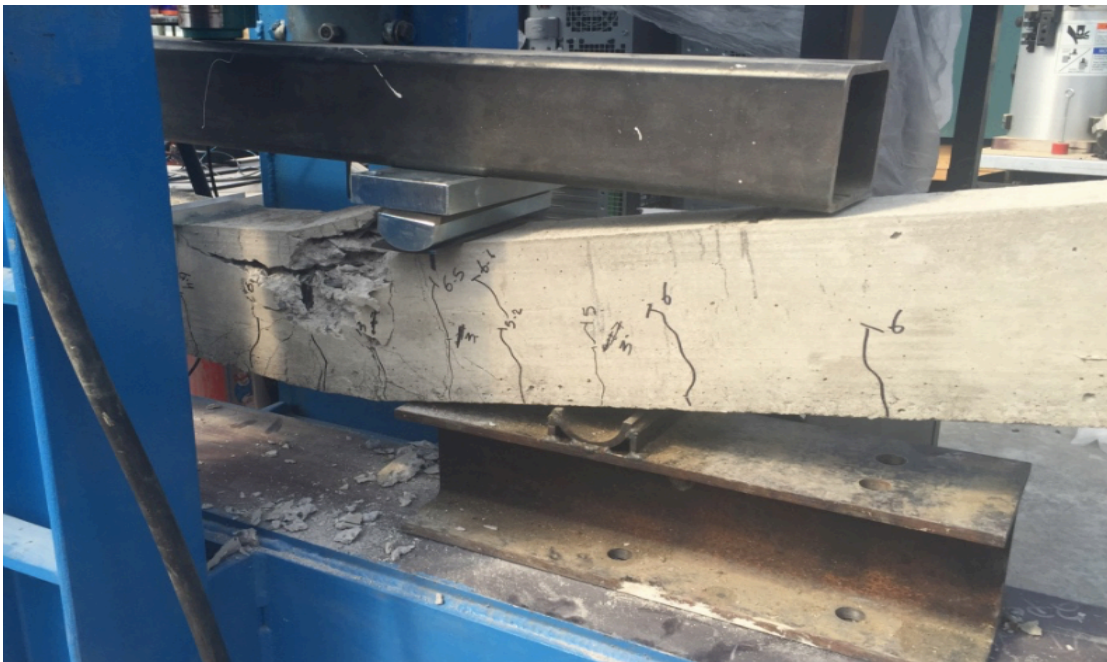
Figure 29: Concrete crushing in the compression zone

Beam #3 was the control beam with un-corroded reinforcement. This beam was used as a reference for the members strengthened with CFRP materials. The maximum load capacity of the beam was 6.8 kips. The deflection corresponding to this load was 1.55 in. This beam experienced a typical ductile failure mode of reinforced concrete beams. Central cracks propagated starting a load of 3kips and continued until a major failure in the shear zone occurred as expected. Yielding of steel was at a second stage until total crushing took place as shown in Figure 29, 30 & 31.

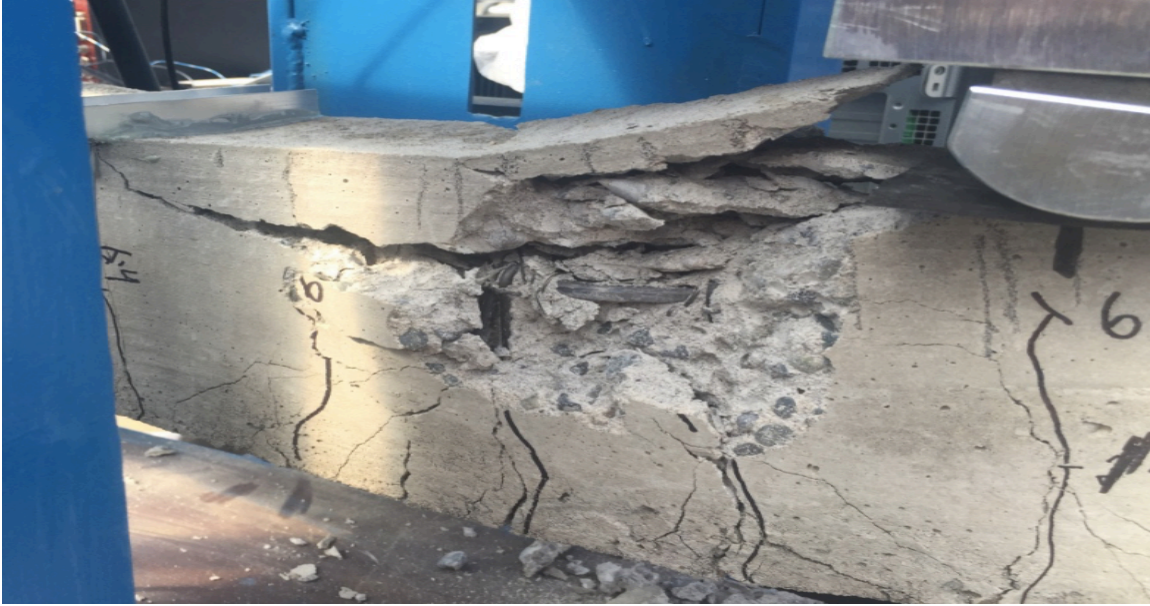
Figure 30: Crushing concrete cover

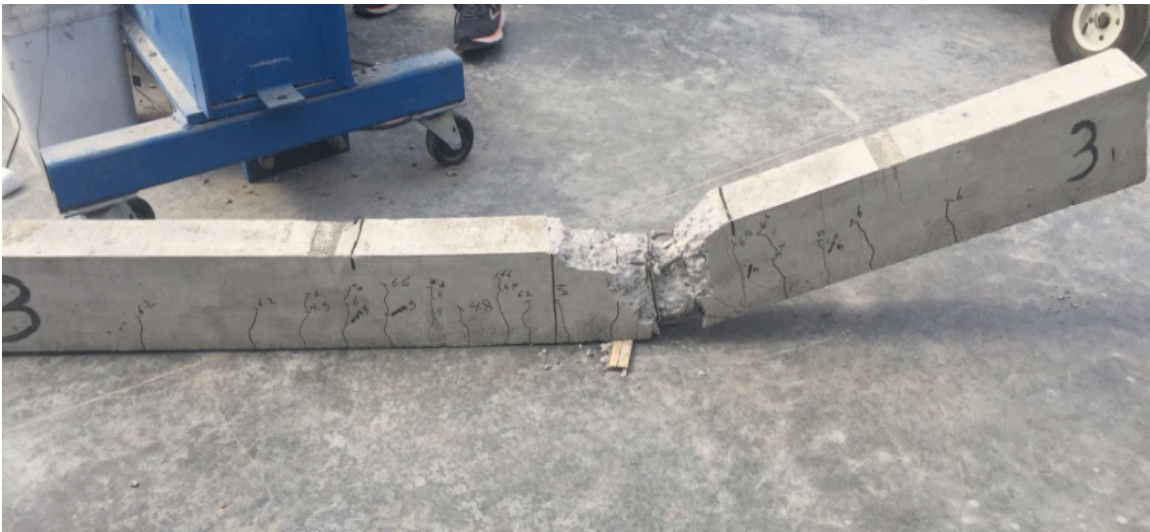
Figure 31: Yield of steel reinforcement in beam #3

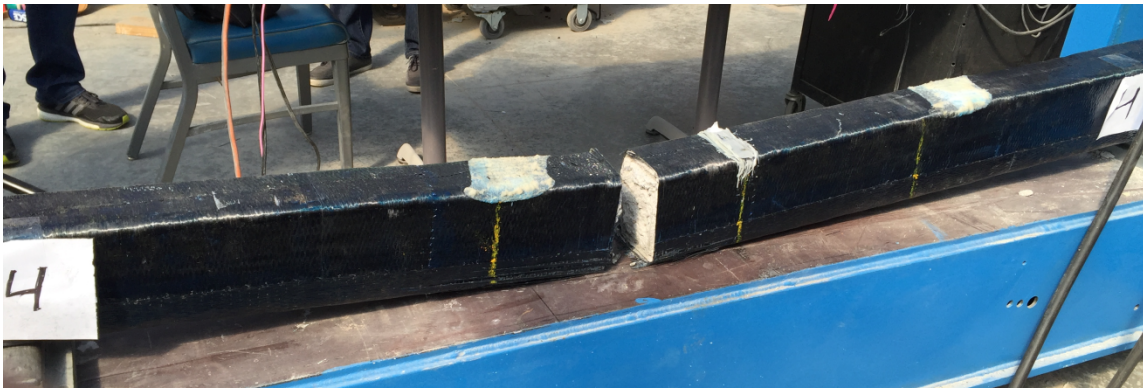
Figure 32: Beam #4 failure mode

This beam is similar to Beam #1 but with one layer of CFRP applied to the bottom of the beam for flexure, and around the circumference for shear. The maximum load was measured as 7.89 kip, with a maximum deflection of 1.78 in. at failure. The failure mode was a combination of rupture of the carbon fabric in shear and tension sides, and sudden brittle failure due to the lack of steel reinforcement as shown in Figure 32 & 33.

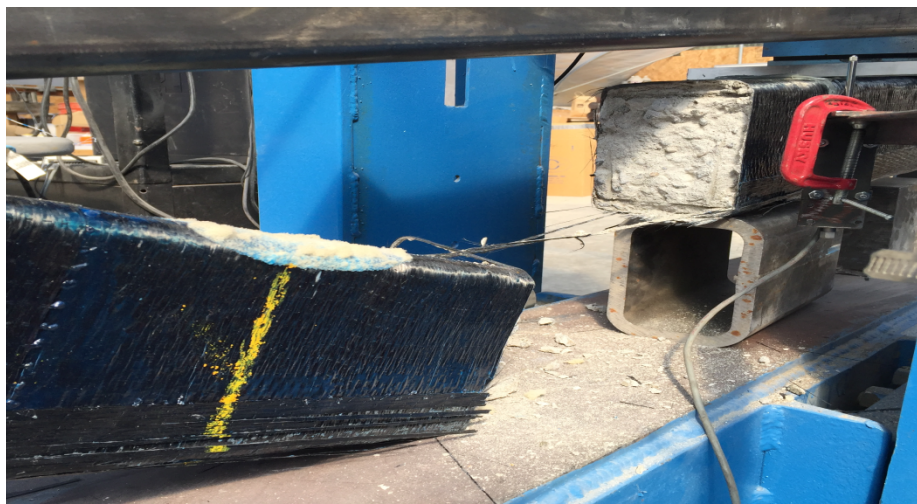
Figure 33: Combined rupture and brittle failure

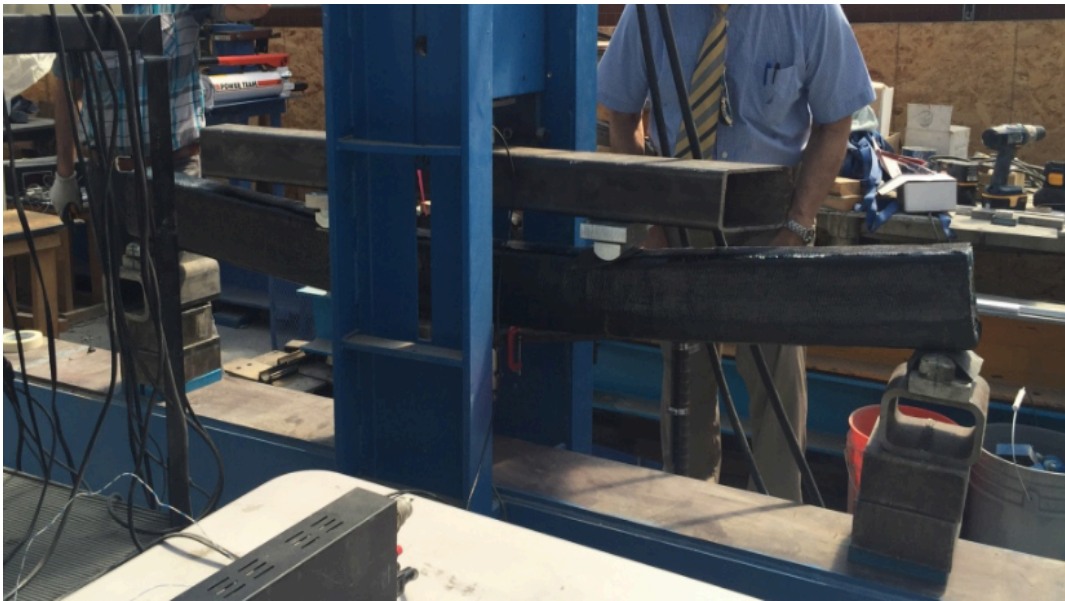
Figure 34: Beam #5 deflection capacity

This beam was the same as Beam #4, however; two layers of CFRP were externally bonded in flexure and shear. Due to the increase of number of layers and CFRP thickness, one can expect the beam capacity to increase at least twice that of Beam #4. Beam failure occurred at a maximum load of 14.58 kip. The measured deflection at failure was also higher at 3.05 in., Figure 34.

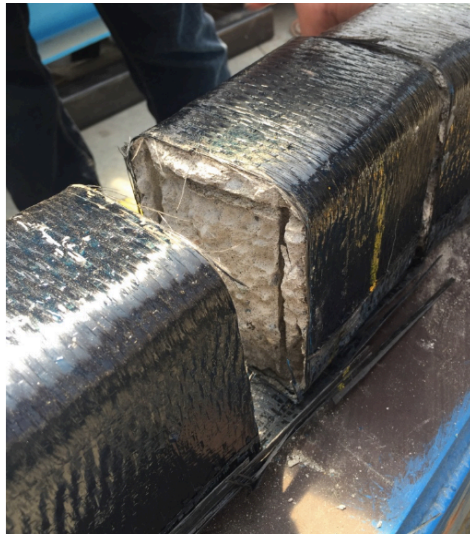
Figure 35: Beam #5 shear failure

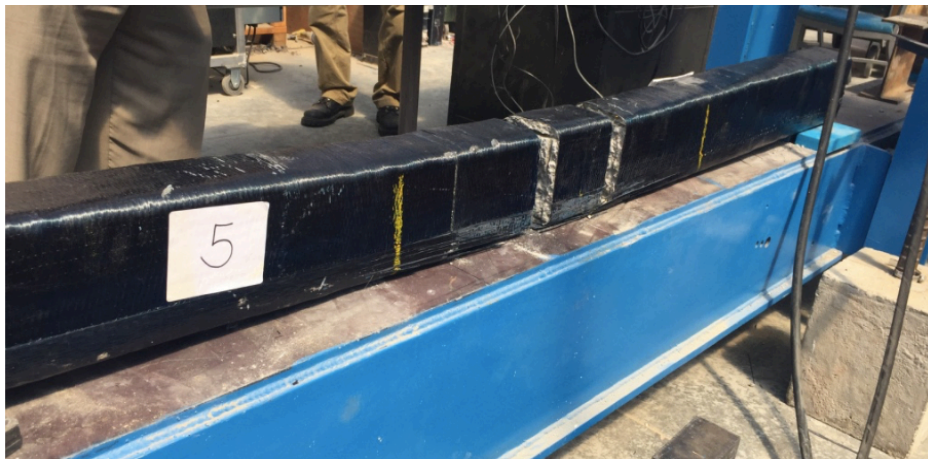
Figure 36: Beam failed half span distance

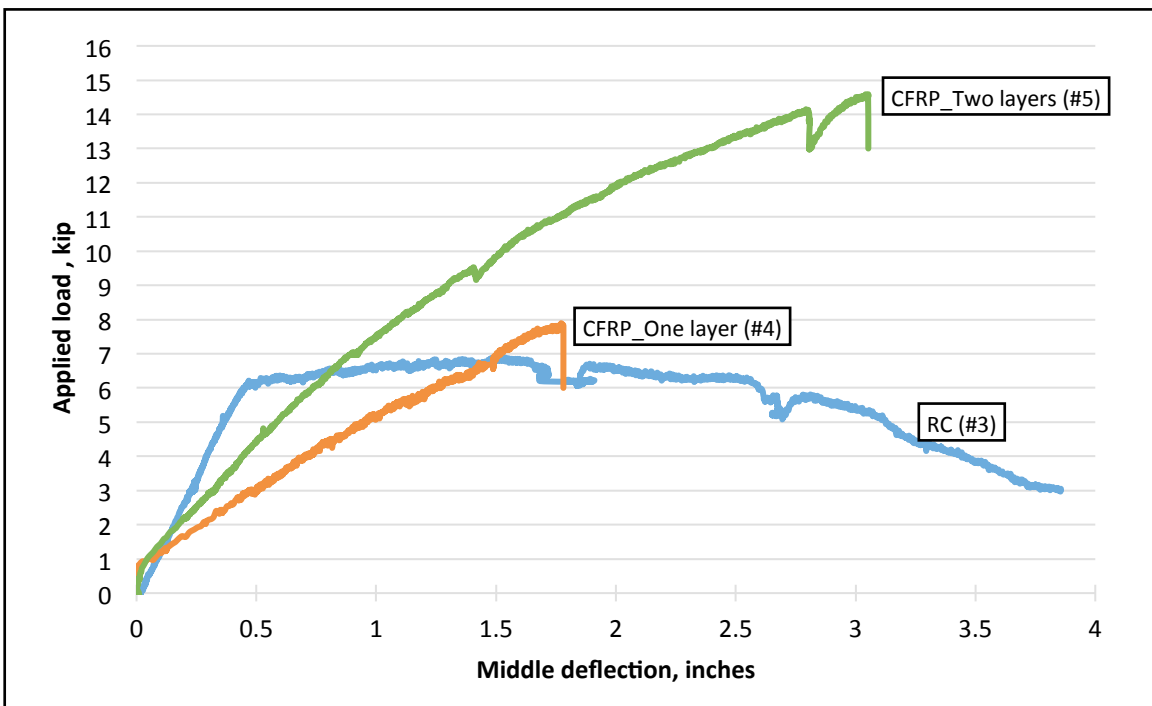
Figure 38: Load-deflection relationship for reinforced and retrofitted beam

Plain and deteriorated beams had a small load carrying capacity relative to the other three beams, which is evidenced by their almost imperceptible load deflection curves (Figure 39). Thus, by comparing the load-deflection relationships for all five beams in Figure 39, it is obvious that strengthening the beams circumferentially and longitudinally with CFRP improved the

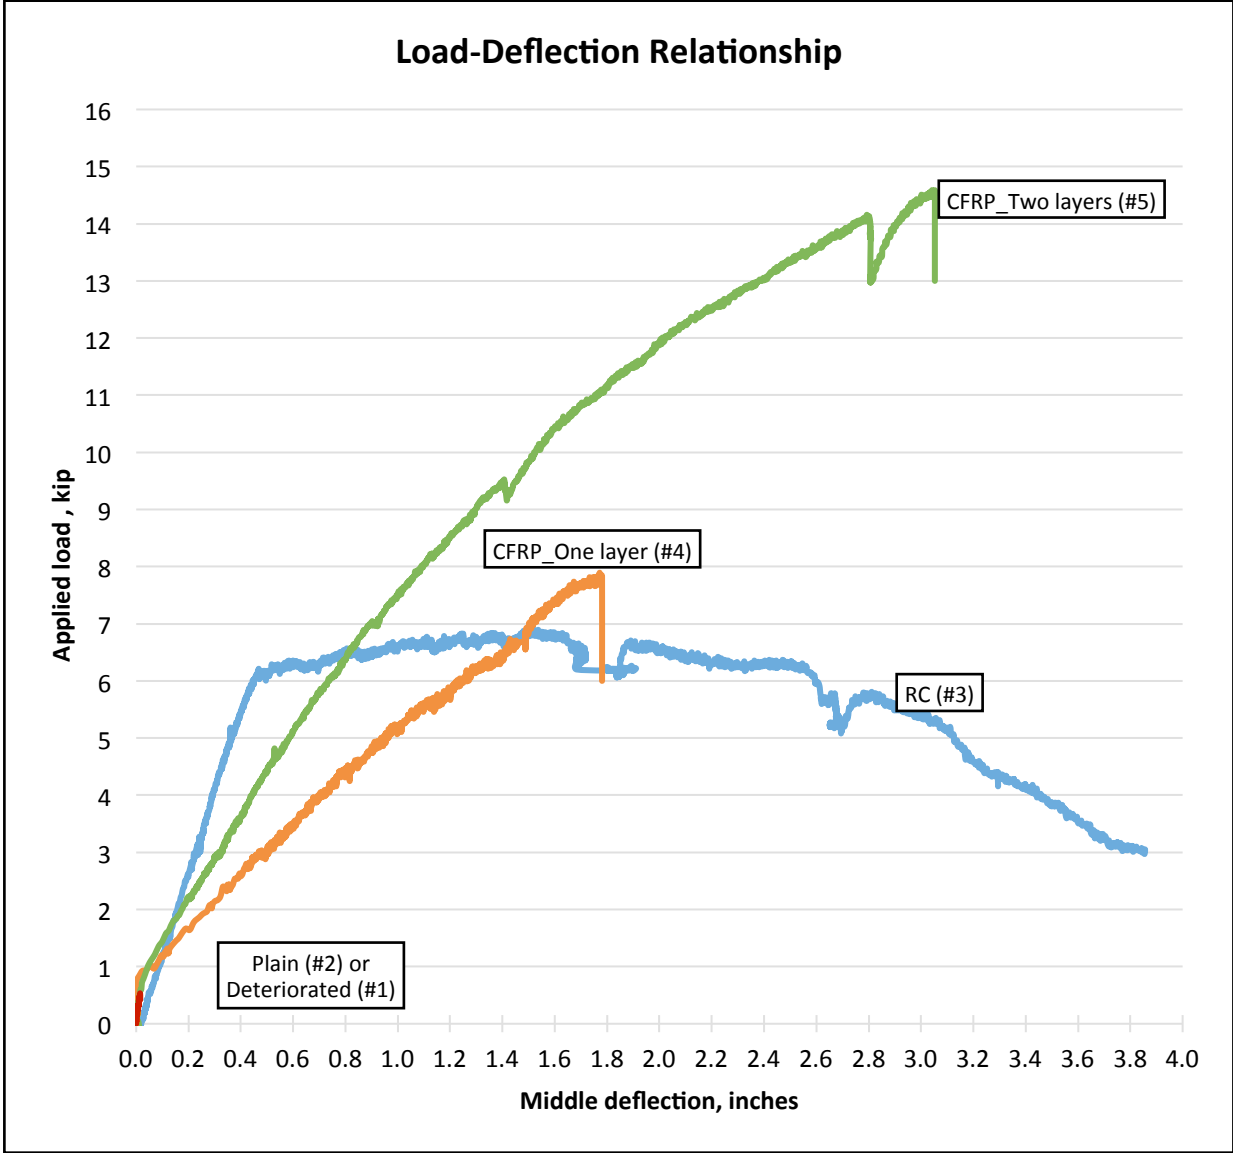
Figure 39: Load-deflection relationship for all beams
