Behavior of Concrete Beams with Corroded Reinforcement Retrofitted with Carbon Fiber Reinforced Polymer

A research project submitted in partial fulfillment of the
requirements for the degree of

MASTER OF SCIENCE
IN
CIVIL & ENVIRONMENTAL ENGINEERING

Portland State University
©2016

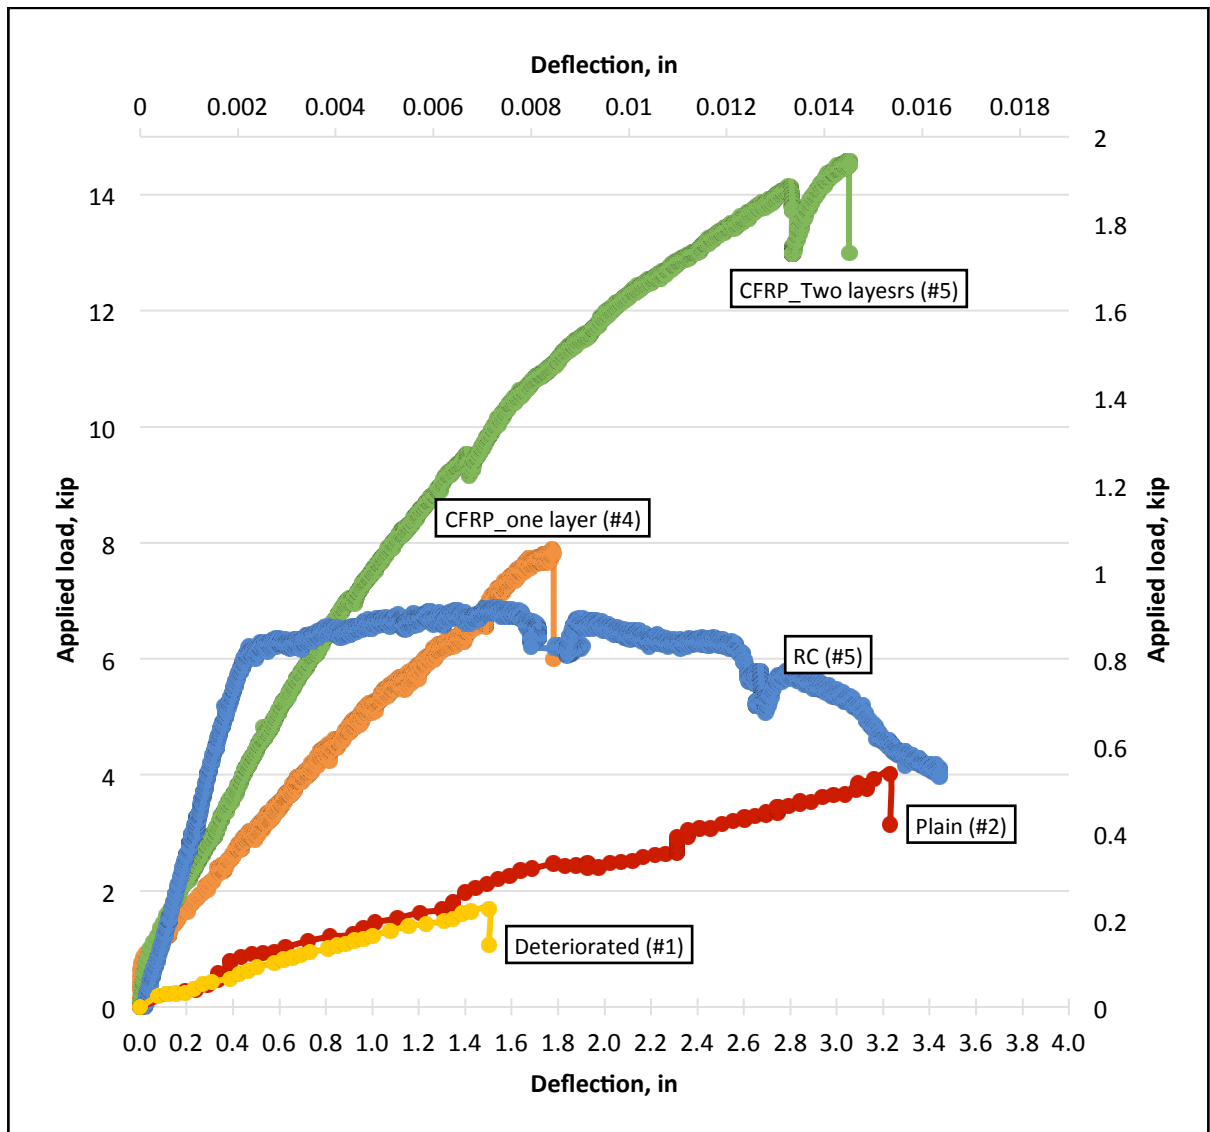
Figure 40: Load-deflection relation for all five beams on separate axis

beams' load-carrying capacity. Better view of the comparison between all beams is shown in Figure 40. Note that Beam #1 and #2 are shown on a secondary axis.

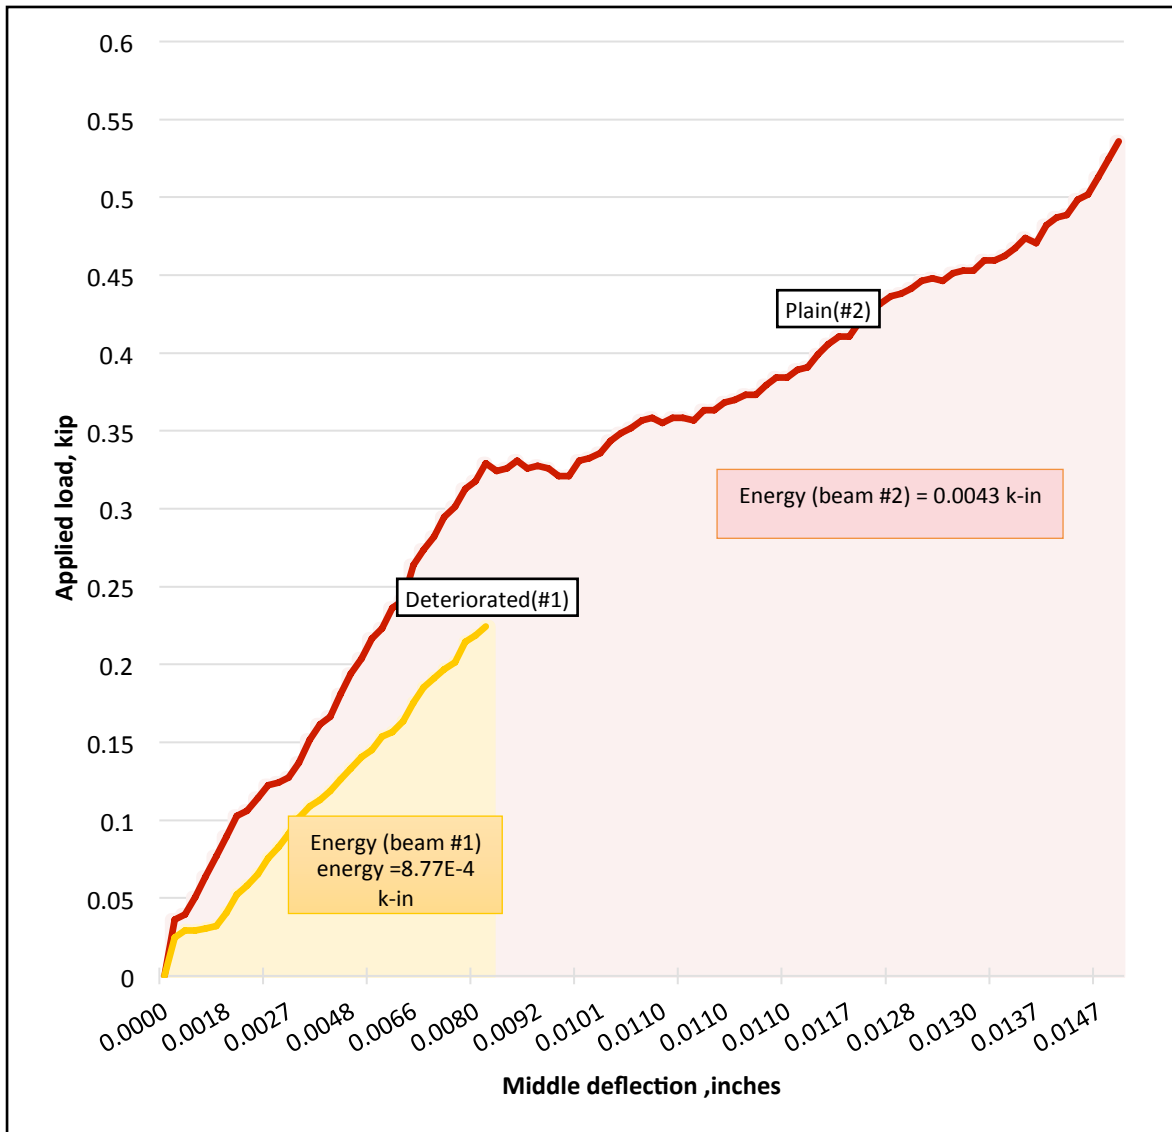
Figure 41: Energy absorption for beam #1 & #2

The area under the load-deflection curve is used to estimate the energy-absorbing capacity or toughness of the material, Figure 41. Increase of the toughness also means improved performance under loading. From Figure 42, the energy absorption is larger for fiber-reinforced specimens than that for plain concrete specimens. This implies that the fiber-reinforced specimens require more energy to fracture than the plain concrete.

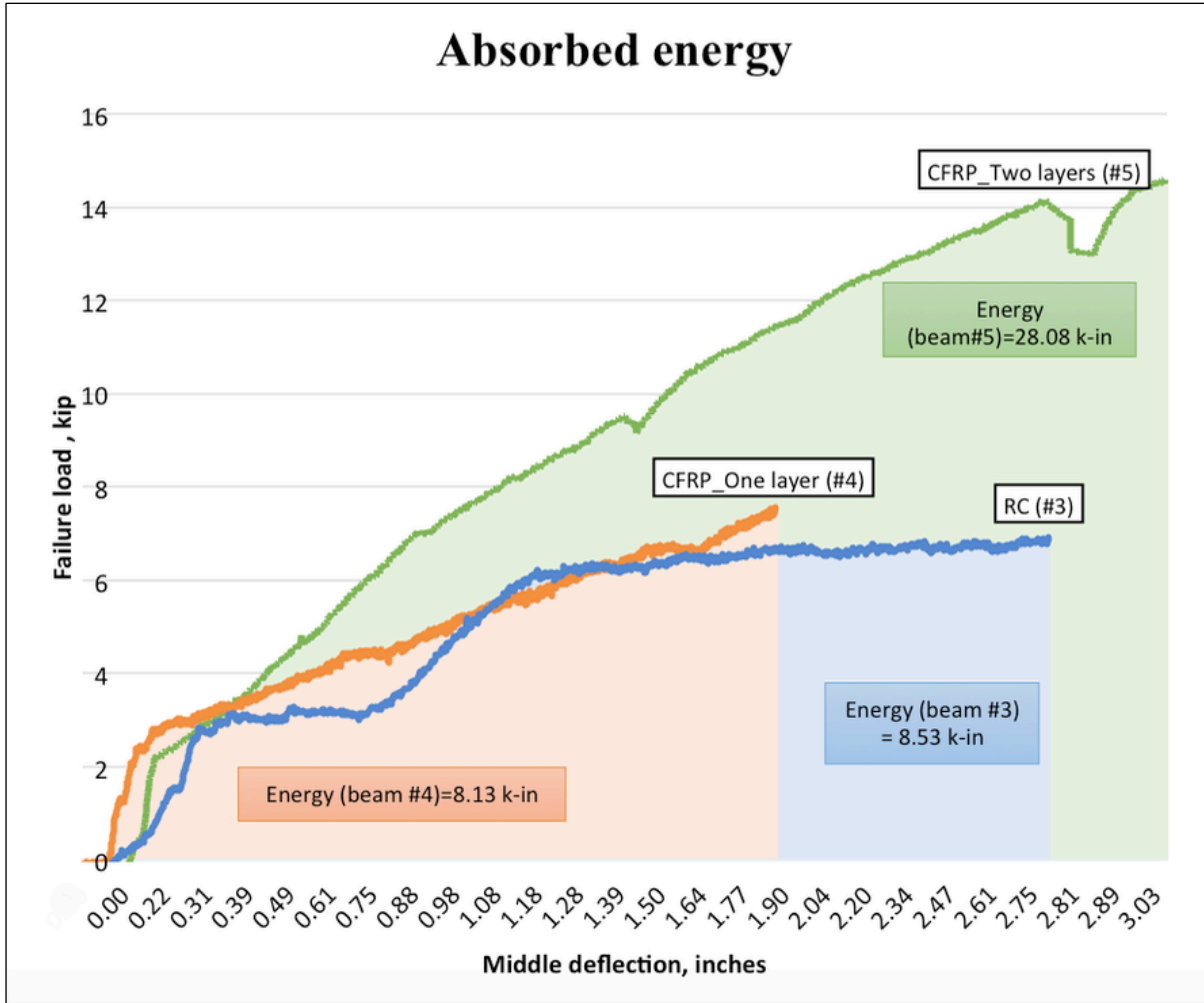
Figure 42: Energy absorption for beams #3, #4 & #5

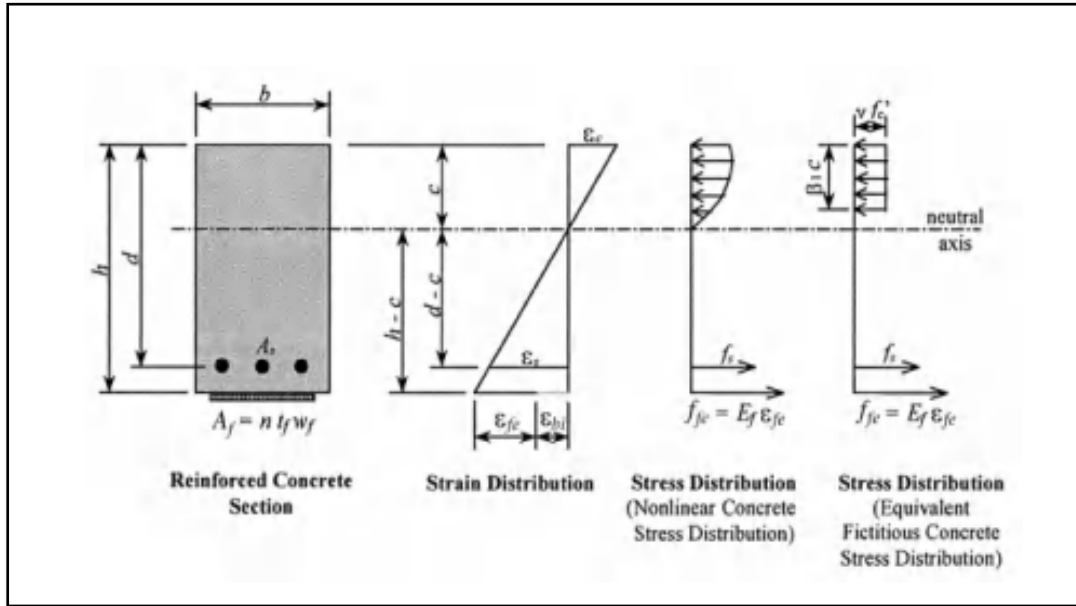
Figure 43 :Internal stress-strain relationship for tensile RC [32]

strengthening effect of adding longitudinal FRP reinforcement to the tension face of a reinforced concrete member [32].

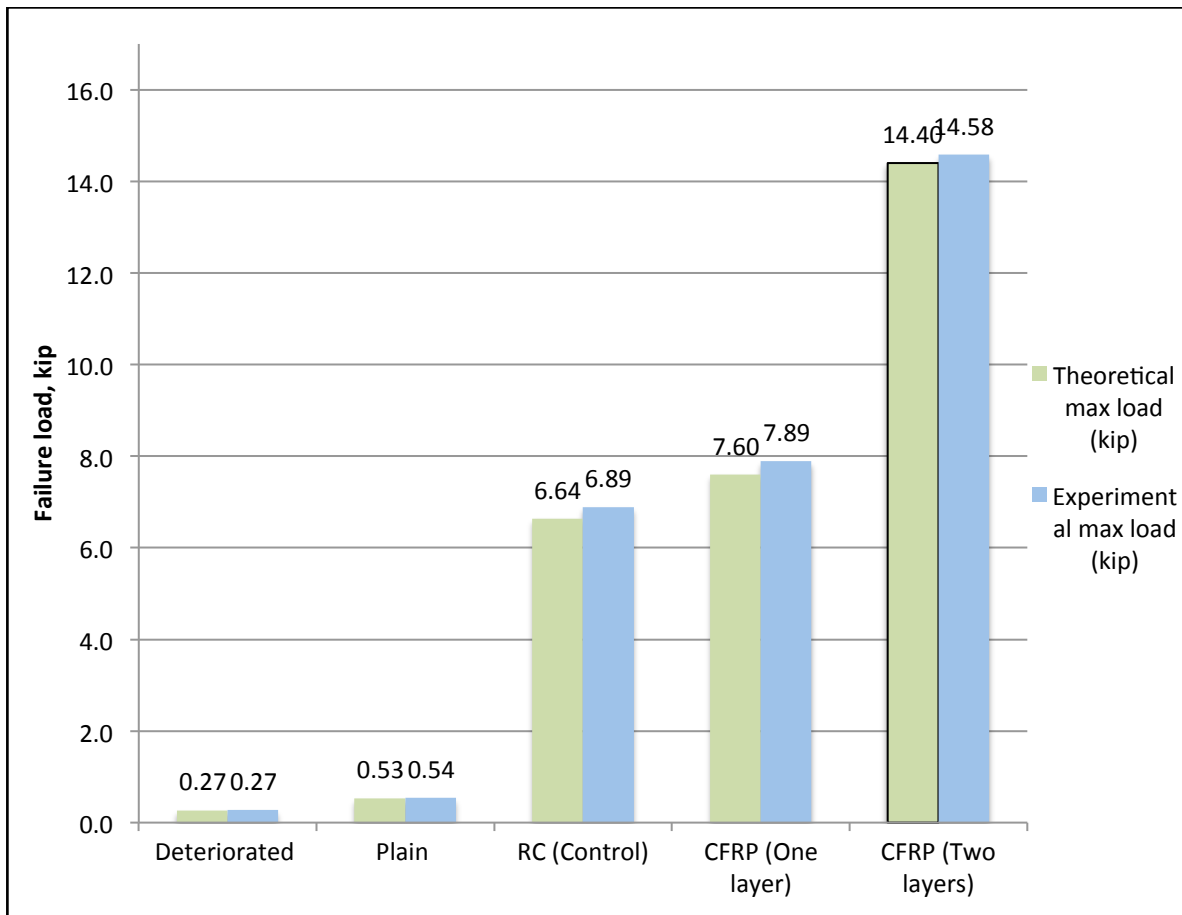
Figure 44: Theoretical vs. experimental load values

Beam	Beam No.	Experimental max load (kip)	Theoretical max load (kip)	Ratio P_{exp}/P_{theo}
Deteriorated	1	0.274	0.266	1.03
Plain	2	0.538	0.531	1.01
RC	3	6.89	6.64	1.04
CFRP (One layer)	4	7.89	7.60	1.04
CFRP (Two layers)	5	14.58	14.40	1.01
