Maroon Ponds

A case-study of wetland and stream habitat restoration from planning to post-construction

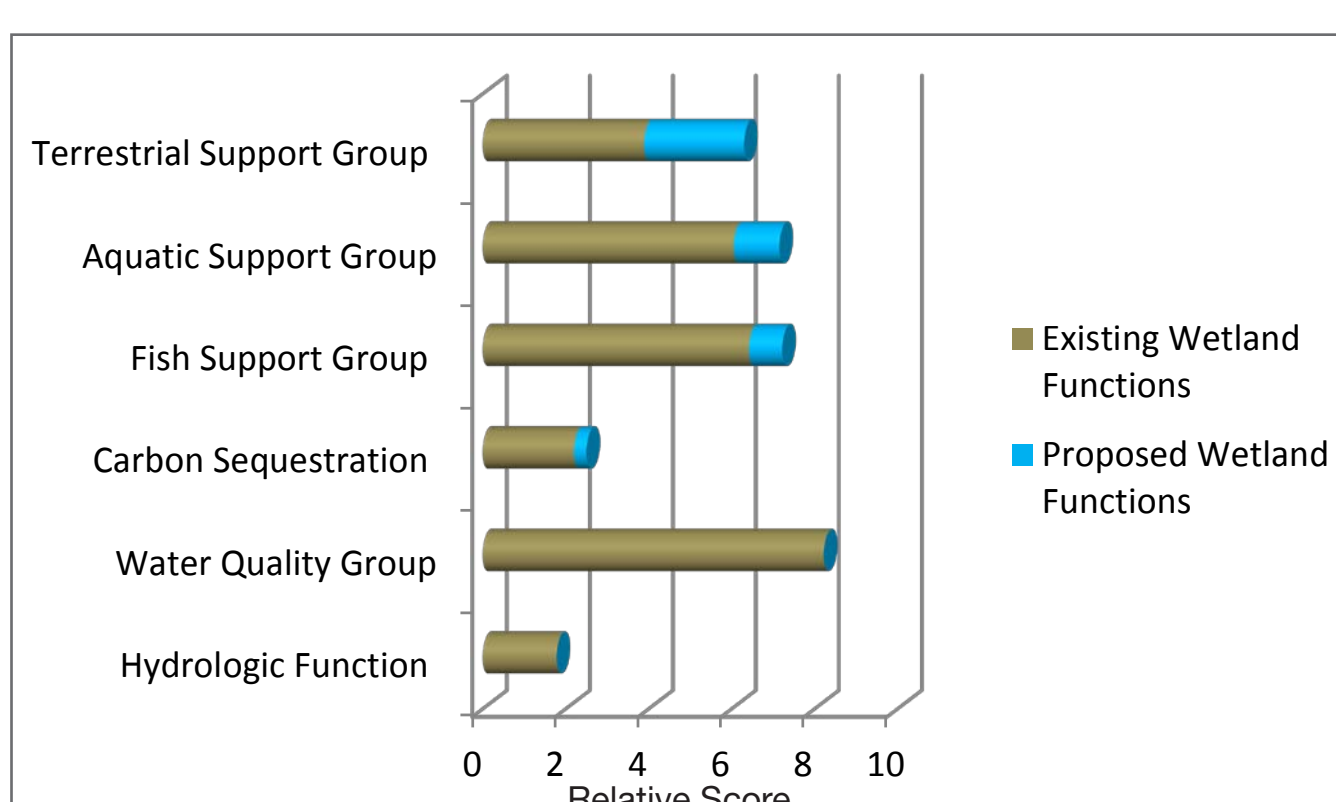
Figure 1: Comparison of Existing and Predicted Functions of Upper Maroon Pond using the Oregon Rapid Wetland Assessment Protocol (ORWAP).

- Ten month design and permitting schedule.
- Justify converting Upper Maroon Pond into a hillside wetland/stream complex by showing substantial (greater than 0.5 increase) gains in terrestrial wildlife habitat, aquatic habitat and fish habitat.

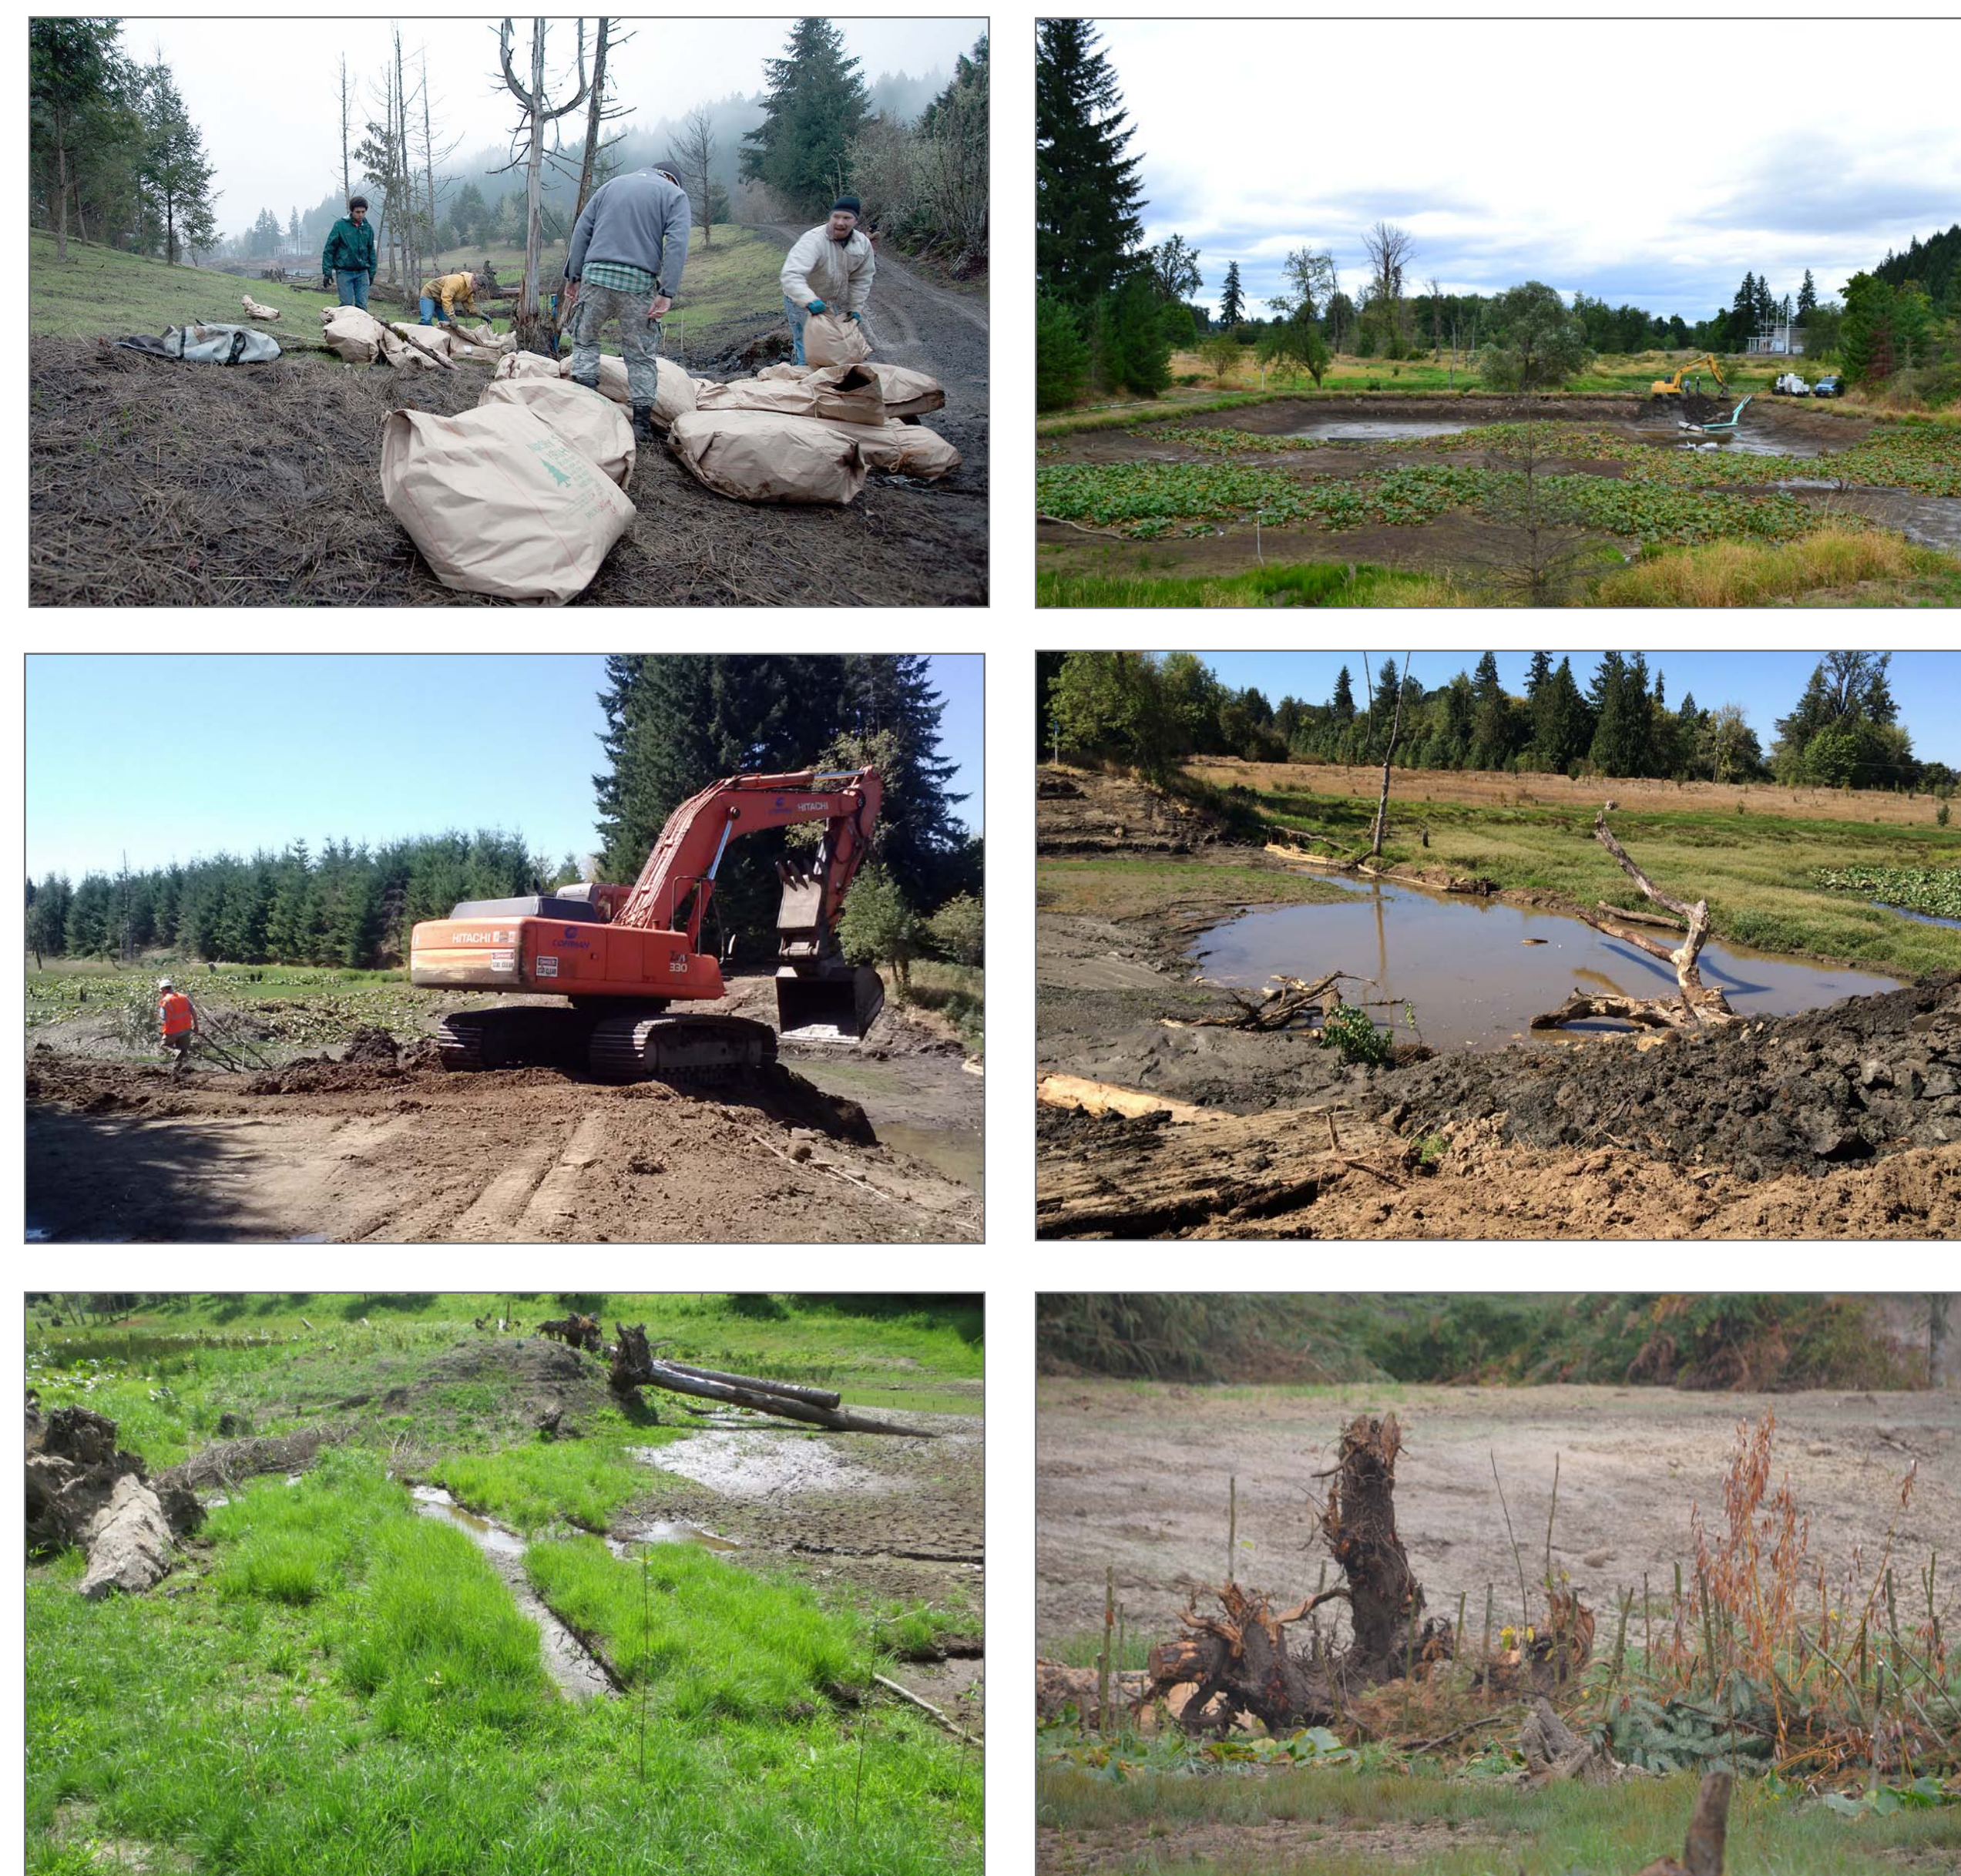
- Remove failing push-up dam to restore hillside wetland/stream complex.
- Rely on resident beaver to restore hillside step-pools in Upper Maroon Pond area.
- Replace reed canarygrass and meadow foxtail with diverse native plant communities.
- Add large wood to increase habitat complexity and the supply of basking logs for western pond turtle.
- Maintain sparsely vegetated areas for turtle nesting habitat.

- Draw-down pond over two weeks in July.
- Excavate the dam and lower bench September 2014.
- Strategically place live stakes/brush structures (starter dams) to promote beaver activity and the creation of step-pools (Pollock et. al. 2012).
- Plant 7,000 bare-root shrubs and trees along the edge of former Upper Maroon Pond.
- Install 4,300 live cuttings on the pond bottom for beaver.
- Install 20 large wood structures including basking logs and anchored pieces.
- Thin Douglas firs to release oak and madrone growth.

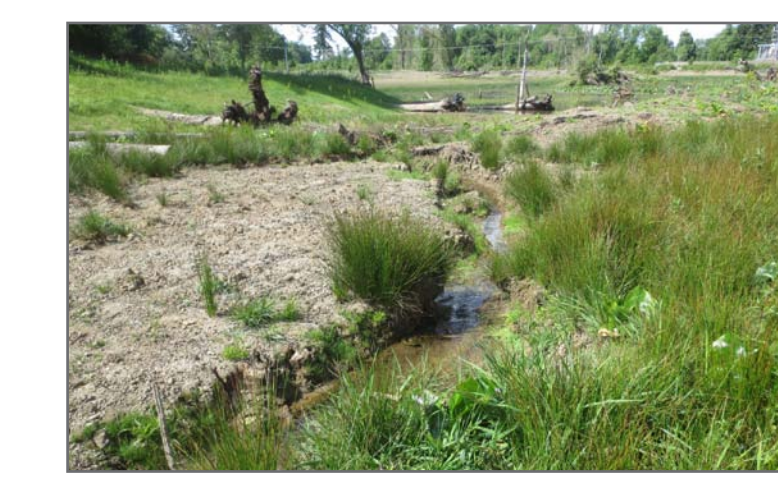
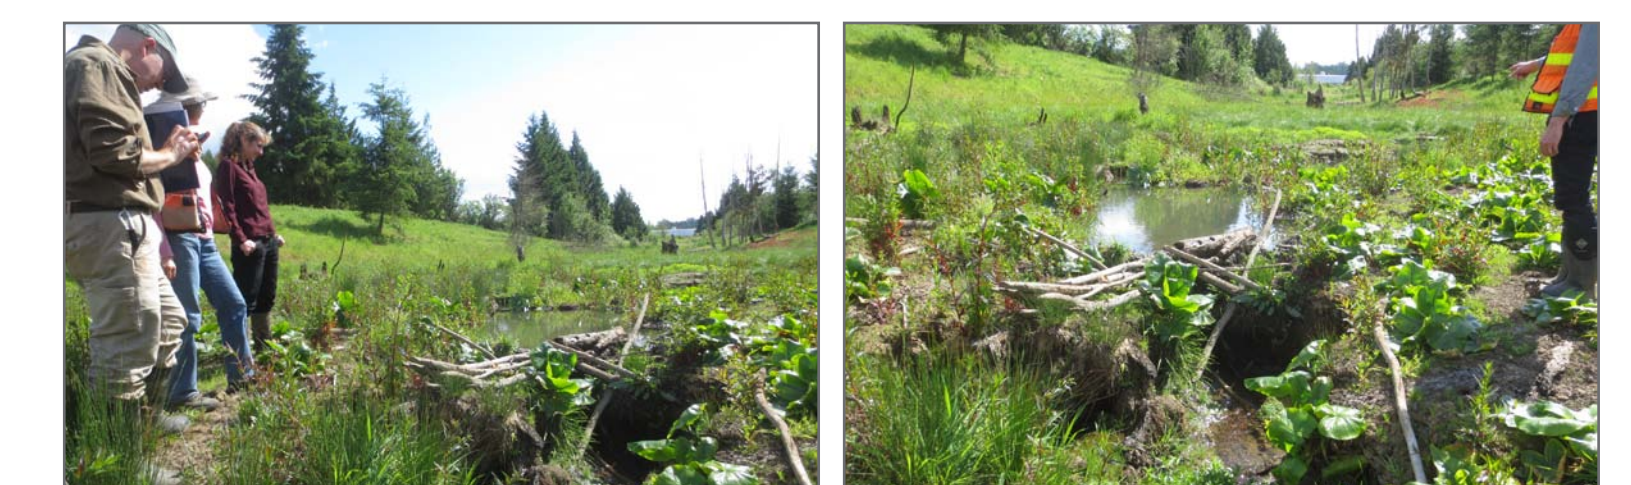
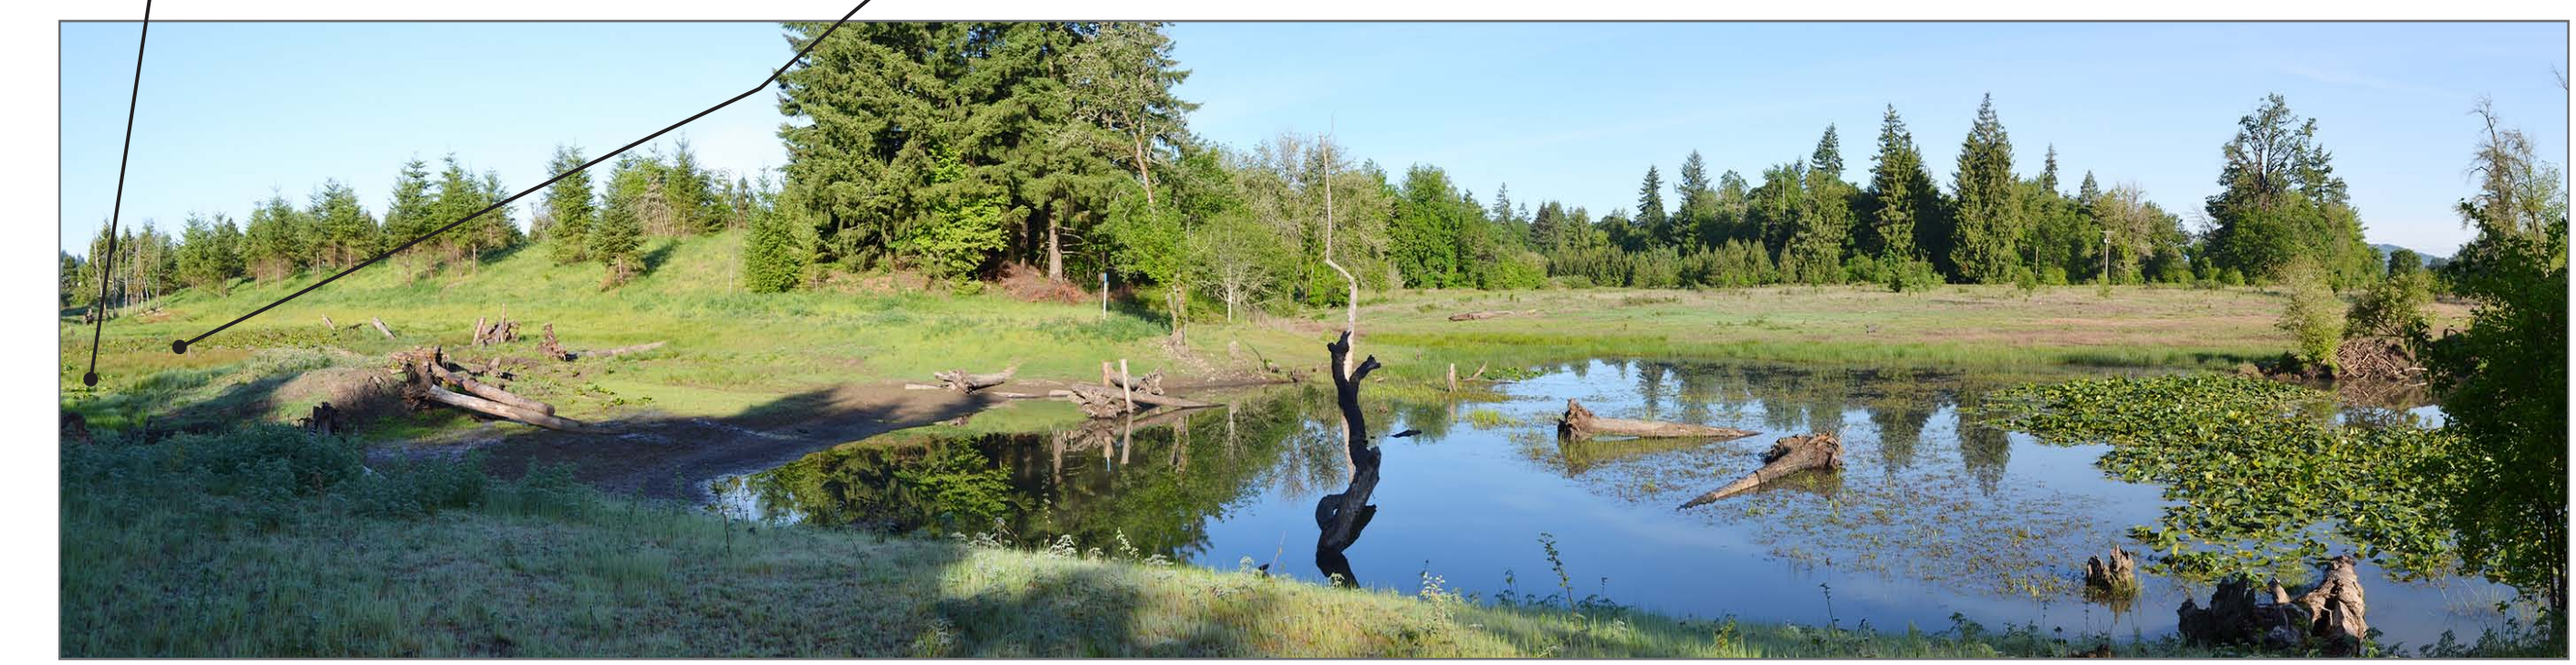
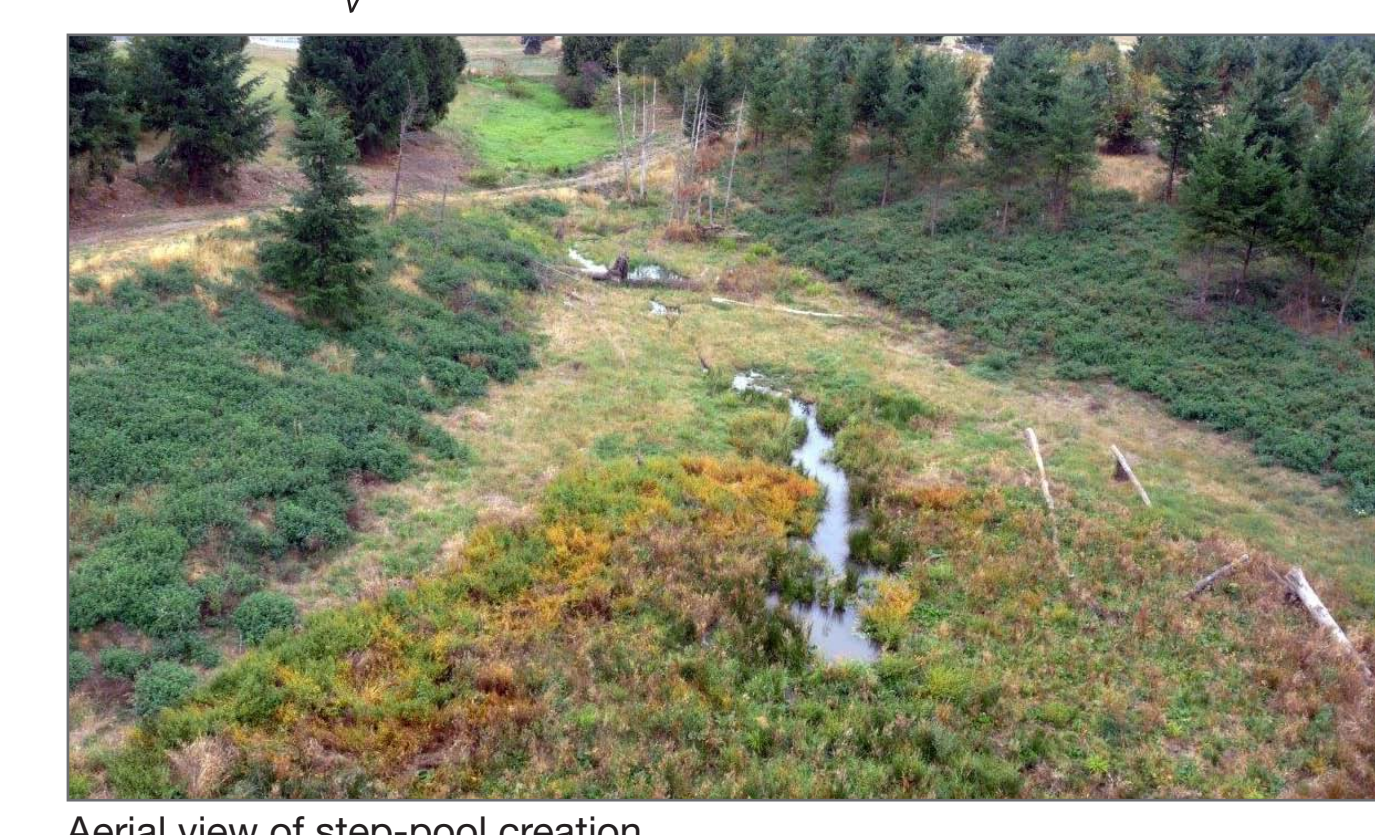
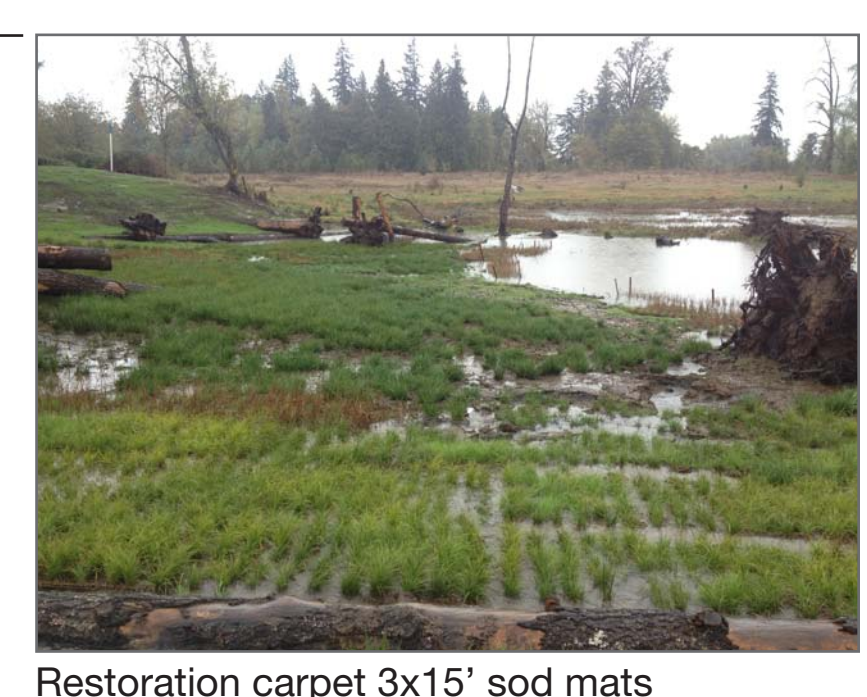
- Beavers added to starter dams and created two step-pools on the hillside within a few months of completing earthwork and live-stake planting.
- Numbers of amphibian egg masses dramatically increased (winter 2014).
- Western pond turtles were seen basking on restoration logs (spring 2014).
