# Clear Creek Estuary Restoration: Establishing an Ecological Monitoring Program and Baseline Conditions

June 28, 2016

Masters of Environmental Management Project

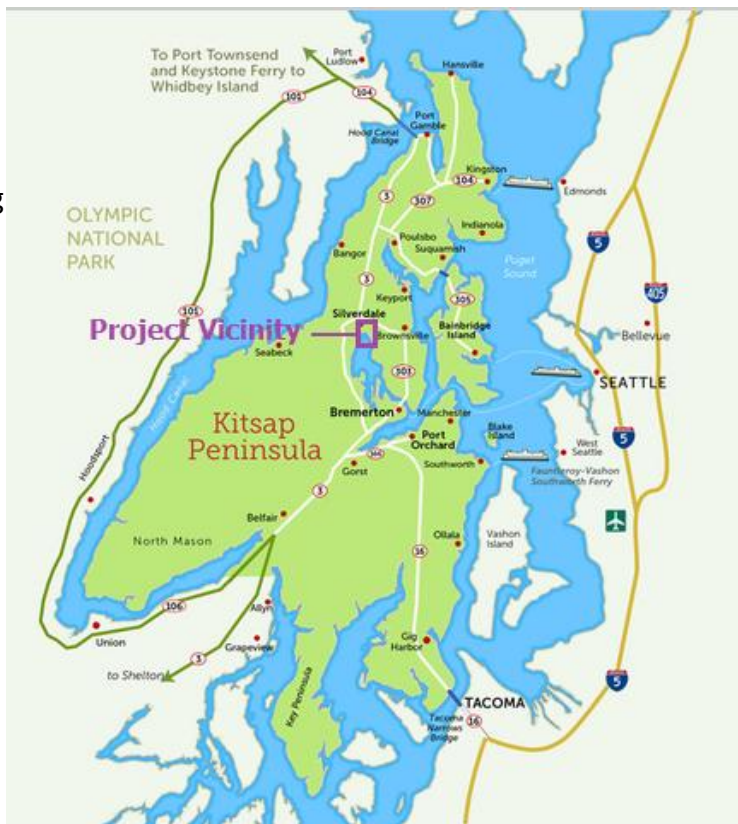
Figure 1 The Clear Creek Estuary, which is the project vicinity, is located on the northwestern shore of Dyes Inlet and in the unincorporated township of Silverdale, WA. Courtesy of [Scripps Media, Inc](#)

There were four locations selected for observation and data collection. These field locations will be used to characterize the tidally influenced areas of the estuary of Clear Creek/Dyes Inlet (Figure 1). Two sites were selected, south of the existing Bucklin Hill Bridge, which have more marine environmental characteristics (Site 1 and Site 2). The other two sites, with more estuarine features (Sites 3 and 4), are located north of the bridge. By collecting water quality, invertebrate and insect information, along with sediment and vegetation profiles from the four sites along the range from Old Mill Park to the top edge of the salt marsh where the tidal influence diminishes, we can obtain a characterization of habitat conditions of this portion of the watershed.

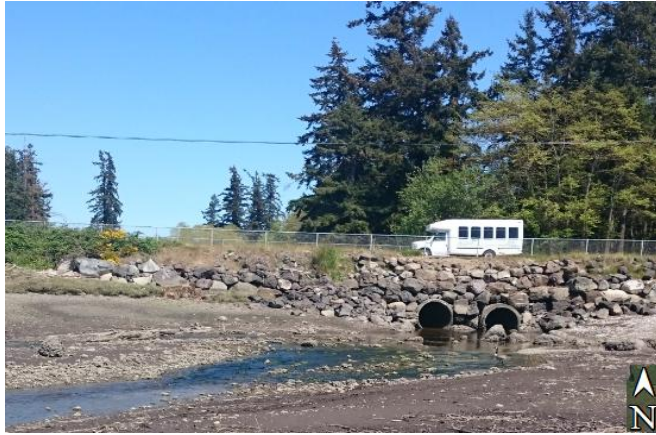
Figure 6: Erosion on the marine side of the Bucklin Hill Bridge culverts has created perched culverts above the stream bed thereby restricting access for incoming salmon to high tide periods. June 2015

In addition to challenges associated with managing anthropogenic inputs of stormwater, the basic freshwater and marine water exchange has been disturbed (Otak - WA, 2013). The bridge separating Dyes Inlet and Clear Creek (the Bucklin Hill Bridge) is a low elevation structure built on a 13 foot high, man-made land extension composed of soil, timber, and rock which bisects the estuary (KCPW, 2013; Otak - BA, 2013; Otak – WA, 2013). Creek egress and tidal inundation are both channeled through two six-foot culverts that connect Clear Creek to Dyes Inlet. The culverts are inset into the embankment supporting the bridge structure. Ecological functions such as nutrient exchange and sediment transport have been degraded as a result of the berm and culverts constriction of the estuary (Otak - BA, 2013). This condition is a common effect of dam and dam-like structures (Bednarek, 2001) and the Clear Creek Estuary is no exception.

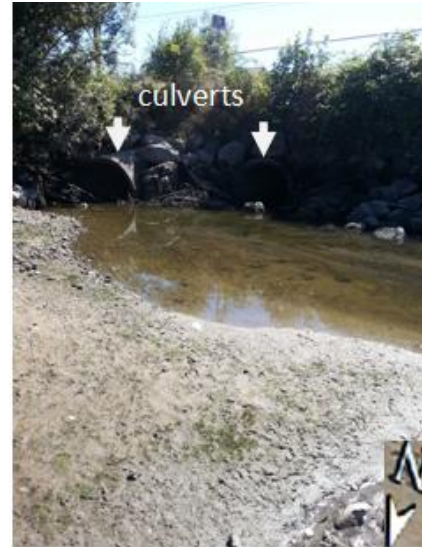
Figure 7: Sediment has built up over 70 years as Clear Creek drops fines during its approach to the northern side of the Bucklin Hill Bridge culverts. September 2014

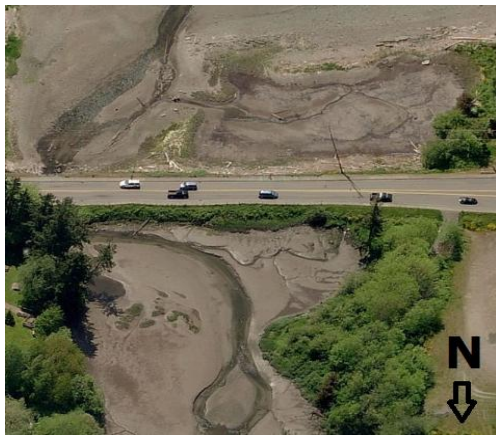
Figure 8: Existing Bucklin Bridge consists of two lanes over an embankment and two 72 inch culverts (Courtesy of Google Earth May 2014)

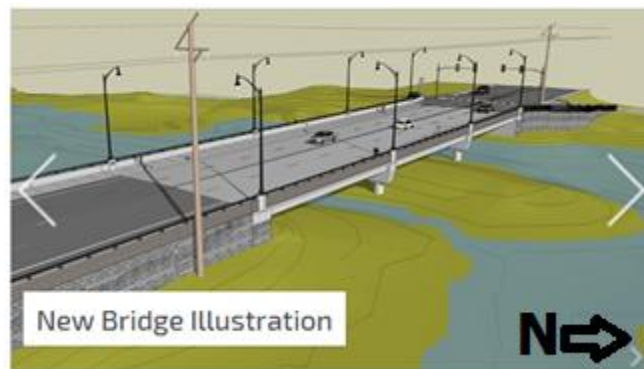
Figure 9: Artistic rendition of new four lane open span bridge with two creek channels. Courtesy of [Kitsap County Public Works: Bridge Illustrations](#)

drainage facilities will be installed at the abutments and along pedestrian lanes to capture and treat road runoff to meet or exceed Washington State Department of Ecology standards. Both the east and west outfalls will be replaced. The west side outfall will include a tide gate for fish exclusion and concrete pad for energy dissipation. The east side outfall design includes a screened energy diffusing trough running parallel to and along the full length of the abutment. ([Otak – BA, 2013](#)). Pedestrian access ramps to estuary viewing platforms on the bridge and separate trail access to the beach beneath it will be added. Utilities currently buried in the roadway fill such as power lines, telecommunications lines, sewer and stormwater pipes will be relocated. Nine of the utility lines will be mounted under the bridge. The power lines will run overhead of the new bridge ([KCPW, 2013](#); [KCPW 2015](#)).

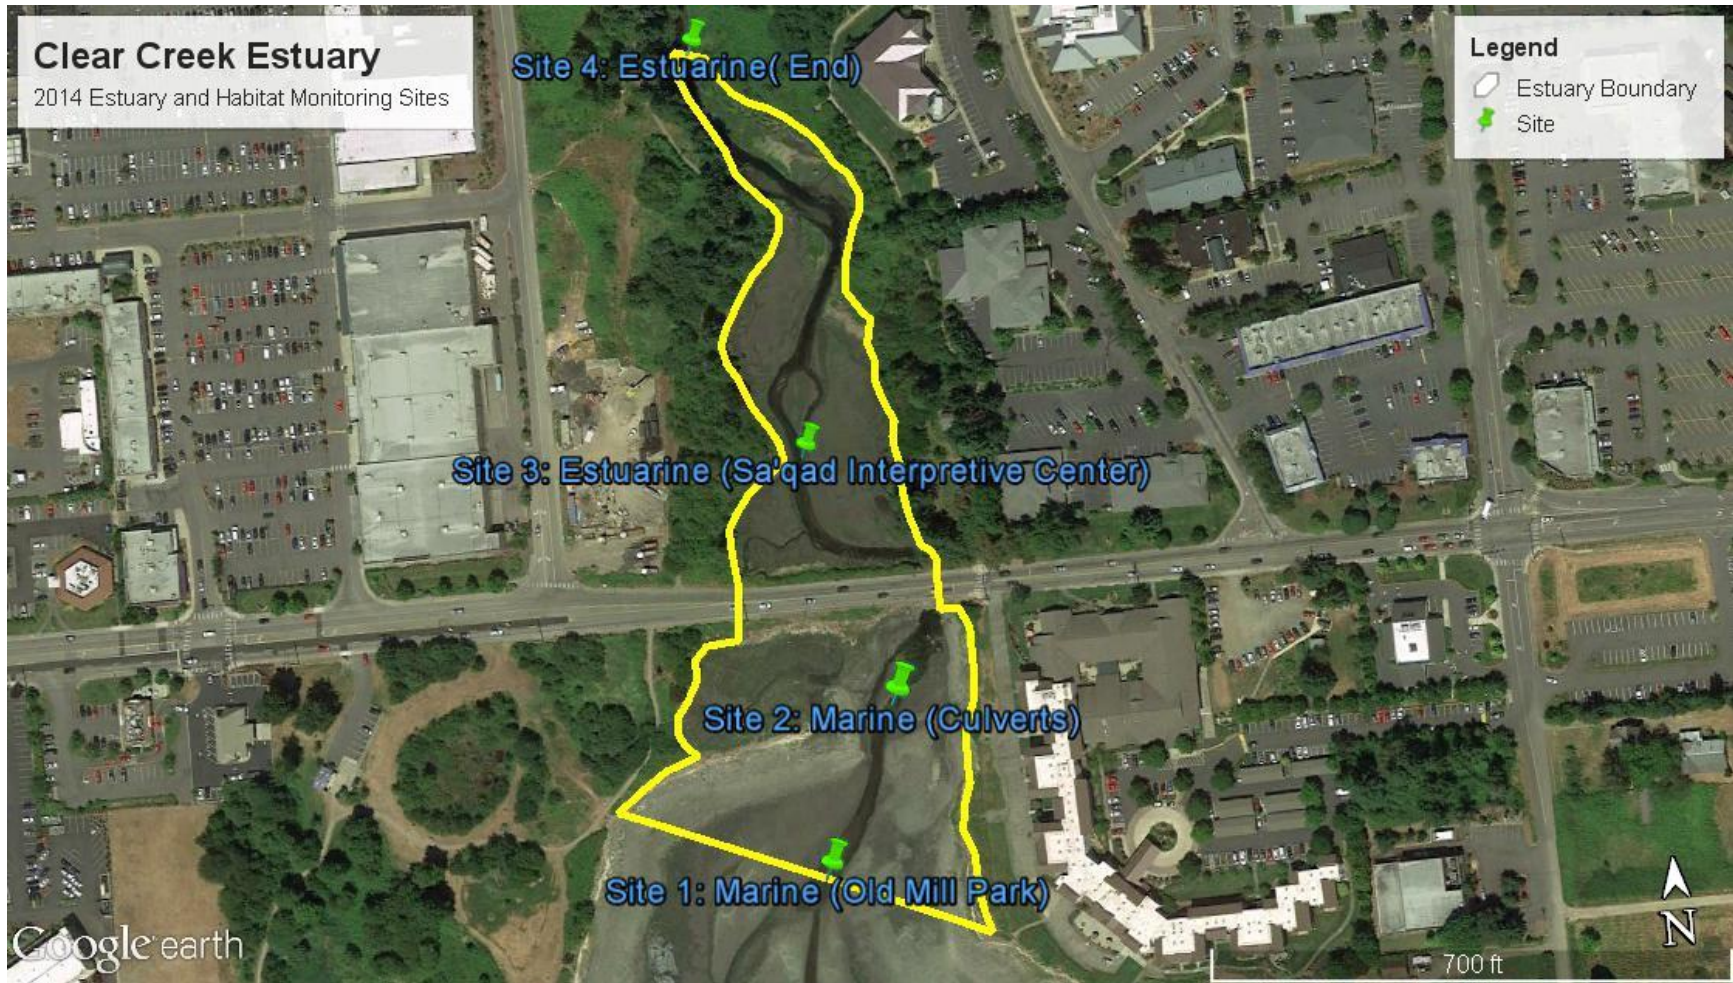
Figure 11: Monitoring Sites on the Clear Creek Estuary include two sites north of the existing culverts and two sites south of them. Courtesy of Google Earth.

There were four locations selected for observation and data collection. Field locations attempt to characterize the tidally influenced areas of the estuary of Clear Creek/Dyes Inlet (Figure 11). Two sites were selected, south of the existing Bucklin Hill Bridge, which have more marine environmental characteristics (Site 1 and Site 2). The other two sites, with more estuarine features (Site 3), located north of the bridge (Site 4), were also chosen for monitoring to access changes in estuary portion of Clear Creek. By collecting extended term water quality data from four points along the continuum from Old Mill Park to the top edge of the salt marsh where the tidal influence is expected to diminish, we can obtain a full characterization of water quality conditions of that portion of the watershed.

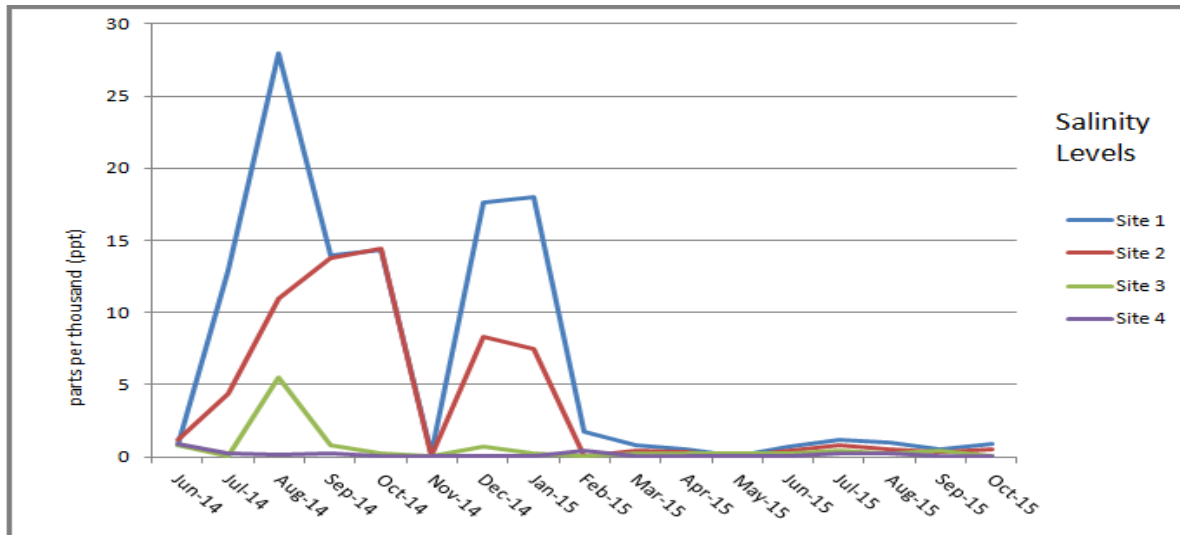
Figure 13: Salinity in parts per thousand (ppt) for all monitoring sites over a 17 month period. Sites 1-3 salinity results demonstrate more than 5% of the samples have a concentration of 1 ppt or greater which result in the application of marine water standards. All Site 4 samples have concentrations less than 1 ppt therefore freshwater use standards apply.

lowest at Site 4. For sites 1, 2, and 3 the percentage of samples with salinity values greater than 1 part per thousand (ppt) over a 17-month period (or 12) results in marine water Aquatic Life Use categorization. For Site 1, 56% of the samples had values greater than 1ppt. At Site 2 and at Site 3, more than 5% of the samples had greater than 1ppt salinity (43.8% and 5.9%, respectively). At Site 4, salinity results indicate that the application of freshwater use criteria is appropriate since none of the samples had a salinity reading greater or equal to 1ppt [figure 13].

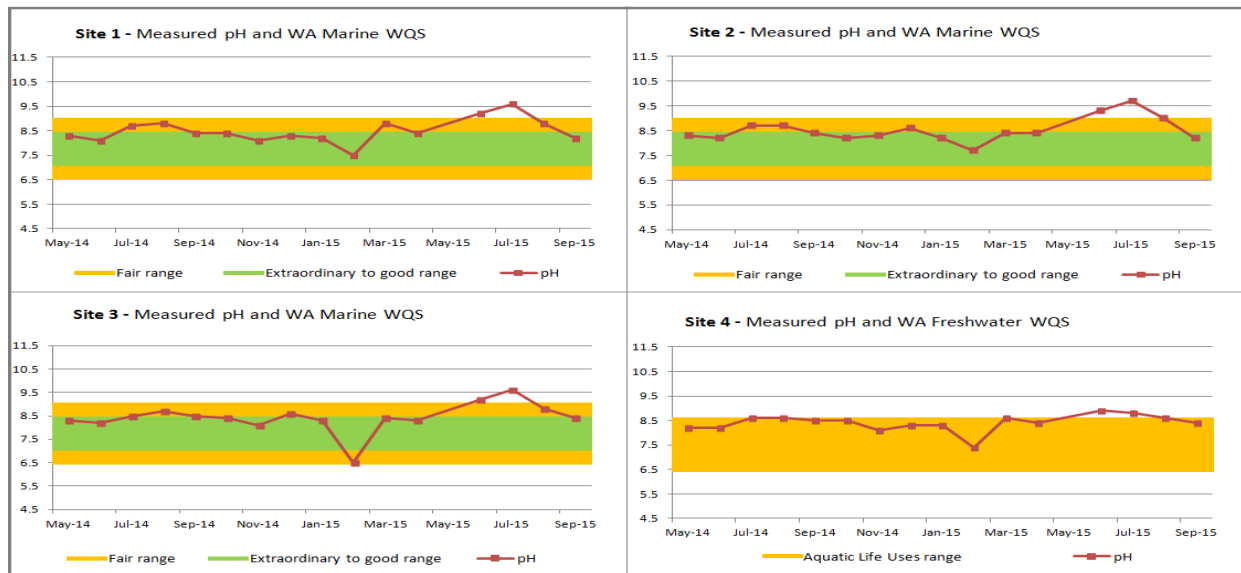
Figure 14: Collected pH values at Sites 1-4 are compared against Washington State Water Quality Standards for pH. There are two categories for marine waters: “Extraordinary values to good levels” range from 7 to 8.5. “Fair” pH levels range from 6.5 to 9. Although there are two freshwaters groupings, the ranges are both 6.5 to 8.5. Excursions occurred in June and July 2015 at all sampling locations.

pH levels were generally in the extraordinary to good range (7.0 to 8.5), which is a Washington State water quality designation for marine waters, however several measurements during the summer were outside the “fair” range (6.5 to 9.0). Of particular note are the excursions at sites 1-3 in June and July of 2015 where pH values ranging from 9.2 to 9.7 were recorded. Observational data noted a die-off of more than 30 graceful crabs (*Metacarcinus gracilis*) at sites 1-2 on each of these monitoring dates. High pH values were also recorded at Site 4 in the same time frame of 2015. The lower allowable value for pH is 6.5. The ceiling for freshwater aquatic use standards is 8.5, however pH readings were 8.9 and 8.8 for June and July, respectively [figure 14].

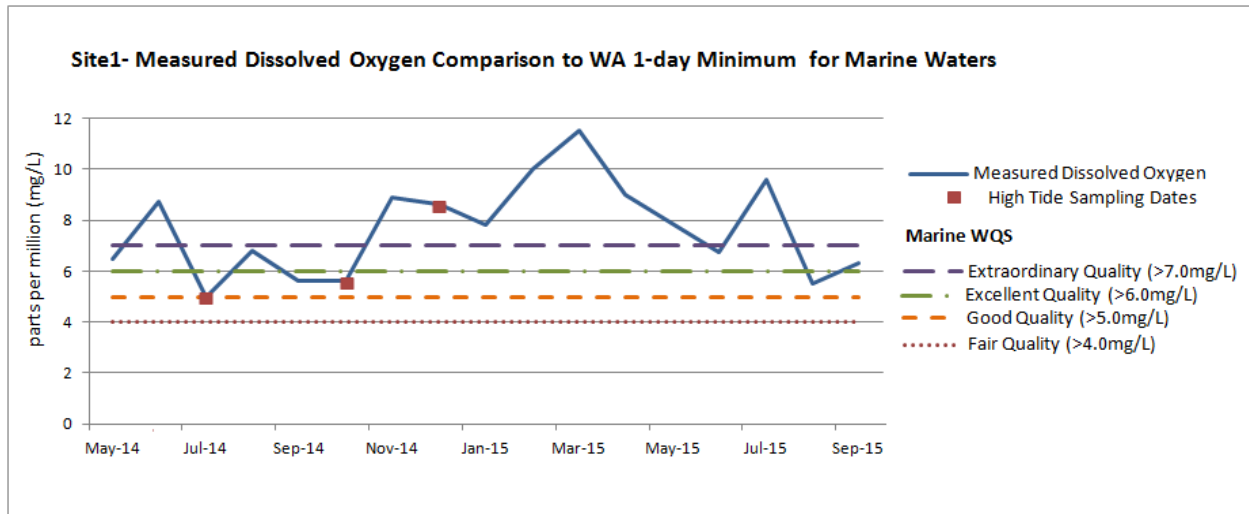
Figure 15: Site 1 Dissolved Oxygen (DO) versus Washington marine water quality standards shows collected data equate to “good to above extraordinary” concentrations except in August 2014 where DO levels dipped below 5mg/L and into the fair quality range.

**Dissolved Oxygen** samples collected over the baseline project period generally indicate adherence to Washington water quality standards (WA WQS) at good quality or higher rating for marine waters [5mg/L or more]. Exceptions exist at sites 1 and 2 during summer months. At Site 1, the August 2014 sample analysis produced a concentration of 4.8mg/L DO which is of fair quality by marine standards [figure 15]. This sample was collected in the late afternoon (4:16pm), 58 minutes before the second daily low tide. At Site 2, the July 2015 sample had a DO concentration of 4.6mg/L, also indicating only fair quality [figure 16]. This sample was collected at 12:40pm, 1.26 hours prior to the low tide. Site 3 DO samples are generally excellent quality or better [figure 17]. Based on average salinity, Site 4 falls under Freshwater Uses. At site 4, nearly all samples demonstrate DO concentrations lower than the minimum standards for Freshwater Uses except for during the “Salmon Rearing and Migration Only” periods [figure 18].

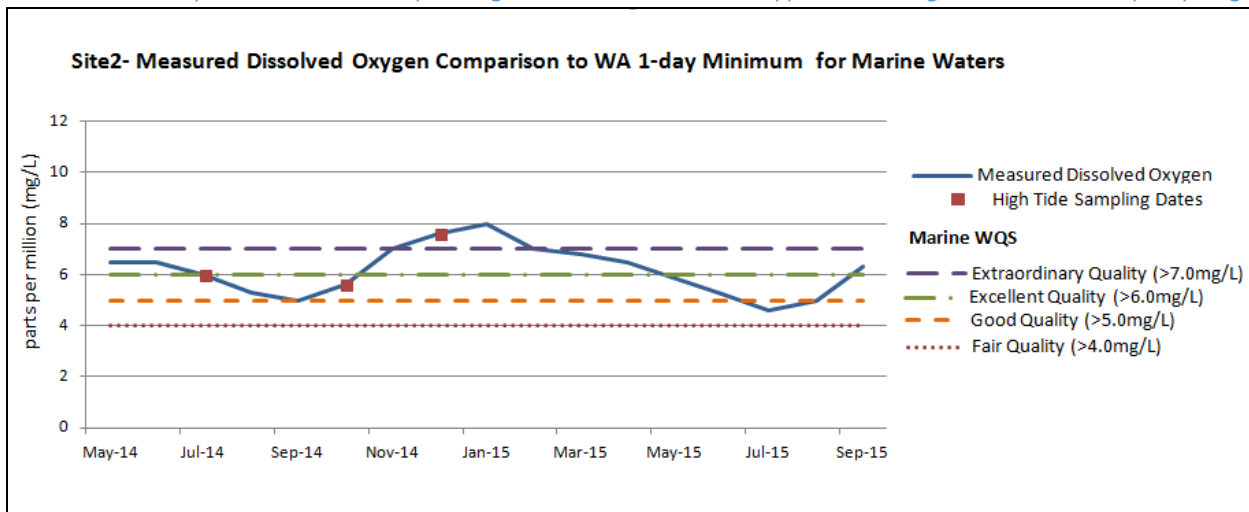
Figure 16: Site 2 Dissolved Oxygen (DO) versus Washington marine water quality standards shows collected data equate to “good to above extraordinary” concentrations except in July 2015 where DO registered below 5mg/L and therefore was of “fair quality”.

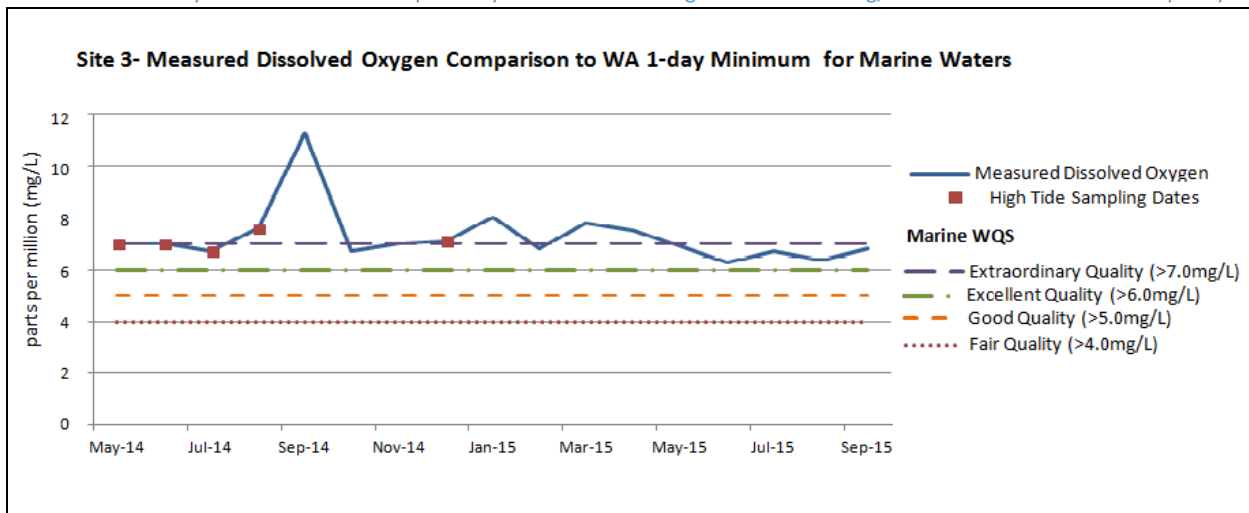
Figure 17: Site 3 Dissolved Oxygen concentrations versus Washington marine water quality standards data were found to be in the

“excellent” or greater category, except in August 2014 when the level dips into the “good” quality range at less than 6mg/L.

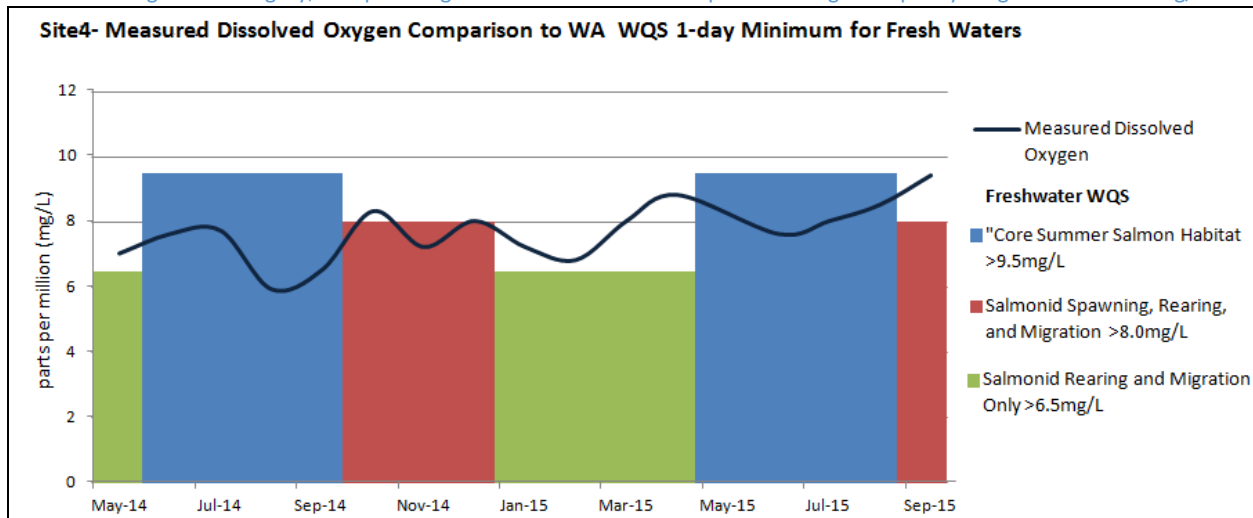
Figure 18: Site 4 Measured dissolved oxygen (DO) versus Washington fresh water quality standards show adherence to guidance for Salmonid rearing and migration only periods, however they were frequently found to be lower than the 1-day minimum guideline during Core Summer Salmon Habitat as well as during Salmonid Spawning, Rearing, and Migration use category periods.

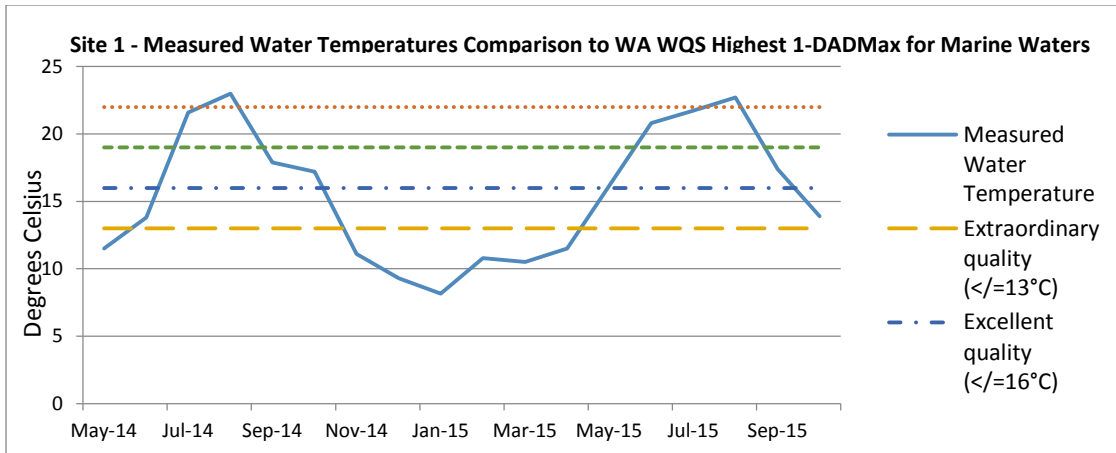
Figure 19: Comparison of measured temperatures to Washington State Water Quality Standards for Marine water at Site1 reveal a pattern of higher temperatures in summer and lower in winter months. Temperatures are generally of “good quality” or better, however excursions occurred in August 2014 and 2015 when measured water temperatures exceeded 22°C.

Marine standards set guidance limits for maximum allowable temperatures as “1-day maximum temperature or 1-DMax” collected as instantaneous or continuous recordings. Freshwater guidance calls for recording the arithmetic mean of a 7 consecutive daily maximum temperature sampling, the “7-DMax.” Instantaneous water temperatures taken at Sites 1-3 were compared to WA WQS Marine Use criteria based on salinity results. Site 4 is compared against WA WQS Freshwater Use values, also based on sampled salinity results. As with DO concentrations, Site 1 demonstrated excursion from WA WQS. Temperatures during August of 2014 and 2015 reached more than 22°C [figure 19]. Sites 2 and 3 remained within acceptable limits [figures 20 and 21, respectively]. Site 4 also exceeded standards during the summers of 2014 and 2015 by reaching temperatures above the maximum of 16°C for Core Summer Salmonid Habitat in fresh water [figure 22]. This value was a 1-day maximum versus a 7-DMax value.

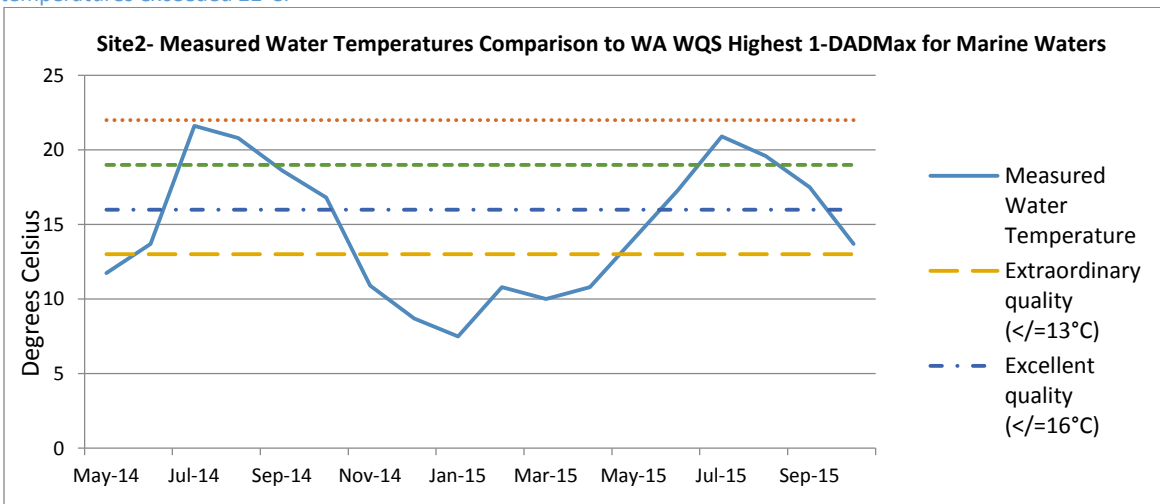
Figure 20: Comparison of Measured Temperatures to Washington State Water Quality Standards for Marine water at Site2. Standards are met year round for at least a fair quality rating.

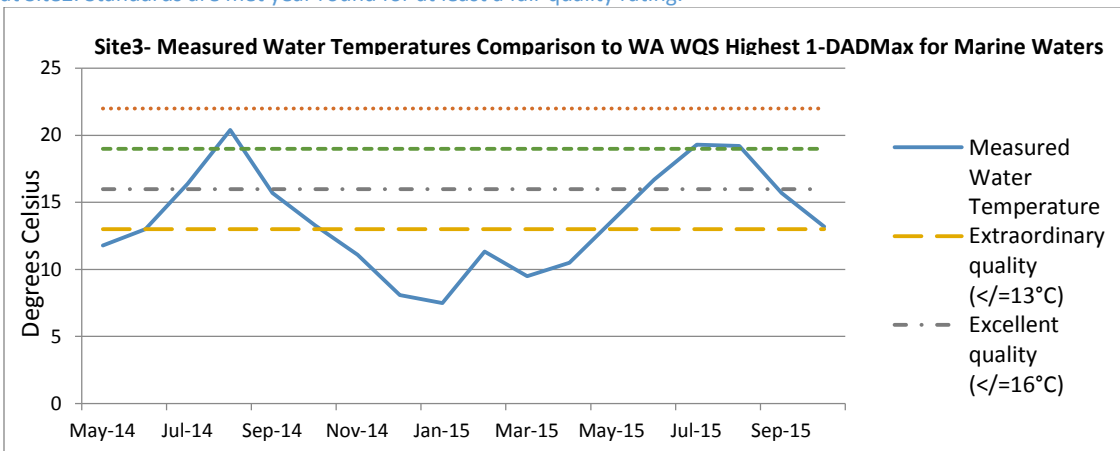
Figure 21: Comparison of Measured Temperatures to Washington State Water Quality Standards for Marine water at Site3. Standards are generally good quality or better. A fair quality rating would apply in July 2014 and 2015

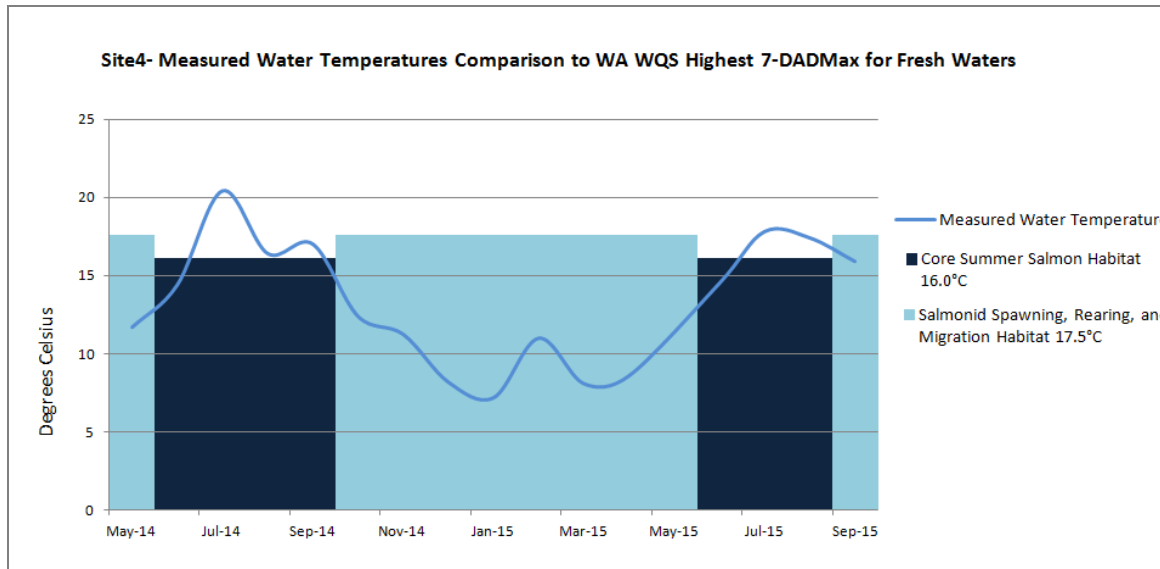
Figure 22: Comparison of Measured Temperatures to Washington State Water Quality Standards for Freshwater water at Site4. Excursions occur during July of 2014 and 2015 and in August 2014 when temperatures exceed 16.0°C, however this was a single day data collection versus a week long data collection maximum.

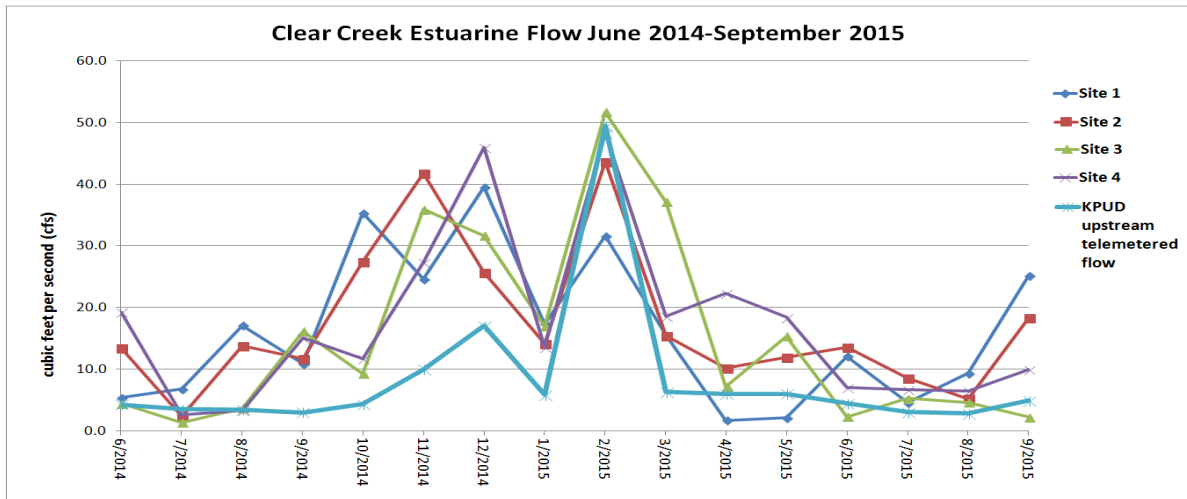
Figure 23: 2014-2015 measured flows in Clear Creek Estuary at Monitoring sites and Kitsap Public Utilities Department’s (KPUD) telemetric gauge for the Clear Creek mainstem show a consistent pattern of low summer and high winter flows .

The methods used captured mainly surface flow and illustrate moderate flow rates with seasonal differences in capacity from June 2014 through October 2015. Measures of the streams carrying capacity generally indicate low to moderate power to transport silt from fresh to marine waters. Flow rates were predictably higher during winter months and generally in line with stream flow data recorded at the Kitsap Public Utilities Department’s upstream monitoring gauge [figure 23]. High peak flows occurred in December 2014 and February 2015 at all monitoring sites. Lower flows predictably were recorded during summer months, although in the project data higher flows were measured in 2014. This is related to sampling at high tidal stages. Site 1 flows ranged from 1.7cfs in April 2015 to 39.5 in December 2014. Site 2 flows showed a similar range at 5.21cfs in August 2015 to 43.6cfs in February 2015. Site 3 flows ranged from 2.22cfs in September of 2015 to 40.7cfs in February 2015. Likewise Site 4 had flows ranging from 2.6cfs in July 2014 to 48.3cfs in February 2015.

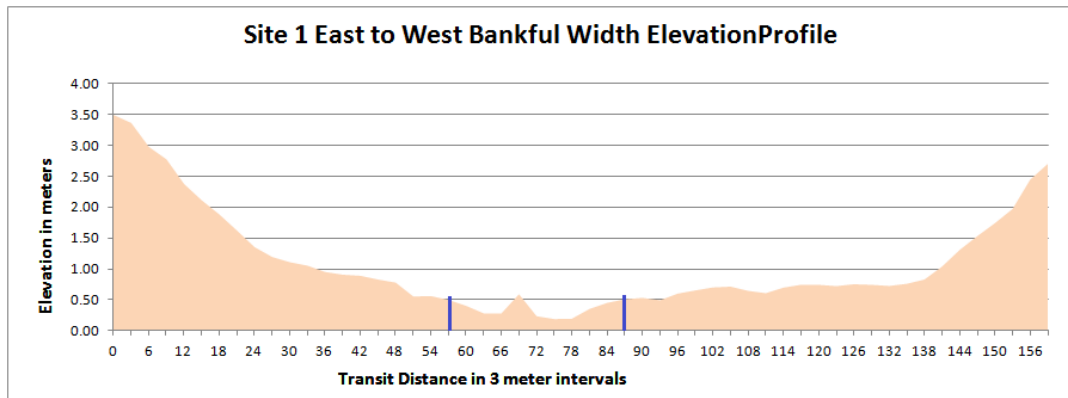
Figure 24: Site 1 at 161.8m is the widest and most southerly transit. Starting from the eastern bank and moving westward, the elevation decreases rapidly then continues to sink at a more gradual rate. The area between 57m and 87m is nearly always wetted. A six meter wide sand and silt bar is situated between 66 and 72m. This was the northern tip of a much larger sediment deposition that split the creek egress into two channels. Approaching the last 30m of the profile, the elevation again changed rapidly; however the gain was not a great as it reached 2.67m high on the western bank versus 3.5m high on the eastern side.

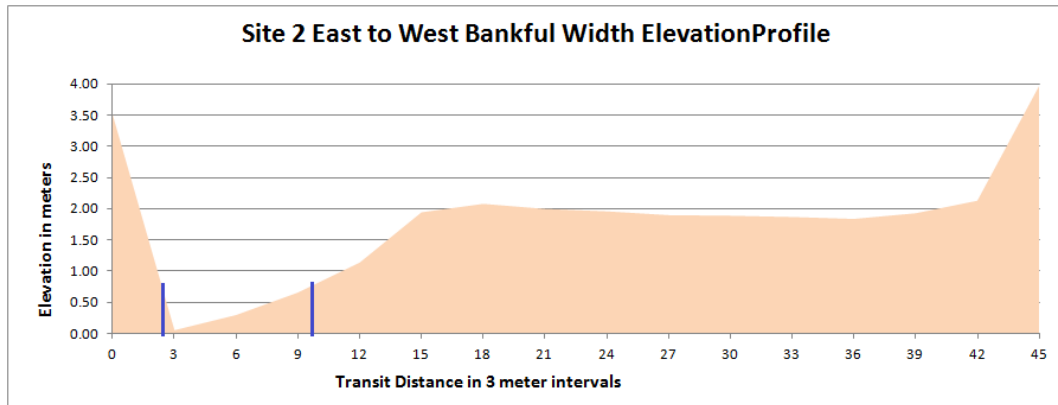
Figure 25: Site 2 is 44.02m wide and most the deepest transit. This site lies 42m downstream of the culverts. Starting from the eastern bank and moving westward, the elevation decreased immediately to the thalweg. The area between 2.75m and 9.25m was nearly always wetted. The slope began to rise at a more gradual rate in the westerly direction then leveled off over the width of the old mill pond. The final 2m showed a steep rise in elevation.

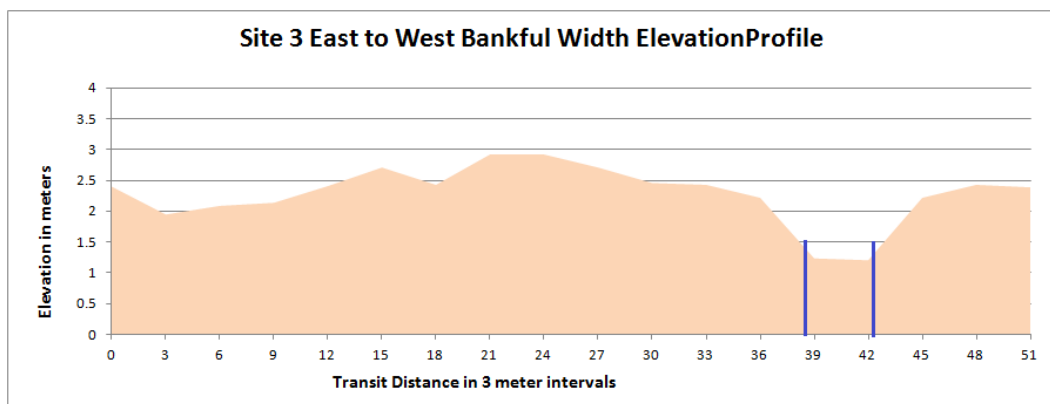
Figure 26: Site 3 at 52.10m is the north of the culverts and existing berm which imposed an eastward bend in the creek. At this location, load deposition created the most heavily silted sediments of all the sites. Aside from mounds of saltwort/glasswort found at 15m and 21m from the eastern bank this profile exhibited low to moderate elevation changes. A meter drop occurred in the thalweg area, between 38.75m and 42.1m, where it is nearly always wetted. The western bank rises rapidly then levels off.

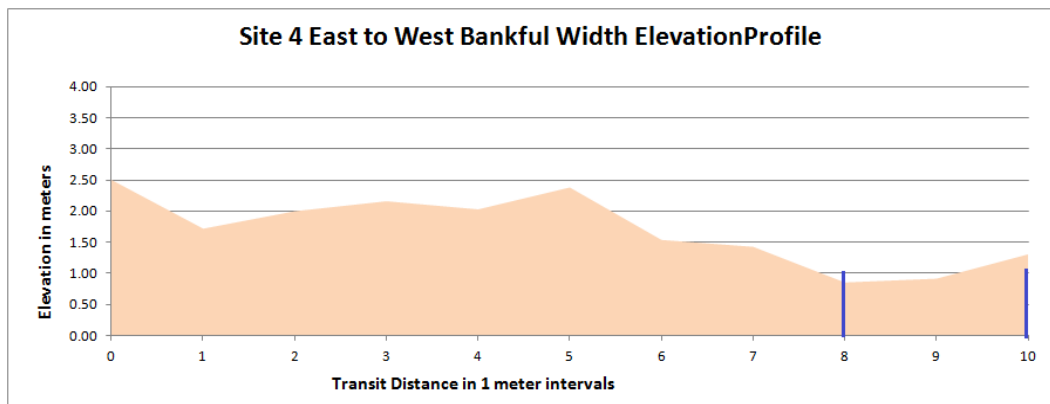
Figure 27: Site 4 at 10.4 m is the transit furthest north from culverts and least often fully inundated with tidal waters. It is also the narrowest transit; therefore measurements were taken in 1 meter intervals. From the eastern bank the profile declines through a -shallow slough then rises again across a flattened salt marsh plain. At the edge of the plain, the land drops steeply to a silty sand bank which was frequently wetted. The area between 8m and 10.4m is nearly always wetted.

Site 4 at 10.4 m was furthest north from culverts and least often fully inundated with tidal waters. It was also the narrowest stream channel; therefore measurements were taken in 1 meter intervals. From the eastern bank the profile declines through a shallow slough then rises again across a flattened salt marsh plain. At the edge of the plain, the land drops steeply to a silty sand bank which was frequently wetted. The area between 8m and 10.4m was nearly always wetted [figure 27].

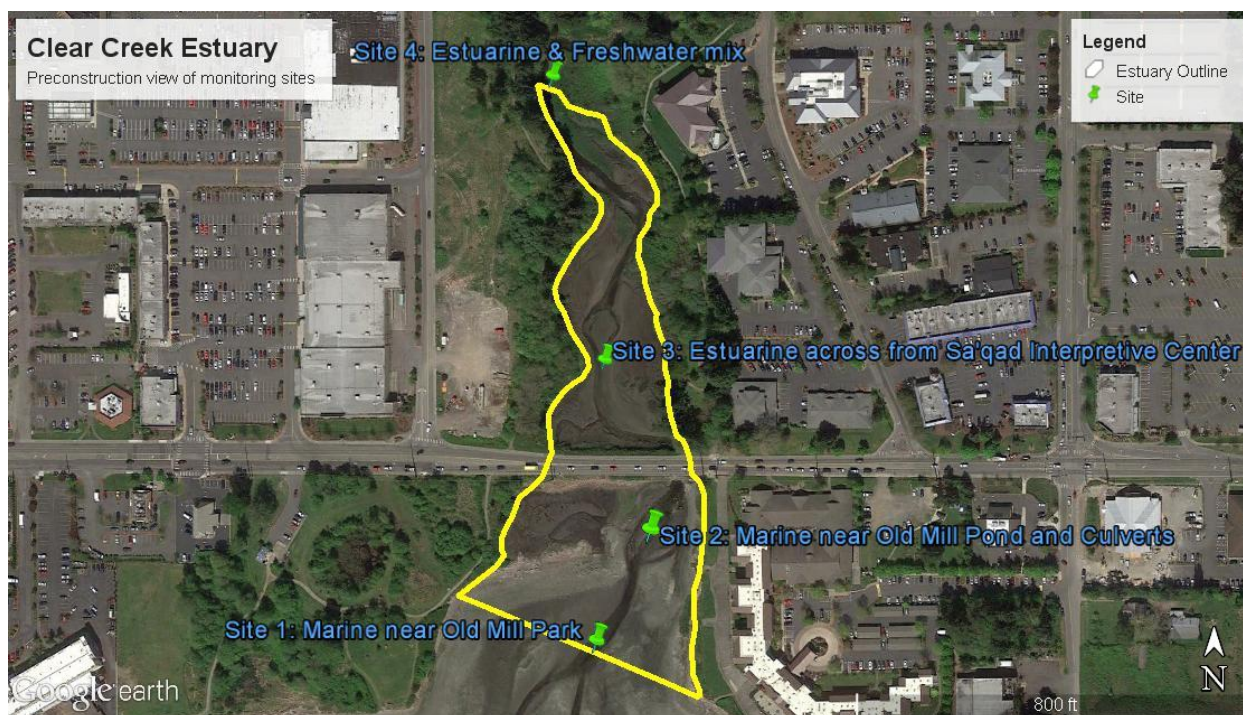
Figure 28: Monitoring Sites on the Clear Creek Estuary include two sites north of the existing culverts and two sites south of them. Courtesy of Google Earth.

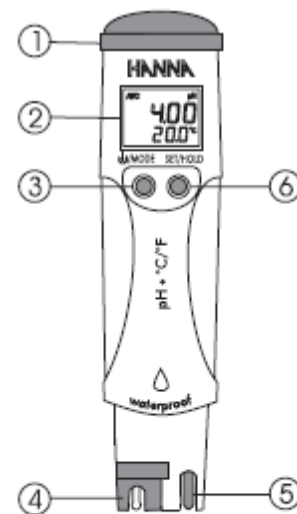
1. Battery compartment
2. Liquid Crystal Display (LCD)
3. ON/OFF/MODE button
4. HI 73127 pH electrode
5. Temperature sensor
6. SET/HOLD button

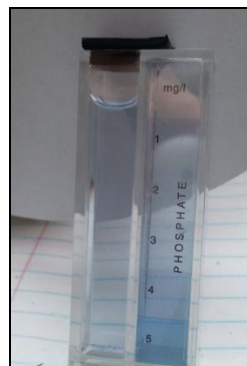
Figure 33: Colorimetric Analysis of phosphate ( $\text{PO}_4$ ) concentrations in a solution is a comparison of the prepared solution to a standardized color scale.

2) **Colorimetric analysis (C)**: Method used to measure the concentration of a specific element or component by adding a reactive ingredient (reagent) to the solution then visually comparing the resulting color to a predefined scale (standard) of that particular element or compound (figure 6). Tests by colorimetric process are marked with (C).

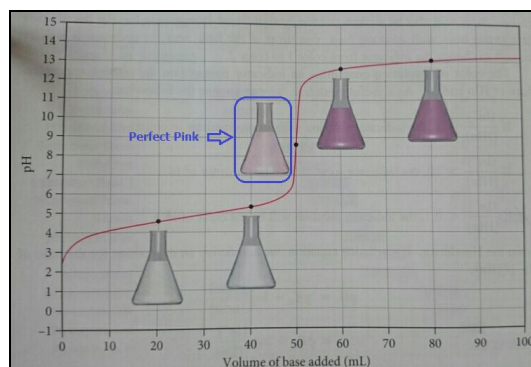
Figure 34: Phenolphthalein indicator is used to calculate acidity concentration in an aqueous solution. Equilibrium of acidic ions to alkaline ions is reached when the solution is a light pink hue aka "Perfect Pink."

Much aquatic life is sensitive to pH levels and will thrive within more neutral ranges. Acid added to a stream would cause an immediate change in the pH. In determining the concentration or amount of acid (free hydrogen ions) in the water sample, a diluted sodium hydroxide is used as the titrant or buffering solution. Strong acid contribution to the sample is known as *methyl orange* acidity. Total acidity is caused by both mineral and organic acids and is called *phenolphthalein* acidity.

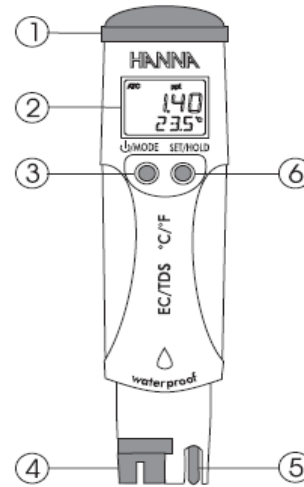
1. Battery compartment
2. Liquid Crystal Display (LCD)
3. ON/OFF/MODE button
4. HI 73311 EC/TDS probe
5. Temperature sensor
6. SET/HOLD button

The TDS value (automatically compensated for temperature) is shown on the primary (larger) LCD at the top of the screen while the secondary (smaller, lower levels) LCD shows the temperature of the sample.

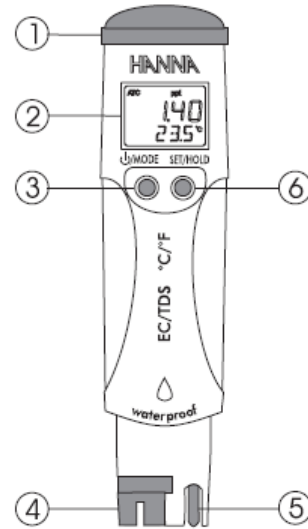
1. Battery compartment
2. Liquid Crystal Display (LCD)
3. ON/OFF/MODE button
4. HI 73311 EC/TDS probe
5. Temperature sensor
6. SET/HOLD button

on the top left of the LCD disappears. The TDS value (automatically compensated for temperature) is shown on the primary (larger) LCD at the tops of the screen while the secondary (smaller, lower level) LCD shows the temperature of the sample (see figure 3 or 43).
