# Laboratory Performance of Highway Bridge Girder Anchorages Under Simulated Hurricane-Induced Wave Loading

**OTREC-RR-12-05  
July 2012**

School of Civil and Construction Engineering  
Oregon State University

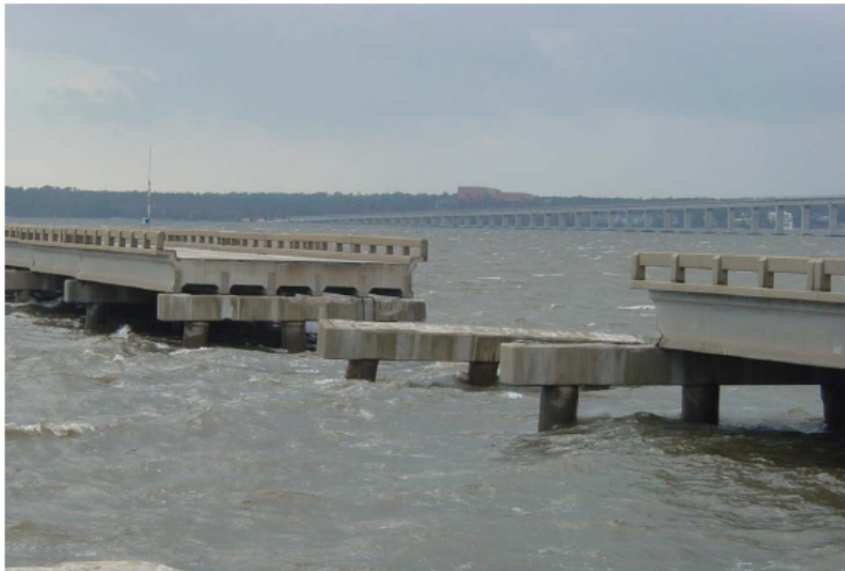
Figure 1: Example of damage at Escambia Bay, FL, after Hurricane Ivan (Courtesy W. Nickas).

Recent strong hurricanes have caused significant damage to the transportation infrastructure along the U.S. Gulf Coast, shown in Figure 1. Hurricane Katrina caused over \$100 billion in total damage in 2005, with at least \$1 billion allocated to bridge repair and replacement (Padgett et al., 2008). Bridges are particularly critical assets as they limit the transportation system's capacity and can delay rescue, recovery and rebuilding efforts after an event. As the severity and frequency of Gulf Coast hurricanes may be expected to increase in the future, it is critical to identify bridges that are susceptible to damage and determine rehabilitating strategies so that bridges exhibit desired performance during these events.

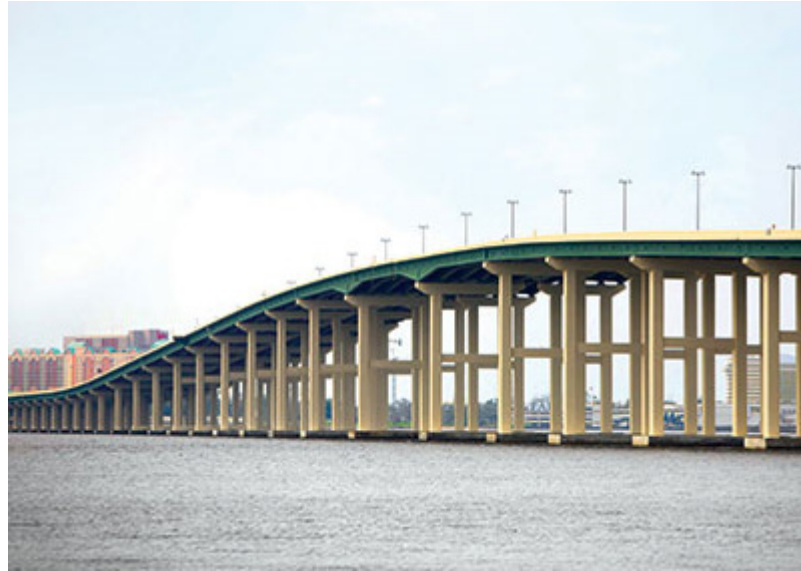
Figure 2: Replacement bridge at Biloxi Bay, MS (B. Hull, MDOT).

Since 2005, damaged bridge spans have been replaced by bridges with significantly higher superstructure elevations, shown in Figure 2. It is unlikely that future storm surges will be sufficiently high as to damage these new superstructures; however, the approach spans for

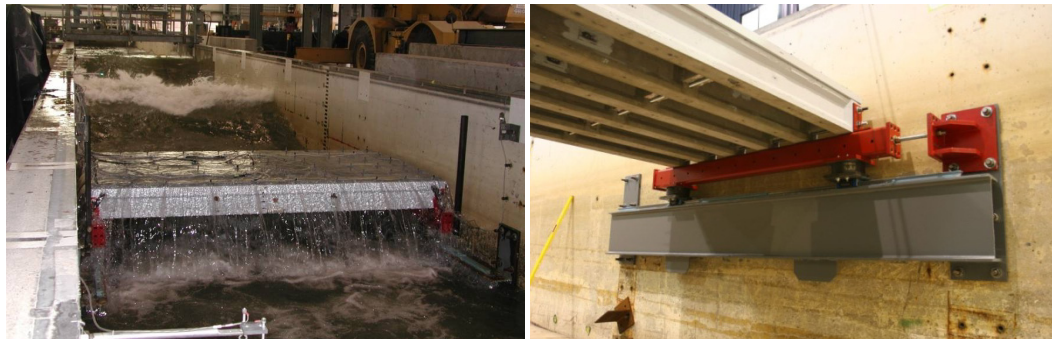
Figure 3: Hydrodynamic 1/5-scale model of bridge span in wave flume (Bradner, 2008).

Previous research performed at Oregon State University's O.H. Hinsdale Wave Research Laboratory large wave flume produced wave load response data on a 1:5 geometric scale based on the bridge geometry of I-10 over Escambia Bay, FL. A picture of the scaled span in the flume is shown in Figure 3.

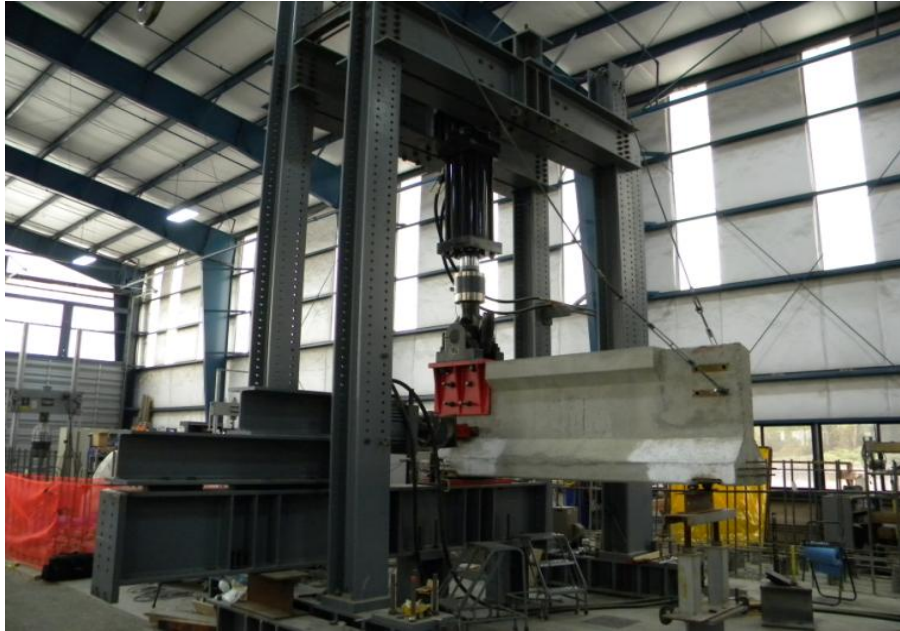
Figure 11: Laboratory setup.

centered between the two frames. W12x120 columns were supported by two W14x159 stiffened steel beams 9 feet in length, which were anchored to the strong floor with 1¼-inch diameter high-strength threaded rods, shown in Figure 11.

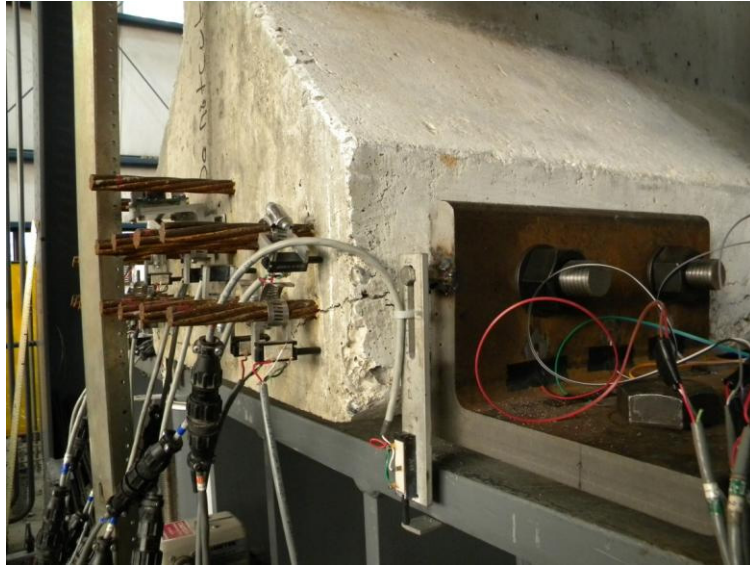
Figure 15: Example specimen instrumentation.

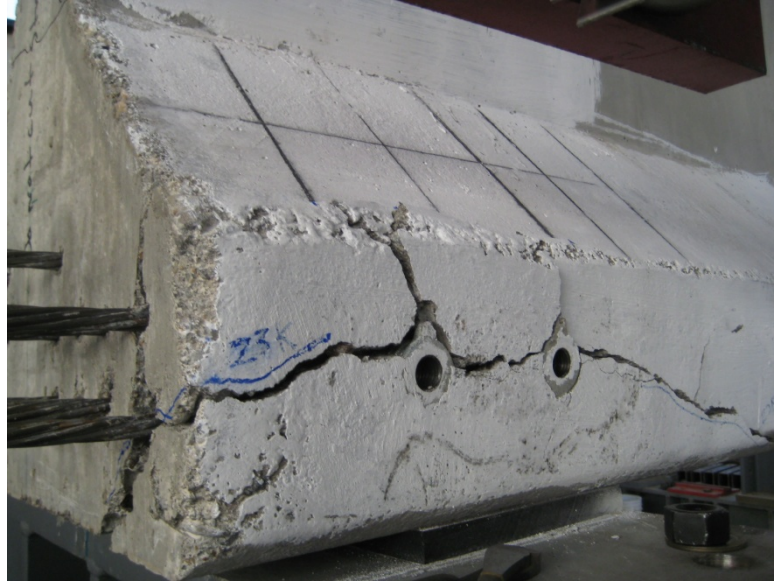
Figure 19: Cracking pattern specimen CB-1.

The failure plane of the anchorage is characterized by splitting of the concrete around the threaded inserts. The crack propagated at a 35° angle until reaching the edge of the flange, as shown in Figure 19.

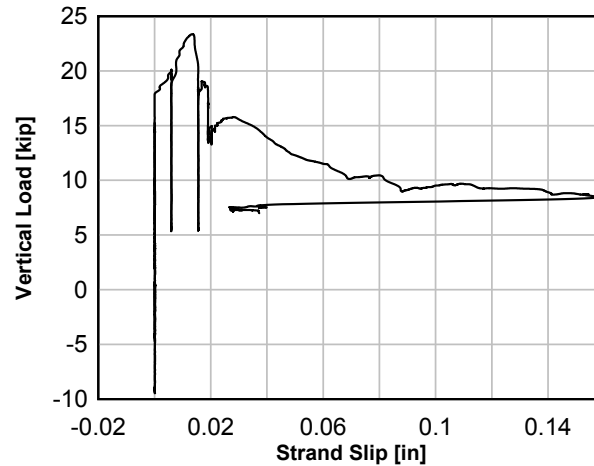
Figure 20: Load vs. Strand slip for strand #9 CB-1.

disrupted by the formation of cracks. Figure 20 shows the load versus strand slip of the specimen for strand 9. No yielding of the steel angles was measured.

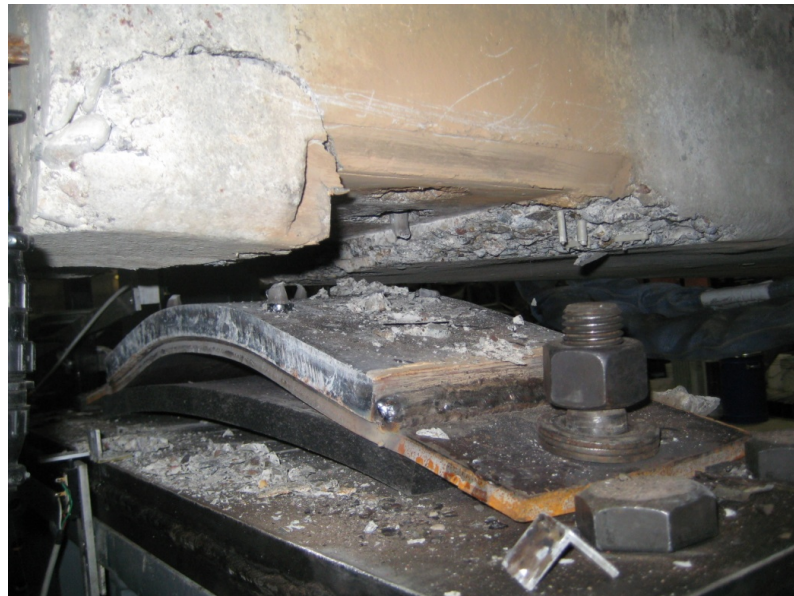
Figure 21: Failure of specimen HS-1.

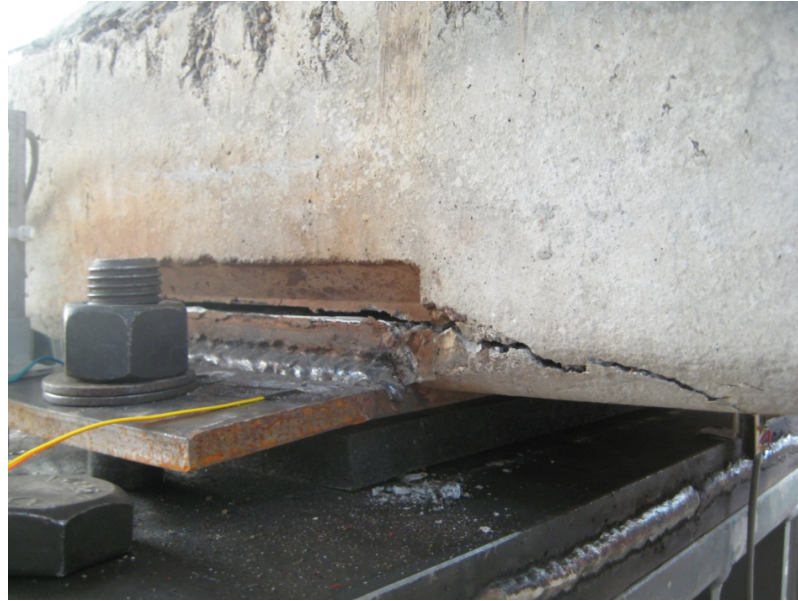
Figure 22: Cracking of specimen HS-1.

overall plate bending and local bearing at the bolt holes. Concrete cracking was observed around the corners of the embedded steel plate as seen in Figure 22, but no strand slip was measured by the instrumented strands, indicating that damage was localized and limited to the headed studs and concrete around the embed plate. The in-situ conditions at Escambia Bay used 1-inch diameter A307 swedge bolts in place of the 1¼-inch diameter A325 bolts used in the present experimental setup. The smaller and lower strength bolts used in the actual construction of the bridge were observed to have failed during Hurricane Ivan.

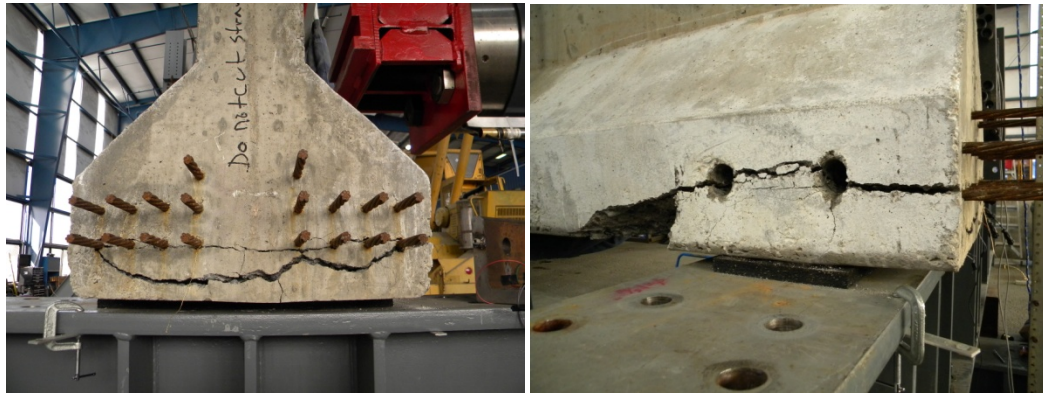
Figure 23: Failure cracks in specimen TB-1.

The specimen was loaded in tension in increments of 10 kips. The specimen failed at an applied vertical load of 34 kips tension. The load deformation response of the specimen is shown in Figure 18c. Starting at 15 kips, cracking of the concrete flange was observed prior to failure below the bottom layer of prestressing strand across the width of the girder flange. The concrete cracks propagated under the steel banding below the prestressing strand and mild steel. The test was stopped after the crack propagated across the width of the girder. Failure was categorized as tensile failure of the concrete surrounding the bolt holes, followed by bending of the bolts. Minimal rotation of the specimen was observed during the test. Maximum vertical displacement of the specimen was 1.02 inches at failure. No yielding of the steel angles was observed.

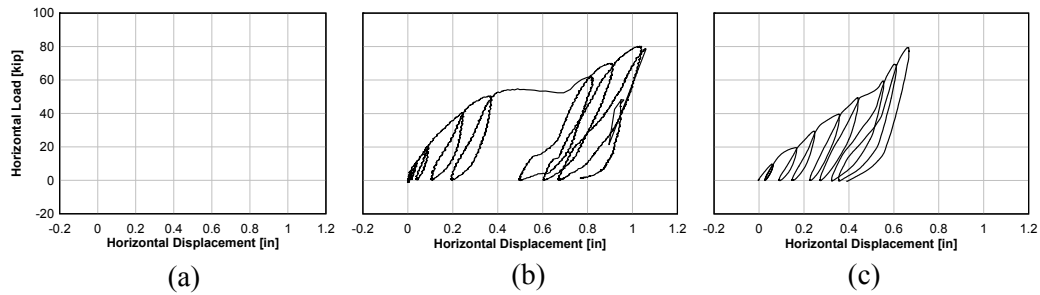
Figure 26: Horizontal load-deformation response for CB-2 (a), HS-2 (b), TB-2 (c).

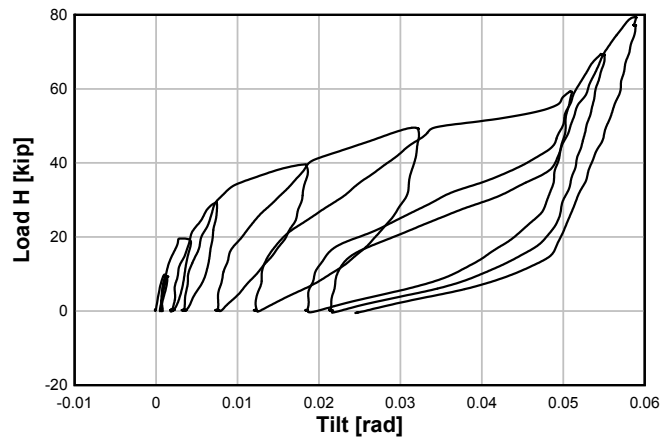
Figure 27: Horizontal load v. Tilt for specimen TB-2.

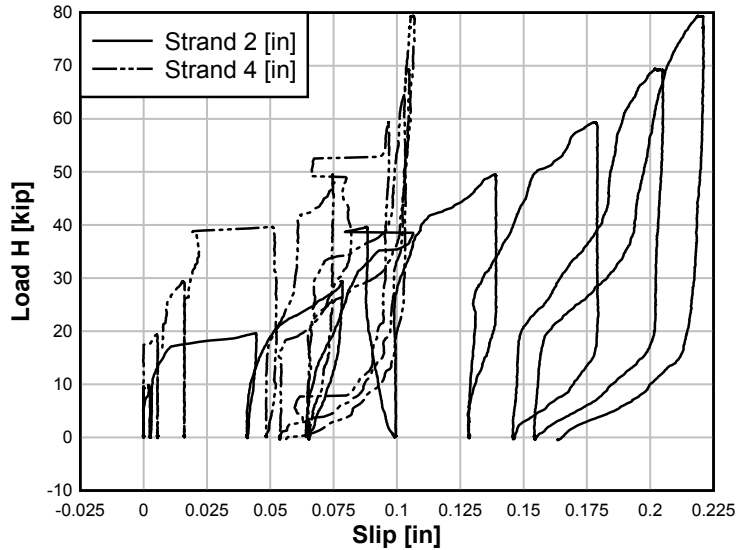
Figure 28: Horizontal load v. Strand slip for specimen TB-2.

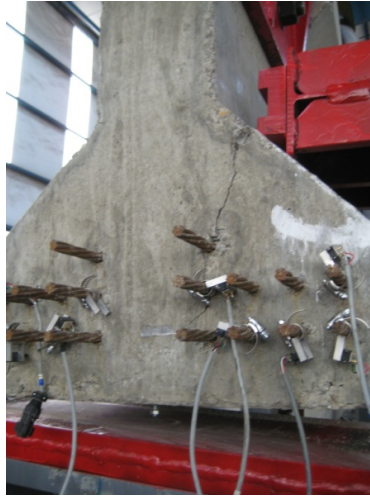
Figure 31: Cracking of specimen HS-3 due to bearing of flange on horizontal actuator loading plate.

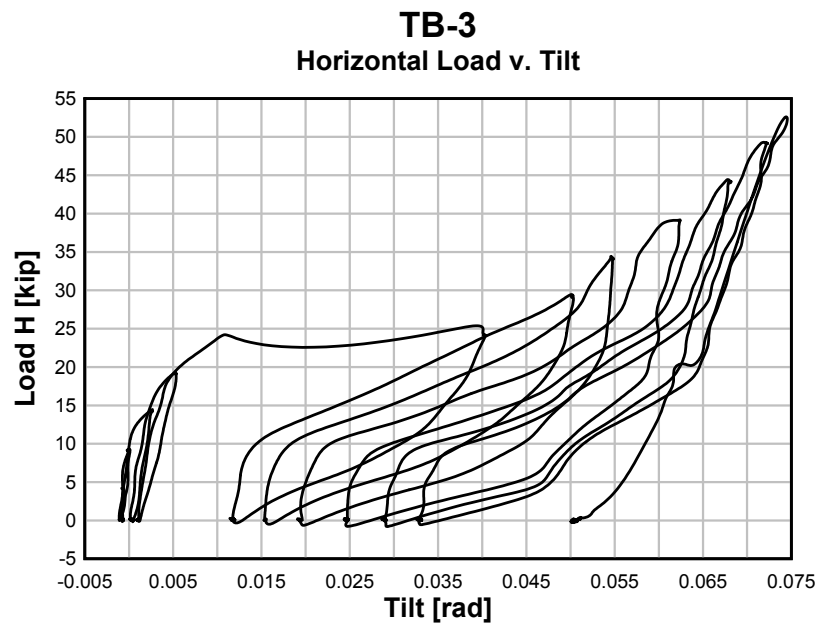
Figure 32: Horizontal load vs. Tilt for specimen TB-3,

propagate to failure. After initial cracking, the specimen began to rotate as seen in Figure 32. The primary cracking of the beam began at the through bolts and extended down below the bottom layer of strand, following the banding. At failure, when the beam cracked completely across the cross section, the through bolts did not displace as much as the rest of the specimen, pulling down on the bottom layer of strand and causing a secondary crack to form. This exposed more of the prestressing strands, as well as the mild steel reinforcing to the stem of the girder. During the course of the test, sensors from strands 3, 4 and 7 were damaged, but slip was measured prior to damage. Strands 1,5,6 and 10, located on the upper layer of strand, measured less than 0.007 inch during the test. Yielding of the steel angle was measured by all six strain gages on the loaded side of the specimen. Maximum strain was 1,360  $\mu\epsilon$  measured by gages 4, 5 and 6.

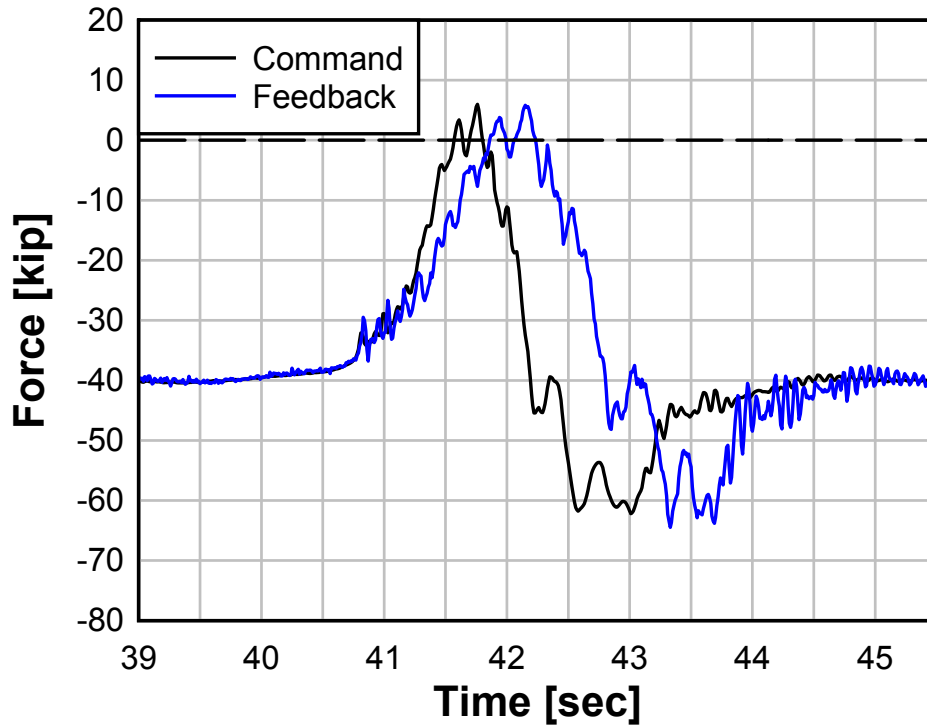
Figure 34: Example of command and feedback of applied vertical load history for specimen CB-4.

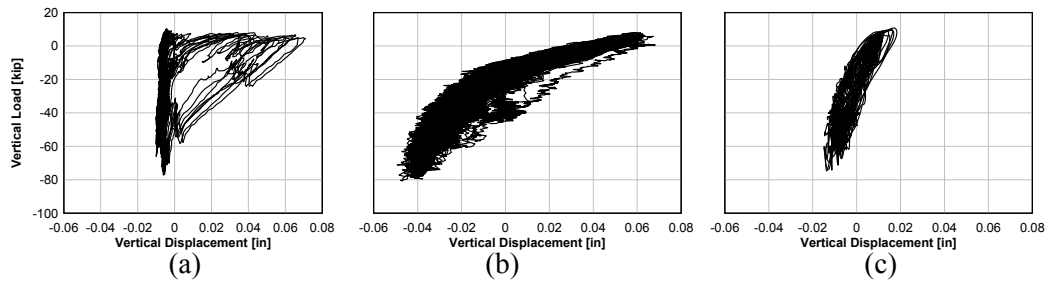
Figure 37: Vertical load-deformation response for CB-4 (a), HS-4 (b), TB-4 (c) (Initial Test).

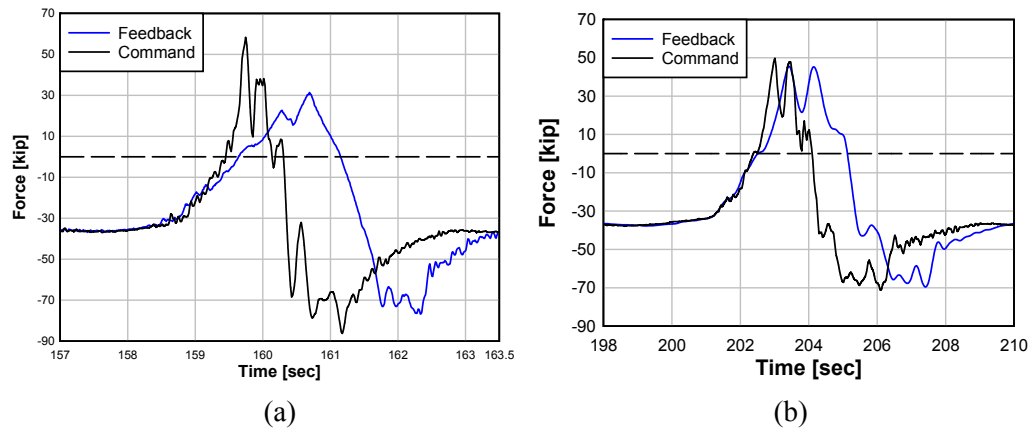
Figure 39: Example of command and feedback of applied vertical load history for HS-4 Real Time (a) and Half Time (b),

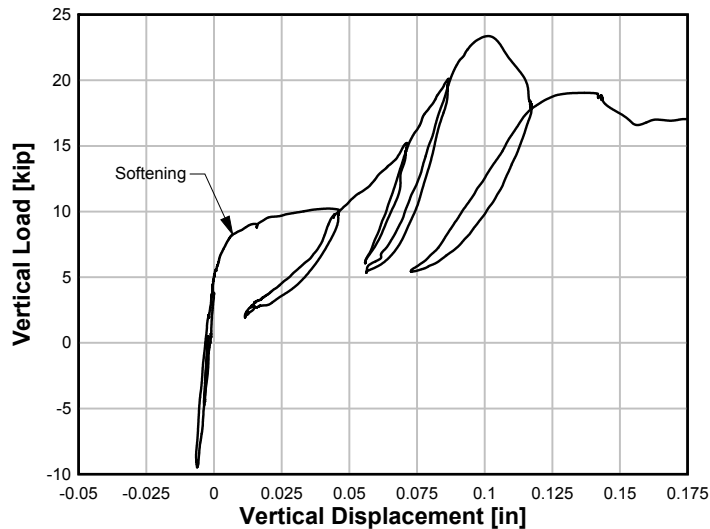
Figure 42: Initial part of vertical load-vertical displacement behavior for specimen CB-1 showing softening.

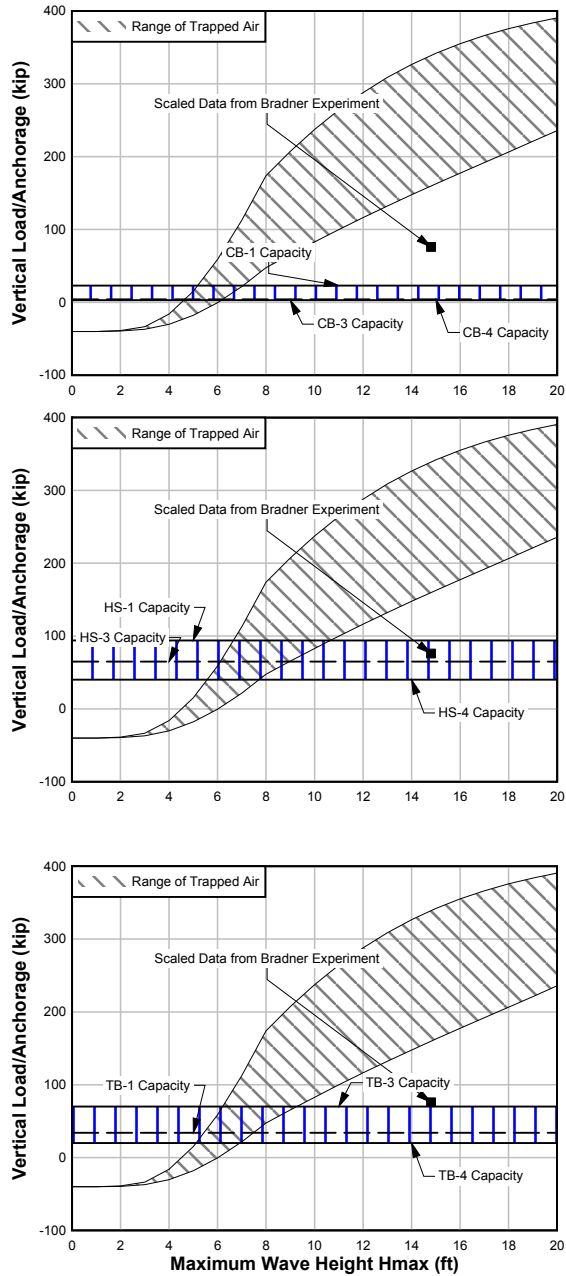
Figure F- 1: Maximum Vertical Load per Anchorage for Four Anchorage Points

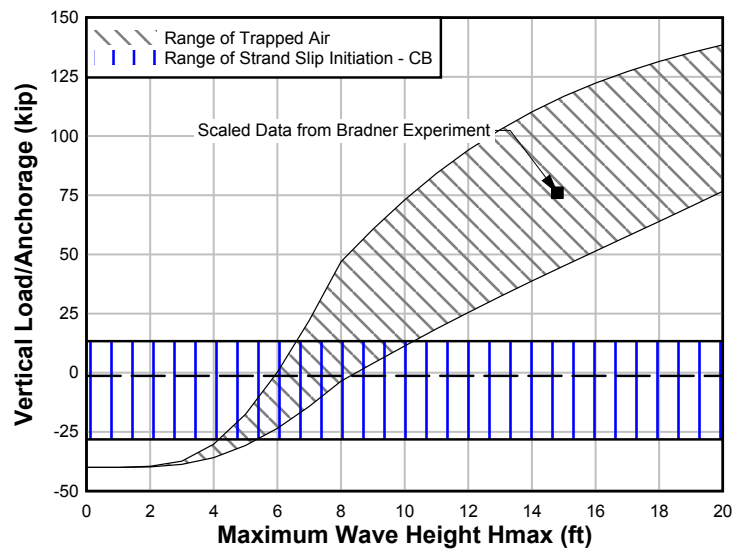
Figure F- 2: AASHTO Vertical Load per Anchorage and Strand Slip - CB Anchorage

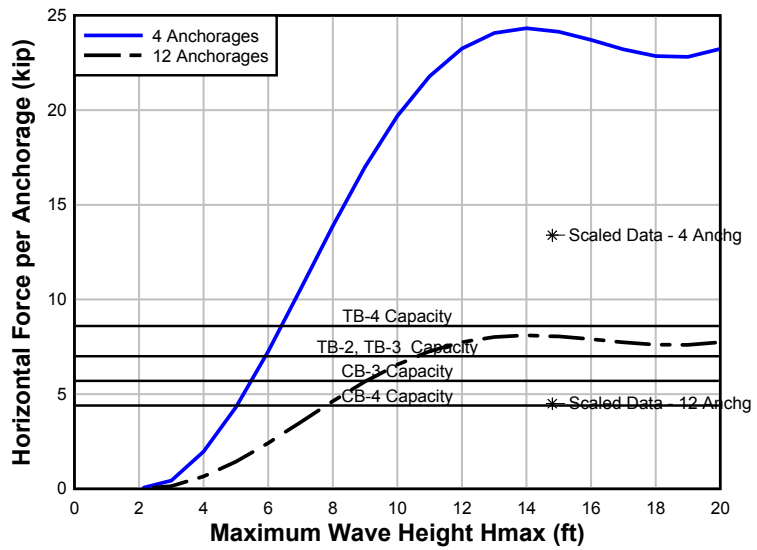
Figure F- 4: AASHTO Horizontal Load per Anchorage and Strand Slip

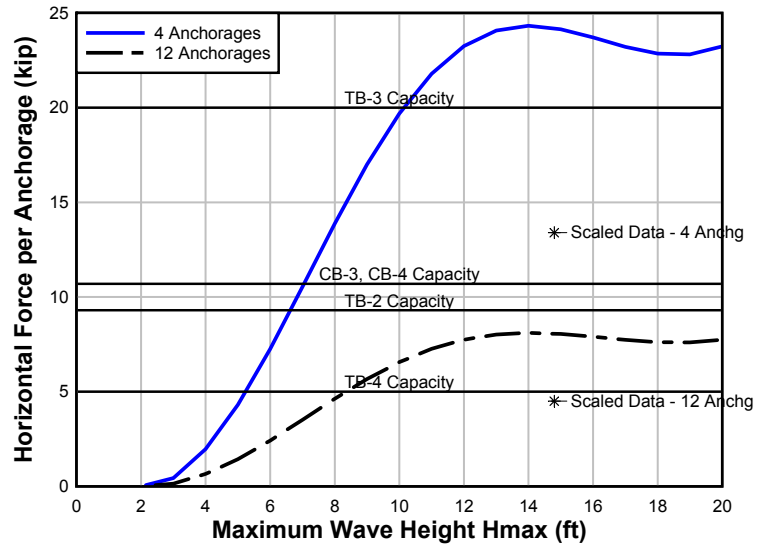
Figure F- 6: AASHTO Horizontal Load per Anchorage and Crack Initiation

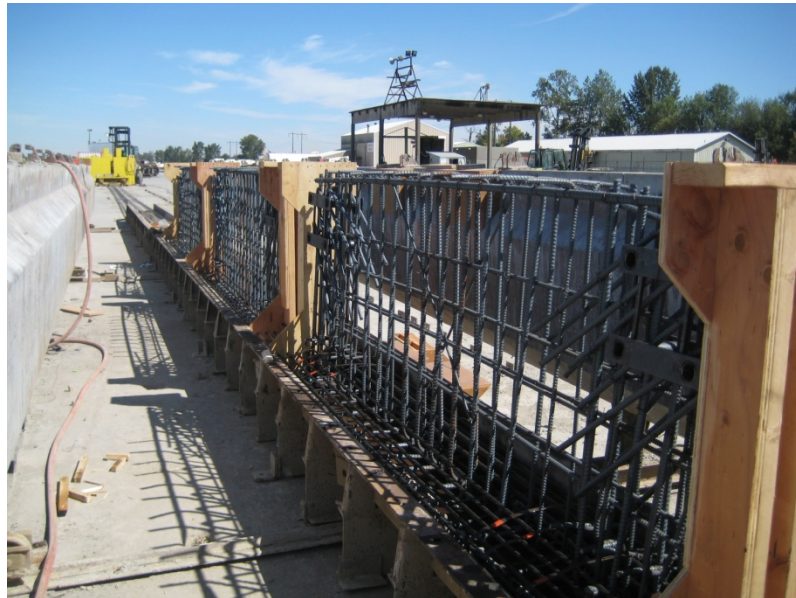
Figure G- 1: Knife River Prestressing Bed

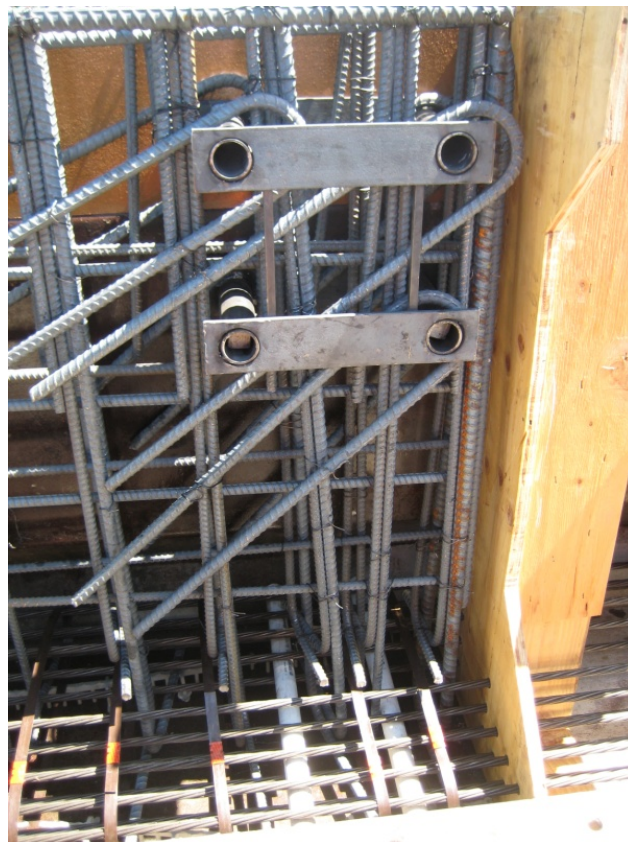
Figure G- 2: Reinforcing Modifications to Test Specimens

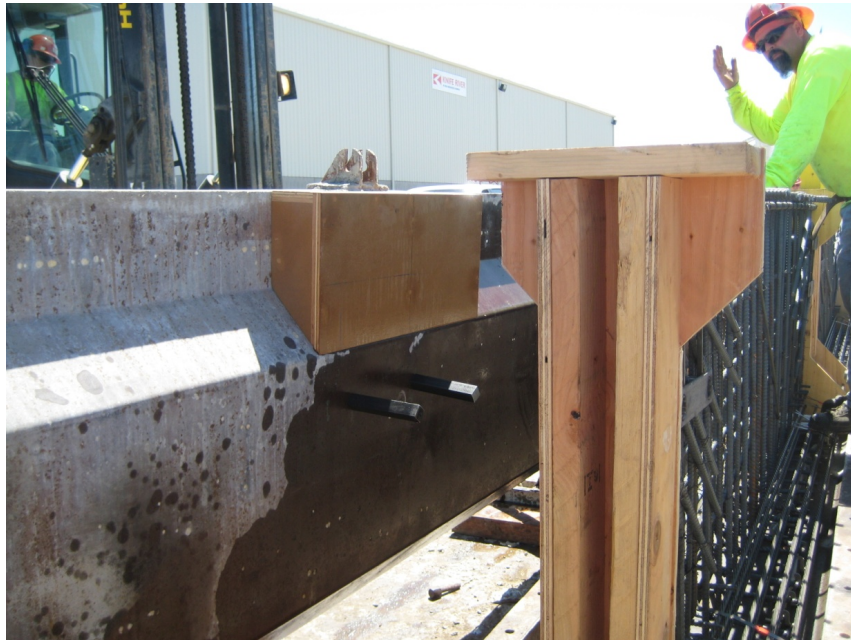
Figure G- 3: Top Flange Blockouts

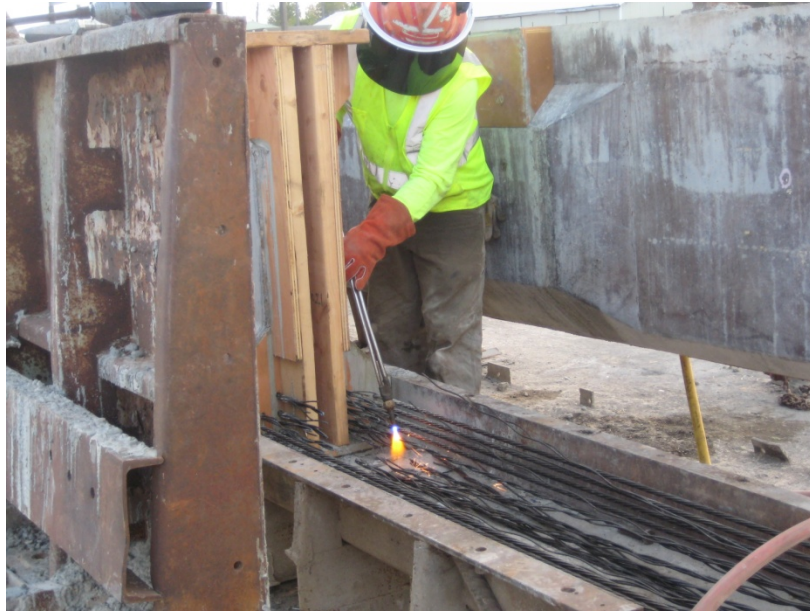
Figure G- 7: Torch Cutting of Prestressing Strand

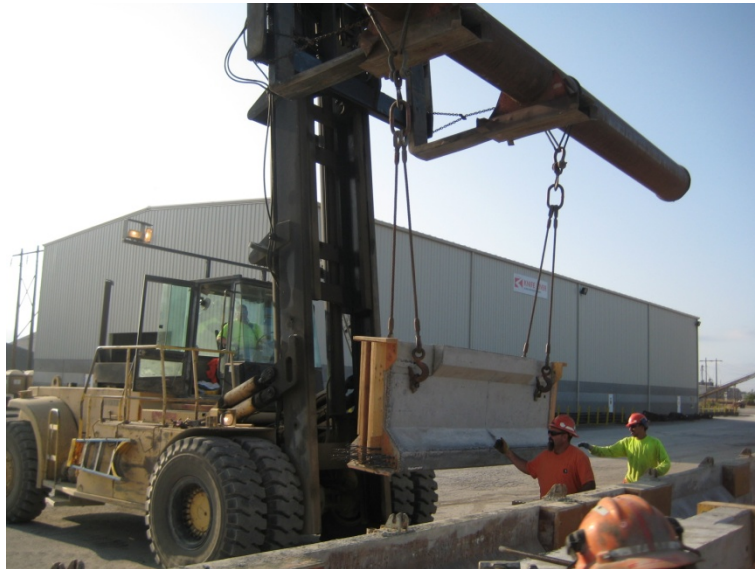
Figure G- 8: Removal of Specimen from Formwork
