# Mapping of Unstable and Potentially Unstable Slopes in Sogne og Fjordane

NGU Rapport 2011.055

Mapping of unstable and potentially unstable  
rock slopes in Sogn og Fjordane  
(work report 2008-2010)

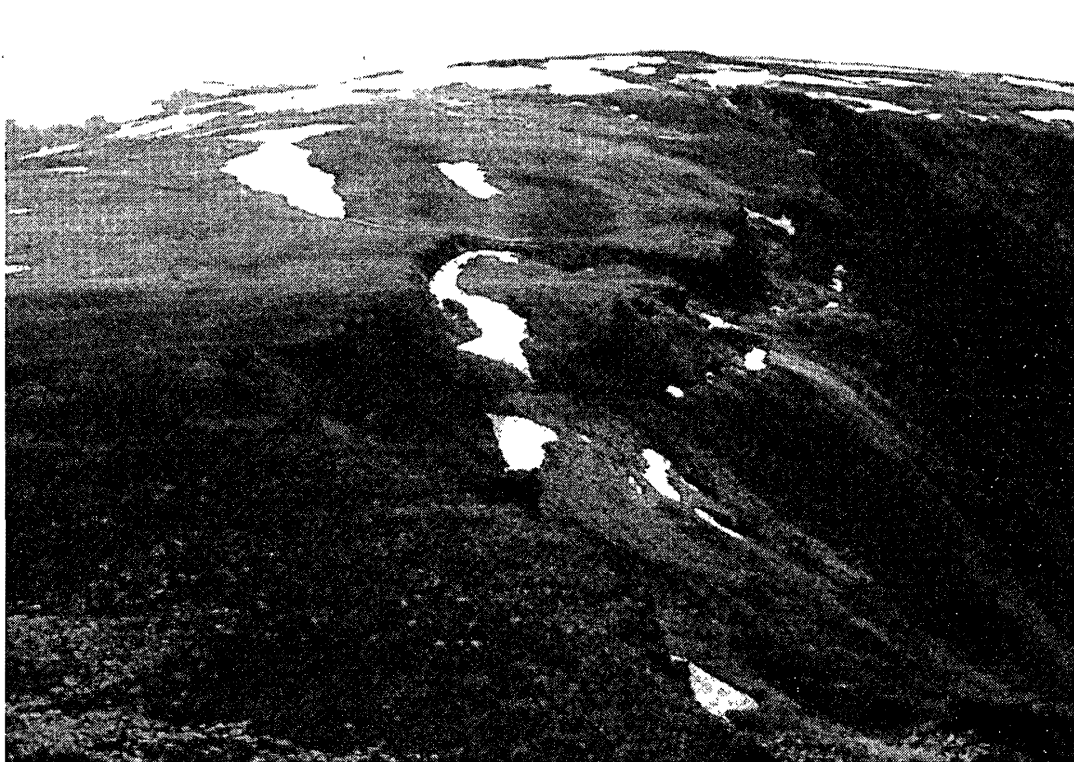
*Figure 5. Photo from the top above the unstable site Osmundneset in Hyenfjord, showing the top scar and the different detached and displaced blocks.*

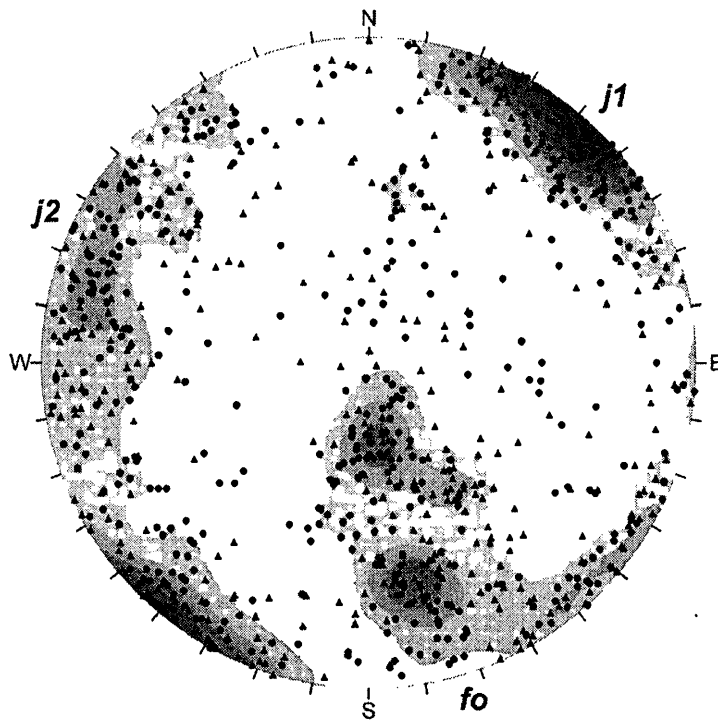
*Figure 14. Lower hemisphere stereonet showing the poles of all structures measured in the field (triangles) and the structures extracted from the TLS point cloud (circles). Shaded areas indicate Fisher concentrations of 1-2%, 2-3%, 3-4%, 4-5%, and 5-6% from lightest to darkest. Three major structures are present throughout the site: foliation (Fo), and two sub-vertical joints (J1 and J2).*

The bedrock on this side of the fjord consists mainly of gneiss, with well developed foliation and pervasive sub-vertical fractures. To document the structural trends of the unstable slope, we took 410 structural measurements in the field in 2008 and 2010, and made an additional 484 measurements using the georeferenced TLS point clouds (Figure 14).

The south-dipping foliation measurements tend to be from the northern part of the landslide complex, the west-dipping points from the center, and the north-dipping from the southern part, which plays an important role in controlling the landslide failure style. The spatial variation in foliation orientation described above defines a broad fold over a ~1 km distance that may control the location of this large rockslide feature over the long term. The first major joint set, J1, is present at nearly all measurement locations and is near vertical with a southwest or northeast dip direction. The orientation of this joint also varies spatially, with northeast-dipping measurements more common in the northern part of the landslide, and

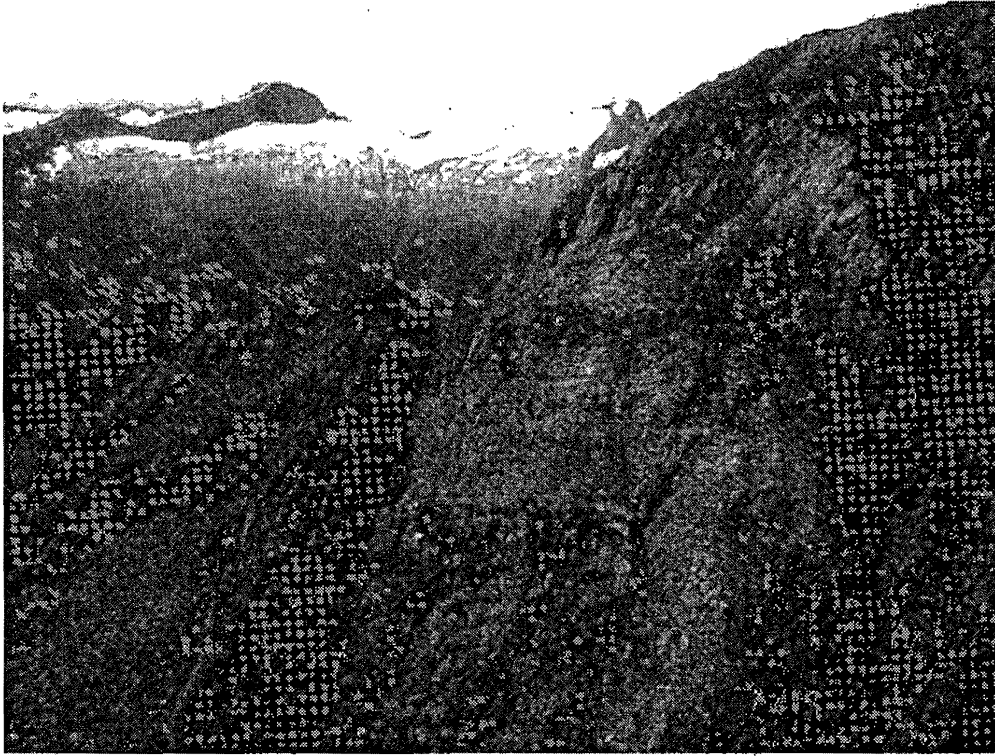
*Figure 34. Lateral view of the topmost part of the unstable area of Skrednipa. Several large, displaced blocks as well as a distinct sliding plane at the back scar are visible.*

Geological structures have been measured manually at different locations on the unstable site (Figure 32) and extracted from the TLS point cloud. Two different joint systems and a foliation were observed. Figure 37 shows the orientation of these geological structure systems at different locations in the upper part of the slope, and Figure 38 the orientation in the lower north-eastern part of the slope. The foliation as well as the joint sets show slightly different pattern in the different blocks. But generally, the foliation as well as the joint sets are with approx. 45-90 degrees relatively steep. This is consistent with the observed steep offsets between the main blocks (cf. Figure 34).

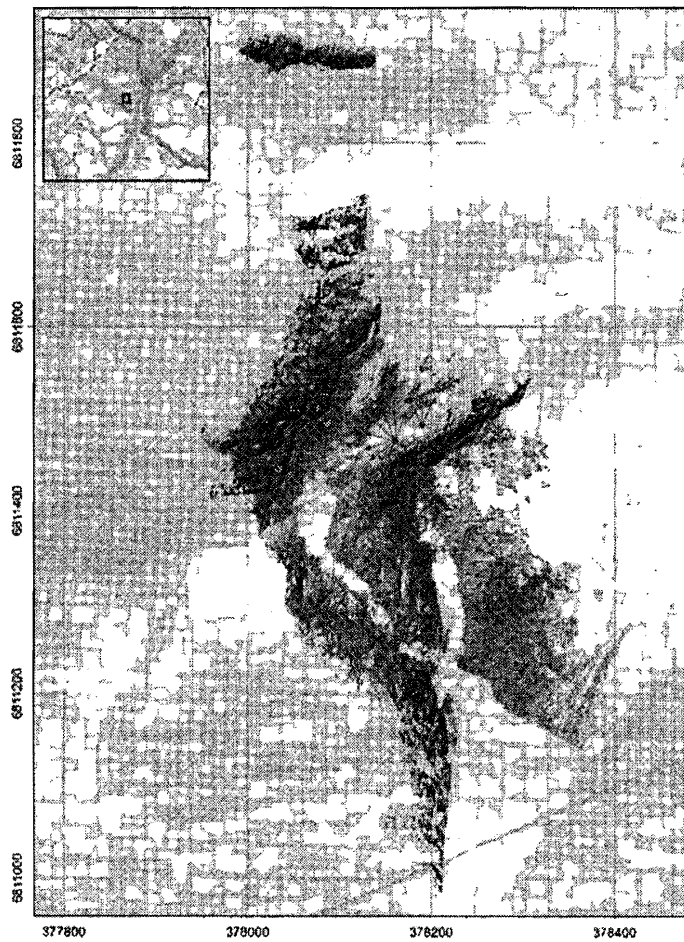
Figure 36. Hillshade of the 2010 TLS-DEM of Skrednipa. The scan positions and directions are indicated (red arrows).

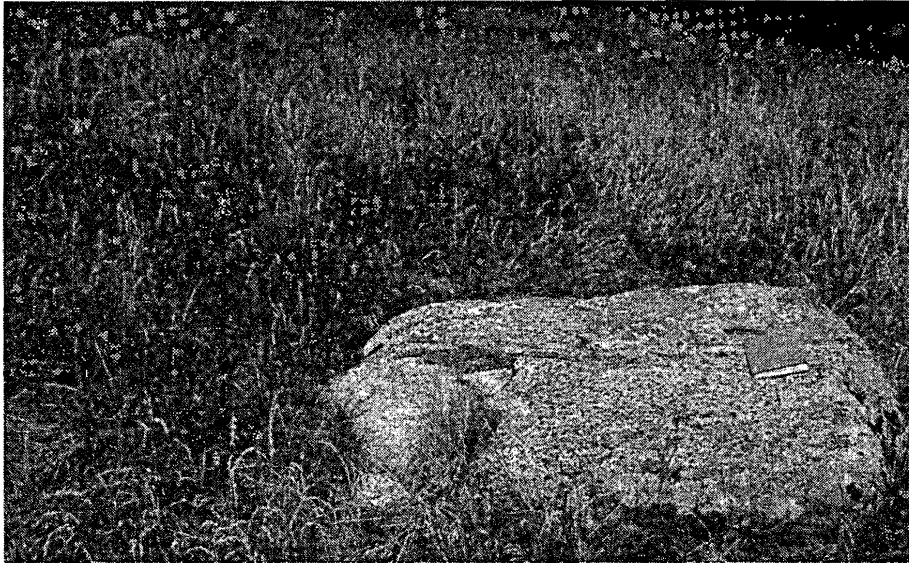
*Figure 40. Well-rounded boulders sparsely covering hummocks on the middle and lower slope are composed of a lithology allochthonous to the slope, suggesting that these deposits represent glacial deposits and not deposits related to a post-glacial rock avalanche as suggested in NGI rapport 76459-1 (1966).*

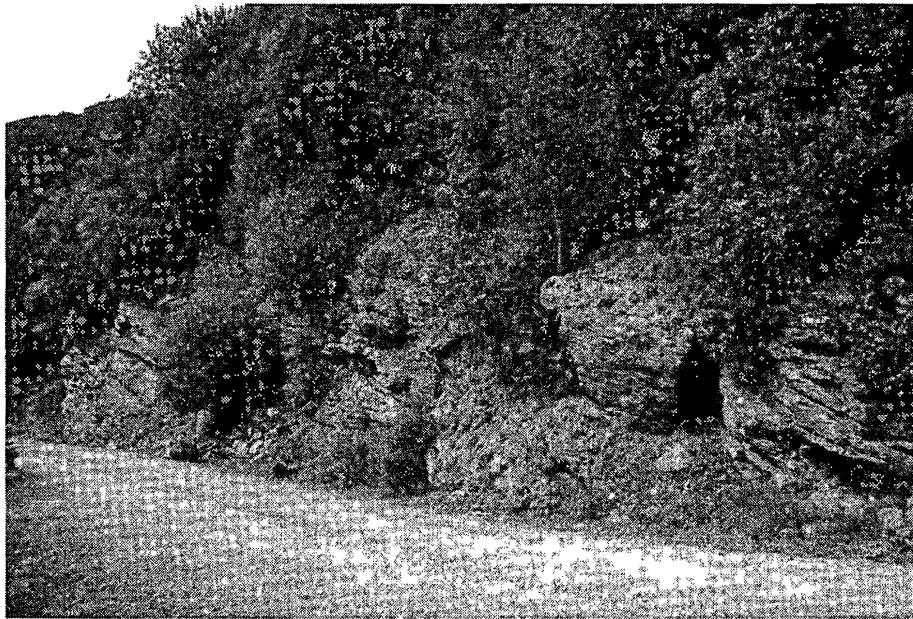
*Figure 41. Phyllitic bedrock with a constantly dipping foliation over the distance of several tens of metres covered by a thin cover of soil. This supports that no post-glacial rock avalanche has occurred.*

could be found (Figure 41). Therefore, we rule out a postglacial rock avalanche for that site and suggest that the obvious scar is due to a rockslide that deposited onto the glacier and has subsequently been removed. The slide event may even have occurred prior to glaciations.

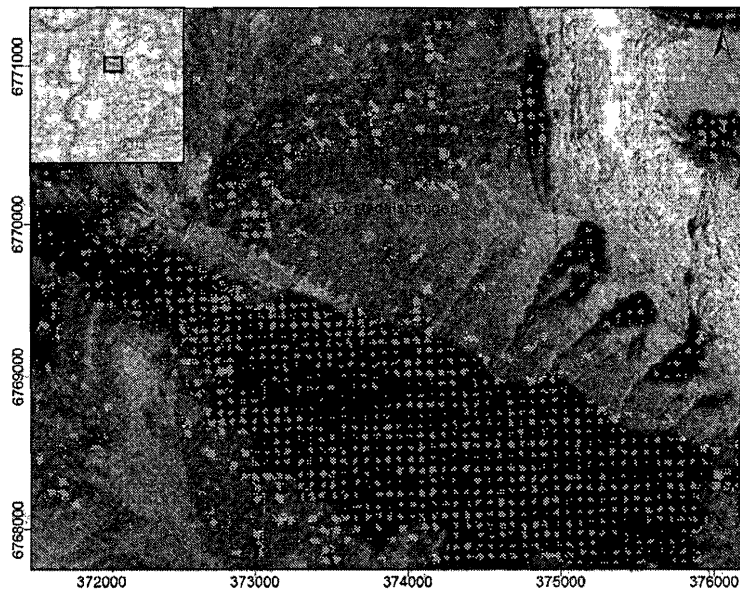
Figure 49. Location of the remotely investigated Øvstedalshaugen site. The whole area was inspected with a helicopter survey.

The location of the remotely investigated Øvstedalshaugen site is situated in the Seljedalen (Figure 49). No signs of an existing large unstable bedrock area were found from the helicopter survey. In some steep riverbeds, where bare bedrock occurs, minor rockfall activity can be observed (Figure 50, lower right photograph). No historical rockfall or rock avalanche is documented on skrednett.no. This site does not need any further investigation within this project.

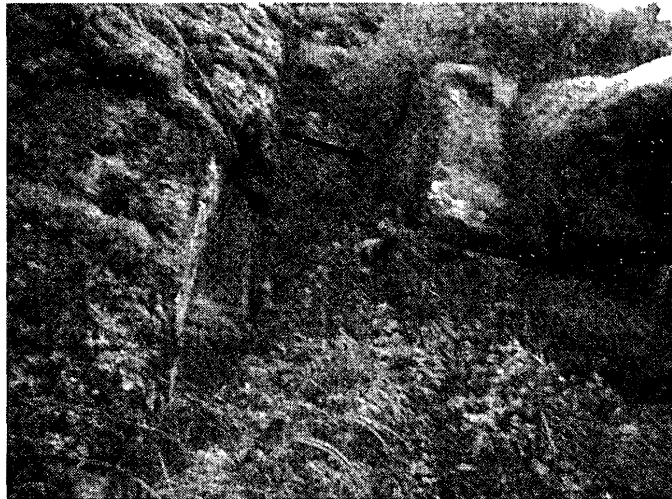
*Figure 58. Minor sliding of detached block on foliation plane*

Smaller blocks may detach from the tectonic fracture surfaces and slide some distance down slope on SE-dipping foliation planes (Figure 58). However, the dip of the foliation is too gentle (Figure 57a) to cause any significant sliding along the foliation planes.

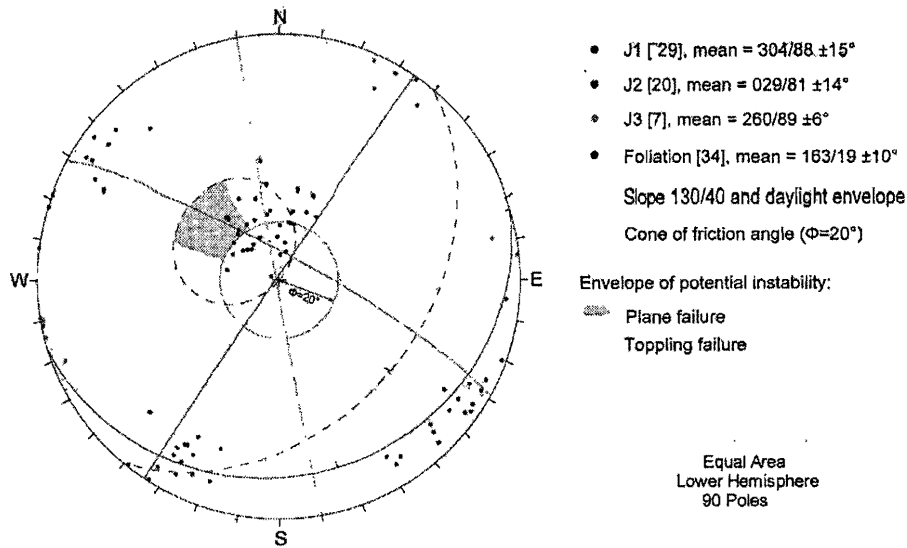
Figure 66. Stereoplot of the in-situ measured geological structures.

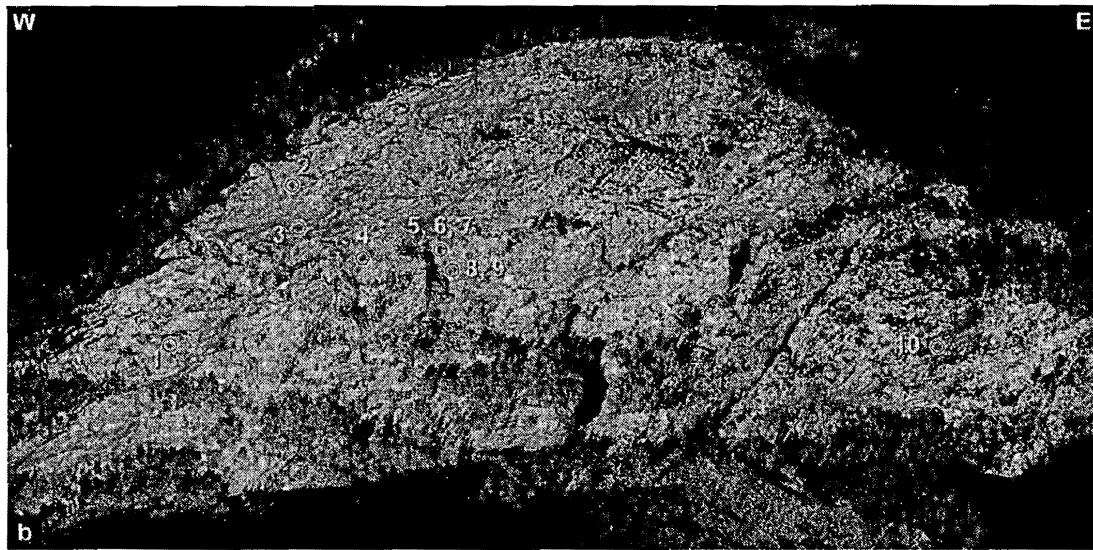
Figure 95. Location of the 2009-2010 rockfalls at Ramneberget (Øvre Årdal): a) panorama picture; b) 3D view of the 2010 TLS point cloud; c) detail of rockfall #4 with the meshed TLS point clouds (2009: light blue; 2010: orange); d) differences between the 2009 and 2010 TLS point clouds showing the missing volume due to rockfall #4.

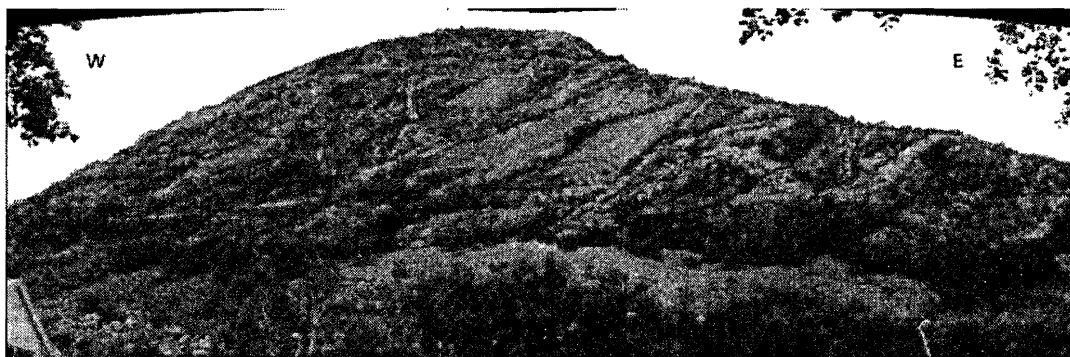
Figure 7: Panoramic view of the cliff with some examples of the main discontinuity sets (red=J1, blue=J2, green=J3, orange=J4, pink=J5).

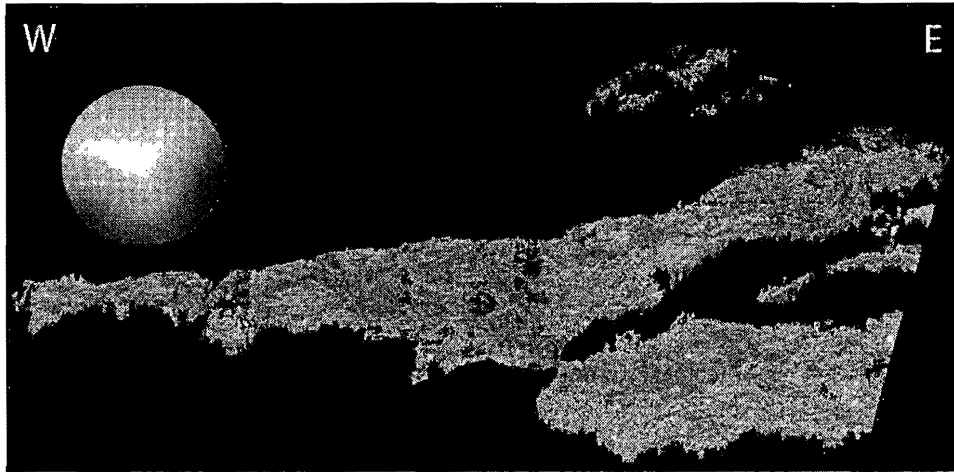
Figure 12: Example of a Coltop 3D view of the point cloud. The color of each point of the scan is given by the orientation (using the pole) of the surface at this point in the colour wheel. The view is from a point at the South of the cliff.

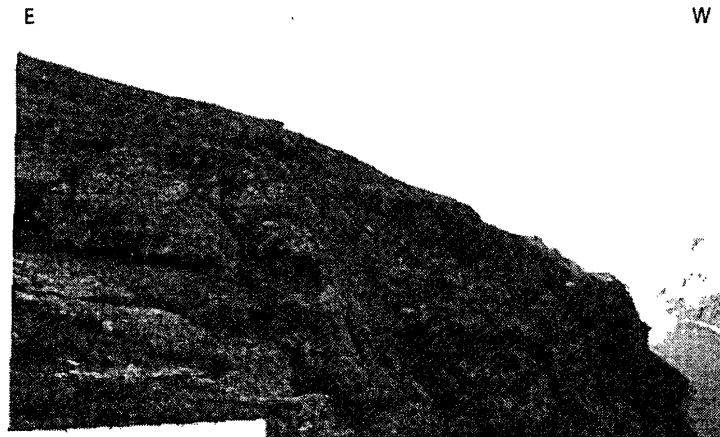
Figure 37: Panorama of the Vidalen site from the scanning point.

This site (Figure 37) is located in the eastern shore of the lake Viddalsvatnet. It is a large rockslide (around 700 m wide) with vertical cliffs and a loose block in the center. This site was scanned mainly for structural analysis.

To have an exhaustive analysis of this site, we recommend to scan again the backscarp and, if possible, from another point of view. This could allow a better identification of the processes active in Vidalen. The loose blocks visible in Figure 37 do not represent a significant threatening as there is no infrastructure right below, but if the entire rockslide falls into the lake, huge waves may be generated in the reservoir. The results obtained for the discontinuities orientations should be used with other topographical and field observations to better constrain the volume of the block that could slide or topple.

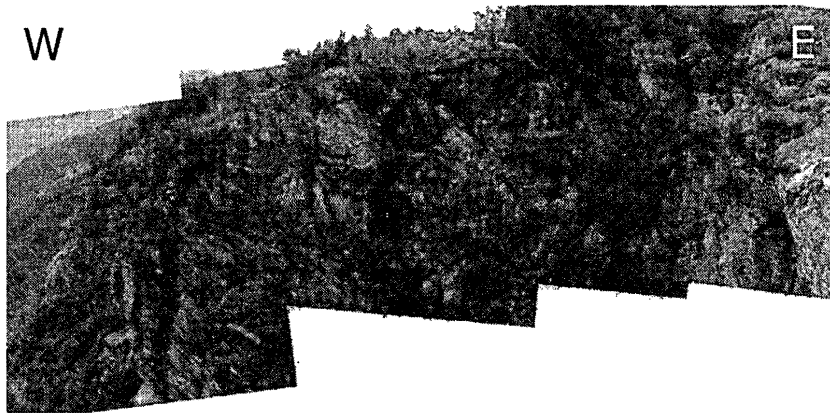
Figure 59: View of the lower site with some examples of the 5 main discontinuity sets (violet=S2, green=J5, brown=J6, pink=J7, orange=J8).

The discontinuity S2, gently dipping NW may represent the main orientation of the foliation. But we cannot exclude that folds affect the foliation and that its orientation is locally very different. As shown on Figures 58 and 59, the SW facing part of the block is mostly controlled by a combination of S2 and J6 discontinuities. The rear of the block and the back scarp seems to be cut according the orientations of J7 and J8.
