# Pacific Spaceflight Research Brief #2015-2

## Incidence of an Astronaut Not Closing the Pressure Garment Visor on Reentry

Cameron M. Smith, PhD

31 Dec 2015

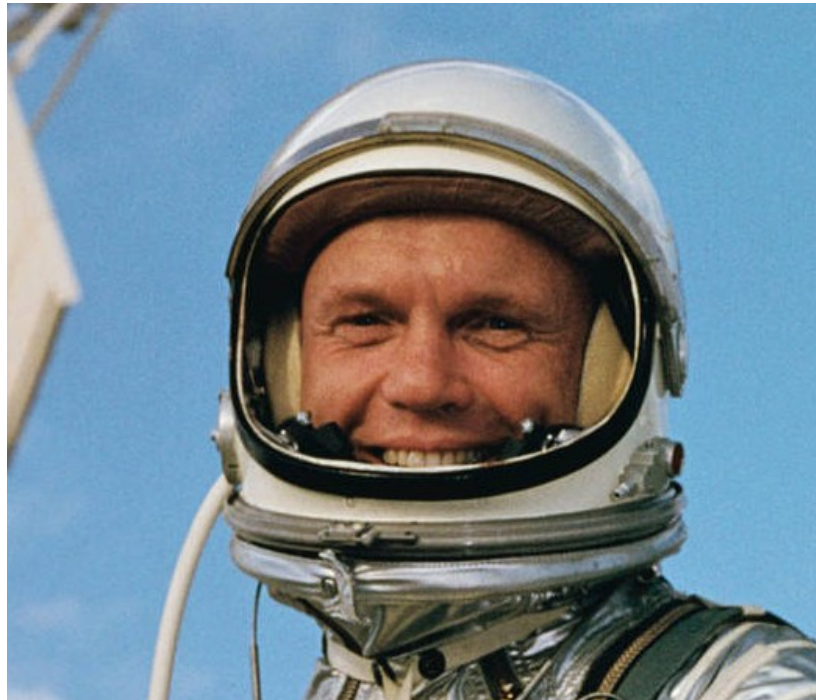
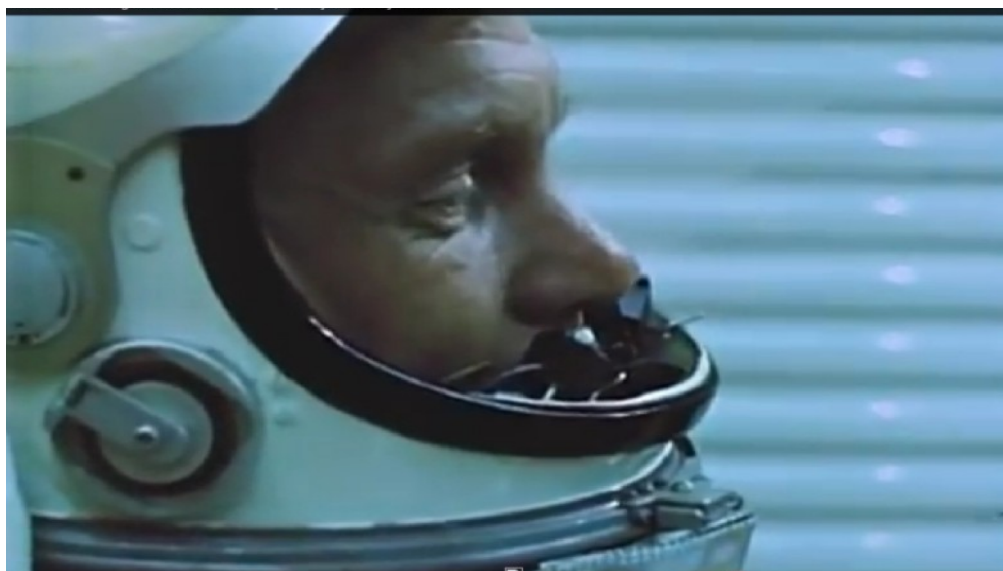
For familiarization with the helmet in question, Figure 1 displays the fiberglass-shell, polycarbonate -visor helmet to the modified Navy Mark V pressure garment. In **Figure 1a**, the helmet visor is up, leaving a distinctive black sealing ring or gasket visible around the perimeter of the face opening; this is seen again in **Figure 1b**.

**FIGURE 1. Mercury 6 Pilot Wearing Pressure Helmet.** In (a) the helmet visor is open, revealing a distinctive black sealing strip around the perimeter of the face opening; this is better seen in (b). 1a derives from a NASA image at <http://www.nasa.gov/content/astronaut-john-glenn-at-cape-canaveral>. 1b is derived from [3].

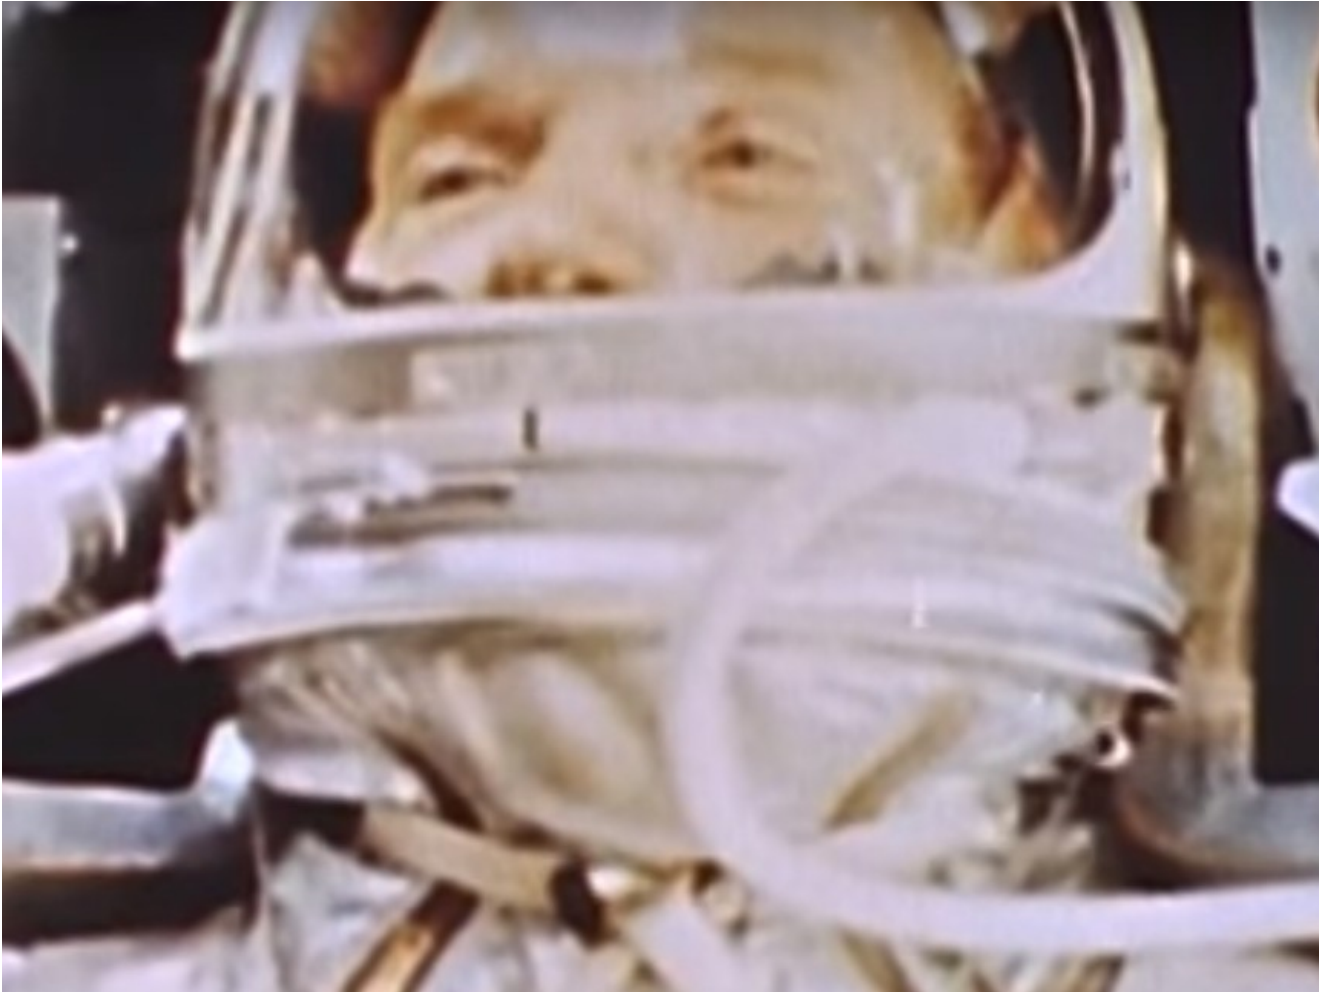
In **Figure 2**, the pilot is listening to the transmission from the ground (row two of Table 1 at 00:04:44), "*Twenty seconds to SECO* (supplementary engine cutoff)."; at this time, the helmet visor is clearly down, with the black sealing

strip noted in Figure 1a and Figure 1b obscured by a metal cover visible in **Figures 1a**.

**FIGURE 2. Mercury 6 Pilot at 20 Seconds to SECO, Visor Closed. Sealant strip visible in Figures 1a and 1b not visible, here obscured by metal visor perimeter strip seen in Figure 1a.**

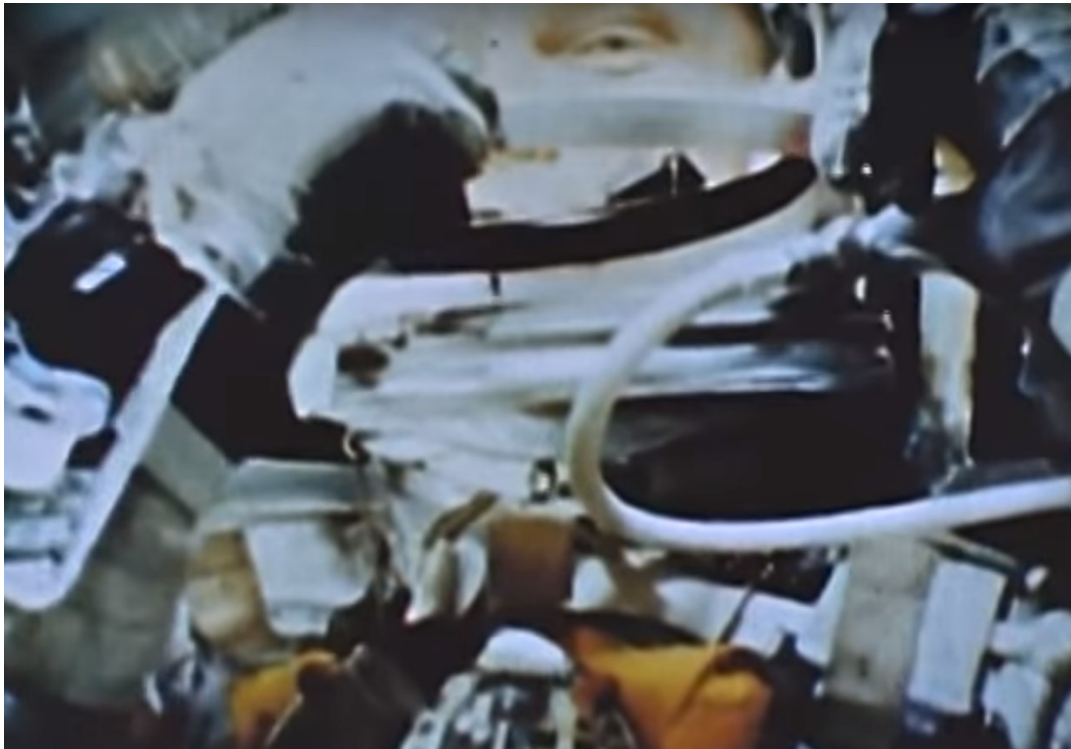
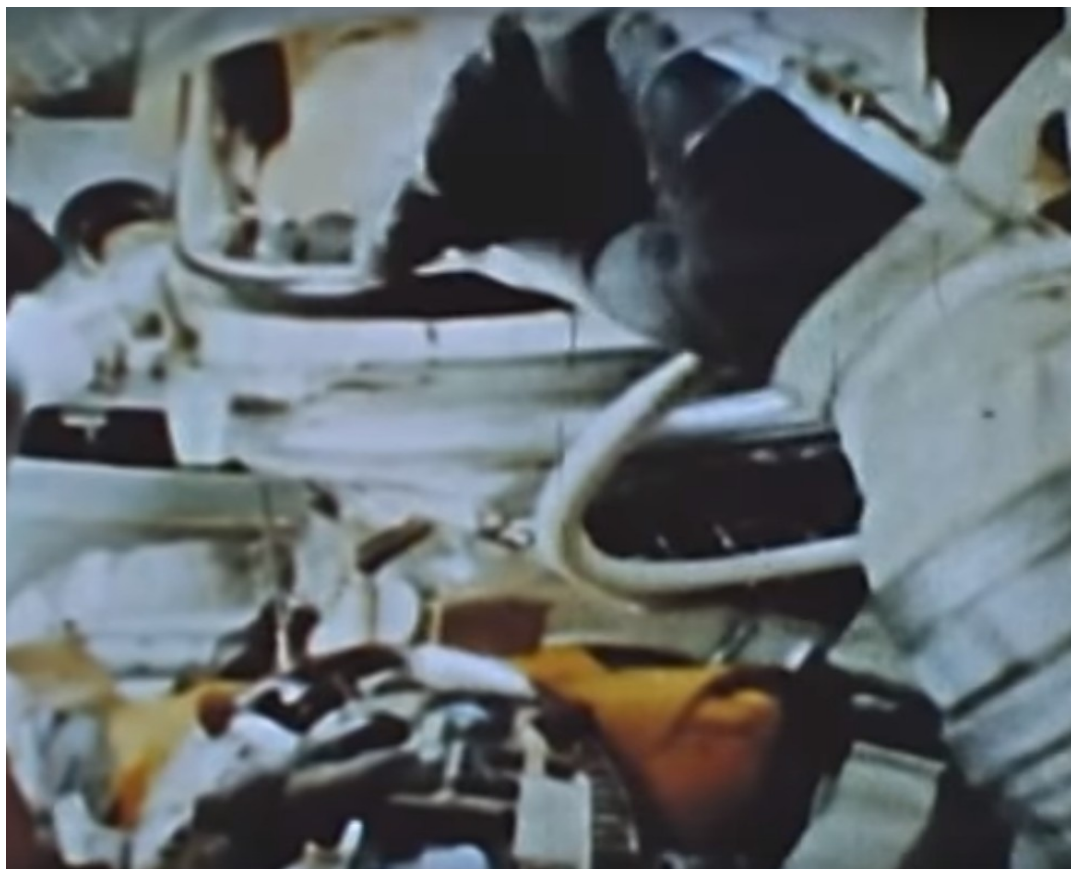
In Figure **3a**, the pilot is opening the visor to take a xylose (sugar) pill about 22 minutes into the flight. In **Figure 3b**, the pill is being consumed, and in **Figure 4** the visor is closed again, just a few seconds after it was opened to take the sugar pill.

**FIGURE 3. Figure 3a: Pilot Opening Visor c.20 minutes Into Flight. Figure 3b: Pilot Consuming Xylose (Sugar) Pill.**

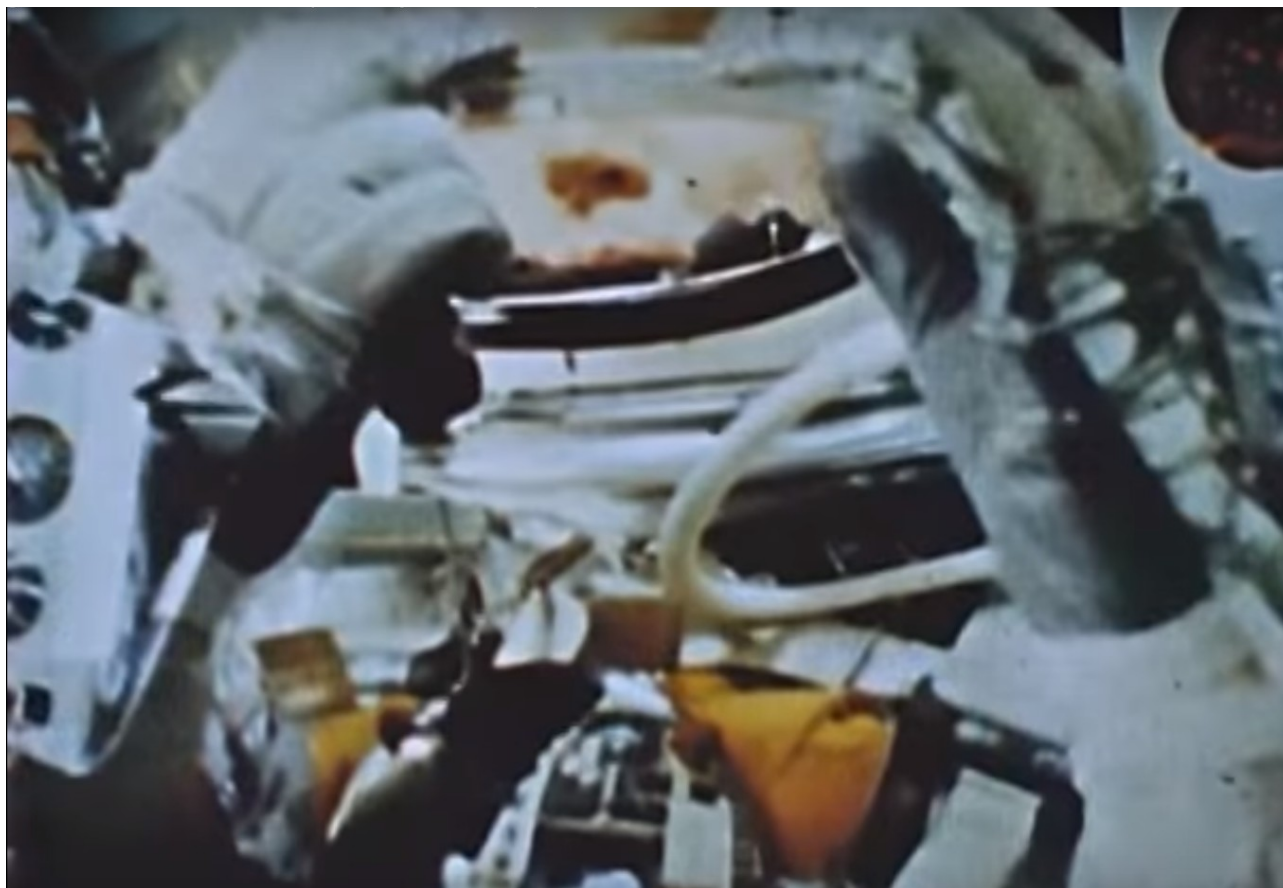
**FIGURE 4. Pilot Closing Visor After Consuming Xylose (Sugar) Pill While in Orbit With Hard Vacuum Beyond Pressurized Cabin Hull.**

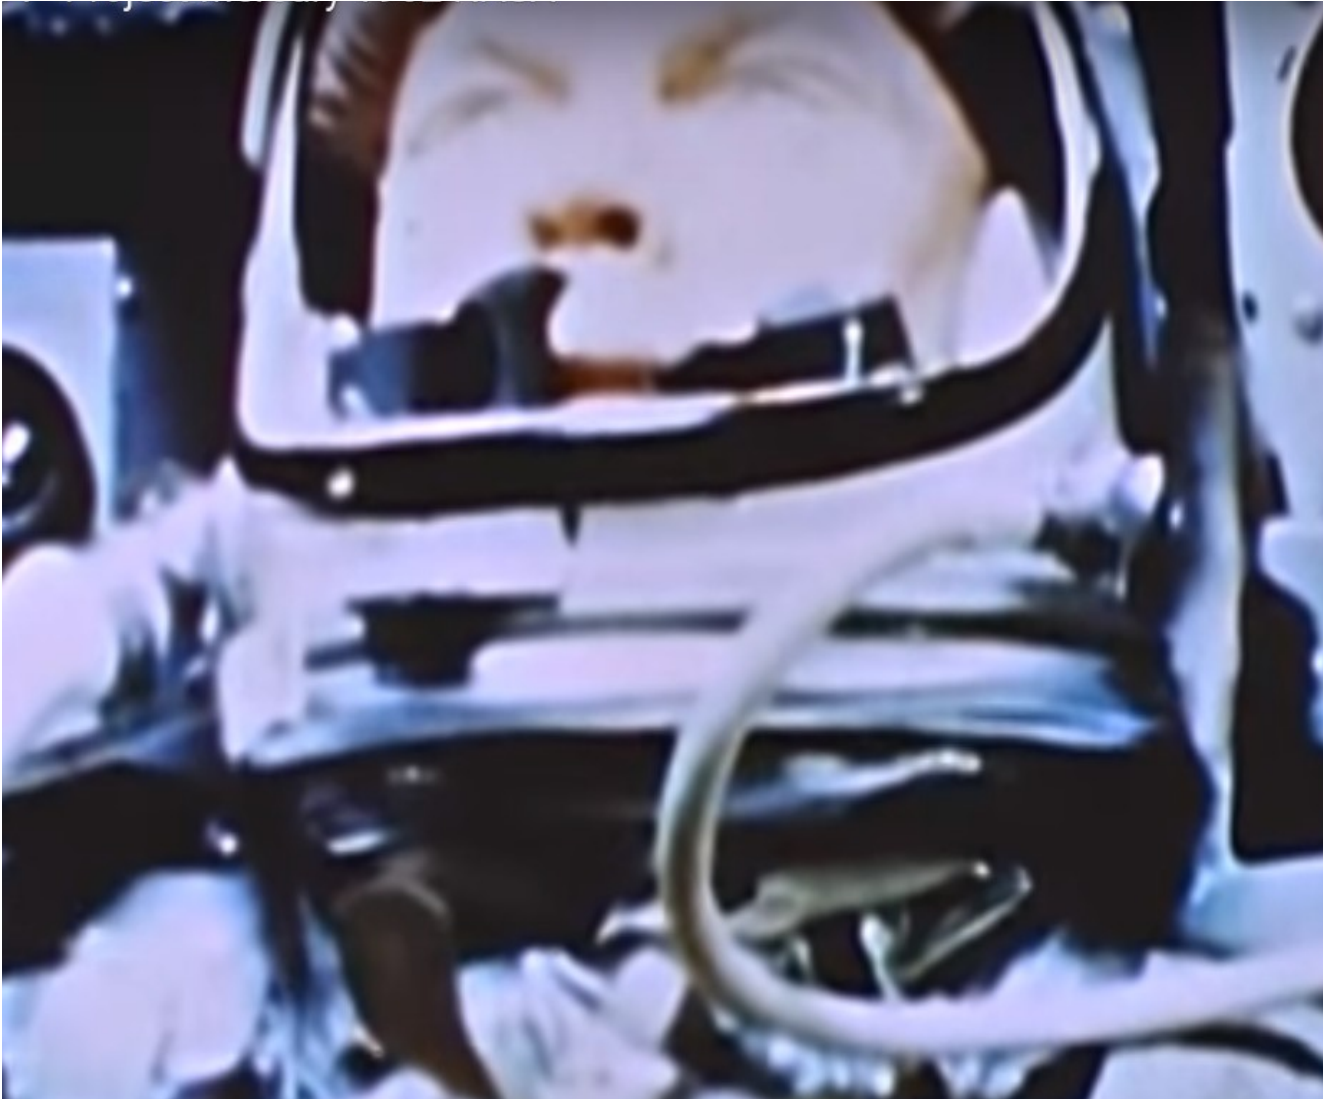
The next video footage pertinent to the subject of this brief is seen at 04:33:09, during the deorbit burn; here (see **Figure 5**) the visor is clearly open, with no metal band covering the black sealing strip identified in other Figures.

**FIGURE 5. Pilot Reporting “*Roger, retros are firing.*” at Entry Interface (Mission Elapsed time 04:33:09), With Hard Vacuum Outside Pressure Cabin and Helmet Visor Open, Altitude c. 360,000' MSL.**

In any case, it is clear that between 01:14:30 and 04:33:09 Mission Elapsed Time, the Mercury 6 pilot opened the pressure garment visor, after which time he does not appear to close it again. Loss of cabin pressure – the contingency the pressure suit was worn to protect against – would likely have been lethal with the visor open through the bulk of the descent, with time of useful consciousness anywhere above 40,000 feet MSL measured in less than 15 seconds [5] (in one case of likely helmet pressure breach, at c.51,000 feet MSL the pilot was heard to exhale briefly before losing consciousness, and was unable to make even the simple motion of resealing the visor with an arm and hand motion [6]).

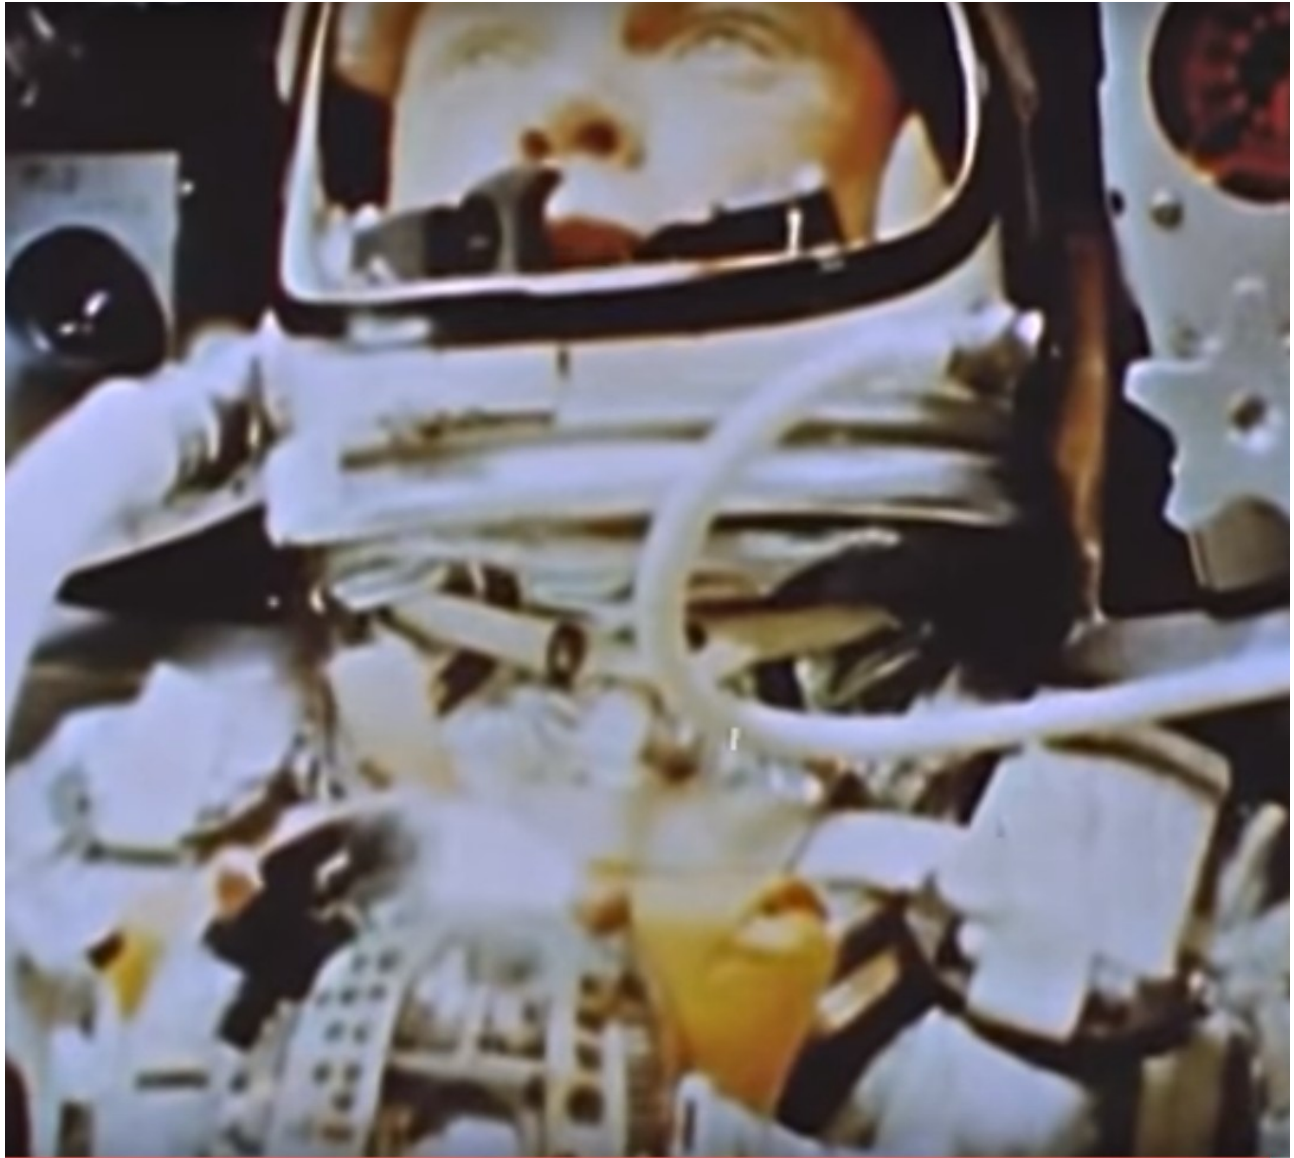
Figures **6, 7, 8** and **9** – all time-stamped to altitudes between orbit and 7,000 feet – show an open visor. Viewing the continuous video footage through this period shows that the visor remained open though deorbit burn and landing [2]. **Figure 10** shows the Mercury 3 pilot with visor clearly down at 50,000 feet (video derived from cockpit camera record archived at <https://www.youtube.com/watch?v=4LziZpAmMy8>); the helmet worn here did not differ from that worn by the Mercury 6 pilot discussed in this report.

**FIGURE 6. Pilot Reporting “A real fireball outside,” During Reentry (Mission Elapsed time 04:43:47), With Hard Vacuum Outside Pressure Cabin and Helmet Visor Open, Altitude >100,000' MSL.**

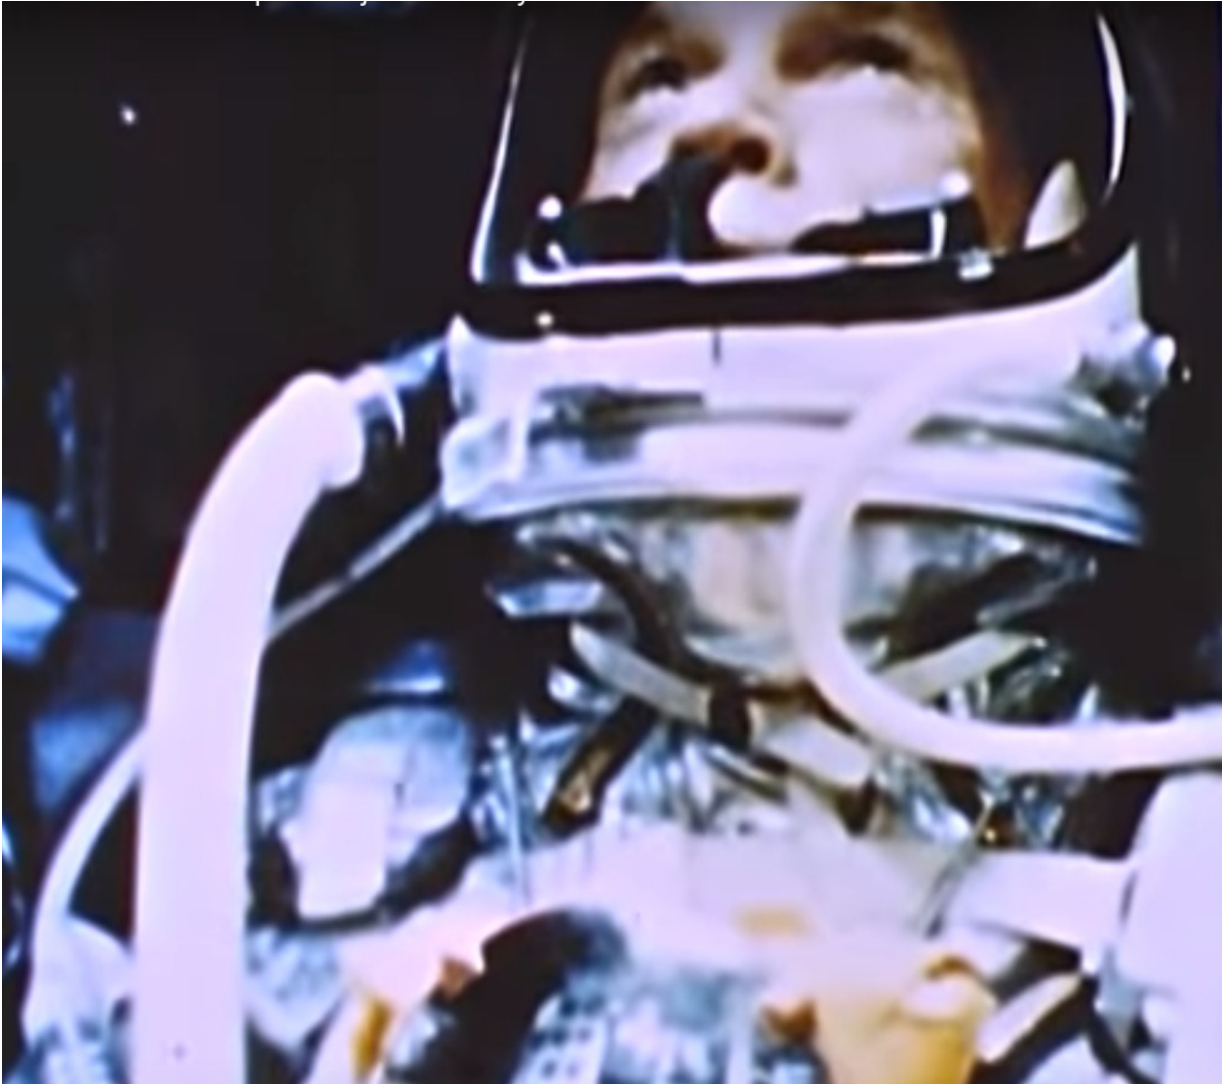
**FIGURE 7. Pilot Reporting “*My condition is good but that was a real fireball outside, boy!*” During Reentry (Mission Elapsed time 04:47:55), With Hard Vacuum Outside Pressure Cabin and Helmet Visor Open, Altitude c. 100,000' MSL.**

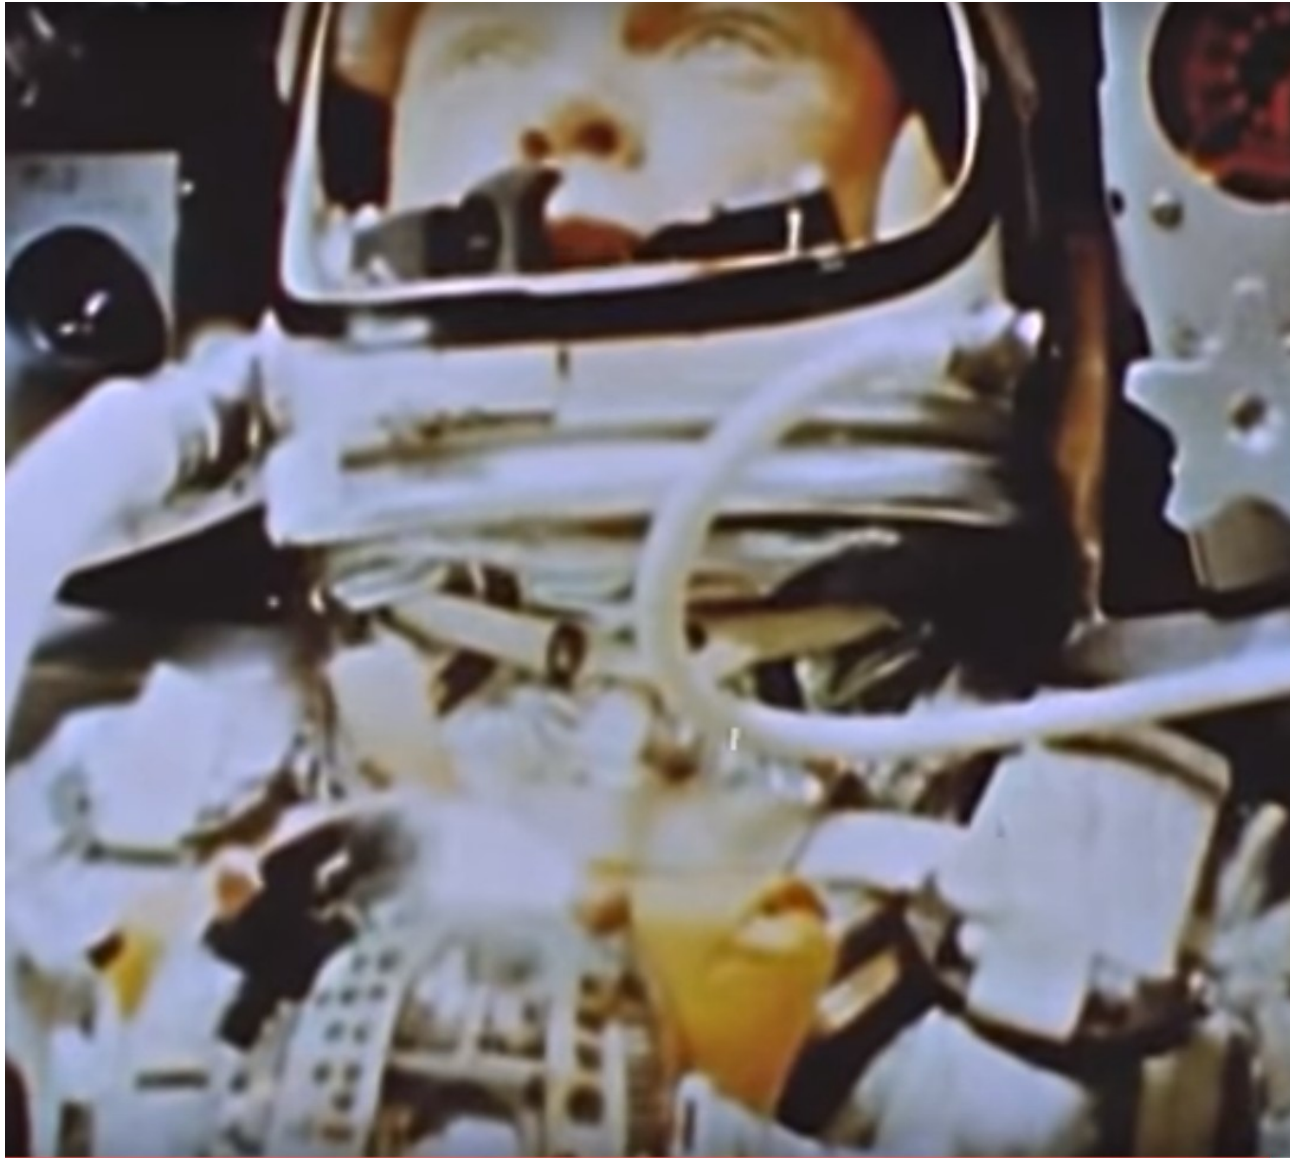
**FIGURE 8. Pilot Reporting “*Altimeter off the peg indicating eight zero thousand.*” During Reentry (Mission Elapsed time 04:48:07), With <0.0psi Ambient Pressure Outside Pressure Cabin and Helmet Visor Open, Altitude 80,000’ MSL.**

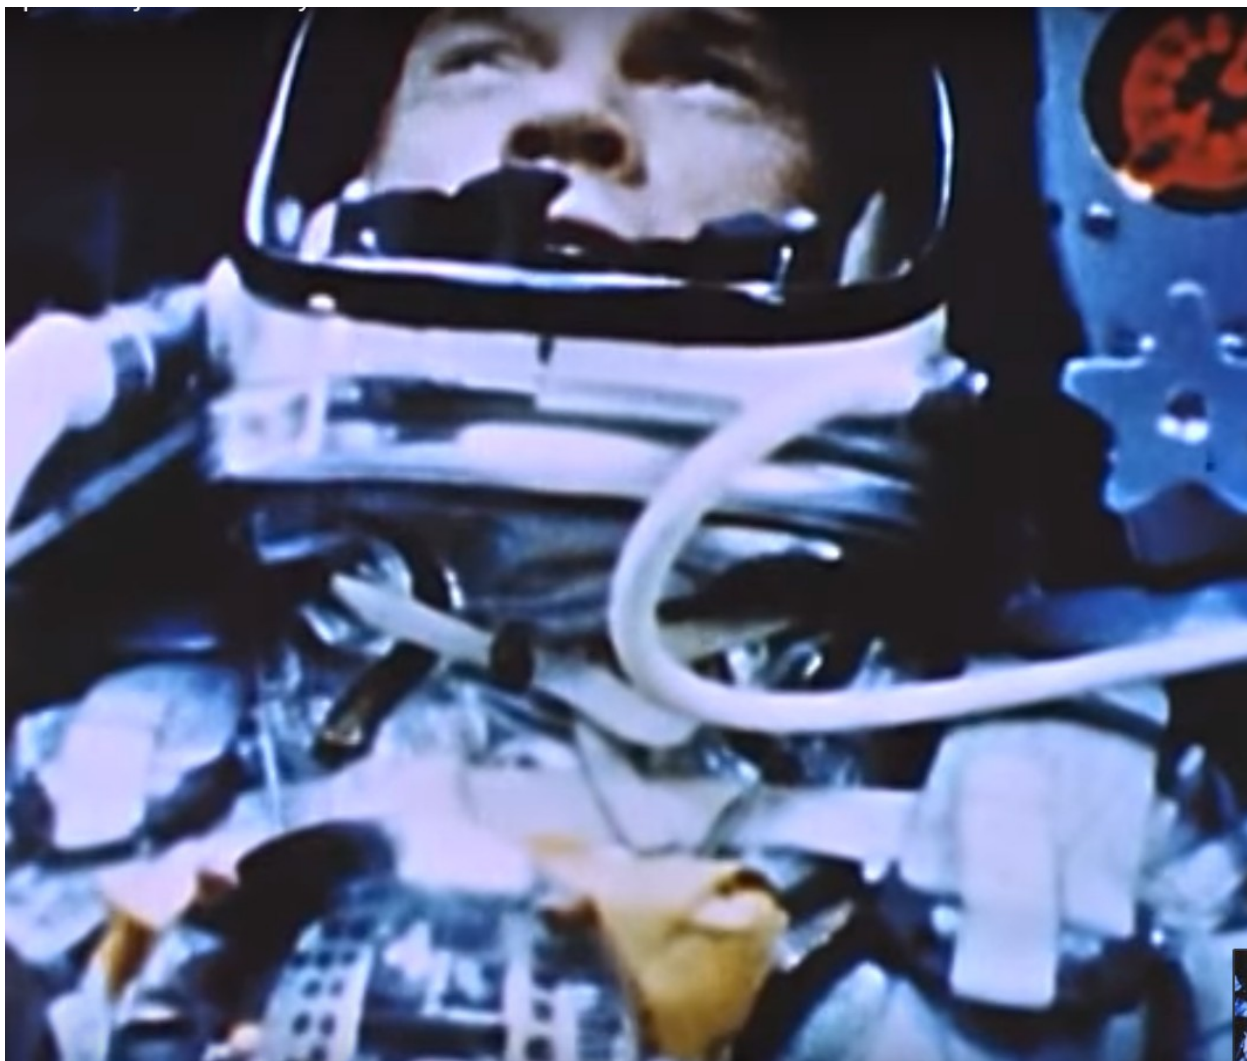
**FIGURE 9. Pilot Reporting “...drogue [parachute] came out at 30,000...” During Reentry (Mission Elapsed time 04:49:20), With 'Only Just Physiologically Safe' Ambient Pressure of 4.3psi Outside Pressure Cabin and Helmet Visor Open, Altitude c. 30,000' MSL.**

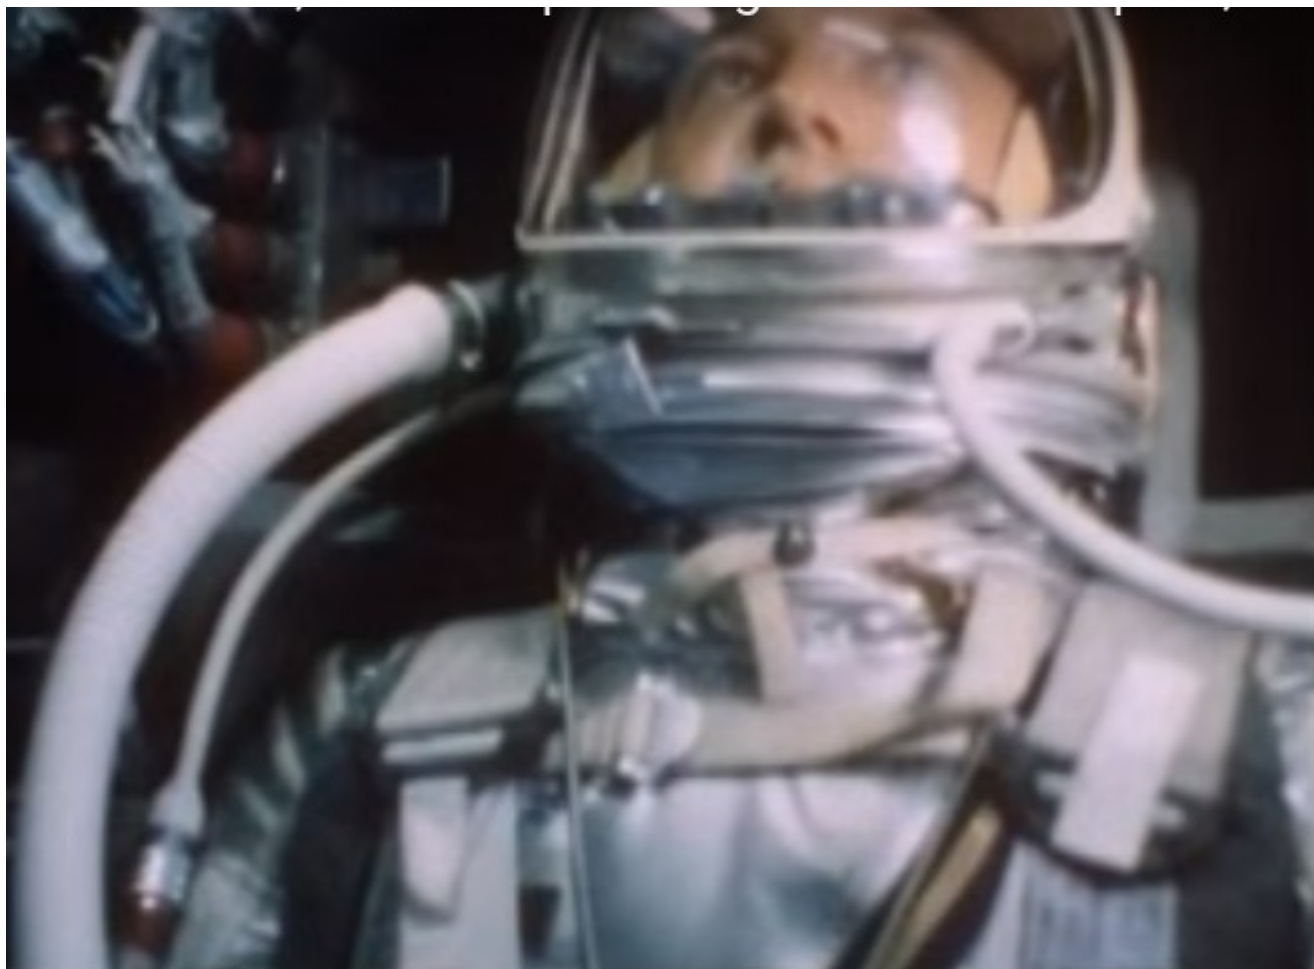
**FIGURE 10. Mercury-Redstone 3 Pilot Reporting Altitude of 50,000' MSL During Reentry With Helmet Visor Closed, Black Sealing Ring Obscured by Metal Visor Rim.**

**Preretrosequence Checklist**, the items are 1. Equipment – STOWED, 2. Control System – CHECK (thruster warmup), 3. Emergency Retro Sequence fuse switch – NO. 1, 4. Transmit Switch – UHF, 5. Retro Man fuse switch – NO. 1, 6. Restraint Devices – CHECK, 7. Crosscheck Attitude – Window/Instruments/Scope and 8. Time check CET. It is only in *Reference List 9* [3] page 82, **Post-Entry Checklist**, that we see mention of the visor status: item 9 is 'Astronaut preparation for landing' and item 9d is Disconnect Visor Seal hose followed by 9e, Open visor. These item 9 items are to be carried out after item 8, which is to check main parachute deployment visually, at an altitude of 10,000 feet. Since the visor position was not listed in these checklists, its status might not have been checked; however, as Figure 10 indicates, other mission pilots did not leave the visor open through descent and landing.
