Flight Test of Pacific Spaceflight Pressure Garment Mark II in Bell 206 Jet Ranger

Pacific Spaceflight Research Brief #2014-1

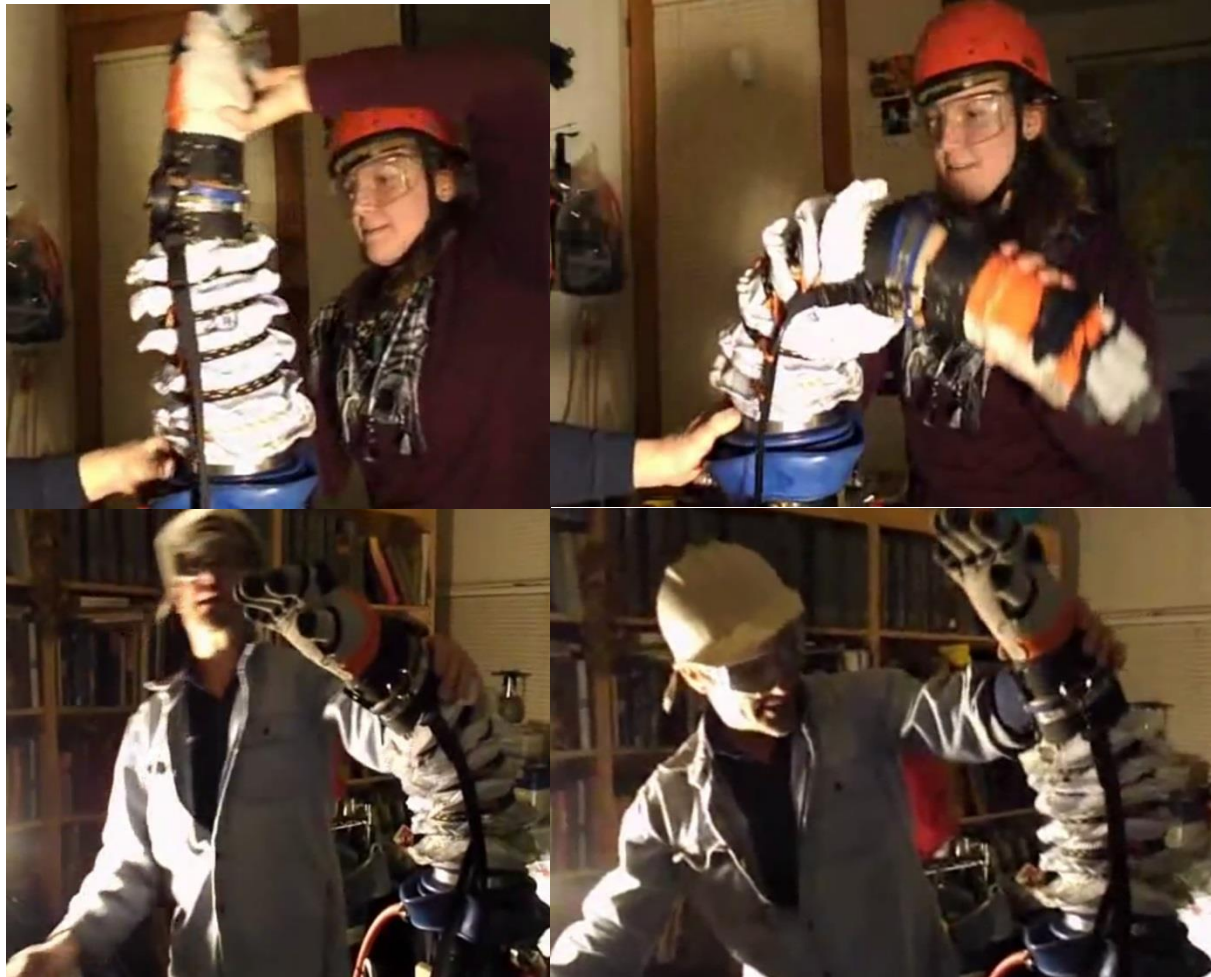
FIGURE 1. Video Frames of Constant Volume Convolute Elbow Joint Being Flexed and Extended Without Difficulty at 3.5 PSIG; upper frames include team member W Magruder and lower, Dr. CM Smith. Video is online at https://www.youtube.com/watch?v=j5gl36VwuHM&list=UUup7MB9ZJJMGYd2NVkK_kJQ.

Following that test, from January - March 2014 constant-volume convolute elbow sections were designed, built and tested (**Figure 1**) and in April 2014, installed in the Mark I suit, graduating it to Mark II status (model change to *Gagarin*) (**Figure 2**). To continue the overall Pacific Spaceflight plan of gradually increasing the altitude at which our pressure garments are tested, it was decided in May 2014 to make an ascent to c.25,000 FT MSL in a local aircraft.

Throughout the flight the suit's convolute elbow sections provided significantly easier flexion of the forearm than the Mark I garment's simple gastight cylinder-sleeves. Though the Mark II butyl convolutes are heavy, and heavily reinforced with steel cables and tubular nylon webbing and other materials, they were designed as proof-of-concept items not for the eventual high altitude flight. In terms of remaining gastight and mobile at high pressure, and under control of the restraint mesh, the convolute elbows proved to be a successful solution to the problem of forearm mobility at suit pressure exceeding about 1.8 PSI.

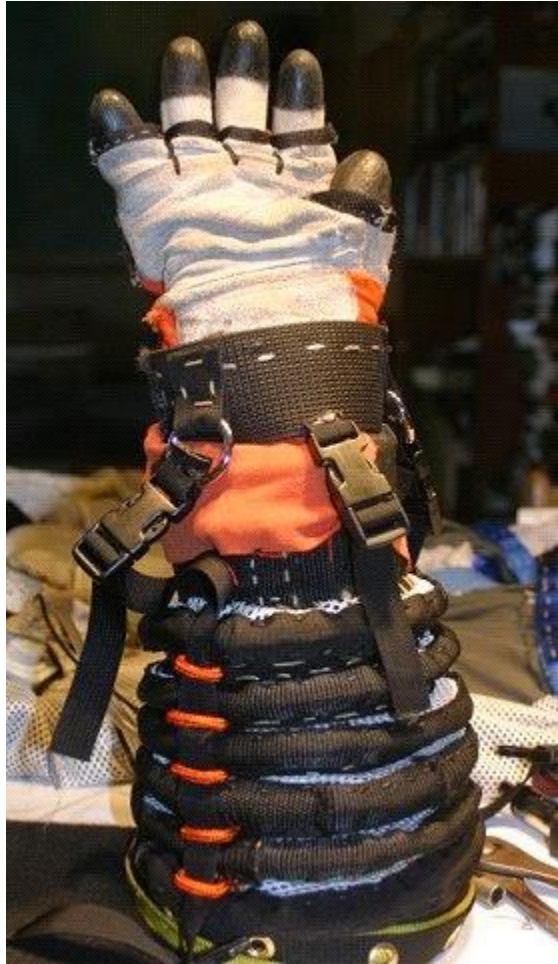
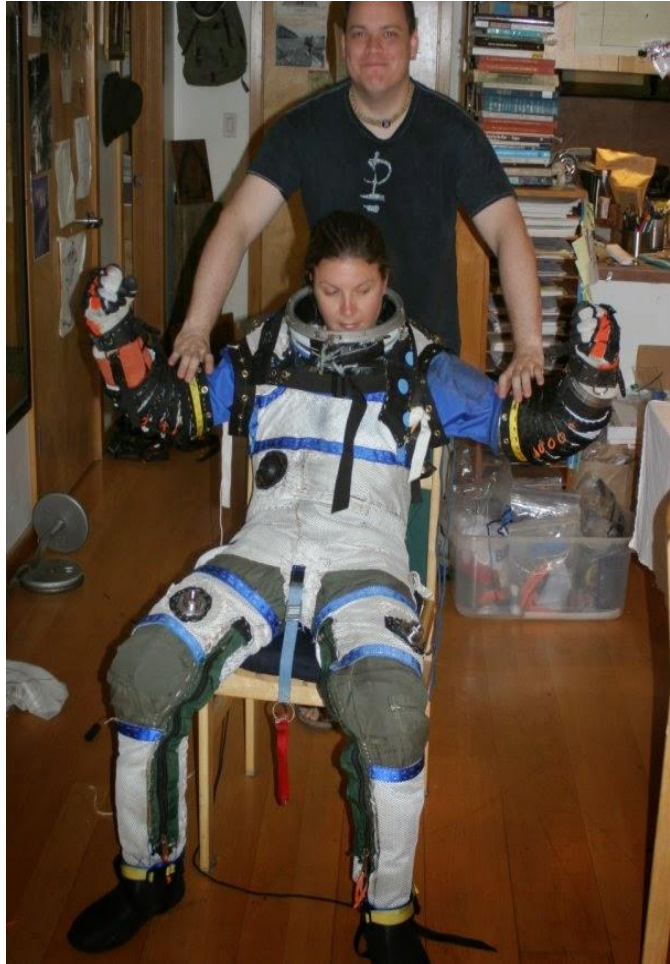
FIGURE 2. Finished Constant Volume Elbow Joint (left) and Joints Installed in Pressure Garment (right).

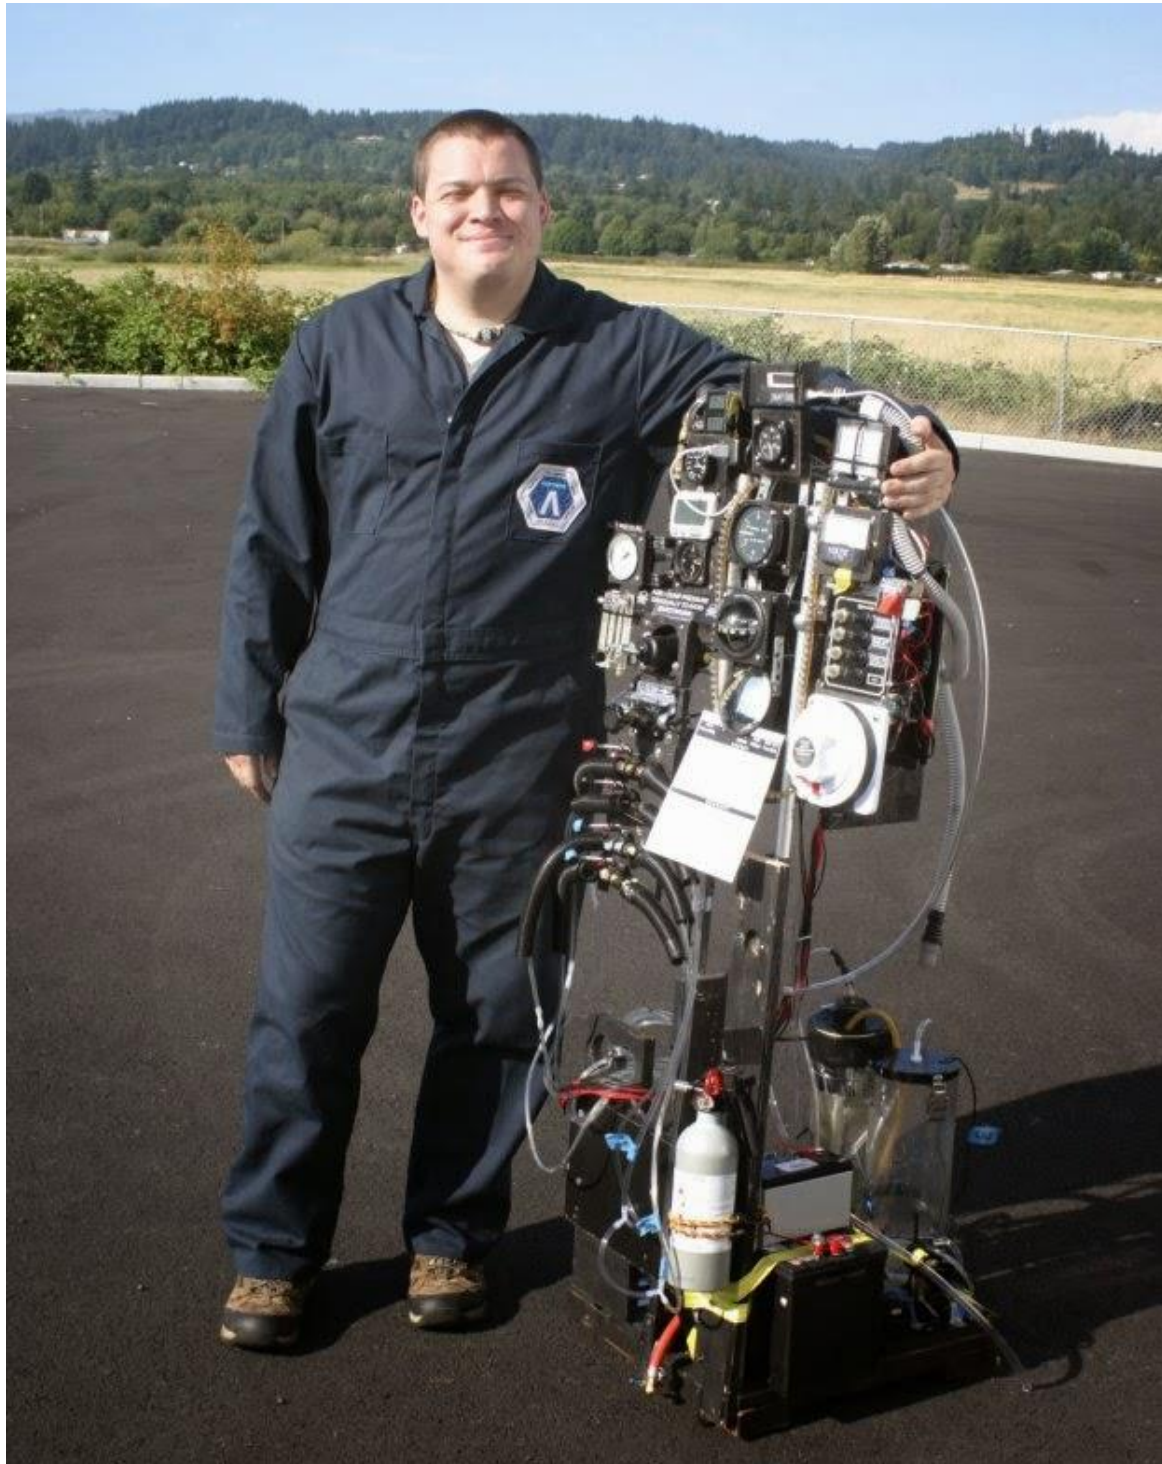
FIGURE 4. Pacific Spaceflight Crewmember AK Knapton With the Portable Life Support System (PLSS) Prepared for Use in Bell 206 Jet Ranger, Before Custom Fitting. SCUBA tank noted in Figure 3 not installed in this photo. This stripped-down PLSS manifestation was named 'Skeletor' as it was significantly reduced in bulk and weight from prior builds.

Figure 3 indicates the essential configuration of the pressure garment and the PLSS in the back seat of the Bell 206 Jet Ranger and **Figure 4** shows the actual PLSS.

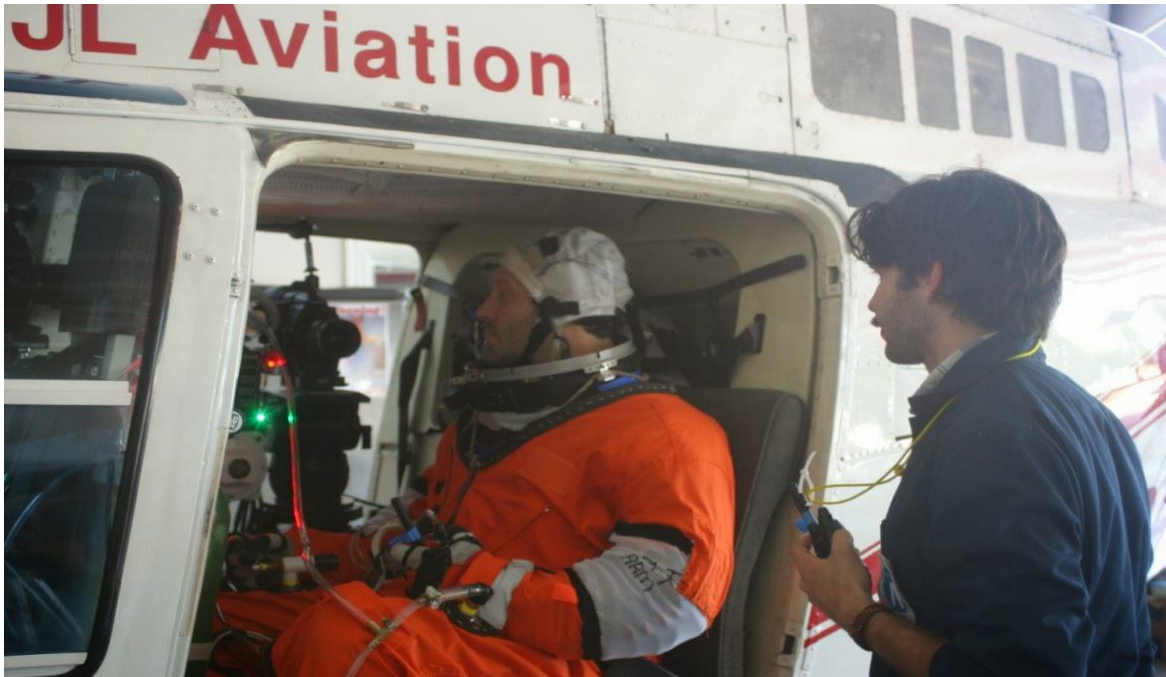
FIGURE 5. (A) Impromptu Custom Fitting of PLSS to Bell 206 Jet Ranger's Starboard Rear Seat by Pacific Spaceflight Team Members B Wilson, K MacAllister and R Kraft, and Dr. Smith Installed in the Rear Seat (B).

Figure 5a shows the installation of the PLSS in the Jet Ranger's rear starboard seat; a hacksaw was used to shorten some elements, a good reminder of the importance of carrying a full tool kit to each field operation. While the PLSS was installed, Dr. Smith was suited by A Magruder, the PLSS was powered and checked by AW Knapton, and Dr. Smith was installed in the rear port seat (**Figure 5b**). Aviation student and aerial cameraman D O'Bryan sat in the front left seat as the Flight Safety Officer, the helicopter being flown by Peter M. Emerson, Director of Maintenance & Lead Pilot/Company Instructor Pilot of JL Aviation, Inc, Boring, Oregon. On several occasions D. O'Bryan visually checked in with Dr. Smith, who hand-signaled "A-OK" as the two did not have a radio link.

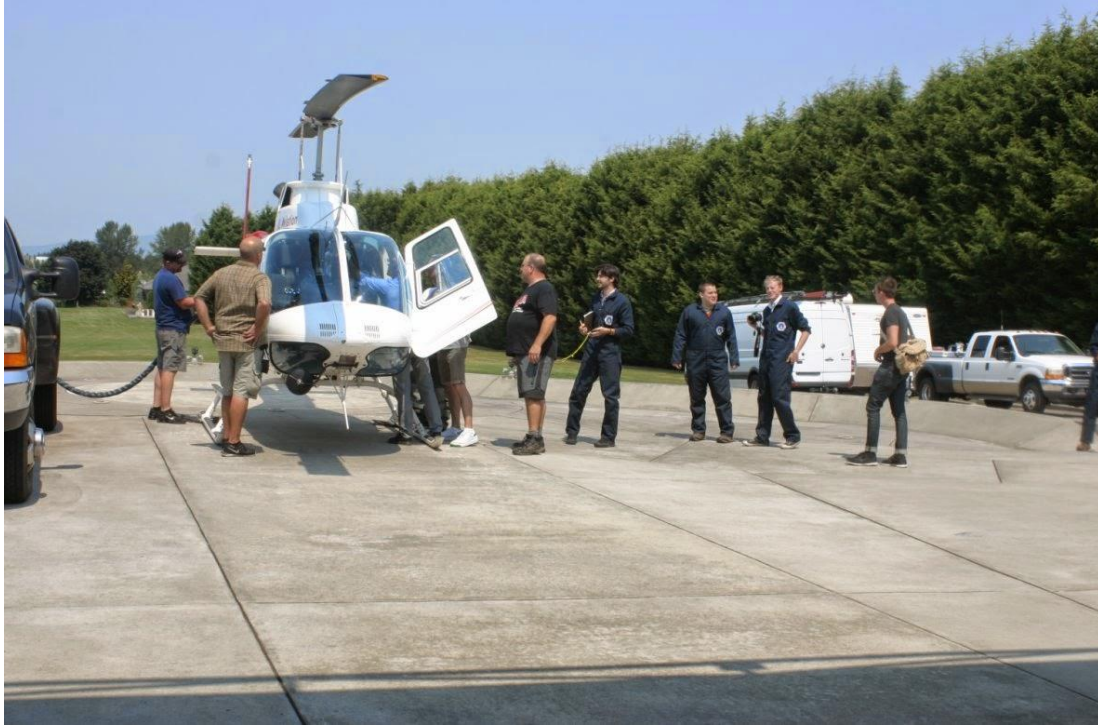
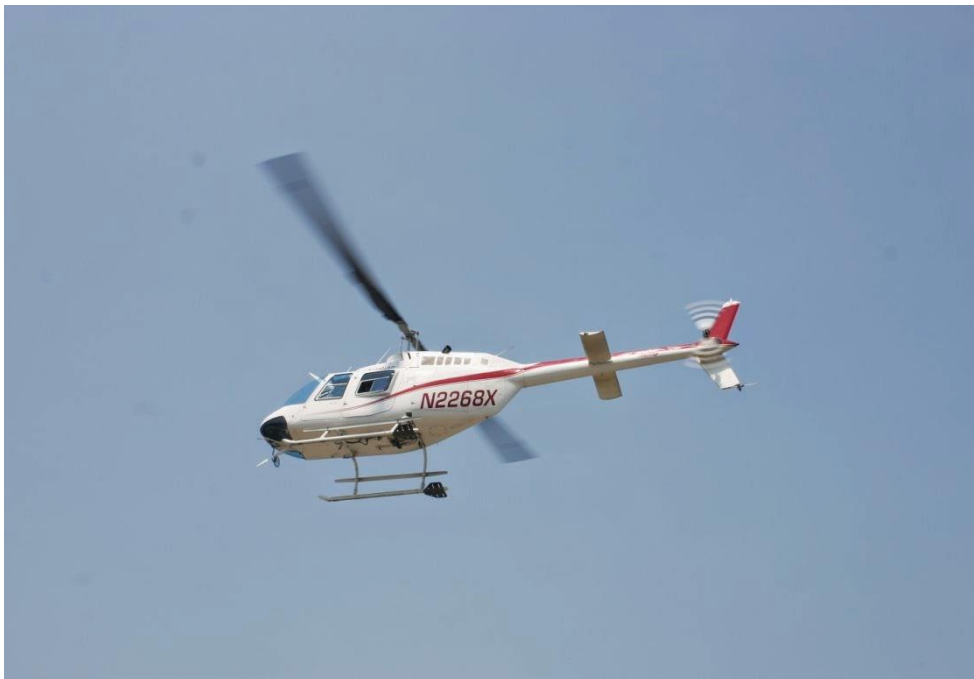
FIGURE 7. Helicopter Fuelling and Final Preflight Preparations (A) and Takeoff (B).

Takeoff (**Figure 7**) occurred just past local noon. **Figures 8** and **9** (a crude transcription of the suit voice recorder into which Dr. Smith made a running commentary through the flight) indicates that in just under 30 minutes, the maximum altitude of c.17,200 feet was attained; at this point Dr. Smith reported a suit pressure of 2.3 PSI and a good CO₂ figure of <300 PPM and generally reported "all well", which was consistent through the 47-minute flight.

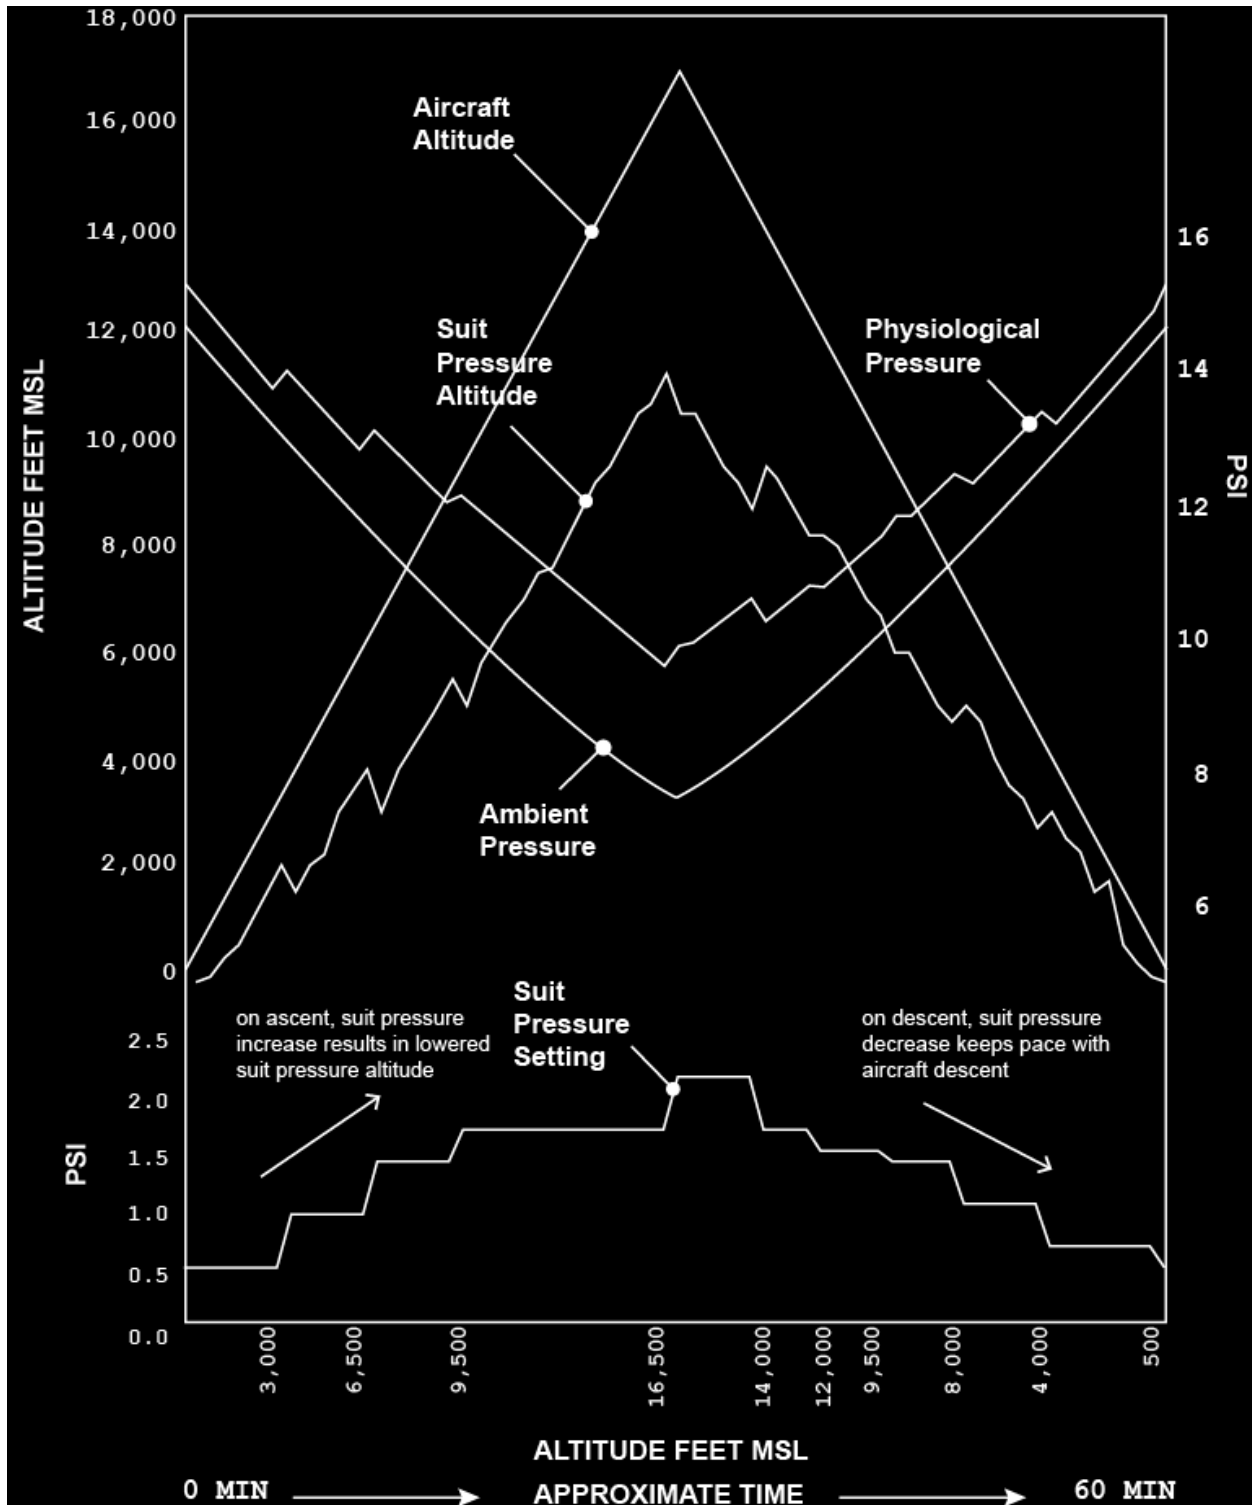
FIGURE 11. Essential Pressure Data for Test Flight 2014-1.

Figure 11 indicates the essential flight pressures against altitudes and time. The highest suit pressure was between 2.3 PSI and 2.5 PSI, while most of the flight was carried out at pressures between 1.2 PSI and 2.0PSI. The suit maintained these pressures with no audible or otherwise evident leaks. At the flight apogee of 17,200 FT MSL, the suit pressure of 2.3PSI was added to the ambient pressure of 7.6 PSI for a total suit pressure of 9.9 PSI, yielding a physiologically-perceived altitude of 10,500 FT MSL, an altitude 6,500 feet below the 17,000 FT MSL altitude threshold where altitude decompression sickness typically begins for unacclimated aviators [2], normally after some 10's of minutes of exposure.

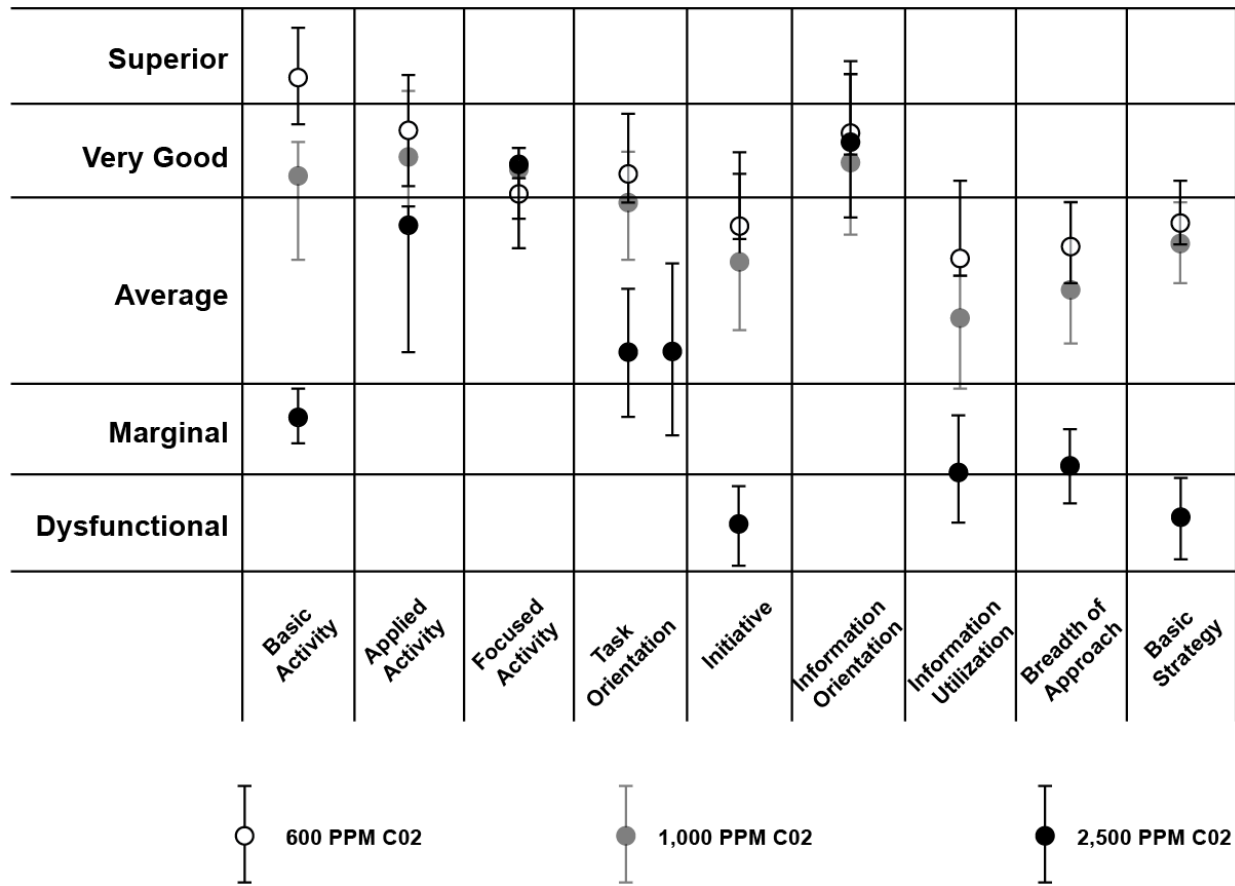
FIGURE 12. Carbon Dioxide Levels and Impairment Effects, 600 PPM – 2,500 PPM (from Satish et al. 2014). Note that effects differ not only by CO2 level but also by variety of cognitive action; nevertheless, levels below 600PPM may be considered generally acceptable and levels above 1,000 PPM may be considered generally unacceptable.

Figure 12 indicates CO₂ levels in the 900's PPM below 12,000 feet and a significant drop below this, into the sub-300 PPM levels above 15,000 feet, only rising slightly by the time of landing. Generally speaking, CO₂ PPM levels above 400 are abnormal outdoors, but they may rise to c.1,000 PPM without cognitive detriment in office buildings, and a report by the National Academies Press allows for 8,000PPM in military submarines [3]. **Figure 11** recapitulates findings of Satish et al., who reported normally mild cognitive

impairment at levels below 2,500 PPM, though with some exceptions [4]; Pacific Spaceflight is currently researching CO₂ levels and designing solutions including high suit gas flowthrough rates and a prototype CO₂ scrubbing system, which is complete in prototype form as of November 2014 and ready for testing in early 2015; also ready at this time, but not at the time of the flight, is a blood oxygenation monitor and data-logger.
