Pressure Test Results Regarding Convolute Elbow Segments and Biomedical Monitoring

Pacific Spaceflight **Research Brief #2015-1**

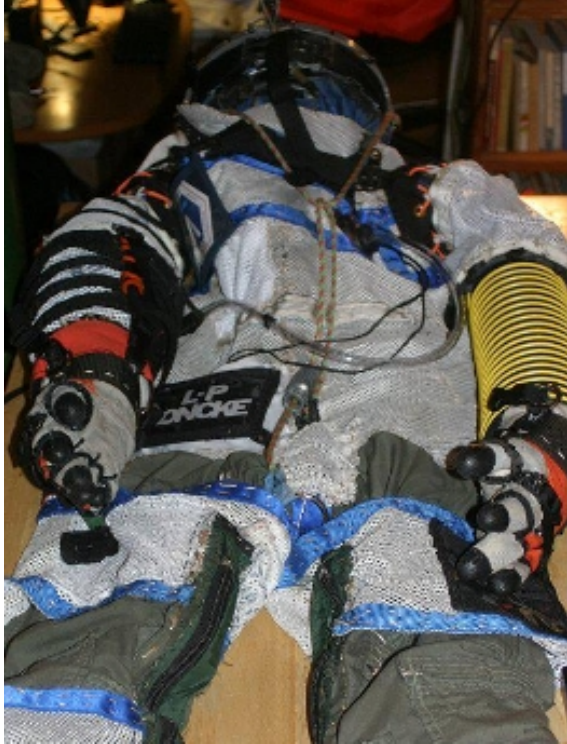
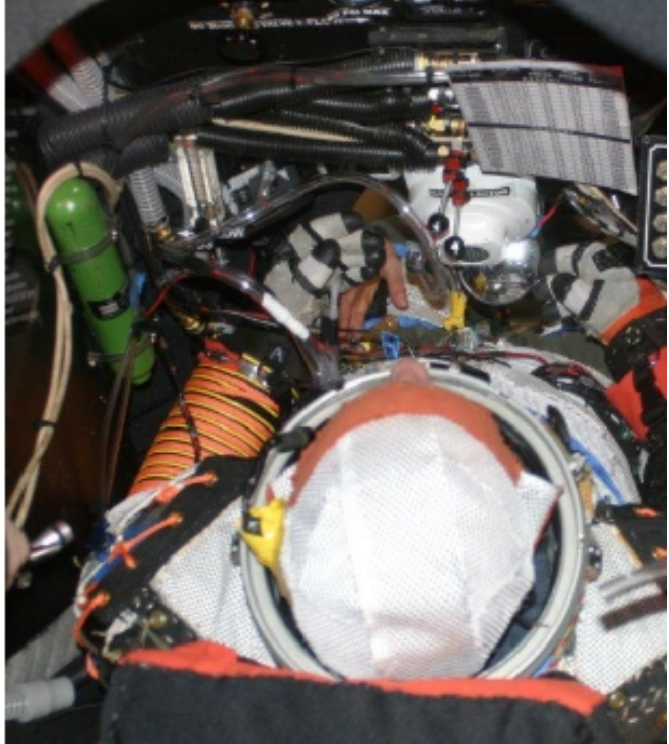
FIGURE 1. Pacific Spaceflight Model II/III Pressure Garment (Left) with lightweight, slim convolute elbow section installed on suit's L arm and older section on suit's R arm. Right photo shows suited person installed in Kazbek trainer.

At pressures above 1.8 psi the suited person evaluated ease of mobility of the elbow and wrist joints in both arms, the left being the newly-built convolute and the right being the convolute built in 2014 (**Figure 1**). Both allowed useful movement of the joints at this and higher pressures than in the Mark I garment, however the new (left) arm convolute was significantly less bulky and easier to flex and twist than the old (right) arm convolute. These are subjective evaluations that should be verified with a load-meter to quantify resistance to bending, but the overall impression is that the new convolute arm sections are radically less bulky and significantly more mobile at higher suit pressures than the older convolutes.

This test indicated superior flexibility and reduced bulk of the newly-built convolute arm section compared to the 2014-built convolute arm section. The sailing vessel's spring-and-cam helmet hold-down cable stop device was found to be potentially unsuitable for this application. The biomedical and other monitors, and communication systems, were found to function adequately. Real-time and post-test reports from the biomedical and CO₂ monitors were found to be tolerably accurate and useful during and after tests,

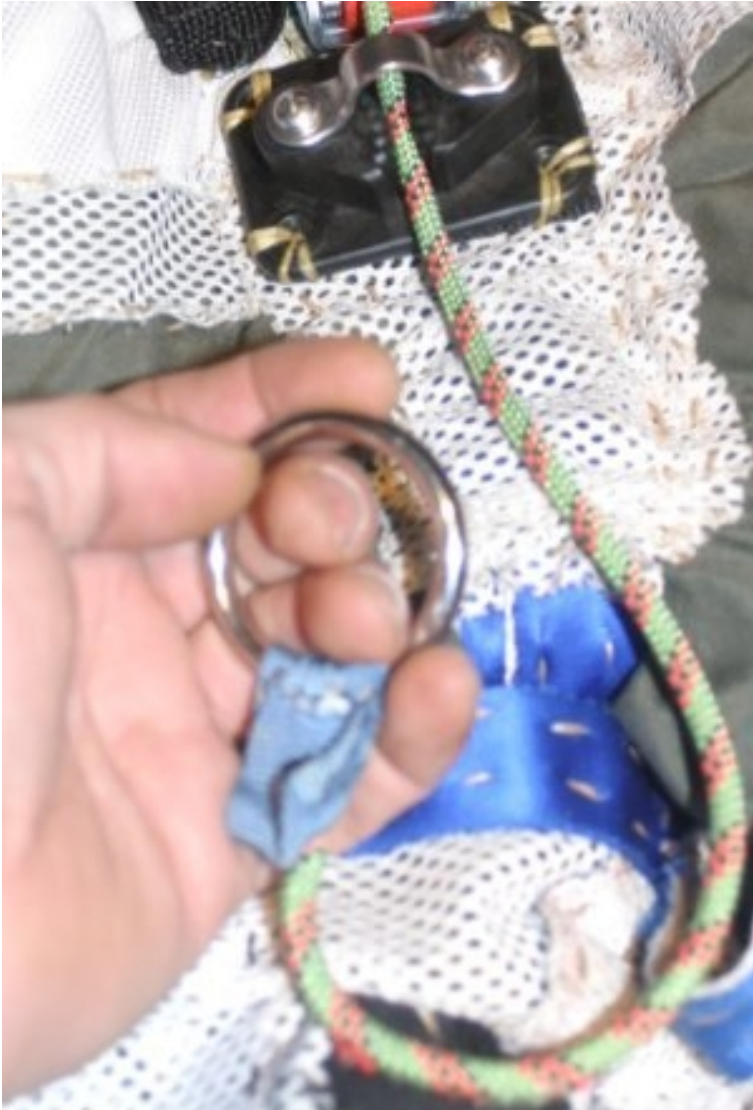
FIGURE 2. Sailing vessel spring-activated cam-action cleat used as helmet hold-down locking mechanism in test reported here.

At the first pressurization to >2psi pressures, the helmet hold-down cable assembly – using a sailing spring-operated one-way sheet cleat (similar to a mountaineering 'jumar' cam device) – released suddenly, allowing the helmet neck ring to 'pop' violently

up (see video frames in **Figure 2** and video at https://www.youtube.com/watch?v=DZiKEGL_4ul with cable blowouts at just after 7:45 and 12:15). This was due to the changing geometry of the pressure garment cable in relation to the cleat when the suit was pressurized, which change allowed the hold-down cable to slip up (anterior to the torso) and out of the cleat cams. In sailing, this is the normal manner of releasing a sheet from the cleat. Unless this can be prevented by reconfiguring the geometry of the cable in relation to the cleat during pressurization and movement in the suit, this device should be excluded from consideration for this function. This device was tested as a lighter-weight alternative to a spring-activated buckle, but that device is unable to fail in the same way, e.g. having the cable disengage from the cable-stopping device.

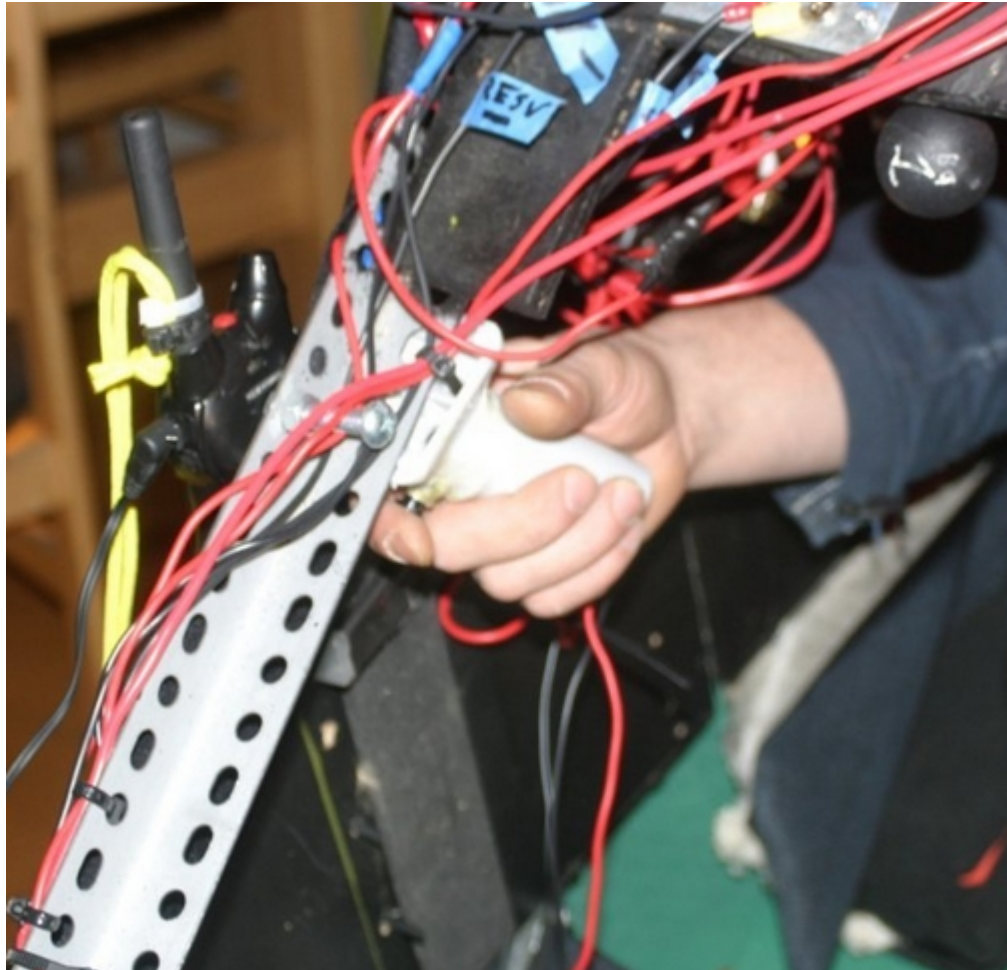
FIGURE 5. Manual push-to-talk momentary button used in reported test to transmit from the Kazbek trainer via mounted Motorola radio (L) and microphone & speaker mounted inside helmet.

Motorola model MR350-R consumer walkie-talkies were used for helmet-to-exterior communications. One radio is mounted on the side of the Kazbek trainer frame, with its leads routed to the helmet (which contains the microphone and speaker) through a gastight helmet throughport. The A push-to-talk transmit button fashioned from a normally-circuit-open momentary switch was mounted in a large grip on the trainer frame (**Figure 5**). This allowed the suited person to transmit by pressing the button only, saving the power and complications of VOX-activated or other modes of transmission, many of which have been attempted, with varying success, in several years of testing these systems. The large grip was installed so that the transmit button could be found easily with somewhat bulky, pressurized gloves, even without visually locating it; once the grip is found, simply by feel if the suited person is engaged in some other activity, finding the small transmit button was easy. It is possible to splice in other such momentary buttons, such that one could transmit by a foot pedal, for example if both hands are engaged; these options will be explored. This system worked well, with loud and clear communications throughout the test.
