Instrumentation for Mechanistic Design Implementation

OTREC-RR-10-02
February 2010

Todd V. Scholz, Ph.D., P.E.
Oregon State University

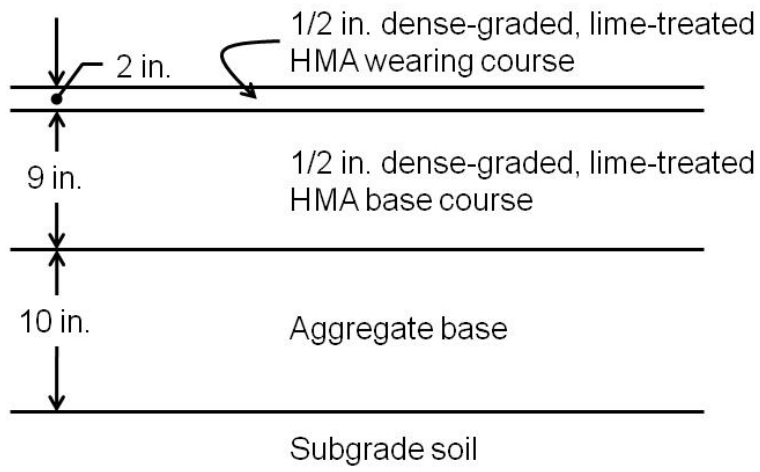
Figure 2.3: Pavement structure at the Redmond test site.

Redmond is in the high desert climatic region in central Oregon. Figure 2.1 illustrates the general location of the test site while Figure 2.2 shows that the test site is located at the south end of the US 97 reroute (bypass) around downtown Redmond. The instruments were installed in the southbound, outside lane about 2,000 feet north of Sisters Avenue. The project involved construction of new pavement along the new alignment designed for moderate truck traffic. Figure 2.3 illustrates the pavement structure at the Redmond test site.

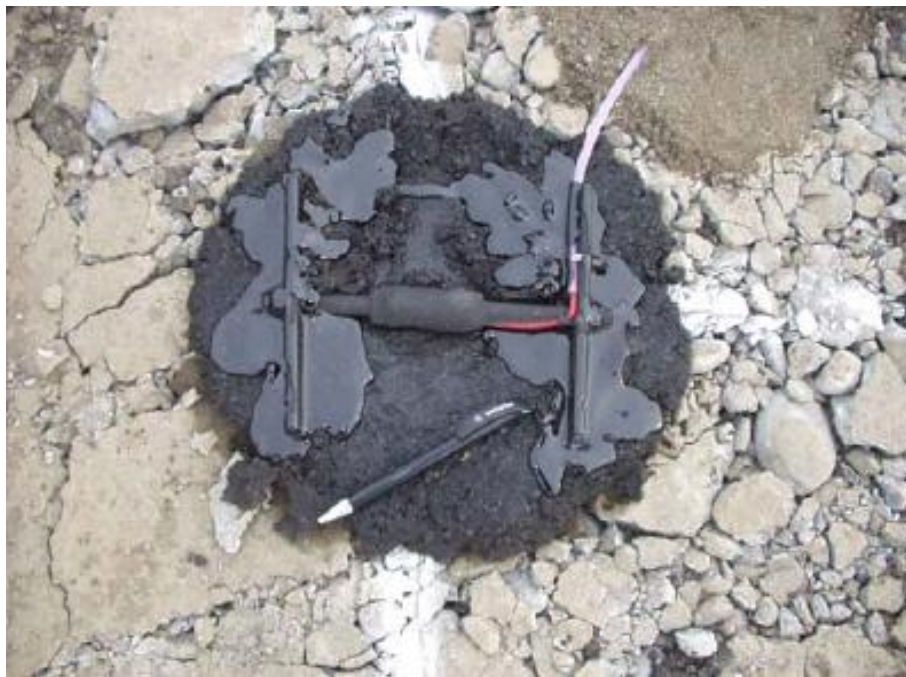
Figure 3.1: Close-up view of an ASG-152 strain gage.

CTL Group ASG-152 strain gages (Figure 3.1) were installed at the Redmond site on June 17 and 18, 2008. An array of nine gages was installed on the surface of the aggregate base course as shown in Figure 3.2. As indicated in the photo, six gages were oriented to measure longitudinal strain and three gages were oriented to measure transverse strain. Figure 3.3 illustrates the distances between the strain gages.

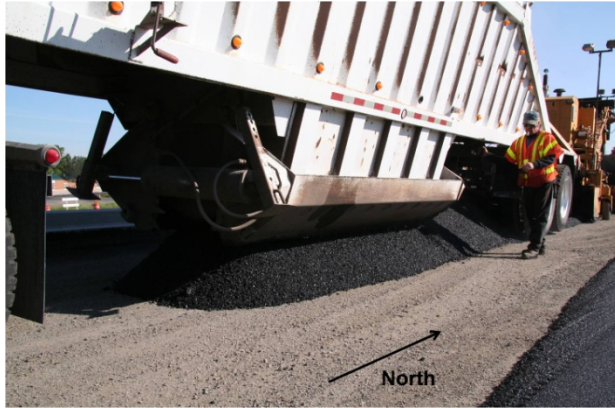
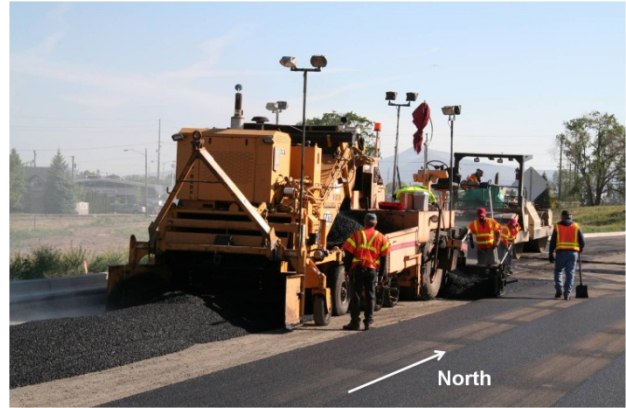
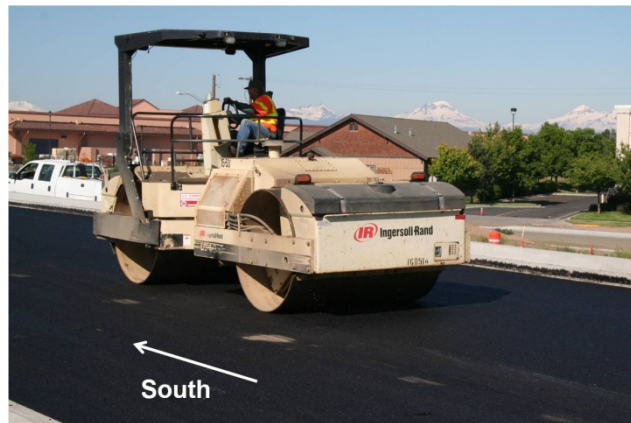
Figure 3.4: Partial construction sequence at the Redmond site.

The strain gages were given a protective covering of cold-mix asphalt prior to placement of the first lift of hot-mix asphalt. HMA was then placed directly over the protected gages in a windrow (Figure 3.4a) which was picked up with an elevator attached to the paving machine (Figure 3.4b), followed by compaction with a heavy roller (Figure 3.4c).

a) HMA windrow placed directly over partially protected gages.

b) Windrow elevator attached to paver.

c) Compacting the first lift of HMA with a heavy roller.

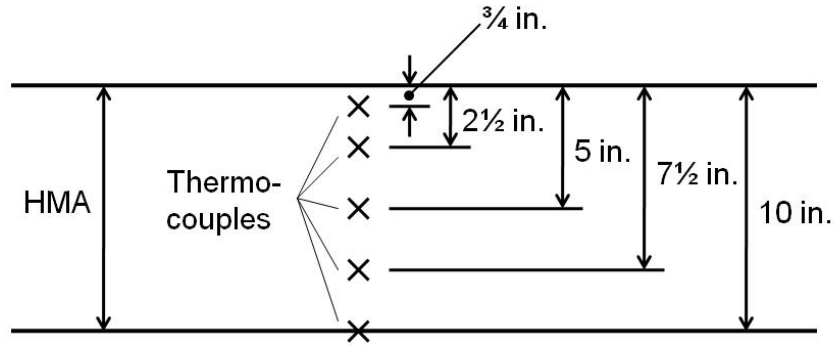
Figure 3.5: Depth of thermocouples installed in the HMA layer at the Redmond test site.

Thermocouples were installed at various depths within the hot-mix asphalt layer at the Redmond test site as illustrated in Figure 3.5. Installation occurred following construction and involved drilling holes to the appropriate depths, inserting the thermocouples, and filling the holes with epoxy. The thermocouples allowed monitoring of the HMA temperature with depth to an accuracy of at least 0.2°F (0.1°C).

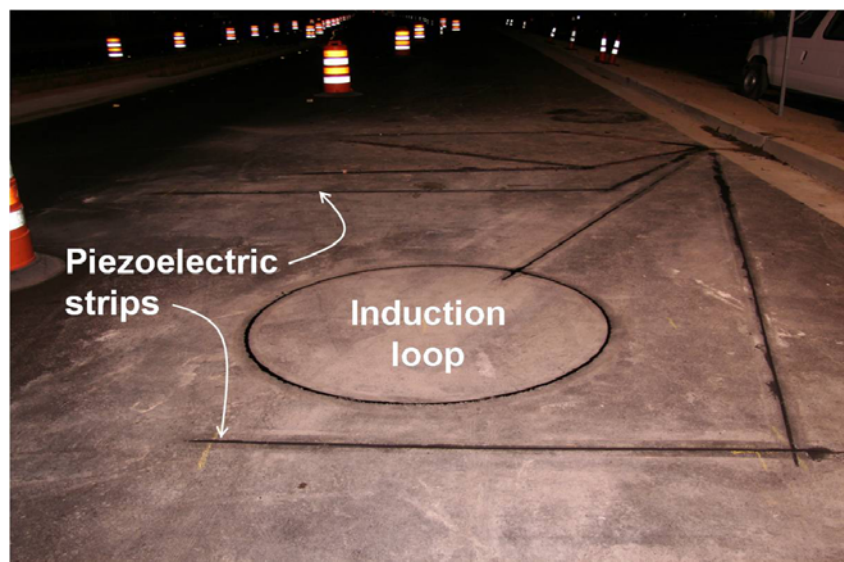
Figure 3.6: Weigh-in-motion (WIM) devices installed on the surface of the pavement.

Following construction, weigh-in-motion (WIM) devices were installed on the surface of the HMA layer during the evening of August 22 and early morning of August 23, 2008. These included two piezoelectric strips and an induction loop as shown in Figure 3.6. A thermocouple was also installed under one of the piezoelectric strips (at 1 inch depth). The piezoelectric strips were used to measure axle loads and velocities of the vehicles crossing the strips, the induction loop was used to classify the vehicles, and the thermocouple was used to measure temperature. Installation involved cutting grooves in the surface of the pavement, cleaning and drying the grooves, placing the devices in the grooves, and filling the grooves with adhesive—epoxy for the piezoelectric strips and thermocouple and liquid asphalt for the induction loops—around the devices. The WIM devices were installed upstream of the strain gages.

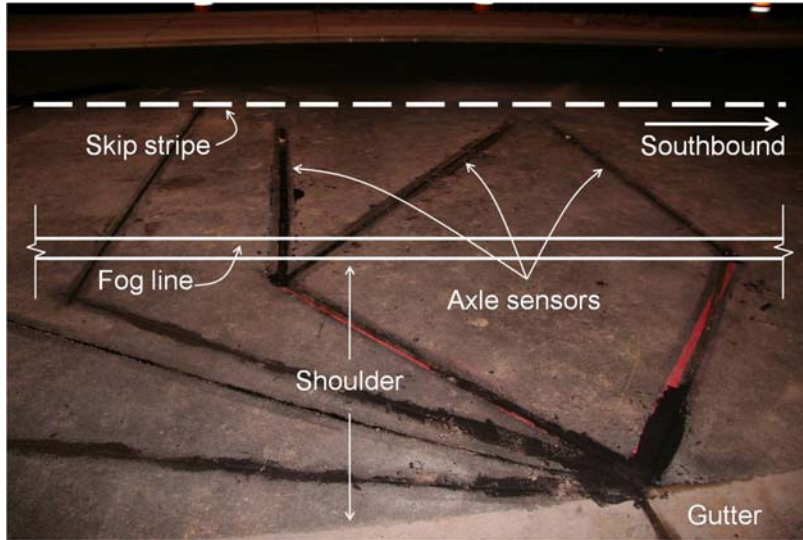
Figure 3.7: Axle sensors installed on the surface of the pavement.

Axle sensors were also installed on the surface of the pavements at the test site (Figure 3.7) following construction to determine the transverse position of vehicles in the travel lane. Installation involved cutting grooves in the surface of the pavement, cleaning and drying the grooves, placing the devices in the grooves, and filling the grooves with epoxy adhesive around the devices. Figure 3.8 illustrates the geometric layout of the axle sensors. The installation of the axle sensors was accomplished approximately 2 months after the strain gages were installed.

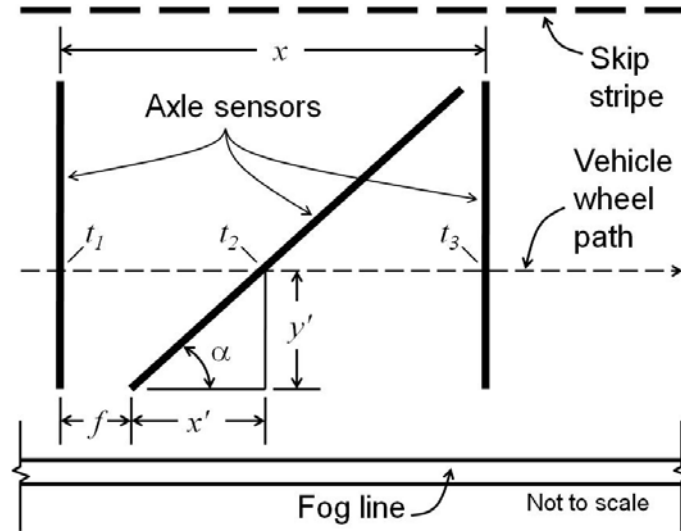
Figure 3.9: Geometric layout of axle sensors for determining the lateral position of a vehicle.

With the assistance of Figure 3.9 it can be shown that, knowing the geometric layout of the axle sensors as well as the time stamps, t_i , of a vehicle travelling over the sensors, the lateral (transverse) position of the vehicle, y' , can be determined. The following derivation for y' is paraphrased from Timm and Priest (1).

The average velocity, v_1 , of the vehicle between the upstream sensor and the point at which it crosses the angled sensor can be expressed by:

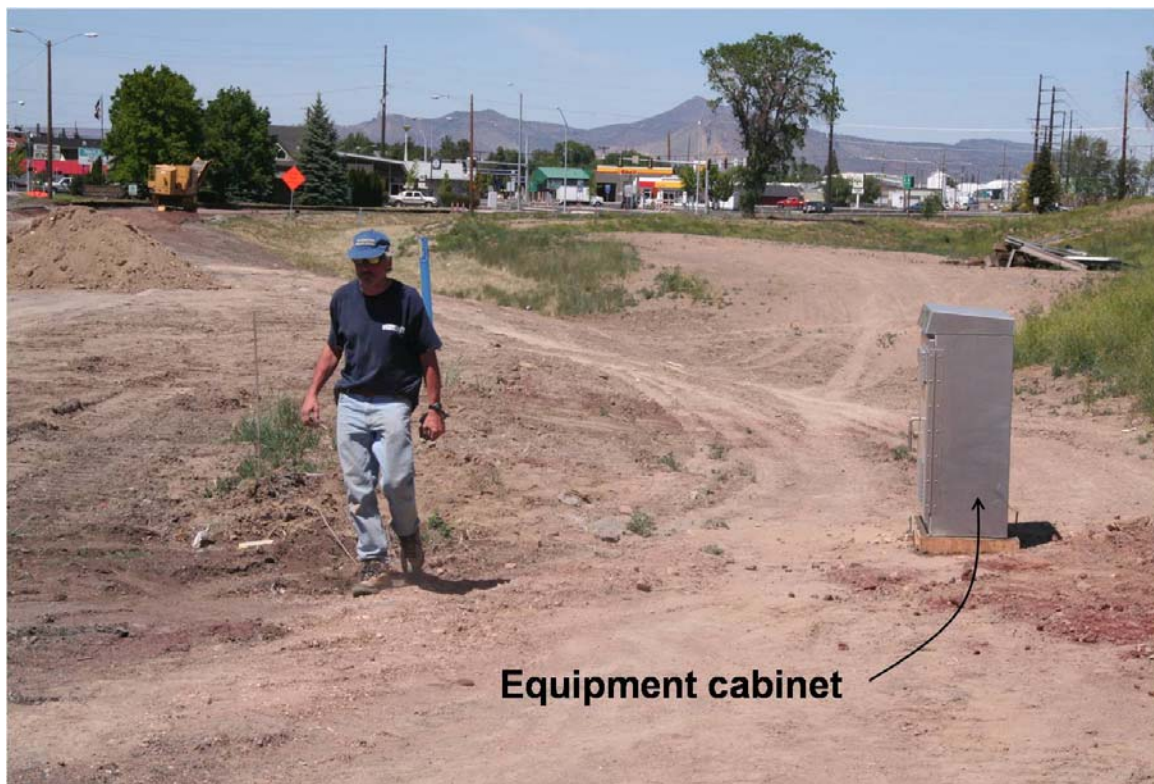
Figure 3.10: Equipment cabinet at the Redmond test site.

An equipment cabinet was installed at the site a safe distance from the highway (i.e., live traffic) to house the equipment necessary for data acquisition. Instrument cables (wires) were routed from the roadway to the equipment cabinet through a trench to prevent damage by traffic, weather, and maintenance equipment. Figure 3.10 shows a picture of the equipment cabinet installed at the Redmond test site.

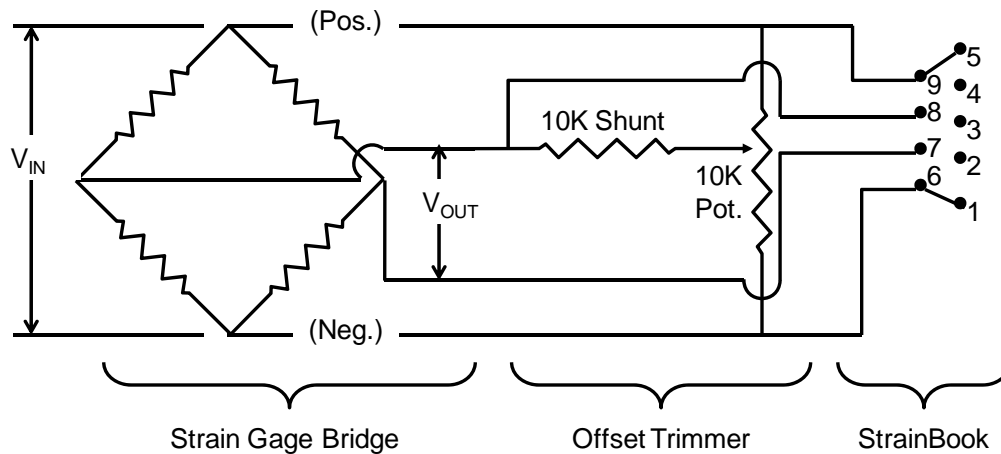
Figure 3.11: Schematic of offset trimmer used to null out strain gage bridge.

In addition, due to the large quiescent strain in the strain gages and limitations of the data acquisition system, each input cable into the data acquisition unit required modification to allow removal of the quiescent strain offset. This entailed inserting a circuit (offset trimmer) comprised of a shunt resistor and potentiometer between the strain gage bridge and StrainBook as shown in Figure 3.11. Adjusting the potentiometer allowed removal of the voltage offset associated with the quiescent strain, which could not be accomplished through configuration of the system using the WaveView or LabView software. The StrainBook was also used to determine the time stamps at which a particular vehicle crossed each of the axle sensors (Section 3.4), but the offset trimmers were not required for this purpose.

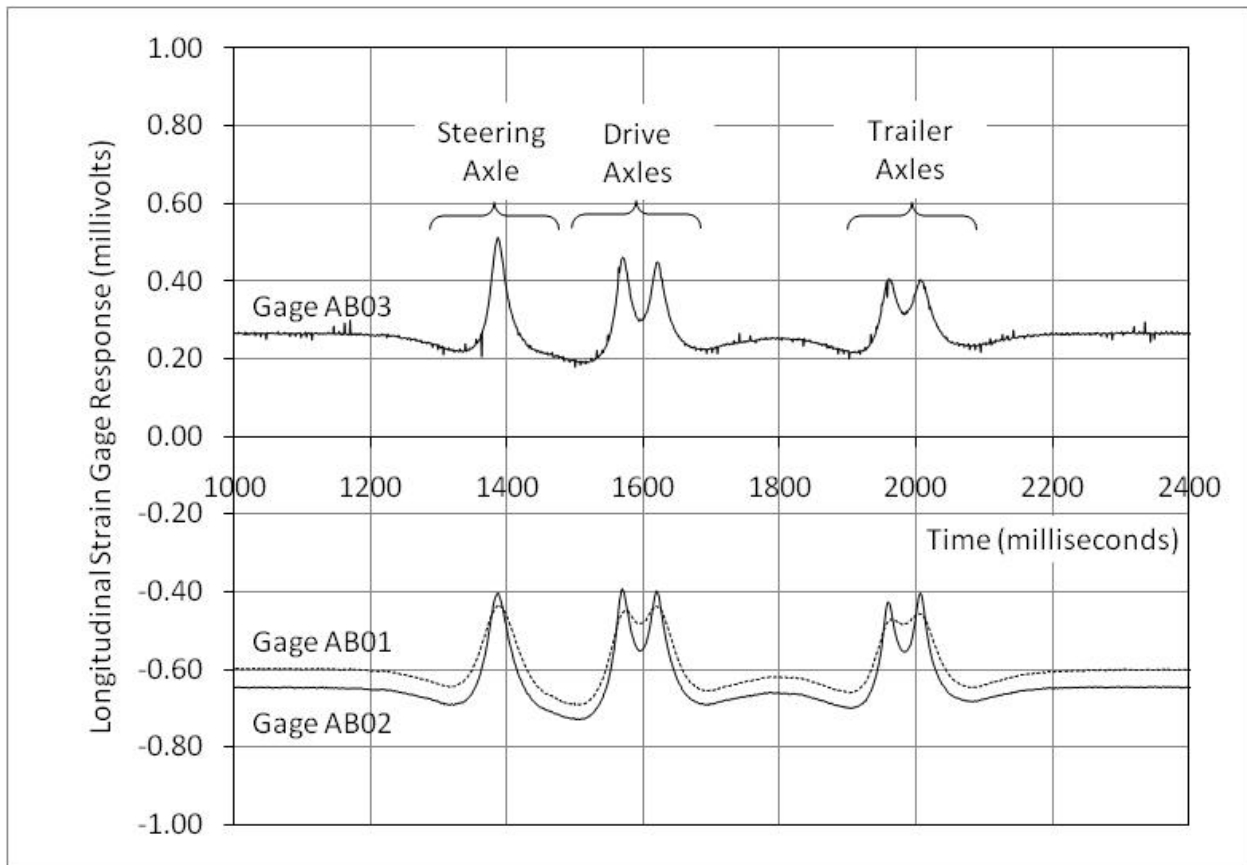
Figure 5.1: Typical set of data obtained from the longitudinal strain gages.

Figure 5.1 illustrates a typical set of data obtained from three longitudinal strain gages (AB01, AB02, and AB03) from the I-5 test site. The chart shows gage response in millivolts plotted against time in milliseconds. The gage responses due to individual axle loads (i.e., steering axle, drive axles, and trailer axles) were clearly evident from data obtained from the longitudinal gages but, in most cases, were not always readily evident from data obtained from the transverse gages as illustrated in Figure 5.2.

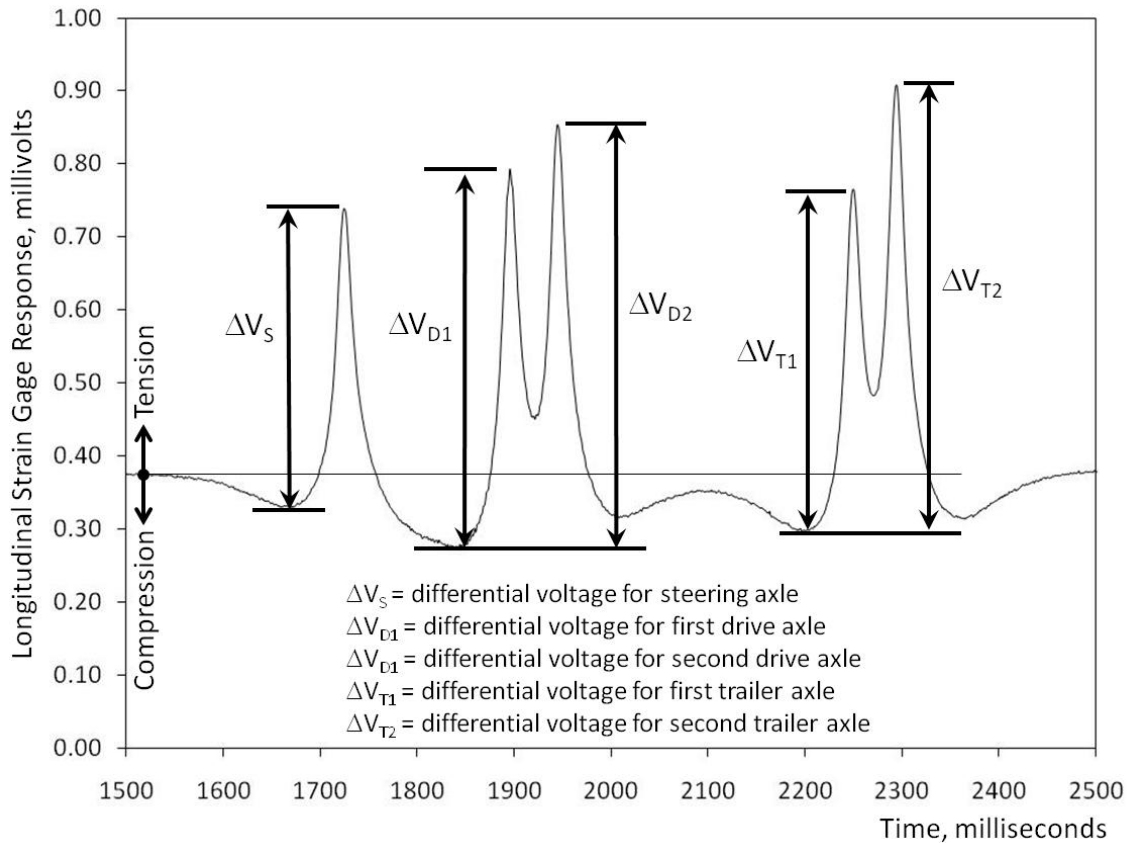
Figure 5.3: Methodology for reducing the longitudinal strain gage data.

Figure 5.3 shows typical responses of a longitudinal strain gage to a passing five-axle truck. It can be seen as the steering axle approached the location of the strain gage, the gage went into compression, and then into tension as the axle passed over the gage, and then into compression again as the axle retreated from the gage location. Further, it can be seen that the gage remained in compression until the first drive axle passed over the gage, but remained in tension between the drive axles. Similar observations can be about the response of the gage to the trailer axles.

For longitudinal strain gages, differential voltages due to tensile loads were determined by subtracting the minimum voltage value from the maximum voltage value as illustrated in Figure 5.3. It is important to note that the amount of tension required to overcome the compression was included as part of the total tensile strain imparted by a particular axle load.

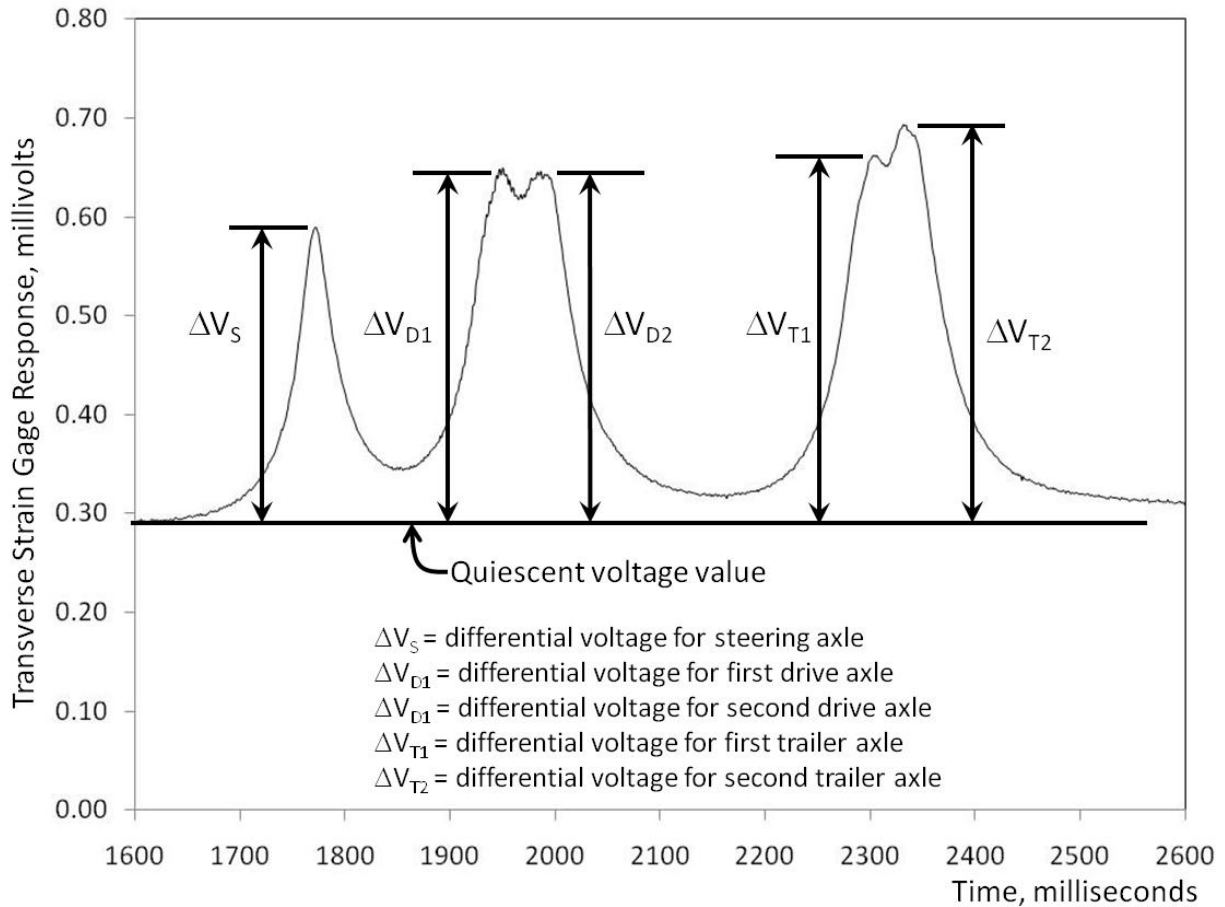
Figure 5.4: Methodology for reducing the transverse strain gage data.

Figure 5.4 shows typical “clean” responses of a transverse strain gage to the same five-axle truck. It should be noted that, in the majority of cases, the responses of the transverse gages were as shown in Figure 5.2. Nevertheless, it can be seen from Figure 5.4 that the transverse gage did not go into to compression. It can be further noted that the gage remained in tension throughout the time it took for the truck to pass over the gage. Indeed, this was true of the responses of every transverse strain gage to every passing axle load. Thus, for transverse strain gages, differential voltages due to tensile loads were determined by subtracting the quiescent voltage value from the maximum voltage value as illustrated in Figure 5.4.

The methodologies for reducing the strain data appear quite simple, but in reality reduction of the data required a substantial effort. The data were imported into a spreadsheet, categorized by strain gage type and location in the grid, and then plotted on graphs. Code was written to import and format the data and to aid in determining the maxima and minima of the voltage values. However, despite having a partially automated process, a significant amount of human interaction was required. A typical set of data from the I-5 site (with 24 gages) took approximately 45 minutes to reduce per truck. Due to the length of time required to reduce each data set, mostly due to human interaction, development of a LabView program to reduce the data more efficiently was initiated. However, it had not been completed prior to the end of this project.

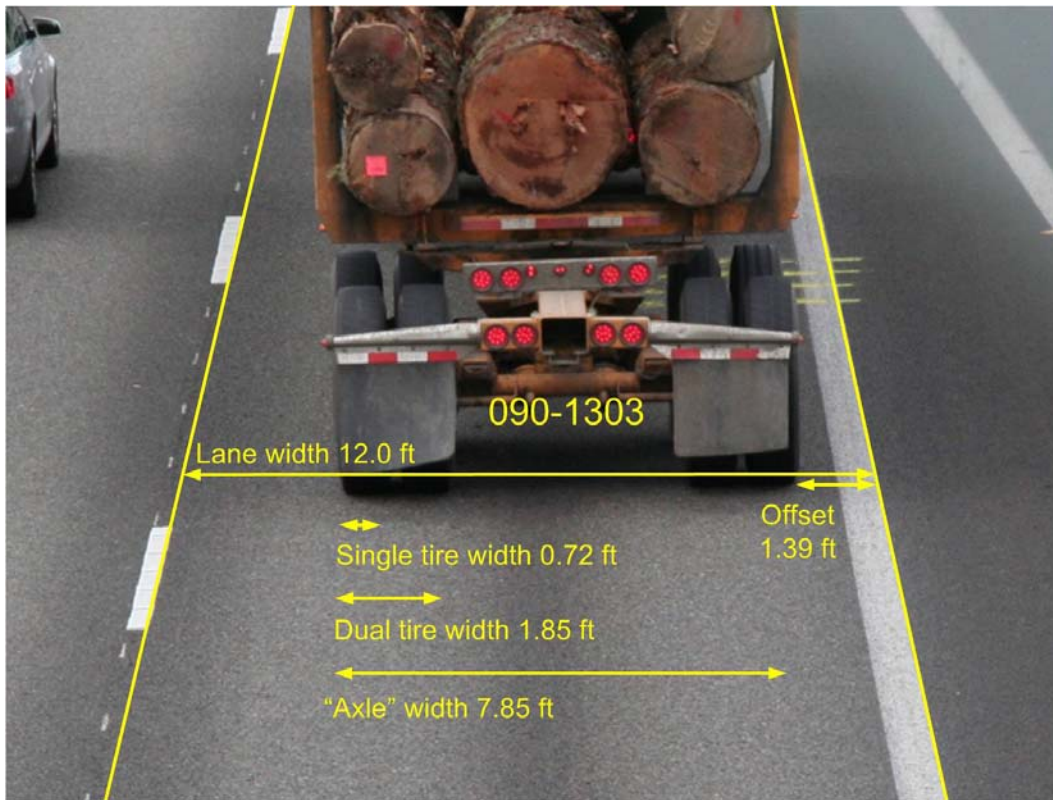
Figure 5.5: Photographic method of determining truck position.

Information in addition to the truck position was also determined from the photos for use in analyses. These included width of single tire treads, the dual tire width (outside of tread to outside of tread), and the axle width (also outside of tread to outside of tread). Analyses of photos of approximately 150 trucks were used to obtain average values for use in further analyses.

The results from the photos were also used to verify the position of the truck derived from the axle sensors. This was only performed at the I-5 site because there was no practical way to photograph trucks at the Redmond site.

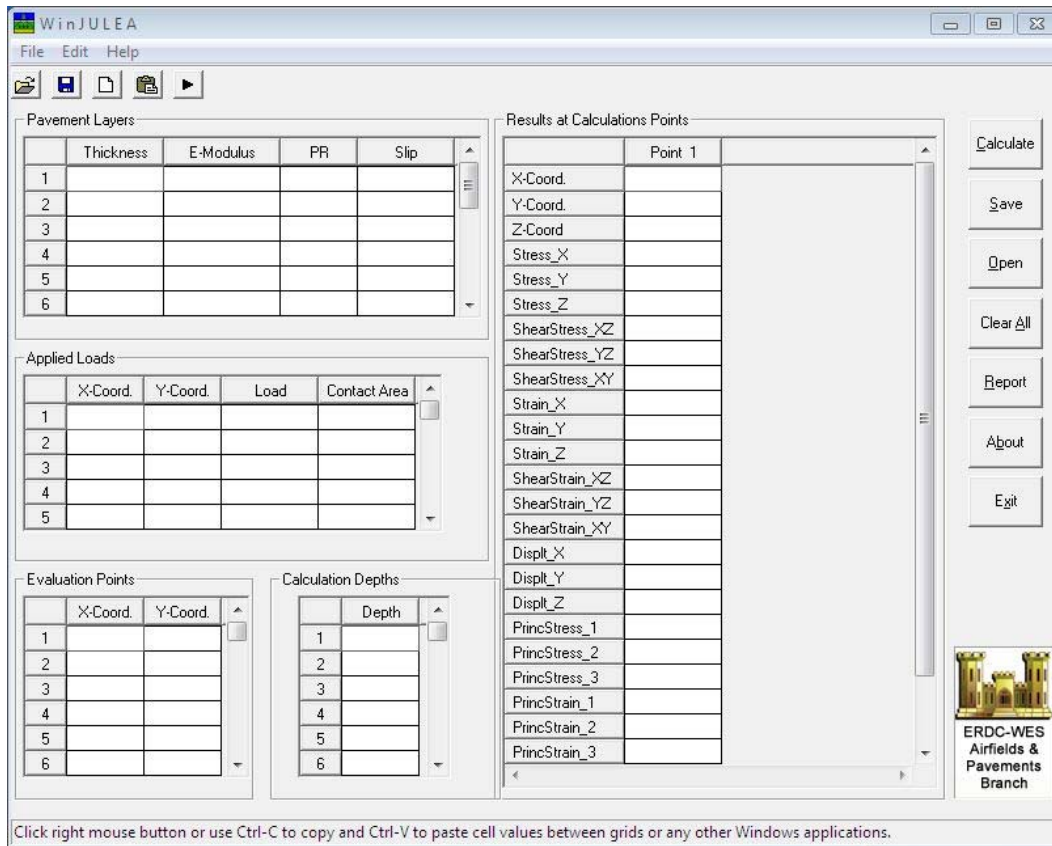
Figure 5.6: Windows version of JULEA developed by USACE ERDC-WES.

To satisfy one of the objectives of the study, the measured strain values were to be compared with predicted strain values obtained from the JULEA layered elastic analysis software program originally developed by Jacob Uzan of Technion – Israel Institute of Technology. Figure 5.6 shows the user interface for a Windows version of the JULEA software developed by the Waterways Experiment Station (WES) of the Engineer Research and Development Center (ERDC) of the U.S. Army Corps of Engineers.

Pavement layer properties are entered in the top left (“Pavement Layers”) grid of the application. These include the thickness, dynamic modulus (“E-Modulus”), and Poisson’s ratio (“PR”) for each layer of the pavement structure as well as the interface conditions (“Slip”) between layers. The “Applied Loads” grid is where the coordinates, load, and contact area of each tire load are entered. Points of interest within the pavement structure for which the program calculates stresses and strains are entered in the “Evaluation Points” and “Calculation Depths” grids. Results are displayed in the grid on the right side of the user interface.

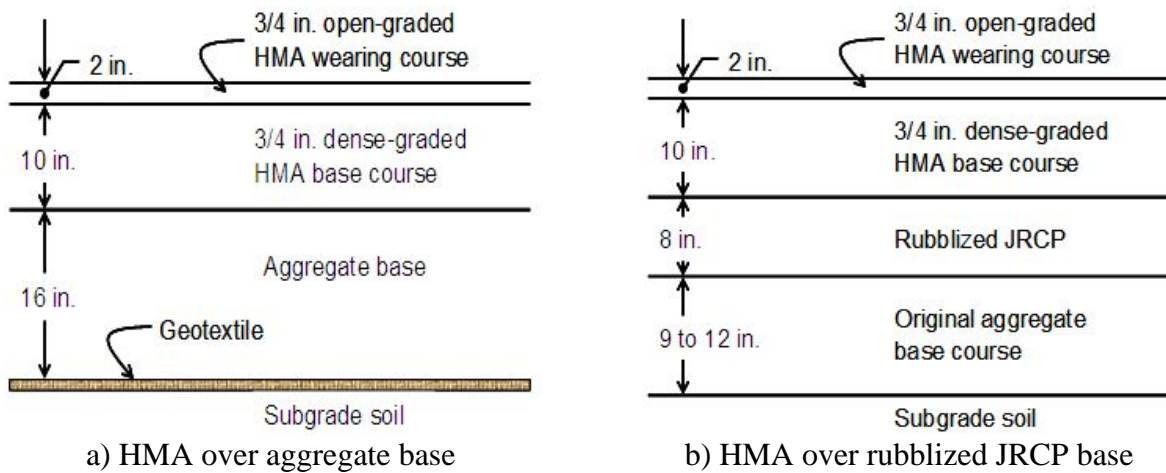
Figure 3: Pavement structures at the I-5 test site.

The test site was located in the southbound lanes immediately downstream of the Dever-Conner interchange near Mile Point 239 as illustrated in Figure 2. The majority of the construction project involved placing a hot-mix asphalt (HMA) overlay over rubblized jointed, reinforced concrete pavement (referred to as Rubblized JRCB Base in Figure 2). To maintain minimum clearance under structures (overpasses), the existing concrete pavement was removed and the pavement structure was reconstructed with aggregate base (referred to as Aggregate Base in Figure 2). Hence, the test site offered two pavement structures in one location. Figure 3 illustrates the two pavement structures at the I-5 test site, both designed for very heavy truck traffic.

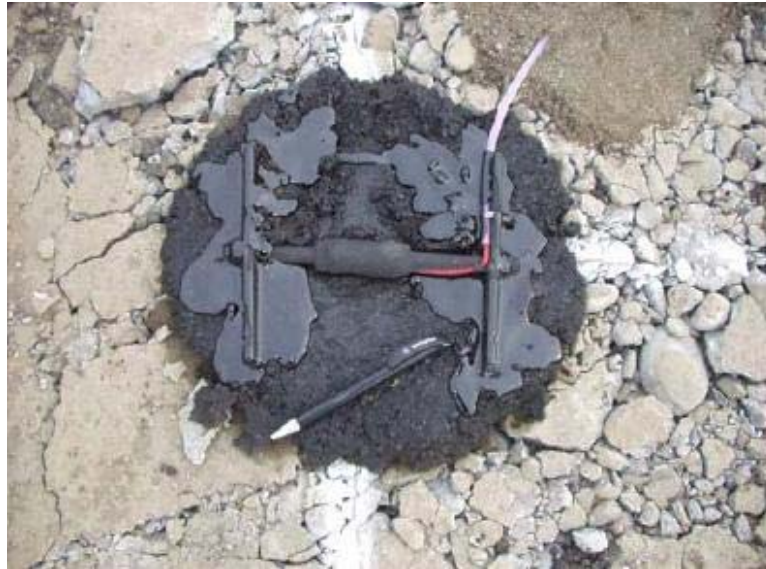
Figure 4: Close-up view of a strain gage over the rubblized JRC base course at the I-5 site.

CTL Group ASG-152 strain gages were placed on the surface of the aggregate base and rubblized JRC base courses as shown in Figure 4. Each gage was tacked to a patty of sand and emulsion mixture to protect them from damage during the placement and compaction of the overlying HMA layers.

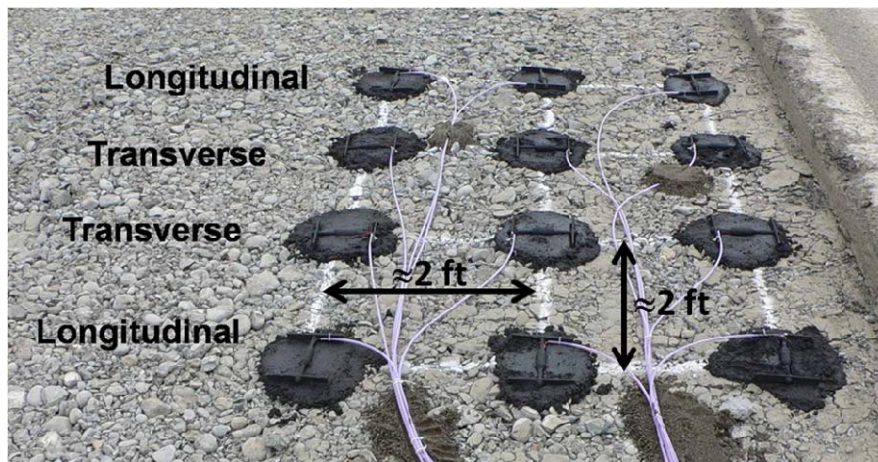
Figure 5: Strain gage array over the aggregate base course at the I-5 test site.

Figure 5 shows a picture of the strain gage array for the section with aggregate base indicating that the strain gages were arranged in an array of 12 gages, with six oriented to measure longitudinal strain and six to measure transverse strain, whereas Figure 6 illustrates the distances between gages for each section. The strain gage arrays were positioned to be directly beneath the outside wheel path of the outside (slow) lane.

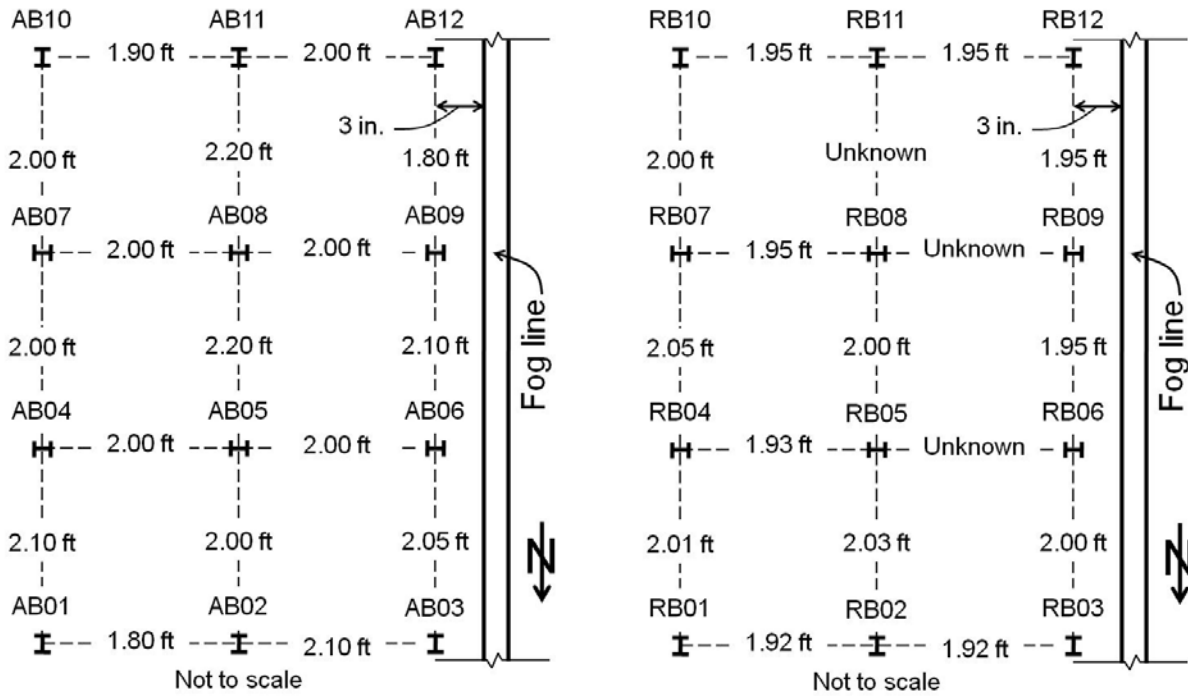
a) Strain gage array over aggregate base

b) Strain gage array over rubblized JRCF

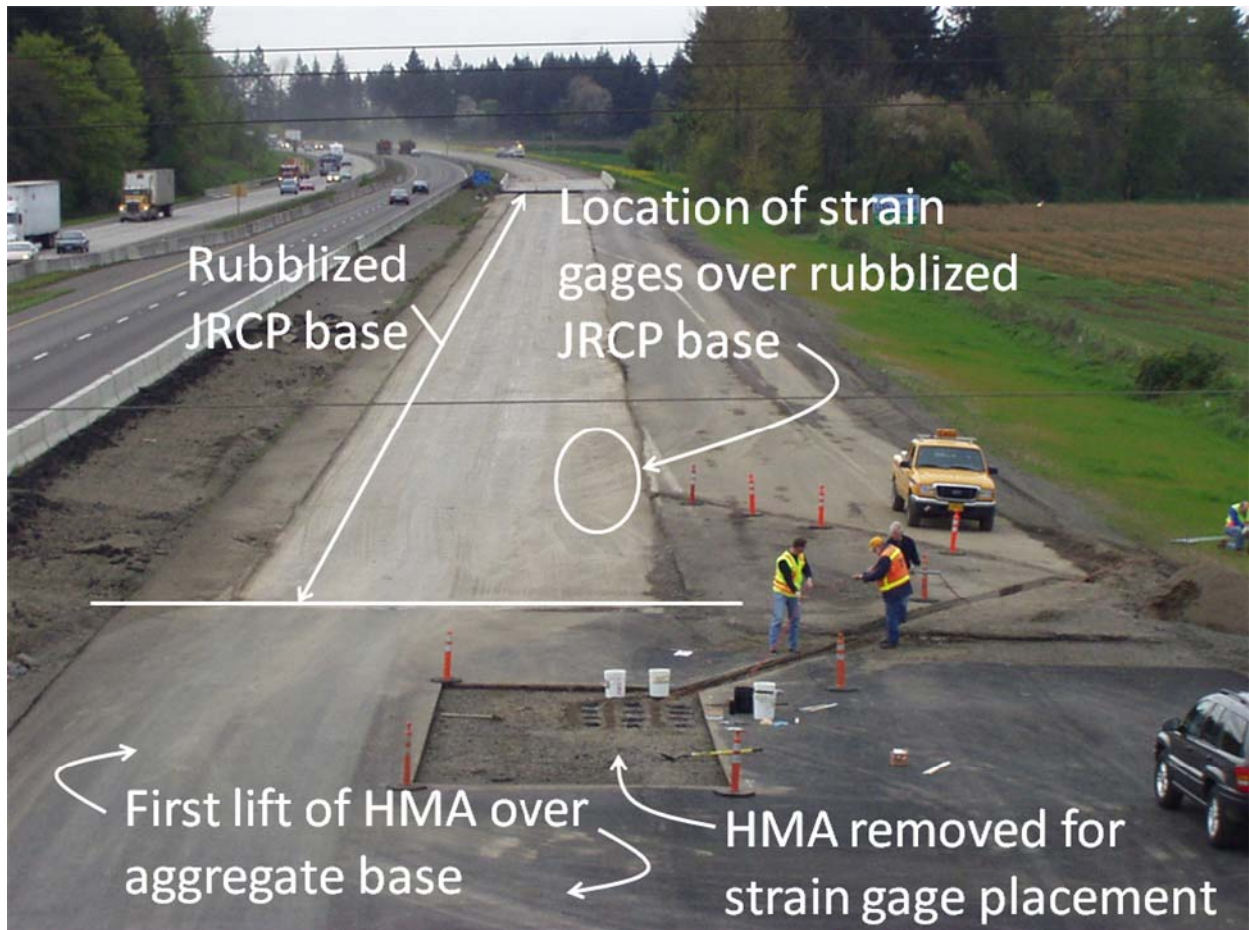
Figure 7: Overview of the I-5 test site during strain gage installation.

Figure 7 shows a picture of the I-5 test site taken from the Dever-Conner overpass. At the time of the strain gage installation, the first lift of HMA had been placed over the aggregate base section. Hence, a portion of the HMA was removed so that the strain gages could be placed directly on the aggregate base course. Figure 7 also indicates where the strain gages were placed over the rubblized JRCF base course, which had not yet received a lift of HMA.

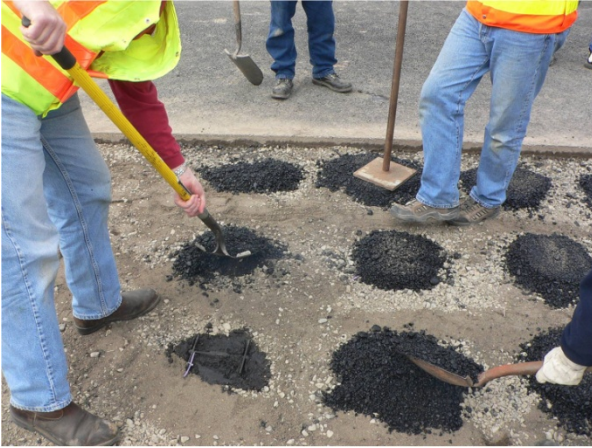
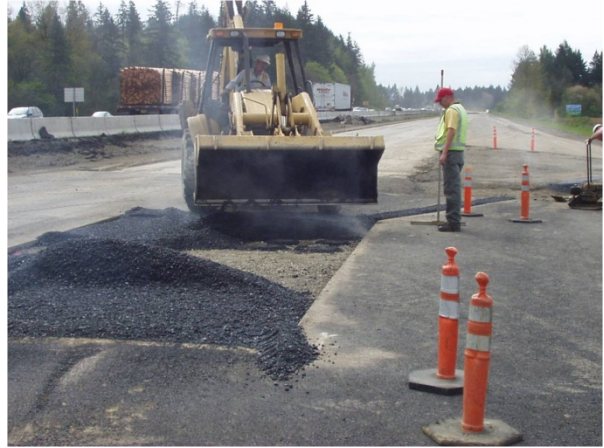
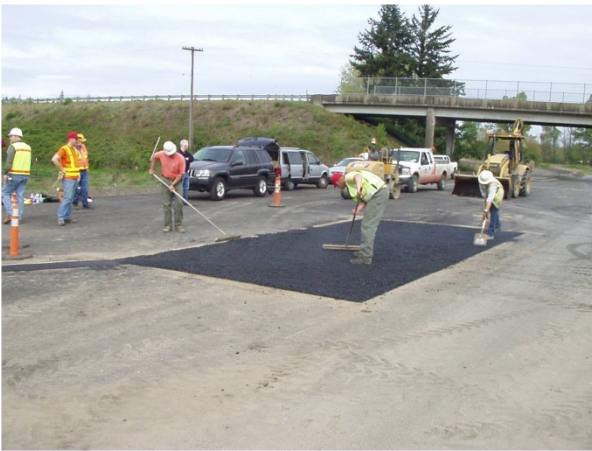
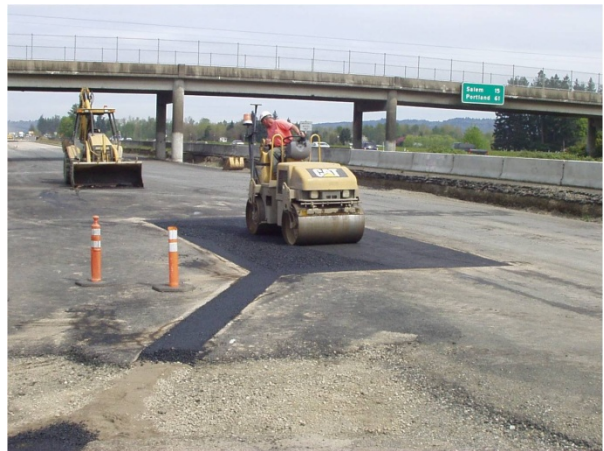
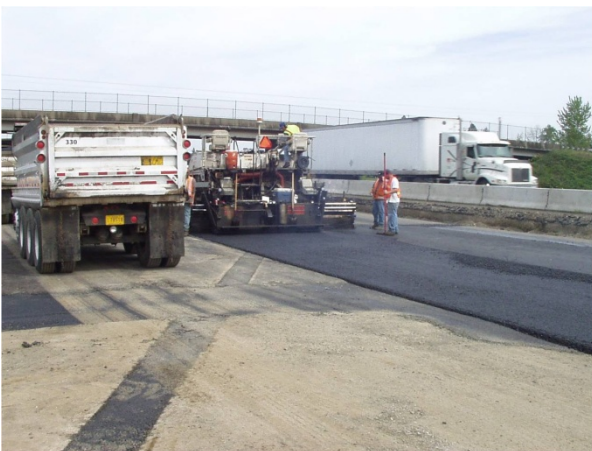
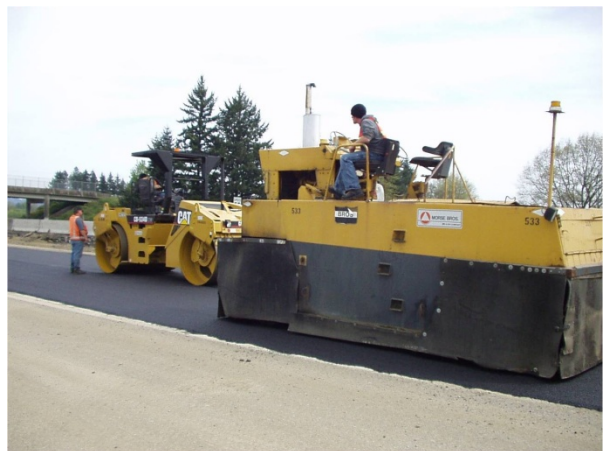
Figure 8: Construction sequence to cover the strain gages over the aggregate base.

Following arrangement of the strain gages in the array over the aggregate base, the strain gages were covered with HMA and compacted as shown in the sequence of photos in Figure 8. The gages were first given a protective covering of loose HMA, which was lightly compacted with a hand tamper as shown in Figure 8a. The cutout was then filled with HMA (Figure 8b), which was spread to uniform thickness (Figure 8c) and compacted using a small roller (Figure 8d). Once the cutout was filled, the second lift of HMA was paved (Figure 8e) and compacted (Figure 8f) using conventional paving and compaction equipment.

a) Protecting gages with loose HMA.

b) Covering gages with HMA.

c) Spreading HMA over gages.

d) Compacting HMA with a small roller.

e) Paving second lift of HMA.

f) Compacting second lift of HMA.

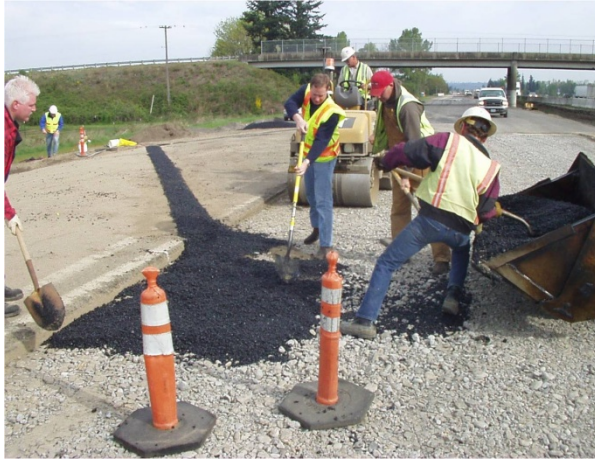
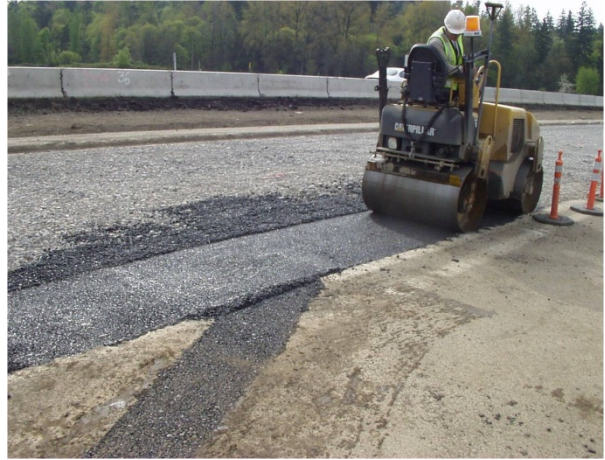
Figure 9: Partial construction sequence to cover the strain gages over the rubblized JRCP base.

For the strain gages placed over the rubblized JRCP base course, the only difference in the construction sequence was that the first lift of HMA had not yet been placed, so a cutout was not necessary. In this case, prior to placement of the first lift of HMA, the strain gages were given a protective covering of HMA which was compacted using the small roller as shown in Figure 9.

a) Covering gages with HMA.

b) Compacting HMA with a small roller.

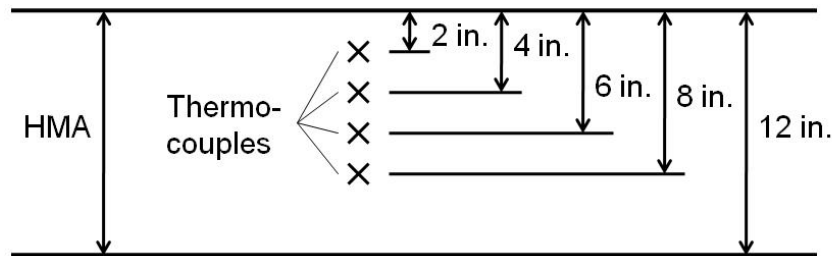
Figure 10: Depth of thermocouples installed in the HMA layer.

Thermocouples were installed at various depths within the hot-mix asphalt layer following construction as illustrated in Figure 10. Installation occurred following construction and involved drilling holes to the appropriate depths, inserting the thermocouples, and filling the holes with epoxy. The thermocouples allowed monitoring of the HMA temperature with depth to an accuracy of at least 0.2°F (0.1°C).

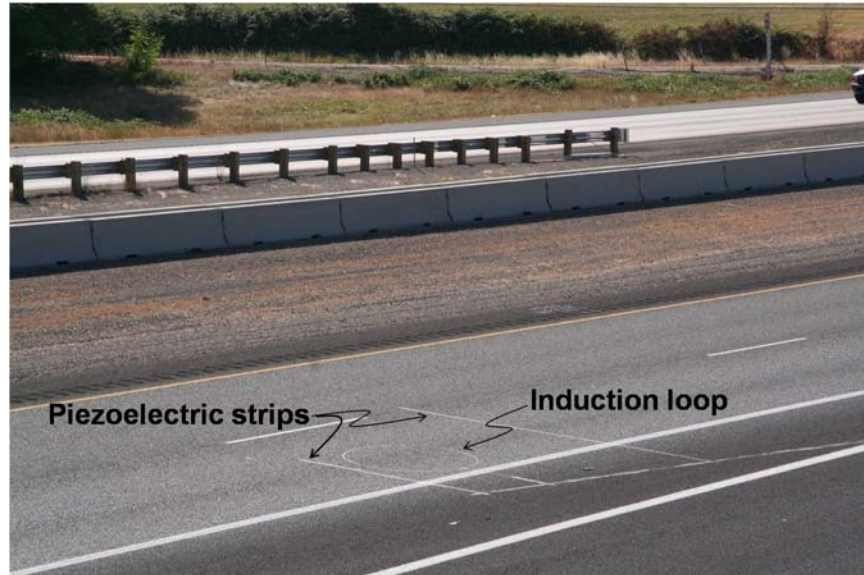
Figure 11: Weigh-in-motion (WIM) devices installed on the surface of the pavement.

Weigh-in-motion (WIM) devices were installed on the surface of the HMA layer following construction. These included two piezoelectric strips and an induction loop as shown in Figure 11. A thermocouple was also installed under one of the piezoelectric strips (at 1 inch depth). The piezoelectric strips were used to measure axle loads of the vehicles crossing the strips, the induction loop was used to classify the vehicles, and the thermocouple was used to measure temperature. Installation involved cutting grooves in the surface of the pavement, cleaning and drying the grooves, placing the devices in the grooves, and filling the grooves with adhesive—epoxy for the piezoelectric strips and thermocouple and liquid asphalt for the induction loops—around the devices. The WIM devices were installed upstream of the strain gages.

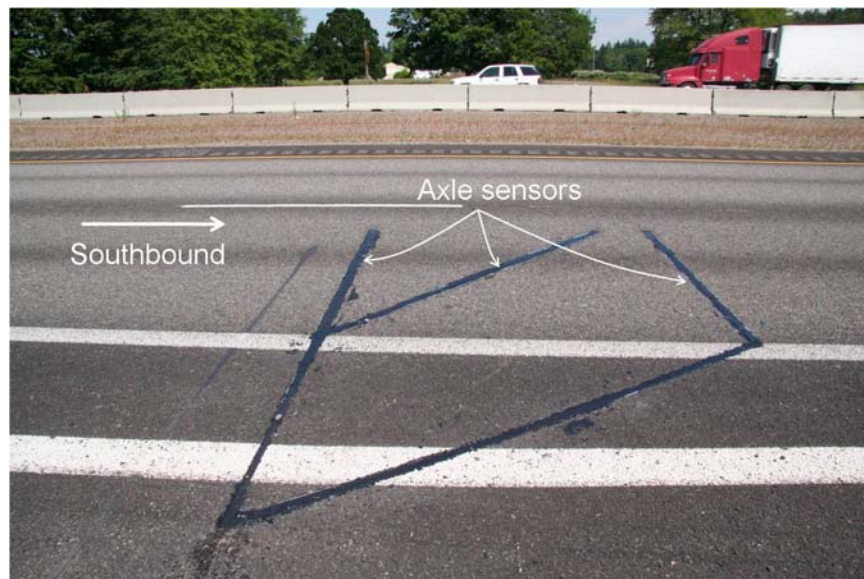
Figure 12: Axle sensors installed on the surface of the pavement.

Axle sensors were also installed on the surface of the pavement (Figure 12) following construction to determine the transverse position of vehicles in the travel lane. Installation involved cutting grooves in the surface of the pavement, cleaning and drying the grooves, placing the devices in the grooves, and filling the grooves with epoxy adhesive around the devices. Figure 13 illustrates the geometric layout of the axle sensors. Installation of the axle sensors was accomplished approximately 2 years after the strain gages were installed.

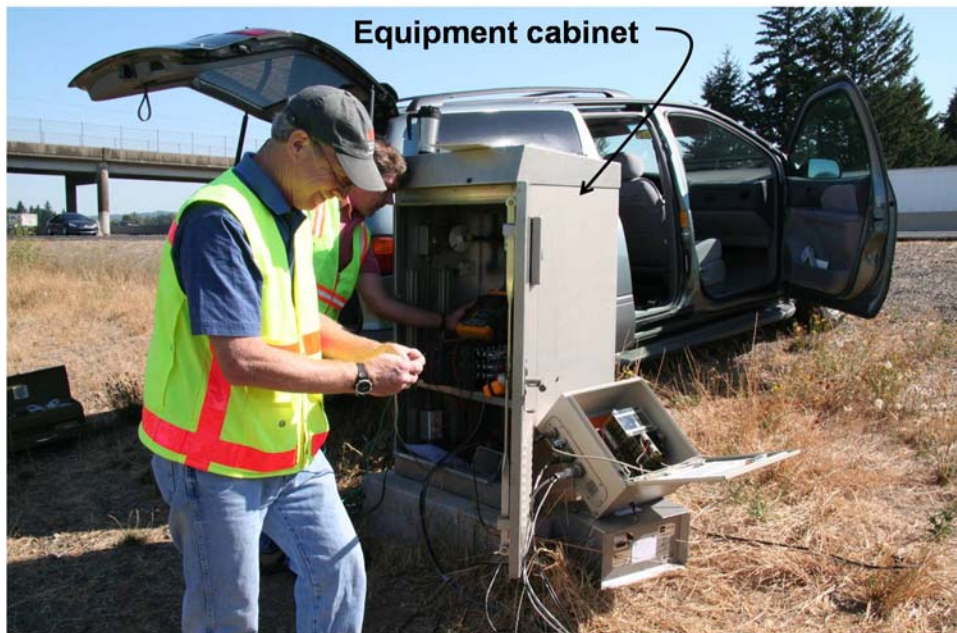
Figure 14: Equipment cabinet.

An equipment cabinet (Figure 14) was installed at the site a safe distance from the highways (i.e., live traffic) to house the equipment necessary for data acquisition. Instrument cables (wires) were routed from the roadway to the equipment cabinet through a trench to prevent damage by traffic, weather, and maintenance equipment.
