Does the Bicycle Detector Symbol Change Cyclist Queuing Position at Signalized Intersections?

1 **Does the Bicycle Detector Symbol Change Cyclist Queuing Position at**
2 **Signalized Intersections?**

28
29 Submitted for presentation and publication to the
30 94th Annual Meeting of the Transportation Research Board January 11-15, 2015

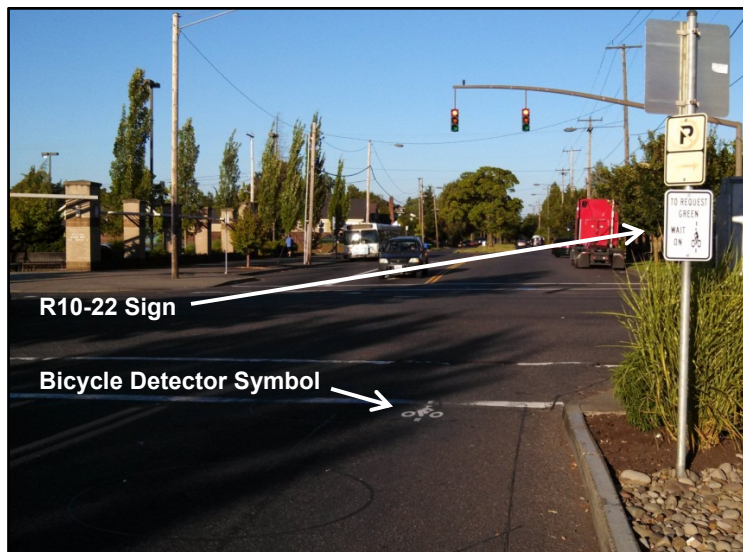
b) Site 2 After Modification – Bicycle Detector Symbol and R10-22 Sign

5 Portable video equipment was installed at each intersection to collect data on cyclists using each location.
6 Initial observations were made of each study site without roadway markings or signage present to indicate
7 where a cyclist should wait over a loop detector in order to receive a green. Once initial video data were
8 recorded, modifications to each study site were made to help cyclists position themselves over the loop
9 detector in order to receive a green indication. Each study site had a different modification made as
10 described previously. Photographs of each intersection after modification are included in Figure 2.

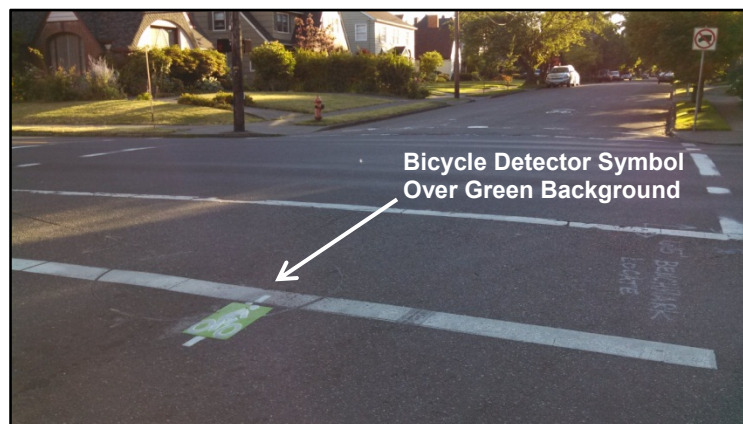
c) Site 3 After Modification Bicycle Detector Symbol with Green Background

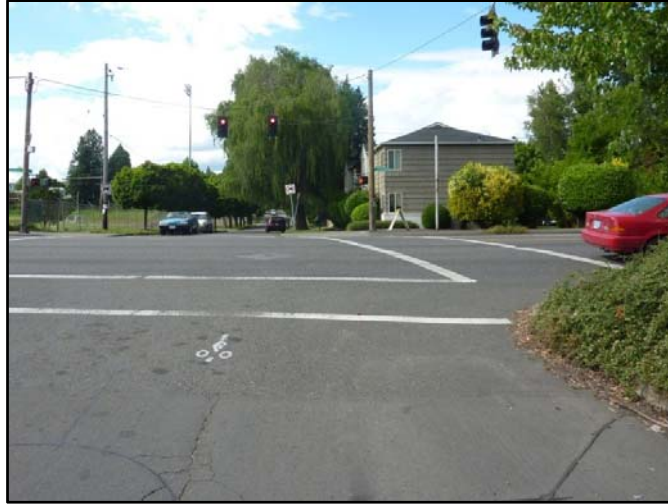
a) Variation 1: Bicycle Detector Symbol

Categorical questions included how often participants rode a bike, number of working bikes they owned, age range and gender. Five open-ended questions were asked. In the first, the participant was shown a laminated picture of the approach to a signalized intersection with a red signal indication displayed. The participant was then asked to use a dry erase marker to mark an X on the picture where they would stop as a cyclist to wait for a green indication. Three versions of this question were created but each survey participant was asked only one randomly chosen variation of this question. In each version the same picture of an intersection was shown but the road marking and signage was different. In the first variation, the only marking present was the bicycle detector symbol. In the second, the bicycle detector symbol was accompanied by a R10-22 sign mounted on the side of the roadway. The third variation was a modified bicycle detector symbol over a green background (see Figure 4).

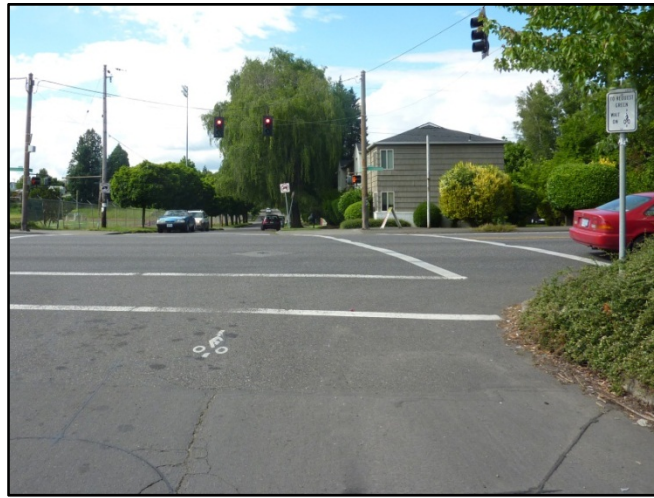
b) Variation 2: Bicycle Detector Symbol and R10-22 Sign

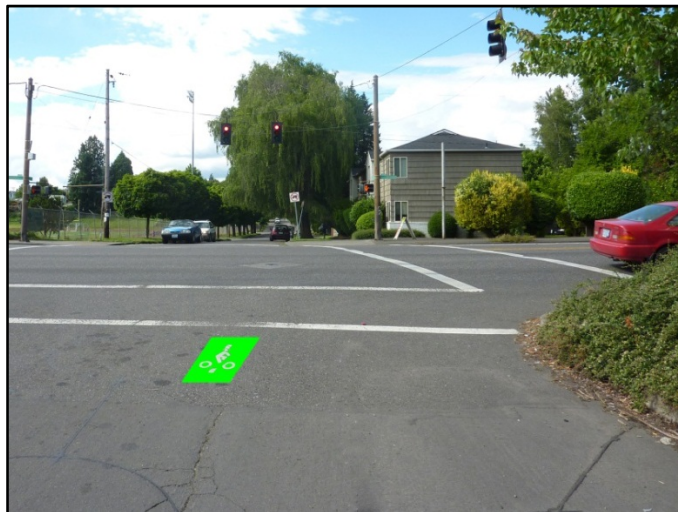
c) Variation 3: Bicycle Detector Symbol Over Green Background
