Building Reuse as a Sustainable Practice in Architecture

Honors Thesis Portland State University

Case Study: The COR Building

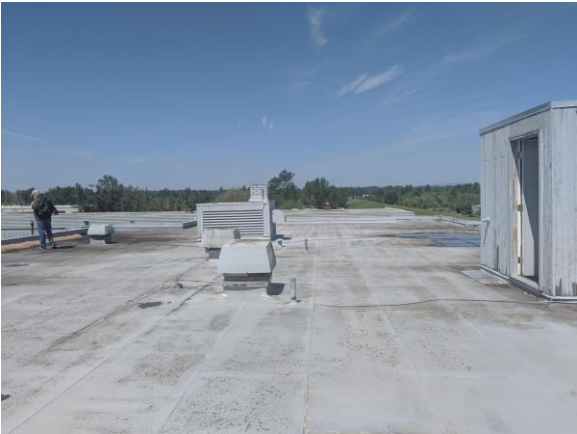
The roof of the building is generally in good shape, however there is some pooling, and some moss growth, which will likely result in repairs or drainage modifications. The roof is currently covered with asphalt rolls, which run at \$39.97/roll, at Lowes based on the damage on the roof, it seems that only the North corners will

need replacing, estimated to be about 4 rolls, totaling \$159.88.²⁶ Due to the pooling it can be assumed that there are likely some support beams that would also need replacing, each 2"x12"x16' beam costing \$20.95.²⁷ The beams would need to span a 40'x20' space, which would require 38 boards costing \$796.10. Estimating the total material cost of roof repair to be \$1752.08 without consideration for labor. However, if it was found by an inspector that the entire roof surface needed replacement, estimates were also sought out. Quoted from Dr. Roof Inc. the material and labor would range from \$3,750-\$15,000.²⁸ Cascade United quoted the roofing cost at \$28,000-\$38,000.²⁹

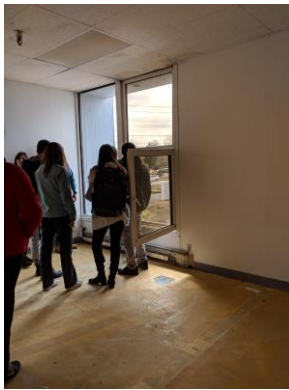
Flooring

Each of the three floors of the office needs reflooring, the basement floors have unfinished tiling, and the upper floors have partial carpeting, where some of it has already been removed. Due to the proximity to the facilities, the regularity of people coming in with dirty work boots will likely happen more often than not, therefore, marmoleum flooring was chosen as a sustainable and hard-wearing flooring option. The flooring has all been torn out by the current owner, so prep and installation are all that is needed. Depending on the state of the underlayment of the flooring the cost of installation will be different.

I received quotes from three flooring companies, Classique Floors, Floor Factors and Linoleum City.

Quoted by Classique Floors using sheets to prep the floors, each sheet being 3'x5', \$70 for labor and \$45 for material per sheet, totaling in \$115 per sheet. To cover all three floors it would take 748.8 sheets costing \$86,112. Cost of installation was quoted at \$5.50/yard for material and \$24/yard for labor, totaling in at \$36,816. A final quote of \$122,928 from Classique Floors.³⁰

Quoted by Floor Factors using a skim coat for basic prep at \$.75/sf it would cost a total of \$8,424. They estimated marmoleum at \$33.20/sy totaling \$41,433.00. Adhesive was quoted at \$143/4 gallon pail and required approximately 23 pails to cover all three floors, totaling \$3,289. Labor was quoted at 400 hours which would cost \$36,000. With material, adhesive, labor and prep, the total from Floor Factor is \$89,146.³¹

Quoted by Linoleum City, without details, totaling \$80,000.³²

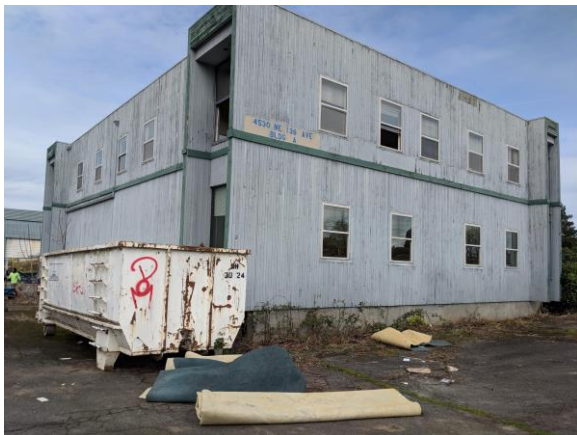
Siding

The current building has wooden siding, which has a life span of 20 years, however in renovating a longer lasting material would be chosen, so for the sake of the study, cost for fiber cement siding, which has a lifespan of 100+ years, was found. The exterior of the building is

approximately 9,580 square feet. In order to remove the siding a local company, NW Commercial Exterior quoted it at 1.65/sf, which would total at \$15,800.³³ An online pricing found for the Portland area provided a range of \$12,698-30,925 for removal³⁴. Based on the information provided by the contractor in Portland, the higher cost of removal may be due to dry rot repair if it were to be found when removing the original siding. Cost for labor and material for the fiber cement panels was estimated to be \$10/sf by KVN Construction³⁵, and \$9.80/sf by NW commercial exterior, meaning that cost for material and labor would be around \$85,262. And total cost to reside the building would be \$101,062. The online estimate gave a labor cost of \$30,160 and material cost of \$54, 643, totaling \$84,803. Making the total for the online estimate approximately \$106,615.³⁶

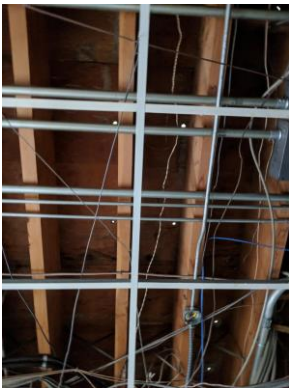
Ceiling Tiles

The entire building has gridding done for 2'X4' ceiling panels, however many of them are missing, or damaged. Because of this, new tiling estimates were found for the entire building, using an estimated square footage of 11,232. If the panels were replaced with a comparable material, each panel would cost around \$.57, totaling in \$6,419. If instead it was decided that a more sophisticated/esthetically pleasing panel would replace them, they would range at around \$1.00/sf totaling in about \$11,232 to retiling the whole ceiling.³⁷

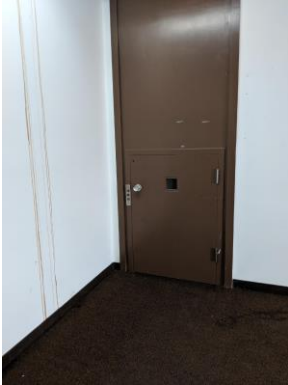
Elevator

The current building already contains two means of egress, and bathrooms that meet code. However, the elevator needs to be updated from a service elevator to an elevator that can transport people, and a kitchenette needs to be updated in the basement to meet the needs of the user. Installing a new elevator was estimated at \$20,000-\$28,000 as a national average for a two to three story building by Reference.³⁸

According to Fixr the cost for the elevator and installation ranges from \$30,000-\$50,000 depending on the location of the mechanical room, and number of stories. Due to the fact that the current mechanical room is separate, but close to the elevator, and that it is a three-story building, it is likely that the estimate for this building would be in the \$40,000-\$50,000 range.³⁹
