# Soil Development and Vegetation Response to Removal of a Small Dam, Lassen Volcanic National Park, California

A thesis submitted in partial fulfillment of the  
requirements for the degree of

Master of Science  
in  
Geography

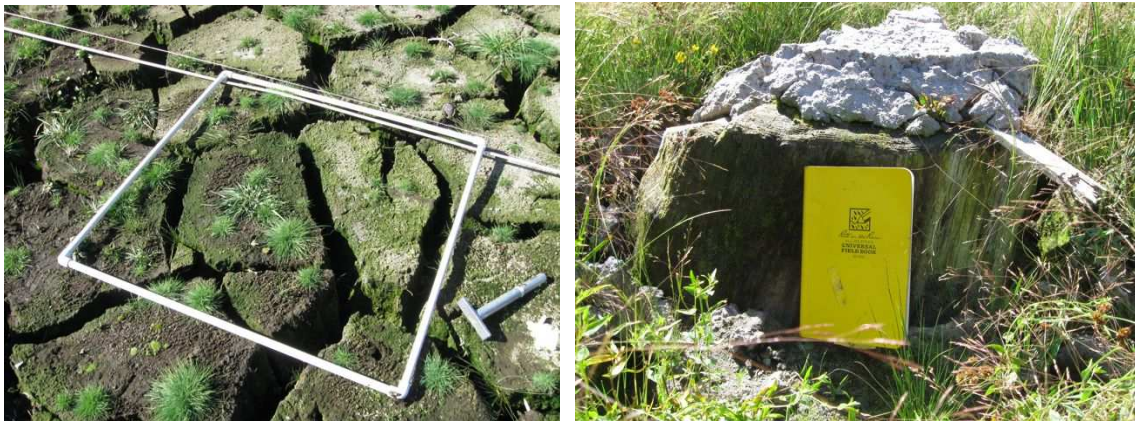
**Fig. 1.** Examples of the physical characteristics of ripening. Left (a): cracking as a result of dehydration of exposed sediment. Right (b): Subsidence indicated by the isolation of sediment from the reservoir surface in the center of the reservoir.

plant growth as roots begin transpiring water from the subsurface. The soil begins to shrink, crack, subside, and increase in permeability (Figure 1). Cracks like those depicted in Figure 1a often result from the sudden drainage of a subaquatic environment; they are rarely seen in areas of natural drainage. Water not only dehydrates vertically through the soil profile, but horizontally as well. The subsidence in diked estuaries is often attributed to dehydration as well as the oxidation of organic material once dewatering has occurred (Pons and Zonneveld 1965).

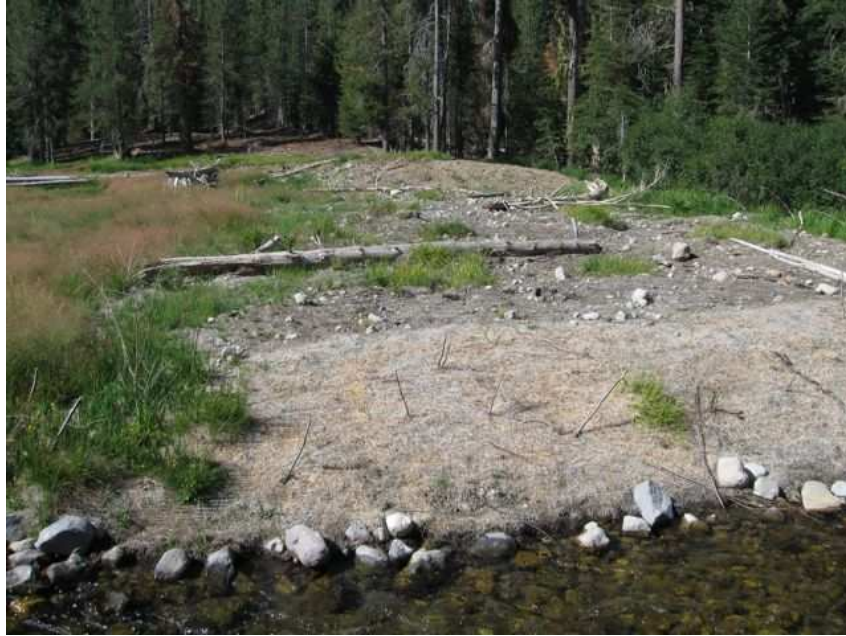
**Fig. 3.** Photo of Dream Lake Dam, following removal and leveling. Outflow channel in foreground was created by NPS during drawdown and draining of the lake in August of 2011.

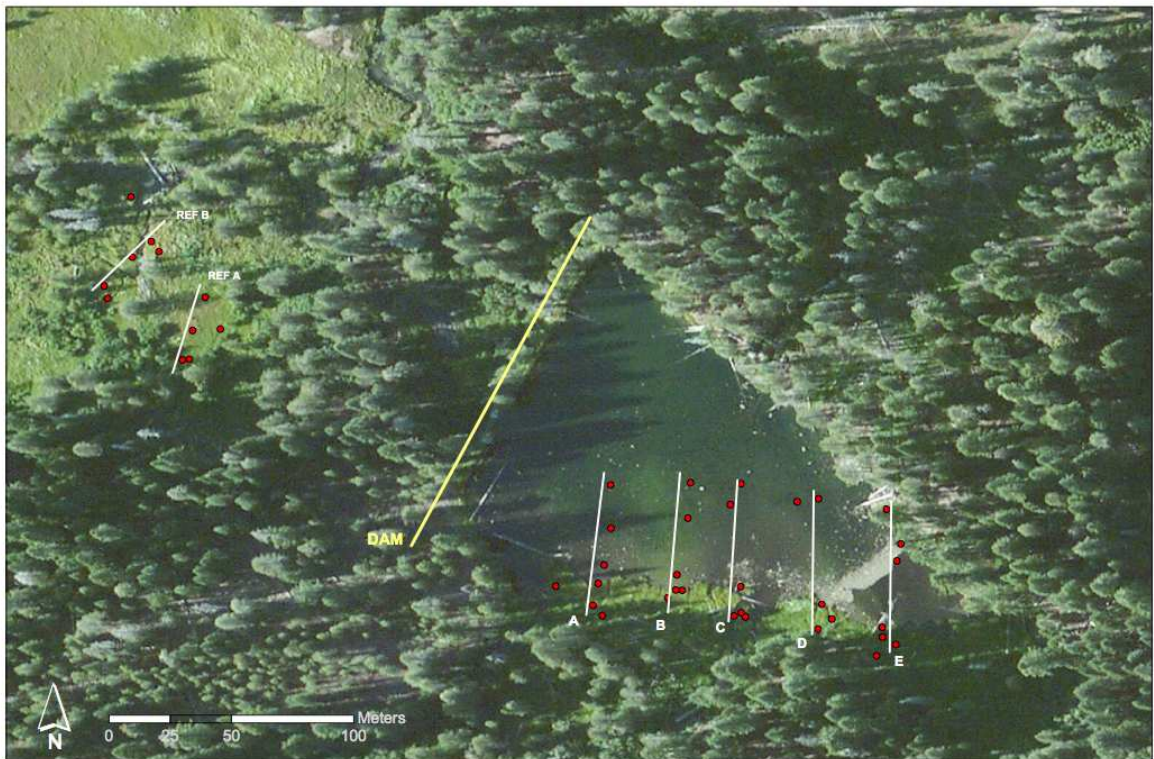
**Fig. 4.** Transect locations at Dream Lake Reservoir (A-E) and transect locations at the meadow site (REF A and REF B).

In order to characterize soil properties after the dam was removed, I collected soil samples from within each quadrat in the former reservoir and in all reference quadrats. To keep within NPS research permit requirements that limited the total volume of soil I could collect, I removed two, 2 x 10 cm soil cores from each quadrat and placed them in a sealed plastic bag. The composite samples were stored in a cooler and then frozen until laboratory analysis could be conducted. Being limited in the volume of allowed sample material, I chose to collect many surface samples rather than to dig a few deep soil pits; thus, my analysis is limited to the top 10 cm of the dewatered sediments but covers the maximum range of elevation in the former reservoir.

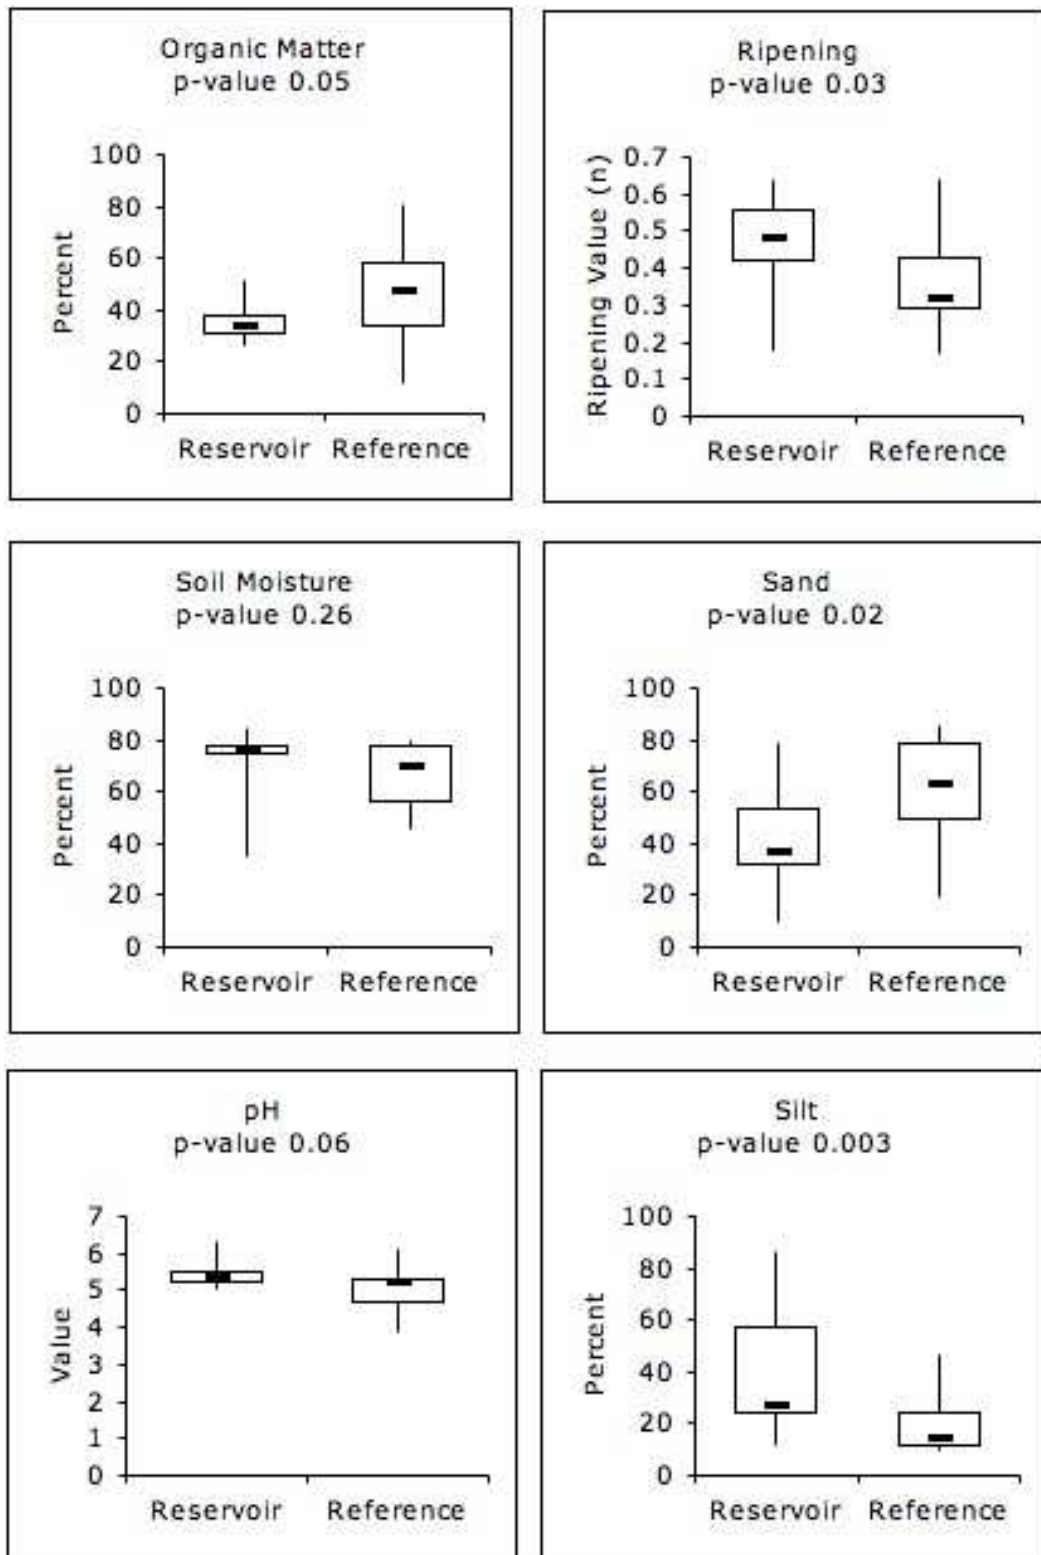
**Fig. 5.** Box and whisker plots comparing mean values of soil properties between reservoir (n=15) and reference (n=16) sites. pH is compared by median values.

Dams not only trap sediment, but also organic matter. Allochthonous inputs of organic material are carried by rivers and streams from upstream sources and sink to reservoir bottoms. Anaerobic conditions, like those in reservoirs, slow the decomposition of organic matter typically causing significant contrasts between reservoir soil and upland soil. Organic matter in the Dream Lake reservoir actually decreased when compared to the reference samples (Table 1), showing a significant difference of  $p=0.05$  (Figure 5).

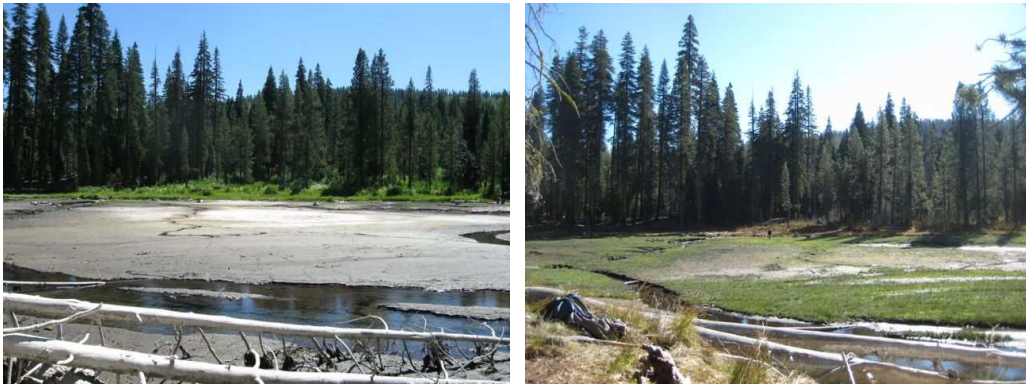
**Fig. 6.** Left (a): Dream Lake immediately following dewatering, August 2011. Right (b): Dream Lake showing rapid plant growth within two months of exposure.

Within three months after draining, the Dream Lake basin had a number of plants growing (Figure 6). Rapid vegetation growth in newly exposed sediment following a dewatering event is not uncommon (Shafroth et al. 2002, Orr and Koenig 2006, Orr and Stanley 2006, Auble et al. 2007). Additionally, studies of drained and abandoned beaver ponds have also reported prompt colonization of sediments with sedges and grasses (Neff

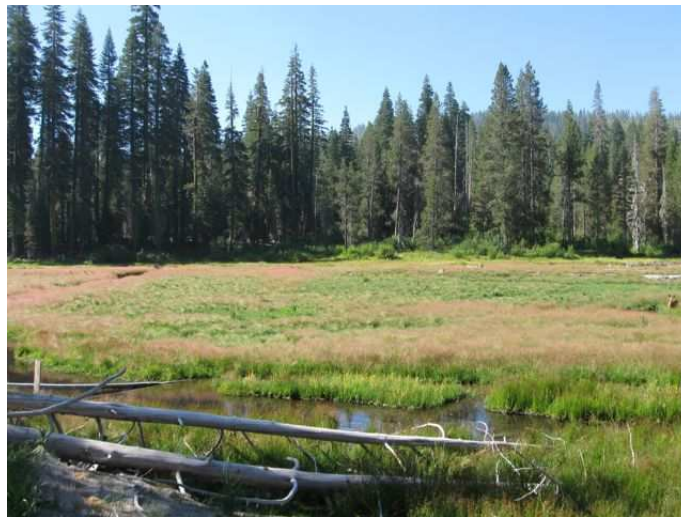
**Fig. 7.** Rapid revegetation of Dream Lake, August 2012.

By the time of this study in August 2012, the Dream Lake basin was lush with grasses, sedges, and herbaceous plants (Figure 7). Overall species richness in the basin was equivalent to the reference sites immediately outside the basin, and actually greater than the isolated western reference location. It is possible that the close proximity of the reservoir reference sites to the basin were influenced by the artificially high water table created by the dam and a full reservoir. Also, the number of hydrologic inputs and the shallow depth of some of the channels draining into the basin may allow a greater number of species to be present in the reservoir reference sites. Wright, Flecker, and Jones (2003) found that soil moisture had a significant effect on herbaceous plant communities in beaver meadows in the Adirondack Mountains in New York State,
