# An Analysis of Bicycle-Vehicle Interactions at Signalized Intersections with Bicycle Boxes

A thesis submitted in partial fulfillment of the  
requirements for the degree of

Master of Science  
in  
Civil and Environmental Engineering

Portland State University  
2014

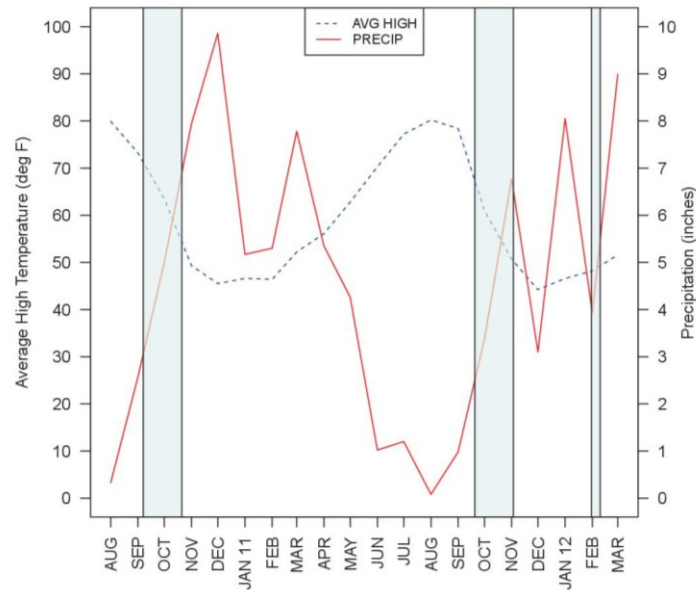
**Figure 2: Average Monthly High Temperature and Precipitation**

Weather data for the average high temperature and monthly precipitation were retrieved from the National Oceanic and Atmospheric Administration for the period of time between the before and after studies and is summarized in Figure 2. The data collection periods are highlighted with horizontal boxes.

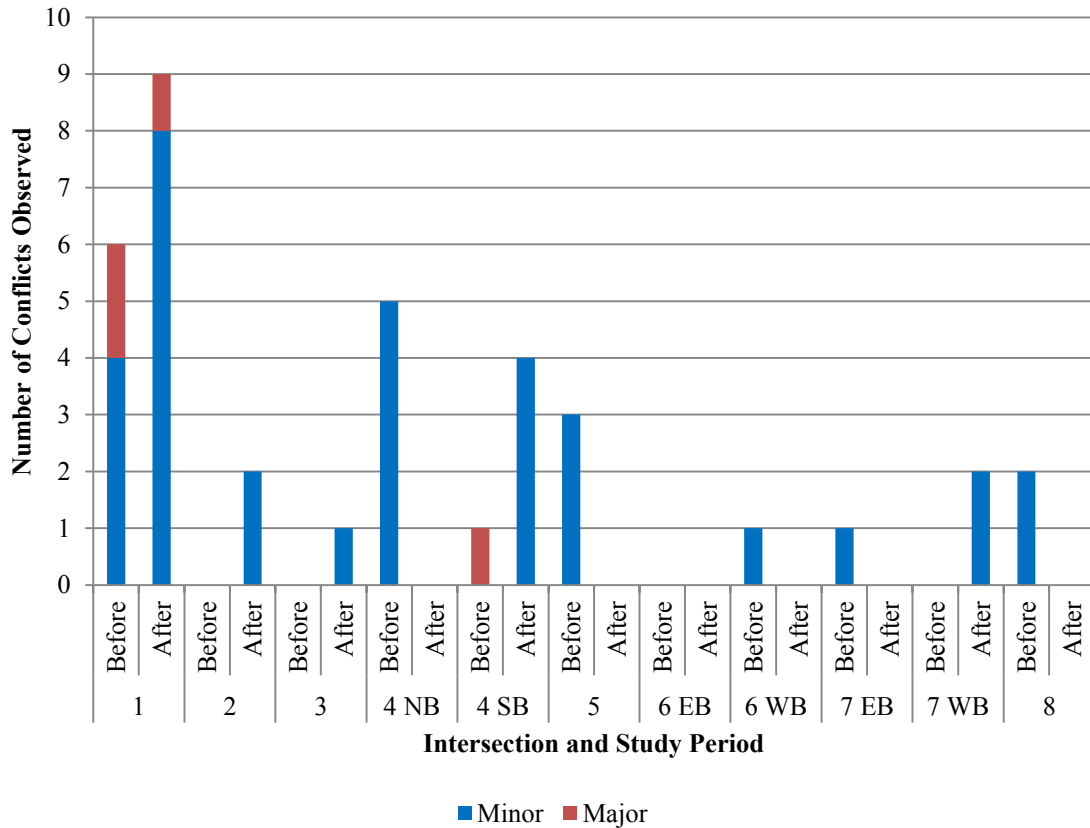
**Figure 3: Minor & Major Conflict Totals at Study Intersections**

The small number of conflicts observed makes statistical comparisons challenging. The most conflicts were observed at the intersection of NE Couch Street at Grand Avenue, with only 15 total conflicts being observed during both valid periods of study. The following subsections review the results at each intersection in more detail.

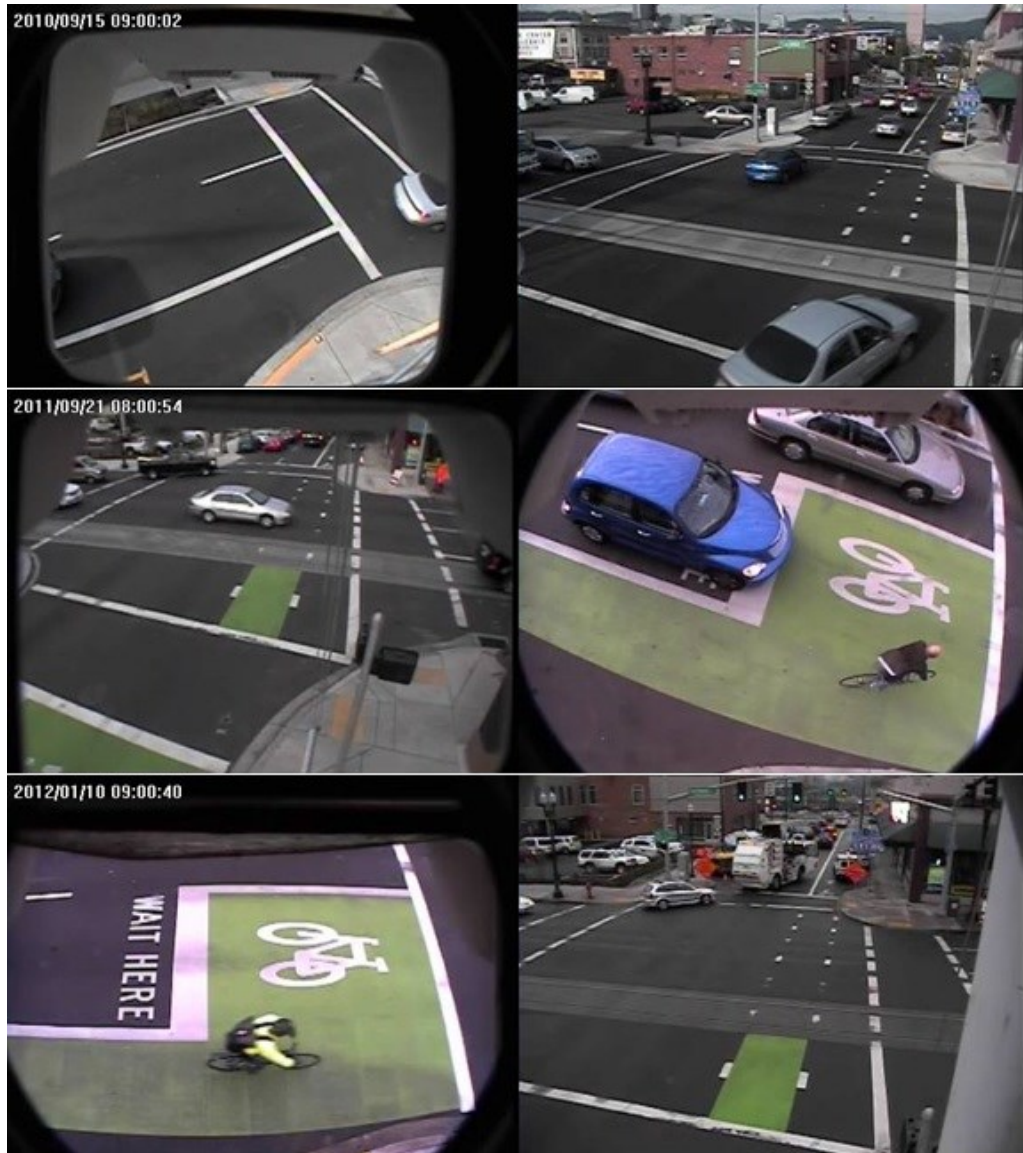
**Figure 4: NE Couch St at Grand Ave Camera Views**

of the conflicts. Figure 4 shows the camera views of the intersection for all three observed periods.

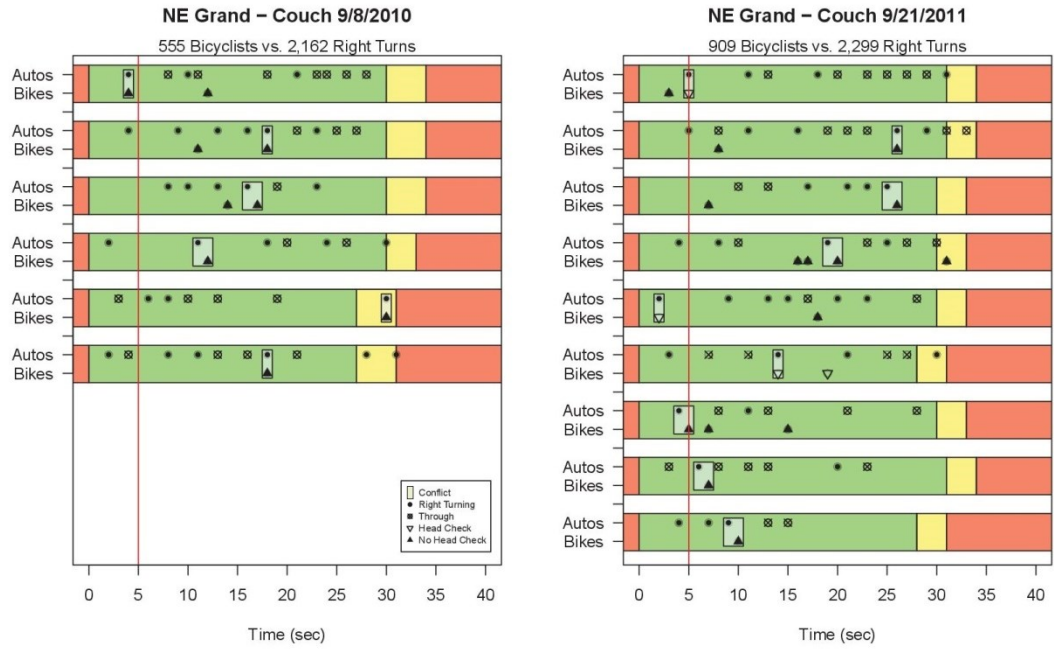
**Figure 5: Event Log Before and After at NE Couch St at Grand Ave**

After the conflicts were narrowed, the intersection video was observed during each of the incidents and events were logged for the each entire phase. Figure 5 shows the event log during each conflict for both the before and after study periods. The event log, as described in the methodology section, depicts the events during a phase in which a conflict occurs. The chart separates motor vehicles and bicycles crossing into the intersection to show their relation in time as well as the motor vehicle’s direction of travel or the bicyclist’s attentiveness to traffic behind them. A reference line was provided in the chart to help identify conflicts that occur within five seconds of the green indication, or when the bike box is assumed to impact the conflict rate the most.

Only one conflict was observed during the start-up of the green phase before the installation of the bike box. This conflict occurred with both parties starting through the intersections from a stopped position. Five of the remaining conflicts occurred between six seconds and twenty seconds into the green phase and one conflict happened at the end of the phase. In four of the six observed conflicts, the bike appeared to be in the process of overtaking the motor vehicle when the conflict occurred. All six of the conflicts involved the bicyclist yielding to the movement of the motor vehicle. None of the bicyclists seen in the conflict clips before the installation were observed checking behind them for oncoming traffic (or performing a “head-check”).

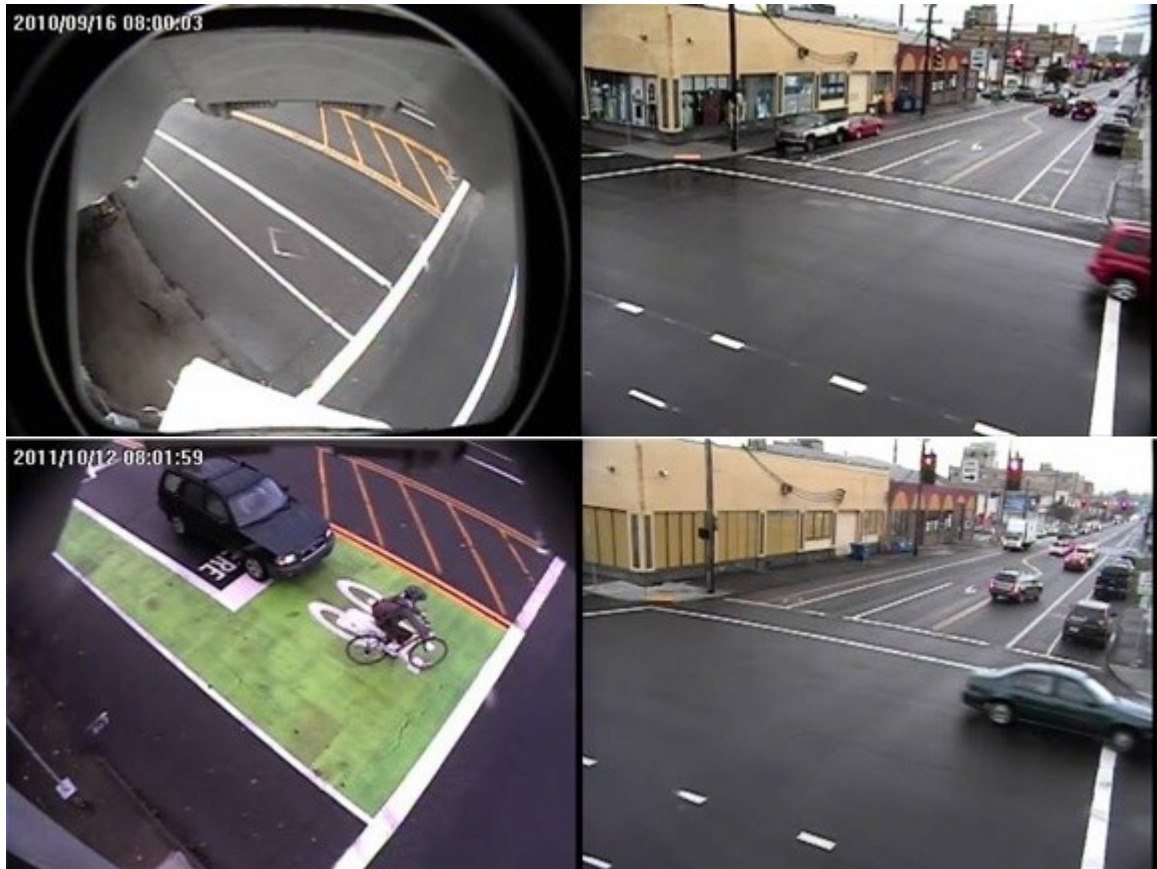
**Figure 6: SE 7th Ave at Hawthorne Blvd Camera Views**

The intersection of SE 7<sup>th</sup> Avenue at Hawthorne Boulevard was observed in the fall prior to and after the installation of the advanced stop box. The bike box was installed on the northbound SE 7<sup>th</sup> Avenue approach. SE 7<sup>th</sup> Avenue is a three-lane, two-way roadway with a center two-way left-turn lane. Bike lanes and on-street parking areas are available on both sides of the street before and after the intersection. Since Hawthorne Boulevard is a one-way street traveling eastbound, there is no left-turn refuge for northbound SE 7<sup>th</sup> Avenue. The bike box installed on the SE Hawthorne approach was observed during Phase I study. Figure 6 shows the camera views at the intersection observed for both periods of study.

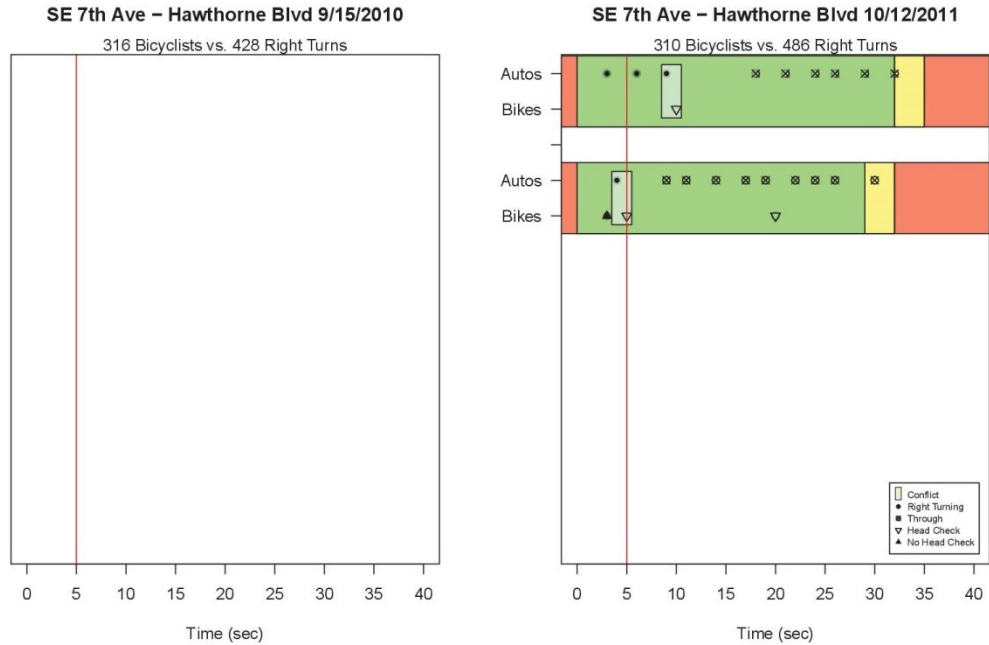
**Figure 7: Event Log Before and After at SE 7th Ave at Hawthorne Blvd**

After the narrowing of the conflicts, the videos were observed again to identify events that occurred during each of the conflicts. Figure 7 shows the event log for the two conflicts observed after the bike box was installed.

Of the two conflicts observed after the installation of the advanced stop box, only one incident occurred within five seconds of the signal turning green. The conflict involved the second bicyclist to pass through the intersection (who was in movement before the signal indication changed to green) and the first motor vehicle (who was at the intersection during red indication). The other incident occurred within ten seconds of the green indication and involved the third right-turning motorized vehicle conflicting with the first bicyclist to approach the intersection. Both conflicts occurred when the bicyclist was in the process of overtaking the motor vehicle and were resolved with the motor

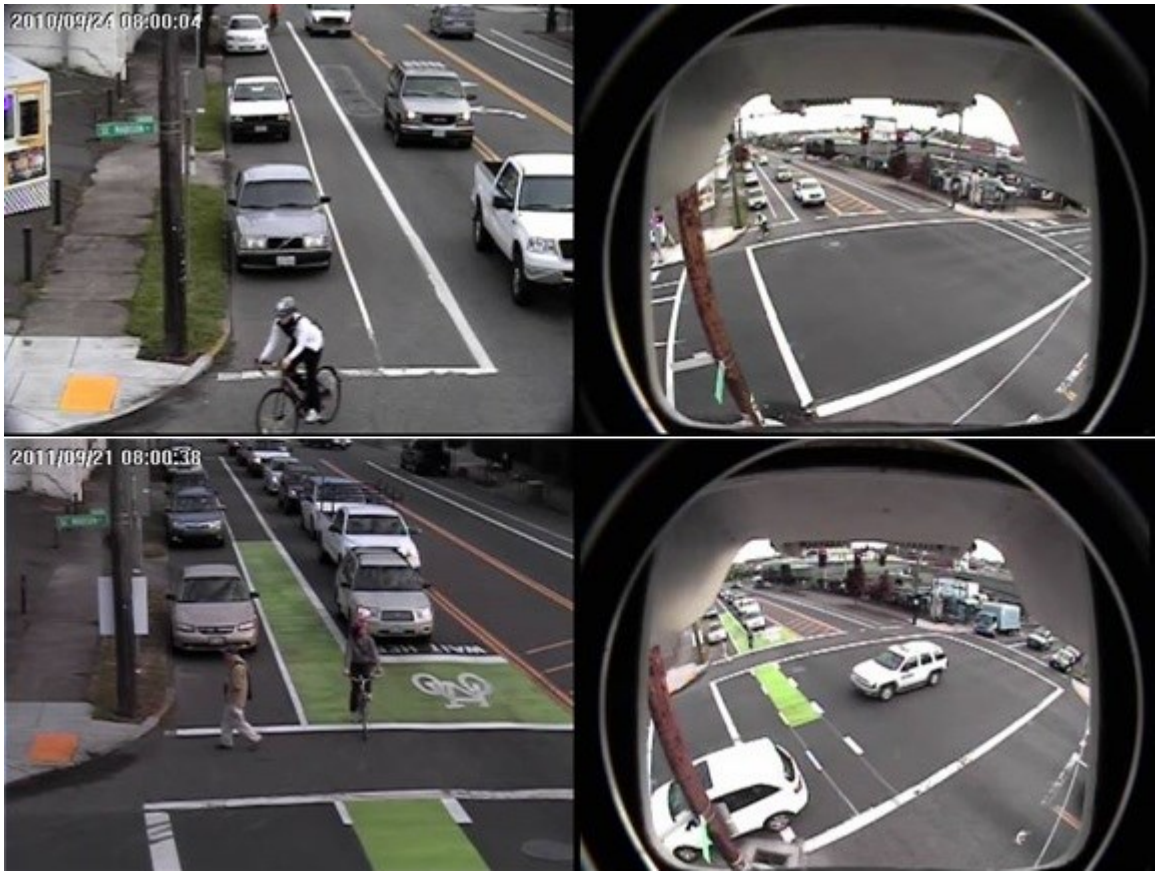
**Figure 8: SE 7th Ave at Madison St Camera Views**

The intersection of SE 7<sup>th</sup> Avenue at Madison Street was also observed at similar periods before and after the installation of the advanced stop box about a year apart. This intersection is two blocks north of the study intersection of SE 7<sup>th</sup> Avenue at Hawthorne Boulevard. The bike box was installed on the southbound SE 7<sup>th</sup> Avenue approach. Much like the intersection at Hawthorne Boulevard, SE 7<sup>th</sup> Avenue is a three-lane, two-way roadway with a center two-way left-turn lane. Bike lanes and on-street parking areas are available on both sides of the street on both sides of the intersection. It was observed in the videos that majority of the bicyclists were turning right to use Madison to cross the Hawthorne Bridge. Since Madison Street is a one-way street traveling westbound, the southbound left-turn from SE 7<sup>th</sup> Avenue is restricted. Figure 8 shows the available camera views at the intersection for both study periods.

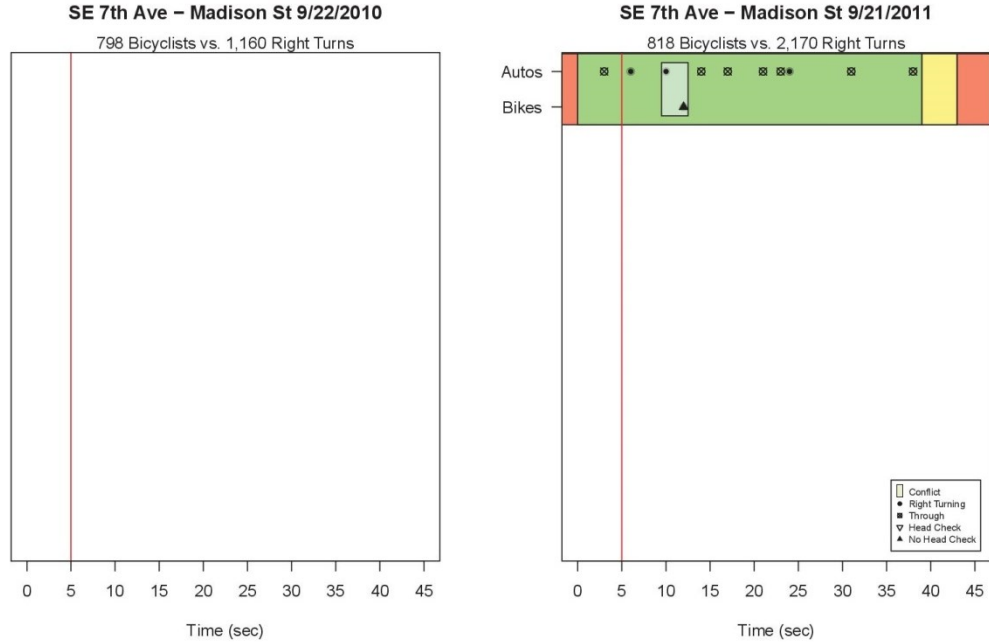
**Figure 9: Event Log Before and After at SE 7th Ave at Madison St**

Figure 9 shows the event log for the one conflict observed after the bike box was installed.

The one conflict observed after the installation of the bike box occurred around fifteen seconds after the green indication and occurred between the second right-turning vehicle and the first (and only bicyclist) to pass through the intersection. The conflict occurred when a motor vehicle was overtaking the bicyclist and was resolved by the bicyclist who yielded to the turning movement of the motor vehicle. The one bicyclist was not observed being attentive to traffic behind them as they passed through the intersection.

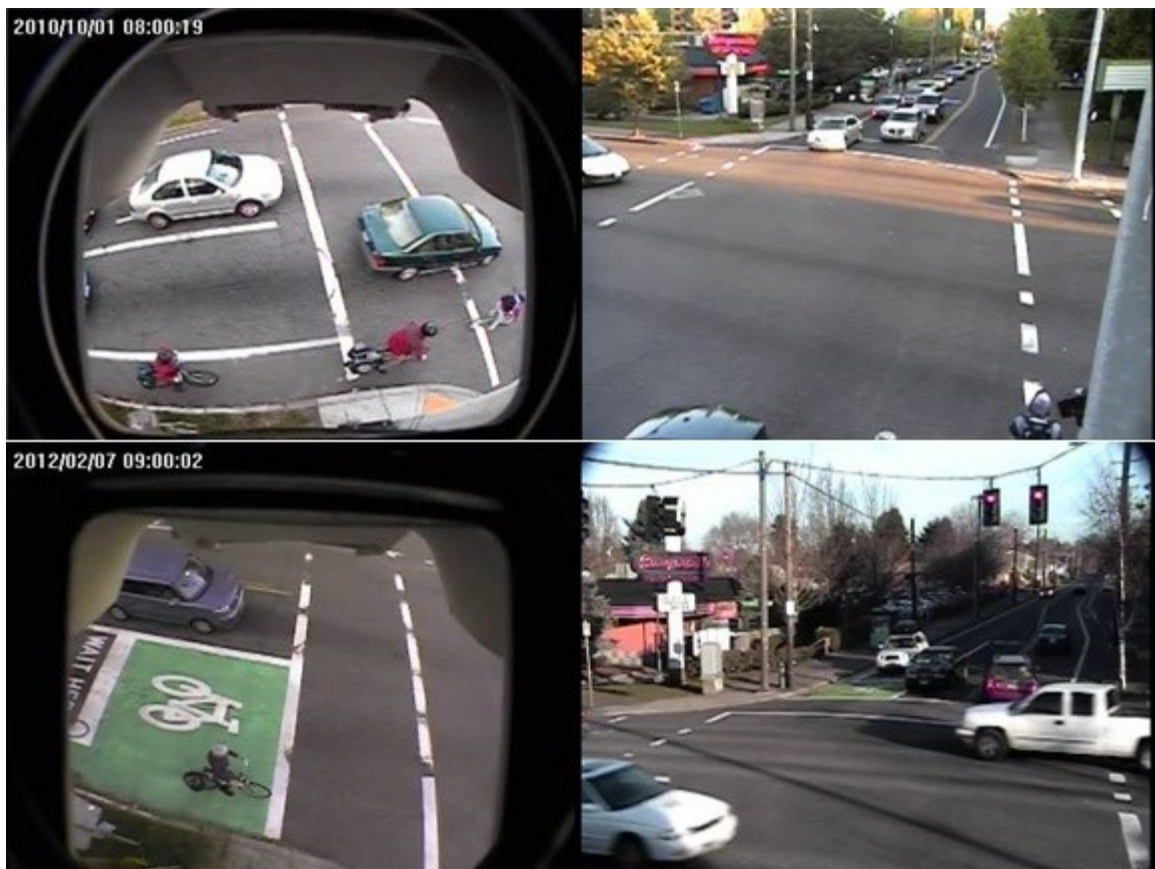
**Figure 10: SE 26th Ave NB at Powell Blvd Camera Views**

The intersection of SE 26<sup>th</sup> Avenue at Powell Boulevard (viewing northbound) was observed in the fall prior to the installation of the bike box and in the winter season afterwards. The bike box was installed on the both approaches of SE 26<sup>th</sup> Avenue; however this video only observed the bike box area on the northbound leg. The approach on SE 26<sup>th</sup> Avenue is a three-lane, two-way roadway with a dedicated left-turn lane at the intersection. Bike lanes are available along both sides of the street on both sides of the intersection. Figure 10 shows the available northbound camera views of the intersection for both study periods.

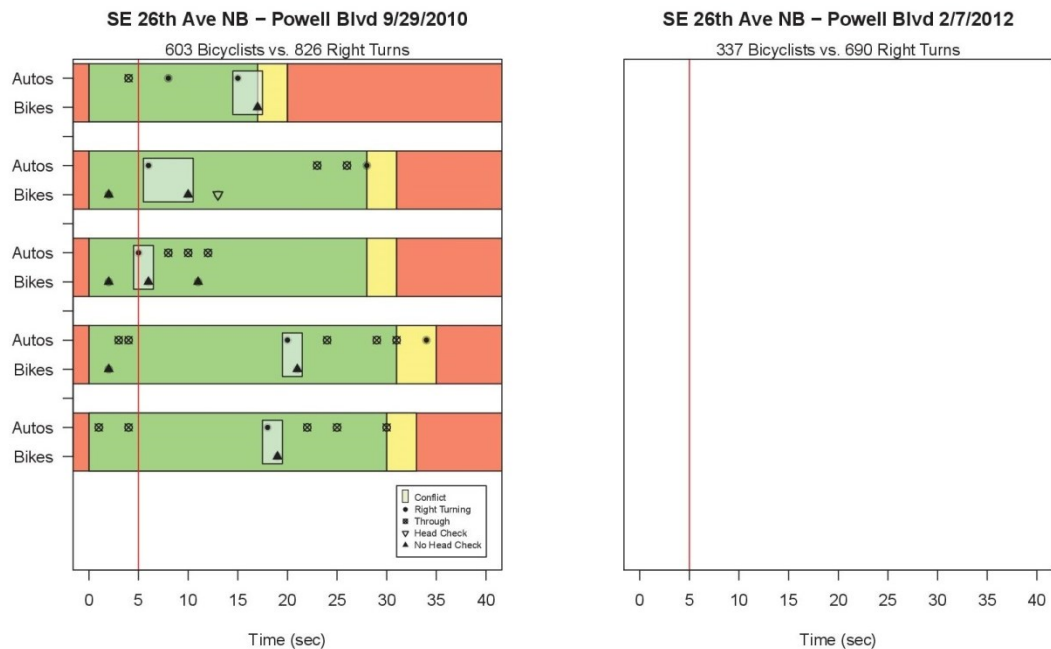
**Figure 11: Event Log Before and After at SE 26th Ave NB at Powell Blvd**

Events during each observed incident were logged after the narrowing the conflicts. The event log is shown in Figure 11 below.

Only one conflict before the installation of the bike box occurred within the five second window of the signal displaying a green indication. The conflict occurred between the first right-turning motorized vehicle (who was stopped when the signal changed from red to green) and the second bicyclist to approach the intersection (who was in motion before the signal changed). One of the other conflicts occurred within ten seconds of the green indication and also involved the first right-turning motorized vehicle and the second bicyclist. The other conflicts observed occurred during the later green period of the phase. All of the conflicts occurred when the bicyclist appeared to be overtaking the motor vehicle. Four of the conflicts were resolved by the bicyclist yielding to the motorist's right-turn movement. Only one bicyclist was observed paying attention to motor vehicles approaching behind them; however, the head-check occurred immediately following a conflict.

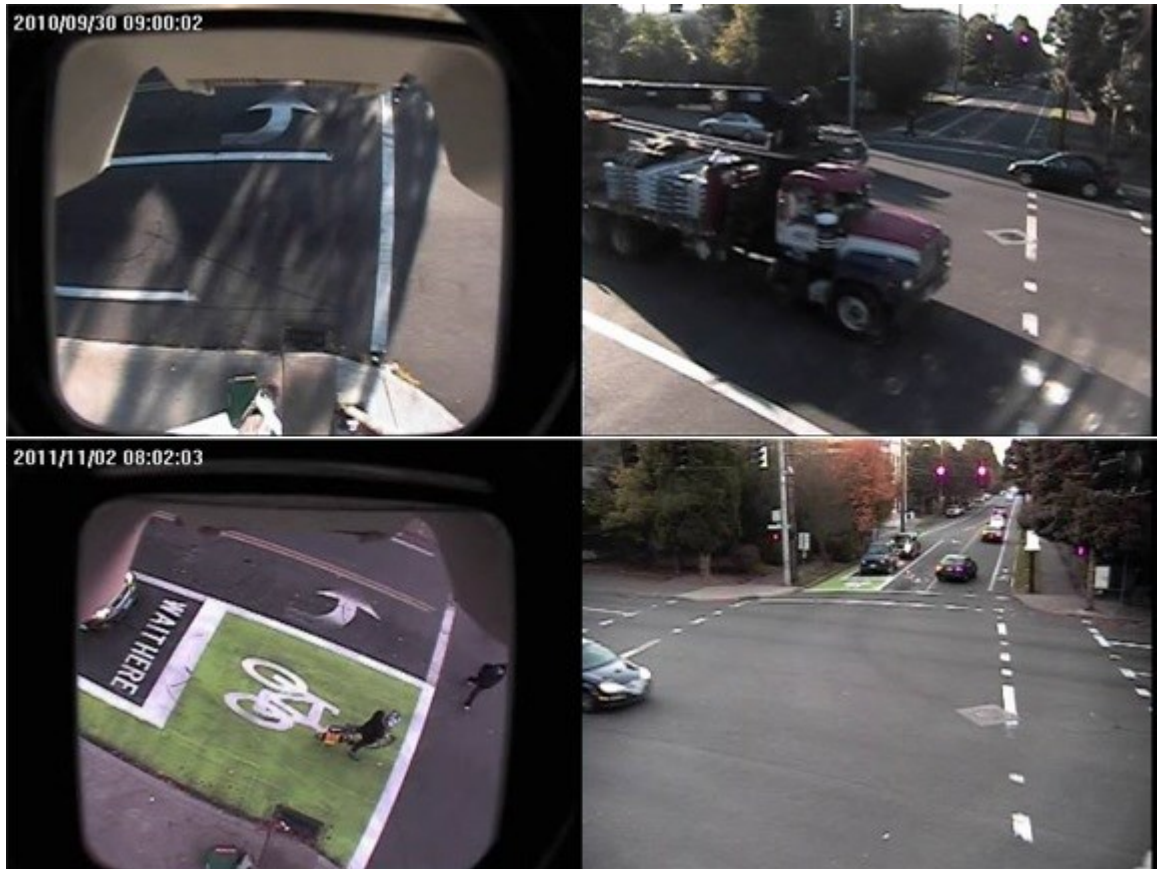
**Figure 12: SE 26th Ave SB at Powell Blvd Camera Views**

The intersection of SE 26<sup>th</sup> Avenue at Powell Boulevard (viewing southbound) was observed in the fall prior to and after the installation of the bike. This bike box is opposite the one explained in the previous section. Like before, the approach on SE 26<sup>th</sup> Avenue is a three-lane, two-way roadway with a center left-turn refuge at the intersection. Bike lanes are available along both sides of the street on both sides of the intersection. Figure 12 shows the available northbound camera views of the intersection for both study periods.

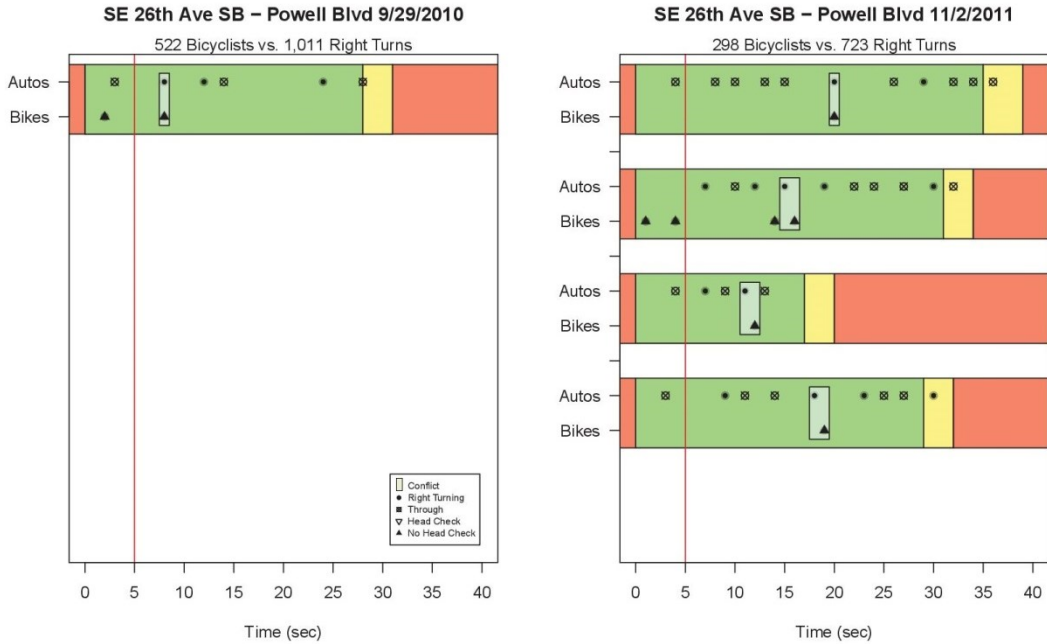
**Figure 13: Event Log Before and After at SE 26th Ave SB at Powell Blvd**

Figure 13 shows the event logs for each of the conflicts recorded during both analysis periods.

No conflicts during either analysis period were observed to have occurred during the start of the green indication. The one conflict observed before the installation of the advanced stop box occurred at about ten seconds into the phase and involved the second motorized vehicle passing through the intersection (first vehicle to make a right turn) and the second bicyclist to approach the intersection. The conflict occurred when the bicycle appeared to be overtaking the motor vehicle and was resolved by the bicyclist yielding to the motor vehicle. No head-check was observed as the bicyclist proceeded through the intersection.

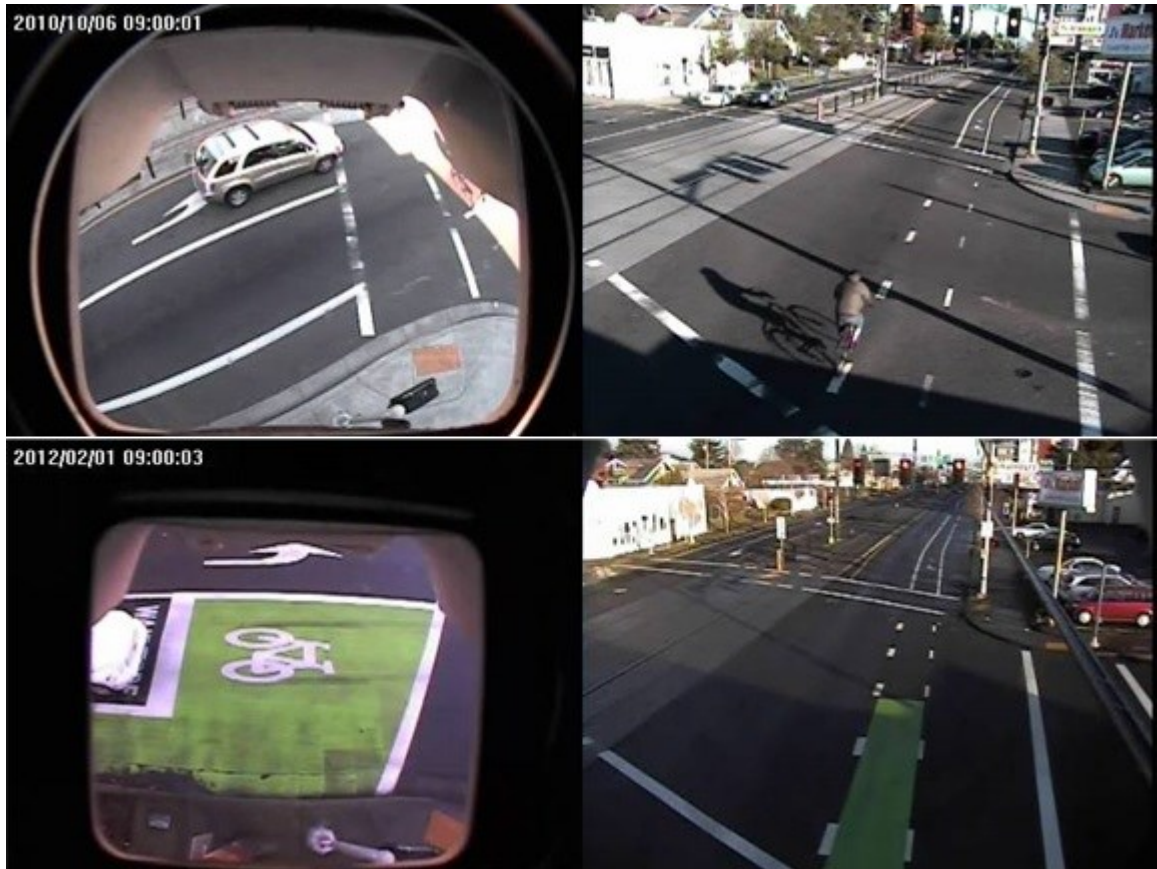
**Figure 14: N Interstate Ave at Alberta St Camera Views**

The intersection of N Interstate Avenue at Alberta Street was observed in the fall prior to the installation of the advanced stop box and in the winter afterwards. The bike box was installed on the northbound N Interstate approach. Interstate Avenue is a single lane, two-way roadway divided by light rail tracks. At the intersection, the roadway expands to include a dedicated left-turn lane. Bike lanes are available on both sides of the street before and after the intersection and on-street parking areas are provided after the intersection. Figure 14 shows the camera views at the intersection observed for both periods of study.

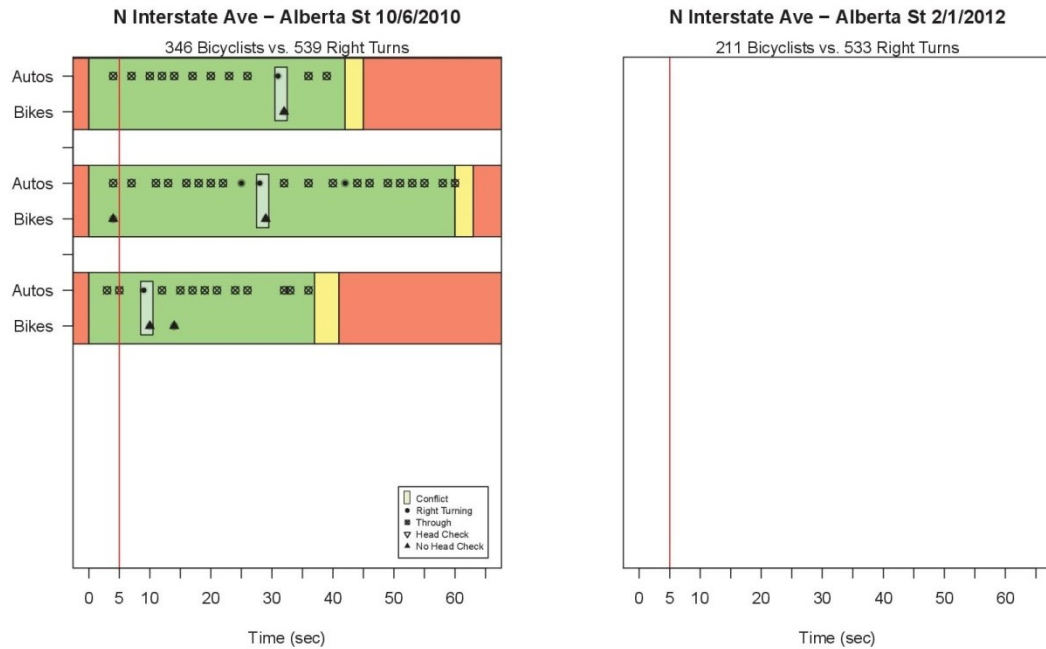
**Figure 15: Event Log Before and After at N Interstate Ave at Alberta St**

After the narrowing of the conflicts by the expert panel, the entire green phase in which an incident occurred was again observed and logged. Figure 15 shows the event log for each conflict that occurred during the study period before the installation of the bike box.

None of the conflicts that were observed happened during the initial start of the green indication. Two of the conflicts, however, occurred between the first right-turning motorized vehicle and the first bicyclist to approach the intersection. In both cases, the incident occurred with the only right-turning vehicle during the green indication. All of the conflicts occurred when the vehicle was overtaking the bicyclist and were resolved by the bicyclist yielding to the motor vehicle. None of the bicyclists were observed during the conflict phases to perform a head-check to view traffic approaching from behind.

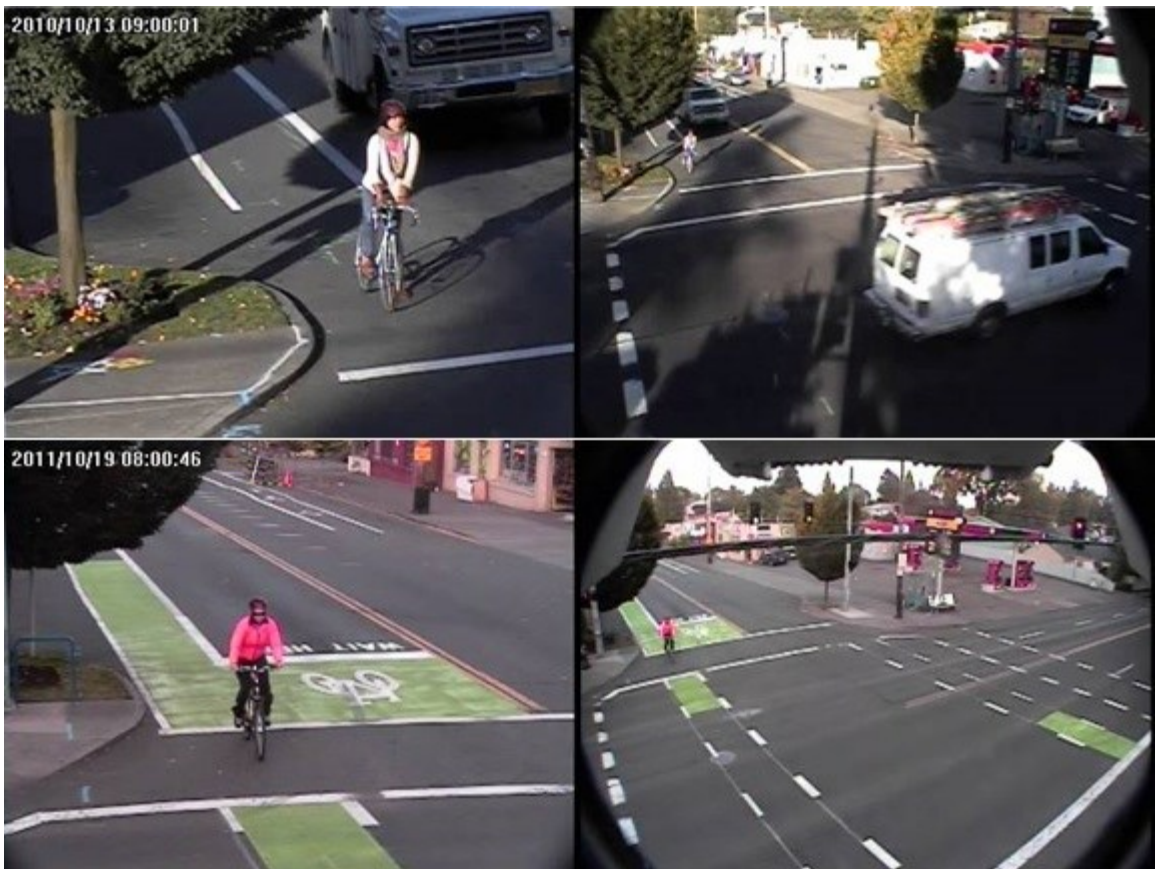
**Figure 16: SE Gladstone St EB at Cesar E Chavez Blvd Camera Views**

The intersection of SE Gladstone Street at Cesar E Chavez Boulevard (viewing eastbound) was observed in the fall prior to and after the installation of the advanced stop box. The bike box was installed on both of the approaches from SE Gladstone Street; however, this video only observed the bike box installed on the eastbound leg. The approach on SE Gladstone is a two-lane, two-way roadway with a single lane used for all turning movements. Bike lanes and on-street parking areas are available on both sides of the roadway on each side of the intersection. Figure 16 shows the available eastbound camera views at the intersection observed for both periods of study.

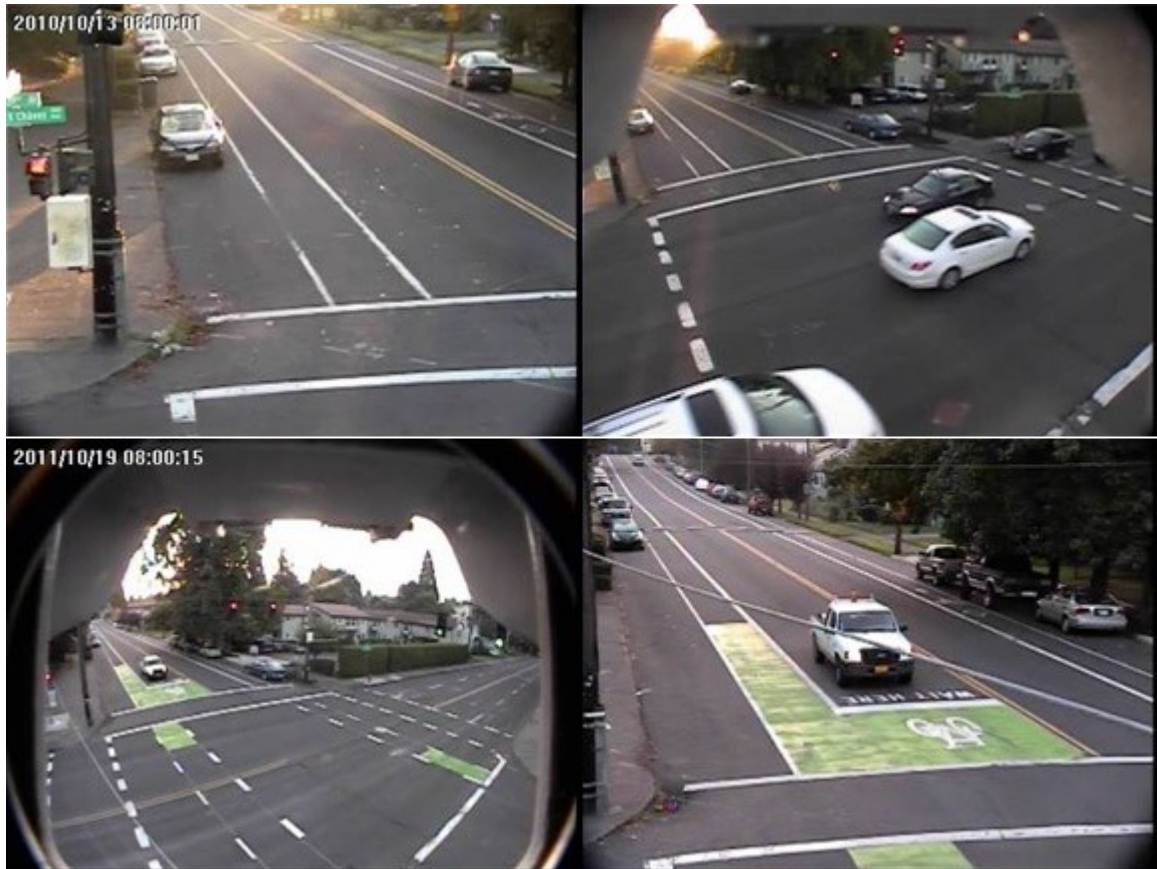
**Figure 17: SE Gladstone St WB at Cesar E Chavez Blvd Camera Views**

The intersection of SE Gladstone Street at Cesar E Chavez Boulevard (viewing westbound) was observed in the fall prior to and after the installation of the bike box. This bike box is opposite the one explained in the previous section. Like before, the approach on SE Gladstone Street is a two-lane, two-way roadway with a single shared lane used for all turning movements. Bike lanes and on-street parking areas are available along both sides of the street on each side of the intersection. Figure 17 shows the available northbound camera views of the intersection for both study periods.

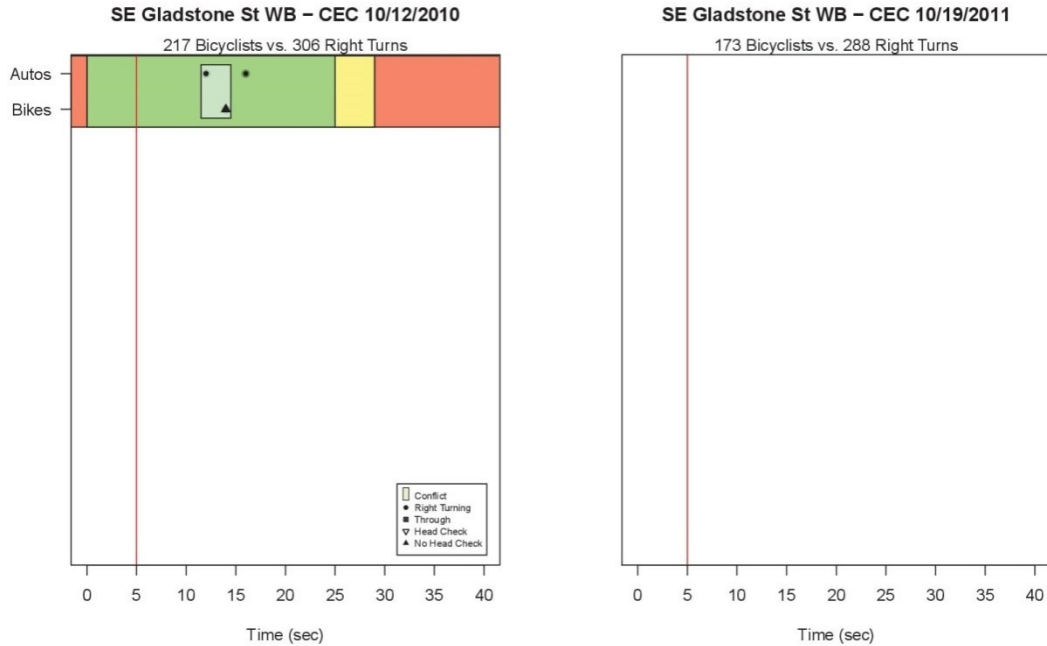
**Figure 18: Event Log Before and After at SE Gladstone St WB at CEC**

The event log for the one conflict that occurred during the study period before the installation of the bike box is shown in Figure 18.

The one conflict that was observed for the westbound direction at the intersection occurred between the first right-turning motorized vehicle and the first bicyclist to approach the intersection. The conflict occurred with the bicyclist overtaking the motor vehicle and was resolved by the bicyclist yielding to the motor vehicle. The bicyclist was not observed performing a head-check.

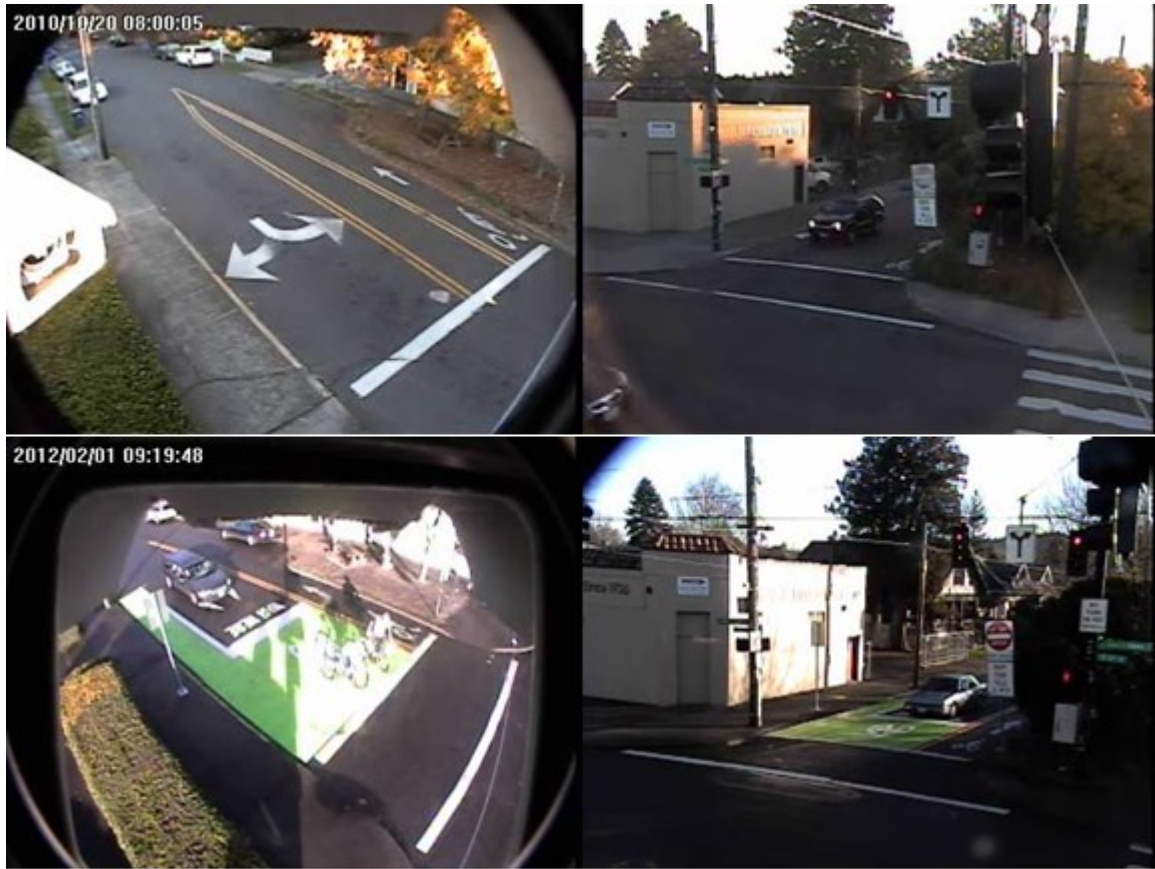
**Figure 19: SE Lincoln St EB at Cesar E Chavez Blvd Camera Views**

SE Lincoln Street is considered a Neighborhood Greenway by the City of Portland in which bicyclists are permitted to take the lane; therefore, bike lanes are not provided prior to or after the intersection. On-street parking areas are available on both sides of the roadway on each side of the intersection. Figure 19 shows the available eastbound camera views at the intersection observed for both periods of study.

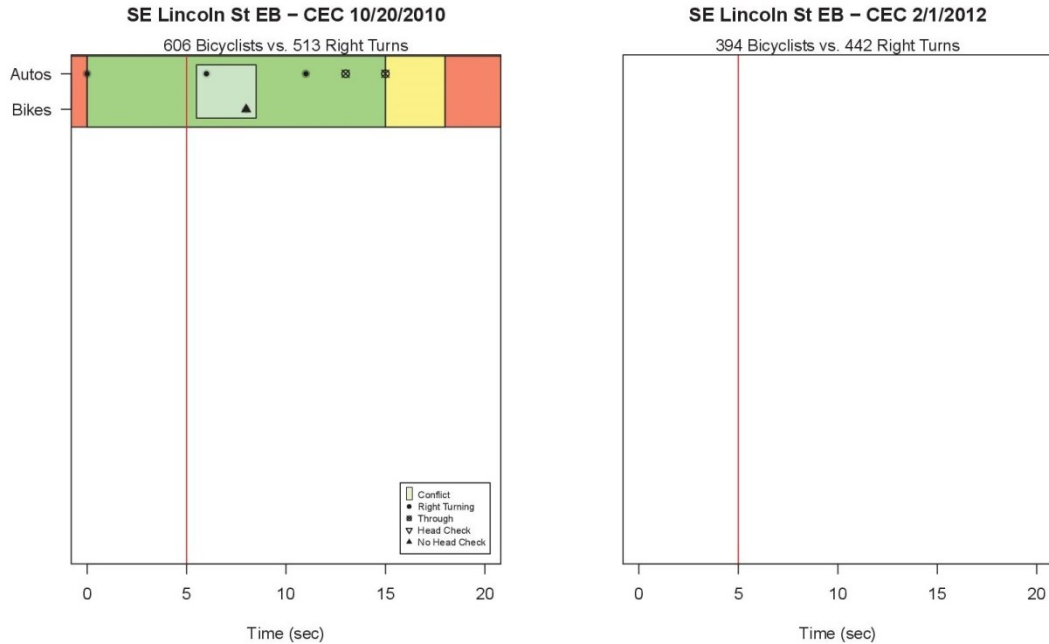
**Figure 20: Event Log Before and After at SE Lincoln St EB at CEC**

Figure 20 shows the event log for the one conflict that was observed for the eastbound direction at the intersection.

The conflict that occurred was witnessed between five and ten seconds after the green indication and involved the second right-turning vehicle and the first bicyclist to approach the intersection. The conflict occurred when the bicyclist was overtaking the motor vehicle and was resolved by the bicyclist yielding to the motor vehicle. The bicyclist was not observed performing a head-check.

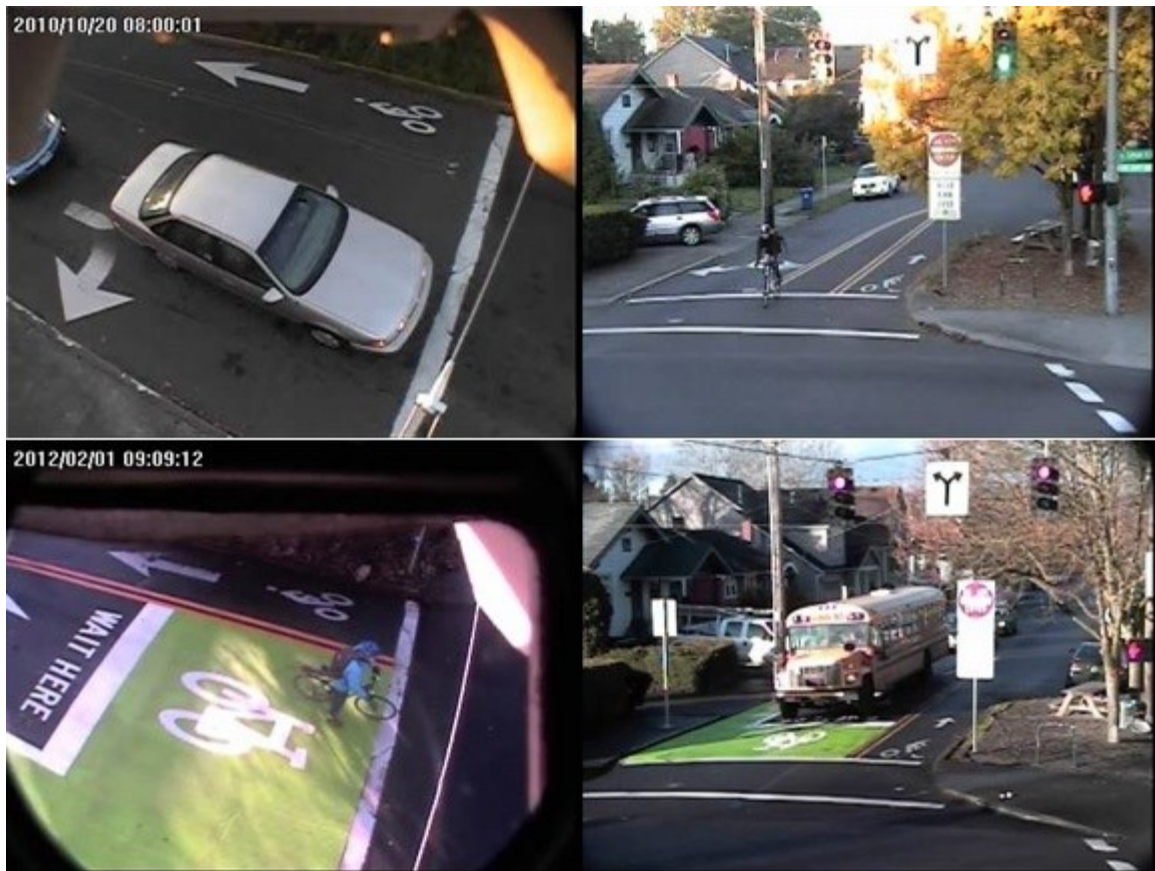
**Figure 21: SE Lincoln St WB at Cesar E Chavez Blvd Camera Views**

similar in design. Like before, the approach on SE Lincoln Street is a two-way roadway, but motorized vehicles are not permitted to travel through the intersection or turn from Cesar E Chavez Boulevard. Bike lanes are not provided beyond the areas for the advanced stop box. On-street parking areas are available along both sides of the street on each side of the intersection. Figure 21 shows the available northbound camera views of the intersection for both study periods.

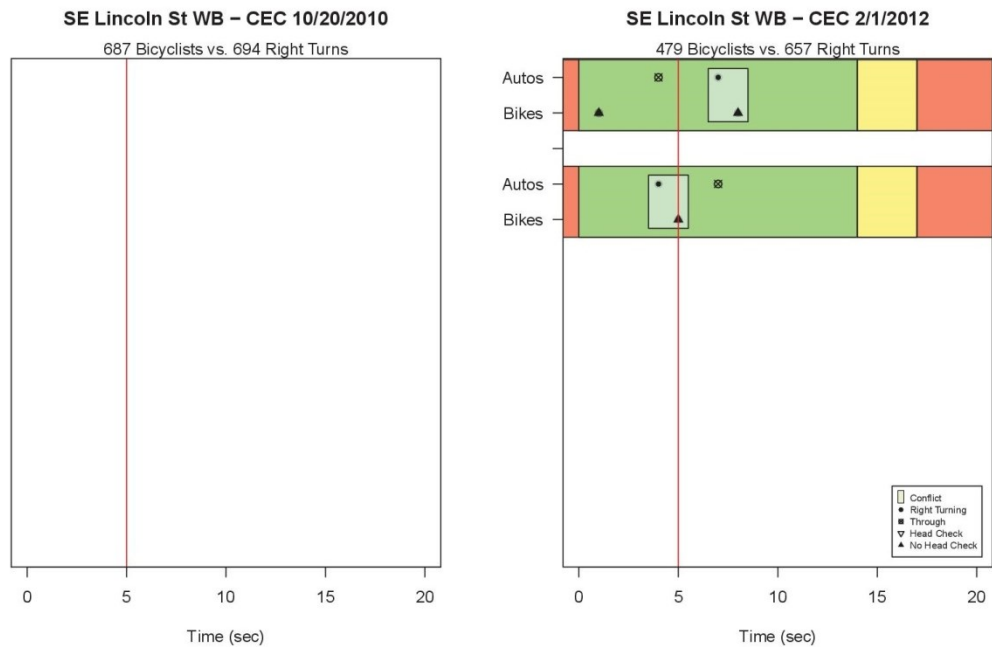
**Figure 22: Event Log Before and After at SE Lincoln St WB at CEC**

The event log for each conflict that was observed for the westbound direction at the intersection is shown in Figure 22.

Only one of the two conflicts occurred within the five second start of the green phase; however, the other conflict that was observed occurred within ten seconds. For the conflict that occurred during the initial green, the bike was stopped prior to the green
