# An Analysis of Bicycle-Vehicle Interactions at Signalized Intersections with Bicycle Boxes

A thesis submitted in partial fulfillment of the  
requirements for the degree of

Master of Science  
in  
Civil and Environmental Engineering

Portland State University  
2014

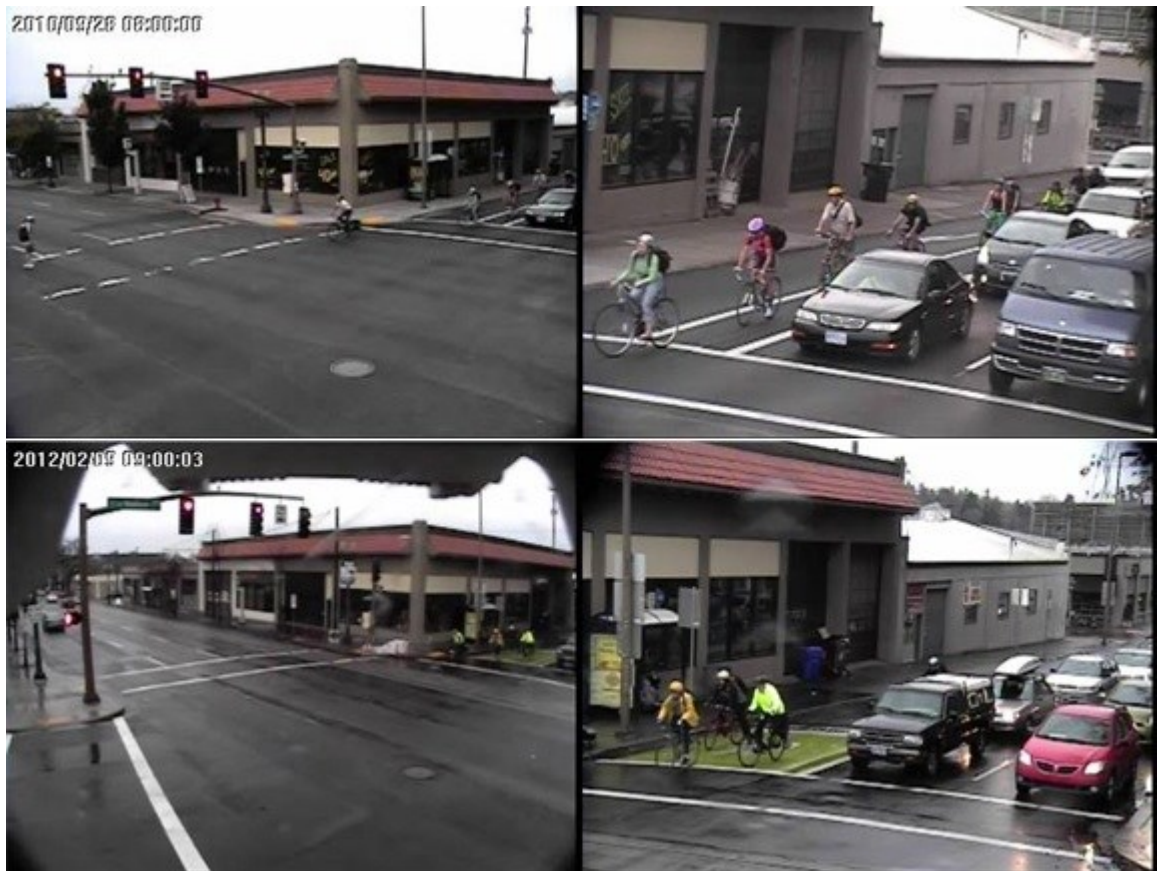
**Figure 23: SE Madison St at Grand Ave Camera Views**

The intersection of SE Madison Street at Grand Avenue was observed in the fall prior to the installation of the advanced stop box and in the winter afterwards. The bike box was installed on the westbound approach of SE Madison Street in the far right lane (within the right-turn refuge). Madison Street is a three-lane, one-way roadway with two through lanes and one dedicated right-turn lane. Bike lanes are provided before and after the intersection. On-street parking areas are available along the right side of the roadway (which is designated as a bus only lane for travel) for a short span at the start of the block, but once the right-turn refuge develops parking becomes restricted. However, a bus stop is present within the right-turn refuge from which buses can instead travel through the intersection. Figure 23 shows the available camera views of the intersection for both study periods.

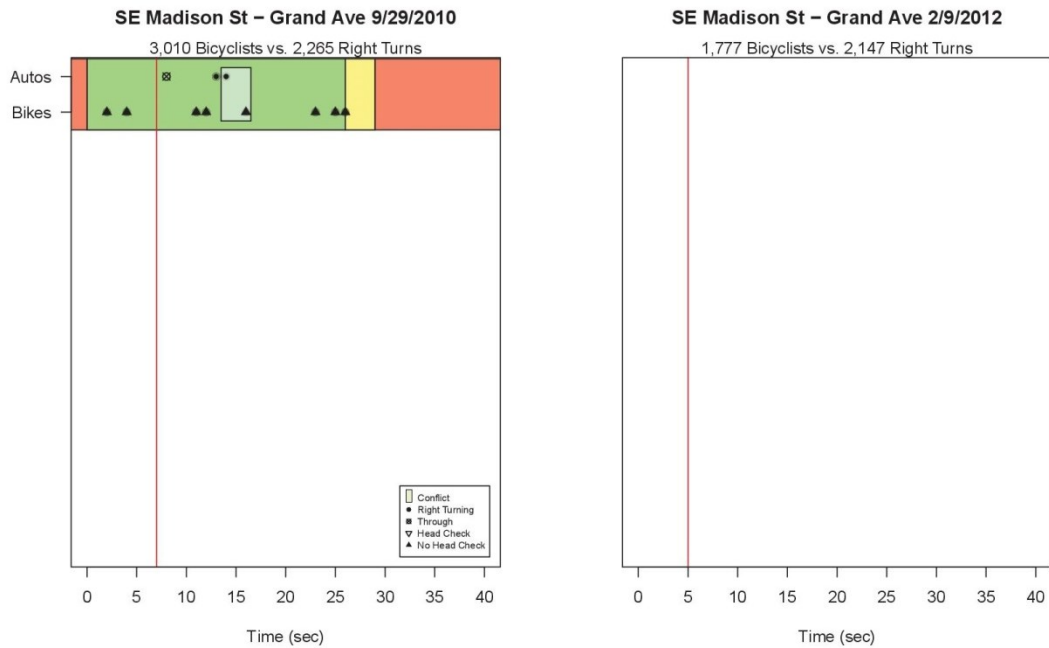
**Figure 24: Event Log Before and After at SE Madison St at Grand Ave**

Figure 22 shows the event log for the conflict that was observed during the green phase of the intersection before the installation of the bike box. The other conflict occurred during the red phase and did not have any events logged.

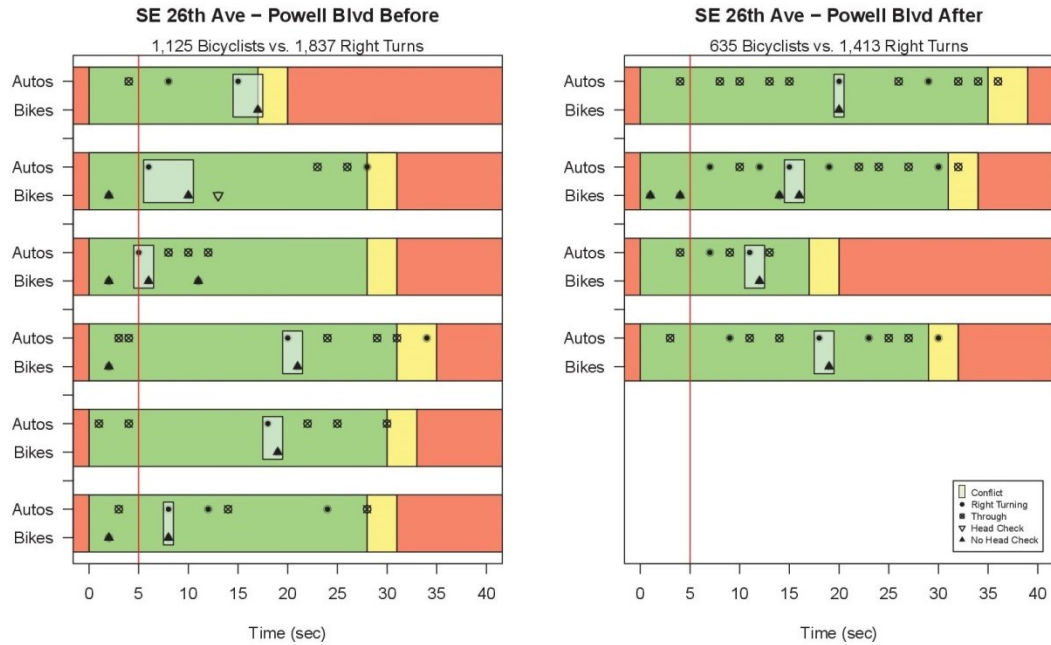
**Figure 25: Event Log Before and After Comparing Both Directions of SE 26th Ave at Powell Blvd**

The event log for each conflict was combined into one graphic for comparison as shown in Figure 25.

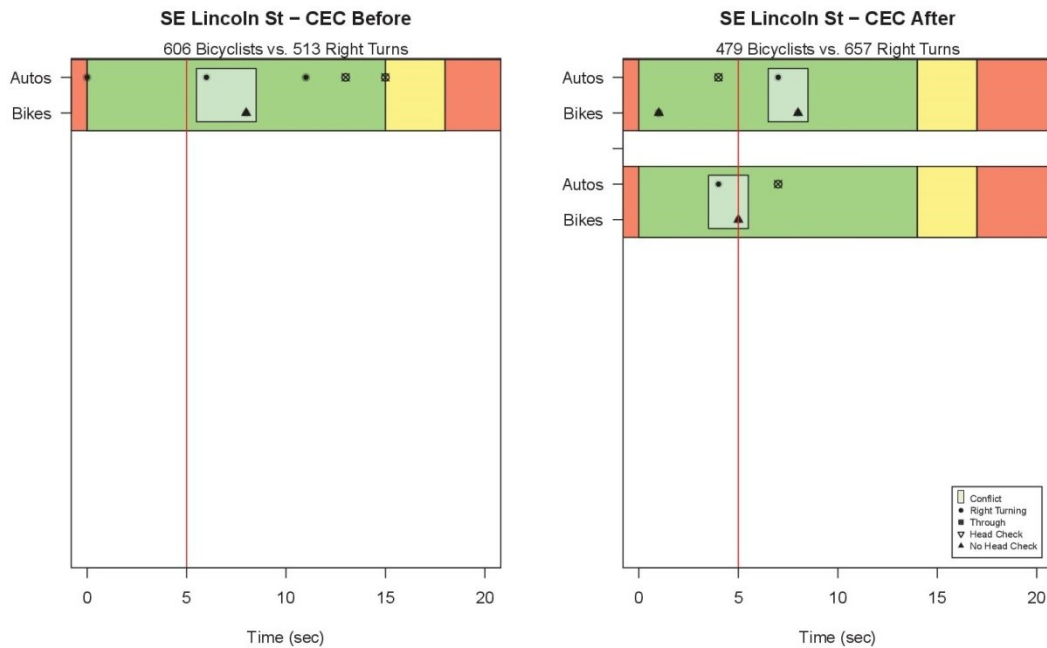
**Figure 26: Event Log Before and After Comparing Both Directions of SE Lincoln St at CEC**

The event log for each conflict was combined into one graphic for comparison as shown in Figure 26.

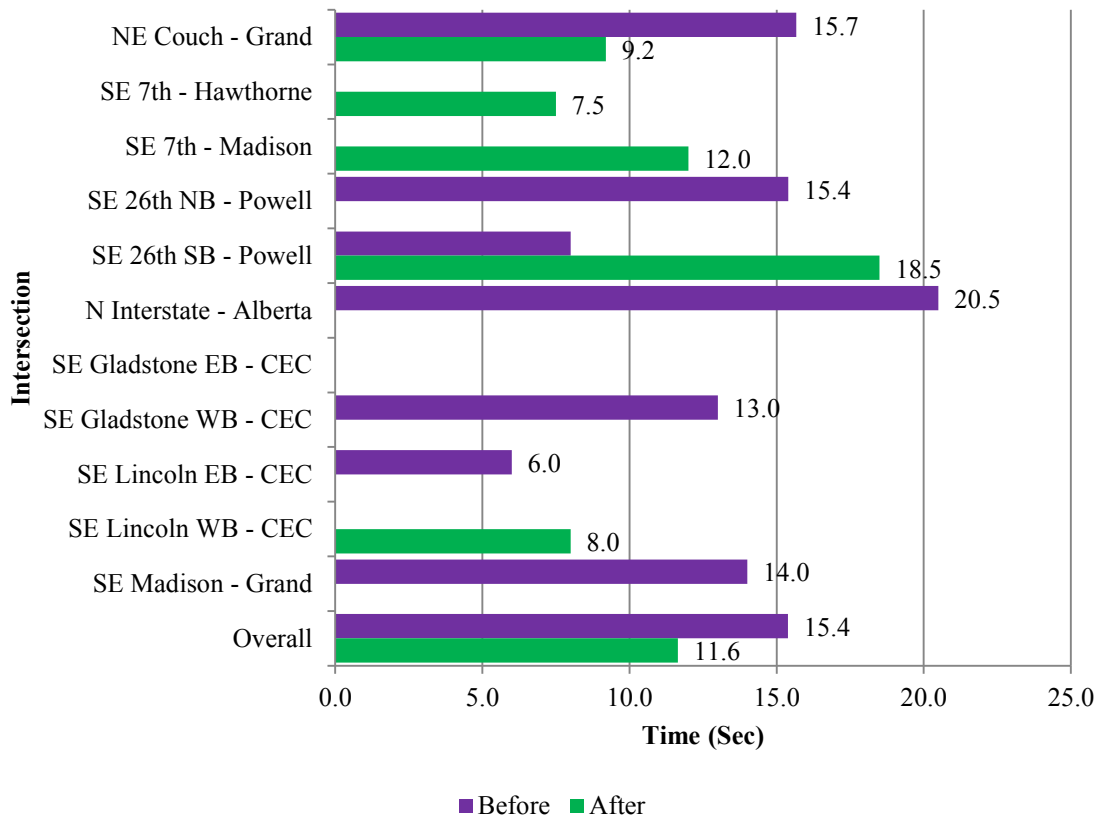
**Figure 27: Average Time Into Green for Observed Conflicts**

These values are shown in Figure 27.
