# Building and Maintaining Plankhouses at Two Villages on the Southern Northwest Coast of North America

Emily Evelyn Shepard  
*Portland State University*

A thesis submitted in partial fulfillment of the  
requirements for the degree of

Master of Science  
in  
Anthropology

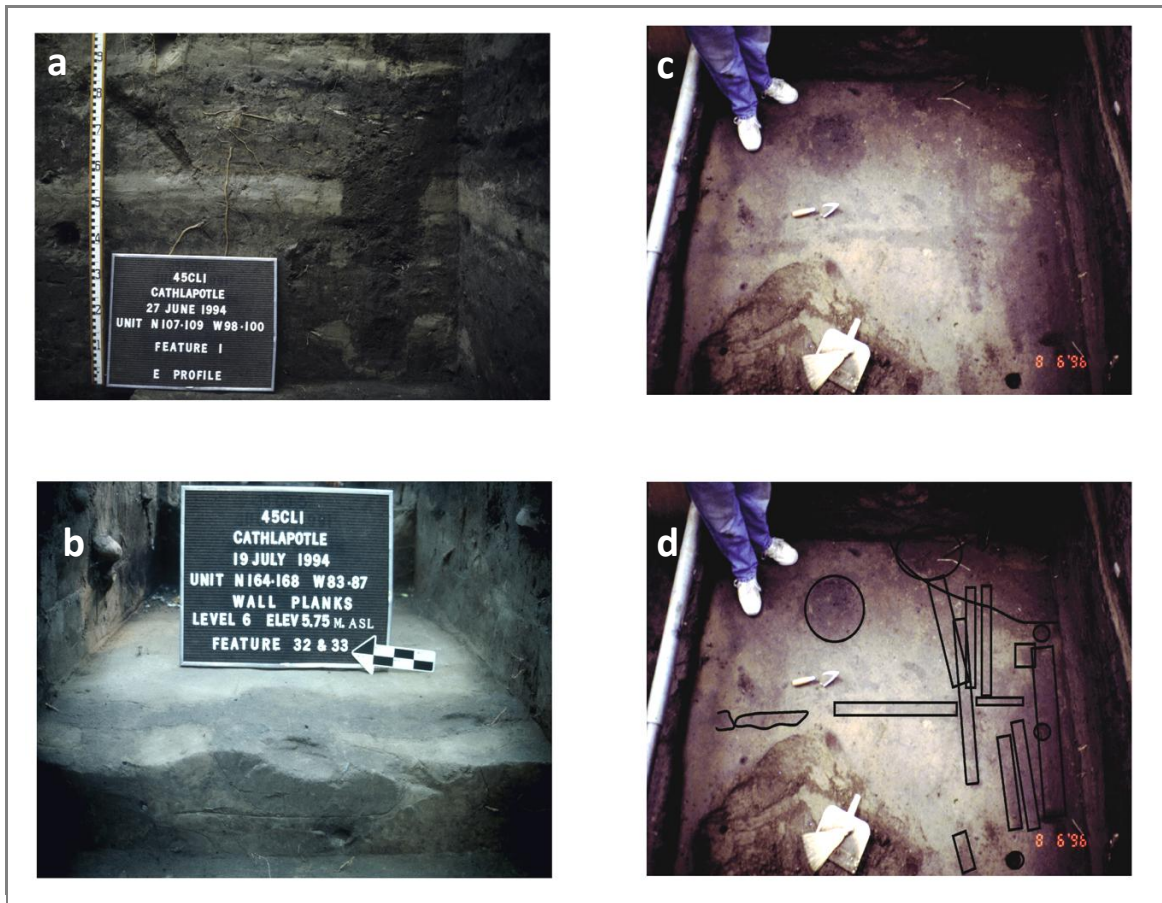
**Figure 5.** Examples of architectural features: (a) postmold in profile (b) wall plankmold in plan and profile (c) plankmolds and postmolds visible on unit floor (d) plankmolds and post features outlined (figure drafted by Kenneth Ames).

As this thesis is focused on architectural features, special attention to formation processes associated with these features is warranted. Figure 5 illustrates plank and post features encountered during excavation. Plankmolds and postmolds are formed by posts

and planks that decayed in situ and are distinguished by stains of decomposed organic material. Postholes are the excavated hole where a post was placed. Postholes were sometimes backfilled in the systemic context after post removal, and may contain artifacts (Verhoeven 2010). Alternatively, postholes can be naturally filled after site abandonment. Wall trenches are the excavated areas where planks were set to form house walls, and are often associated with complex, continuous distributions of plankmolds (Figure 6). Attributes of architectural features detected during archaeological excavation sometimes reveal impacts of systemic site formation processes (Barker 2005:4). Features

During excavation, variation in color between features and the surrounding soil matrix resulted in relatively easy detection of architectural features (see Figures 5 and 6). Investigations at Cathlapotle benefit from exceptional feature preservation and stratigraphic integrity, partially resulting from repeated rapid alluvial deposition (Ames et al. 1999:81; Hodges and Smith 2002). At Meier, plowing obscured many remnants of shallow architectural features (Ames et al. 1992), consequently most features are related to the more-deeply buried house frame.

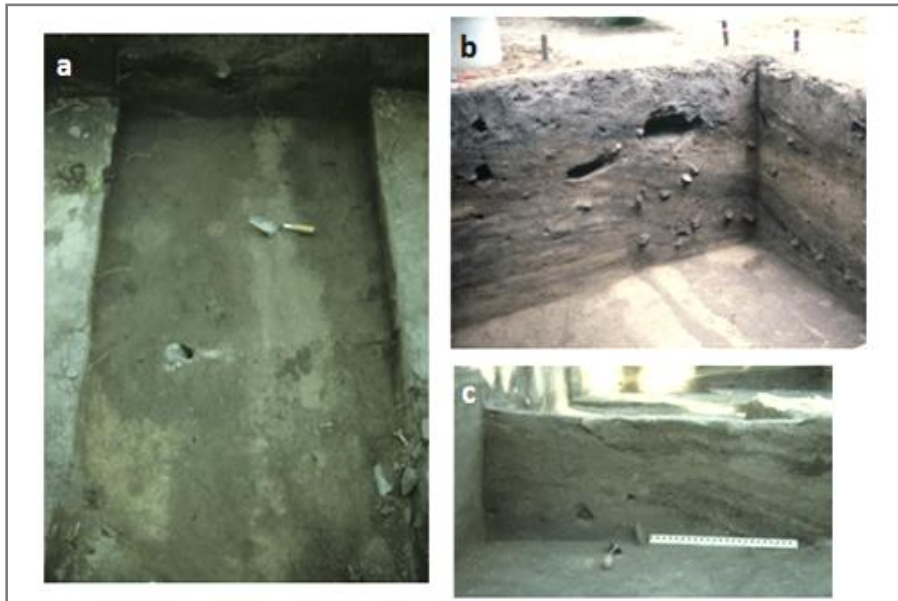
**Figure 6.** Examples of wall trenches in Cathlapotle House 4: (a) West wall beginning to emerge, wall trench is the dark stain left of the trowel. (b) Wall trench of the north wall in plan and profile. One trench is a plank wide and to its right is a larger trench. Fill in the trench is visible above it and merges into storage pits. (c) West wall in profile with sand floors terminating against the wall (figure drafted by Ken Ames).

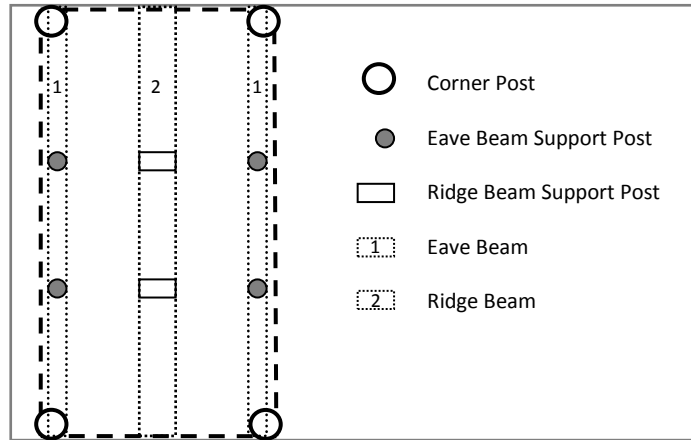
Figure 7. Idealized plankhouse with architectural elements labeled.

The second main aim of this project was to use architectural feature data to quantify labor required to construct and maintain plankhouses in the LCRR. The first step of this process was to quantify how much raw material was involved in building houses. Material used in plankhouses was calculated by examining both plank sheathing and structural elements such as corner posts (see Figure 7).

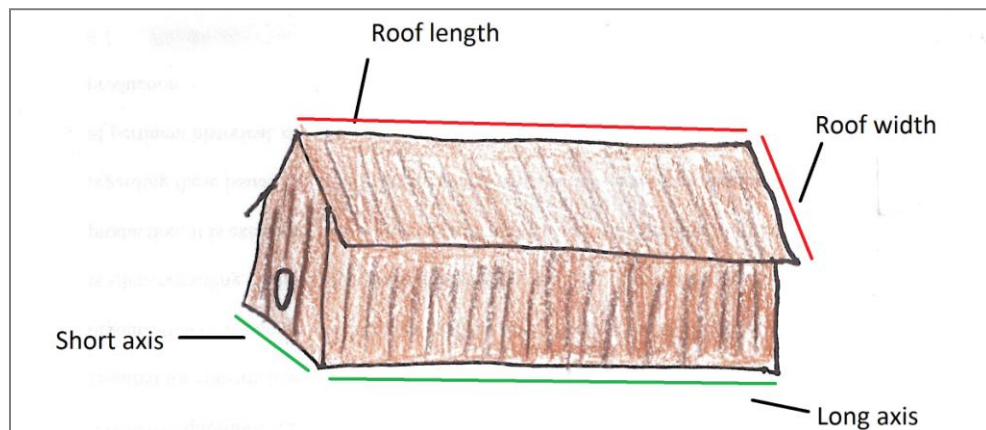
**Figure 8.** Plankhouse long axis and short axis, and roof width and length.

Surface area of siding, roofing and flooring were calculated to determine the area that would need to be covered with planks. Details of all calculations are presented in Appendix B. Roof width was multiplied by roof length to determine the surface area of the roof (Figure 8). Surface area of siding was estimated by adding surface area of the two long axes of the house to the two short axes. Surface area of the long axis was determined by multiplying the length of the houses by the height, using both the small and large range for wall height. Surface area of the short axis was calculated similarly, but took into account the triangular pitch of the roof. At Meier, surface area of the wood floor planking was determined by multiplying the house length by width.

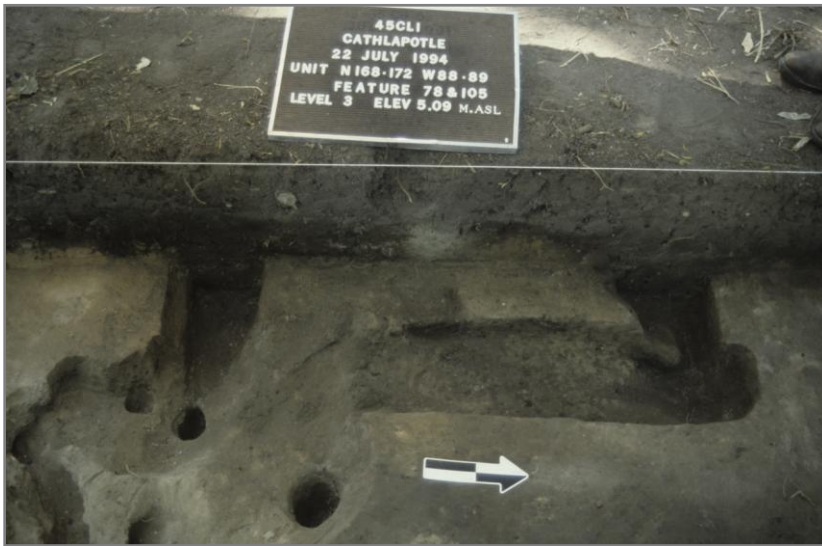
**Figure 12.** Example of incomplete features at Cathlapotle, truncated by both unit walls and other features.

intersection with unit walls or other features (see

Figure 12). Table 6 presents descriptive statistics for features with complete horizontal measurements, no wall trenches had complete horizontal measurements. Four of the feature classes at Cathlapotle were significant for this project: wall trenches, plankmolds, postholes and postmolds. Length, width and depth of these classes were not normally distributed (Appendix A).

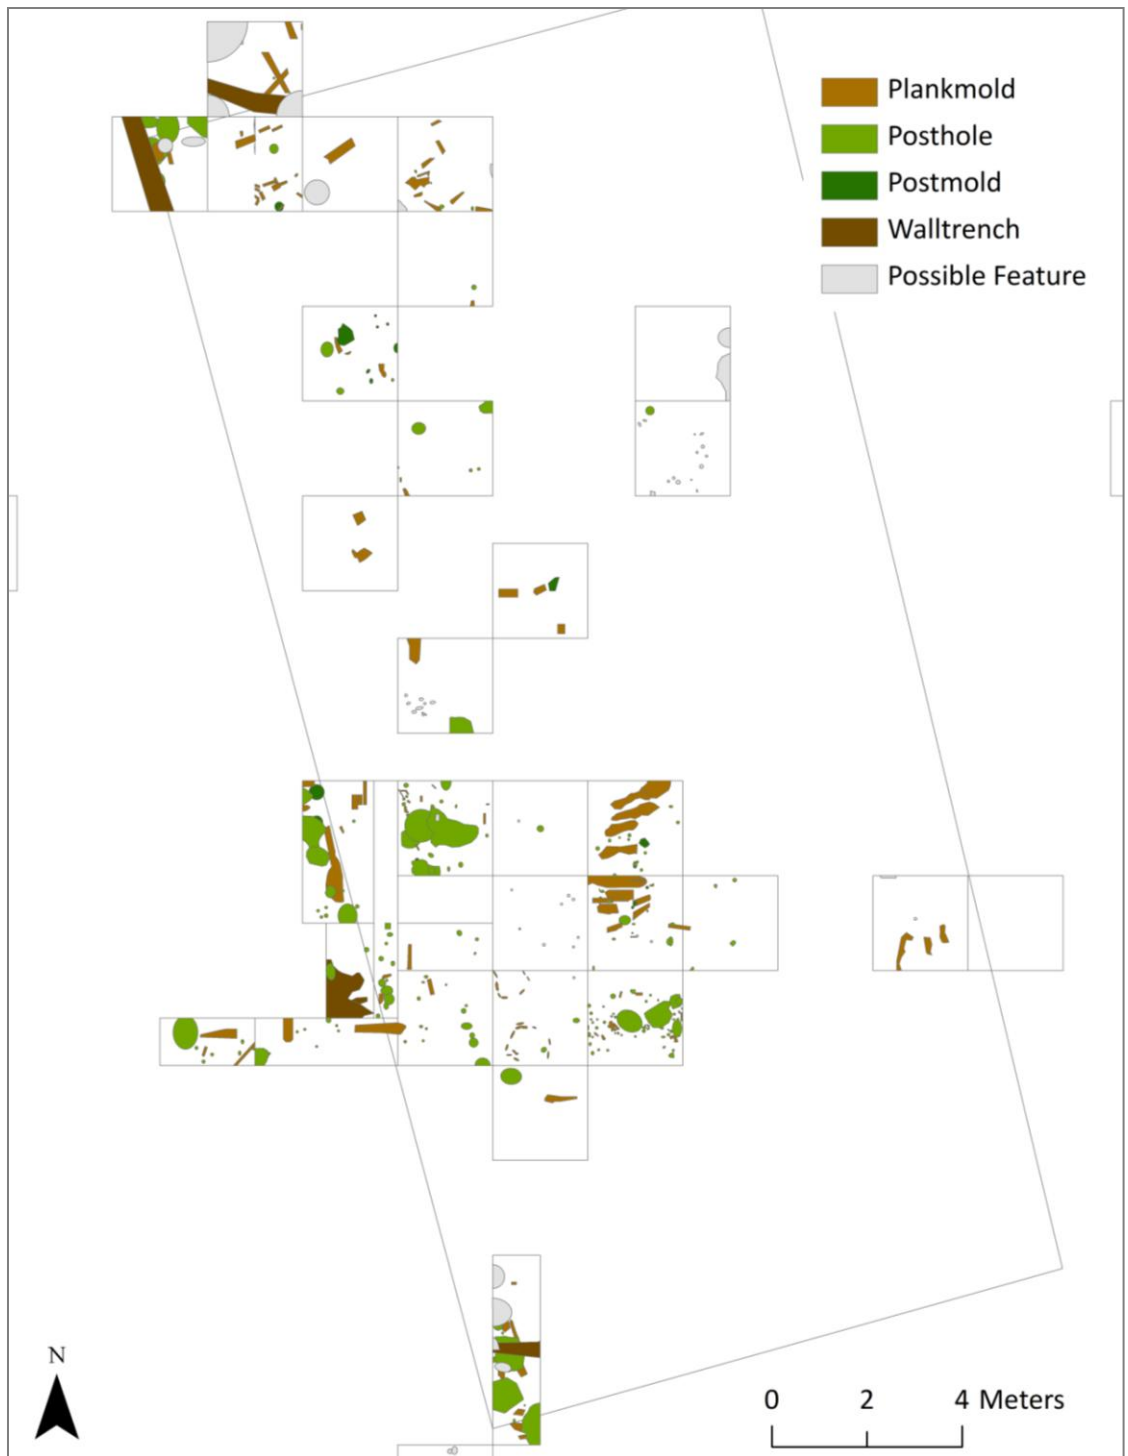
**Figure 9.** Architectural features recorded at Meier, including possible features.

The Meier GIS database contains 387 features related to house architecture (Table 4, Figure 9). Of the final 387 features recorded at Meier, 282 have complete horizontal measurements (Table 5). Some features were truncated by other features or by the walls of excavation units. Other features were considered incomplete because of missing provenience information on excavation forms or maps. Although dimensions of features should not be taken as exact measurements of structural elements, they provide valuable information in the absence of the elements themselves. For details of GIS databases for both sites, see Appendix A.

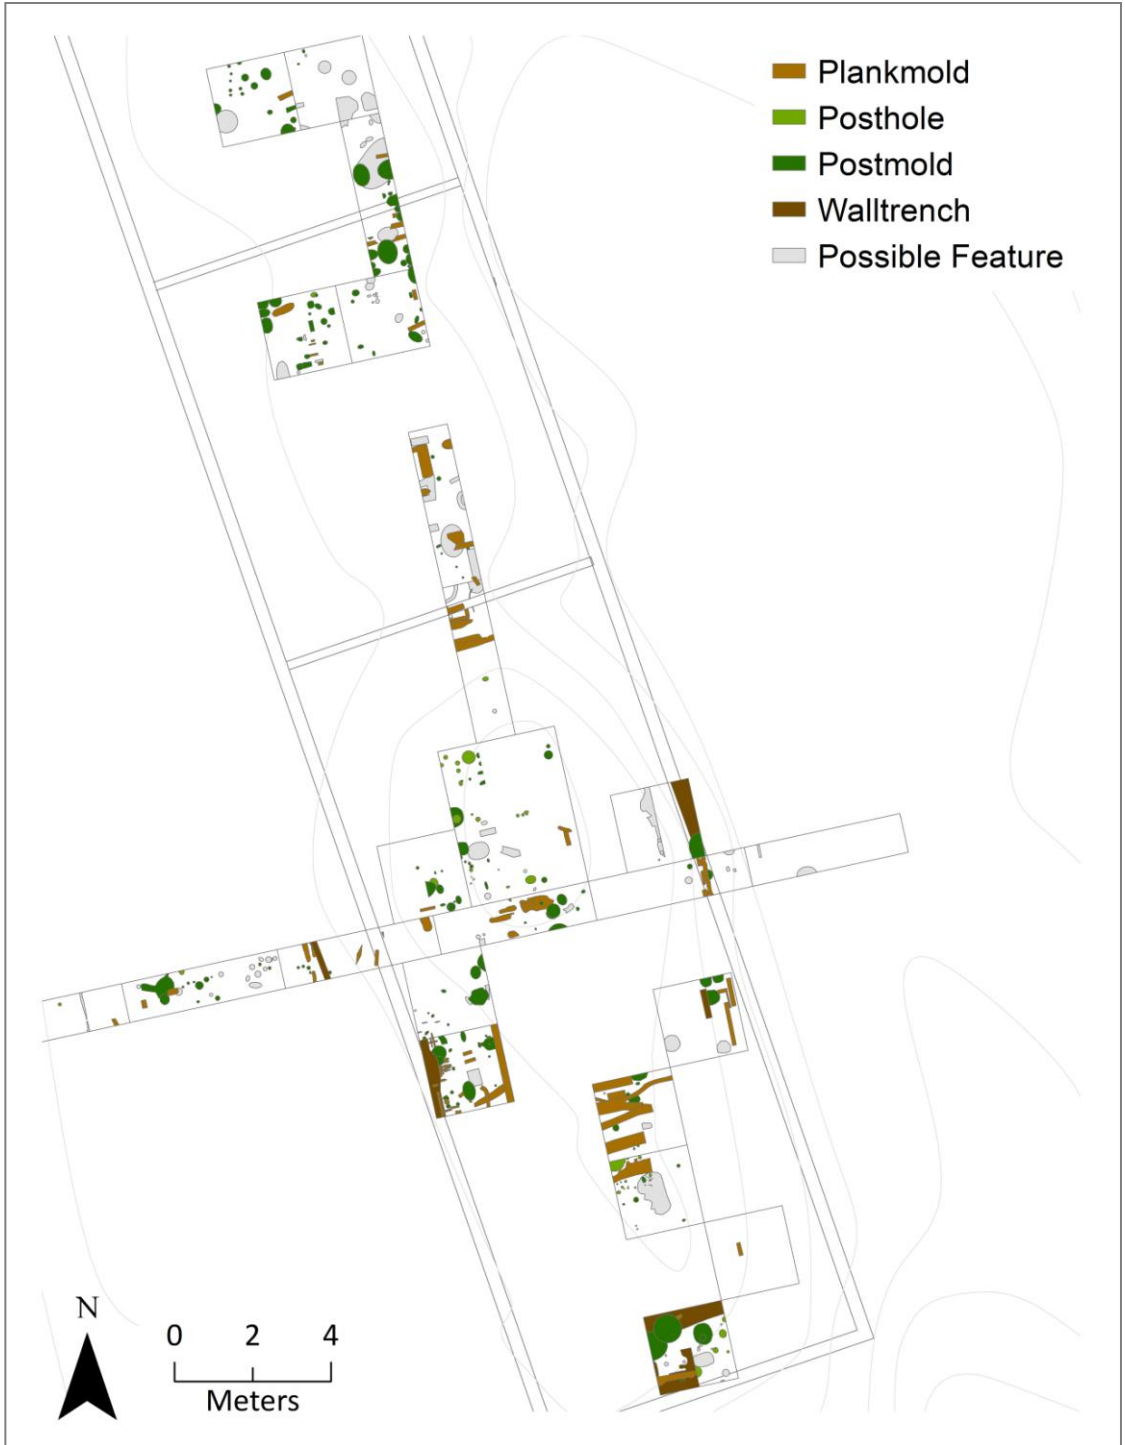
**Figure 10.** Architectural features recorded at Cathlapotle House 1, including possible features.

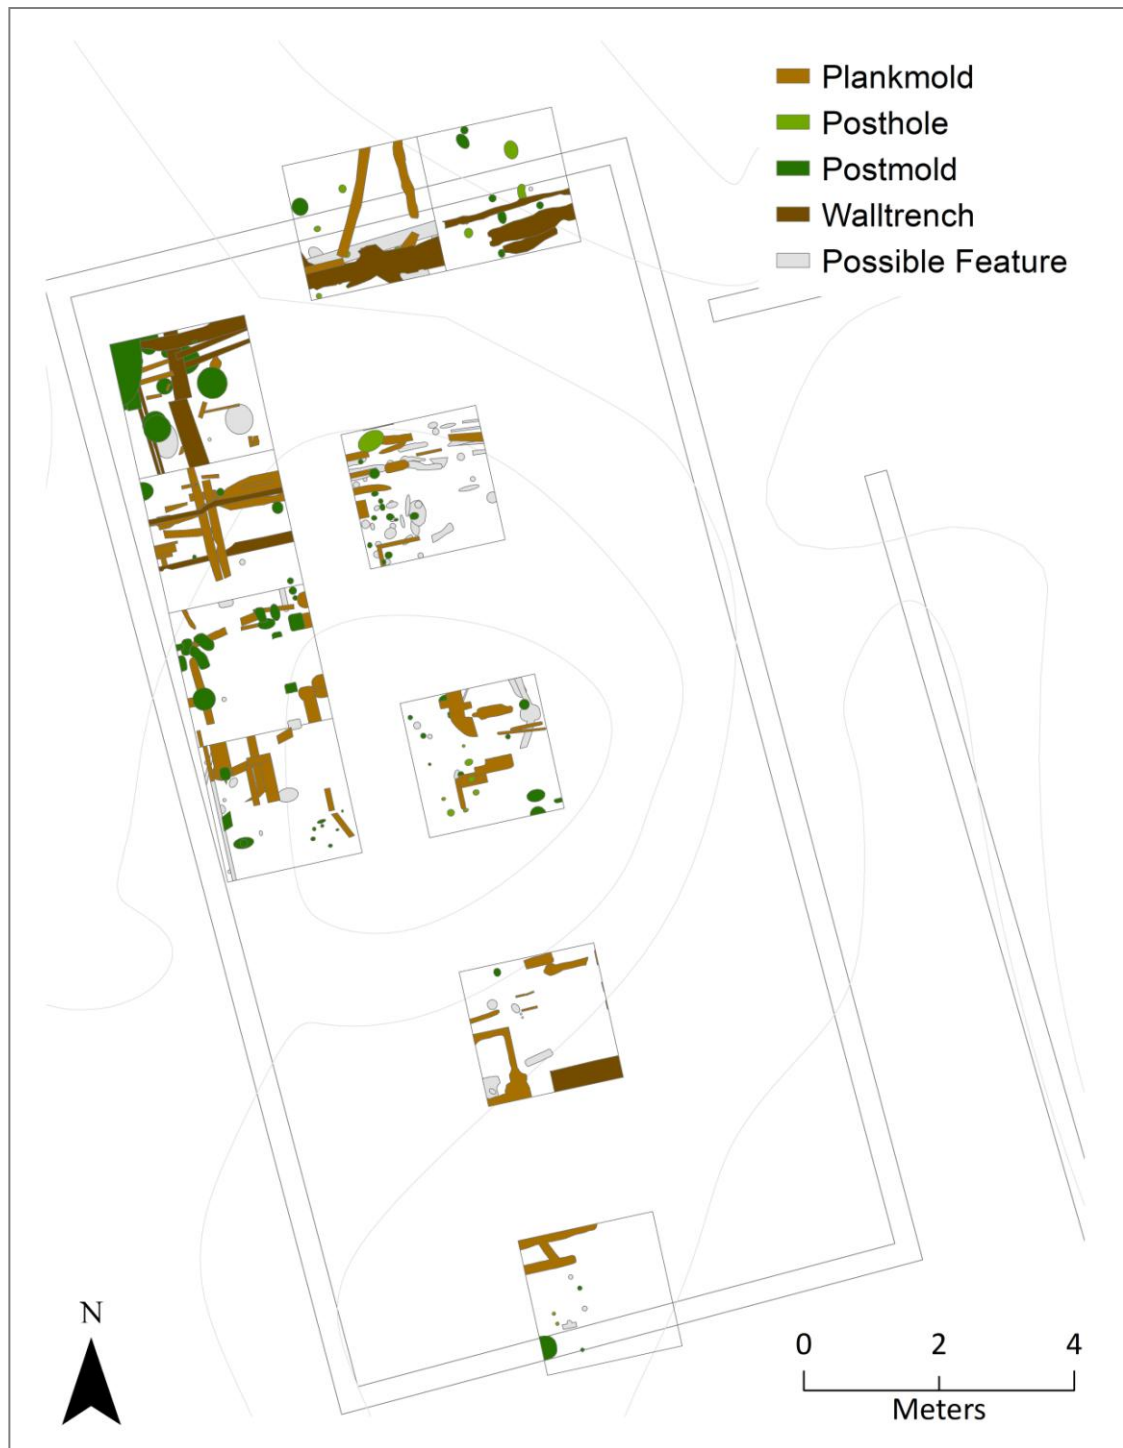
**Figure 11.** Architectural features recorded at Cathlapotle House 4, including possible features.

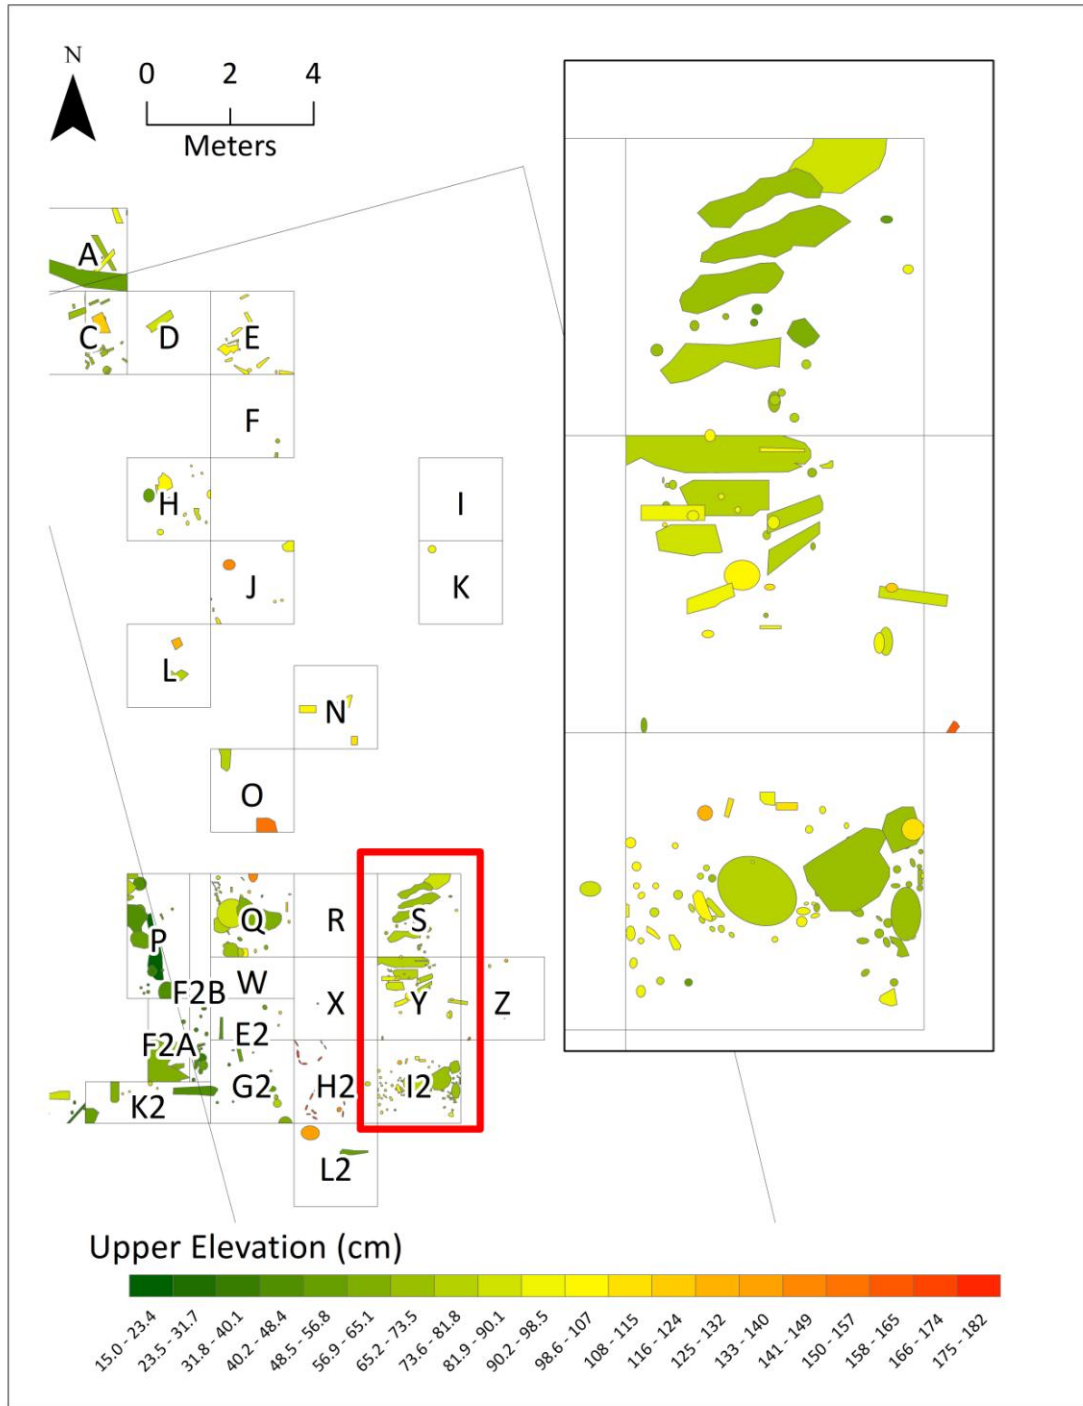
**Figure 16.** Upper elevation of architectural features in central areas, Meier House.

At Meier, several areas in the west wall displayed redundant features with differing upper elevations (Table 8, Figure 15). This suggests features were placed in the same area over time, but that their elevations may have changed slightly. This may have been a result of refuse accumulation in tofts. In the central house area, elements were replaced in very similar vertical and horizontal positions over time (Table 8, Figure 16).

General Area	Specific Area	Units	Observations
Walls (Figure 15)	Northwest corner	A, B, C	Several wall trenches are in close proximity to post features that began on a slightly higher elevation (Units A & B), and to several plank features that began on a lower elevation (Units A & C).
	Central west	E2, F2A, F2B, G2, K2, P, Q, W	Much more variation in beginning elevation than the northwest corner. There are two instances where architectural features in close horizontal location begin at different elevations. (1) In the western edge of the wall, three similarly sized posts began at different elevations (Unit P). (2) East of the wall, there are examples of similarly sized posts layered directly on top of another (Unit Q).
	Southwest corner	M2	Three large post features have very similar upper elevations.
Central area (Figure 16)	All	S, Y, I2	Most features are largely at the similar elevations - many features in the same class have similar horizontal and vertical locations. Some small features are lower in elevation (most are associated with pits).

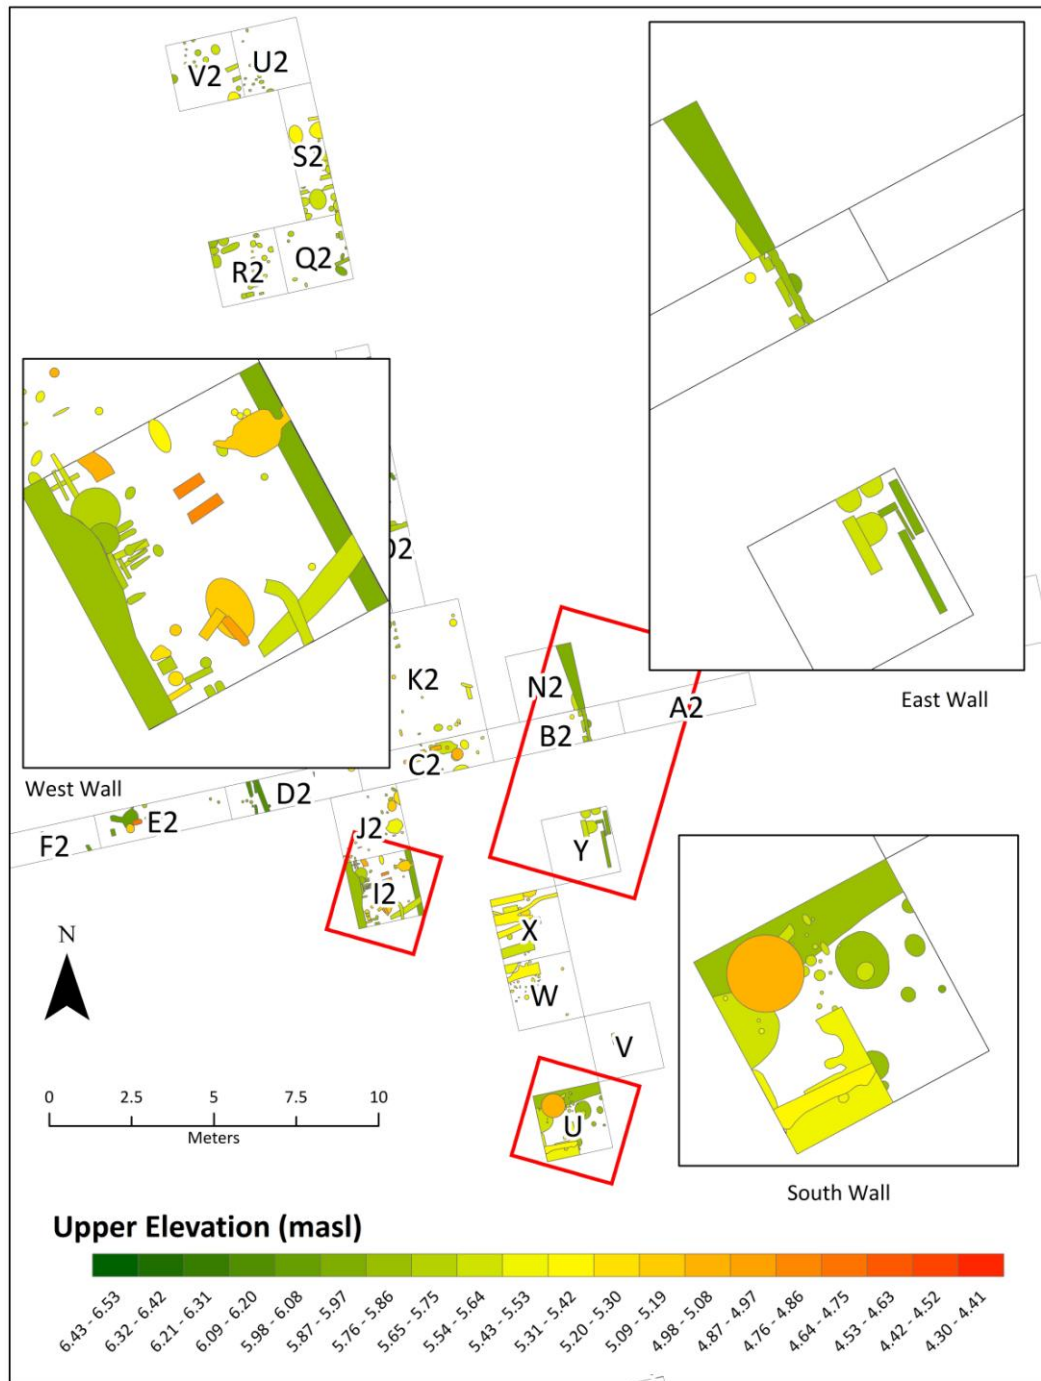
**Figure 17.** Upper elevation of architectural features in walls, Cathlapotle House 1.

At Cathlapotle House 1, most features were in similar horizontal positions, although upper elevation of feature in walls seems to have varied more strongly than at Meier (Table 9, Figure 17). Evidence from postholes and wall trenches in the southern wall suggests possible positioning changes in this part of the house. At Cathlapotle House 1, central areas have high densities of similar architectural features, suggesting that elements were replaced many times although keeping approximately the same elevations during the house's uselife (Table 9, Figure 18). Most evidence for larger planks and frequent replacement of these planks was found in Compartment D, the high status area.

General Area	Specific Area	Units	Observations
Walls (Figure 17)	East wall	B2, N2, Y	Upper elevations of northern features appear slightly deeper than those of the southern line of features.
	West wall	I2	Features vary in upper elevation. This area contains a wall trench and large plankmold with high upper elevations. These features are layered over additional large plankmolds. Several large postholes with even deeper upper elevations are present.
	South wall	U	This area contains several large postmolds with different beginning elevations, and two wall trenches with beginning elevations 30 cm apart. Evidence from postholes and wall trenches in the southern wall suggests possible positioning changes in this part of the house.
Central area (Figure 18)	North central area	S2	Most features are very similar in upper elevation, although a cluster of features in the northern area of the unit are deeper.

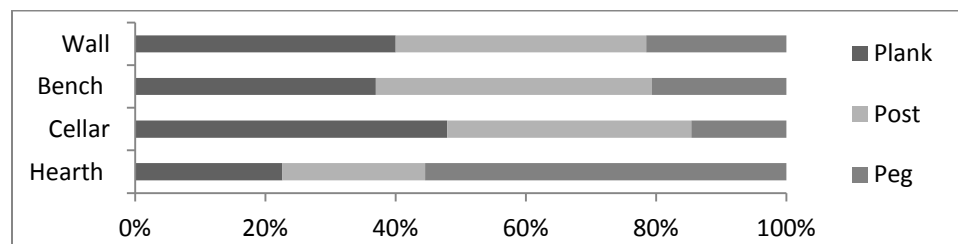
**Figure 24.** Distribution of selected features across plankhouse facilities, Meier.

A chi square test was performed to compare proportions of plankmolds, combined post features, and pegs (posts <7 cm) in bench, cellar, wall and hearth facilities at Meier. Feature classes distributions differ between facilities ( $\chi^2 = 52.232(6), p=.001, n=271$ ). Pegs (posts smaller or equal to 7 cm in length) were more prevalent in hearth facilities (Figure 24). When pegs were removed from analyses, planks and posts are not distributed differently within architectural facilities ( $\chi^2 = 1.002(5), p>.5, n=154$ ).

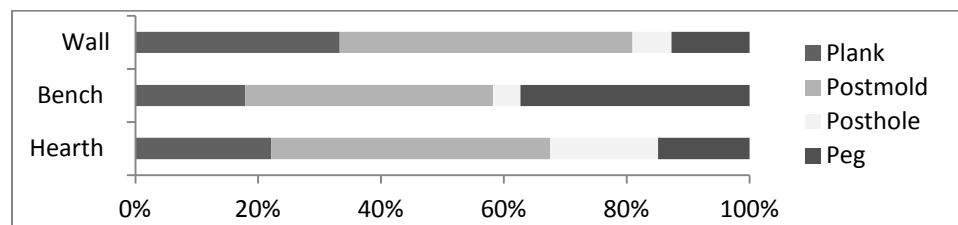
**Figure 25.** Distribution of selected features across plankhouse facilities, Cathlapotle.

The distribution of feature types among facilities at Cathlapotle was investigated with a chi square test. This test compared the distribution of plankmolds, postmolds, postholes and pegs in hearth, bench and wall facilities. As seen in Figure 25, feature classes differ in distribution across the three facilities ( $\chi^2 = 53.741(6)$ ,  $p=.001$ ,  $n=410$ ). A significant difference in distribution is also present when pegs are excluded ( $\chi^2 = 33.952(5)$ ,  $p=.001$ ,  $n=265$ ). Distributions of the combined post category and plankmolds between only hearth and wall facilities also differ from expectations ( $\chi^2 = 24.460(3)$ ,  $p=.001$ ,  $n=247$ ), with more plankmolds present in wall facilities than in hearth facilities.

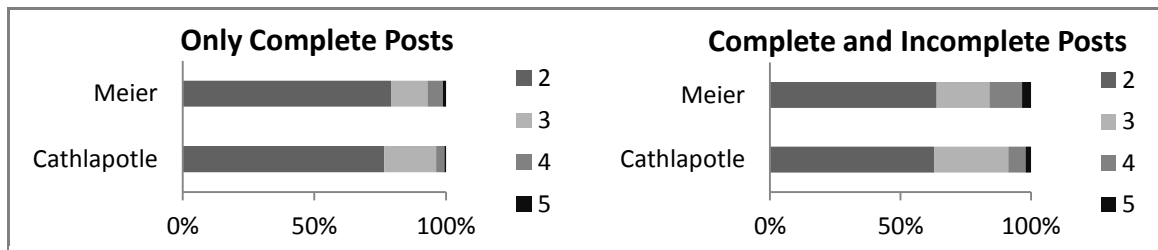
**Figure 26.** Combined posts by size class, Cathlapotle and Meier.

size class distribution is noted for complete posts between Meier and Cathlapotle (Figure 26), ( $\chi^2(3)=2.46$ ,  $p>.5$ ,  $n=274$ ). No significant difference in distribution was found when all posts (complete and incomplete) were considered, although some difference may be present ( $\chi^2(3)=6.44$ ,  $.1>p>.05$ ,  $n=407$ ). When Class 2 posts are removed from analysis and all posts (incomplete and complete) are considered, there is a difference in distribution of size classes between the two sites ( $\chi^2(2)=6.48$ ,  $p=.039$ ,  $n=150$ ). More Class 3 posts were noted at Cathlapotle than expected and more Class 4 posts were noted at Meier than expected.

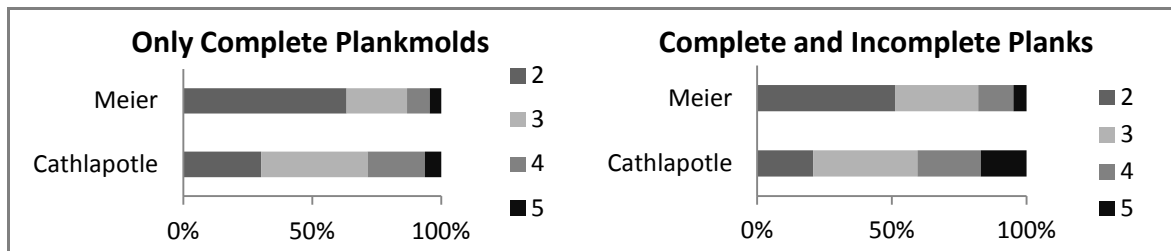
**Figure 27.** Plankmolds by size class, Cathlapotle and Meier.

For plankmold size class between the two sites, test results demonstrate a clear difference in distribution. This is true whether all planks are considered ( $\chi^2(4)=38.1$ ,  $p=0.000$ ,  $n=347$ ), or whether only complete planks are considered ( $\chi^2(4)=18.0$ ,  $p=0.001$ ,  $n=138$ ). This pattern remains when only planks from Meier and Cathlapotle House 1 are compared ( $\chi^2(4)=12.43$ ,  $p=0.006$ ,  $n=219$ ). There are more Class 2 plankmolds at Meier than expected, and more Class 3 and 4 plankmolds at Cathlapotle (Figure 27).

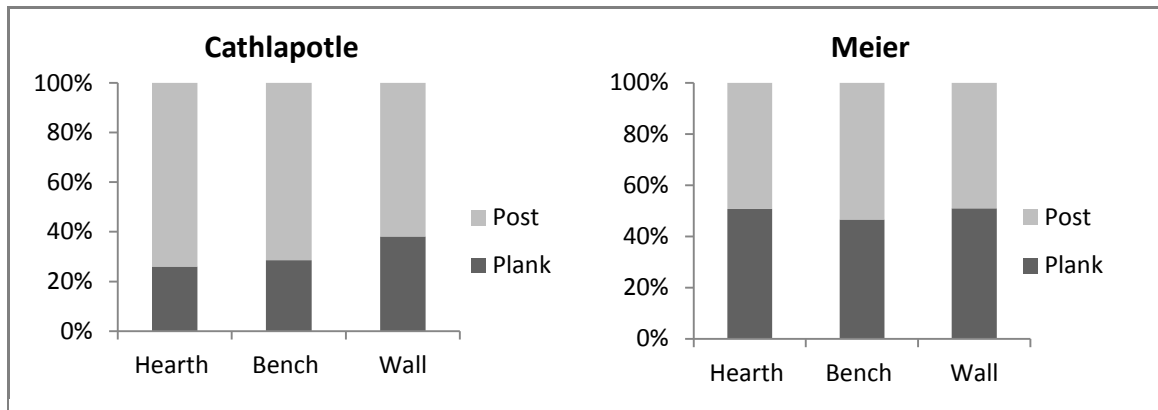
**Figure 28.** Distribution of plank and post feature (>7 cm) across facilities.

Furthermore, in all facilities, Meier contains a higher percentage of planks compared to posts (>7 cm) than Cathlapotle across all hearth, bench and wall facilities (Figure 28). Hence, planks may have been used for architecture or lining storage pits more often at Meier than at Cathlapotle.

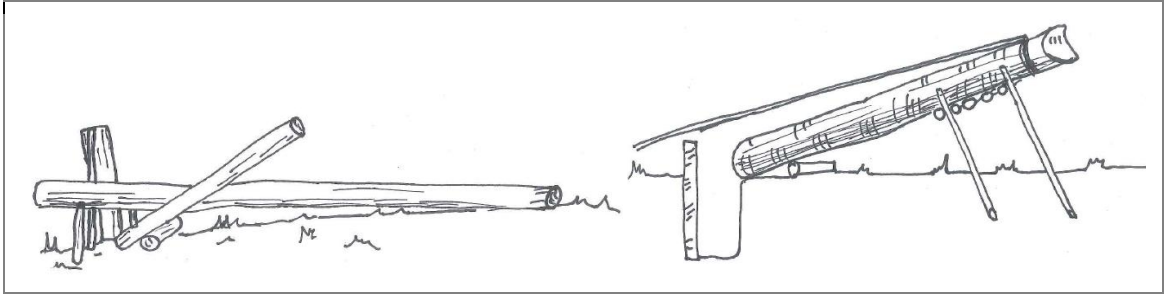
**Figure 29.** Methods of raising posts and beams: (left) a Kwakiutl method of raising a beam (redrawn from Goddard 1972:29), (right) a Clayoquot method of raising a beam (redrawn from Koppert 1930:14).

During house construction, systems of ropes, scaffolding and complex levers were used to raise posts and beams (Figure 29). An 1866 house raising in British Columbia sketched by Henry Elliot (reproduced in Niblack 1970:375) underscores several important aspects of house raisings: (1) use of skids to move large logs, (2) use of ropes in transportation and beam raising, and (3) large amounts of labor needed to move wooden element. House repair activities are not well documented in historical accounts and ethnographies, although Stewart (1984:46) provides examples of sophisticated and time-consuming techniques for repairing warped or split planks.

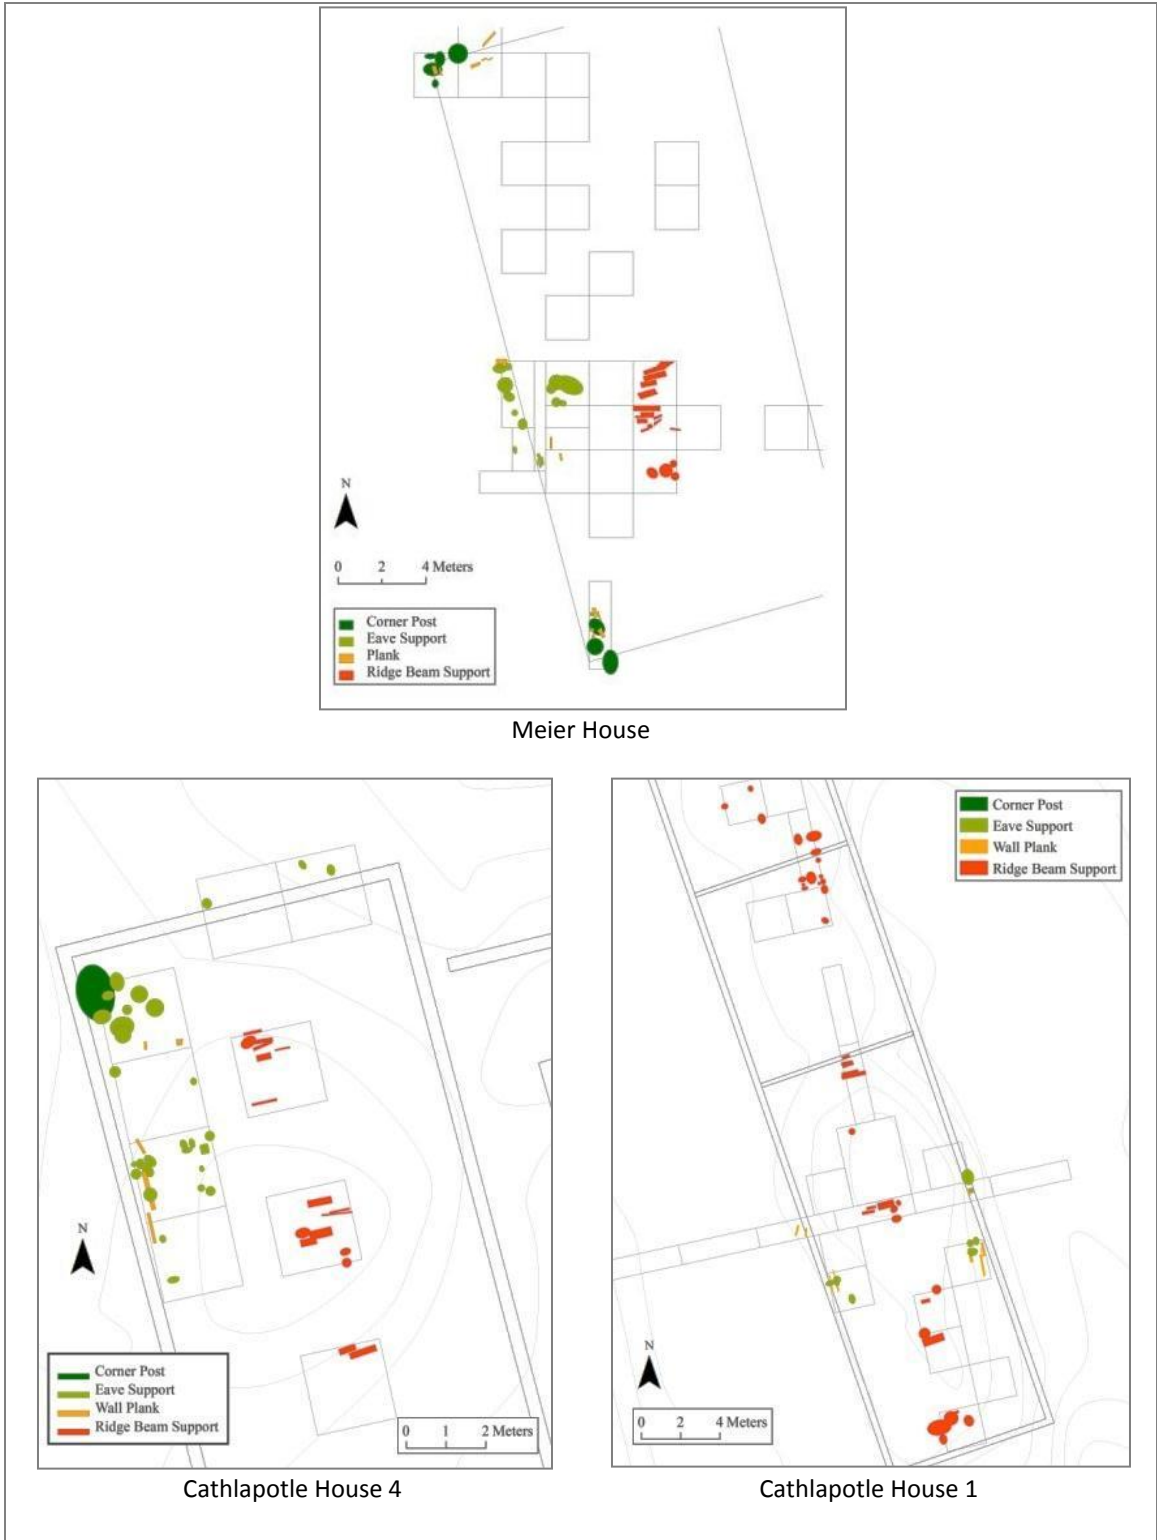
**Figure 33.** Structural features at Meier and Cathlapotle.

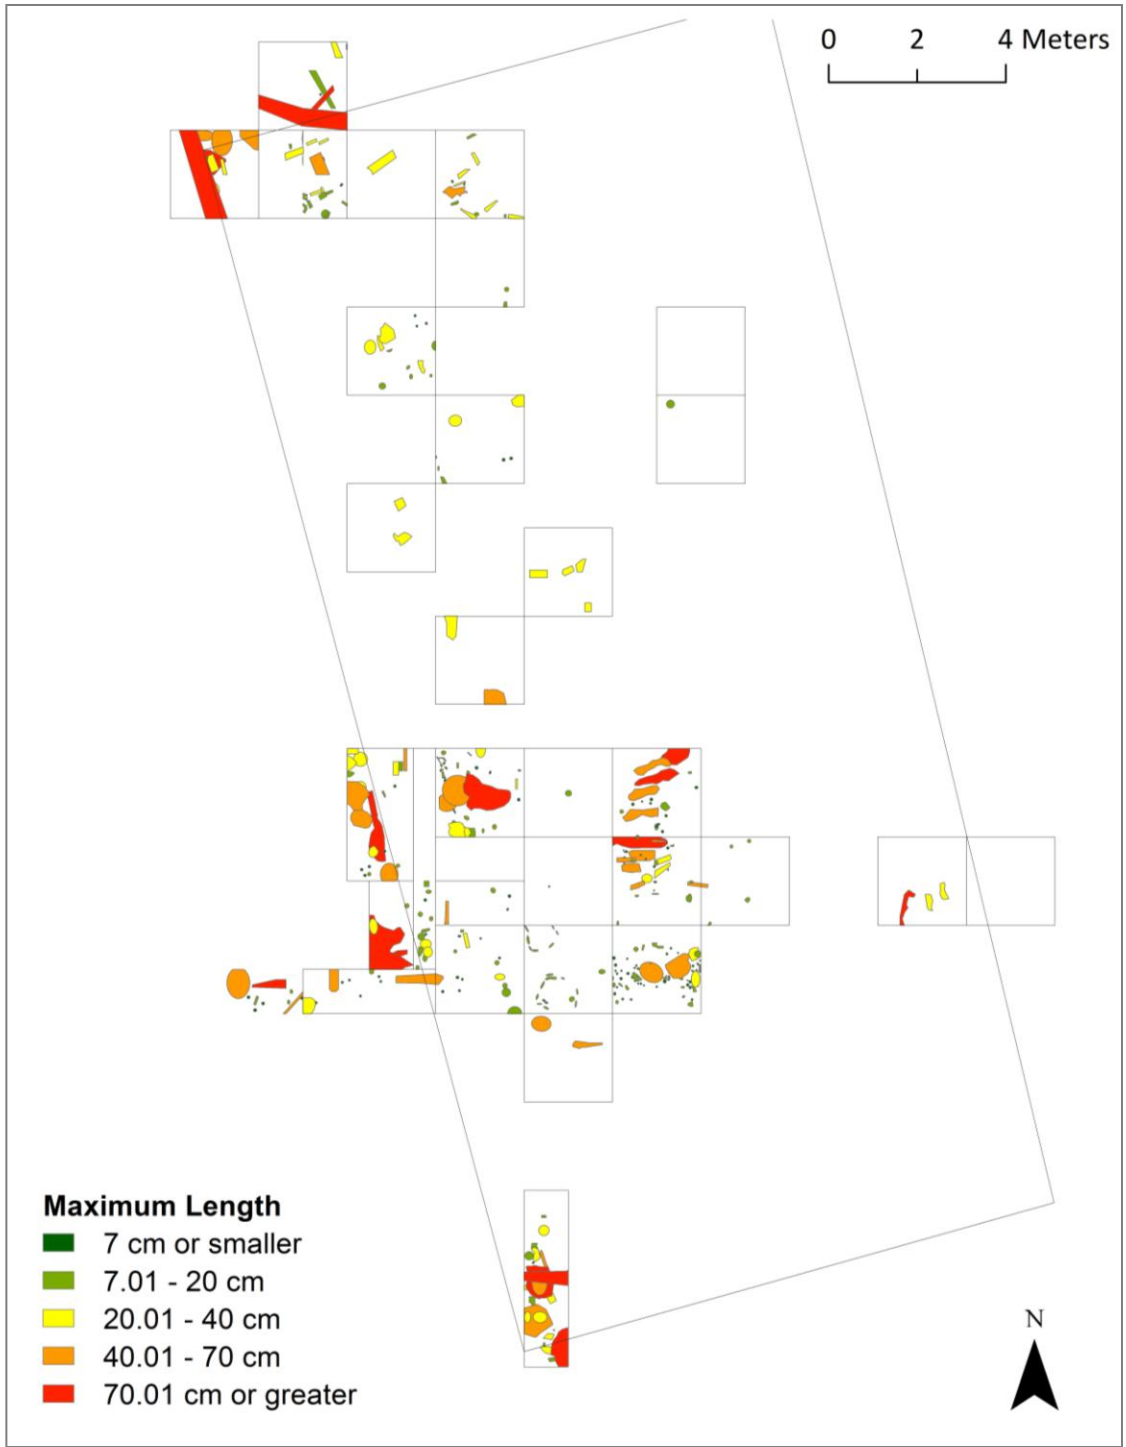
**Figure A-1.** Features by size, Meier.

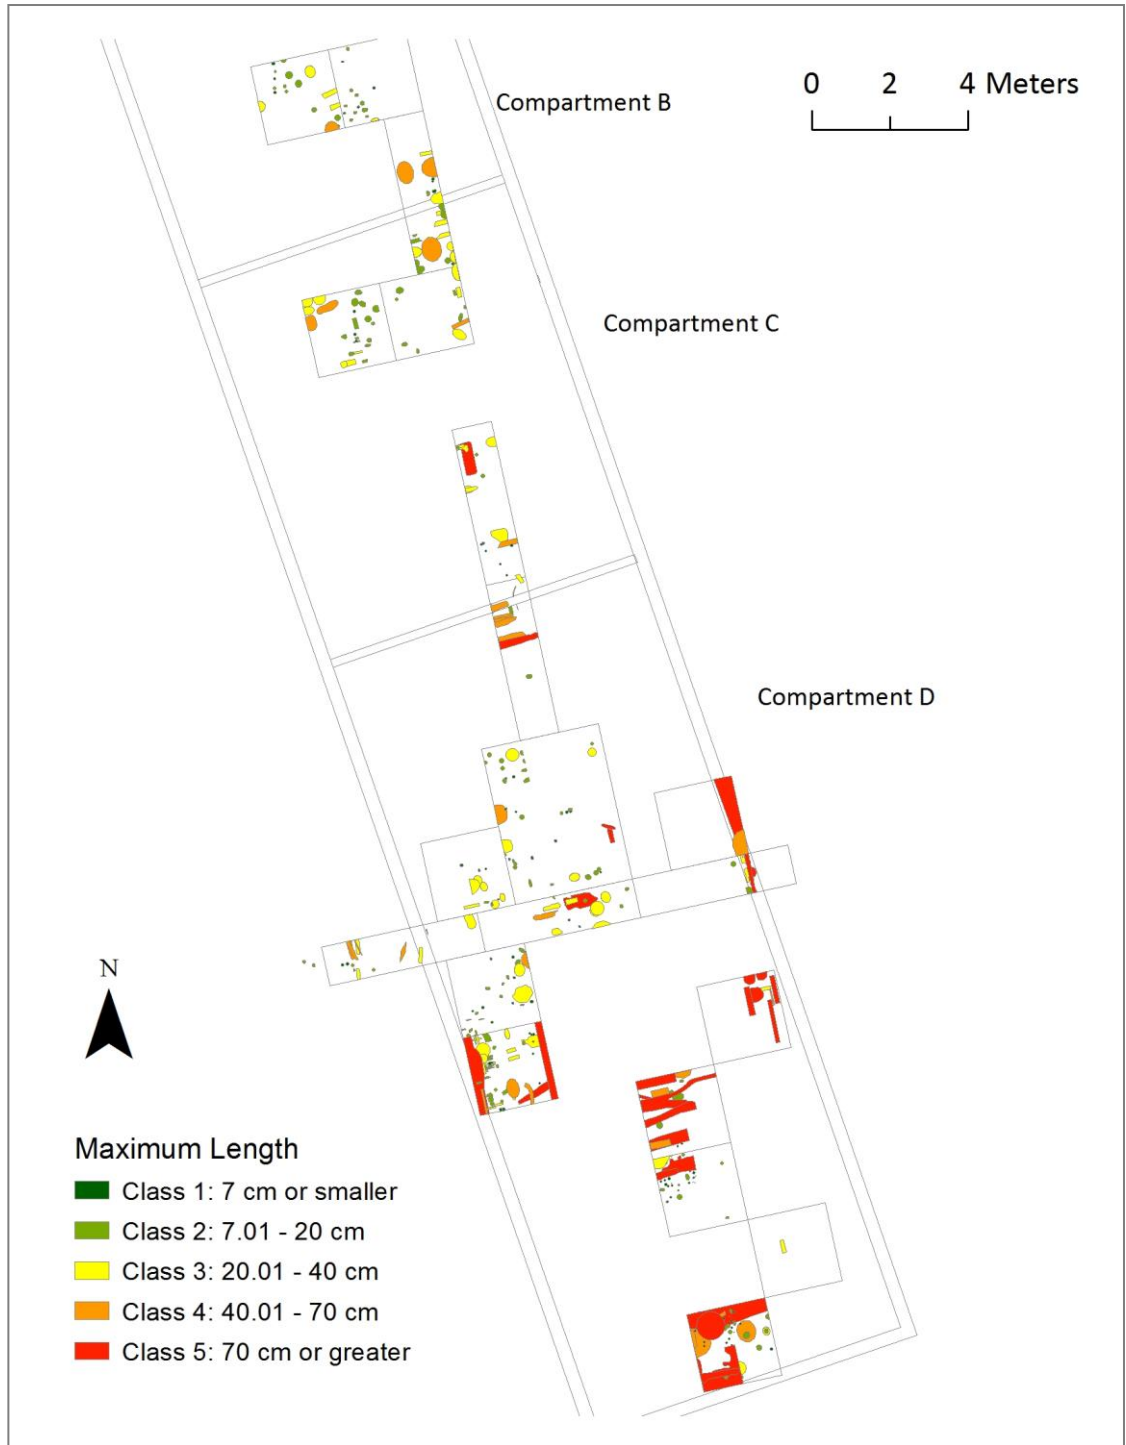
**Figure A-2.** Features by size, Cathlapotle House 1.

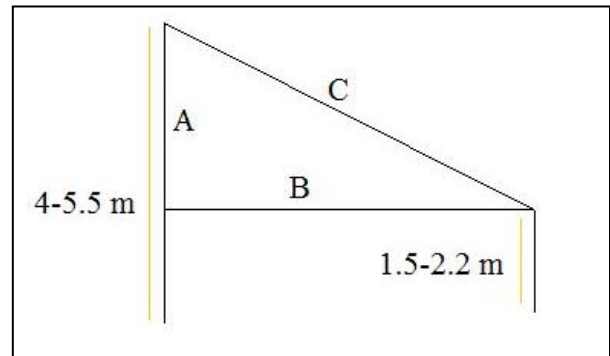
**Figure B-1.** Schematic of roof area calculations.

In order to determine board feet of planking required for houses, I calculated the surface area that would need to be sheathed with planks for siding and roofing. Roof area was calculated using the Pythagorean Theorem (Figure B-1). Wall plank height, ridge beam support height, and structure width were used to complete this equation. Side A was determined by subtracting ridge beam support height from wall height. Side B was calculated by halving the width of the house. Side C was completed with the Pythagorean Theorem, and represents estimated roof width. Roof width was multiplied by the length of the house. This figure was multiplied by two (to account for both sides of the roof), which represents the total roof area in square meters. For each structure, four roof area calculations were obtained representing the different combinations of ridge beam and wall height (Table B-2).

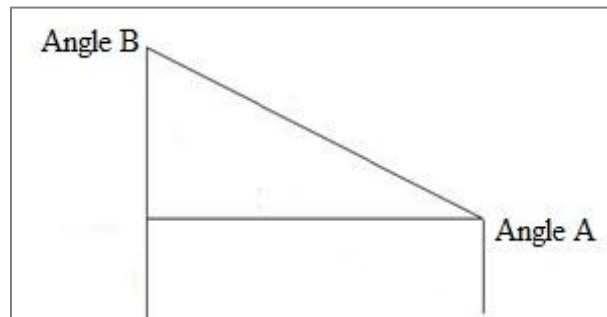
**Figure B-2.** Schematic of roof angle calculations.

Since roof area made up a significant portion of the raw material required for houses, I wanted ensure that my calculations were reasonable. To test roof area calculations, two angles of the roof pitch were calculated for each possible wall height and roof beam support combination that were used to estimate roof area. Angle A represents the intersection of the wall and the roof, and Angle B represents the pitch of the roof (Figure B-2). These angles were then compared to two historical depictions of LCRR plankhouses. In Paul Kane’s painting (Interior of a Ceremonial Lodge), Angle A is 22 degrees and Angle B is 68 degrees (Eaton and Urbanek 1995). In the Richard Dodson’s engraving (Chinook Lodge in 1841, based a sketch by Alfred Agate), Angle A is 37 degrees and Angle B is 51 degrees (Oregon Historical Society 2003). These numbers are within the ranges of angles that I calculated from feature height estimates (Table B-3).
