The West Tidewater Earthflow, Northern Oregon Coast Range

Barry A. Sanford
Portland State University

Title: The West Tidewater Earthflow, Northern Oregon Coast Range.

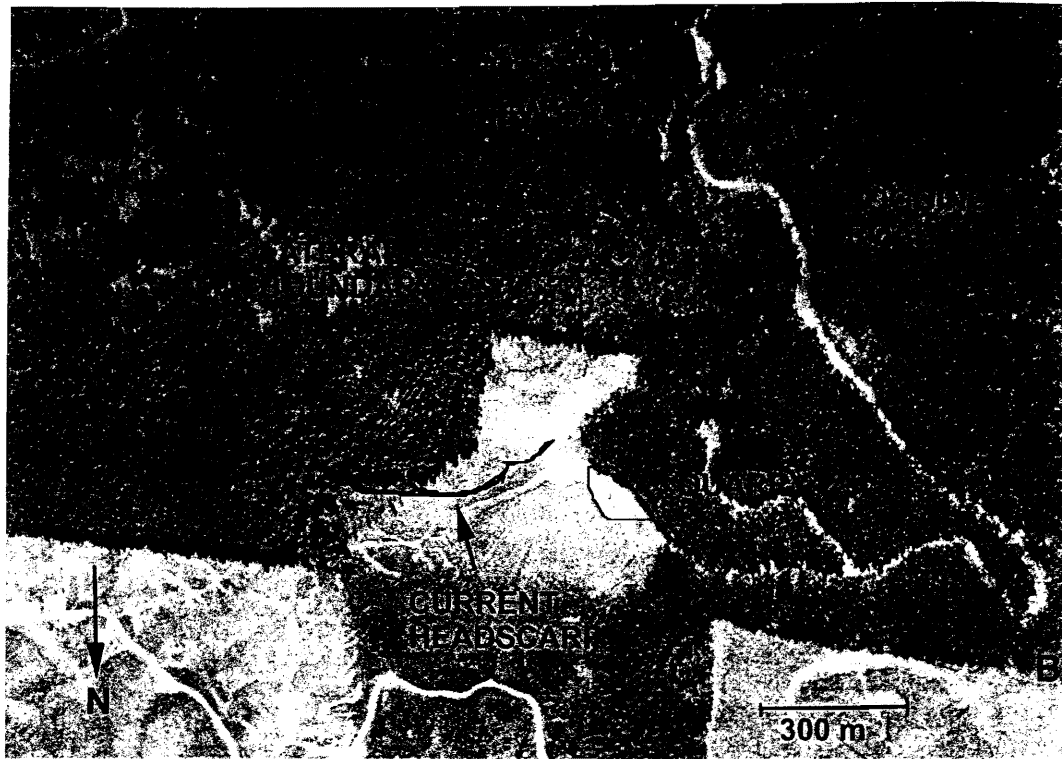
Figure 2. Aerial photo of the Tidewater earthflow study area. Black lines indicate current earthflow features, access roads, and rock quarry. The area of new growth suggests a previous slope failure in the basin. The east west timber cut boundary (AB) parallels the ridge that is the northern margin of the study area. Photo is courtesy of the Oregon Department of Forestry, I.D. # NOW-CLATS-08, 20-30, 04-27-1980.

The drainage basin that contains the West Tidewater earthflow has been subject to at least one, and possibly several historic failures. Aerial photos suggest older earthflow events in nearly the same location as the current failure (Figure 2). Lighter colored new growth vegetation can be seen extending down the drainage basin to the south and west. The standing timber within most of the study area and slide margins was harvested by clear-cut logging methods in 1991 (personal communication, Dave Michael, Oregon Department of Forestry, 1995). The east-west timber cut boundary, also visible in Figure 2, roughly parallels and lies just

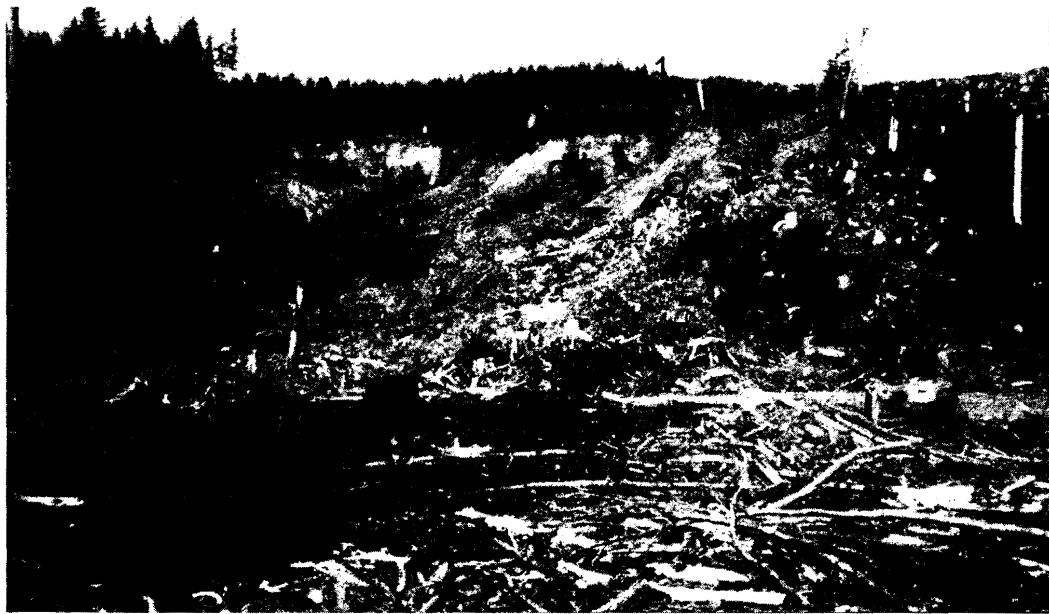
Figure 7. View of the earthflow looking north from instrument station one(Plate 1). Areas of spring outflow are indicated by ♣ symbols. X's indicate piezometers. The ridge at figure right is a groundwater source area. The distance to the headscarp is 400 m.

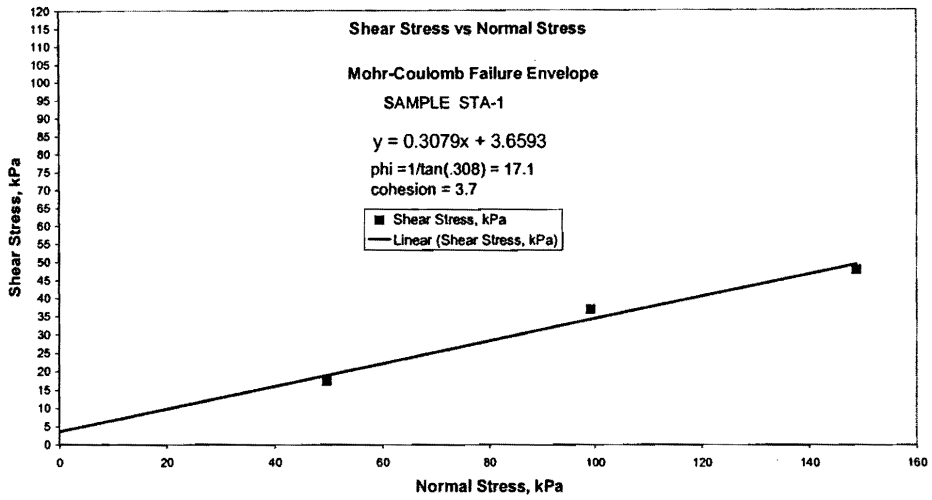
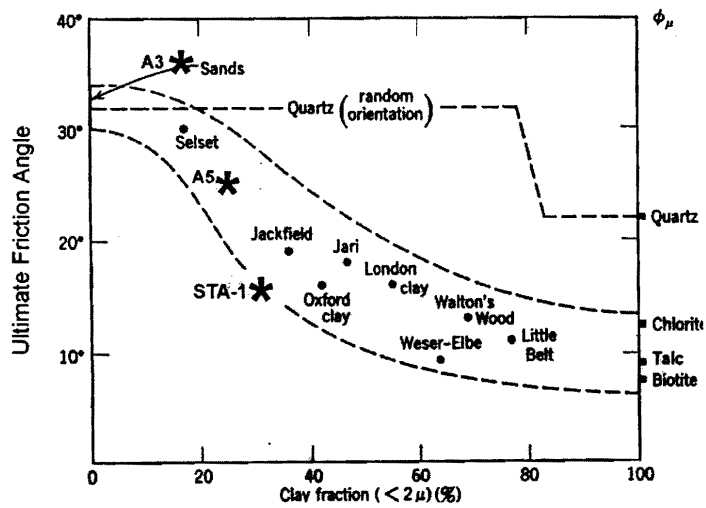
Figure 12. 12A shows the Mohr-Coulomb failure envelope from direct shear tests on sample STA-1. Residual friction angle is 17°, residual cohesion is 3.7 kPa. 12B from Skempton (1964) compares values of ultimate or residual friction angle and the sizes of clay fractions.

The drained samples show effective cohesions ranging from 4 to 8 kPa. The drained effective residual friction angles range from 17° in the clay-rich mudstone to 14-18° in the sandy siltstone. The undrained siltstone sample shows a residual friction angle of 17° and residual cohesion of 4 kPa. The Mohr-Coulomb failure envelope developed from direct shear tests on mudstone sample STA-1 is shown in Figure 12A. The relationship between the size of the clay fraction versus the empirically-derived residual friction value is shown in Figure 12B as a check for reasonable values. The West Tidewater earthflow samples are indicated by labeled stars.

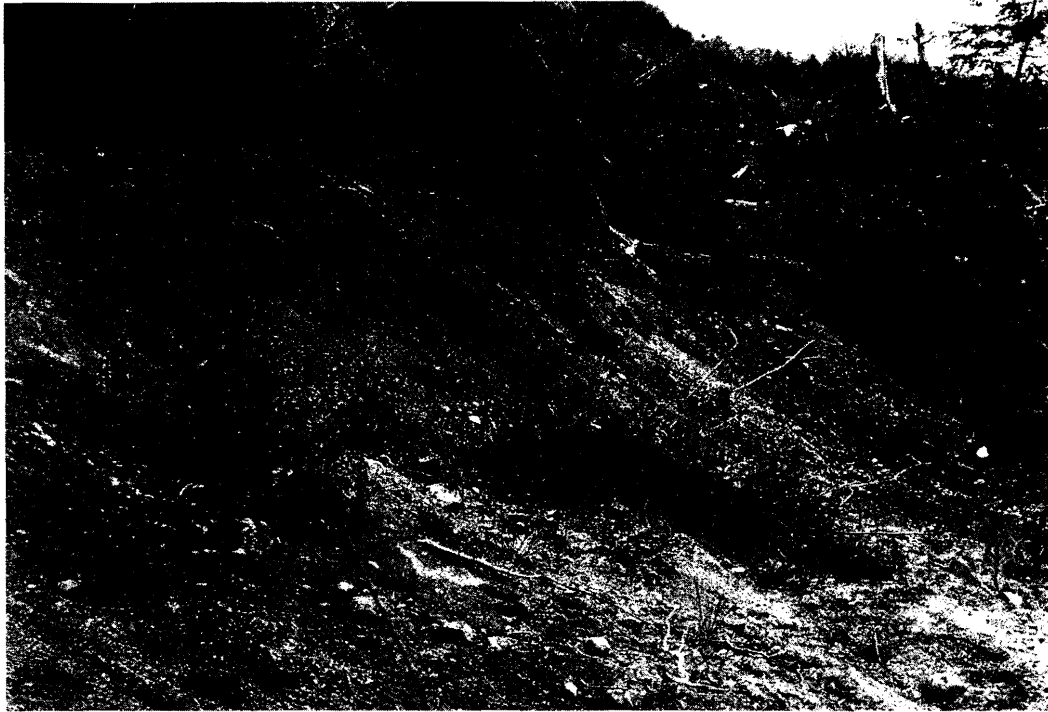
Figure 20. Structural feature located along contour 495 m near the western margin of the earthflow about 40 m downslope from well 2 (Figure 3). The 2 - 3 m height exposes yellow-gray siltstone and colluvium.

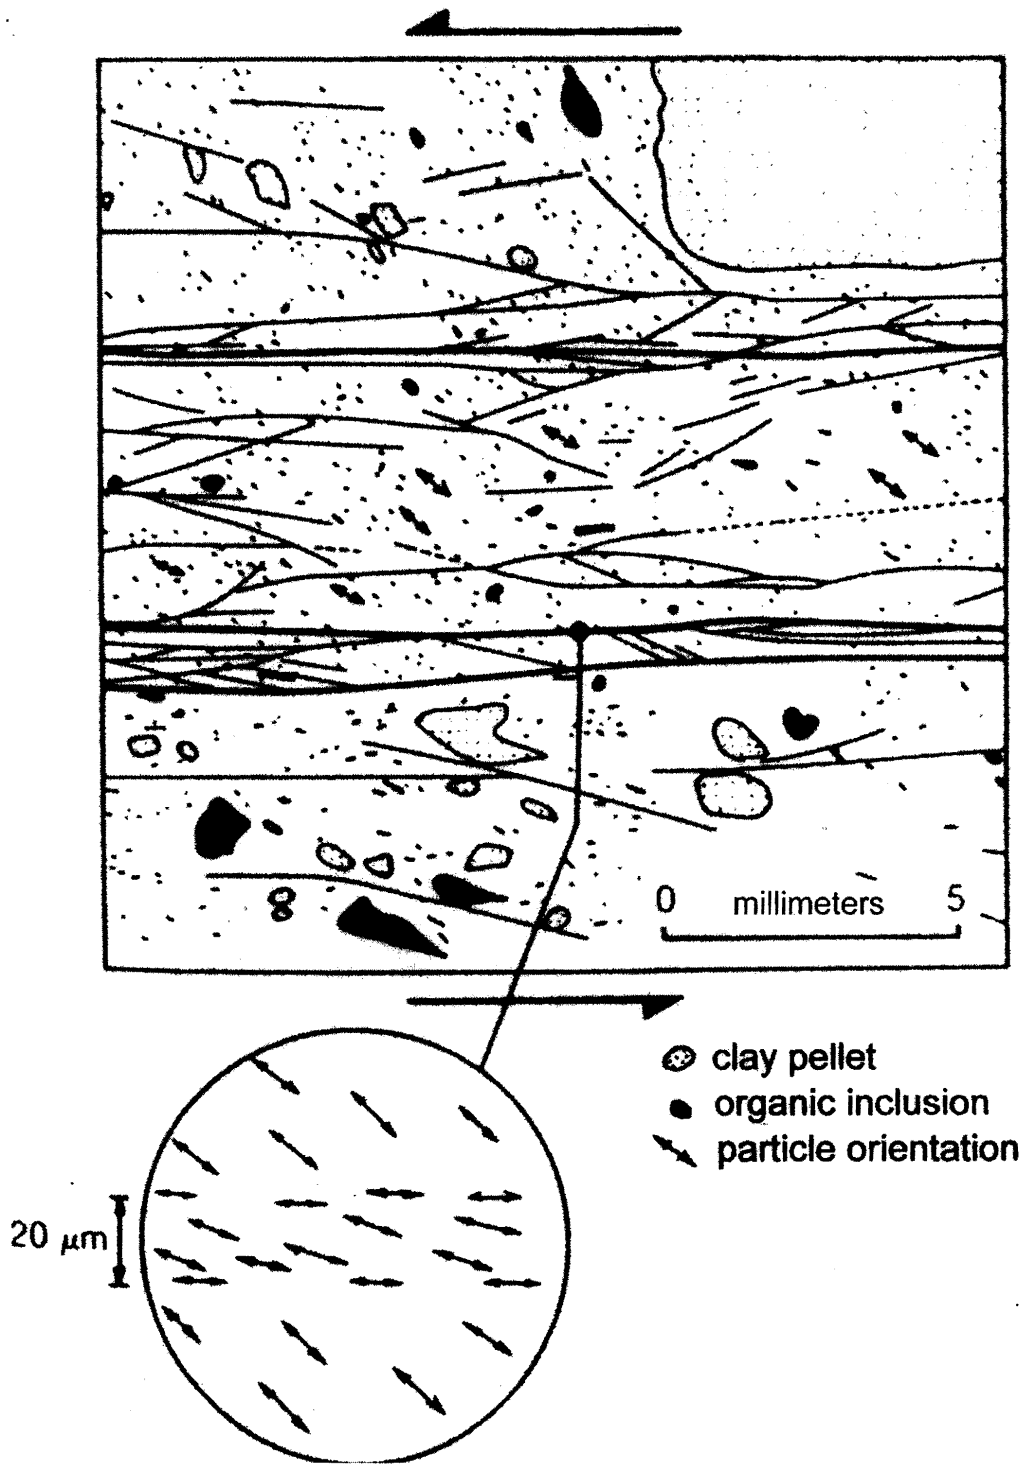
Figure 33. Drawing of particle reorientation during shear. Peak and residual strengths are affected by spacial alteration during soil movement, from Skempton (1985).

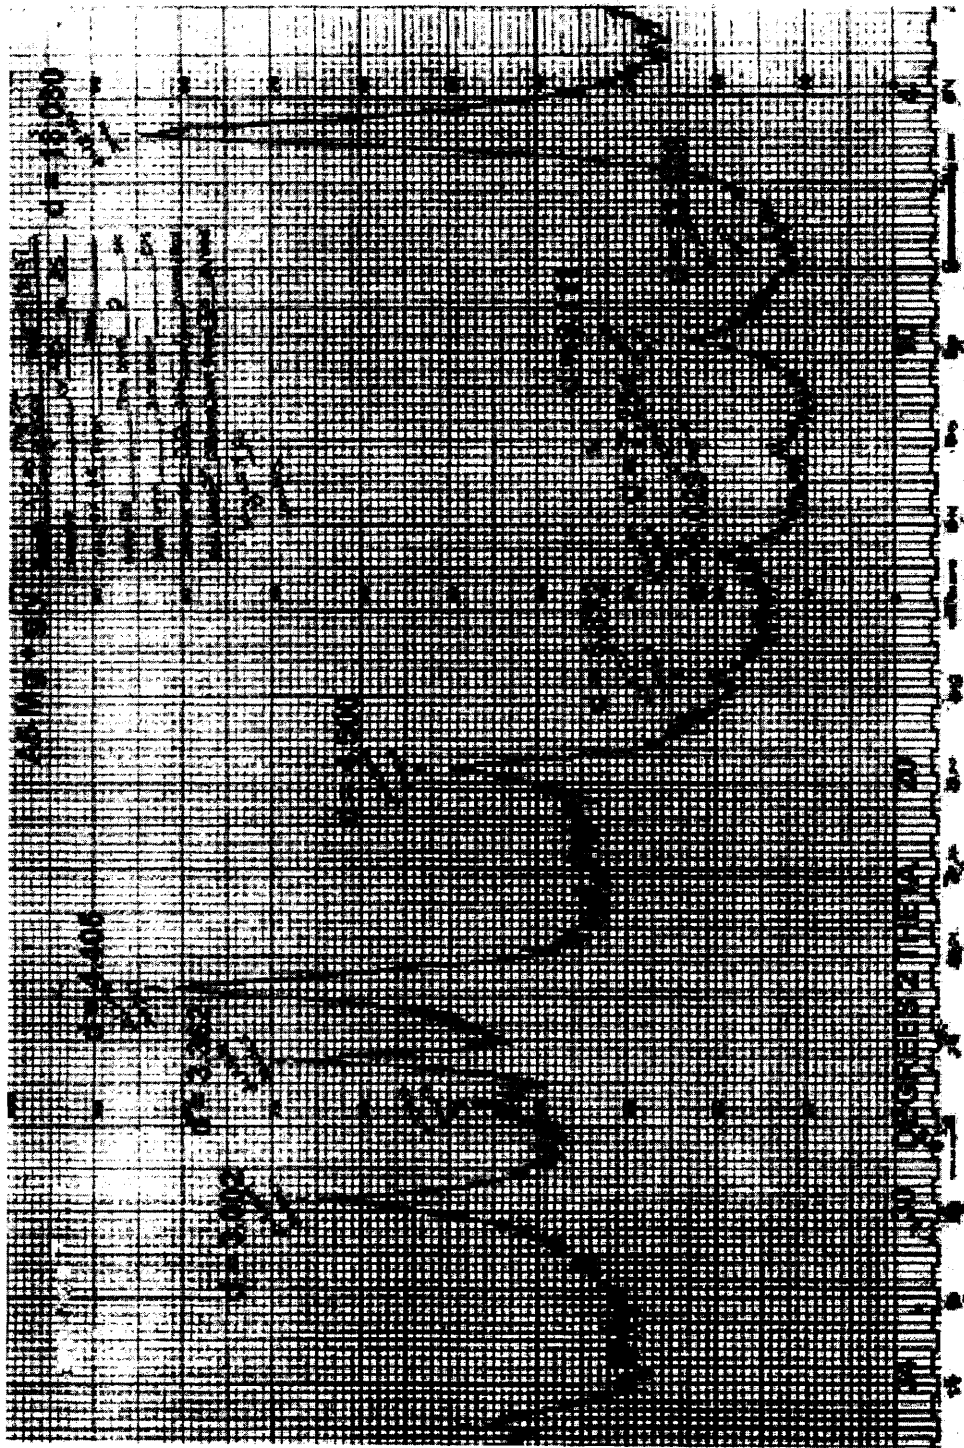
Figure F3. Sample A5 Mg + glycol saturated.
