Cyclic Loading Behavior of CFRP-Wrapped Non-Ductile Reinforced Concrete Beam-Column Joints

Ali S. H. Zerkane
Portland State University

A thesis submitted in partial fulfillment of the
requirements for the degree of

Master of Science
in
Civil and Environmental Engineering

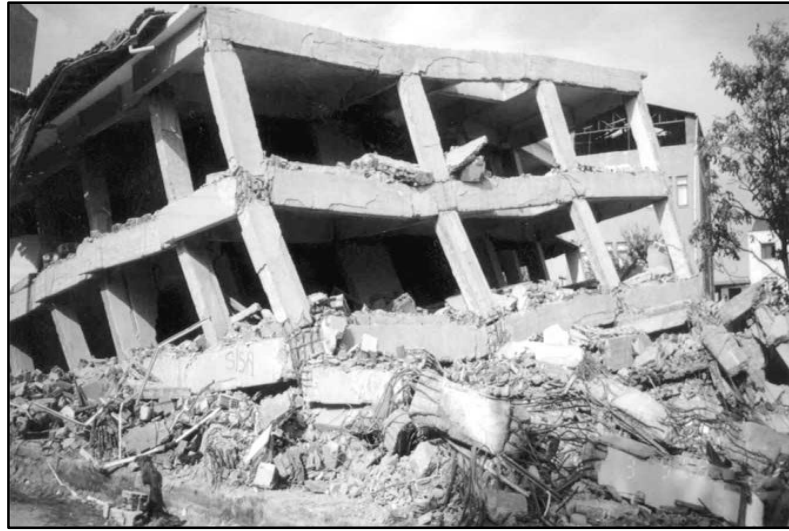
Figure 1-1 Beam-Column Joint Shear Failure, Kocaeli Earthquake

The annual average of successful concrete frames constructed world-wide is on the order of hundreds of thousands. On the other hand, there are a large number of these frames that are unsafe in seismic resistance capacity, especially the buildings that were constructed prior to the 70s. Evidence shows that from earthquakes such as the one in Kocaeli, Turkey, 1999, and the one in Chi-Chi, Taiwan, 1999, that there has been severe damages or complete collapse in these kinds of buildings that were designed and built prior to modern building codes. Most of the buildings designed and constructed based on the earlier codes were characterized by non-ductile performance during the earthquakes because the earlier codes did not include the required reinforcement details for ductility. As a result, non-ductile behavior of these buildings during the earthquakes was expected. Figure 1-1 and 1-2 show an example of this sort of damage that happened after Kocaeli earthquake.

Most older buildings were designed to carry the gravity loads and resist wind lateral loads. The results of the examination of the collapsed buildings during earthquakes have shown the weakness of these buildings to resist the lateral loads created by earthquakes. Furthermore, it has been observed that the weakest part in such structures was the beam-column joints as shown in Figure 1-1 and 1-2, where the beams and columns were intact whereas the joints were crushed.

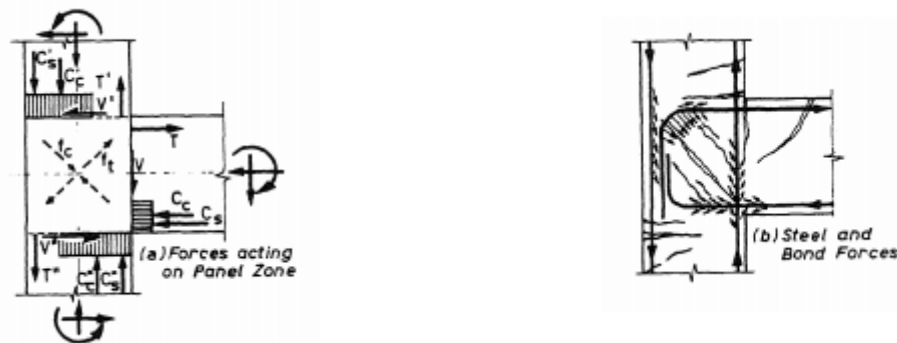
Figure 2-1 Action at an External Reinforced Concrete Joint, Park, T. et al. (1973)

One of the earlier studies by Park, R. et al. (1973) was to test and analyze the behavior of the beam-column joint under simulated severe seismic loading. Thirteen specimens were constructed in full scale. The transverse joint reinforcement and the anchorage length of the beam reinforcement were the main parameters in this experiment. The ACI 318-71 was the main reference for the design of these specimens. The general shape of the specimens consisted of a column with a beam framing one side at mid-height. All of the specimens were tested under small or no axial loads on the column, and an applied cyclic load on the free end on the beam. The external and internal actions in the external beam-column joints are shown in Figure 2-1.

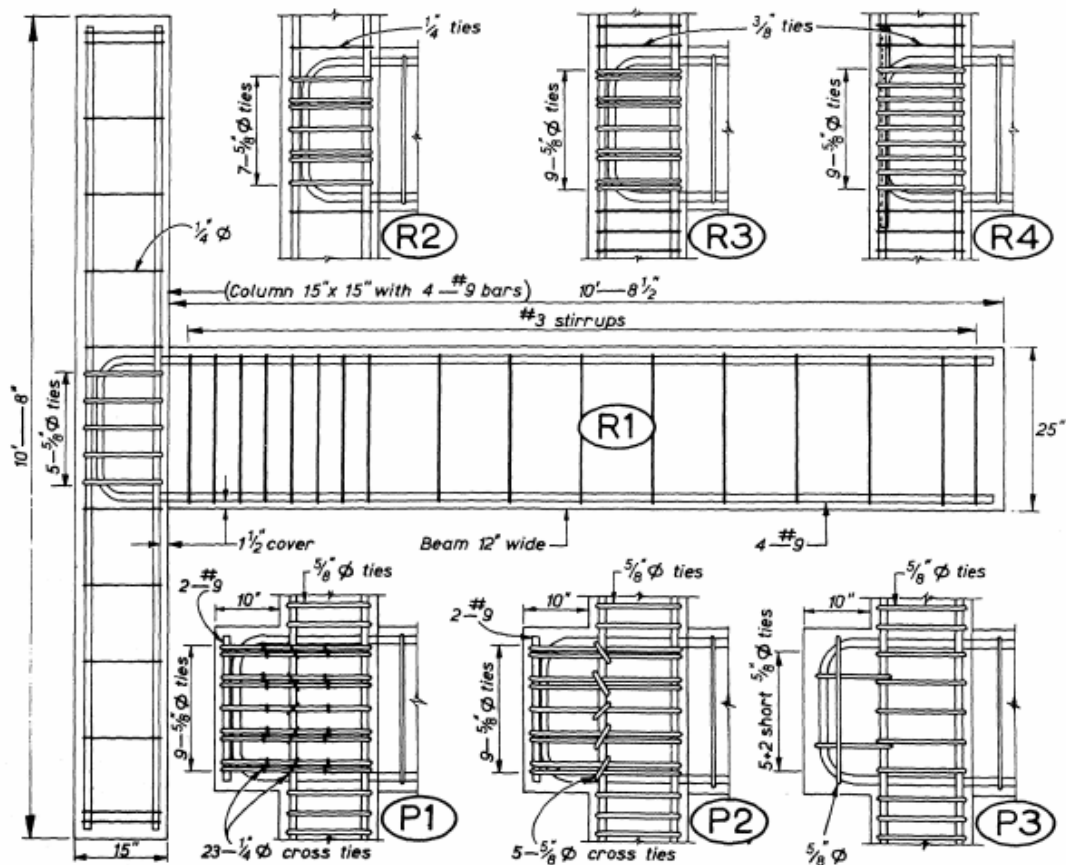
Figure 2-3 Details of the Second Group, Park, T. et al. (1973)

R1, and R2 were normal, based on ACI Code requirements, but spaces between ties were closer in the rest of the specimens R3, R4, P1, P2, and P3. Specimens P1, P2, and P3 had a back stub at the joint region from the back side of the column to give more room in order to add extra reinforcement. The concrete compressive strength of specimens was changed 3.4 to 5.6 ksi.

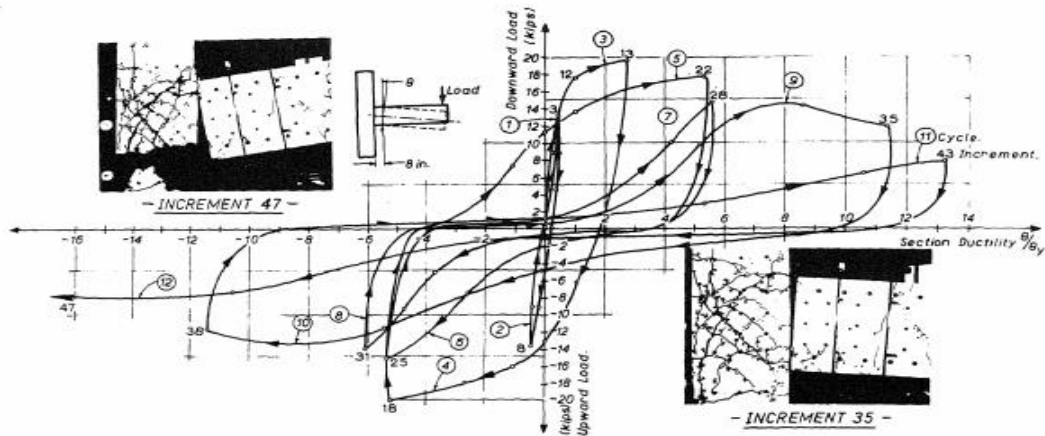
Figure 2-4 The Applied Load versus the Ductility Factor for Specimen (M₃),

The test results of first group showed poor behavior during the test cycles due to the deterioration of the moment capacity and anchorage breakdown. Figure 2-4 shows the relations between the applied loads versus the ductility factor for specimen M₃, and Table 2-1 shows the maximum moment of each cycle versus the ductility factor of each specimen in the first group.

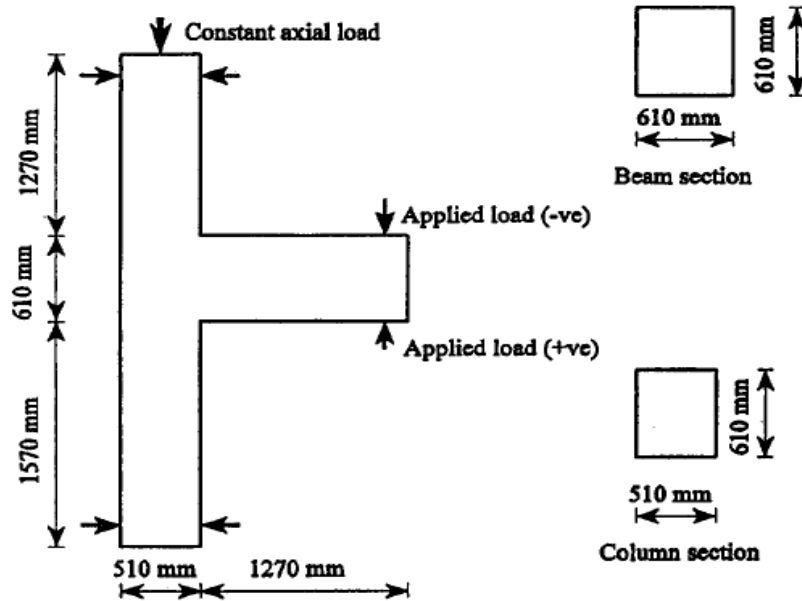
Figure 2-7 Dimensions of Specimens, Biddah, A. et al. (1997)

Biddah, A. et al. (1997) constructed and tested six specimens in one-third scale under static cyclic loading. The specimens represented an external joint of a two story concrete frame in a nuclear power generation plant constructed in 1969. All of the specimen dimensions were identical. Figure 2-7 shows the general shape and the dimensions of the specimens.

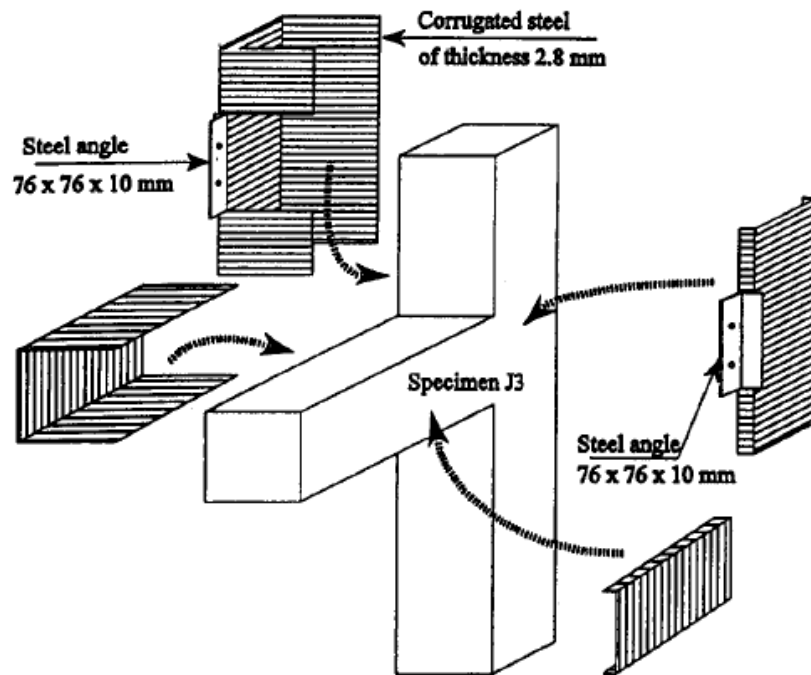
Figure 2-8 Proposed Rehabilitation Technique, Biddah, A. et al. (1997)

Specimens J1, J3, and J5 represented existing joints in terms of reinforcement details in the concrete frame. J3 was retrofitted by using the steel jacket to confine the column and beam, whereas J5 was retrofitted by using the steel jacket to confine the column only. In both specimens, the steel jacket thickness was 2.8 mm. J2 was designed in accordance with CSA A23.3-94, where shear reinforcement was placed within the joint region. J4 and J6 were designed with no shear reinforcement in the joint region, and an inadequate development length of the positive beam reinforcement. J6 was retrofitted by using a steel jacket thickness of 3.5mm around the column, in addition to two steel plates anchored between the beam and the joint. The longitudinal reinforcement of all

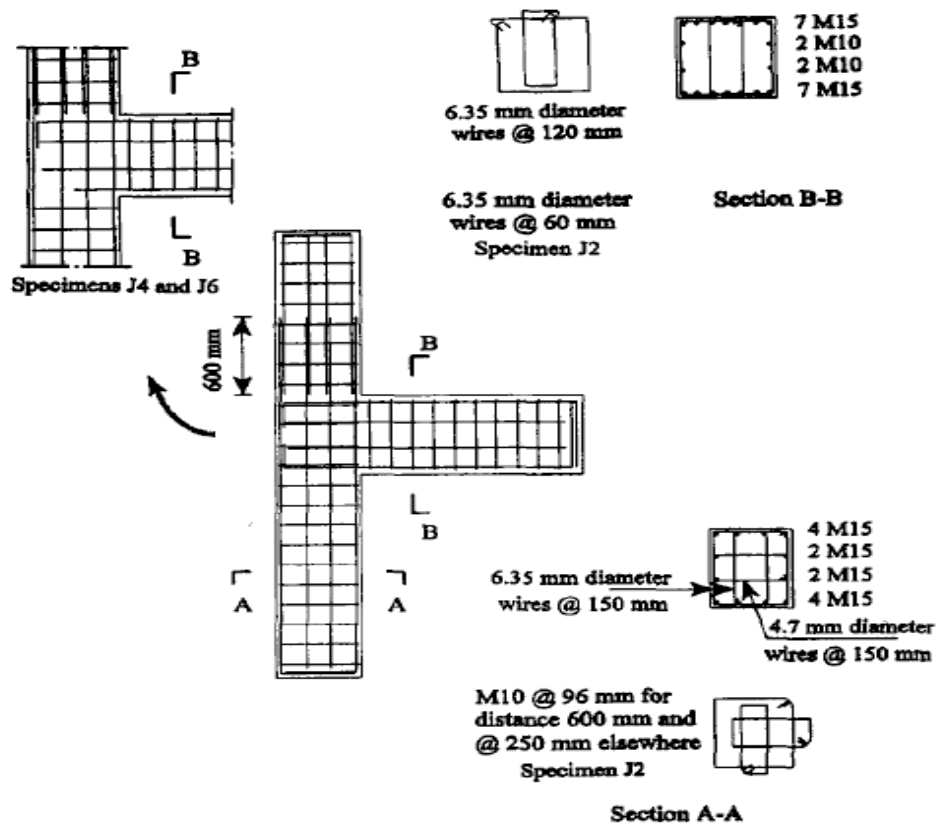
Figure 2-9 Details of Reinforcement, Biddah, A. et al. (1997)

specimens was identical, except for J4 and J6 where the bottom beam reinforcement had a shorter development length. The details of the stirrups are shown in Figure 2-9. The concrete cover was 30 mm in all specimens. Also non-shrink grout of 25 mm used to fill the gap between the concrete and steel jackets. Table 2-2 shows the compressive and tensile strength of the concrete, and Table 2-3 shows the reinforcing and the corrugated steel properties.

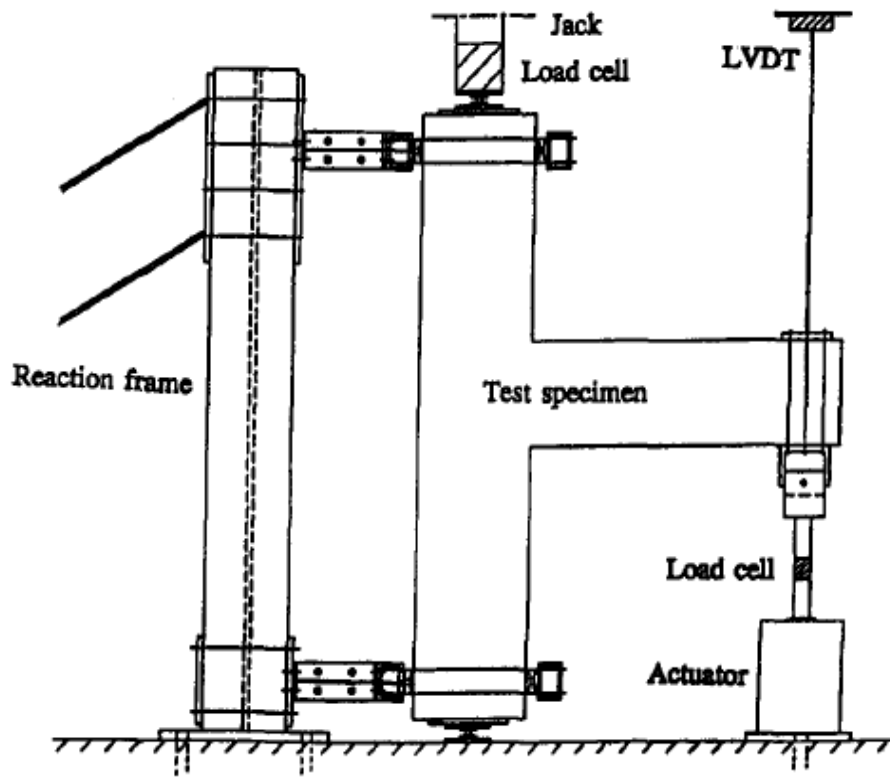
Figure 2-10 Test Setup, Biddah, A. et al. (1997)

The general set-up of the test is shown in Figure 2-10. A constant axial load of 505 KN was applied to the column to simulate the gravity load, whereas the cyclic load was applied on the free end of the beam. After testing all specimens, the specimens representing the existing joints performed poorly under the cyclic load. The final failure mode was brittle at the joint. On the other hand, the joint that was designed according to CSA A23.3-94 exhibited considerable improvement in joint behavior, and the plastic hinge was formed within the beam section. Moreover, the energy dissipation of the

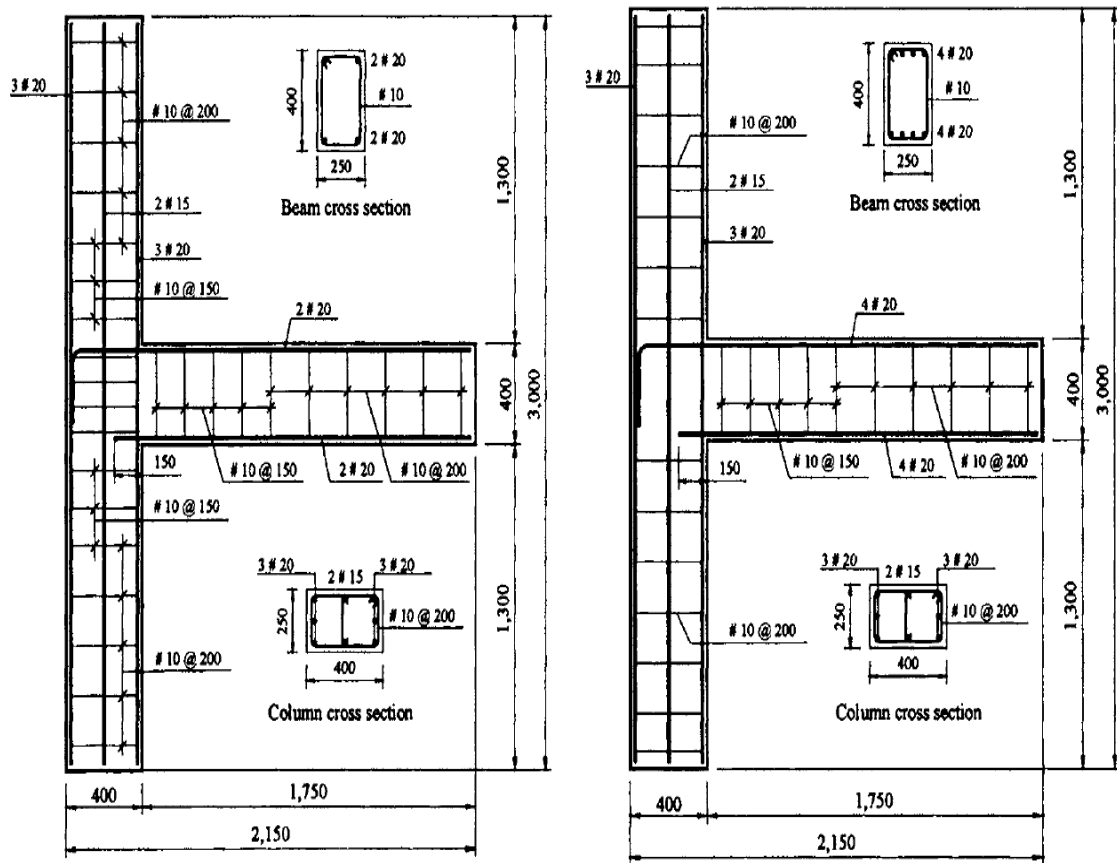
Figure 2-14 The Dimensions and Reinforcement Details of the Specimens, Ghobarah, A. et al. (2005)

Ghobarah, A. et al. (2005) tested six full-scale specimens representing the external beam-column joints designed according to the pre-1970 codes. The specimen shape and reinforcement details is shown in Figure 2-14, where three of the specimens represent the anchorage deficient joints and the rest of the specimens represent both the shear and the anchorage deficient joints. In Figure 2-14 all dimensions are in mm.

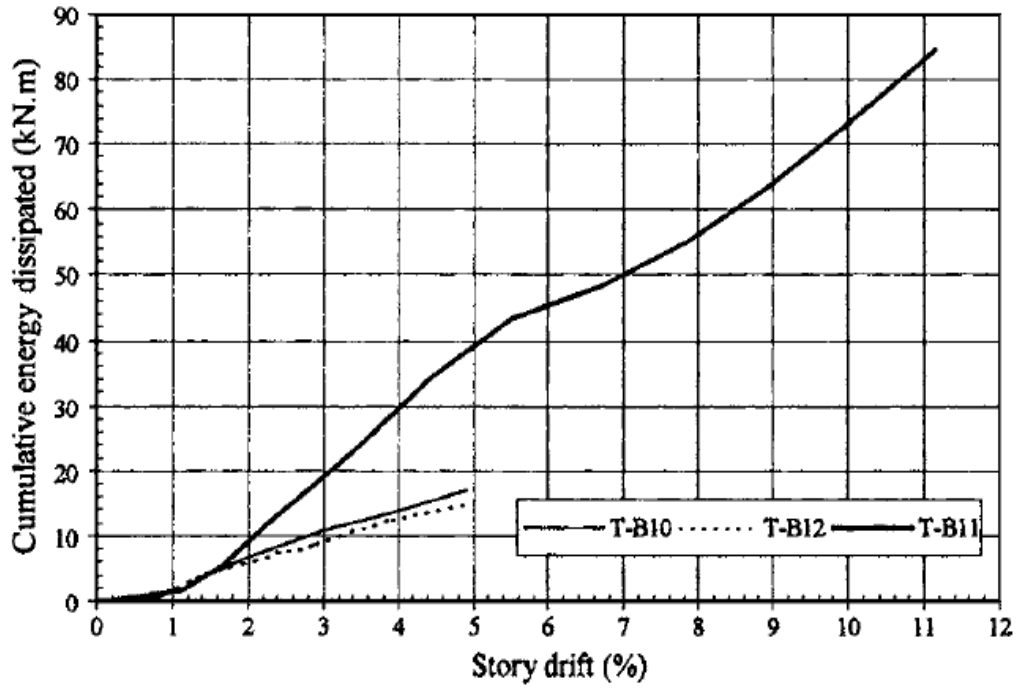
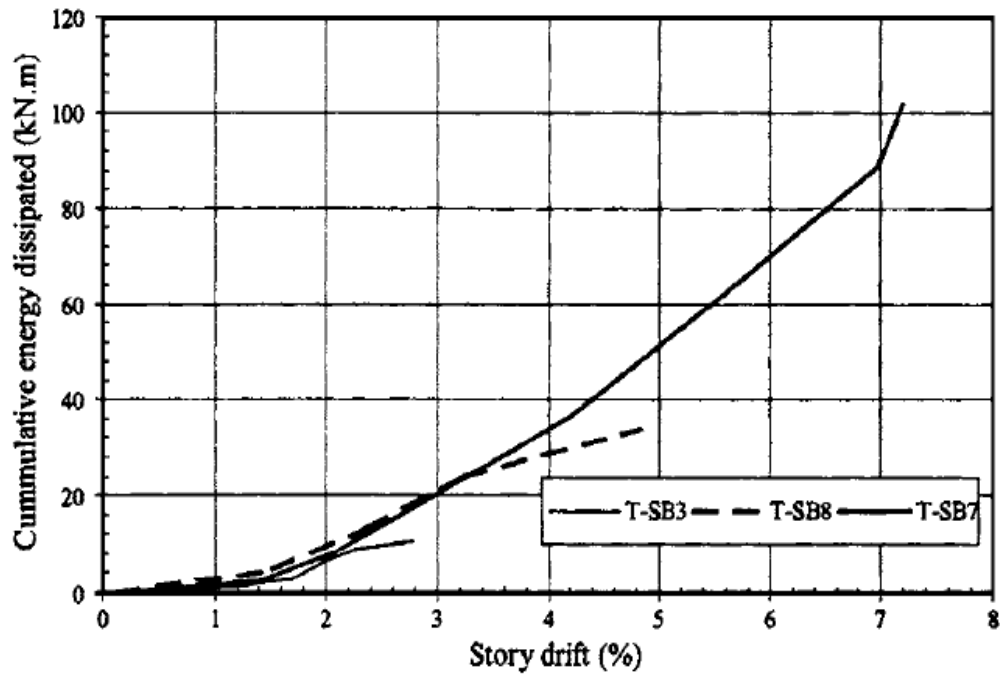
Figure 2-16 Cumulative Energy Dissipation, Ghobarah, A. et al. (2005)

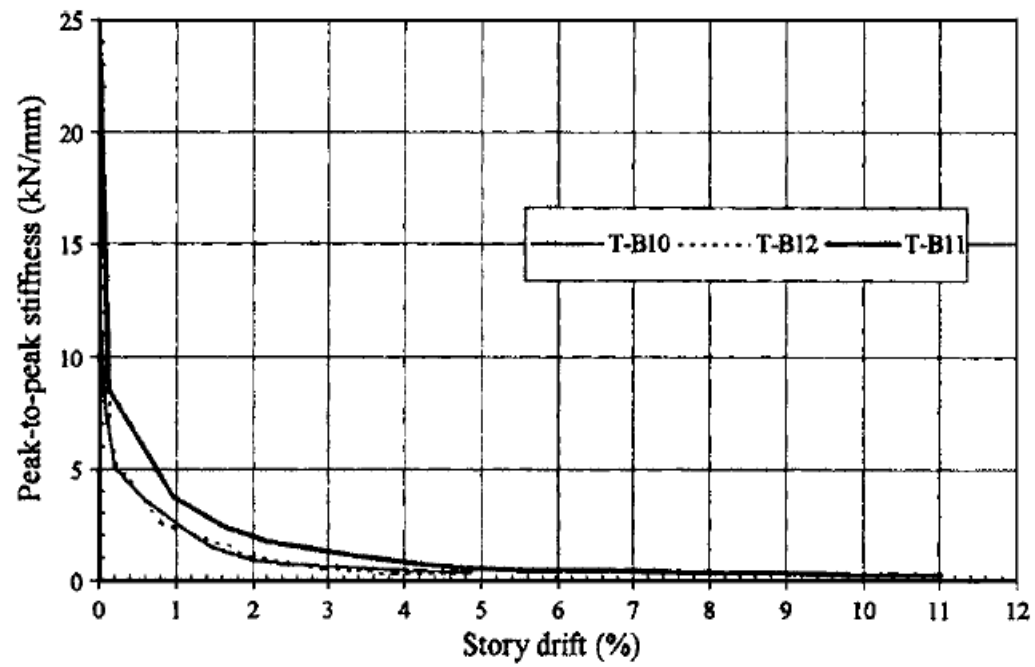
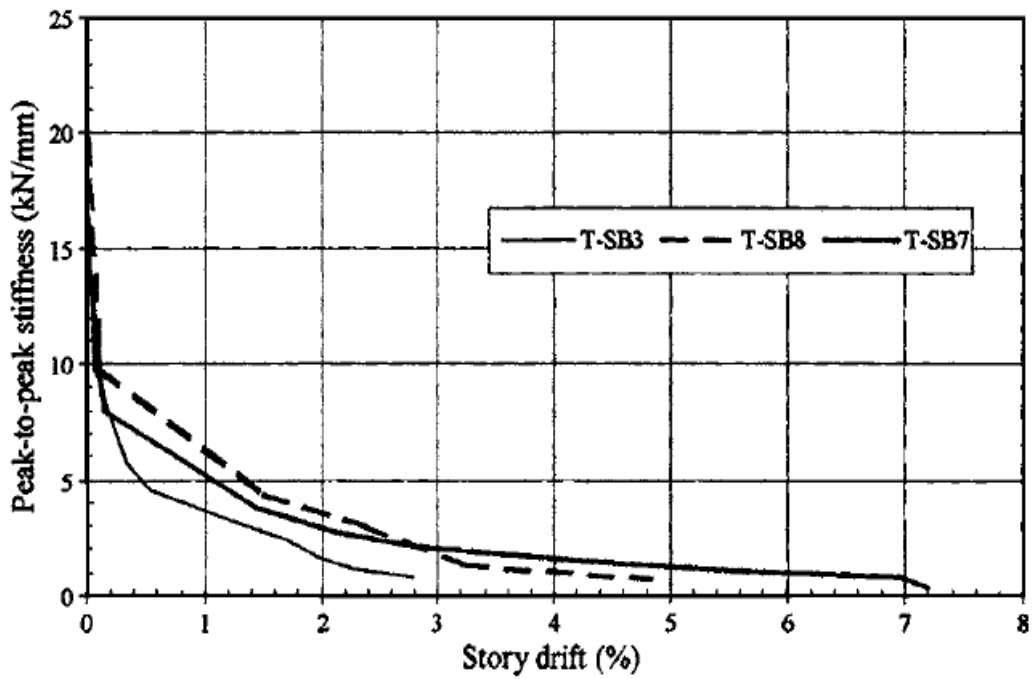
Figure 2-17 Stiffness Degradation, Ghobarah, A. et al. (2005)

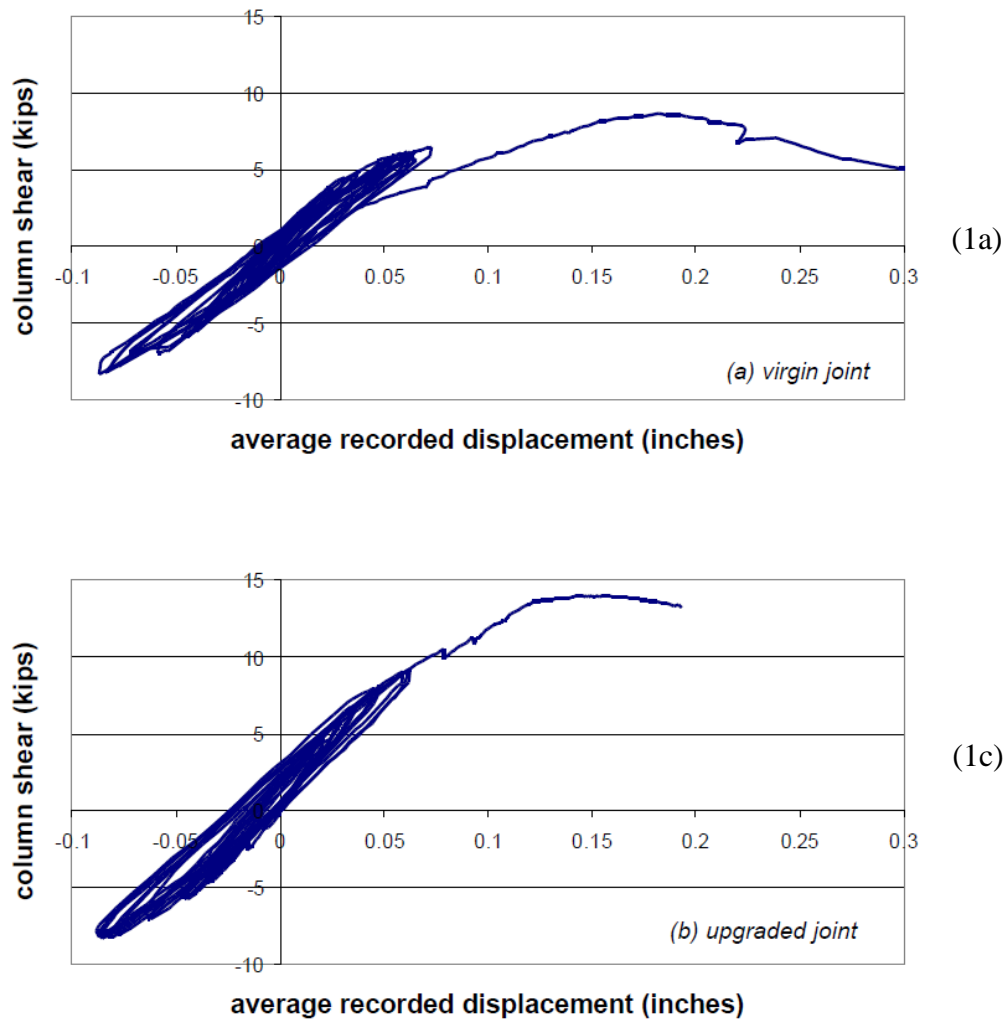
Figure 2-20 Compression between (1a and 1c) Specimens, Prota, A. et al. (2000)

It was confirmed by this experimental study that the combined action of FRP jacketing and NSM rods was a successful technique to retrofit the connections in gravity load designed (GLD) buildings. The retrofitting techniques could be adopted in more than one way to get the desirable failure mode. Figure 2-20 shows the increase of column strength between the control specimen (1a) and the retrofired specimen (1c). The ultimate column shear strength (1c) increased 1.6% compared to the control specimen (1a).

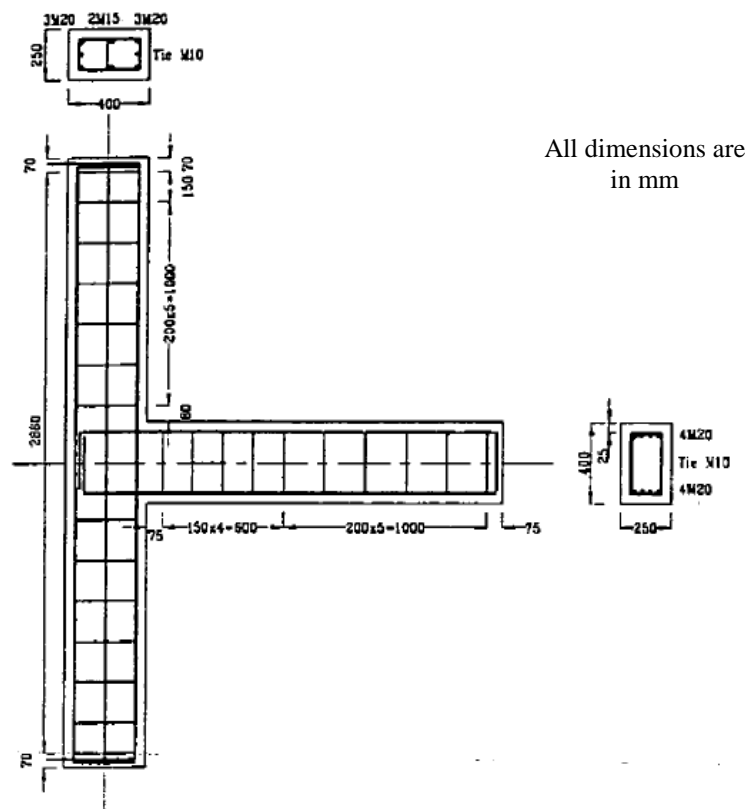
Figure 2-21 The Reinforcement Bar Details and The Dimensions

Ghobarah, A. et al. (2001) used the Glass Fiber Reinforced Polymer (GFRP) laminates as a retrofitting material to retrofit the external beam-column joint. One specimen in full scale was constructed in the experimental work with no shear reinforcement within the joint region. It was expected that the joint would fail before the plastic hinge formation. The reinforcement bar details and the dimensions of this specimen are shown in Figure 2-21. The compressive strength of the concrete was 30.8 Mpa¹ and the yield strength of the reinforcement bars was (454 and 425 Mpa) for M10 and M20² bars, respectively.

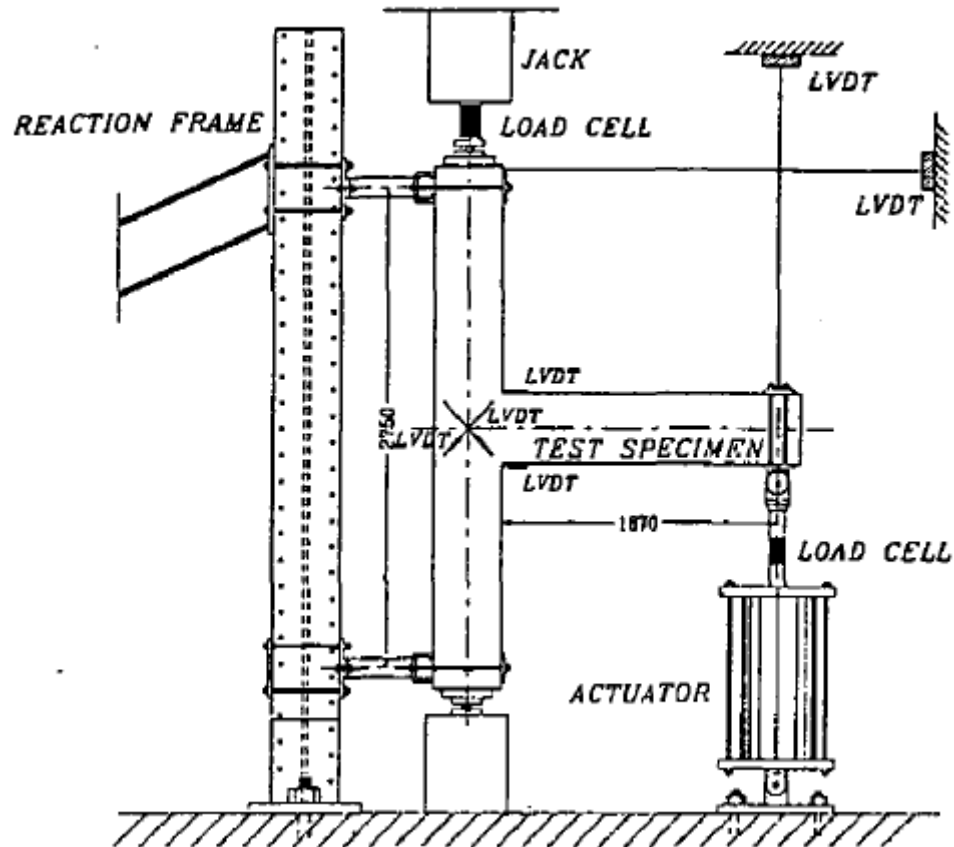
Figure 2-22 The Test Setup and the Instrumentation (Ghobarah, A. (2001))

named T1R. Both the control and retrofitting specimens were tested in the vertical position, where the axial load represented $0.2 A_g f'_c$ applied to the column and the cyclic load applied at the free end of the beam. Figure 2-22 shows the test setup and the instrumentation.

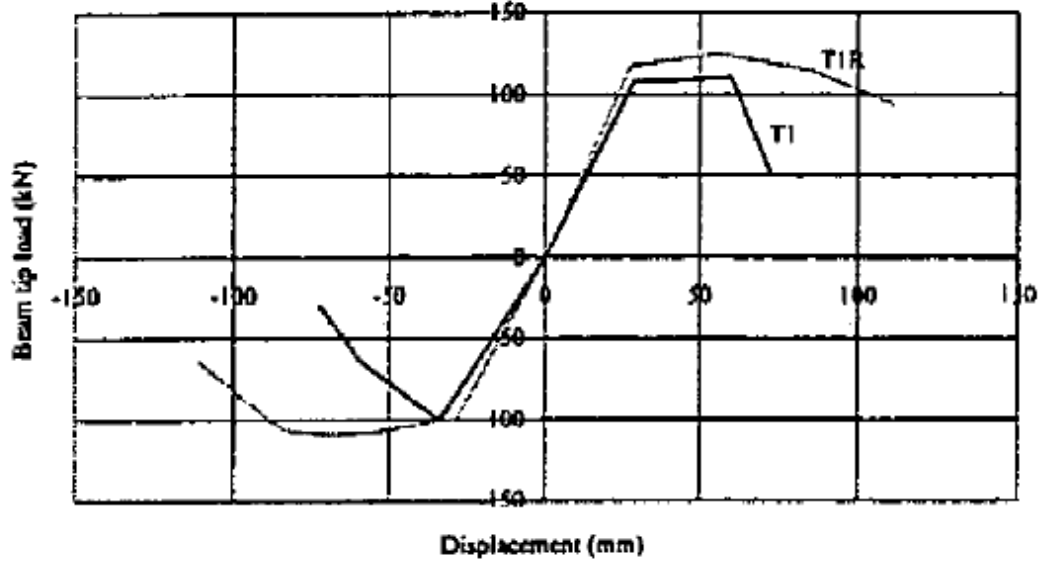
Figure 2-23 Envelopes of the Beam Tip Load-Displacement Curves, (Ghobarah, A. 2001)

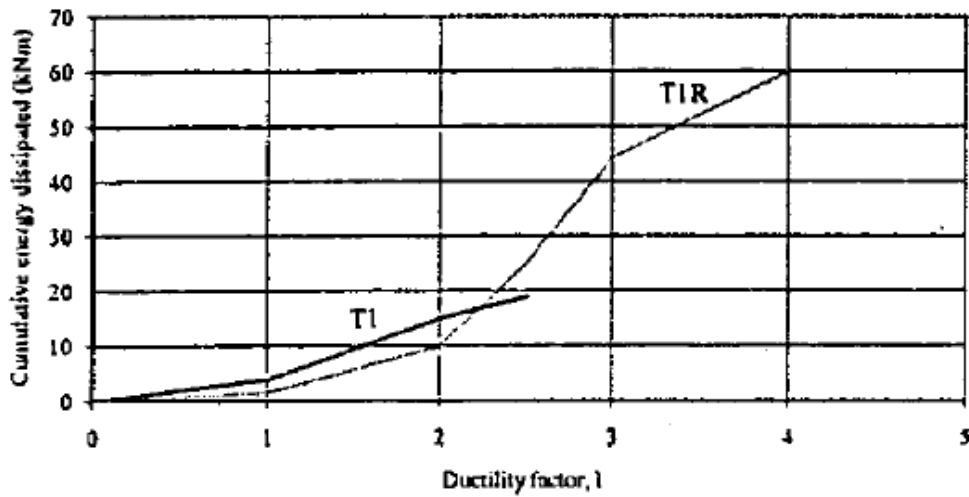
Figure 2-24 Energy Cumulative- Ductility Factor for Specimens (T1 and TR1), (Ghobarah, A. 2001)

the energy dissipation, the repaired specimen T1R showed improvement compared to the un-retrofitted specimen T1. Figure 2-24 shows the energy dissipation of two specimens.

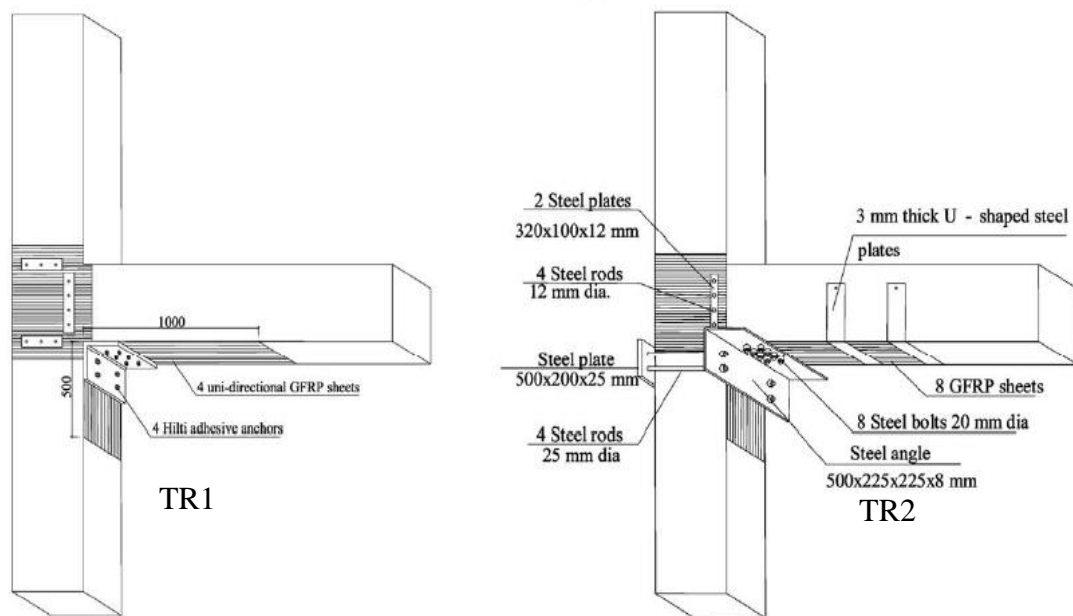
Figure 2-26 The Proposed Technique to Strengthen the Specimens

TR1 was a damaged specimen. After testing specimen T0, the cracked concrete was removed from the joint region and the adjoining members. The specimen was laid inside the wooden form again and new concrete was poured to replace the removed materials. The specimen was retrofitted and tested again as TR1, whereas TR2 was the undamaged specimen which was already retrofitted and tested. The proposed technique to retrofit these specimens by using the Glass Fiber Reinforced Polymer (GFRP) sheets is shown in Figure 2-26, and the properties of the fiber sheets given by the manufacturer are given in Table 2-9. Two layers were used to confine the joint. The first layer was a bi-directional sheet, and the second layer was a unidirectional sheet.

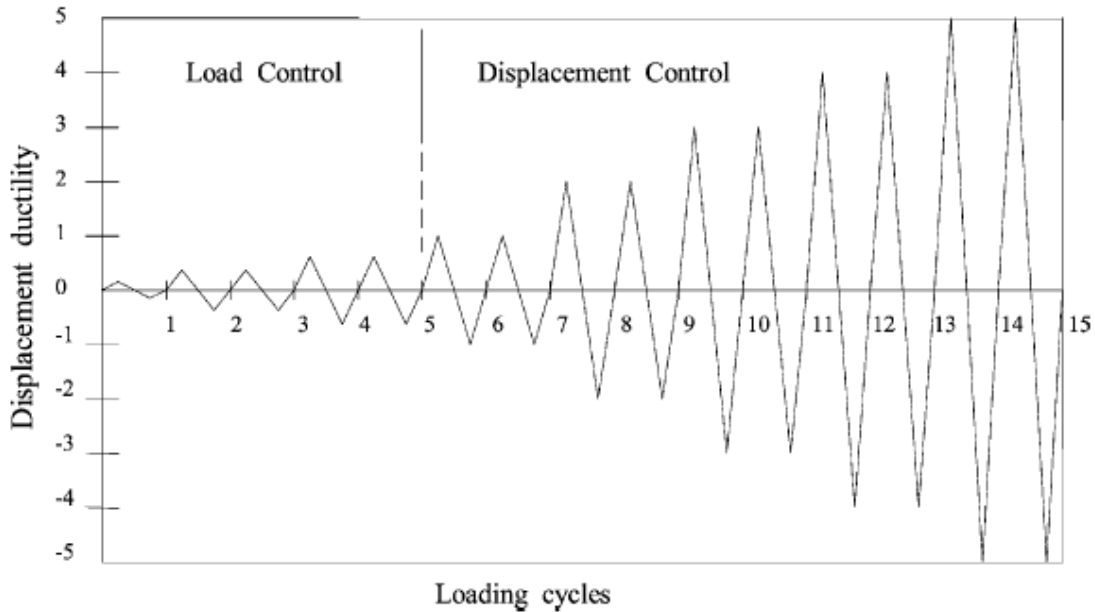
Figure 2-27 Load Routing, El-Amoury, T. et al. (2001)

The load sequence that used in this test consisted of two phases as shown in the Figure 2-27. Figure 2-28 shows the general test setup in this experimental work. The specimens were tested in the vertical position, where the specimen was pinned at the end of columns. An axial load was applied to the top of the column and this load was constant and equal to $0.2A_g f'_c$. At the free end of the beam, the static cyclic load was applied and required data were recorded.

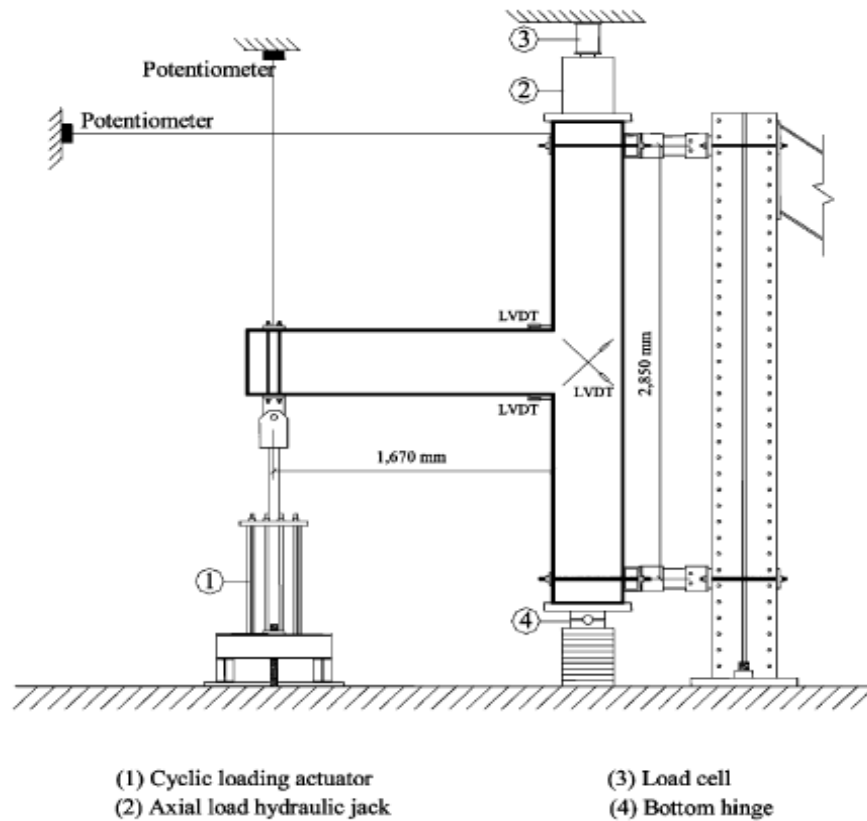
Figure 2-28 Apparatus Details for Testing Specimen (El-Amoury, T. et al. (2001))

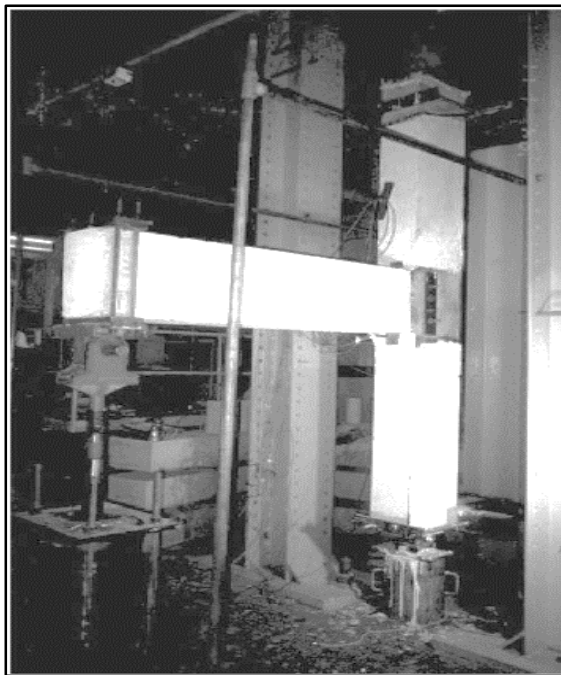
Figure 2-31 Test Setup for Specimen TR1 (Ghobarah, A. 2002)

All of the specimens were tested in the vertical position as shown in Figure 2-31 where the vertical load was applied directly to the column, while the cyclic load was applied at the free end of the beam.

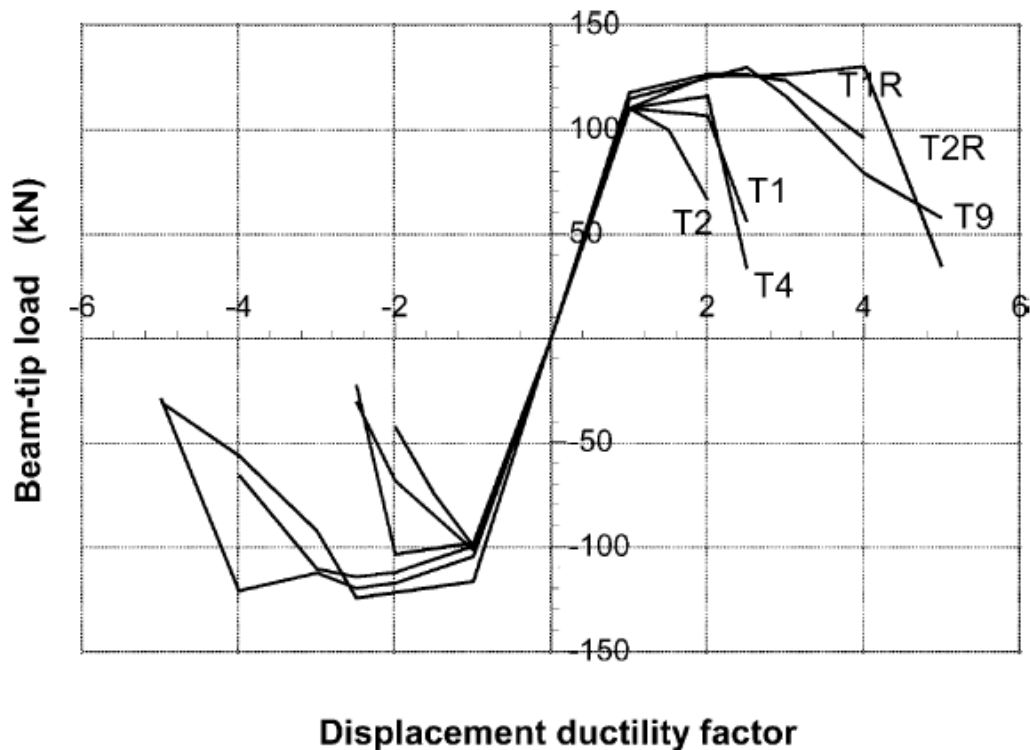
Figure 2-32 Envelop of the Hysteretic Loops, Ghobarah, A. (2002)

Figures 2-32 and 2-33 show the results of this experiment, where the retrofitting technique by using Glass Fiber Reinforced Polymer (GFRP) as a jacket to the beam-column joint successfully improved the behavior of the joints, and moved the failure from the joint region to the beam as shown in Figure 2-34. This gave the plastic hinge opportunity to form in the beam, thereby increasing the shear strength of the joint and providing the confinement of the column. The only issue in the experimental test was the bulging of the GFRP sheets because this effect allowed cracks to form under the fiber sheets. The control specimens T1 and T2 that were tested under two different axial loads exhibited exactly the same kind of the shear failure at the joint at a relatively low ductility factor comparing to retrofitted specimens.

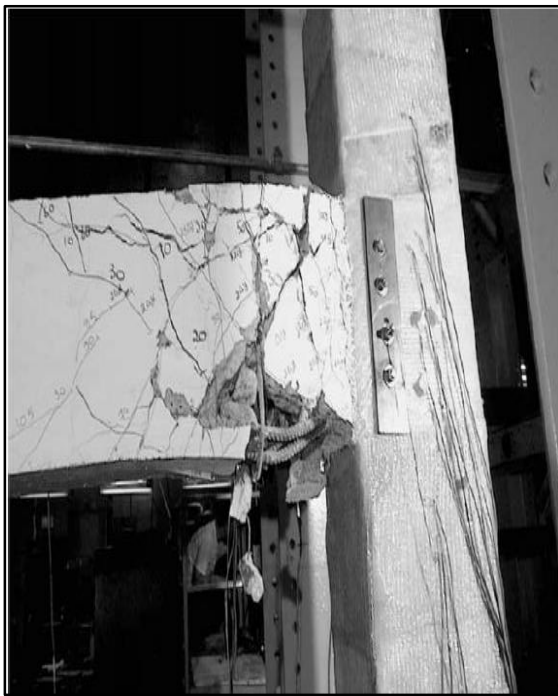
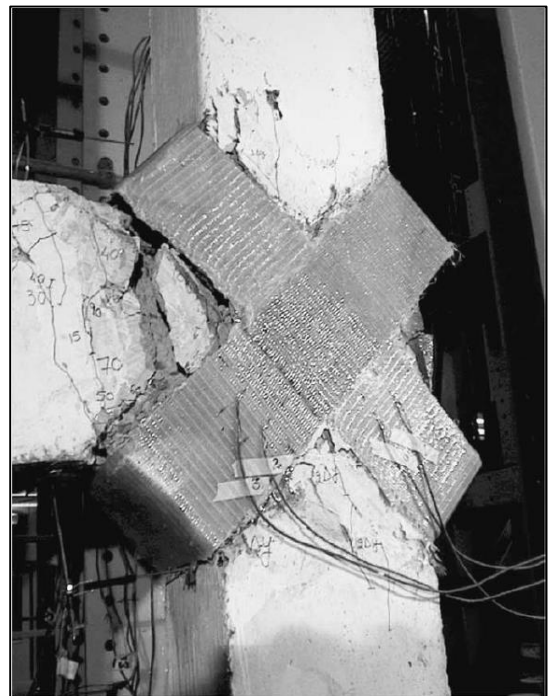
Failure Mode of Joint T2R

Failure Mode of Joint T9

Figure 2-34 Failure Modes of Specimens, Ghobarah, A. (2002)

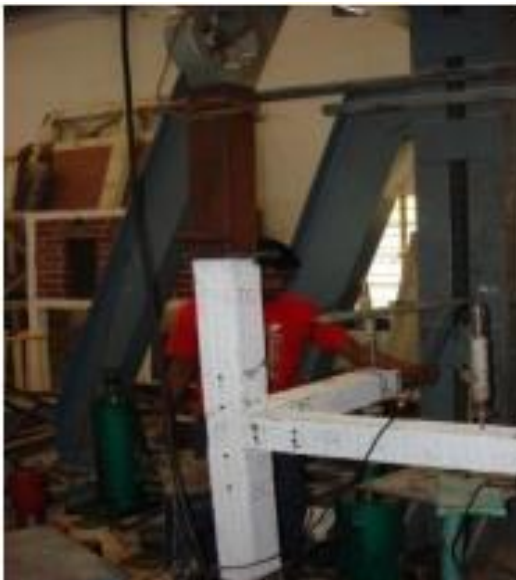
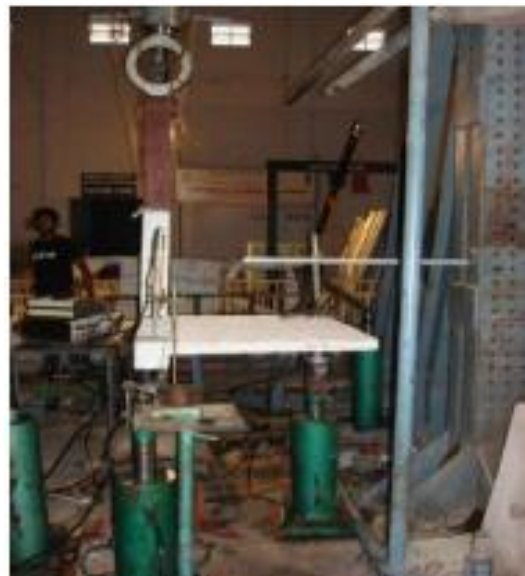
Specimen BCJ

Specimen BCJS

Figure 2-35 Test Specimens with and without the Slab (Revathi R., 2014)

The general shape of each specimen was comprised of column and two beams. The first beam connected to the joint at the north side and the second beam connected with the joint from east side as shown in Figure 2-35. The beam and column section dimensions were 100×100 mm, and the slab thickness was 40 mm.

Figure 2-35 also shows the test setup of these specimens, where the column was pinned at both ends. The specimens were subjected to an axial load equal to 50 KN, and the cyclic loads were applied to the free ends of the beams. The load versus displacement, the energy dissipation, and the crack pattern were checked during the test. All resulting data showed that the slab presence improved the behavior of the corner beam-column joint. Based on the acquired test results shown in Figures 2-36 until 2-38 and Tables 2-12 and 2-13, Revathi, R. recommended that the slab effects on the behavior of the concrete beam-column joints should be considered and included in the Indian Standards.

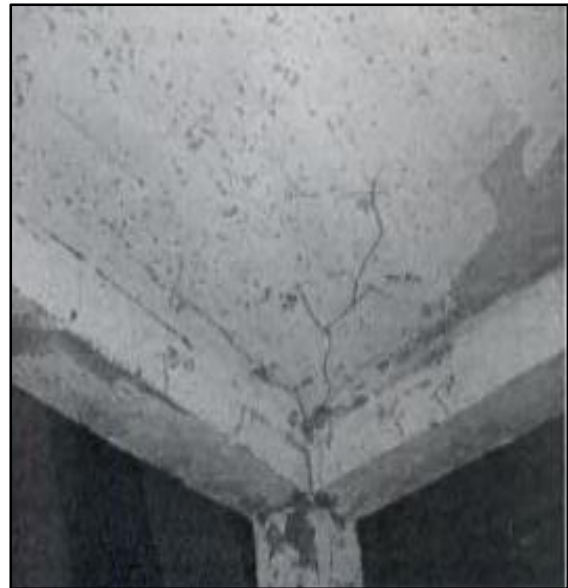
b- Beam-Column Joint with Slab

Figure 2-38 Cracks Patterns of the Specimens

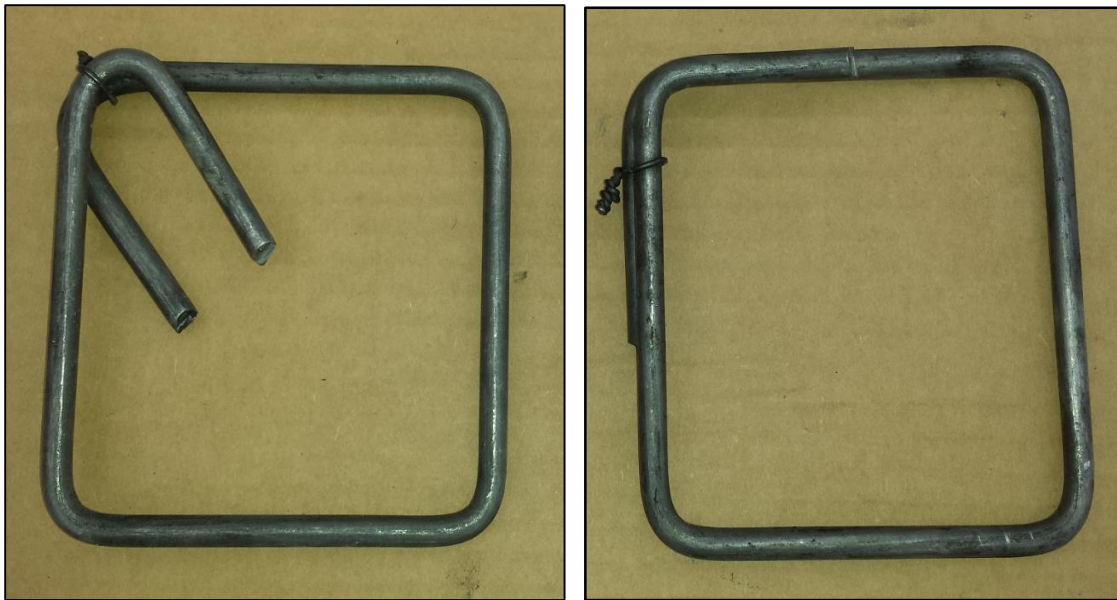
Figure 3-5 The Difference between Shear Reinforcement in Seismic and Non-Seismic Specimens

Figures 3-7 to 3-10 show the reinforcement details of all specimens that had been designed and tested throughout this experimental work. The longitudinal reinforcement bars in all specimens were the same, and the differences between the specimens were represented by the spacing between the transverse reinforcement bars and the stirrup's end hook details. In the non-seismic specimens, the space between the ties in the column was 5 in., and the space between the stirrups in the beam was 2.5 in. In seismic specimen, the space between the ties in the column within the confinement length was 1.3 in. and 3 in. out the confinement length. The space between the stirrups in the beam within the confinement length (hinge zone) was 1.3 in. and 2.5 in. outside of the confinement length. Figure 3-5 shows the details of shear reinforcement in seismic and non-seismic specimens where the length of hooked ends was equal to $6d_b$.

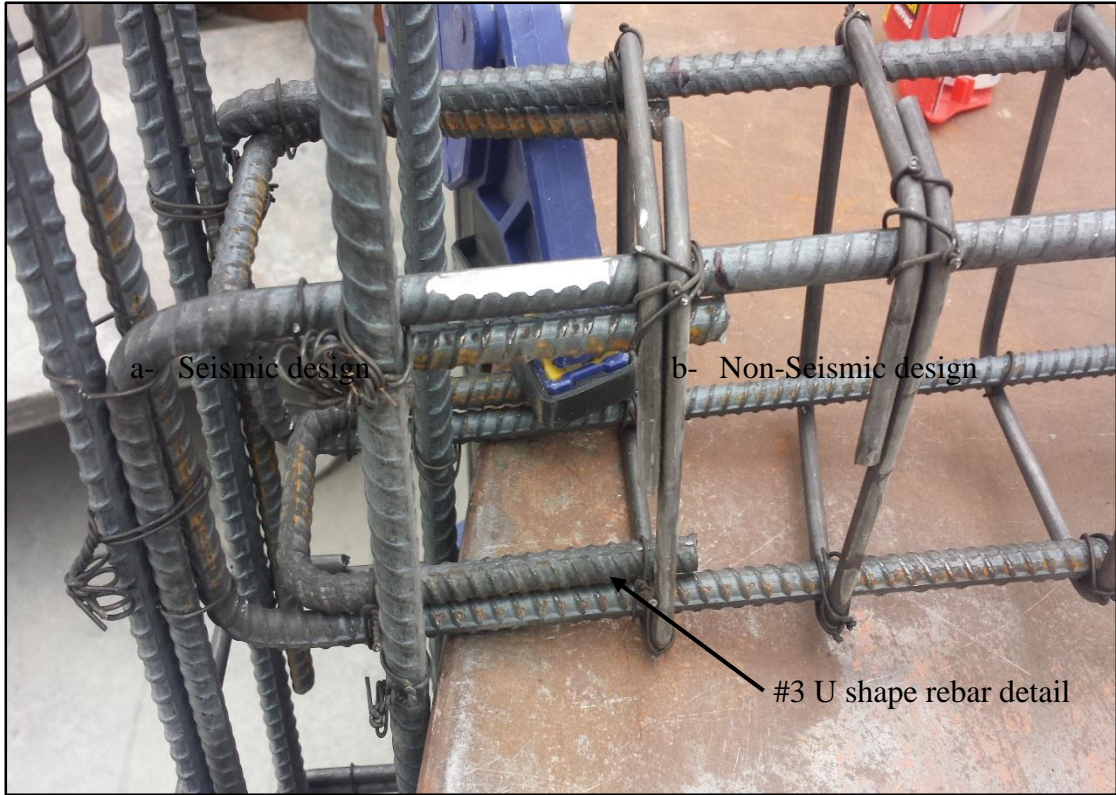
Figure 3-6 “U” Shape Rebar Detail

In order to avoid unexpected failure by lack of development length, a special “U” shape #3 rebar was used at the end of the longitudinal beam rebar to insure that this bar would develop the tensile strength as shown in the Figure 3-6.

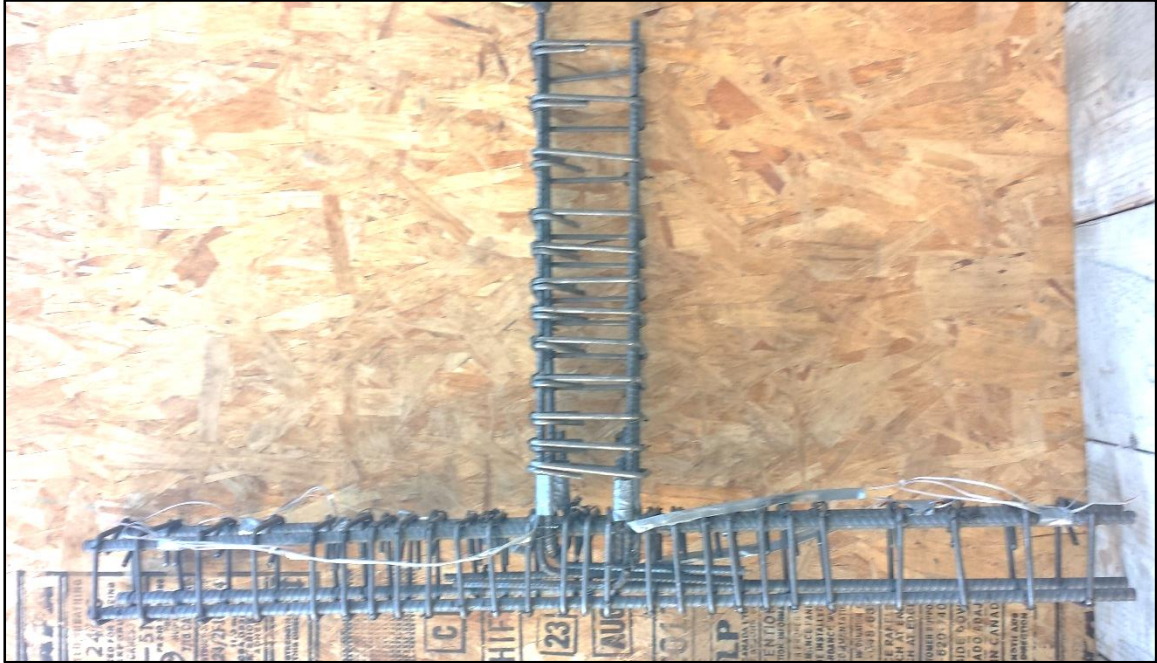
Figure 3-9 Reinforcement Cage of Specimen J1
