Cyclic Loading Behavior of CFRP-Wrapped Non-Ductile Reinforced Concrete Beam-Column Joints

Ali S. H. Zerkane
Portland State University

A thesis submitted in partial fulfillment of the
requirements for the degree of

Master of Science
in
Civil and Environmental Engineering

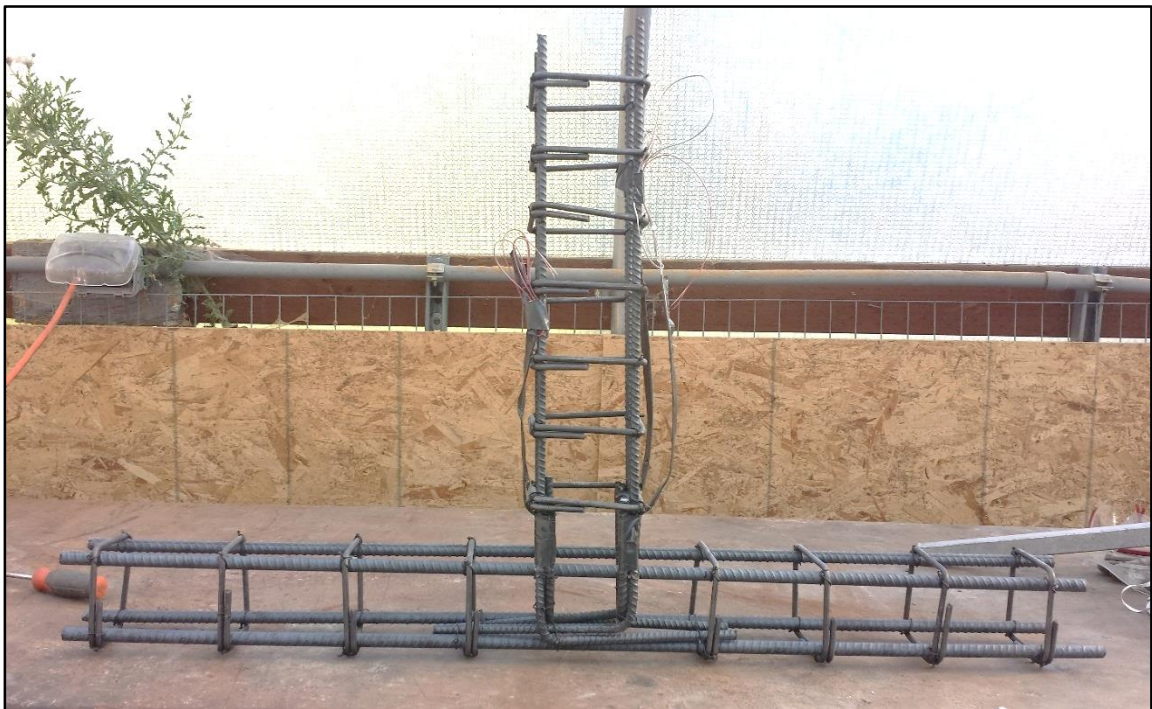
Figure 3-10 Reinforcement Cage of Specimen J2

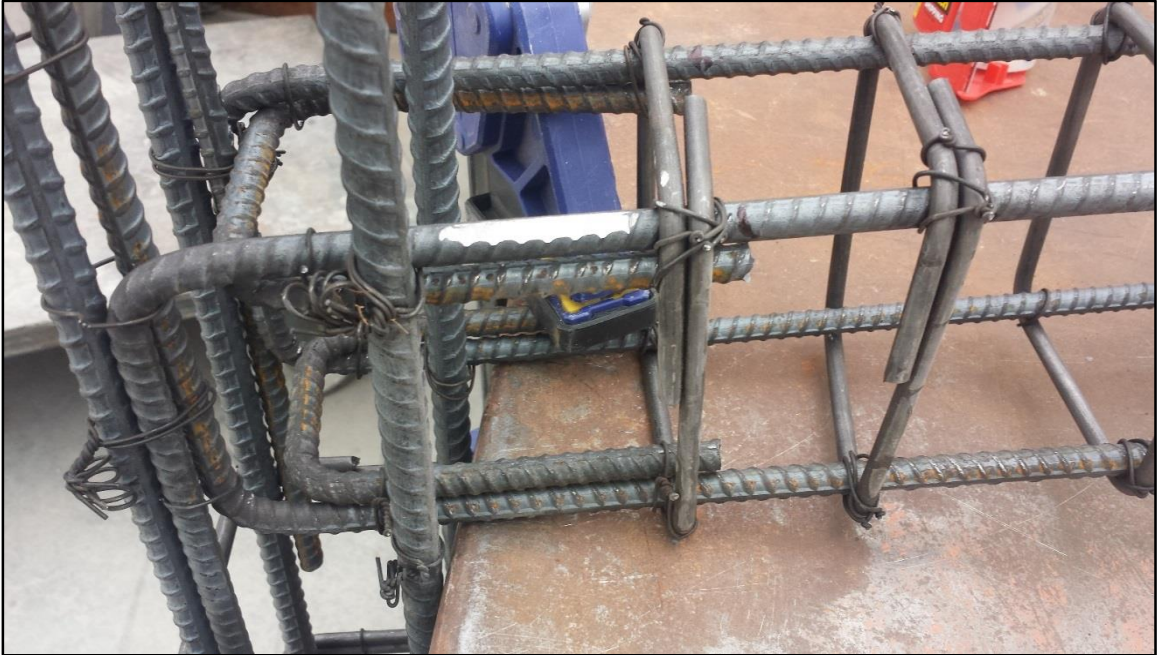
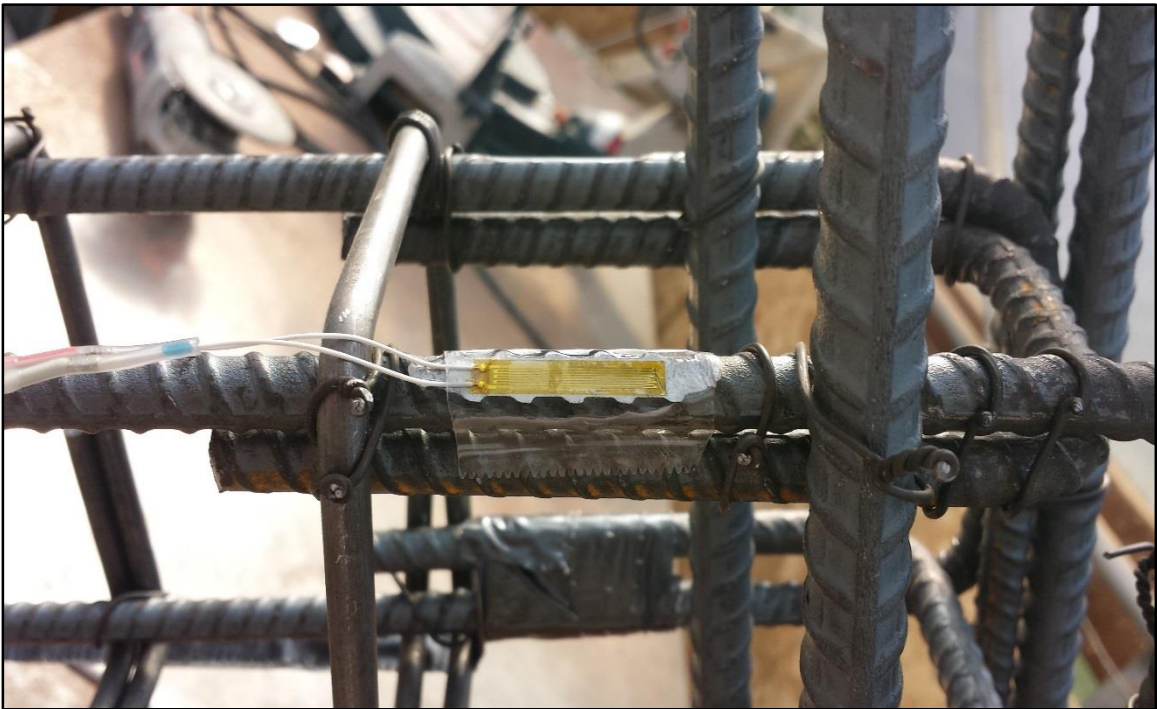
a- Surface Preparation

b- Strain Attachment

Figure 3-11 Strain Gage Installation

When the reinforcement cages were ready, for the control specimens J1 and J2, four steel strain gages were attached to the beam longitudinal reinforcement of each one. The strain gage types “KFH-20-120-C1-11L1M2R” were purchased from Omega Engineering, Inc. The properties of these strain gages as provided by the company are shown in Table 3-5. Steel bar surface preparation was done by using a manual grinder and sand paper to ensure that the proper bonding of the strain gage was done perfectly. Epoxy glue was used to attach the strain gages to the steel bars, then duct tape was used to wrap both the strain gages and bars to protect them. A voltmeter was used to check these strain gages regularly to detect any potential problem before the casting of the concrete. There were six steel strain gages in each of retrofitted specimens. Four steel strain gages were attached to the beam longitudinal reinforcement, and the other two gages were attached directly to the Carbon Fiber Reinforced Polymer (CFRP) sheets (one on each side of the joint) in order to measure the CFRP strain up to the failure. Figures 3-11 and 3-12 show strain gage locations, preparation and attaching.

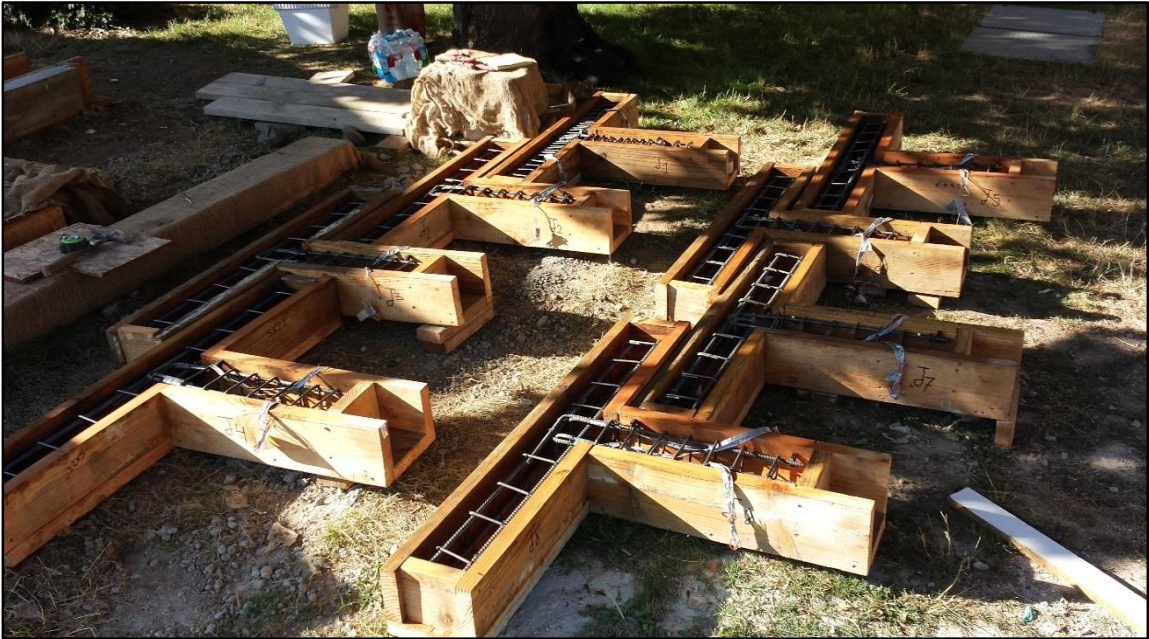
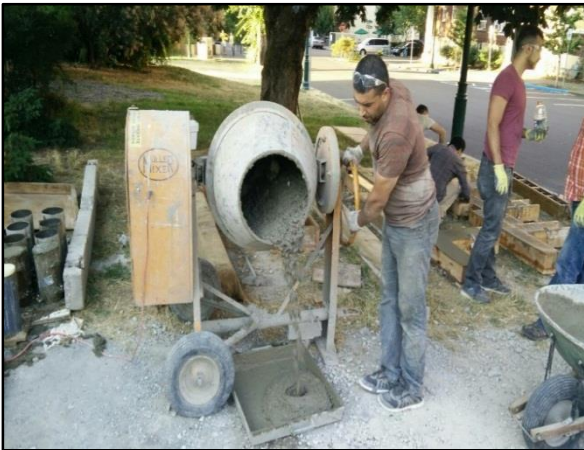
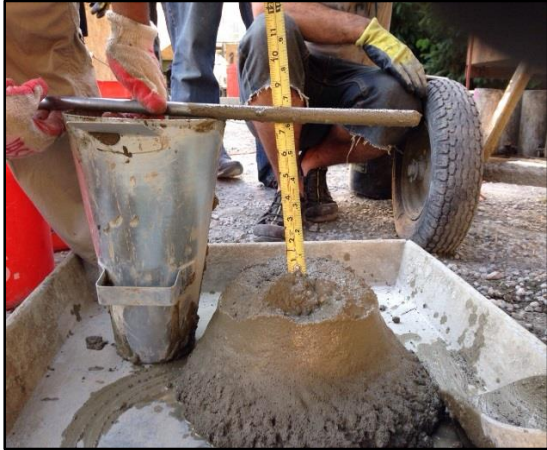
a- Preparing the molds for casting

b- Mixing

c- Slump test

Figure 3-14 Concrete Mixing Steps

When the wood molds were ready, the reinforcement cages were placed inside of the molds. All of the molds were then placed in the front yard of the lab on the ground as shown in Figure 3-14. A concrete mixer of 2.25 ft³ capacity available in the South Greenhouse Lab was used. The interior surface of the mixer was cleaned and moistened before placing the materials inside. While the mixer was running, half of the coarse aggregates were put in, and then the water was added to the aggregate. After 30 seconds,

the cement was added to the mixture followed by half of the sand amount. One and a half minutes later, the rest of the coarse aggregate was added and same procedure was repeated. After all of the materials were put into the mixer, it took about three minutes for the mixture to be ready for slump test, which was done in order to check the workability of the mixture before casting the concrete in molds. The desired slump was 7-8 in., which was achieved by the mixtures.

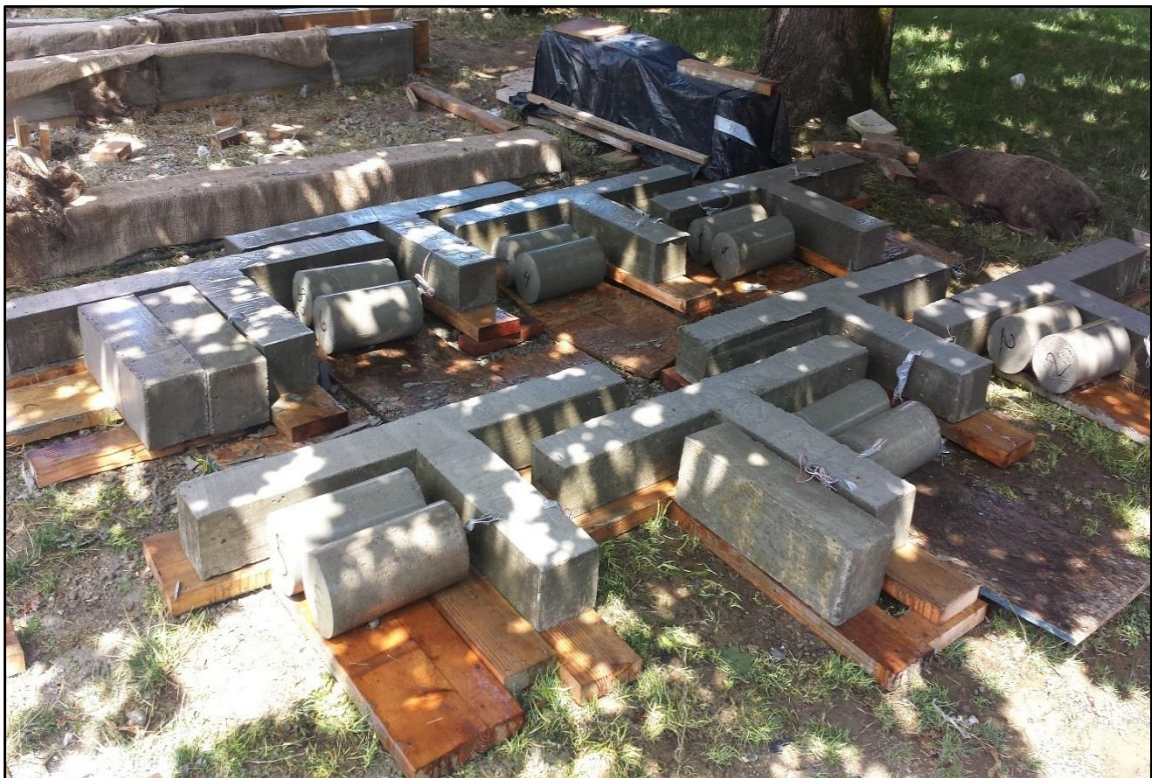
Figure 3-15 Curing Condition of Specimens

The temperature was 99 F° at casting time and the humidity was 55%. Right after casting the specimens and cylinders, three layers of natural burlap and one layer of plastic sheets were used to cover all specimens in order to keep the moisture as long as possible. After five days, the wood molds were removed and all of the cylinders and flexural samples were placed beside the specimens to subject them to the same weather conditions as shown in Figure 3-15. Tap water was used to spray the specimens twice a day. This process continued up to first month age of specimens then the curing depended on the humidity of the atmosphere where all of the specimens and cylinders were placed inside the Greenhouse Lab.

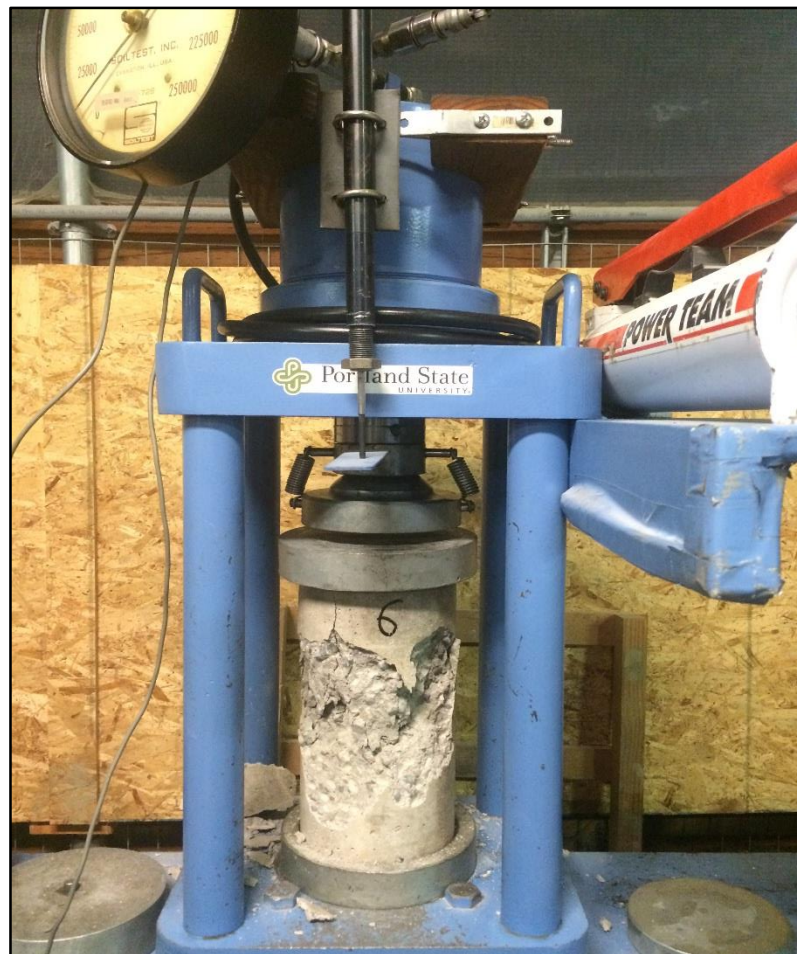
Figure 3-16 Compressive Testing Machine

The compressive strength of concrete was carried out in accordance with ASTM-C39 using 6×12 in. concrete cylinders loaded uniaxial by a compressive strength machine as shown in Figure 3-16. This was available at South Greenhouse Lab where the maximum compressive capacity of the machine is 250 kips. For each specimen, one cylinder was tested on the same day of the test. The results are given in Table 3-7.

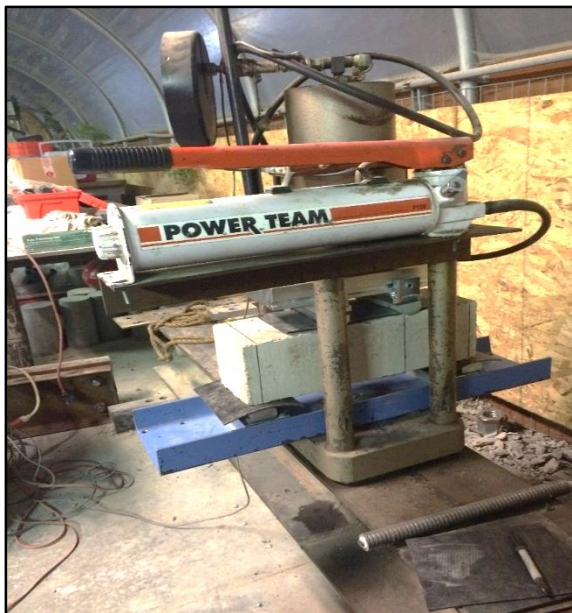
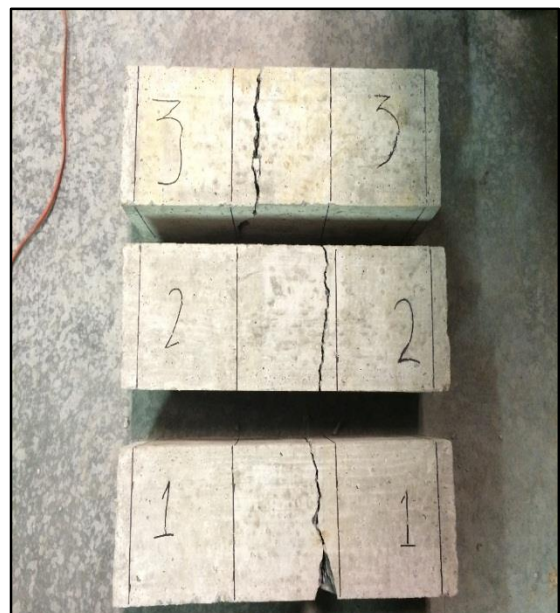
a- Test Setup

b- Failure Modes

Figure 3-17 Modulus of Rupture Test

Flexural strength (modulus of rupture) tests were carried out on three normal concrete specimens in accordance with ASTM- C 78. These specimens were casted and cured under the same conditions as the main specimens at the Greenhouse Lab and were tested after 42 days. The flexural strength tests are made on 6×6×18 in. simple beam specimens loaded at third points. The experimental results are shown in Table 3-8 where all of the failures occurred within the middle third of span length of the beams as shown in Figure 3-17. Moreover, Table 3-8 also shows the comparison between the experimental and theoretical results. The theoretical calculations were done by using the ACI 318 equation:

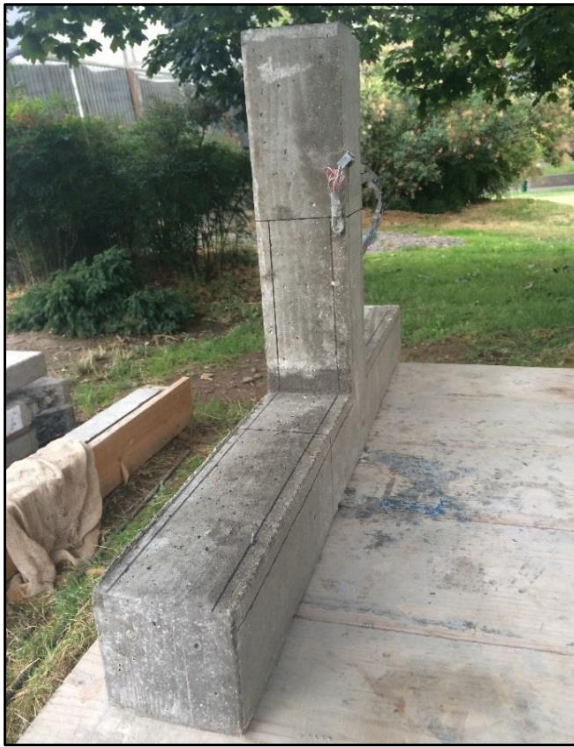
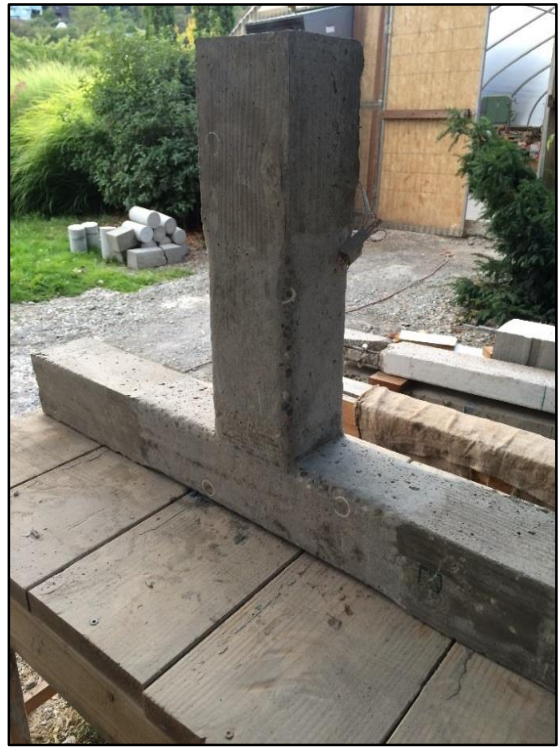
a- Before the grinding

b- After the grinding

Figure 3-21 The Concrete Surface Preparations of the Specimens

Four of the non-seismic specimens were strengthened by using CFRP sheets, where the sheets were attached to the specimens by a special epoxy recommended by the manufacturer. In order to achieve the best bond between the concrete surface and the CFRP sheet, a special preparation of the concrete surface was needed. The concrete surface preparation was done by using a manual grinder. The concrete surface was roughened, as shown in the Figure 3-21, in order to gain the highest adhesion between the

concrete and the CFRP sheets. The sharp corners of the column were rounded to a 0.75 in. radius by using a grinder to avoid any unnecessary fractures in the sheets caused by the sharp corners as shown in the same figure. When the grinding was done, a few small holes appeared on the concrete surface, as shown in Figure 3- 22. A simple mortar consisting of 2:1 cement to sand (by volumetric ratio) was used to fill these holes.

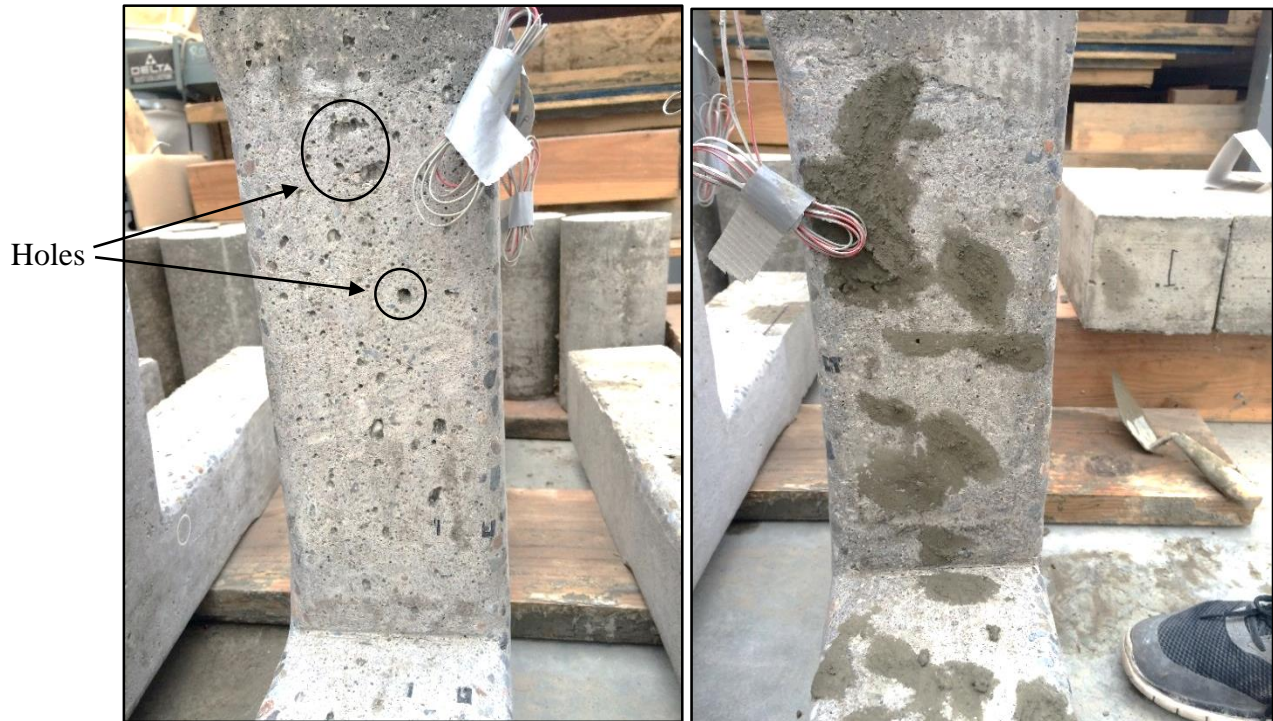
Figure 3-22 Holes on the Concrete Surface

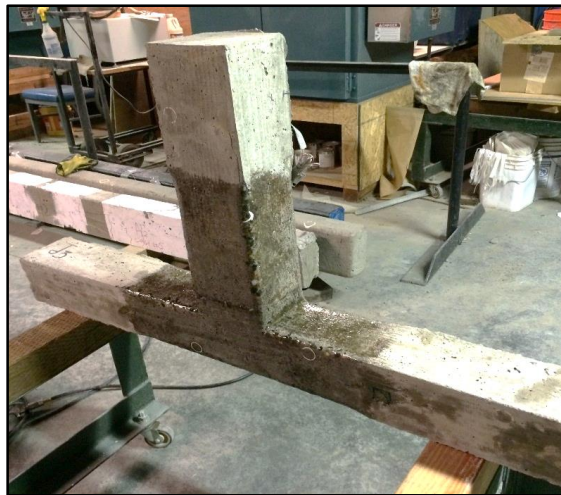
Figure 3-23 Applying the Prime Layer to the Concrete Surface

After the preparation of the concrete member was done as recommended by the manufacturer, the primer layer, which is the first layer of the MasterBrace System, was applied to the concrete member. The primer layer was applied in order to provide good adhesion between the MasterBrace System and the member, as shown in Figure 3-23.

Before the mixing process, the concrete surface was cleaned with water, and then sun-dried. On the day of application, the concrete member was cleaned by using an air compressor that was available at the Greenhouse Lab, then the MasterBrace P 3500 was applied by using a paint brush. Spray paint is not recommended with this product. The recommended curing time for this layer was twenty four hours.

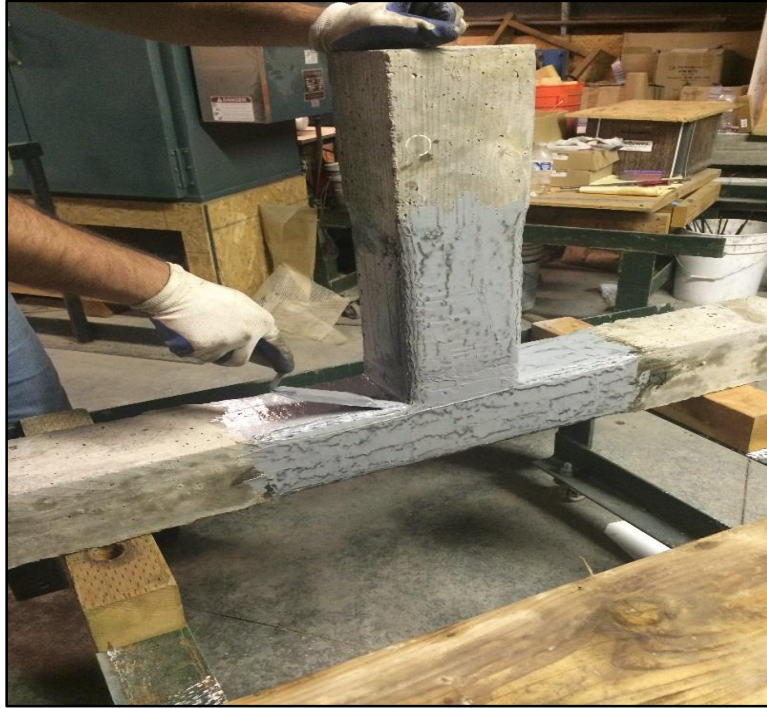
Figure 3-24 Applying the Putty Layer to the Concrete Surface

After twenty four hours, the second layer of the MasterBrace F 2000 was applied over the primer layer. The main purpose of this layer was to level out the small surface defects, and to provide a smooth surface where the MasterBrace System was attached to the specimen, as shown in Figure 3-24. The mechanical properties were provided by the manufacturer as shown in the Table 3-14. This layer also consists of two parts A and B. These parts were mixed based on the provided mix ratio of 3:1 (part A to part B) by volume or 100:30 (part A to part B) by weight. The MasterBrace F 2000 was applied by using a steel trowel. The recommended curing time for this layer was twenty four hours.

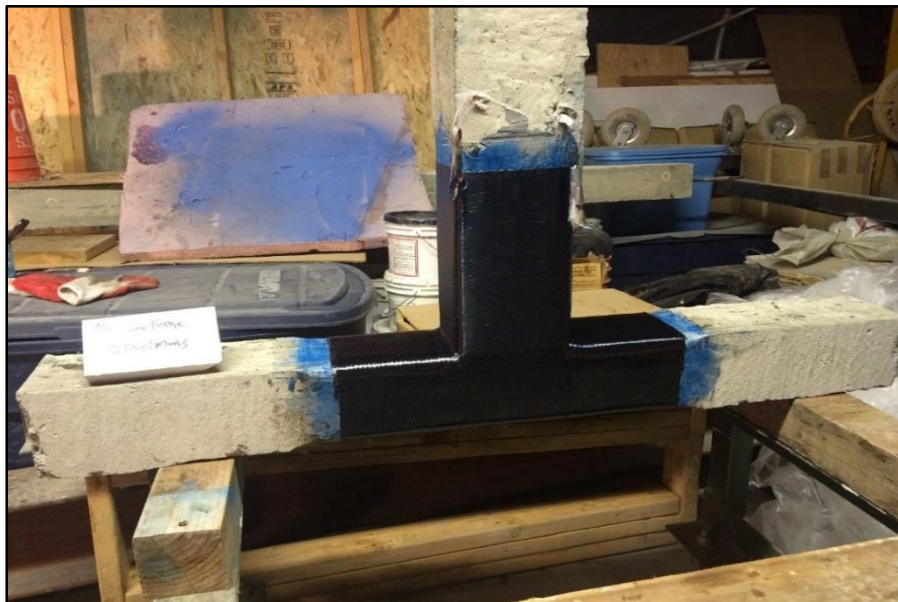
Figure 3-25 Specimen Wrapped by CFRP Sheets

The process that was used to attach the CFRP sheets for all of the retrofitted specimens was similar. After the preparation of the concrete surface, as described in the previous section, applying the CFRP sheets was the final step of this process. This step started by using the Saturant layer to paint the areas to be strengthening. After the painting these areas with MasterBrace SAT 4500, the CFRP sheets were attached to the concrete surface. A plastic roller was used to make sure that all of the CFRP sheets were attached to the concrete surface, and that the leftover epoxy bled through the CFRP fibers. The CFRP sheets were left to cure for at least seven days at room temperature. The previous procedure was followed for one layer of the Carbon Fiber Reinforced Polymer (CFRP) sheet. In order to use two layers or more, the same procedure is usually used. Figure 3-25 shows the wrapped specimen that was retrofitted and left for curing as recommended by the manufacturer.

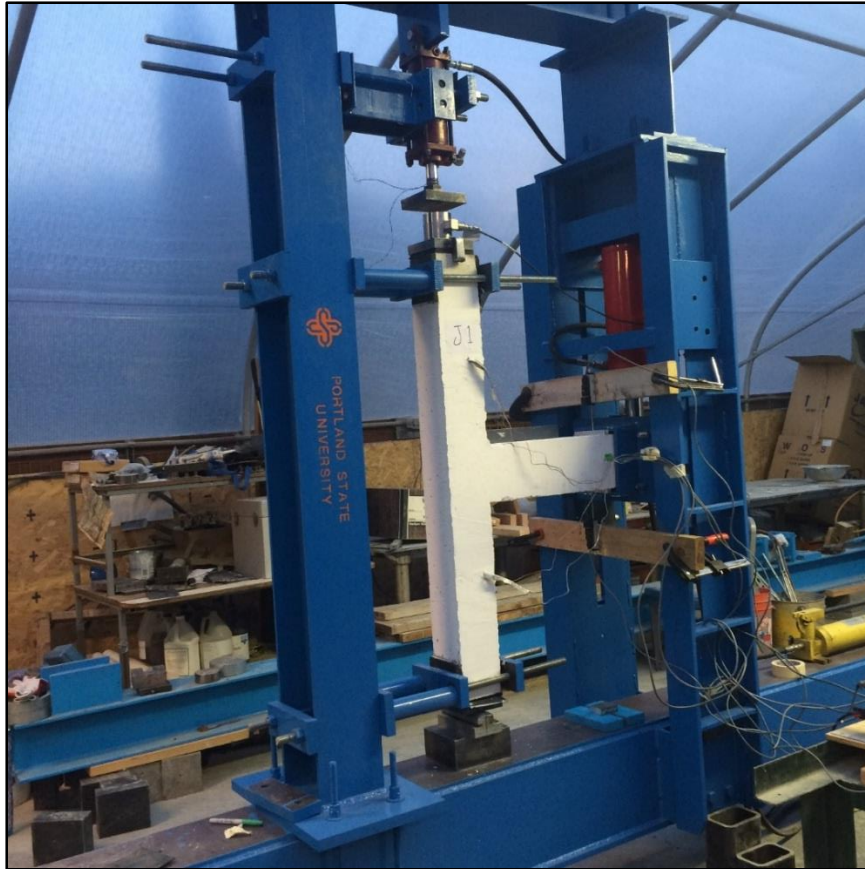
Figure 4-1 Test Setup of Joint J1

The general behavior of the seismic joint J1 which was the control specimen representing a ductile joint that designed based on the seismic provisions in the current code (ACI 318-14). As described in previous chapters, this specimen was prepared and cast at Greenhouse Lab at Portland State University and tested two and half months after casting. All specimens were tested using the Blue Frame that was first modified to have the loading system to perform the tests. Loading system was designed to simulate the type of stress that the joint would be subjected to during an earthquake. Figure 4-1 shows how the specimen was placed in the frame and set for the test.

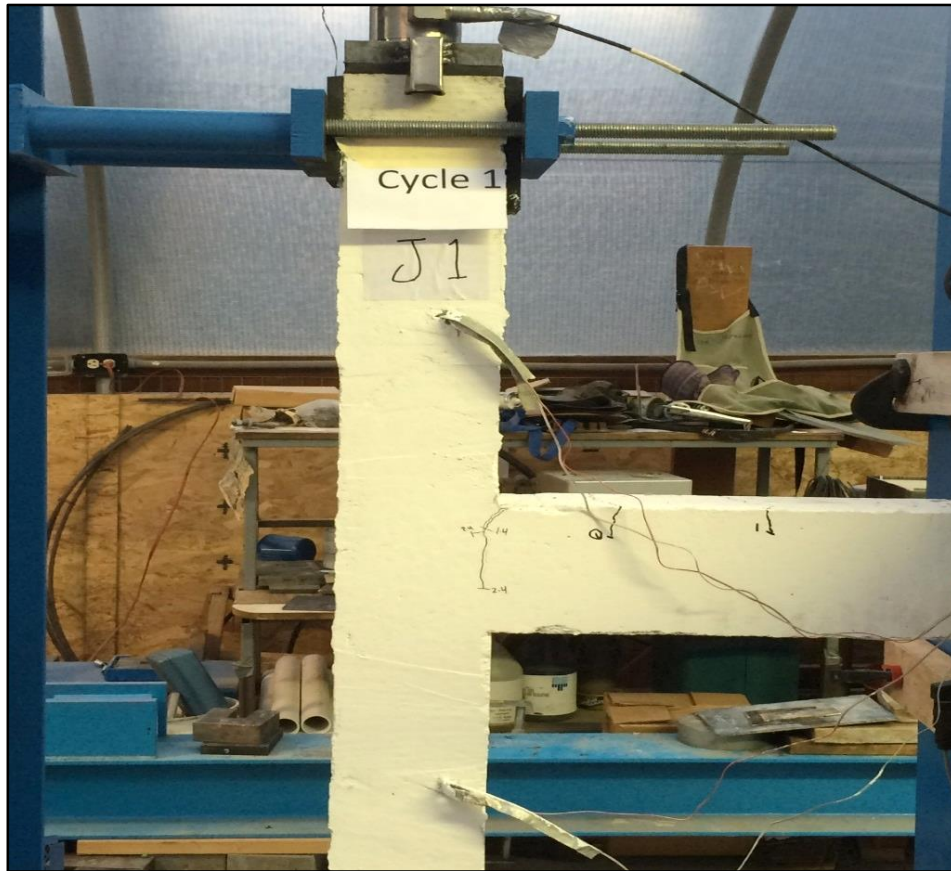
the length and the width was the one closest to the column face. The crack width was 1 mm and 0.5 mm at the loading and at the release respectively.

Figure 4-2 The Development of the First Cracks at the First Cycle, J1

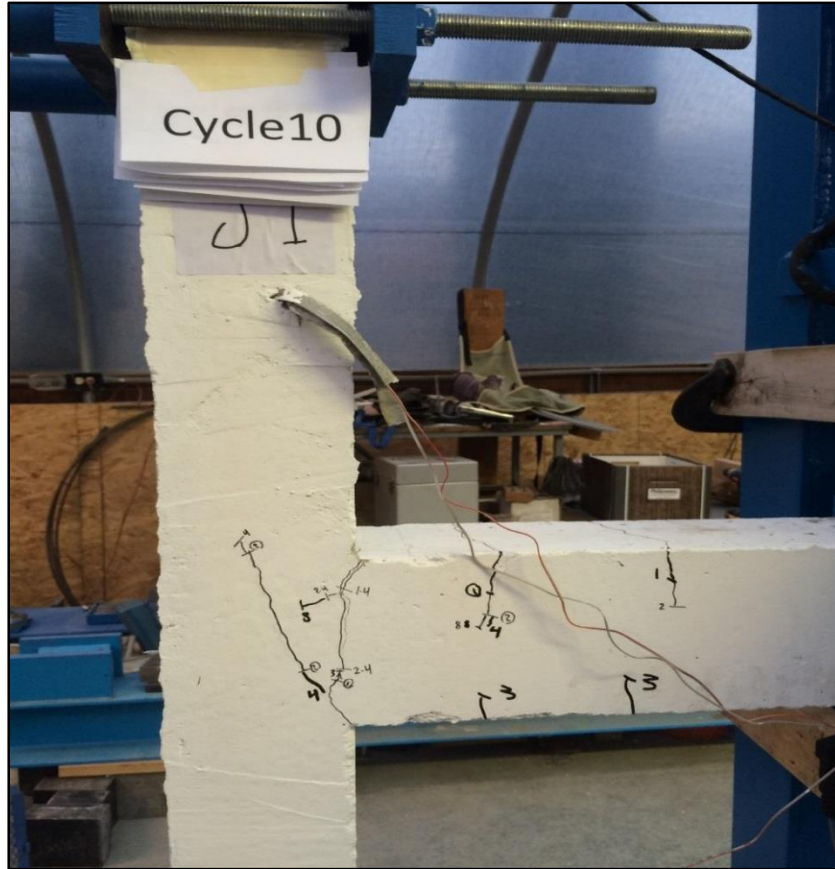
For the rest of the first set of cycles, no new cracks developed. The only change was in crack widths, especially in the crack that formed at the interface between the beam and column. This crack width was 1.6 mm by the end of cycle 10 within the load control. Figure 4-4 shows the specimen J1 at the end of first set of load cycles.

Figure 4-4 Specimen J1 at the End of First Set of Cycles.

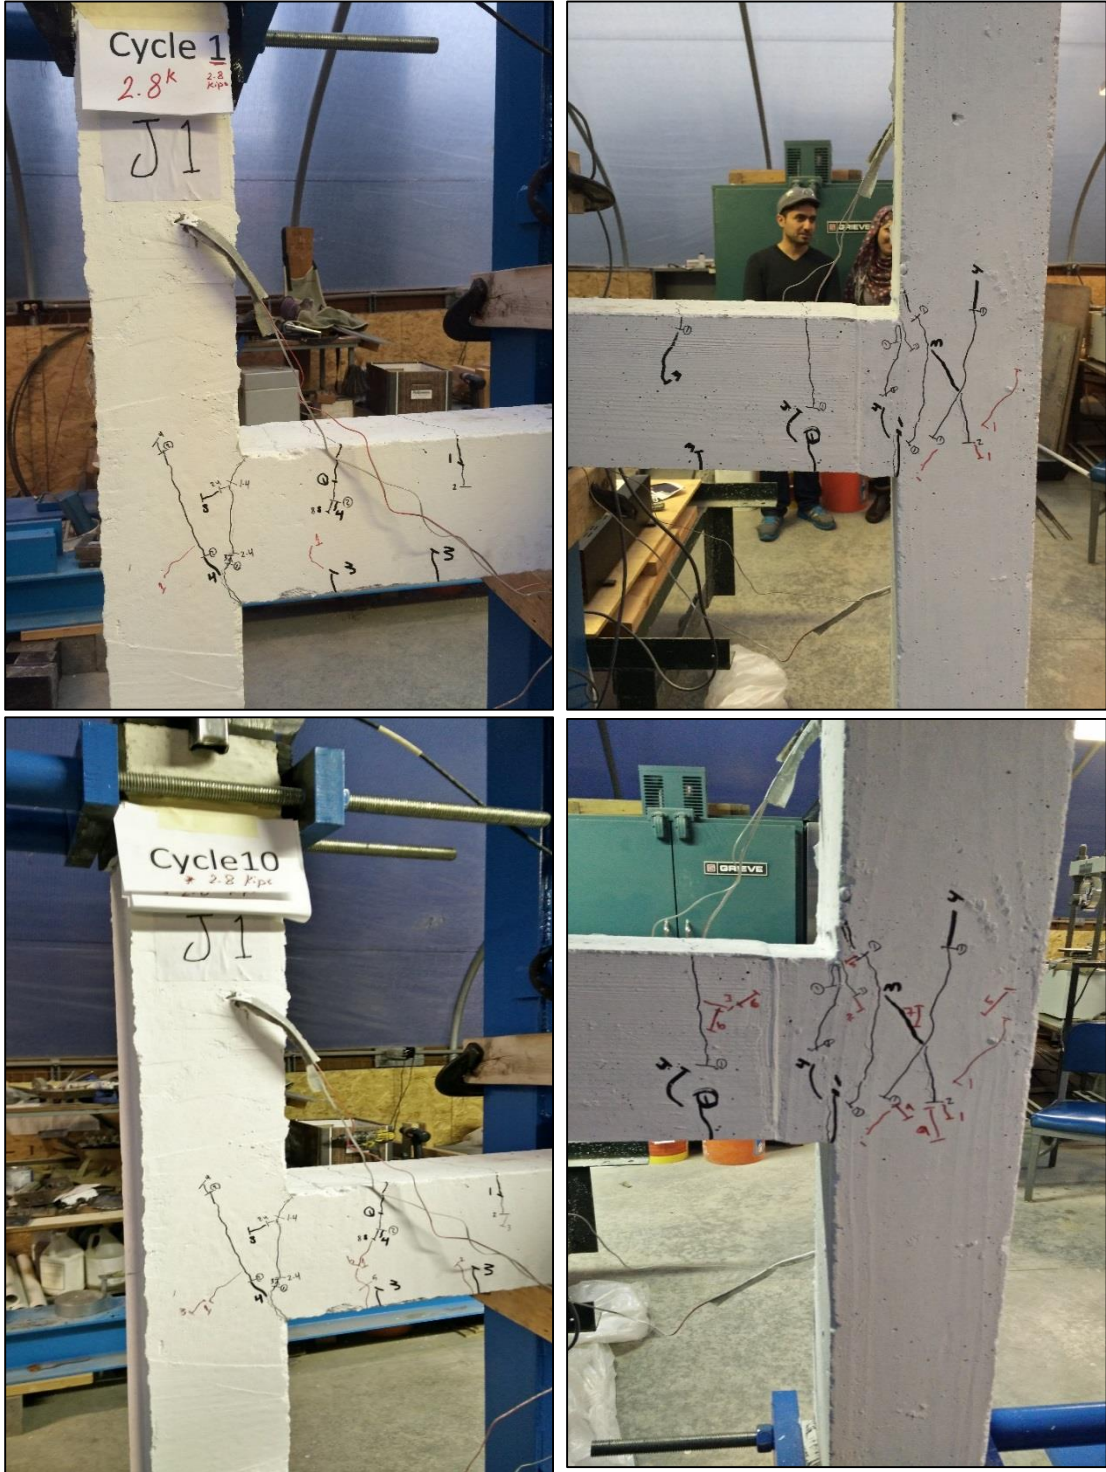
In order to visually recognize the new cracks within the second set of cycles, red colored markers were used to highlight the cracks, whereas a black marker was used for the first set. Similar to the previous test procedure, the applied cyclic load on the free end of the beam in the second set was equal to 90% of the maximum theoretical load of the beam capacity. As expected in these cycles, the joint did not show any degradation in strength despite showing a few cracks within the joint region. Some of the existing cracks in the beam developed further, as shown in Figure 4-5.

Figure 4-5 Crack Patterns Developed During Second Set of Applied Cyclic Load, J1

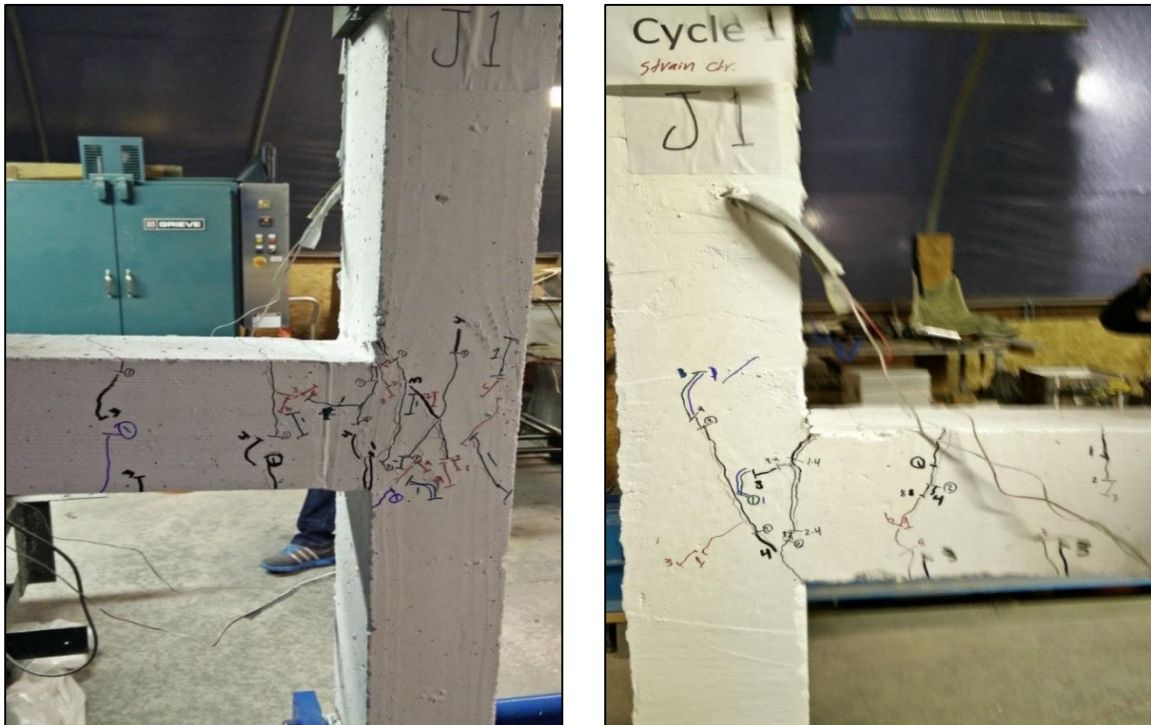
The next set of cycles represented the strain control where the cyclic load was applied to the free end of the beam until the strain was two times the yield strain to find out how the specimen would behave under severe earthquake effects. The first cycle in this phase developed the cracks within the joint region and formed diagonal cracks in “X” shape on both sides of the joint. The average cyclic load used in this phase was two times greater than used in the first set of load (75% maximum theoretical beam capacity). Blue Markers were used to highlight these cracks. Figure 4-6 shows the crack pattern at the first cycle within strain control phase.

Figure 4-6 Crack Pattern of Cycle 1, Strain Control, J1

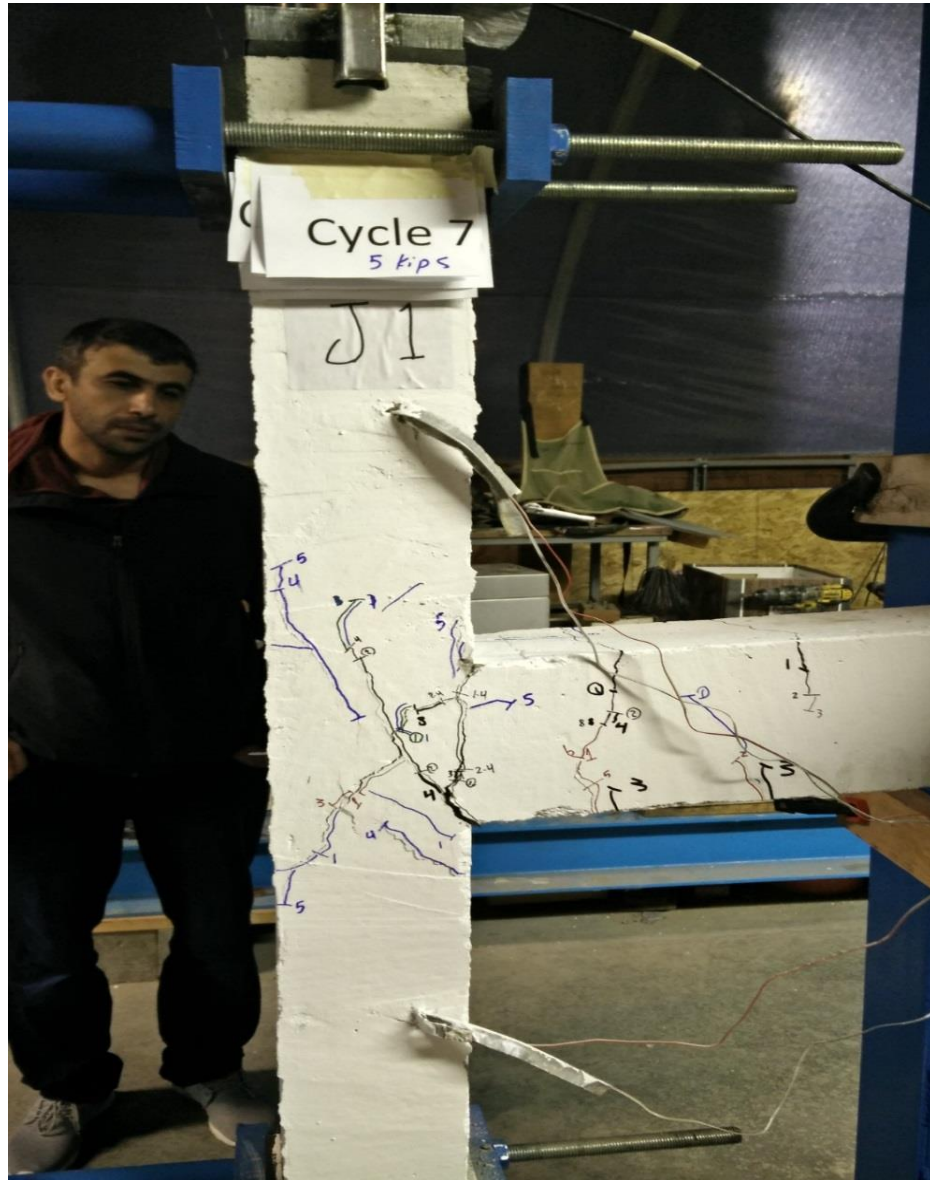
As the strain control cycles progressed, the flexural crack that developed at the interface between the column and the beam became wider. Meanwhile, the side concrete covers started to gradually crack on both sides, especially at the seventh cycle in this set. Figure 4-7 shows cracking of concrete within the joint region.

Figure 4-7 Concrete Cover Splitting, J1

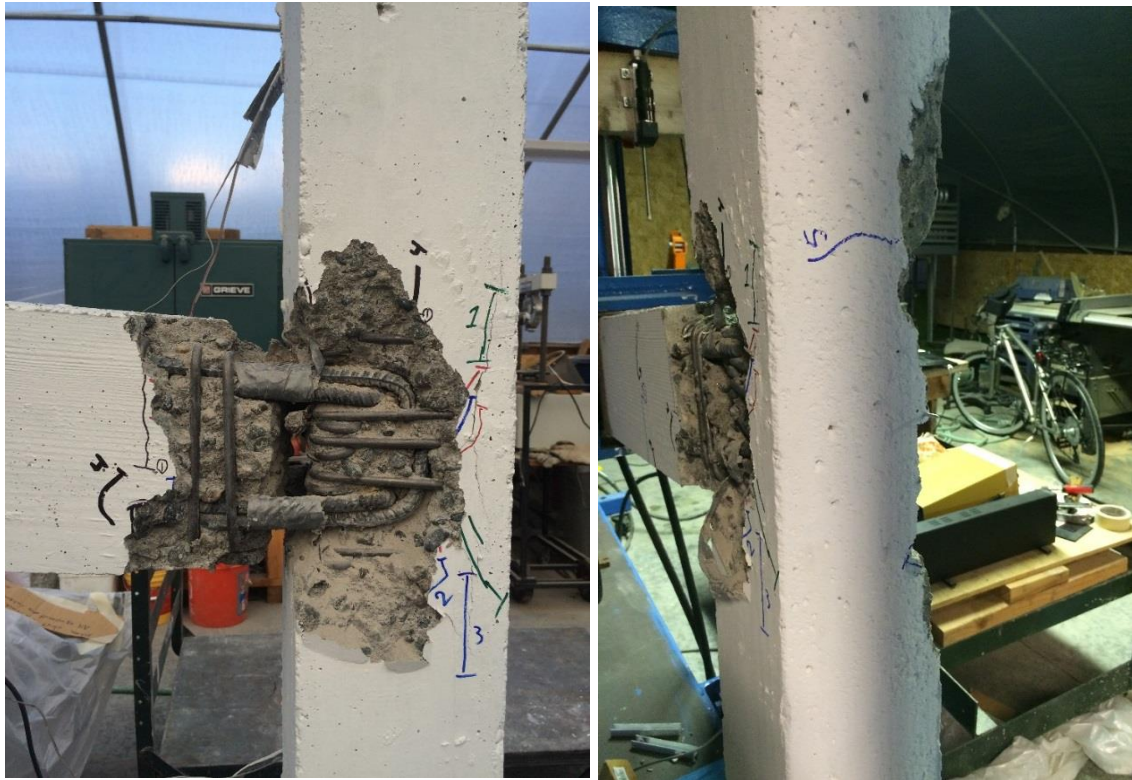
This specimen showed very good ductility. There was no degradation of the strength recorded through this set of cycles. After nineteen cycles in strain control, the jack stroke maxed out and this was the only reason why the test was stopped. At this point, the back side of the column was still intact with no crack. Figure 4-8 shows the final crack pattern of ductile specimen J1.

Figure 4-8 Specimen J1 (final crack pattern)

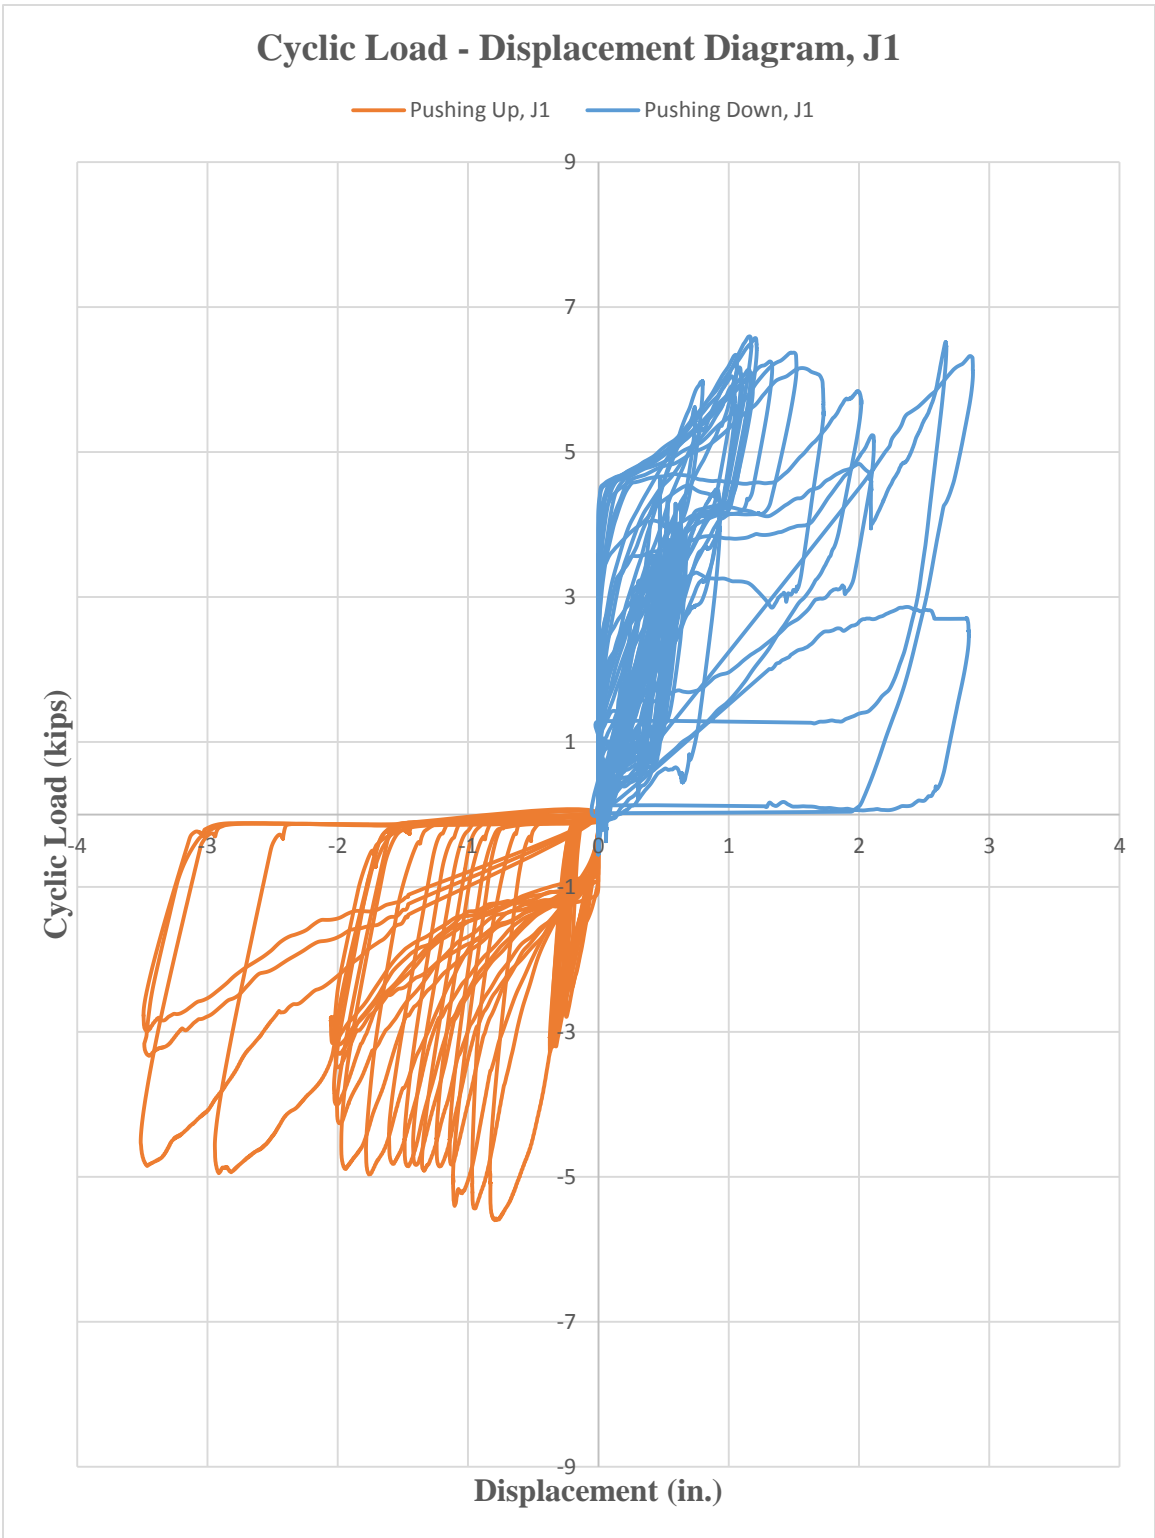
Figure 4-9 Load-Displacement Diagram, J1

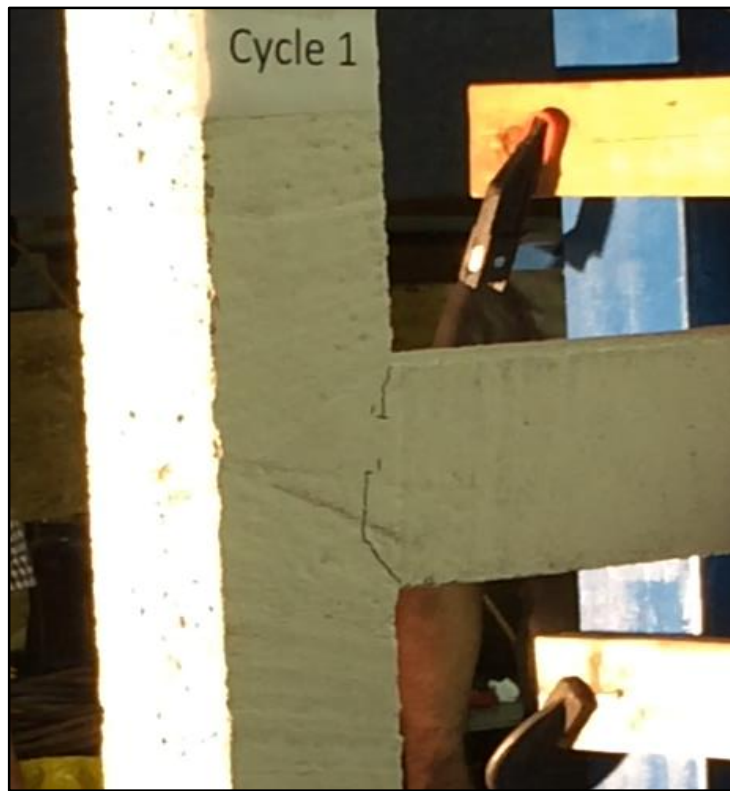
Figure 4-12 The Cracks of Joint J2 at the End of Cycle 1

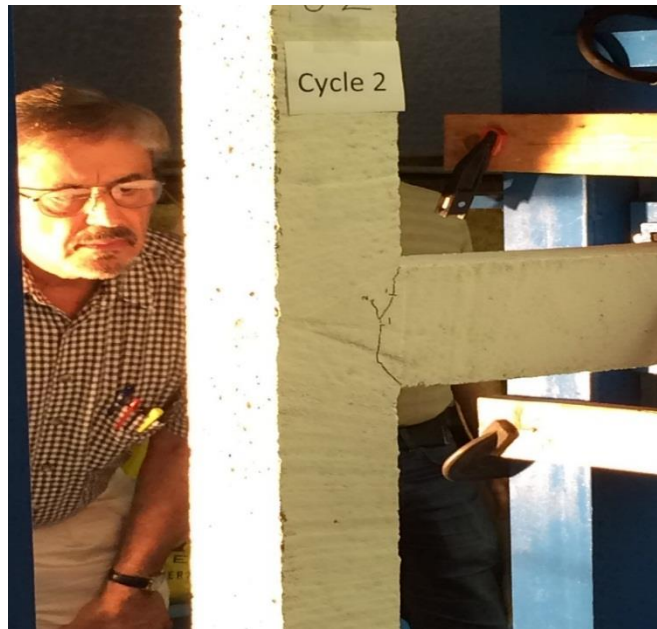
Figure 4-13 The Cracks of Joint J2 at the End of Cycle 2

When the second cycle was applied, both the upper and lower cracks elongated until they connected with each other. Moreover, the cracks' width increased. The upper crack width changed from 0.2 mm to 0.3 mm, whereas the lower crack width changed from 0.2 mm to

0.25 mm. Figures 4-13 and 4-14 show the cracks in joint J2 at the second cycle on both sides of the specimen.

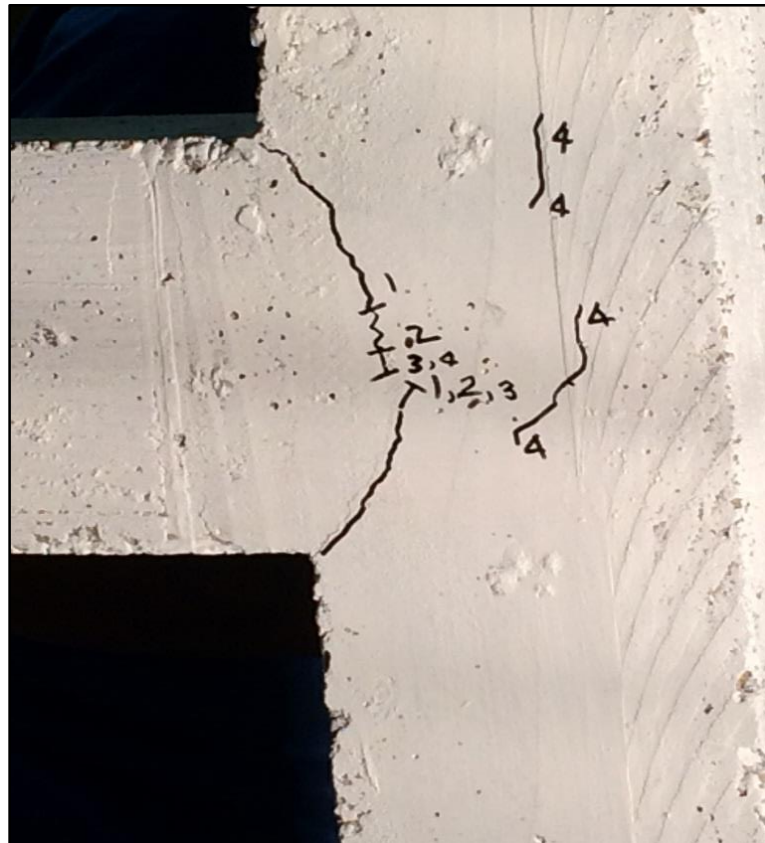
Figure 4-15 Developed Cracks at Cycle No. 4, J2
