Cyclic Loading Behavior of CFRP-Wrapped Non-Ductile Reinforced Concrete Beam-Column Joints

Ali S. H. Zerkane
Portland State University

A thesis submitted in partial fulfillment of the
requirements for the degree of

Master of Science
in
Civil and Environmental Engineering

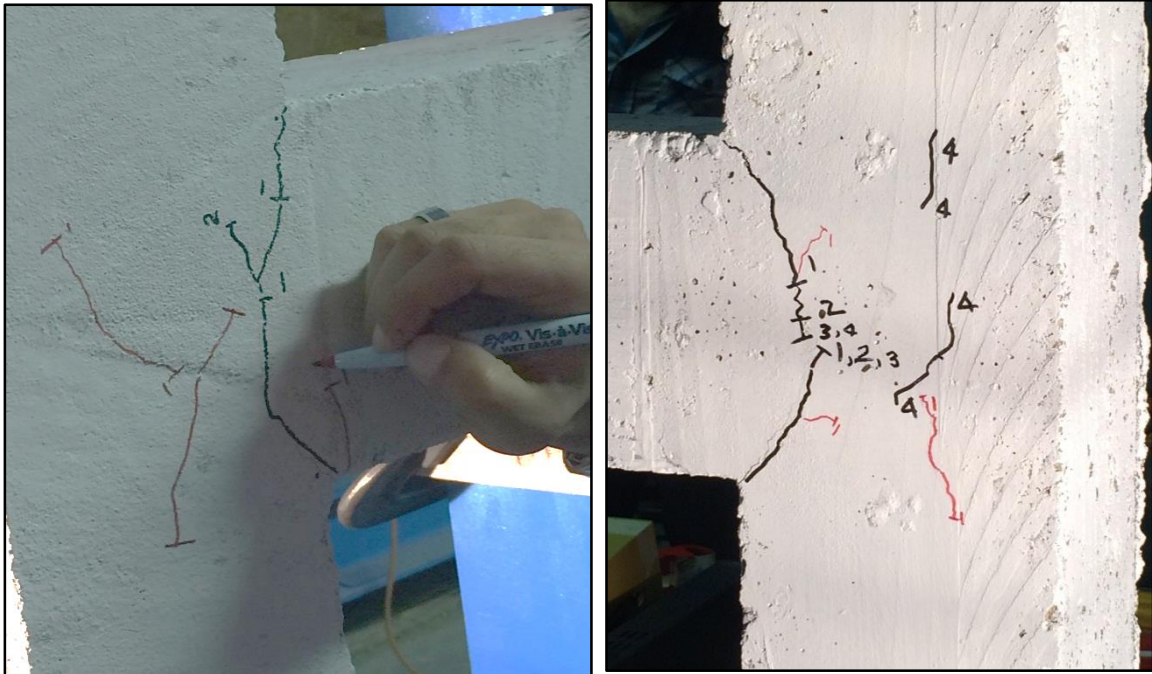
Figure 4-17 First Shear Cracks, J2

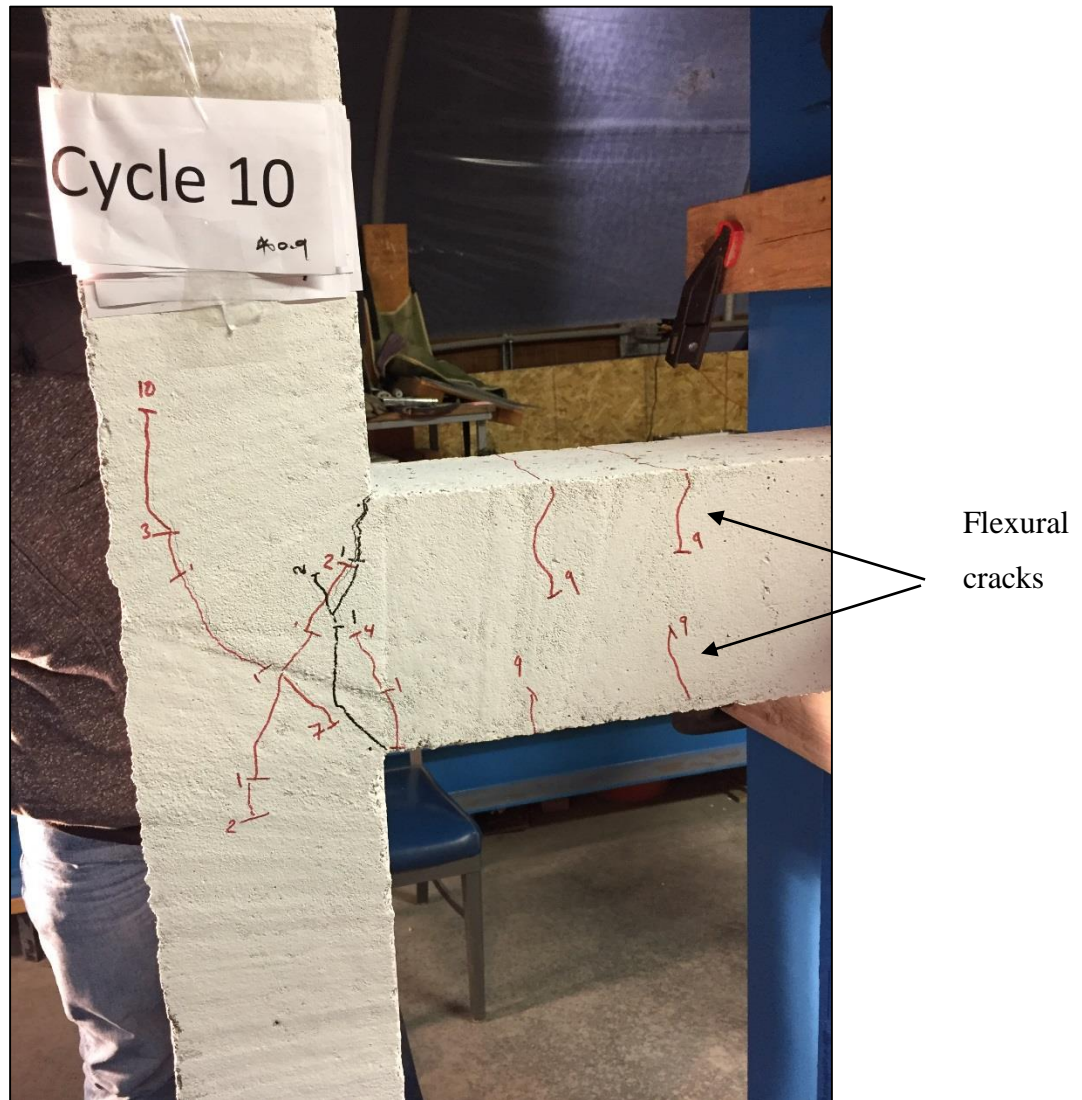
Figure 4-18 Developed Cracks within the Load Control Phase, J2

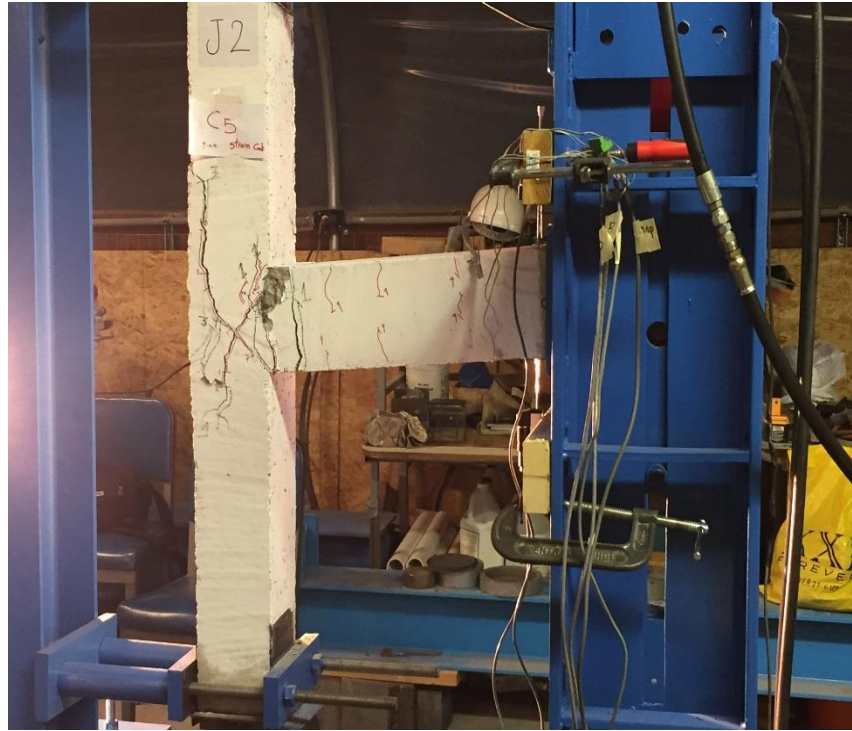
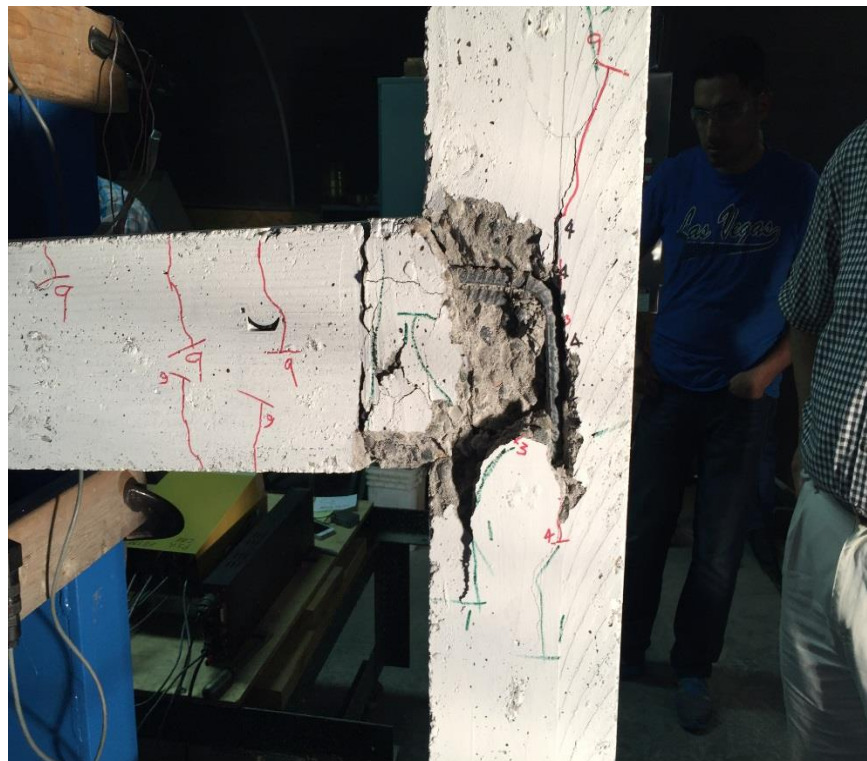
Figure 4-19 The Failure Pattern of Specimen J2

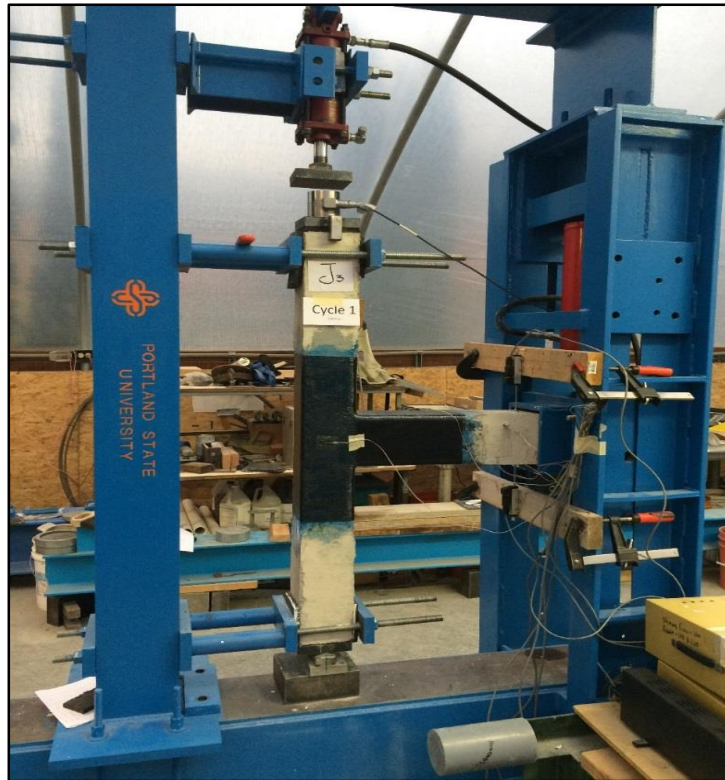
Figure 4-21 Test Setup of Specimen J3

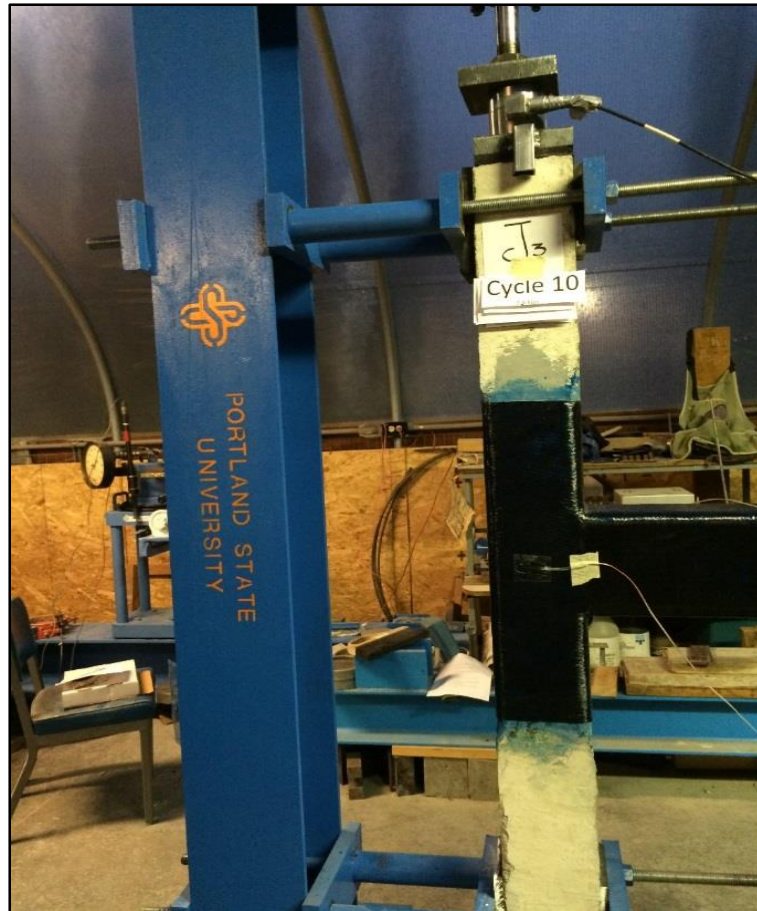
Figure 4-22 Specimen J3 at the End of cycle 20

Two additional strain gages were used in this test on either sides of the joint at the middle of the joint region in order to measure the strain would develop in the CFRP sheets before the start of the test. The same load sequences were followed where the test started by applying the axial column load, then the cyclic loads on the beam. Because the joint and surrounding areas were wrapped with CFRP sheets, it was not possible to track the cracks. In the first two sets (twenty cycles) of the cyclic loads (phase 1), which represented 75% P and 90% P, there was no deterioration in the specimen's strength. Figure 4-22 shows the specimen J3 at the end of cycle twenty.

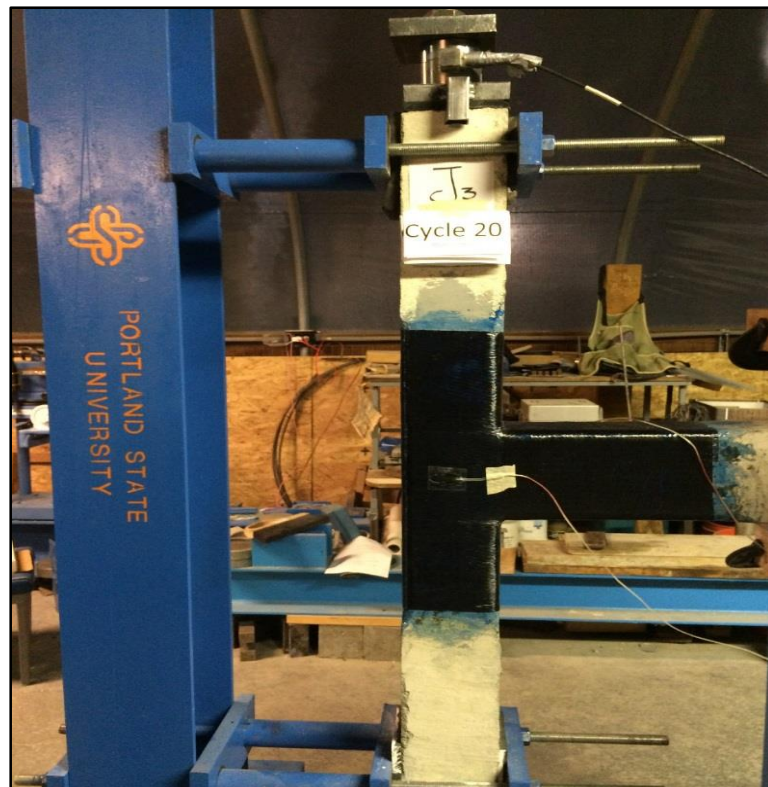
Figure 4-23 Specimen J3 at the End of Cycle 20, Strain Control Phase

At this point, the strain control stage started, where the cyclic load was applied until the strain in the beam flexural bars reached 0.4%. Twenty load cycles were applied on the free end of the beam. During these cycles the CFRP sheets showed a small fold that appeared at both corners, but without rupture failure. The maximum strain that developed in the CFRP sheets was around 0.4%. Figure 4-23 shows the joint J3 at the end of the first 20 cycles in the strain control phase.

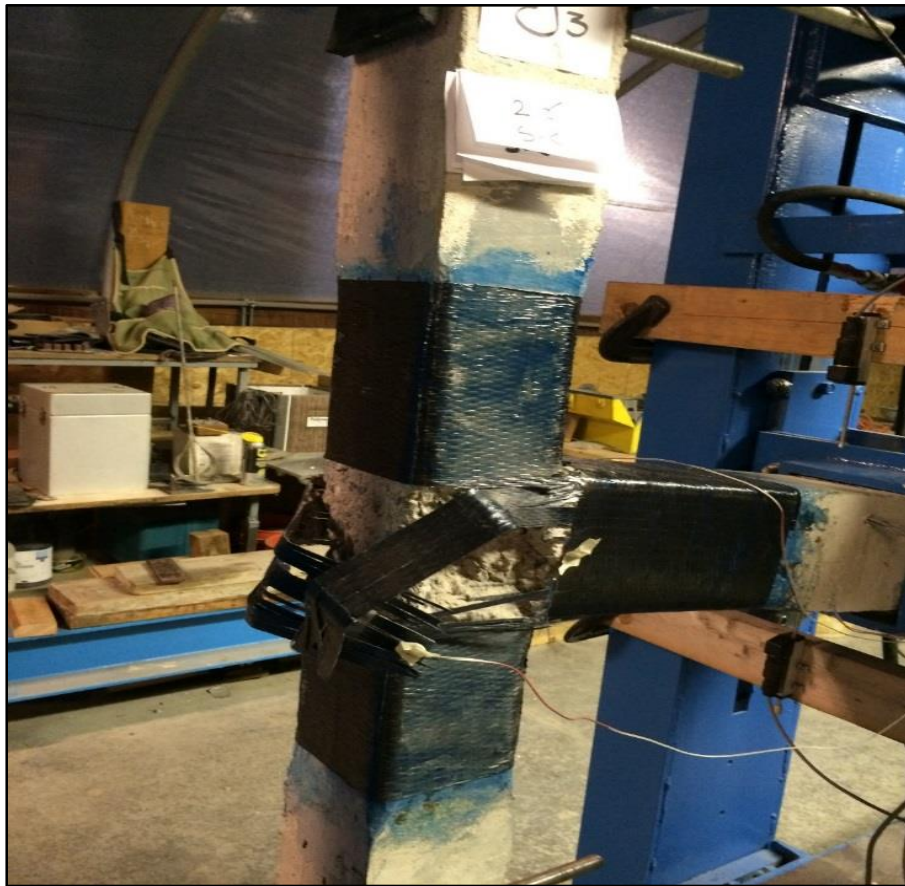
Figure 4-24 Specimen J3 at the Failure

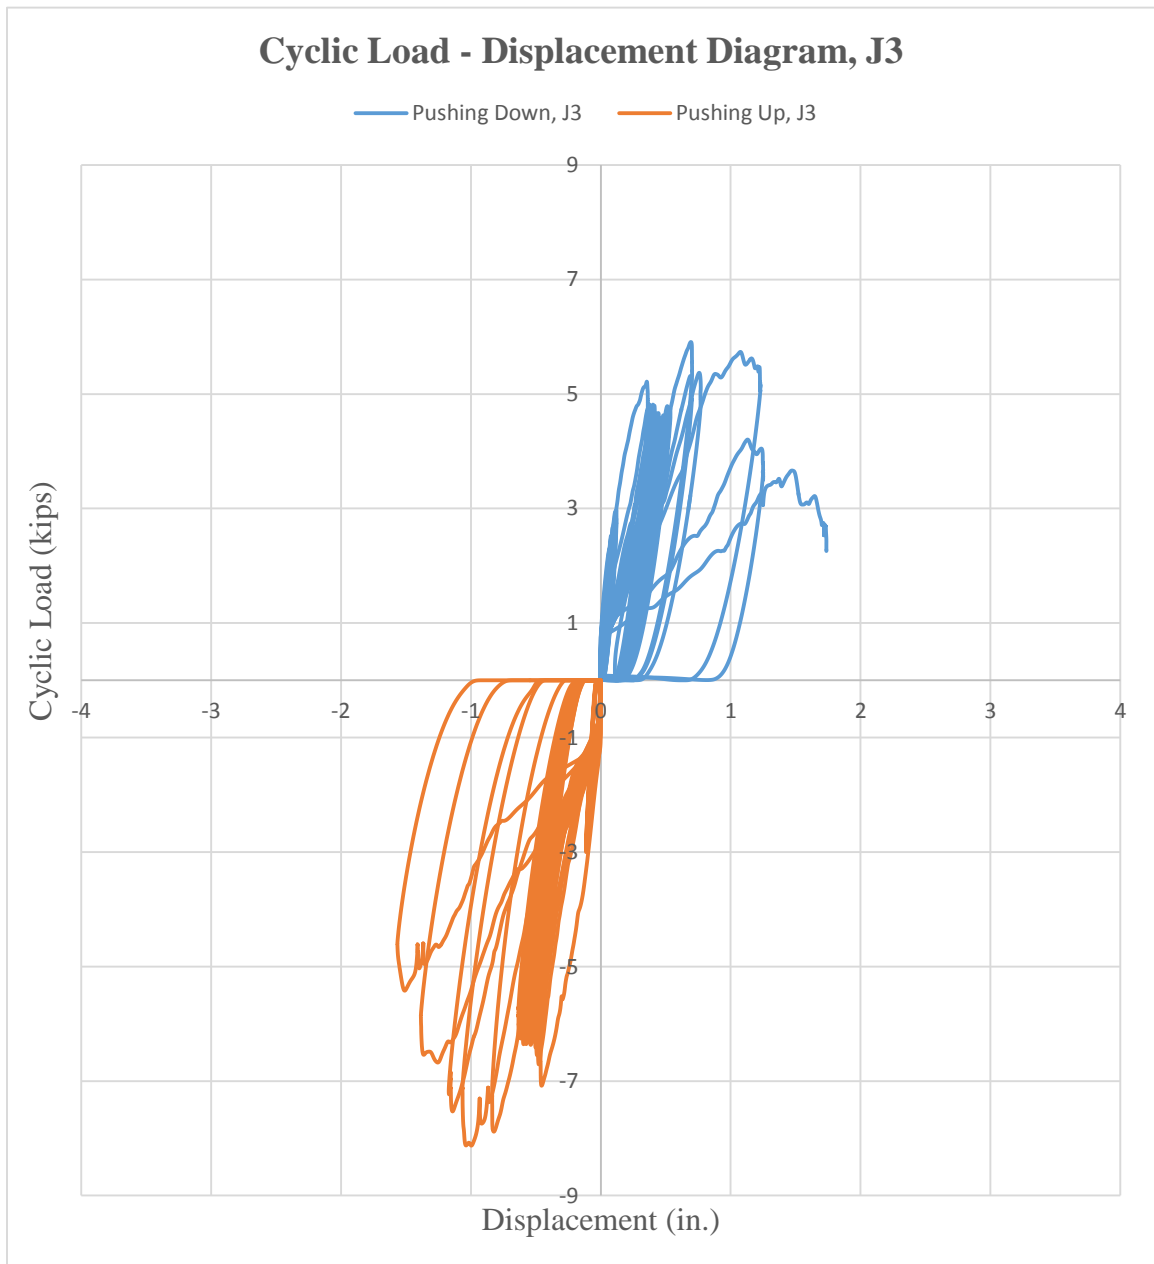
Figure 4-25 Load-Displacement Diagram, J3

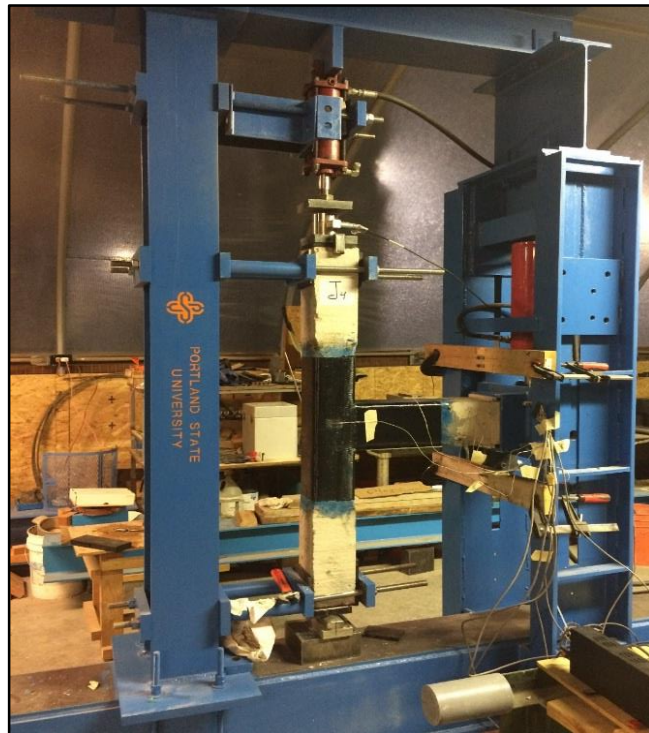
Figure 4-26 Test Setup of Specimen J4

The general behavior of retrofitted joint J4 represents the behavior of the non-ductile concrete beam-column joint, which was designed according to the earlier codes used before the development of modern seismic code. This specimen was retrofitted using two layers of the carbon fiber reinforced polymer sheet. This specimen was prepared and cast at Greenhouse Lab at Portland State University. After three months, this specimen was tested using the Blue Frame in the lab. Figure 4-26 shows how the specimen was placed in the frame and set for the test.

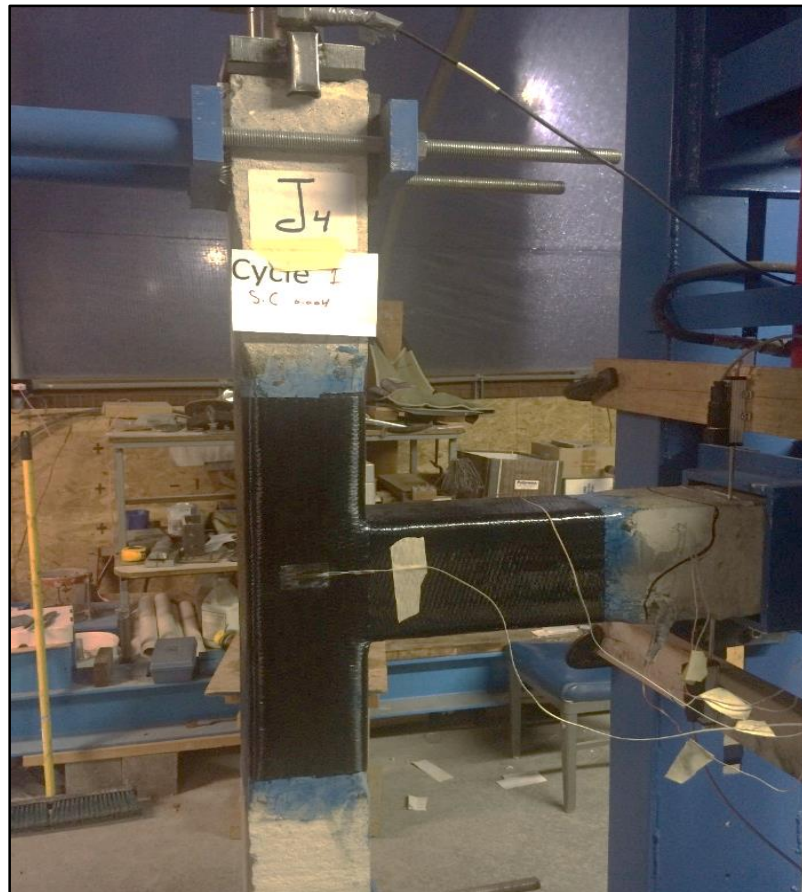
Figure 4-28 Specimen J4 at the Failure

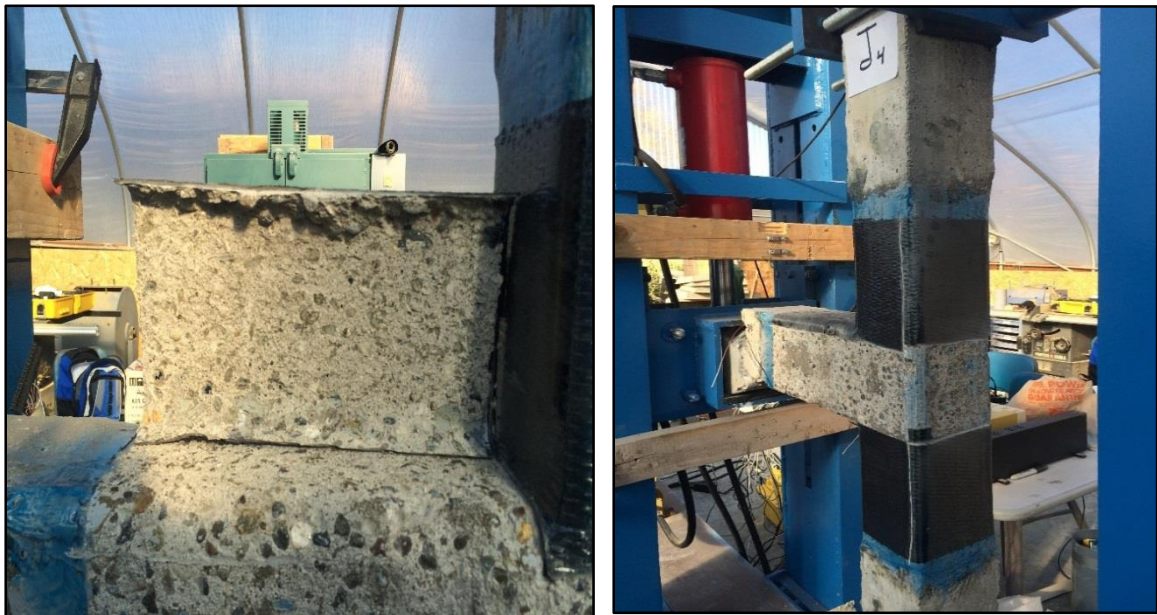
Figure 4-29 Areas under CFRP Sheets at the End of the Test, Specimen J4

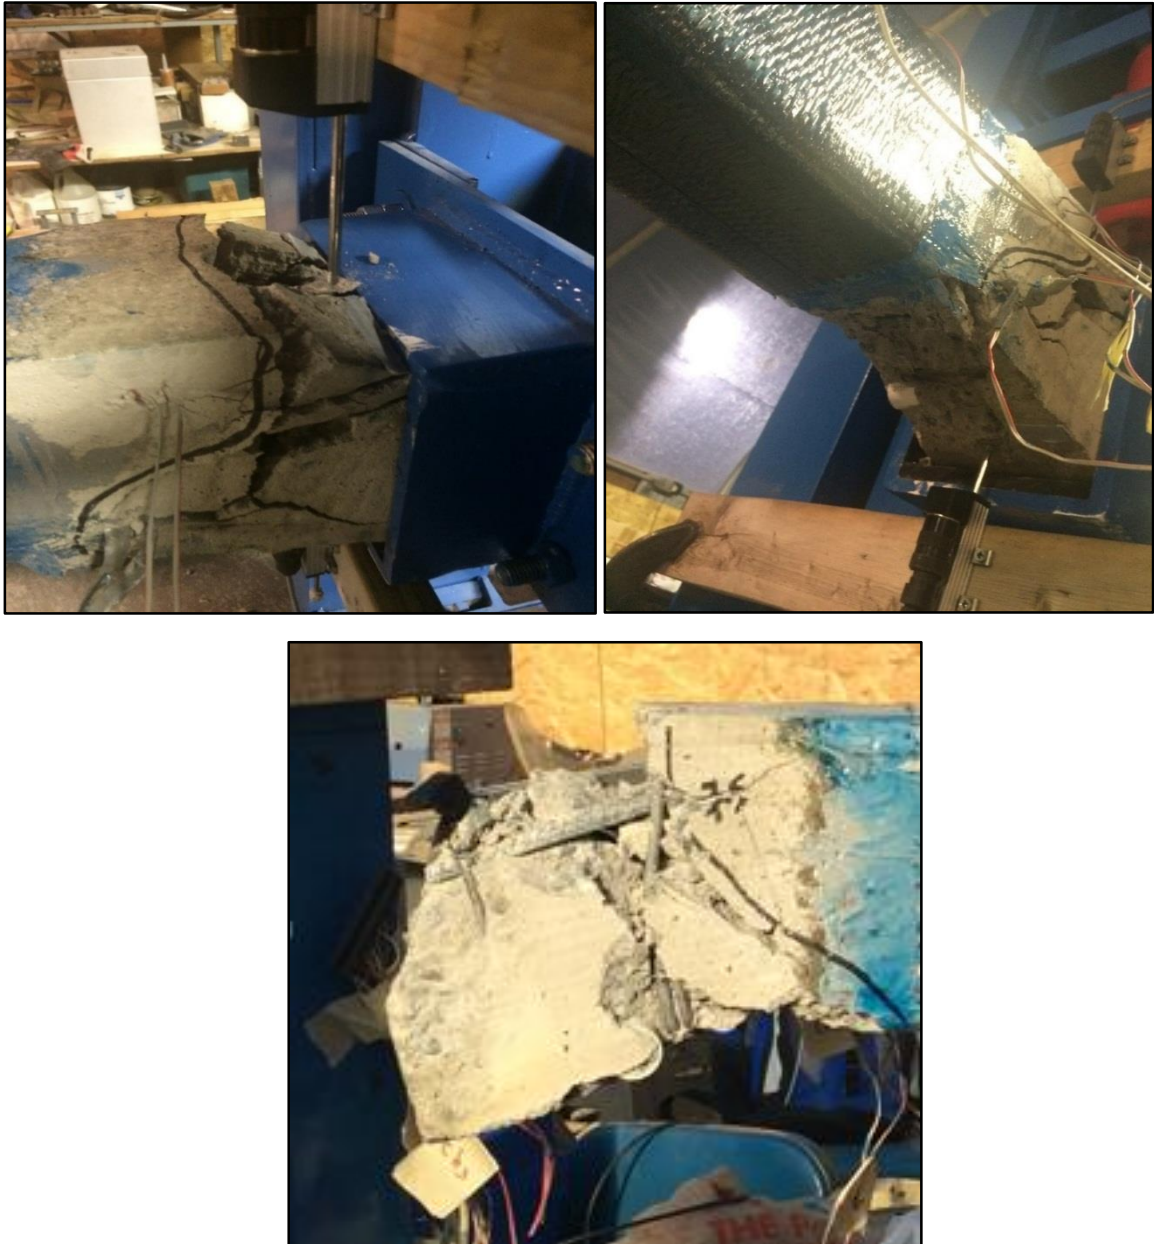
Figure 4-31 Failure of Specimen J4

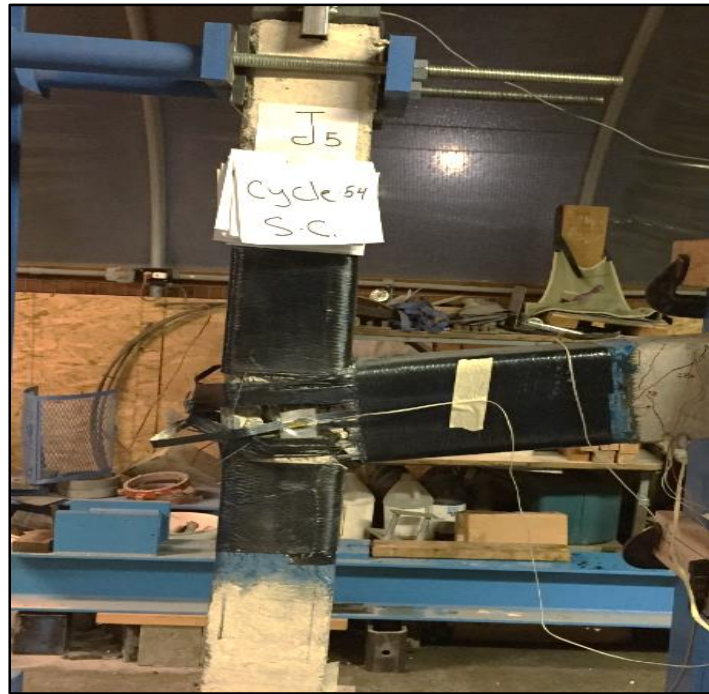
Figure 4-34 Failure of Specimen J5

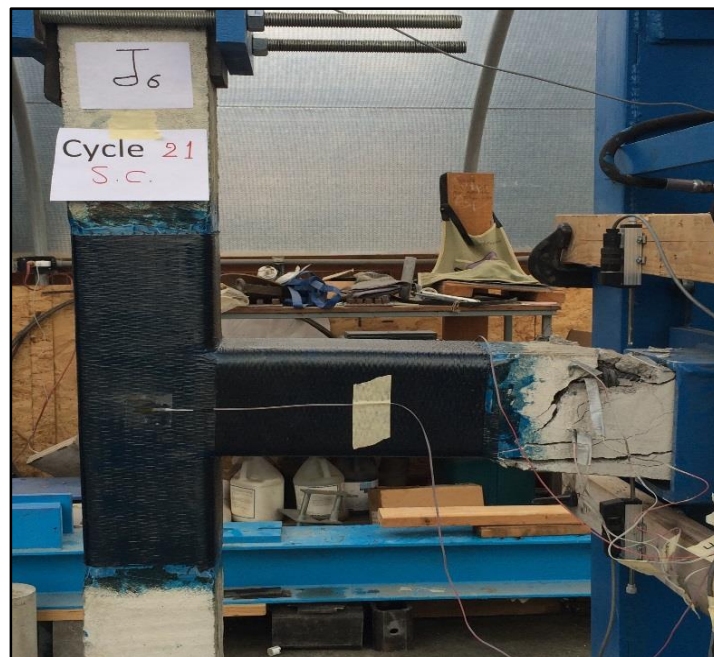
Figure 4-35 Failure of Specimen J6

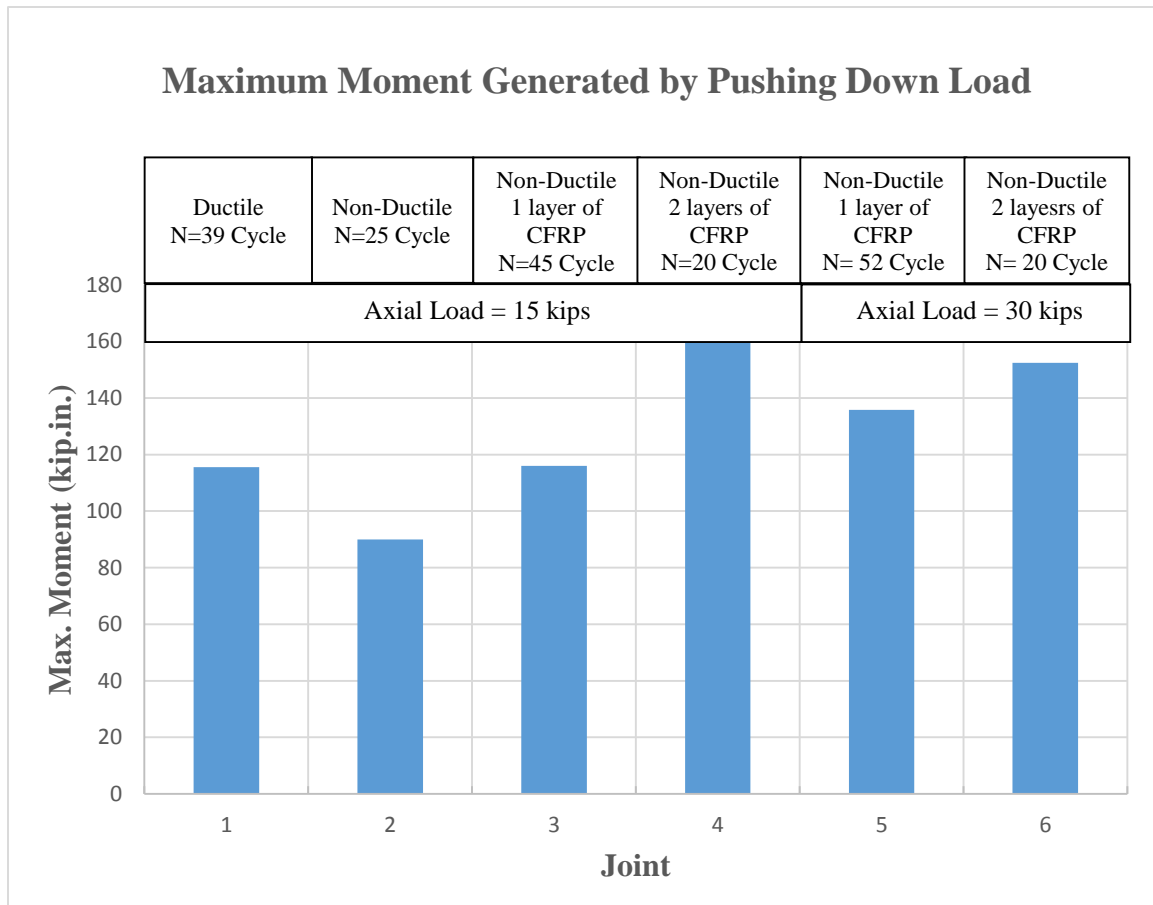
Figure 4-36 Maximum Moment at Face of the Column, Pushing Down Case

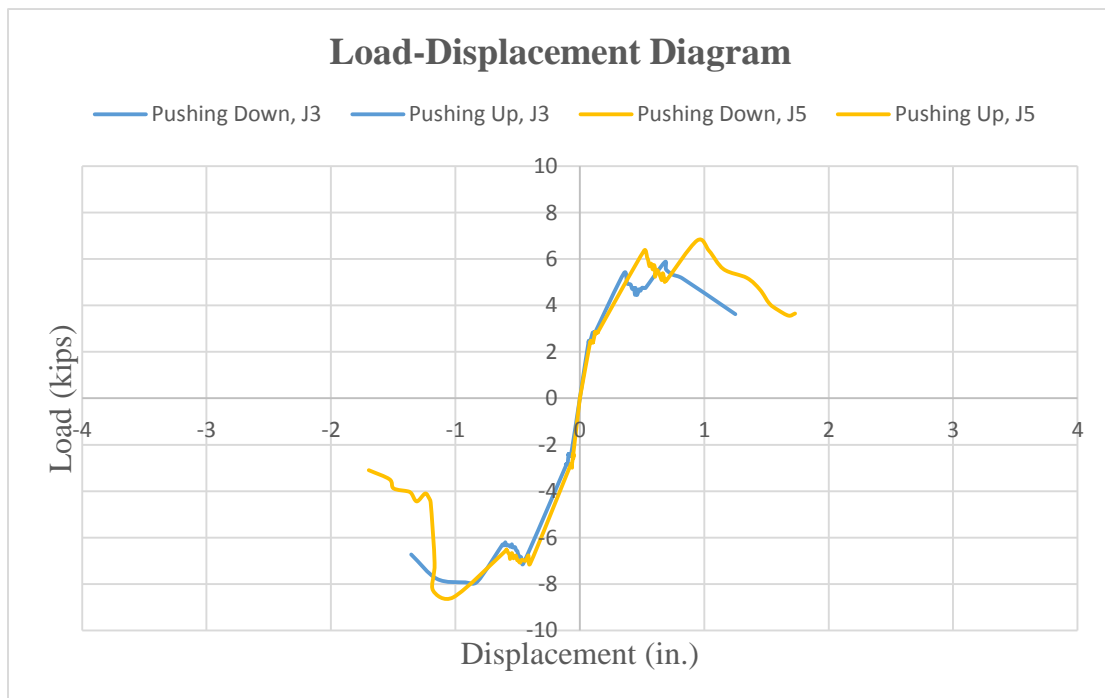
Figure 4-44 Cyclic Load- Vertical Displacement Relationship of Specimens (J3 and J5) Tested under a Different Axial Load (20% and 40% of the Column Capacity)

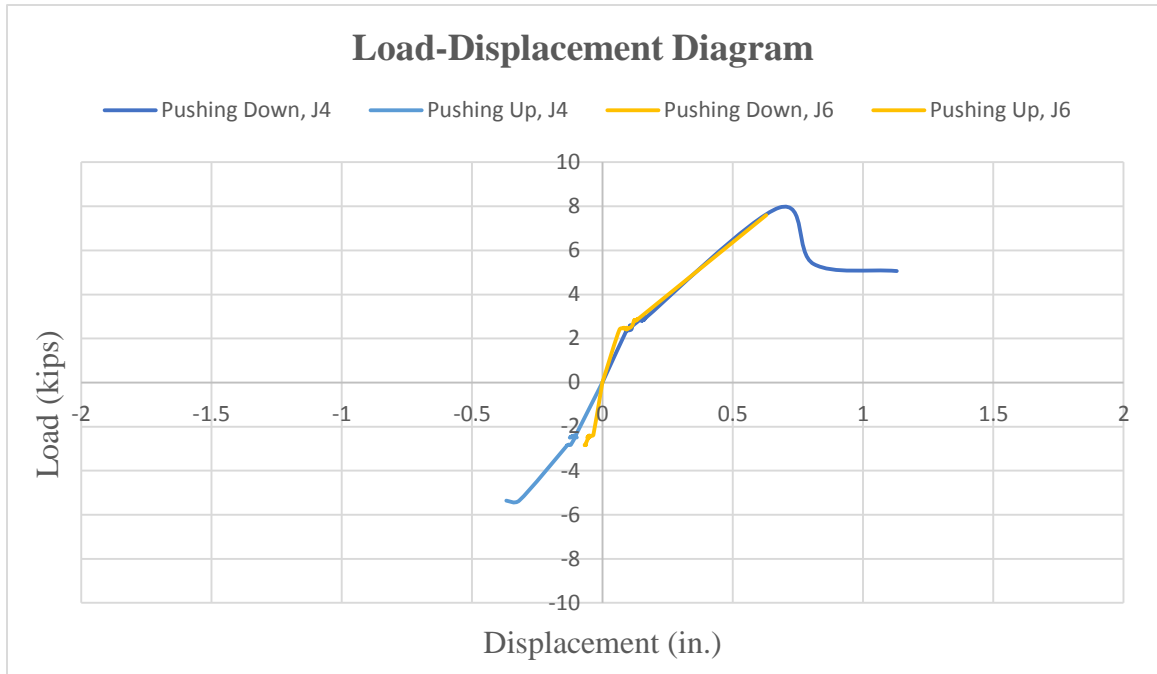
Figure 4-45 Cyclic Load- Vertical Displacement Relationship of Specimens (J4 and J6) Tested under a Different Axial Load (20% and 40% of the Column Capacity)

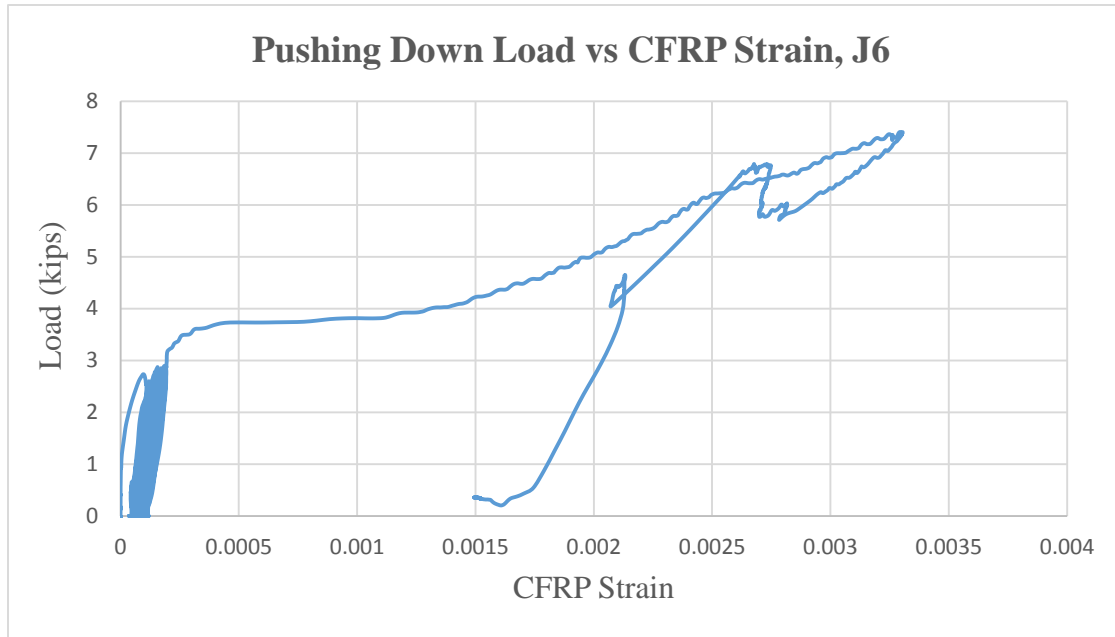
Figure 4-49 CFRP Joint Strain versus Cyclic Load for Specimen J6

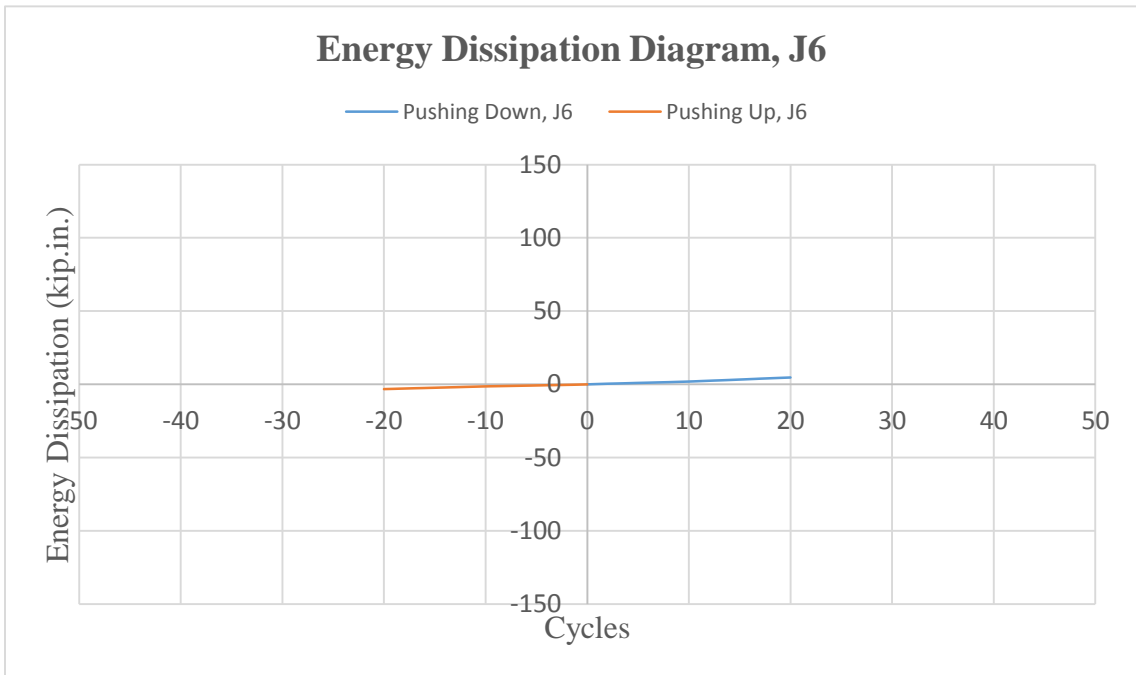
Figure 4-55 The Cumulative Energy Dissipation of Specimen J6

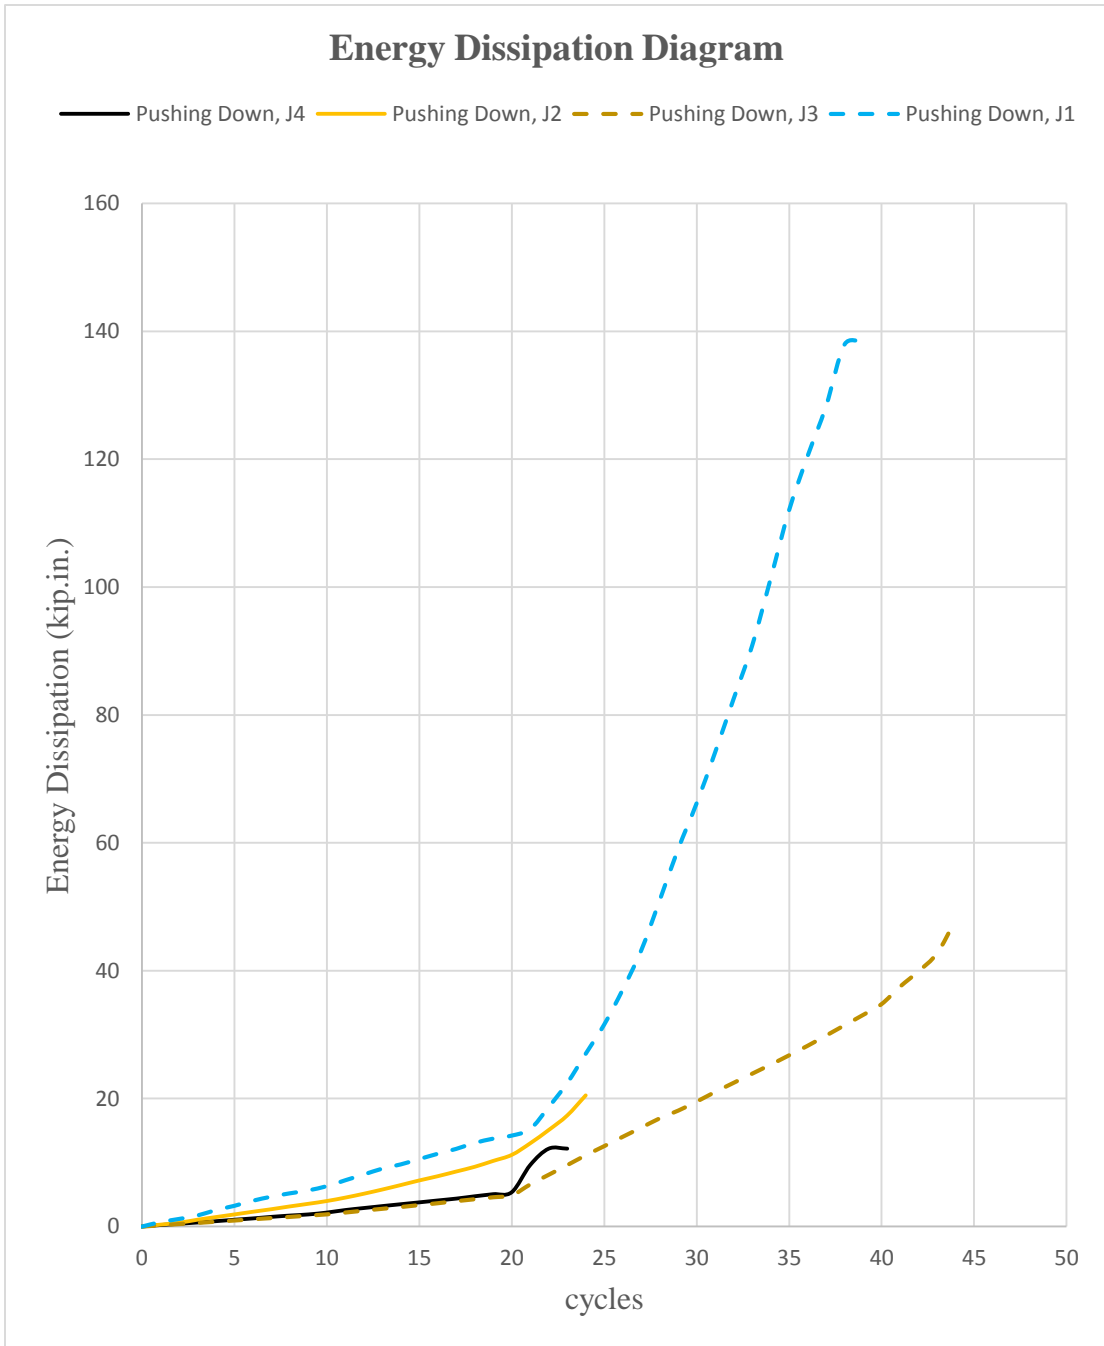
Figure 4-56 The Cumulative Half Cycle Energy Dissipation of Specimens J1, J2, J3, and J4

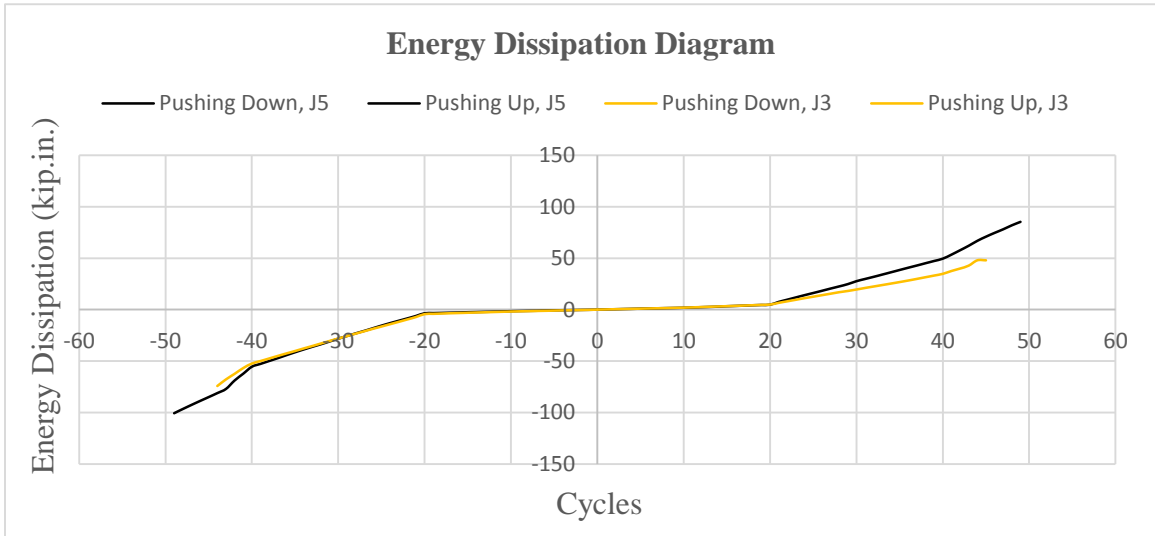
Figure 4-57 Compare between the Cumulative Energy Dissipation for Specimens J3 and J5

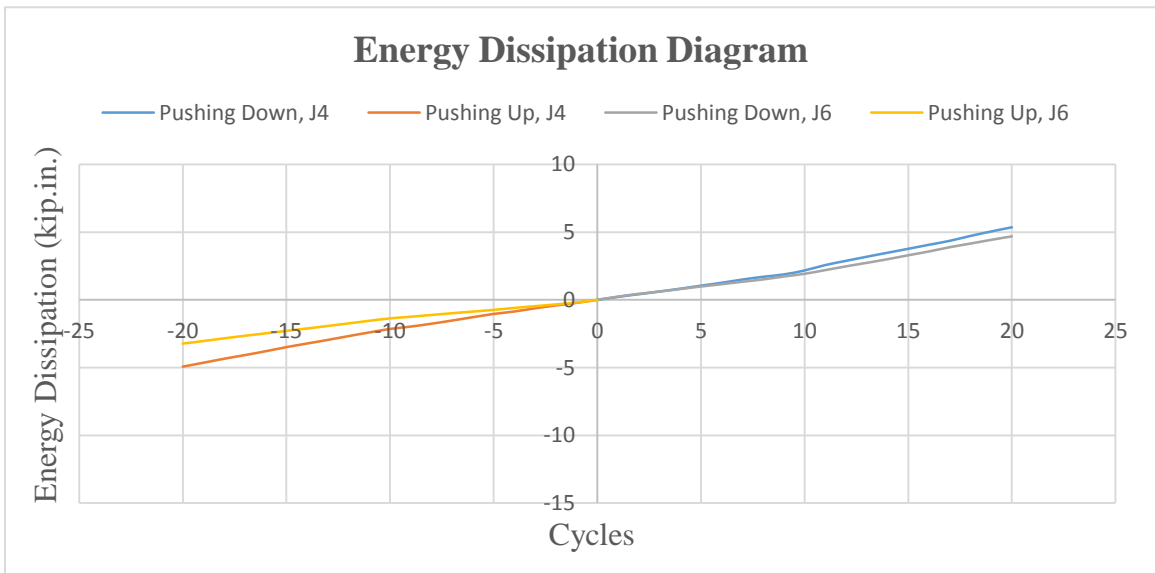
Figure 4-58 Compare between the Cumulative Energy Dissipation for Specimens J4 and J6

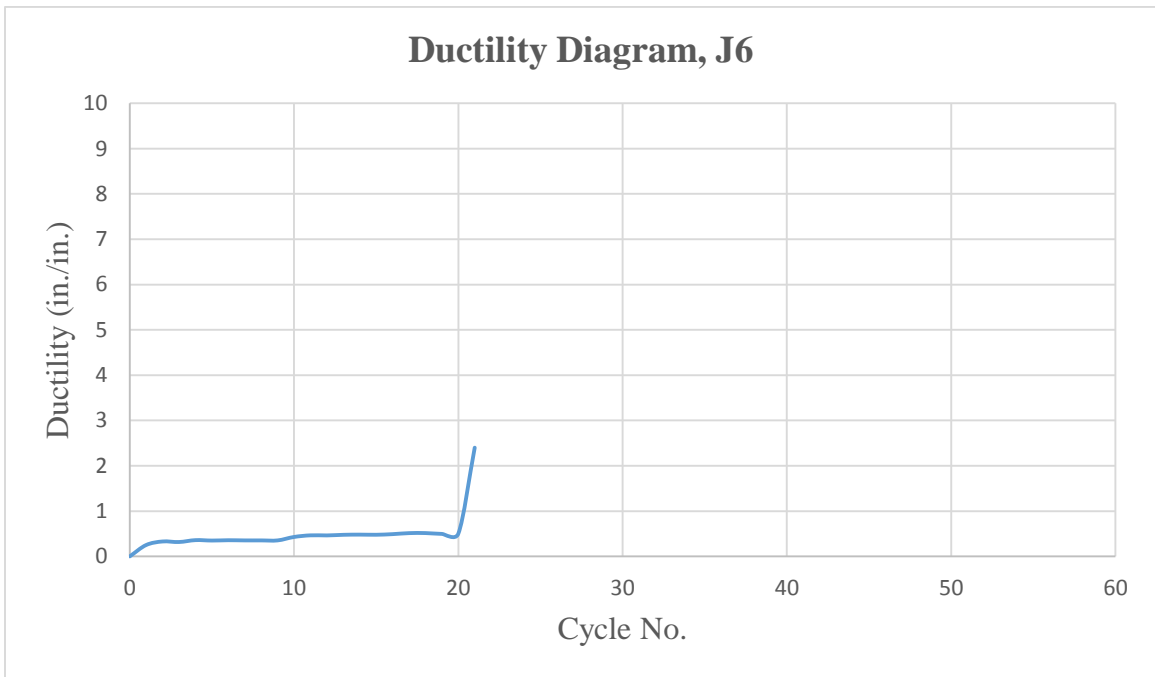
Figure 4-64 Ductility Factor Diagram (Half Cycle) of Specimen, J6

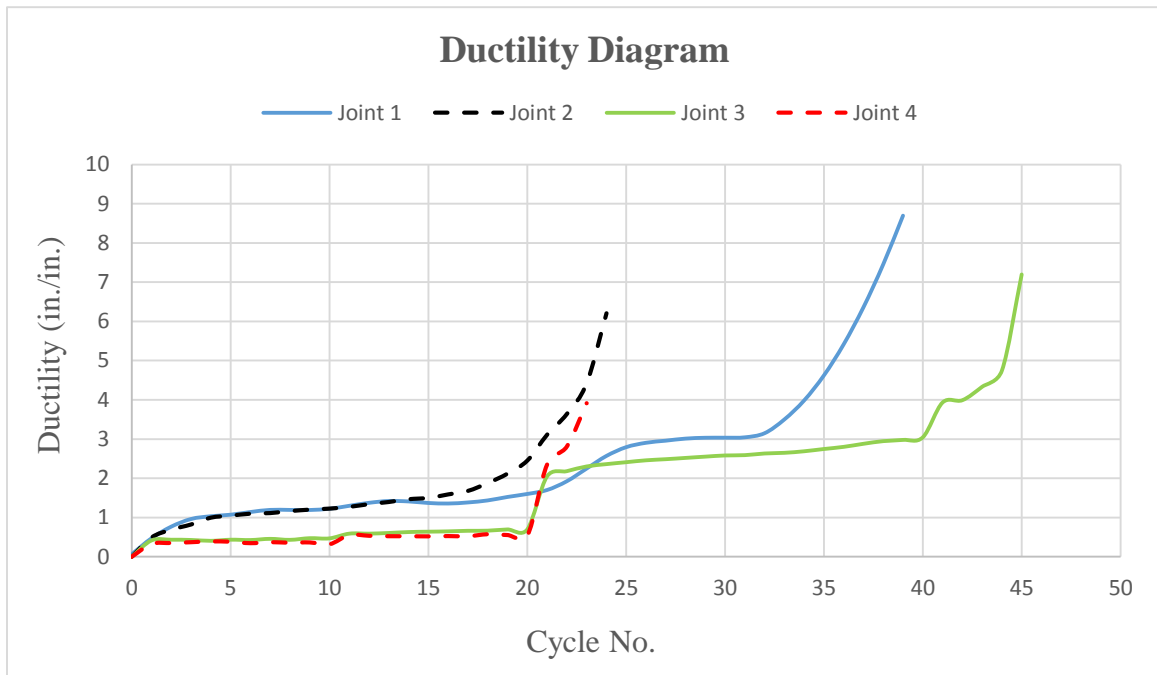
Figure 4-65 Compare of Ductility (Half Cycle) for Specimens J1, J2, J3, and J4
