Improving Bicycle Crossings at Unsignalized Intersections  
through Pavement Markings:  
Analysis of the City of Portland Innovative Strategy

A thesis submitted in partial fulfillment of the  
requirements for the degree of

Master of Science  
in  
Civil and Environmental Engineering

Portland State University  
2021

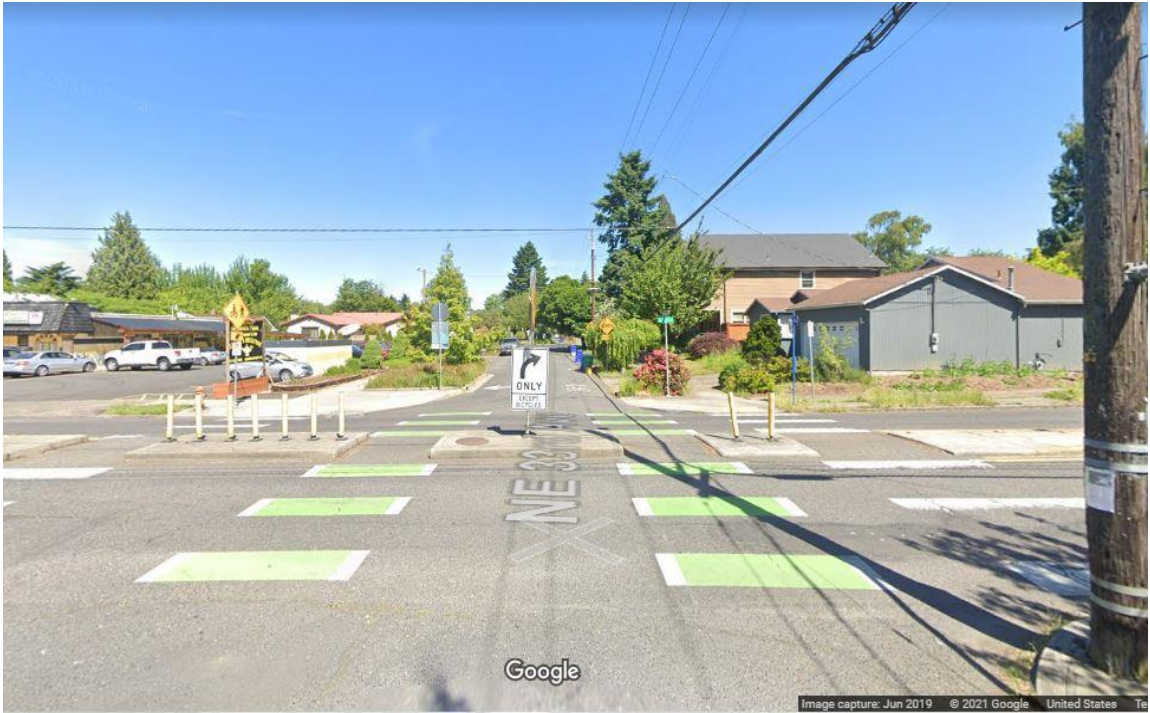
**Figure 1: Typical intersection with cross-bike pavement markings.** Source: Google Maps

Cross-bikes are visibly prominent pavement markings that are the equivalent of crosswalks for bicyclists installed at intersections to heighten the visibility of the facility as a bicycle crossing. These markings are green and are marked similar to a continental pedestrian crosswalk. Figure 1 below shows a typical intersection with the cross-bike markings. The city of Portland has adopted this innovative strategy to heighten the visibility of intersections to enhance bicyclist's safety at intersections. The treatment has been installed at selected unsignalized intersections within the Portland metro area over the years. To

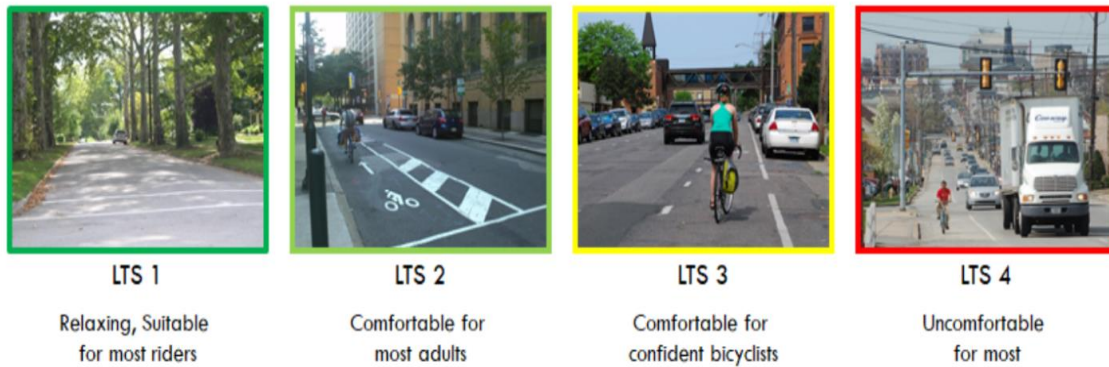
**Figure 2:Types of roadways with associated bicycle level of traffic stress. Source : BLTS Types**

**LTS 4** are stress levels tolerated by cyclists who are characterized as strong and fearless. It represents high stress due to moderate to high speeds and high traffic volumes. At busy intersections, there are complex, wide, and high volume/speed of traffic that can be perceived as unsafe by adult users which make it difficult to cross safely. The figure below shows example of each stress level and the facility type.

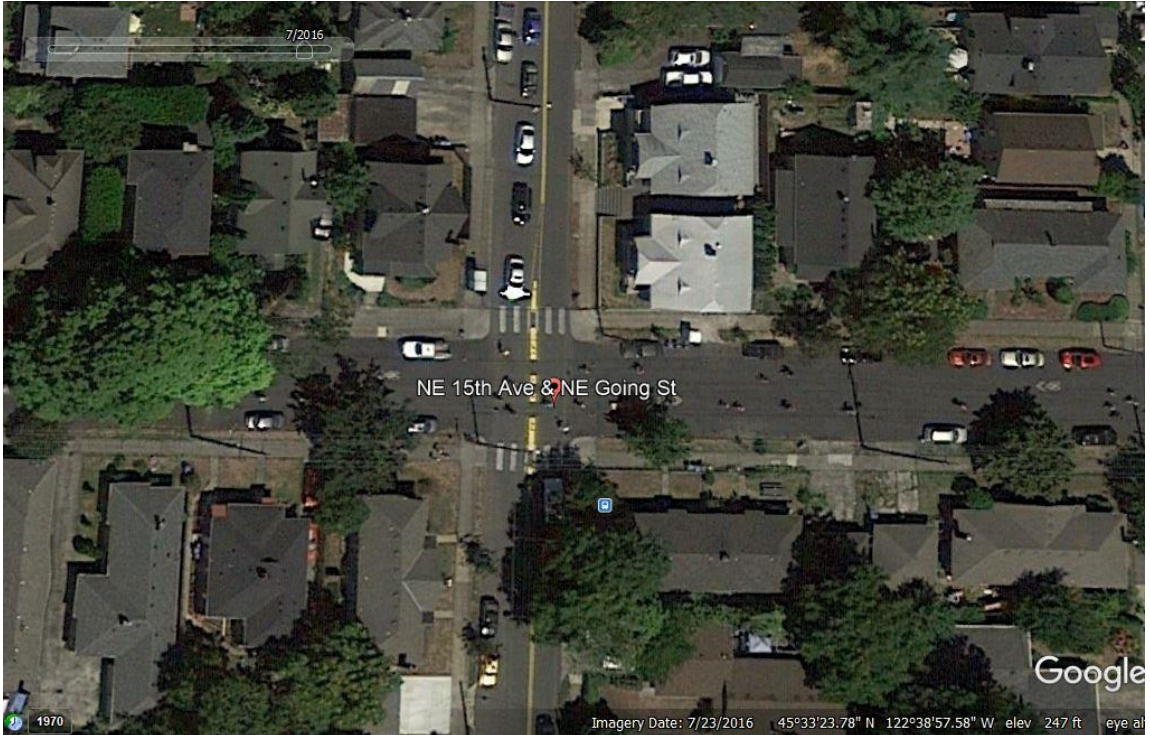
Figure 3: Plan view of NE Going & NE 15th Ave before cross-bike. Source: Google Earth (2016).

NE Going and NE 15<sup>th</sup> Ave is a four-leg unsignalized intersection with a two-way road for all the approaches. NE Going runs east to west with average daily traffic of 890 vehicles including bicycles. NE 15<sup>th</sup> Ave has been prioritized for bicycles and hence serves some bicycle traffic. There are on-street parking for both crossroads with a marked crosswalk and transit bus stops on both approaches of NE 15<sup>th</sup> Ave. Figure 3 shows the plan view of the location.

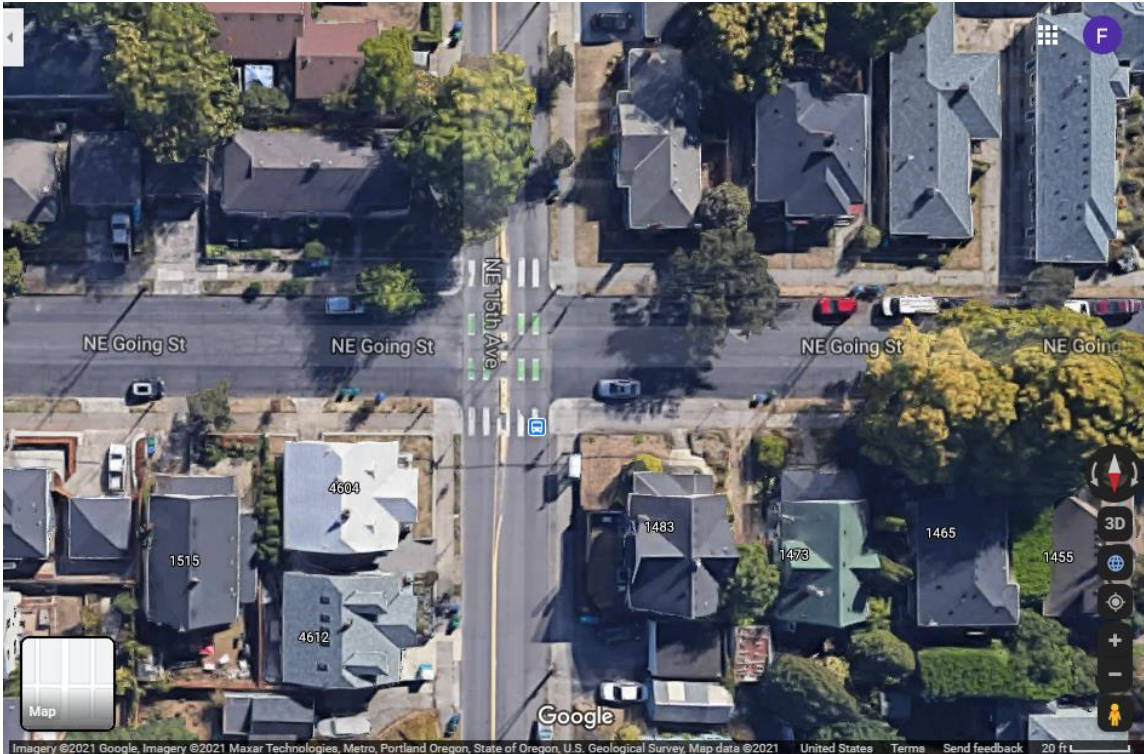
Figure 4: Plan view of NE Going & NE 15th Ave after marking. Source: Google Map

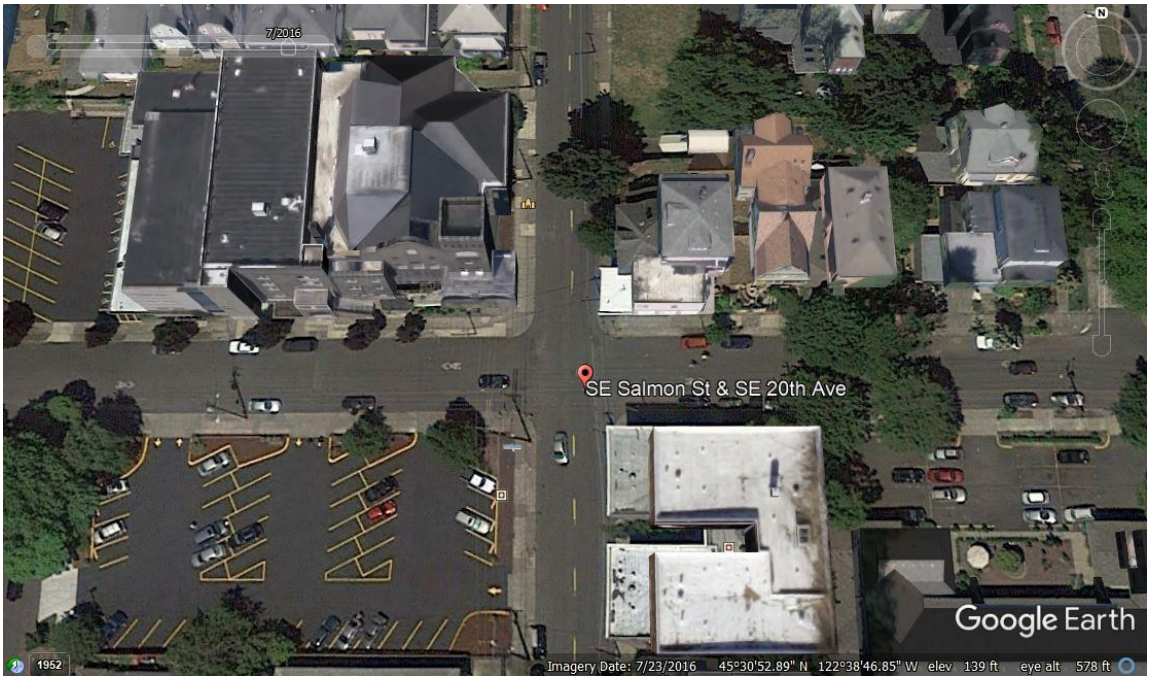
**Figure 5: Plan view of SE Salmon & SE 20th Ave. Source: Google Earth (2016).**

Also, a four-leg unsignalized intersection with a two-way road for all the approaches. All approaches have posted speeds of 25mph. SE 20<sup>th</sup> Ave is a north south roadway and serves a mixed traffic with average daily traffic of about 4,000 which are predominantly motor vehicles. SE Salmon is a bicycle boulevard. It serves average traffic of about 785 vehicles including bicycles. The site had no marked crosswalk on any of the approaches prior to the studies.

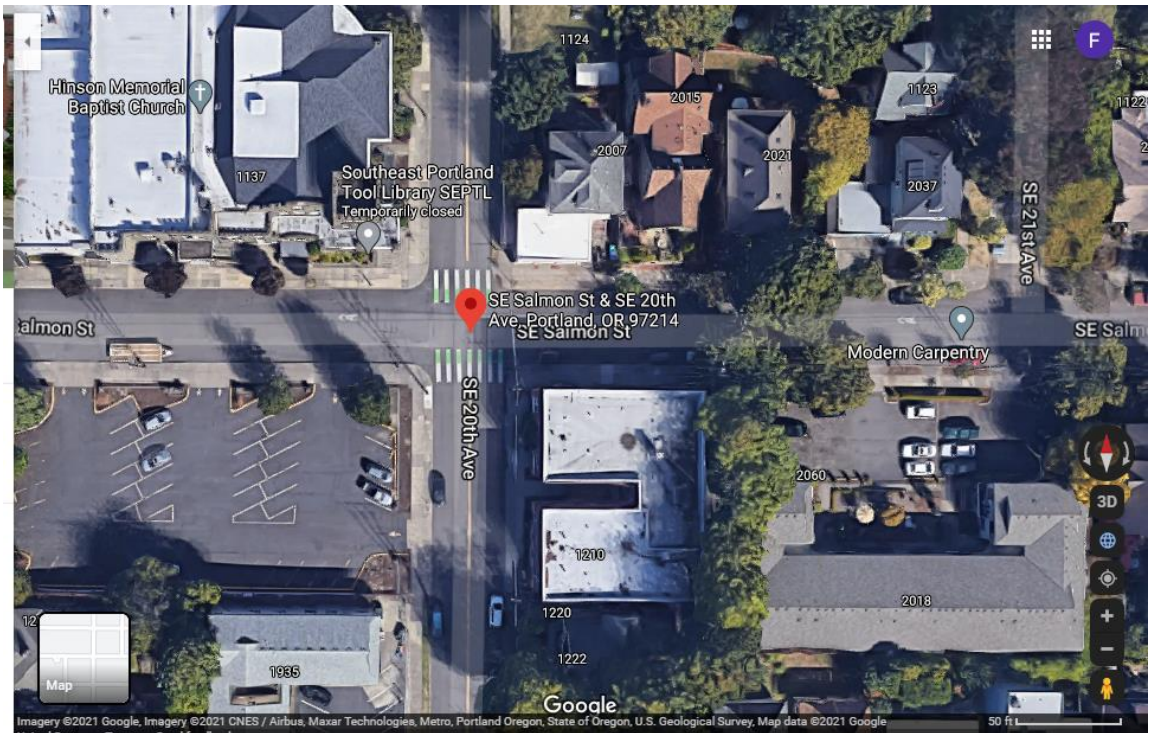
**Figure 6: Plan view of SE Salmon & SE 20th Ave after cross-bike marking. Source: Google Map Photo.**

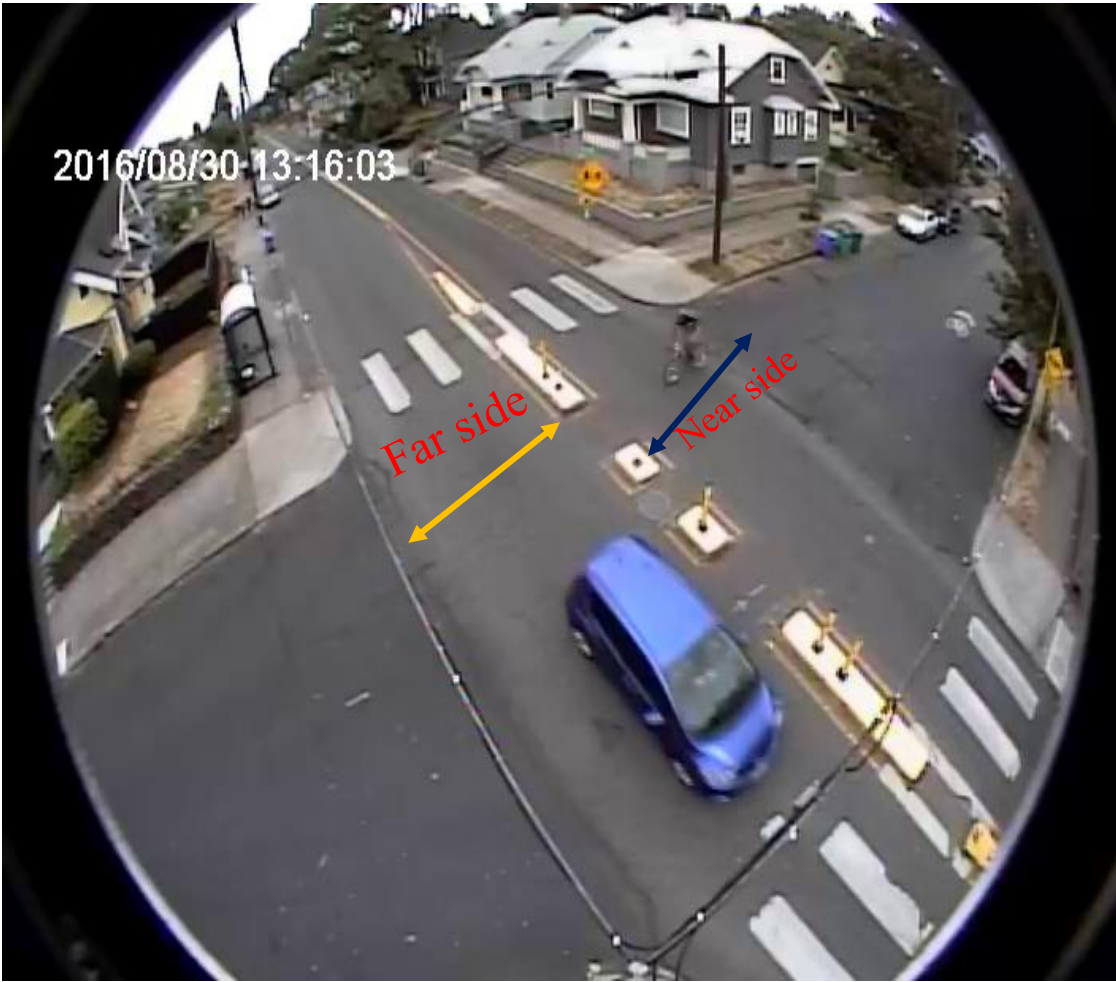
**Figure 12: Plan view of NE Going & NE 15th Ave illustrating near and far sides for a bicycle crossing.**

**Near & Far side:** Relative to the location of the waiting bicyclist, the near and far side at the crossing changes. The near side is usually the immediate lane where the cyclists waits for safe gap to cross the street. The figure below gives a pictorial detail of the positions being discussed. The lane adjacent the waiting cyclist is the near side while the lane where the blue car is the far side with respect to this bicycle crossing.

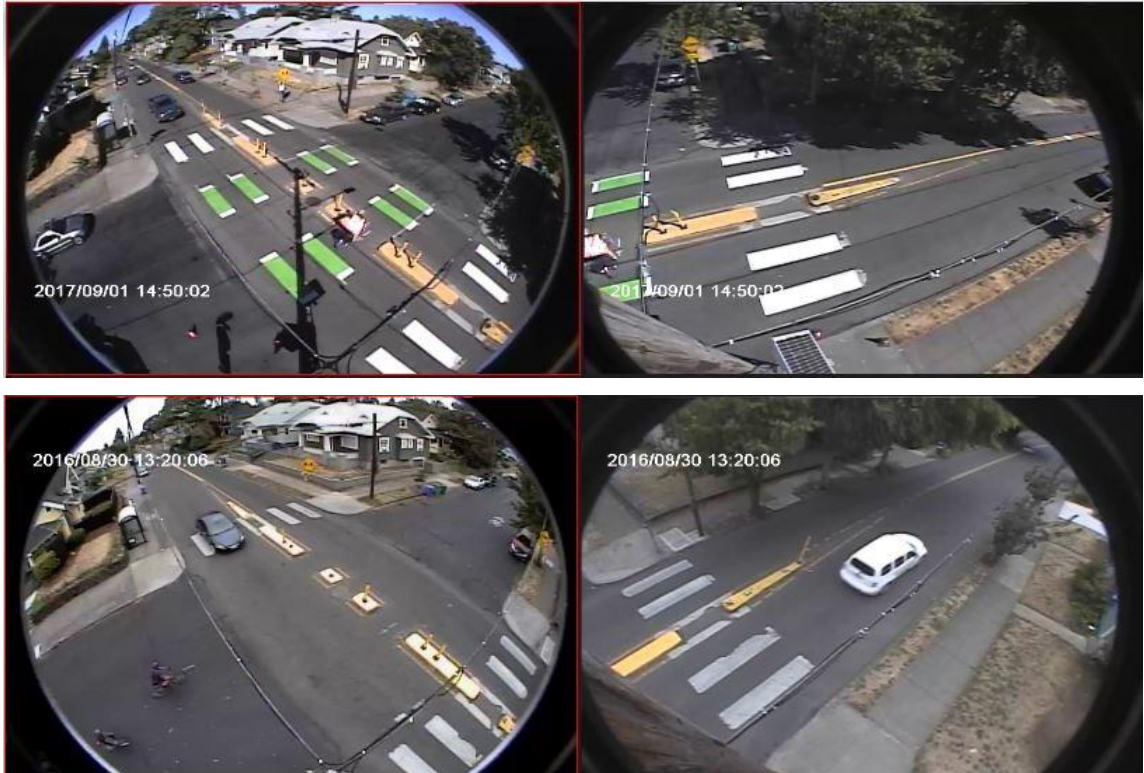
**Figure 13: View of data reduction at NE Going & NE 15th Ave for before and after cross-bike installation.**

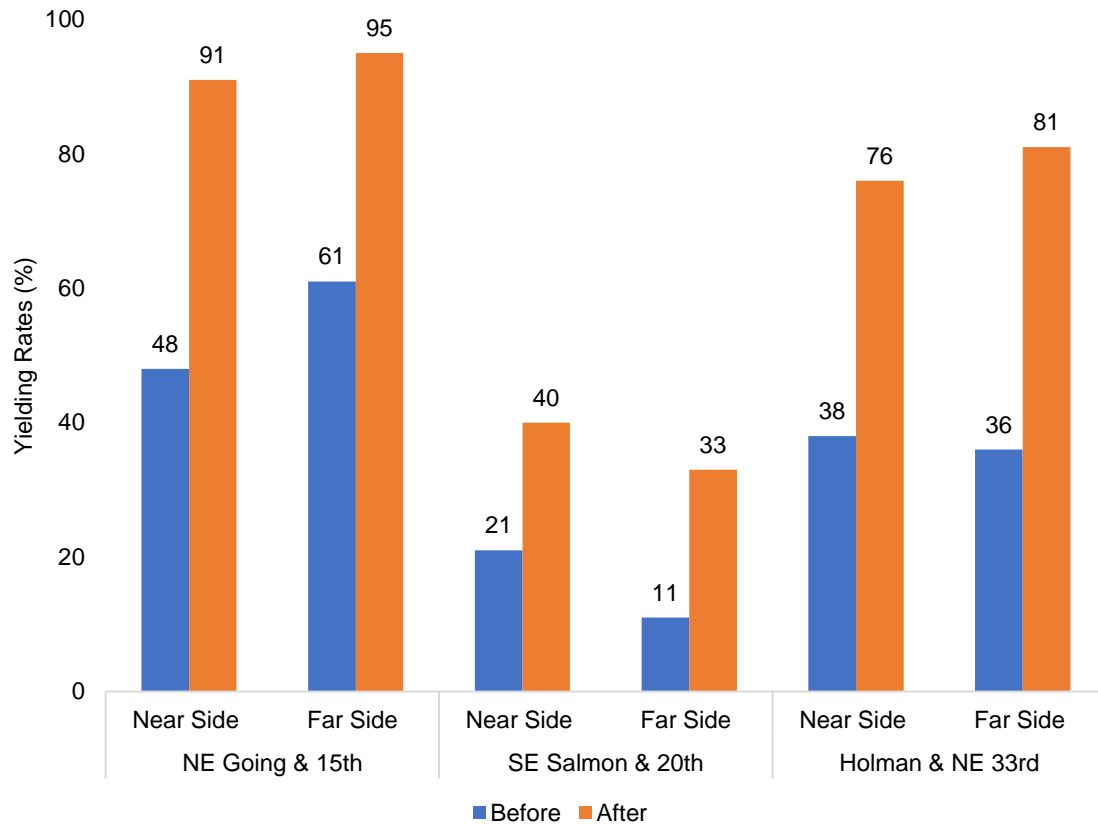
**Figure 17: Motorists yielding rates to bicyclists by site.**

Motorists yielding rates among the sites were compared to find out if there are any substantial differences in driver yielding behavior. The existing conditions at the sites differed in characteristics. SE Salmon and SE 20<sup>th</sup> was adopted to be the base model for which the other two sites were compared to. This site was assumed to be the base model because the existing site characteristics consisted of only two-way road with no marked crosswalk and median as compared with the other two sites. The before condition revealed that the rate at which motorists stopped for bicyclists were higher at NE Going and NE 15<sup>th</sup> Ave as well as Holman and NE 33<sup>rd</sup> as detailed in the table 10 below for near and far side.

Part of the reason for these higher rates of yielding could be the combined effect of marked crosswalk and median islands at these sites. Similar trend of higher yielding rates were observed after installing cross-bike at the intersection.

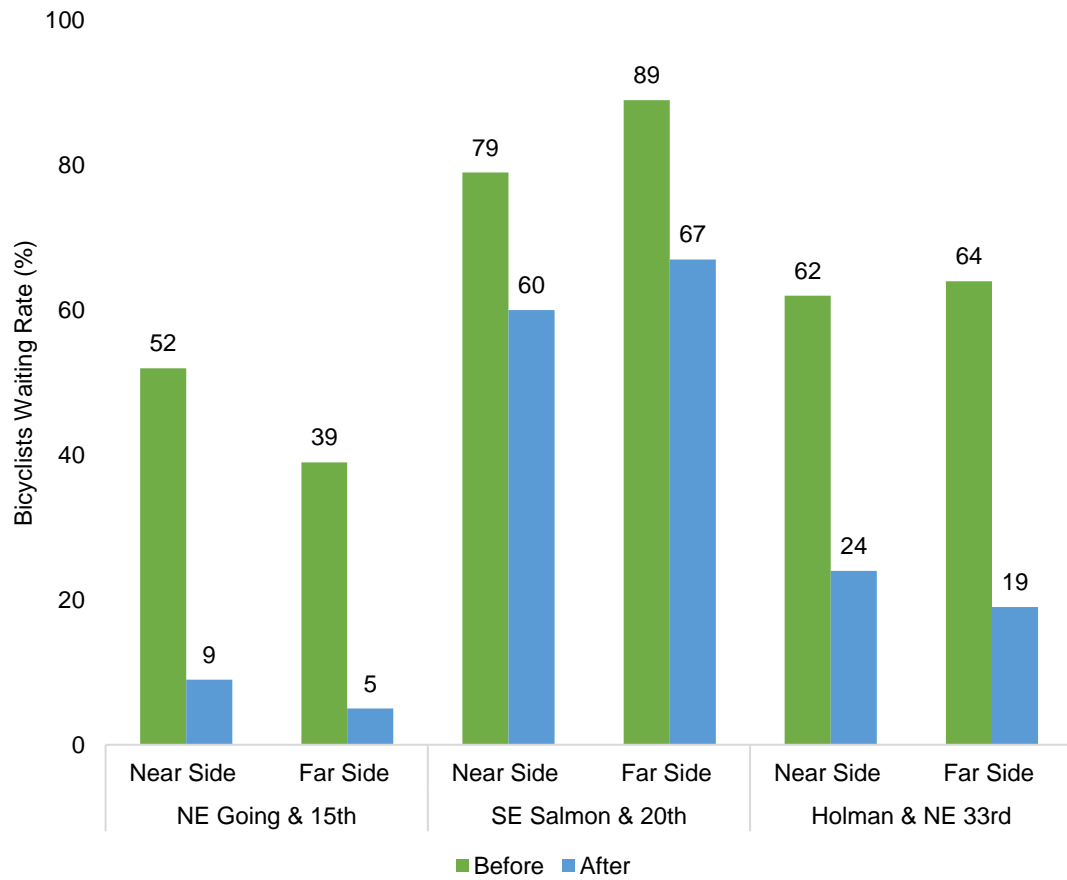
**Figure 18: Bicycle waiting rates analysis by site.**

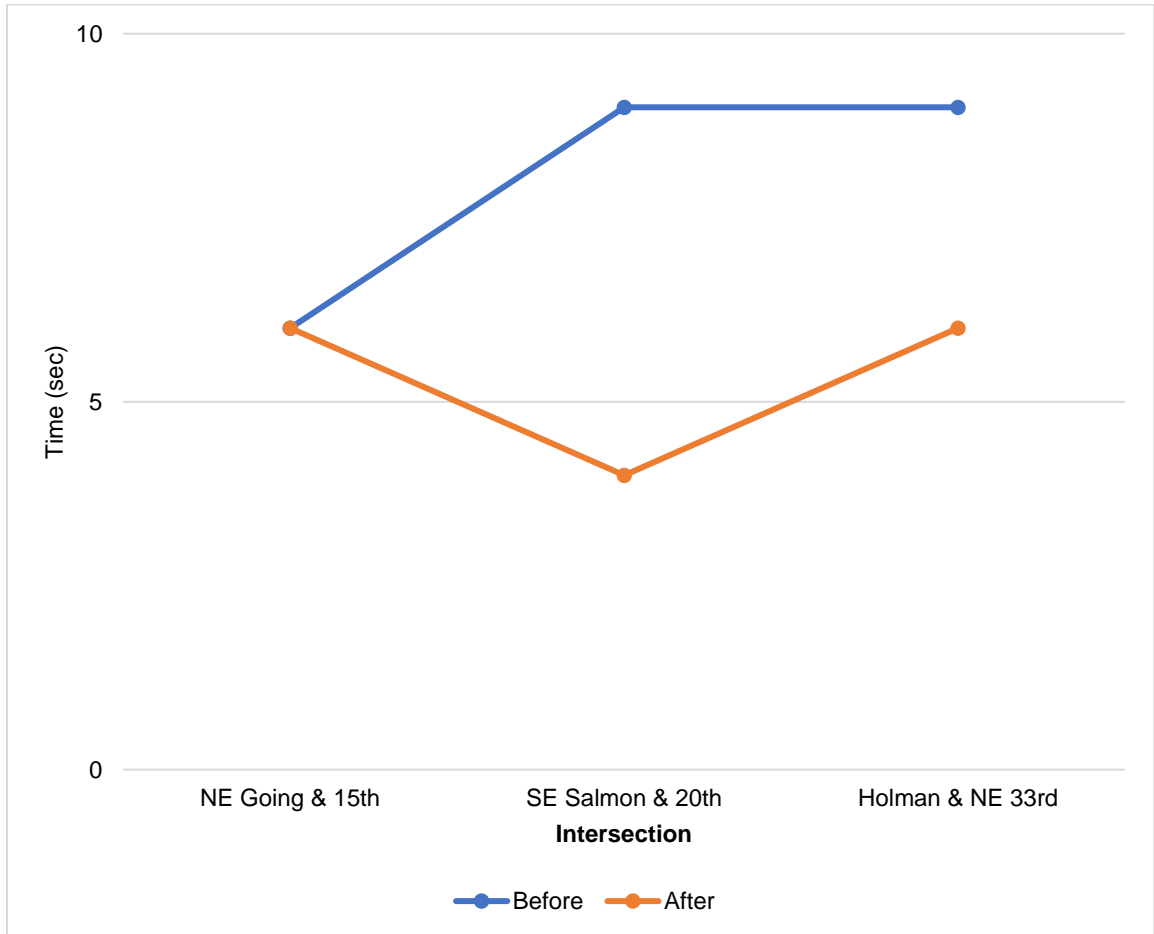
**Figure 22: Total average wait time by site.**

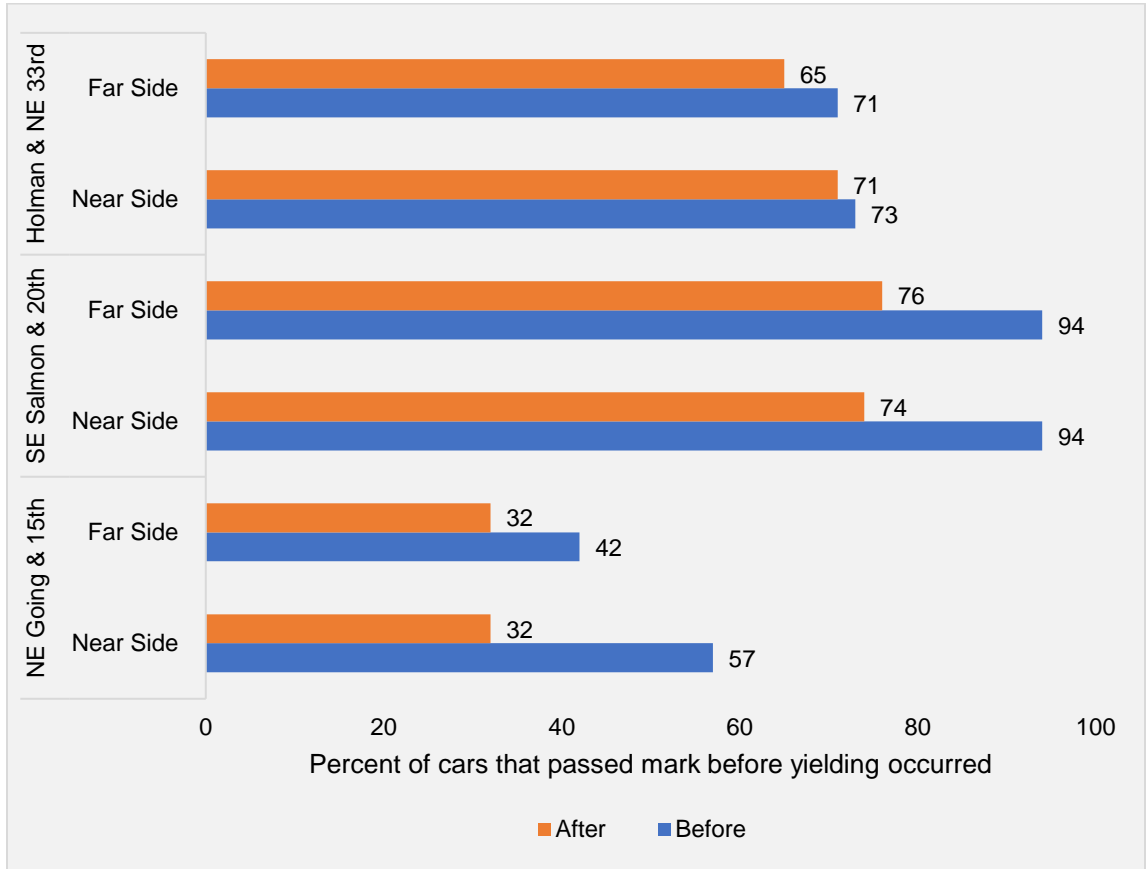
**Figure 23: Percent average number of cars that passed mark before yielding by site.**

The reduced data took record of the average number of cars that passed the mark before the cyclist gets a car to yield. This data was analyzed for the before and after improvement to evaluate if the treatment had a significant impact on the number of traffic that failed to yield for a waiting cyclist. The earlier discussion established a significant increase in motorists yielding rates after the treatment. However, the subsequent impact on the number of cars that passed the mark before first car yielded was not brought to light by the yielding rates. Evaluating the average number of cars that passed the mark before yielding occurred, it was revealed that each site recorded a substantial decrease in the number of cars that failed to yield. Figure 19 shows the percentage reduction in the number of cars that passed mark before yielding occurred. NE Going & NE 15<sup>th</sup> recorded a decrease in percentage from 57% and 42% in the near and far side for the before condition to 32% after the cross-bike marking was installed. SE Salmon & 20<sup>th</sup> also had high percentage of 94% for the number of cars that passed before yielding occurred being reduced to 76 %.
