Pressure Test Results Regarding Convolute Elbow Segments and Biomedical Monitoring

Pacific Spaceflight **Research Brief #2015-1**

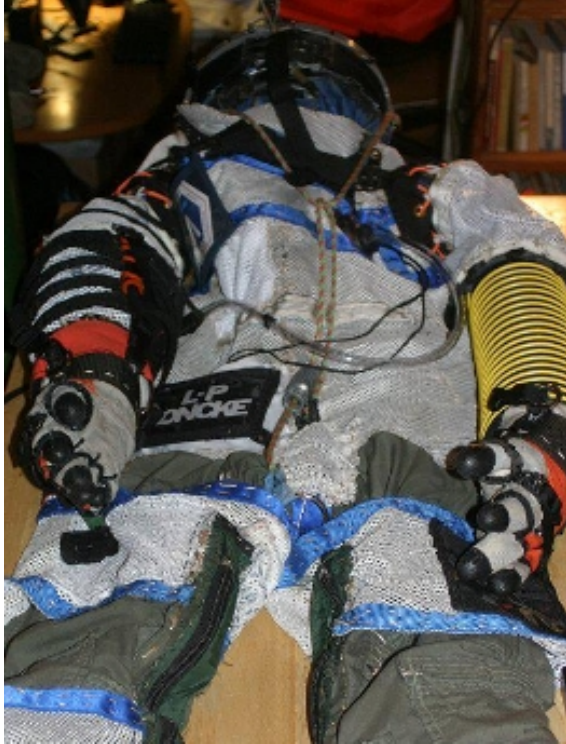
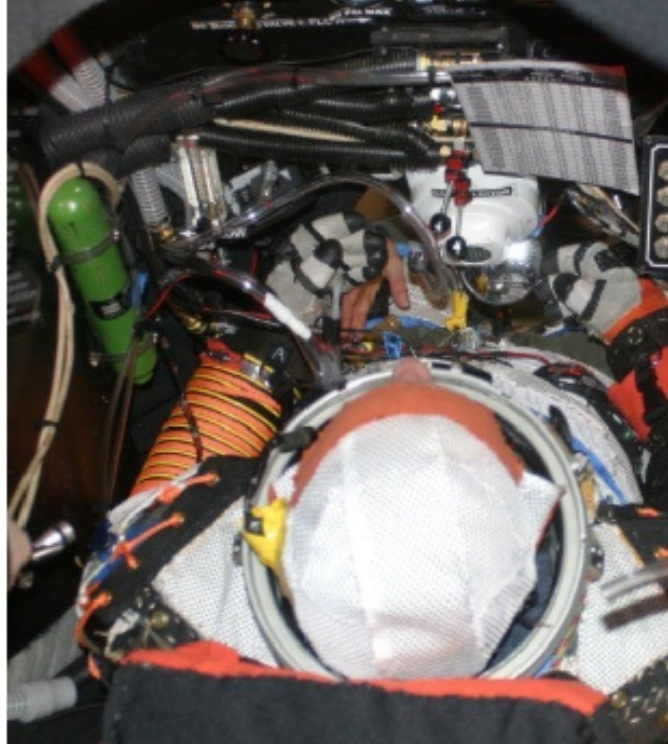
FIGURE 1. Pacific Spaceflight Model II/III Pressure Garment (Left) with lightweight, slim convolute elbow section installed on suit's L arm and older section on suit's R arm. Right photo shows suited person installed in Kazbek trainer.

At pressures above 1.8 psi the suited person evaluated ease of mobility of the elbow and wrist joints in both arms, the left being the newly-built convolute and the right being the convolute built in 2014 (**Figure 1**). Both allowed useful movement of the joints at this and higher pressures than in the Mark I garment, however the new (left) arm convolute was significantly less bulky and easier to flex and twist than the old (right) arm convolute. These are subjective evaluations that should be verified with a load-meter to quantify resistance to bending, but the overall impression is that the new convolute arm sections are radically less bulky and significantly more mobile at higher suit pressures than the older convolutes.

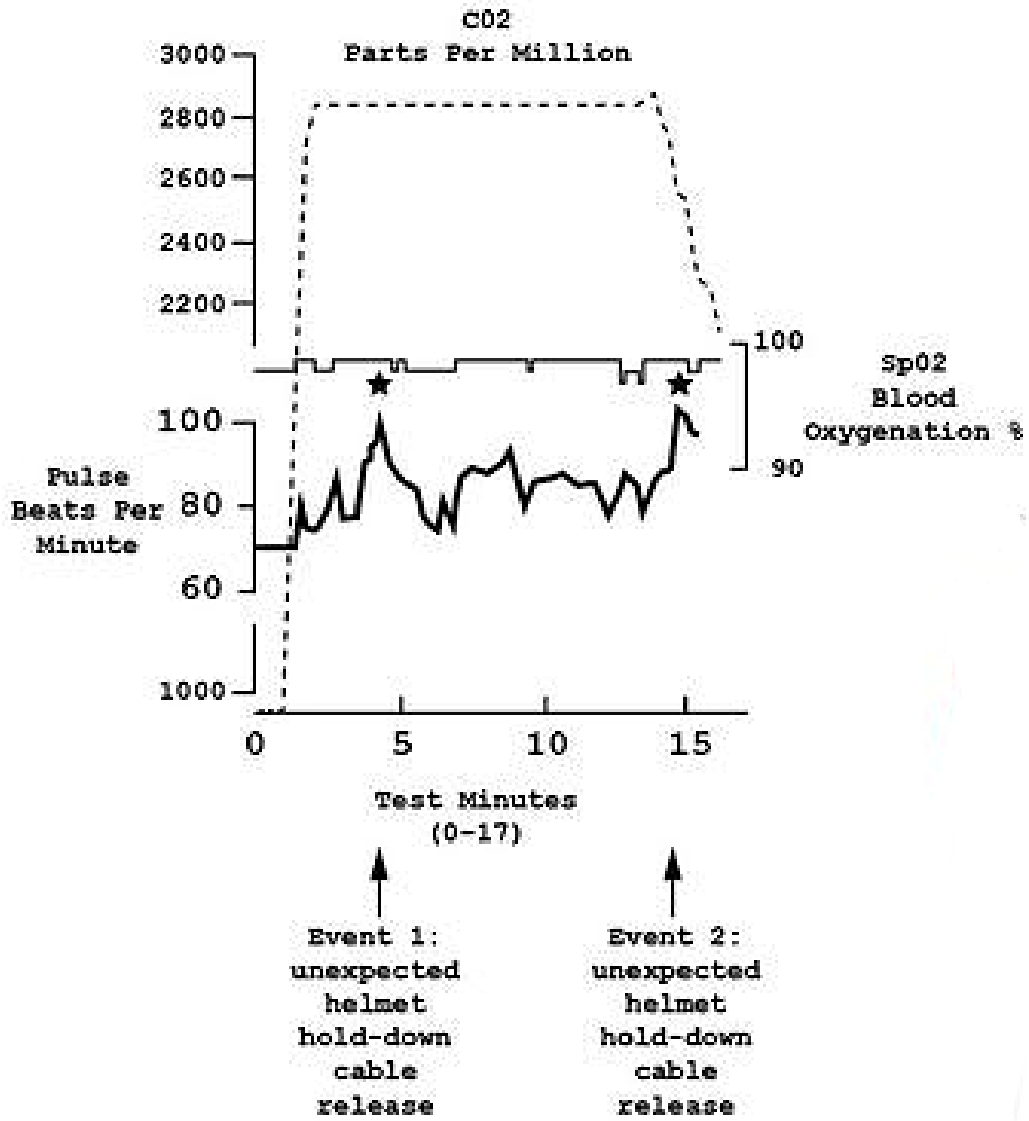
FIGURE 3. Biomedical data visualizations for 17-minute test reported here. See text for discussion.

A CONTEC CMS60D pulse oxymeter monitored and recorded the suit operator's blood oxygenation (SpO₂ %) and heart rate (Beats Per Minute) via an ear-clip reporting via a cable routed from inside the helmet through a gastight helmet port to the monitor unit and a PC screen installed in the Control Cabinet. The earclip was effective, but it was easily dislodged by movement of the head and should be secured to the ear with medical tape in the future. The audio and visual representations of these measures were effective monitors for AK to ensure normal physiology of the suited person. Recorded figures are seen in **Figure 3**.

Pulse averaged in the 70's to 80's (slightly higher than normal for the suited person), climbed rather steadily as the suited person increased suit pressure, anticipating the usual loss of mobility at these pressures, and then spiked (to just over 100 BPM) at both times that the helmet hold-down cable released unexpectedly (stars indicated in Figure 3). As suit pressure was relieved and the problem was understood, pulse returned to normal. Note that there is a slight data dropout of pulse less than 2 minutes before the end of the test.

Blood oxygenation was a normal figure for the suited person (98-99%) throughout the test, with perhaps momentary drops immediately after helmet hold-down cable release events, though it is not clear if these are causally correlated.

An RAD-0301 Miniature CO₂ and Temperature Monitor was used to monitor suit gas exhausted from the suit through its manual pressure setting valve installed inside the Kazbek trainer. Data recorded are seen in **Figure 3** and discussed below.

Although the CO₂ scrubbing system pumps were run during the test (to monitor their power consumption rates and to test the gastight properties of their various chambers and hoses), the scrubbing chamber contained no CO₂ absorption medium. Thus, high CO₂ levels were noted throughout the test, averaging just over 2800 parts per million, a figure that if
