Rapid Repair of Seismically Vulnerable Bridge Columns Following Earthquake Induced Damage

RAPID REPAIR OF SEISMICALLY VULNERABLE BRIDGE COLUMNS FOLLOWING
EARTHQUAKE INDUCED DAMAGE

MASTER OF SCIENCE
IN
CIVIL AND ENVIRONMENTAL ENGINEERING

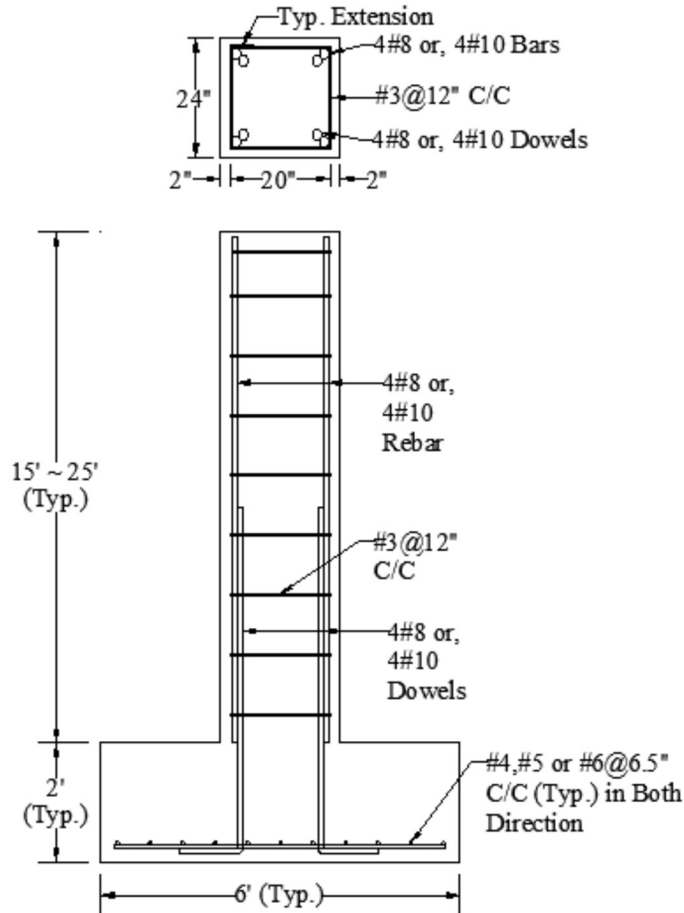
Figure 3.1: Typical substandard ODOT bridge column (Murtuz, Dusicka, & Schumacher, 2020)

Reinforced concrete bridges columns built in Oregon before 1990 are generally considered to be seismically substandard. Reinforcement detailing does not meet modern code requirements leaving them vulnerable to seismic events. To define a typical substandard bridge, SPR #802 investigated data from the National Bridge Inventory and ODOT. It was concluded that the most common type of concrete bridge in Oregon is the Concrete Continuous Stringer/Girder (CCSG) bridge. SPR #208 reviewed drawings of 113 CCSG bridge substructures and established a typical detail for reinforced concrete bridge columns built in Oregon prior to 1990. The typical detail is illustrated in Figure 3.1

The typical column is part of a multi-column bent; in most cases a two-column bent. The typical column has a square cross section, 2ft by 2ft, with a height between 15 and 25 feet. Longitudinal reinforcement is typically 4 #8 bars or 4 #10 bars placed at the column corners. Transverse reinforcement consisting of #3 rebar is spaced at 12 inches – significantly further than modern code permits. The column is connected to the footing through dowels that have a moderate splice length (between excessively short and modern splice length). The typical footing reinforcement consists of a single layer mat at the bottom whereas modern detailing requirements usually include a cage with a second rebar mat at the top of the footing.

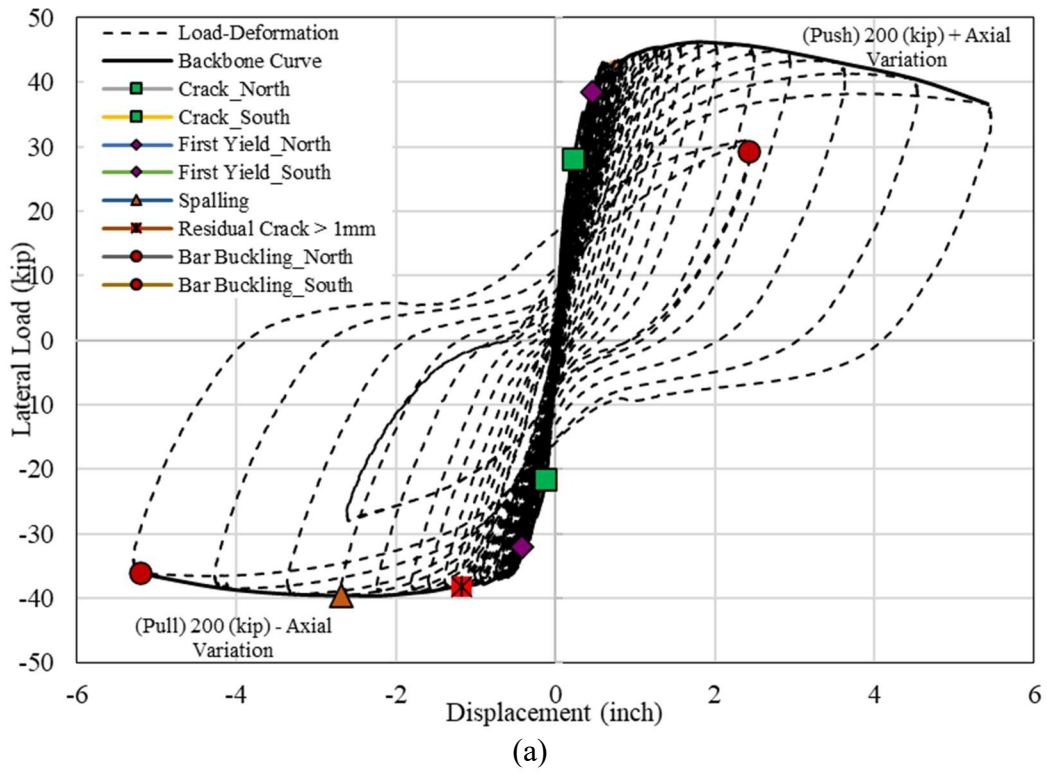
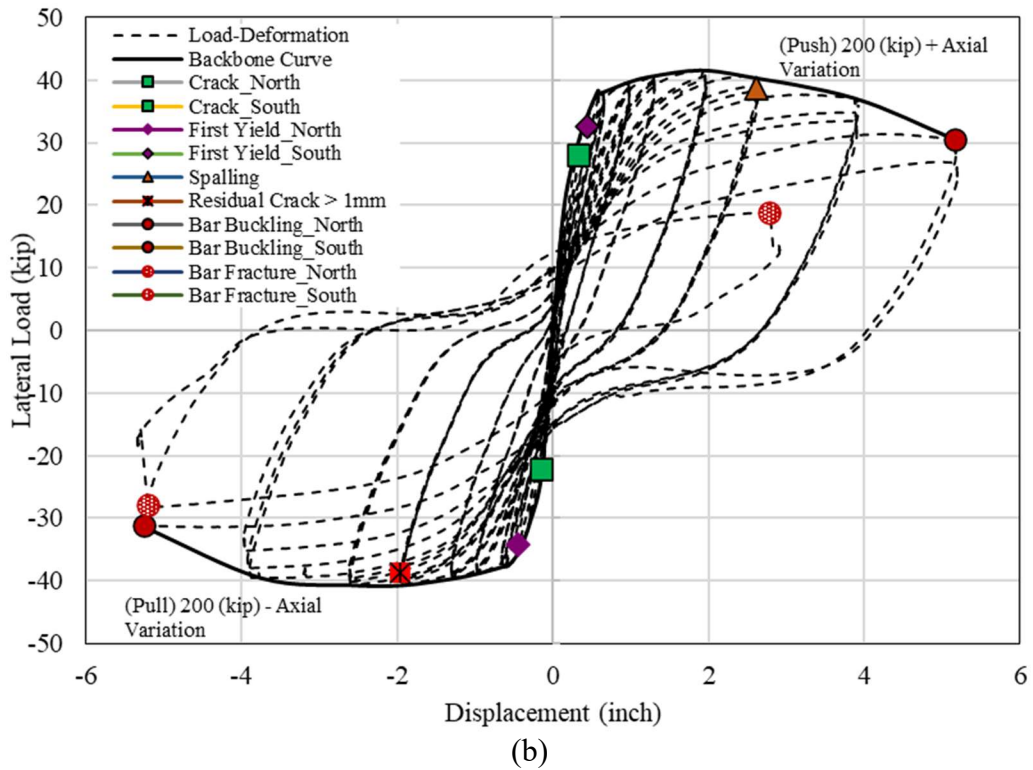
Figure 3.6: As-built performance of substandard column (a) specimen SVF#8, (b) specimen LVF#8 (Murtuz, Dusicka, & Schumacher, 2020)

The cyclic hysteresis of specimen SVF#8 and LVF#8 are shown in Figure 3.6 (a) and (b), respectively. The peak lateral loads were 44.9 kips and 40.3 kips. The difference in peak load between positive and negative displacements can be attributed to the variation in axial load. Both specimens demonstrated strength degradation of more than 15% at large drift angles.

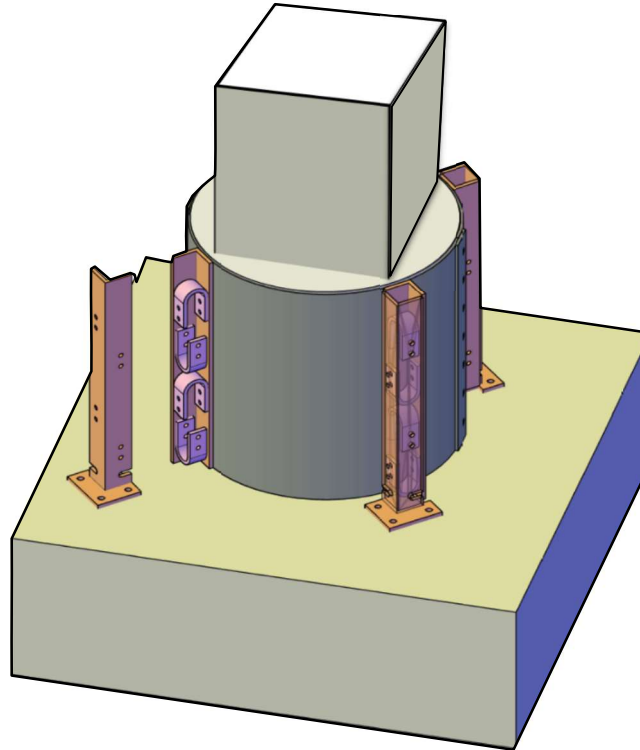
Figure 4.1: Proposed Repair Methodology

The adopted repair concept is to utilize a short external steel collar that is used to encase the damaged parts of the column. The collar utilizes externally attached ductile fuses to bypass the damaged zone and connect to the rest of the bridge to restore the lateral capacity. The advantage of this approach is bypassing the internal rebar continuity within the damaged zone, which can significantly simplify the repair, and also provides control over the strength of the hinging by selecting appropriately sized ductile fuses. The number of fuses and their individual capacity then controls the behavior, leaving the rest of the repair to be relatively generic. Figure 4.1 is an

illustration of the proposed repair methodology. In this illustration, one of the hold-downs is pulled away from the jacket, exposing the arrangement of ductile fuses.

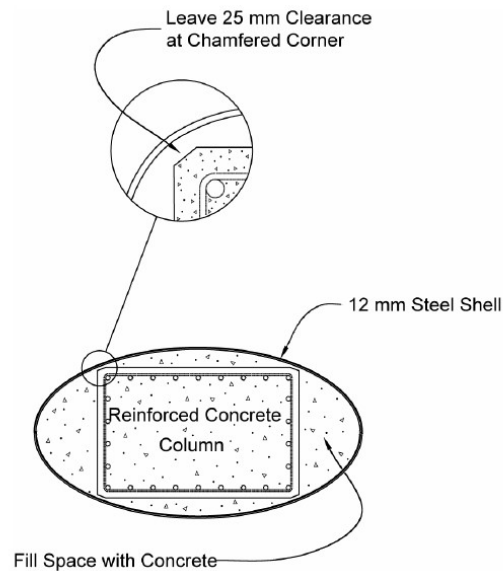
Figure 4.2: FHWA steel shell recommendations (Buckle, et al., 2006)

The Seismic Retrofitting Manual for Highway Structures (Buckle, et al., 2006) suggests that the steel jacket be comprised of two steel plate half-shells that are rolled to a diameter large enough to leave 1 inch of clearance at the corner of the column. Figure 4.2 illustrates the clearance space required at the column corners. The purpose of this clearance space is to allow the flow of grout around the corner of the column. However, the manual also suggests for grout to be poured from all four openings as to not rely on the flow of grout around the corners. For repair of the 24-inch square test specimen, a shell diameter of 36 inches was selected, leaving a clearance space of approximately 1 inch at each corner.

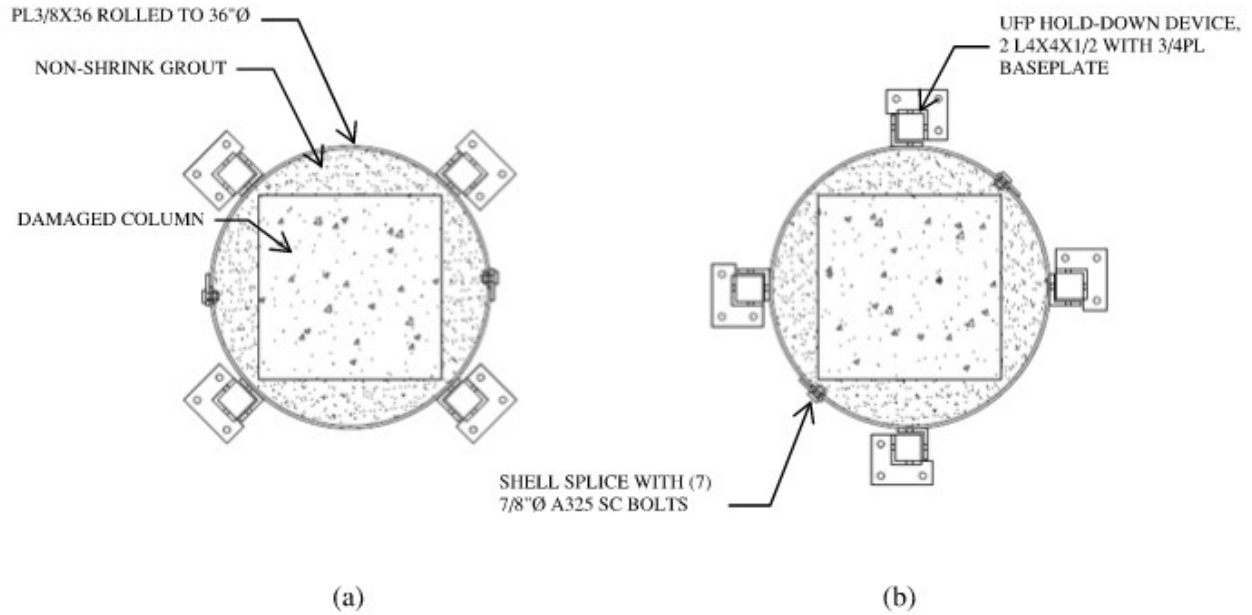
Figure 4.3: Hold-down orientations (a) corner orientation (b) face orientation

Figure 4.3 illustrates two possible orientations of the hold-downs around the column. In Figure 4.3 (a), the hold-downs are oriented at the column corners and will be referred to as corner orientation, while Figure 4.3 (b) has the hold-downs oriented at the column faces and will be referred to as face orientation. Hold-down orientation has performance implications because it alters the lever arm distance for each hold-down. Both corner and face orientation were tested as part of this study and the performance implications were explored.

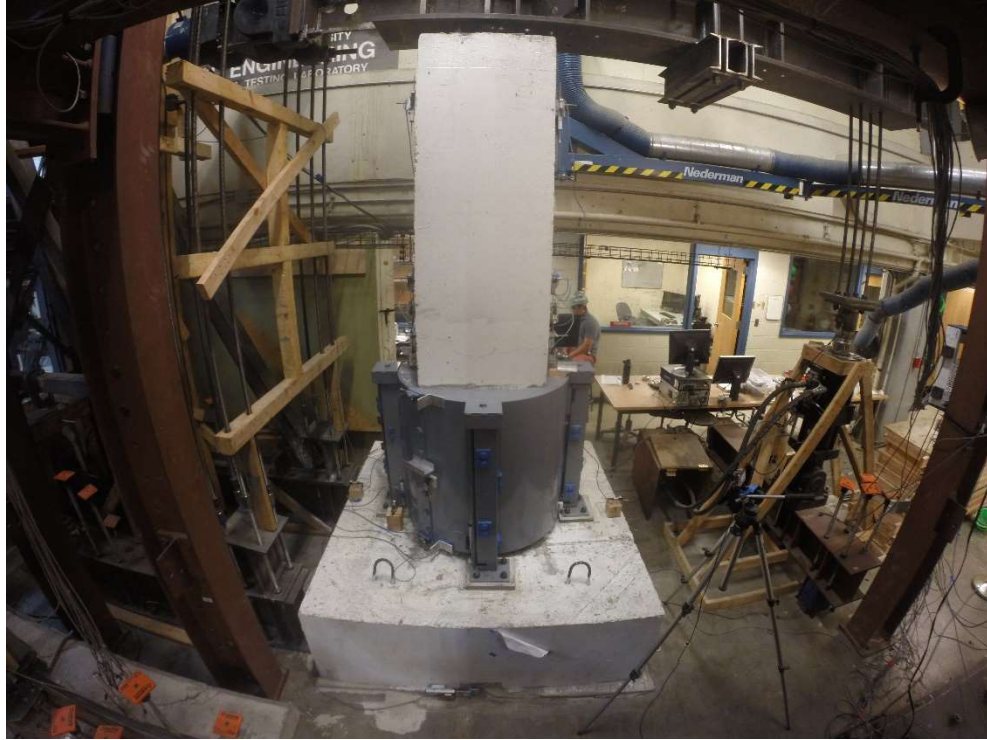
Figure 5.14: Test 2 initial state

- (1) Oversized holes and plate washers - the first repair revealed constructability issues due to bolt hole alignment tolerances. It was found that imperfections in UFP bend geometry and zero tolerance from welded nuts created misalignments between bolt holes. Installation was difficult and time consuming. To improve constructability and reduce assembly time, oversized holes and plate washers were added to the exterior leg of the hold-down. This resulted in a much easier and faster installation.

- (2) Reduced section plastic hinge – A reduced section was introduced at the base of the exterior hold-down legs. 1 ½ inch slots with a ½ inch radius were cut into the legs of the L4X4X1/2, reducing its cross-sectional properties to that of a L2-1/2X2-1/2X1/2. This hinge allows the hold-down to rotate with the column and shell, while limiting flexural forces to the previously failed weld.

For the second test, specimen LVF#8 was repaired using the face orientation and the three design modifications were implemented. The standard laboratory lateral loading protocol was used for both the as-built test, and the repaired test. The hold-down UFP's were the same as test 1, PL1/2X2-1/2 grade A36 steel with a bend diameter of 3.25 inches. The expected maximum hold-down force was also the same as test 1, 32.7 kips. However, the expected maximum lateral load was 48.9 kips which is an increase due to the hold-down orientation. The repaired specimen and test setup are pictured in Figure 5.14 in its initial state before testing.

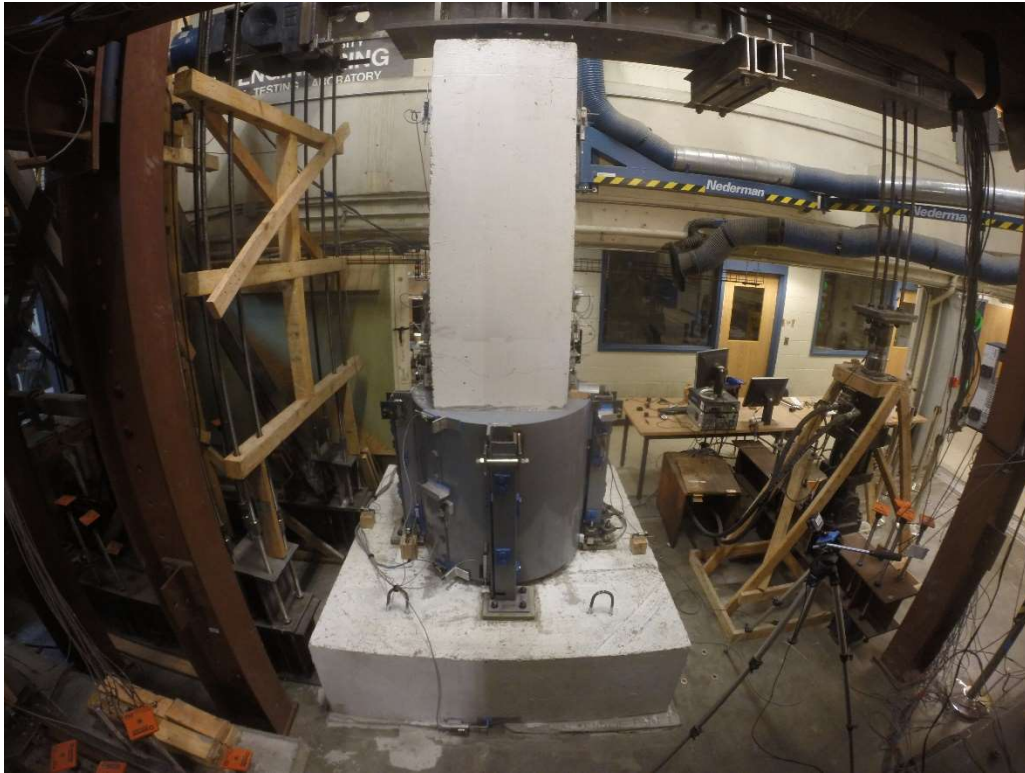
Figure 5.17: Test 3 initial state

- (a) The third test was a repeated repair on specimen LVF#8. The shell remained attached to the column in face orientation. Only the hold downs were replaced. The hold-down UFP's were the same as test geometry as test 1 and 2, PL1/2X2-1/2 grade A36 steel with a bend diameter of 3.25 inches. The subduction zone loading protocol was used. The repaired specimen and test setup are pictured in Figure 5.17 in its initial state before testing. The hold-down rollers functioned as intended, preventing separation of the hold-down legs.**

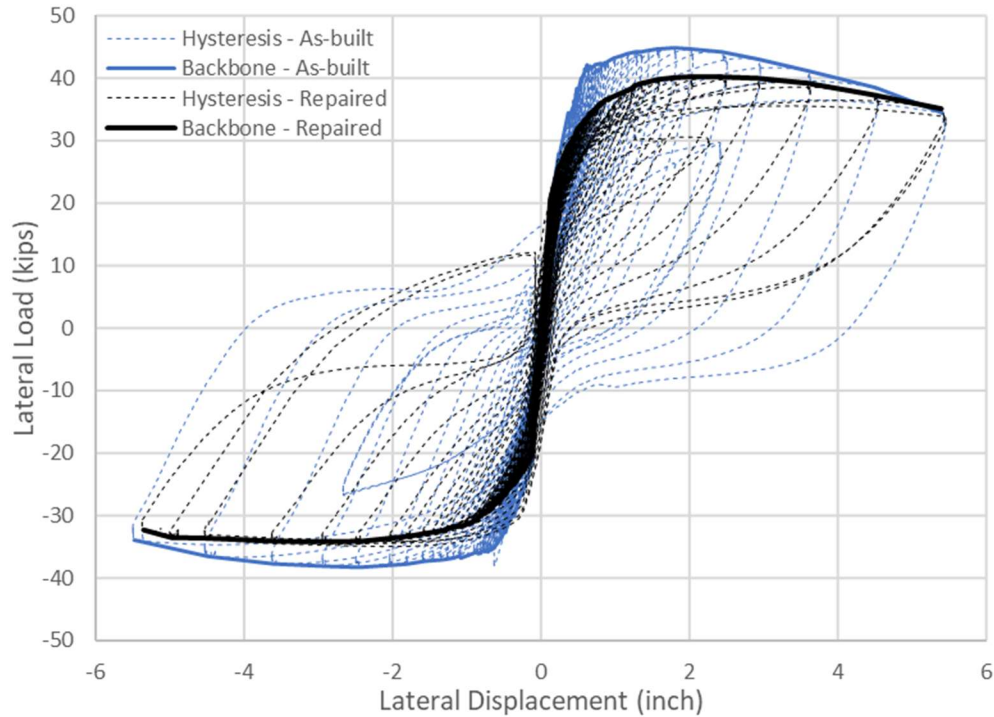
Figure 5.20: Test 1 Hysteresis

The lateral load-displacement response for test 1 is shown in Figure 5.20. The peak lateral load from the as-built column was 44.9 kips and the target peak lateral load was 46.4 kips. The peak lateral load measured from the repaired test was 40.2 kips, 13.3% less than target. The hysteresis shows self-centering behavior. On the return cycles, as the lateral displacement is returned to zero, the lateral load approaches zero. This behavior is a result of the location and magnitude of the axial force, working to restore the column to its original position.

There are two negative displacement cycles on the repaired column test which are different than the rest. These cycles occurred when the axial load actuator stroked out and axial load was lost. Following these two cycles, the test-setup was adjusted, and the test continued. These cycles can be observed in the hysteresis on Figure 5.20 where the load decreases to 0 at a displacement of approximately -2.75 inches and does not follow the typical self-centering behavior of the hysteresis.

The repaired column shows less strength degradation than the as-built column. At the maximum displacement of 5.4 inches, the as-built column lateral load has degraded to

approximately 77% of its peak while the repaired column maintains approximately 85% of its peak lateral load.

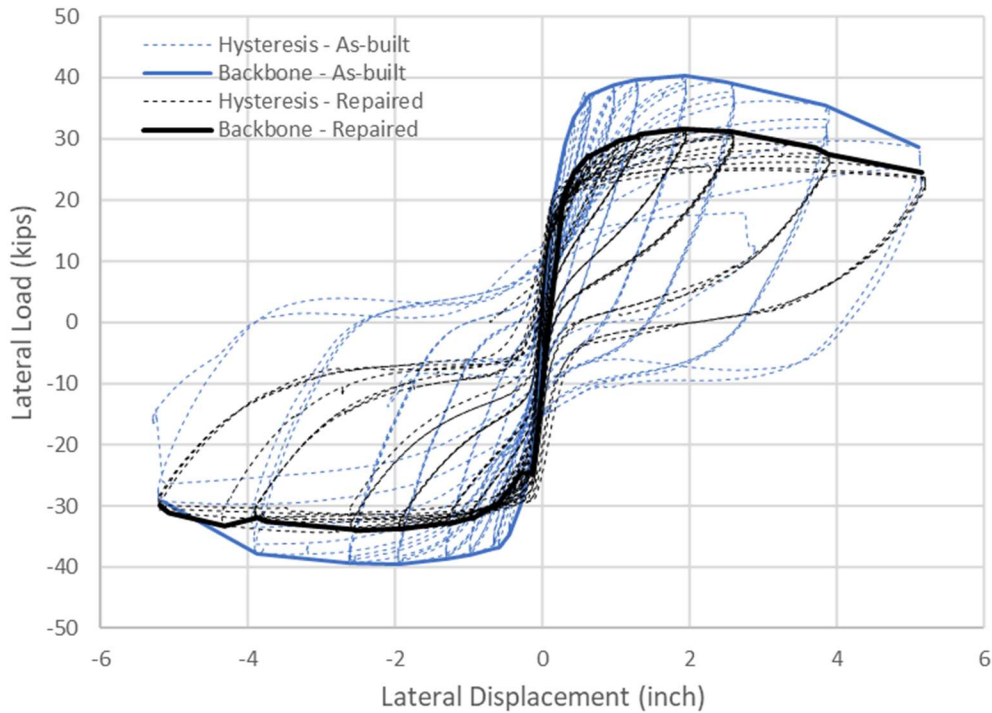
Figure 5.21: Test 2 Hysteresis

The second specimen was repaired for Test 2 and the conventional ACI lateral loading protocol was used for the as-built column test and the repaired column test. The repair was oriented with the hold-downs at each face of the column and the hold-down caps were installed. The lateral load-displacement response for Test 2 is shown in Figure 5.21. The as-built column had a peak horizontal load of 40.3 kips, and the expected lateral load based on the static analysis is 48.9 kips. The measured peak lateral load for the repaired column was 31.6 kips, 35% less than expected and 21% less than as-built. Test 2 showed

greater strength degradation than Test 1. At the final cycle displacement of 5.4 inches, the strength degradation was 25% compared to 15% in Test 1.

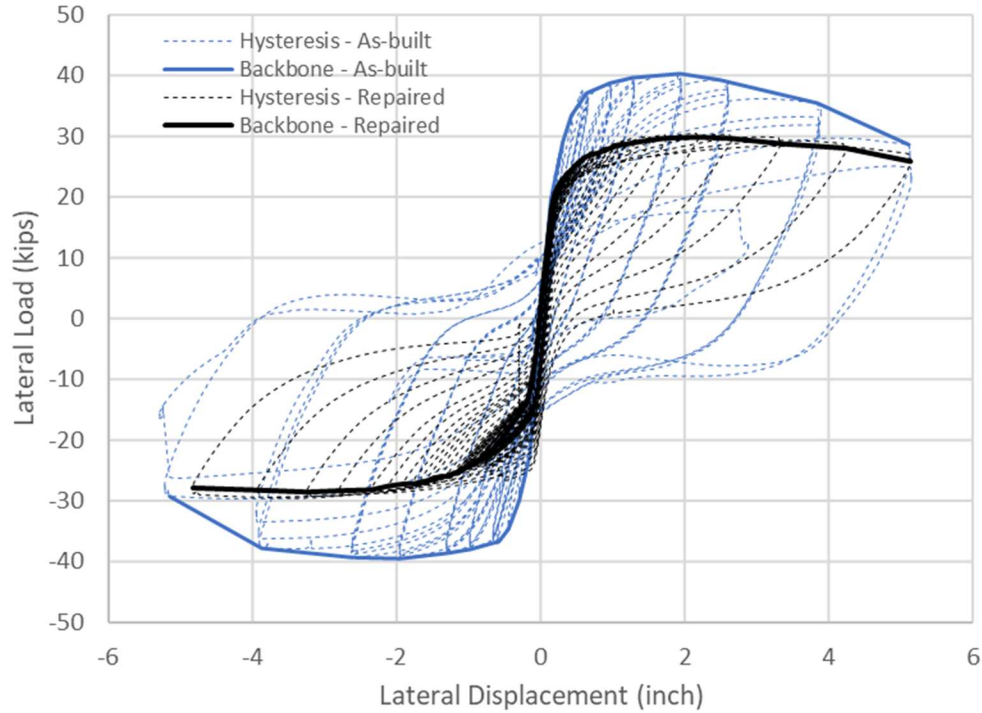
Figure 5.22: Test 3 Hysteresis

After Test 2, new UFPs were installed and the specimen was used again for Test 3. The UFP's matched the geometry of those in Test 2. Therefore, the as-built peak horizontal load and expected repaired peak horizontal load are the same as Test 2, 40.3 kips and 48.9 kips respectively. The differences between Test 2 and Test 3 are the addition of the hold-down rollers and the cyclic history of the specimen. The lateral load-displacement response for Test 3 is shown in Figure 5.22. The measured peak lateral load for the repaired column was 30.5 kips, 37% less than expected based on the static approach and 24% less than as-built.

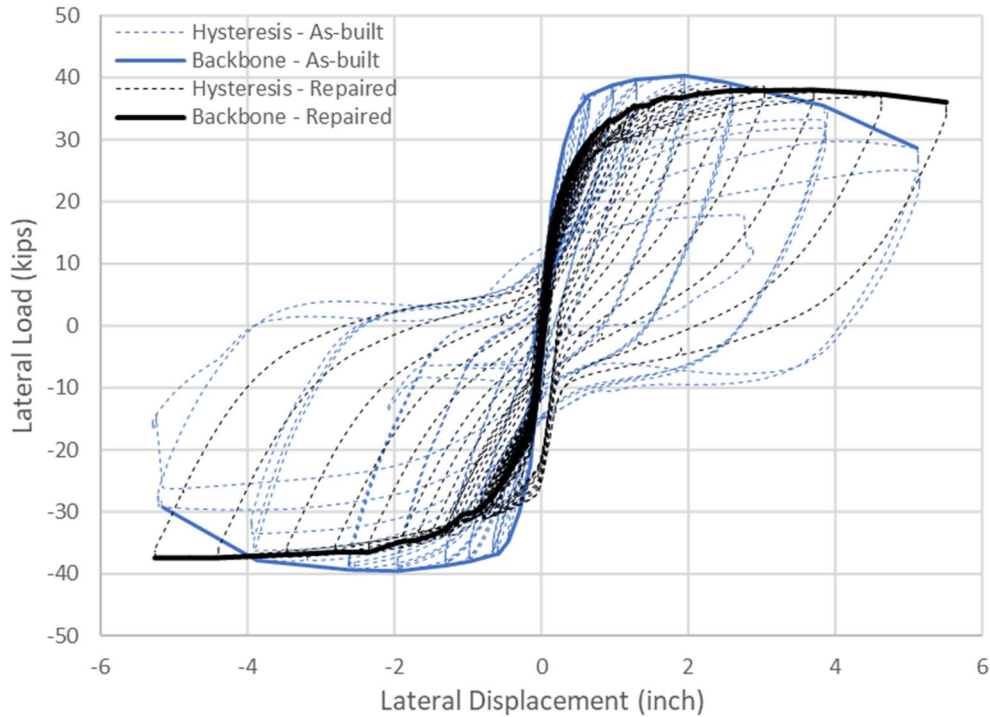
Figure 5.23: Test 4 Hysteresis

The repair for Test 4 utilized the same specimen from Test 2 and Test 3; however, Test 4 was designed to increased lateral capacity. The UFP thickness was increased by 1/8th inch which results in an expected hold-down force of 53 kips, 62% greater than the previous three tests. The lateral load-displacement response for test 4 is shown in Figure 5.23. The peak lateral load measured from the repaired test was 38.6 kips, up from 30.5 kips in the previous test.

The increase in hold-down strength reduced the self-centering behavior which was observed in the previous tests. The hysteresis shows that on the return cycles, as the lateral displacement is returned to zero, the lateral load does not return to zero. This behavior is a result of increased hold-down strength and the plastic deformation. The axial force is not enough to restore the hold-downs to their original position.
