Factors for Improved Fish Passage Waterway Construction

**FACTORS FOR IMPROVED FISH
PASSAGE WATERWAY
CONSTRUCTION**

Final Report

**SPR 654
OTREC-RR-11-19**

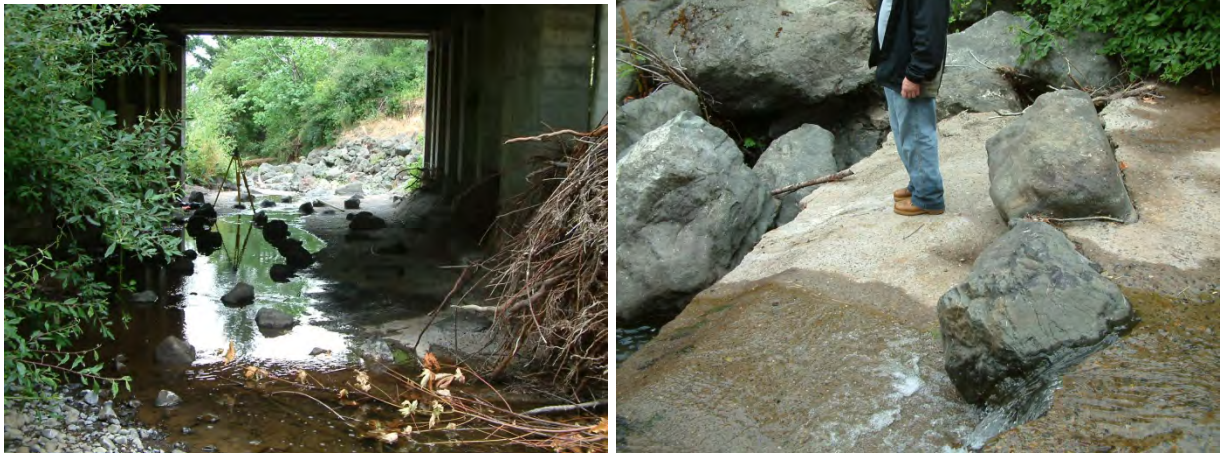
Figure 4.4: Site 01 – Gooseneck Creek upstream and downstream

Gooseneck Creek is located in Polk County; it is a roughened channel under a bridge carrying Highway 22 at Mile Post (MP) 3.97. The area under the bridge is concrete, embedded with boulders. The concrete seems to have been cast in two sections since there are two jumps created at the end of the concrete bed downstream. The downstream and upstream channels have a large accumulation of gravel and cobble (Figure 4.4).

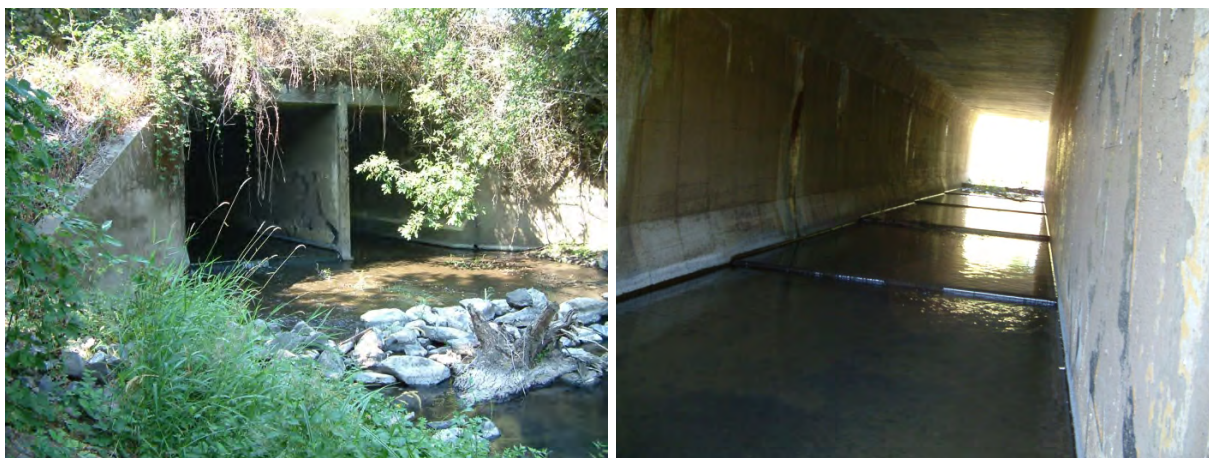
Figure 4.6: Site 04 – Oak Creek downstream and structure

Oak Creek was conveniently located within the city of Corvallis in Benton County, and it crosses Highway 20 at MP 55.16. Access to the creek is not very obvious, since the upstream side is steep, while the downstream side is covered by blackberry bushes. The upstream side has an accumulation of silt and was very deep. It was very difficult to measure depth and cross-sections upstream with the available field equipment. The structure consists of two rectangular culverts, one with baffles. Cross-sections could not be measured at the downstream side due to vegetation. Photos of the Oak Creek site are shown in Figure 4.6.

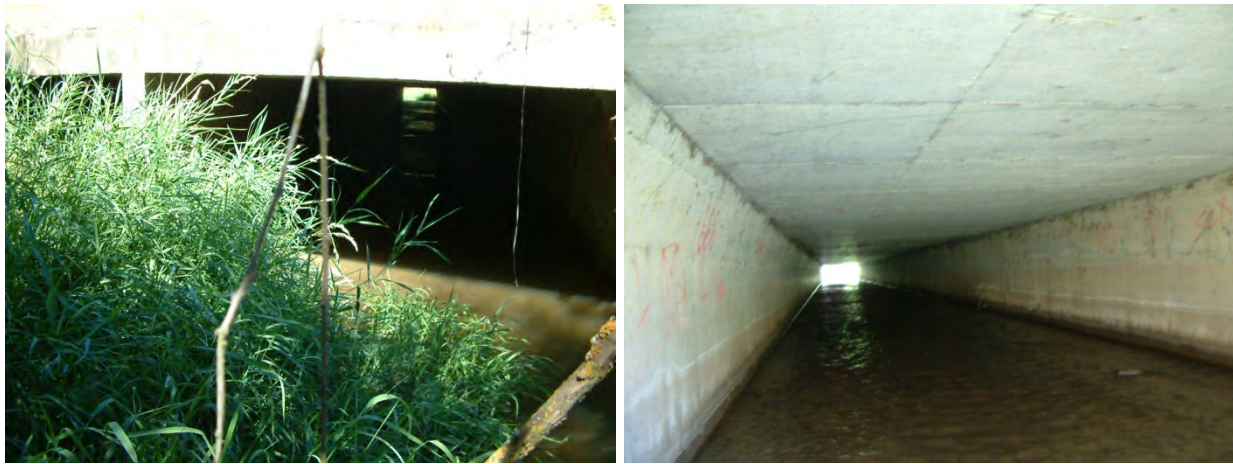
Figure 4.7: Site 06 – Griffin Creek downstream and structure

Griffin creek is located in Jackson County. Griffin Creek is reached by following an exit from the interstate towards Blackwell Road and then following an unnamed gravel road. The local authorities blocked the road in order to clear the area of transients; for that reason, the only way the investigators could access the road was from Interstate 5, and only after crossing the protective fence separating the Interstate from the surrounding area. The site had a large amount of vegetation and the cross-sections could not be measured. The structure consisted of two culverts, one of which had baffles and weirs, while the other had no flow due to gravel and sand accumulation in the culvert. Accumulation of gravel and sand was evident in the culvert that was carrying water also. Photos of the Griffin Creek site are shown below in figures 4.7 and 4.8.

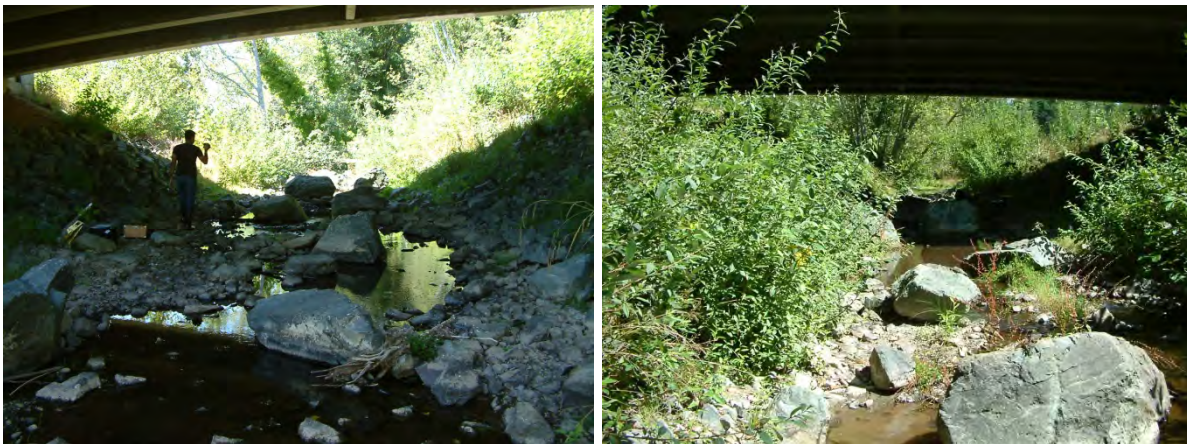
Figure 4.16: Site 14 - Bethel Creek under structure and downstream

Bethel creek is located in Coos County and crosses highway 101 at MP 284.79. The site was easily accessible, but the investigators had to jump the protecting fence separating the highway from the surrounding area. Access to the creek was from upstream. There were no major concerns about the area and river cross-sections were taken. Views of the structure are shown below in Figure 4.16.

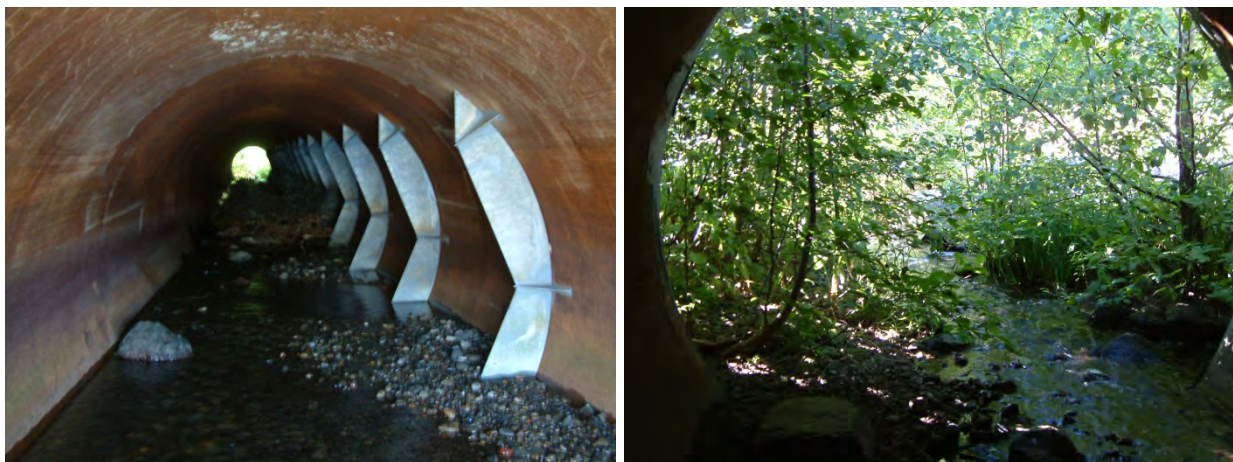
Figure 4.20: Site 18 - Perham Creek structure and upstream

Perham Creek is located in Hood River County and crosses Interstate 84 at MP 57.67. It has a relatively easy access from the upstream side of the river (Figure 4.20 right). Due to increased vegetation, the slopes and the river cross-sections could not be measured. The outlet of the culvert is located in the south bank of the Columbia River. Fish passage through the culvert, and up into the creek drainage, depends on the stage of the Columbia River being high enough to backwater the culvert outlet.

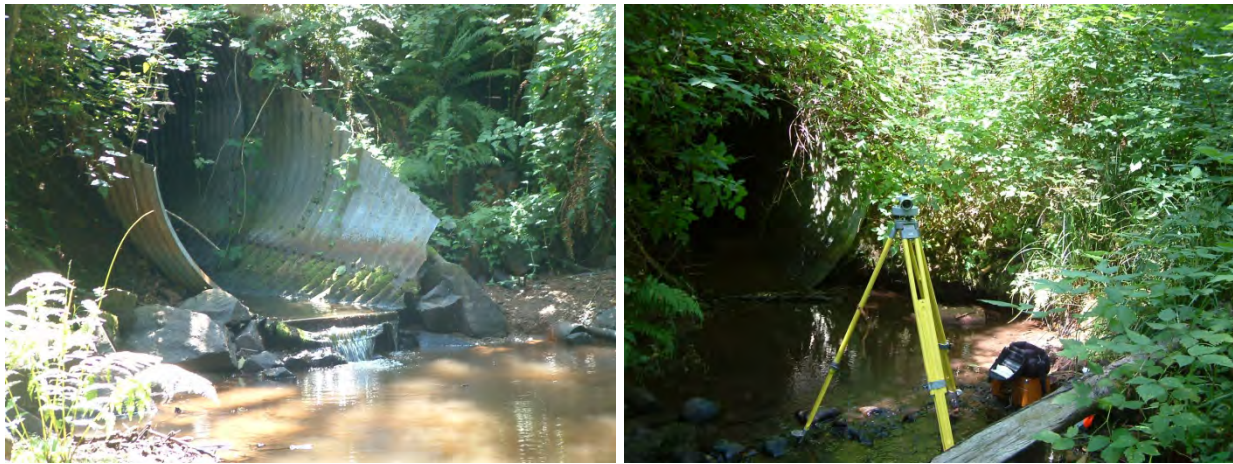
Figure 4.22: Site 20 - Tickle Creek downstream and upstream

Tickle creek is located in Clackamas County and crosses Highway 26 at MP 21.89. Access to the culvert is not obvious from the highway, and the researchers spent some time trying to find an alternative access; the sides of the highway have steep banks and the creek is at a much lower elevation. The great amount of vegetation did not allow visual observation of the creek from the highway. The creek was finally accessed from upstream (Figure 4.22 right) after asking for permission for a resident to pass through his land. Elevations and measurements were taken for the upstream side. The downstream (Figure 4.22 left) was accessed through the culvert, which was 477 feet (145 m) long. Cross-sections were not possible due to heavy bank vegetation.

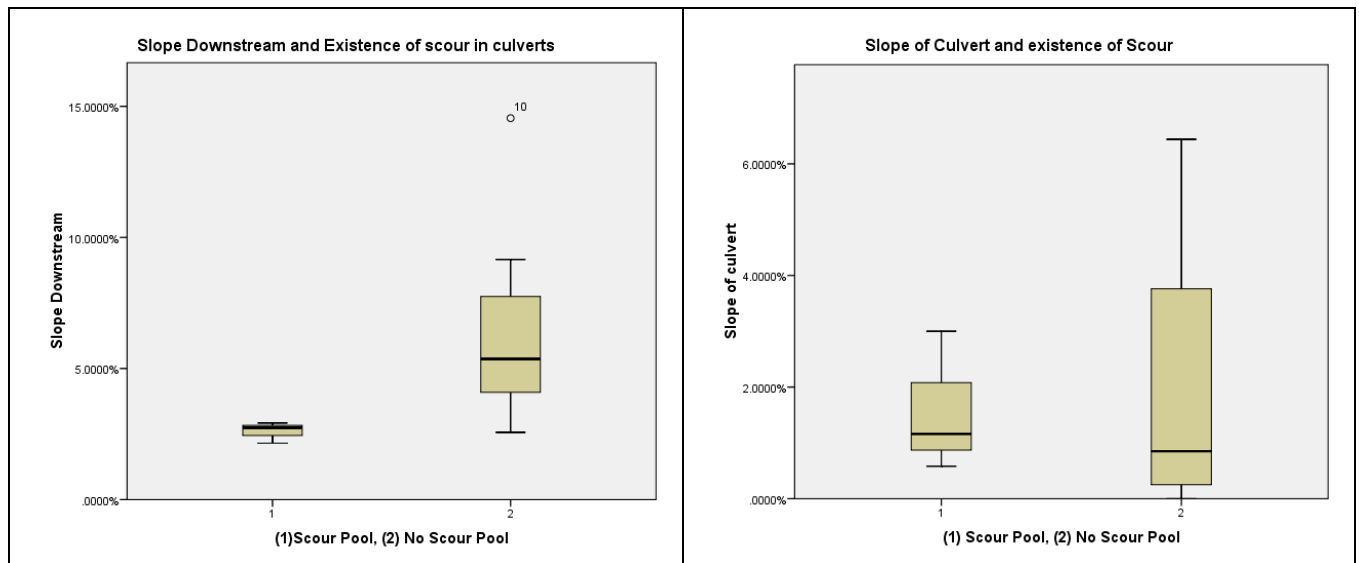
Figure 5.7: Waterway system slopes vs. scour

As observed in Figure 5.7, when the downstream slope is high, scour pools were less likely to be observed. Scour pools were only observed when the downstream slopes were low; ranging between 2.15% and 2.74%. This may be an indication that low slopes streambeds must absorb high velocity flows and for that reason turbulent conditions exist at the culvert outlets, which cause scour.

As noted in Figure 5.7, scour was present when the downstream portion of the streams had low slopes. Scour occurred in a number of locations where the downstream slope is very low; ranging between 2.15% and 2.74%. The streambed downstream at low slopes needs to absorb a

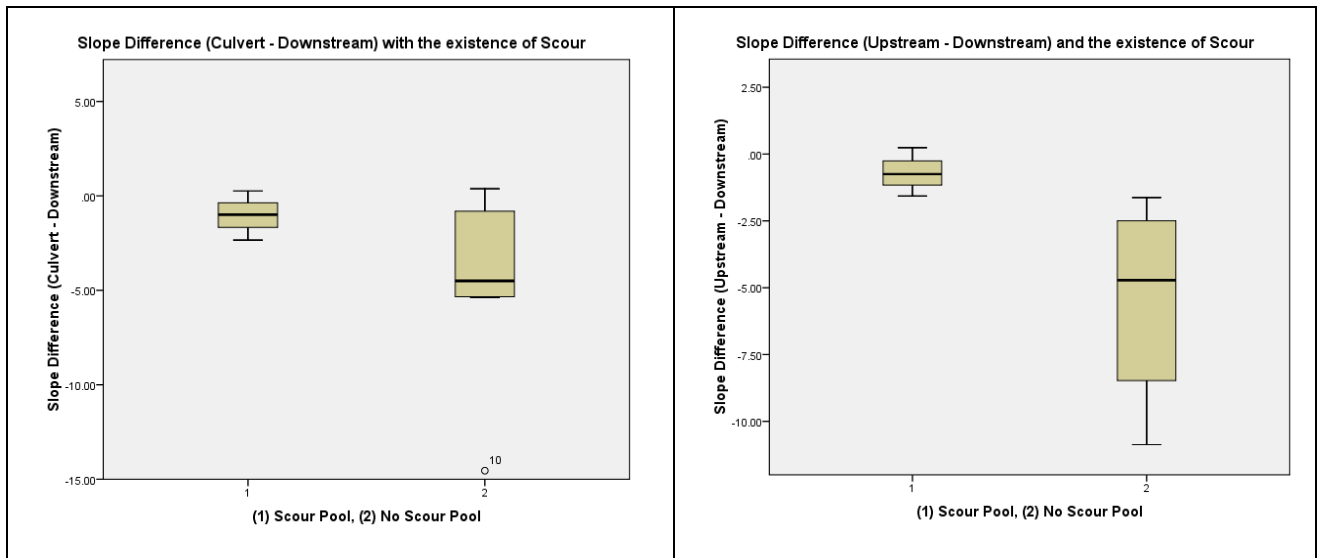
Figure 5.8: Slope Differentials vs. scour

The first Slope Differential relationship with scour reported here is the difference between the slopes of the culvert and the downstream sections of the stream. It is observed in Figure 5.8 that scour was present when there was very little difference in slope between the structure and the downstream. All the sites that had experienced scour were within the range of slope difference between -2.34% and 0.26%. Structures that did not have scour had a range of slope differentials from -14.55% to 0.38%. This suggests that there is a lower likelihood for scour to exist when the slope of the downstream portion is greater than the slope of the culvert.
