# The Engineering Geology of the Fountain Landslide, Hood River County, Oregon

Susanne L. D'Agnese  
*Portland State University*

Title: The Engineering Geology of the Fountain Landslide  
Hood River County, Oregon.

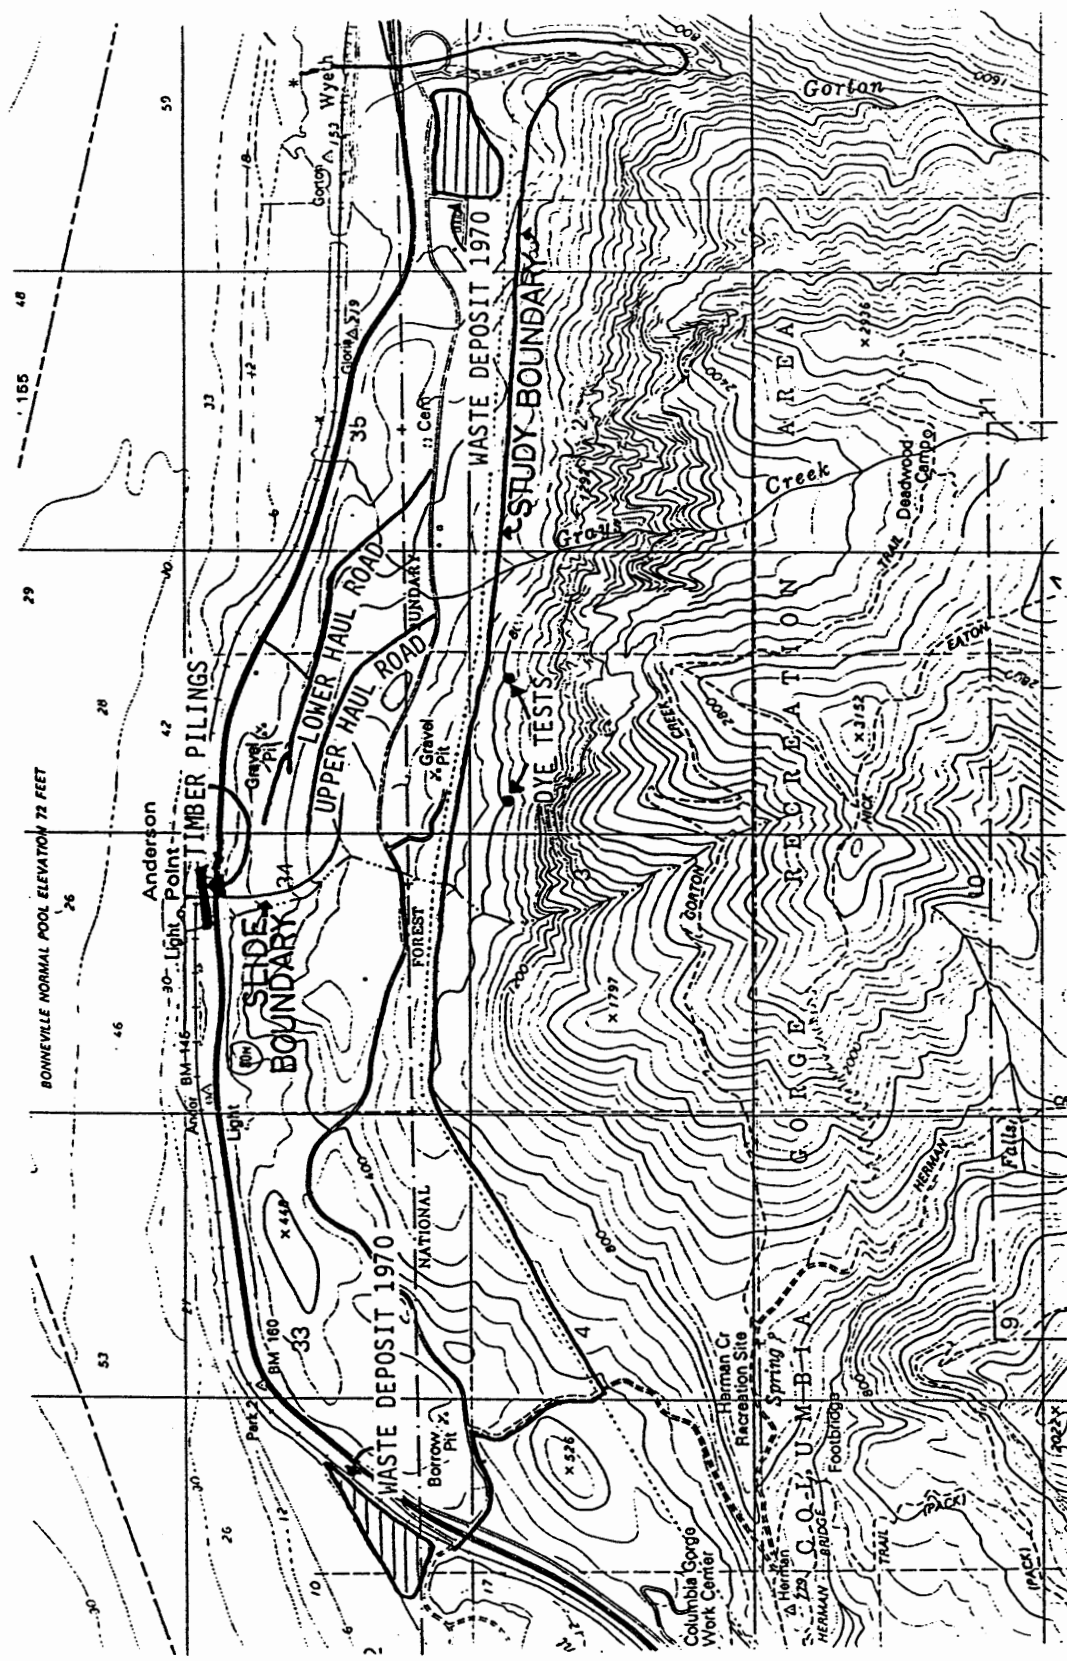
Figure 6. Location of timber pilings, die test, and the waste deposit and haul roads, 1970.

repair. The amount eventually paid to the Union Pacific Railroad was estimated from limited data files at the Oregon State Highway Division to exceed \$2000 and was probably much higher. Track movements were eventually stopped when the Oregon State Highway Division drove two sets of timber piling buttresses (personal communication Mr. Dennis, 1983), shown on Figure 6.

into the talus south of the landslide (see Figure 6 for test locations). No trace of the dye was ever found. The test results were inconclusive as to where this water traveled.

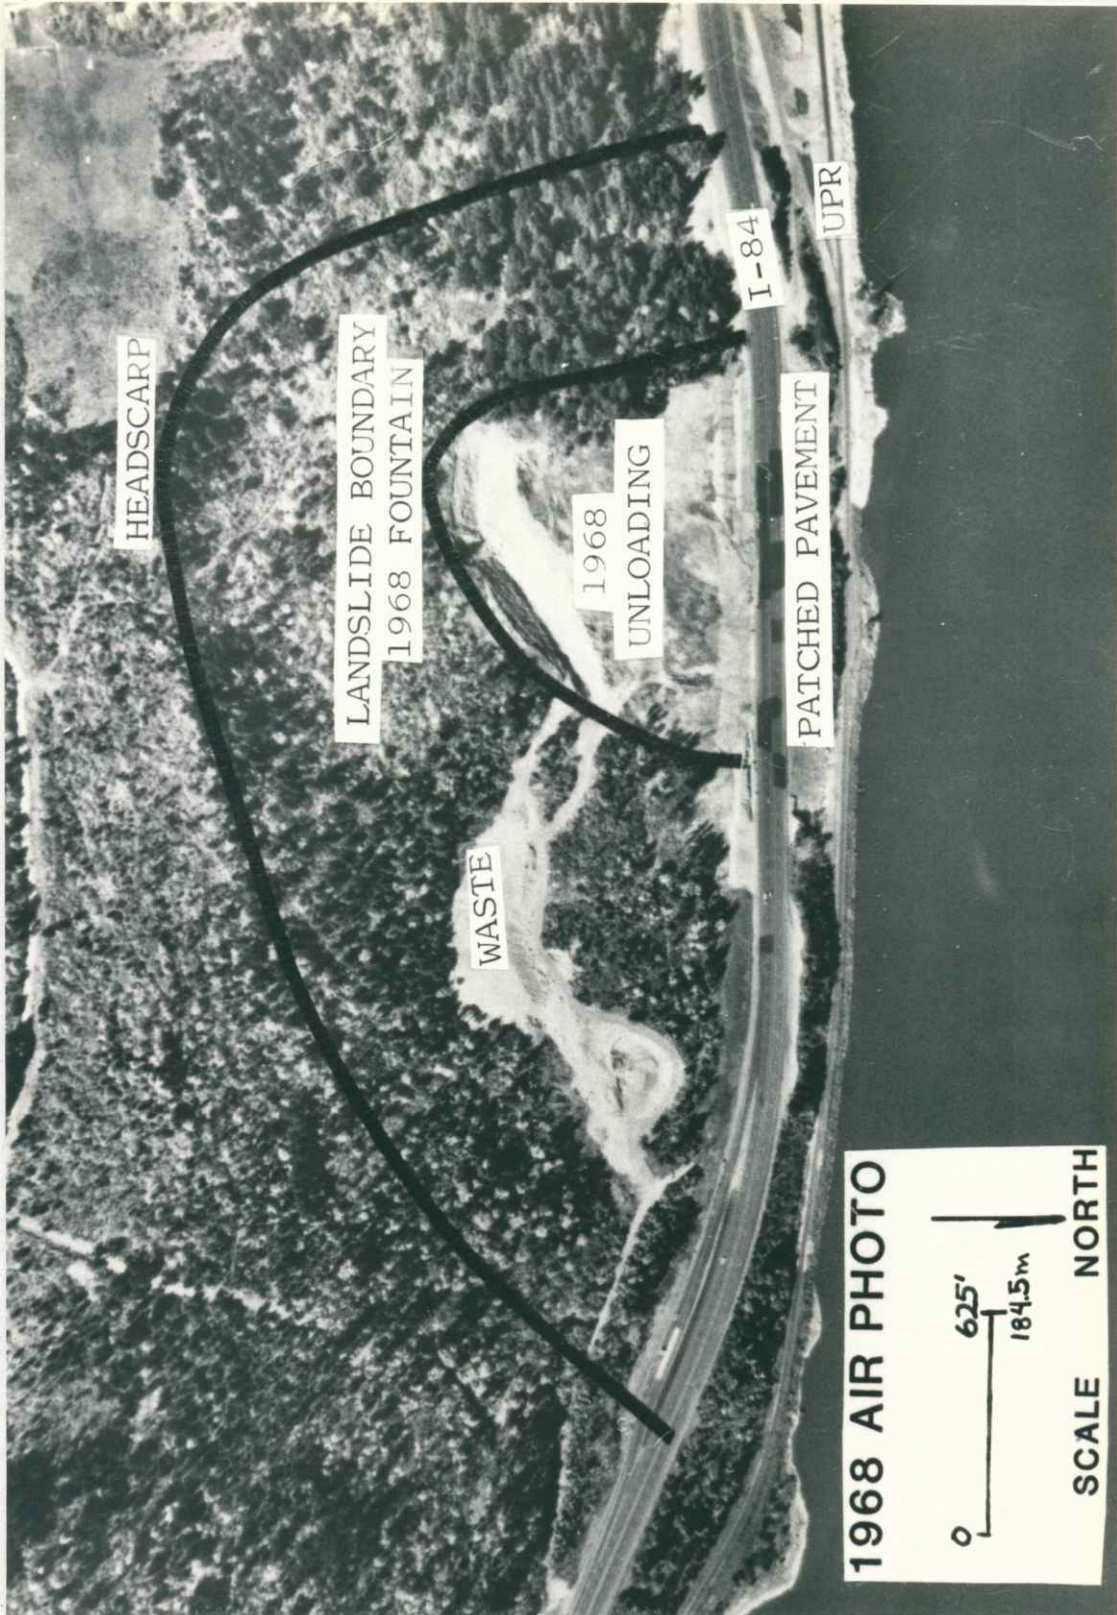
Figure 8. 1968 aerial photograph. (O.S.H.D. 1"=500')

head of the landslide. The 1968 aerial photograph shown in Figure 8 shows the completed construction, the location of I-80N (I-84), the extent of the unloading, and the area where the debris was deposited immediately to the east, within the boundaries of the old headscarp.

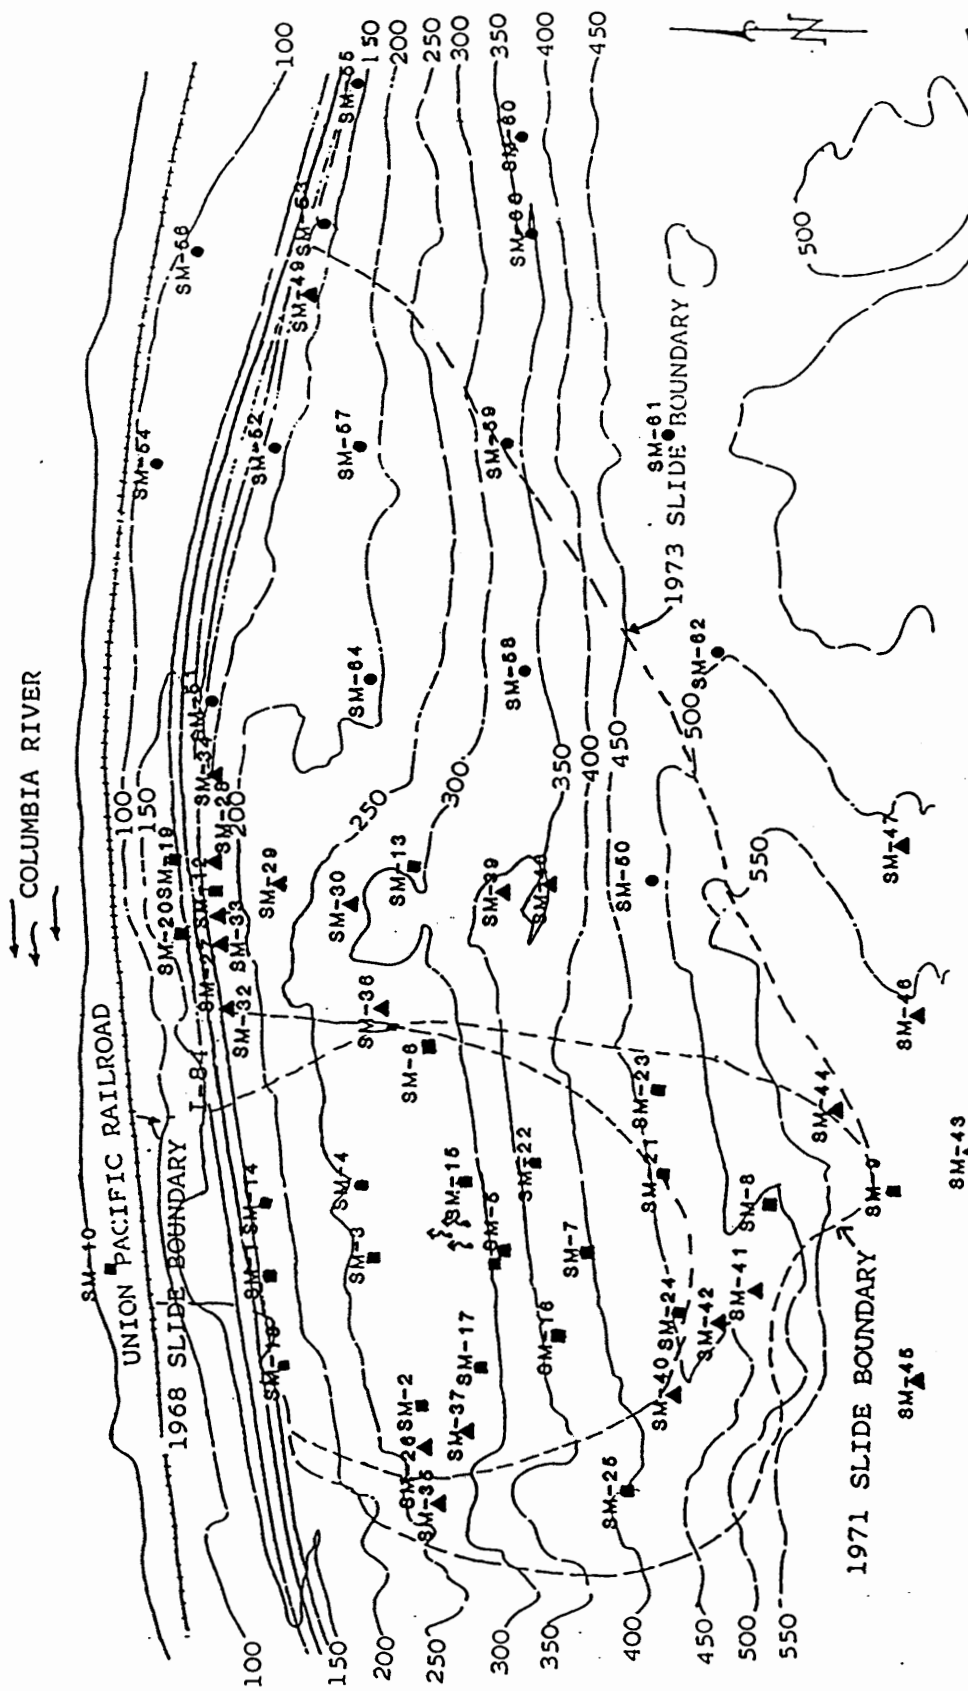
Figure 15. Drill hole locations. Those installed before 1971 - ●. 1971-1972 - ■. 1972-1973 - ○.

The length of highway affected by slide movement enlarged to the east beginning in January 1971 (Gano, 1971a). After examining the area the Oregon State Highway Division found the boundary to be enlarged to the south and the east (see Figure 15). The enlarged boundaries were defined by the presence of 0.3 to 0.65 meter (1 to 2 foot) scarps across the haul roads constructed for the unloading process. A photograph of the the scarp on the upper haul road is shown in Figure 17.

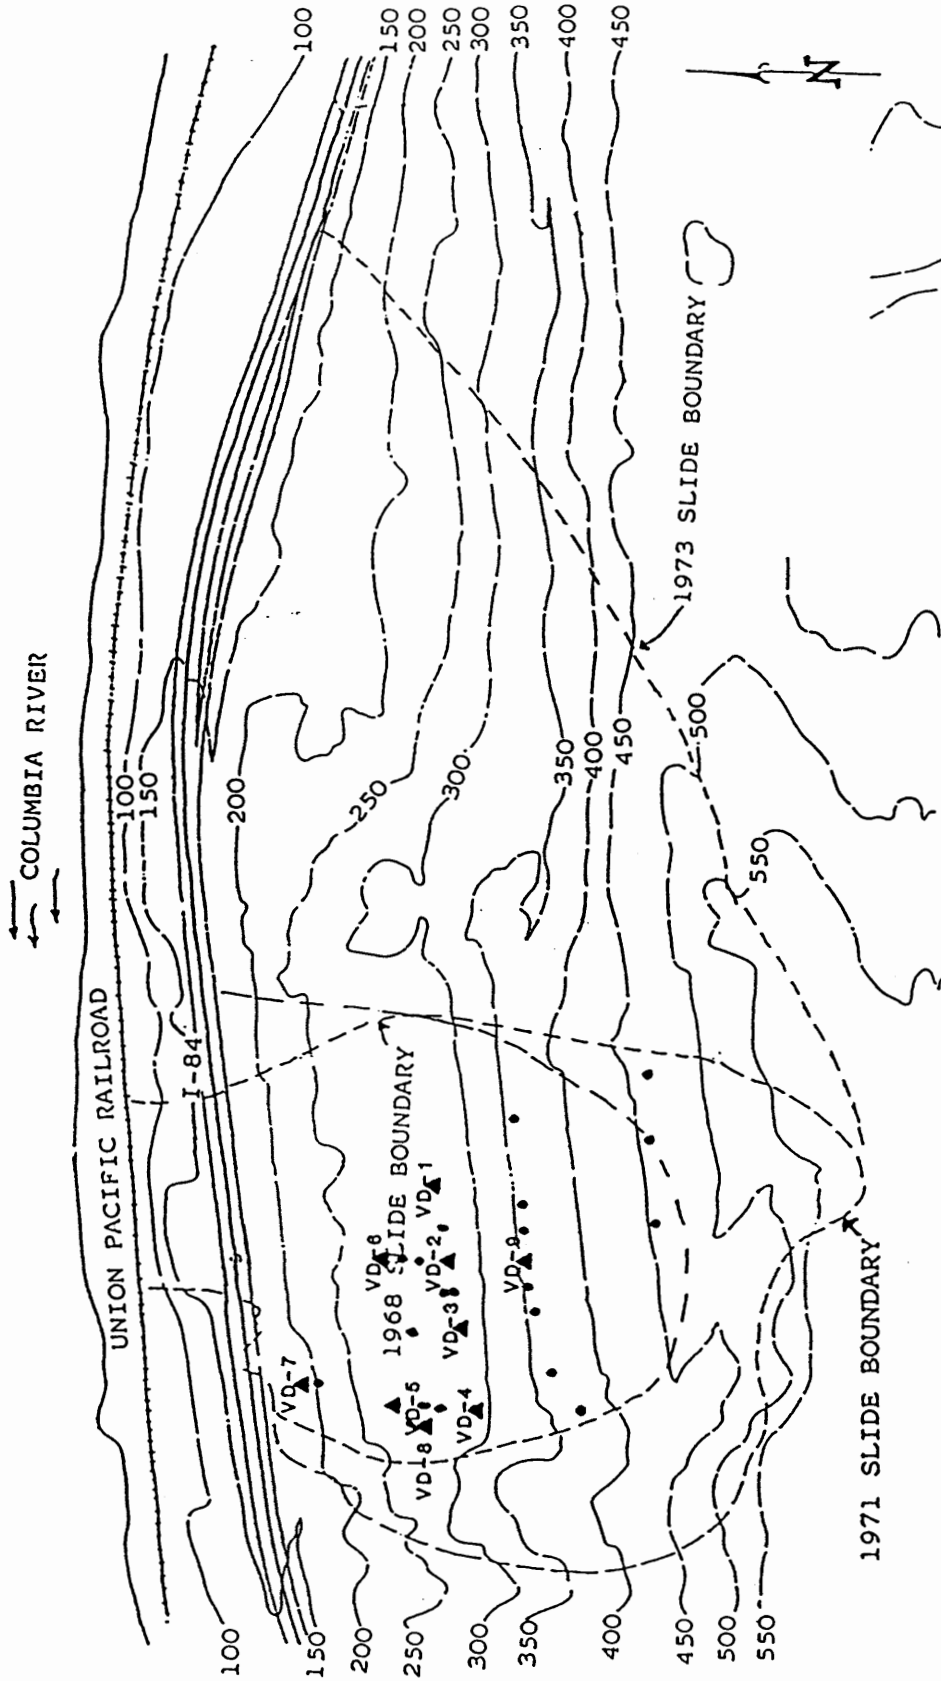
Figure 16. Location of vertical drains (▲) and observation wells (●).

Only vertical drain 2 gave satisfactory results. The other wells were in areas much too impermeable for the drains to function effectively. The one favorable result led to the installation of seven more vertical drains and thirty-two observation wells (Figure 16). The results were presented in the March 10, 1972 progress report. Only

vertical drain 5 and vertical drain 2 functioned effectively with 52 gpm and 45 gpm respectively. These generally poor results caused this approach to be abandoned.

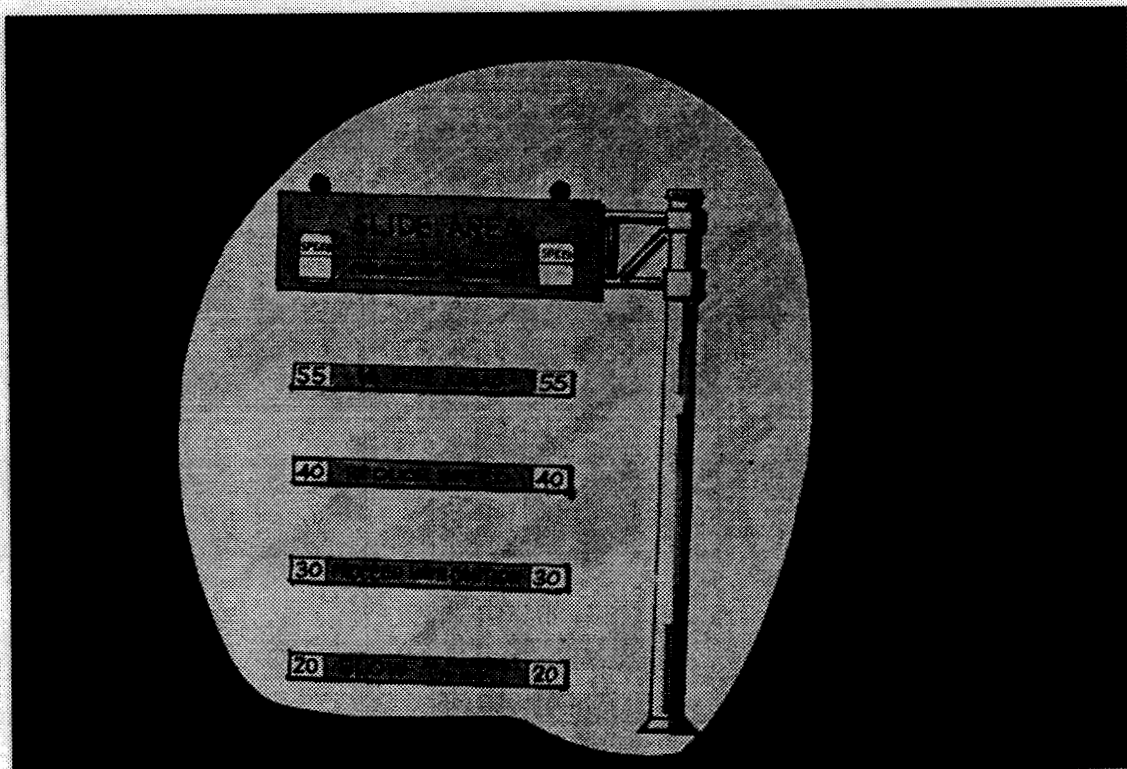
A warning system was installed in 1975 to provide for motorist safety. The system included settling tubes and tensometers installed below the surface of the highway monitored by computers. The computer could activate changes in the three part warning sign shown in Figure 19, and notify the authorities. This system was never operational due to many system failures.

Figure 19. Drawing of the warning sign installed.  
The computer activated alternate messages shown below it.  
(from OSHD files)

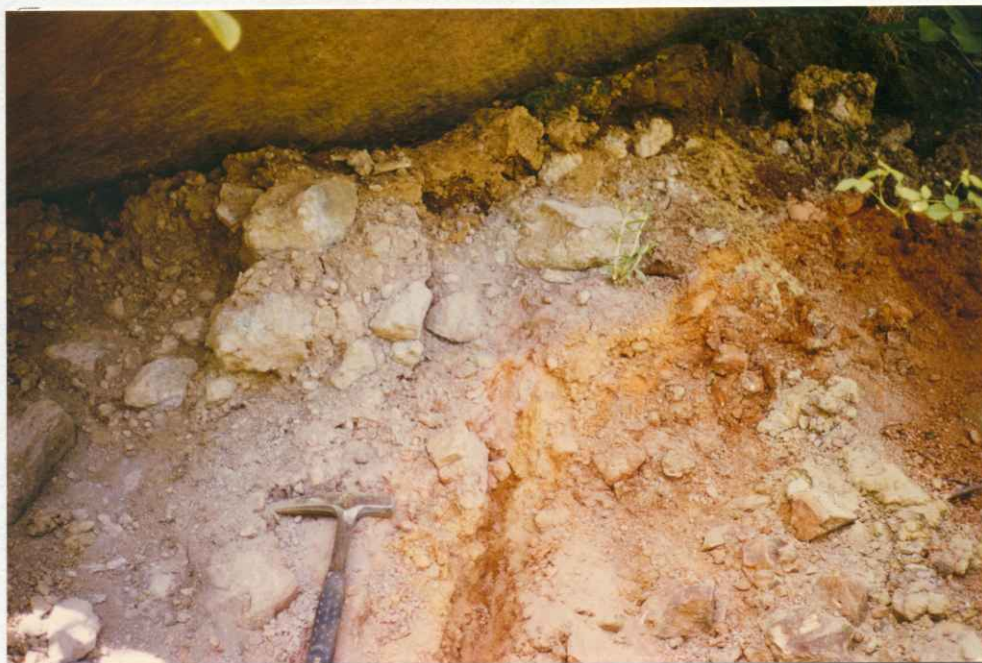
A relatively intact outcrop of the pink colored WRL is found in the the gravel pit (outcrop A in Figure 25). Figure 26 is a photograph of this outcrop and shows a zone below the pink colored WRL where the color changes downward in soil from pink to purple, to red, to orange and finally tan colored basalt. The same pattern is seen elsewhere in the gravel pit, higher to the north of this outcrop and lower to the south. The apparent dip of the zone is 22SE.

Figure 26. Photograph of outcrop at the gravel pit.

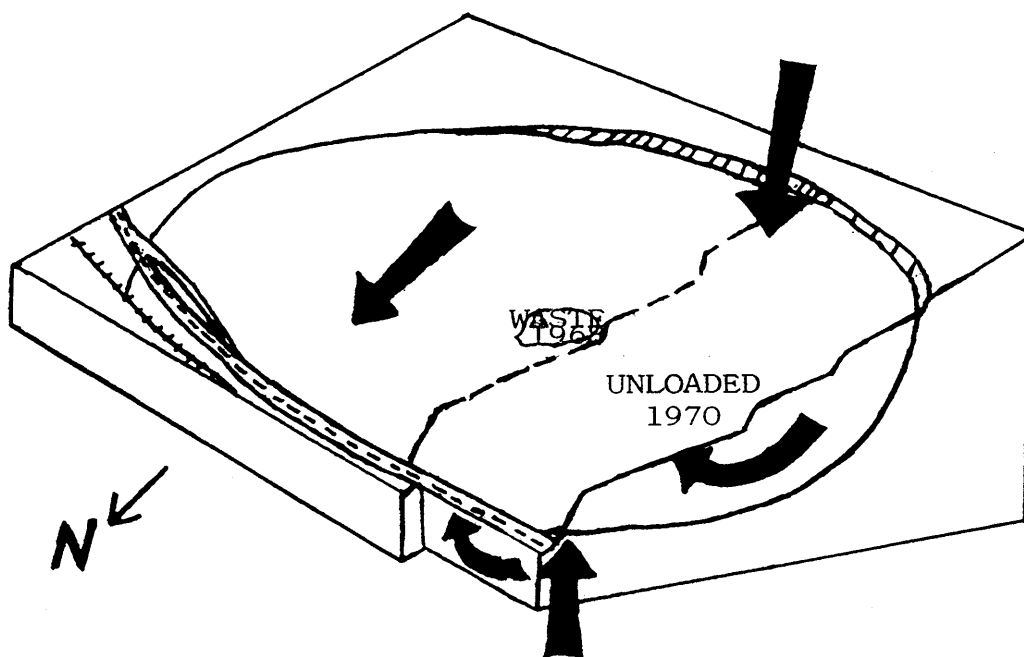
The major movement directions of the slide mass can be determined from the distribution and attitude of surface cracks, scarps and depressions. Figure 35 diagrams the major movement direction of the landslide. The slide moves northward, the entire head of the slide drops, the western margin is dropping, and the toe heaves. There are graben features also seen at the head as the slide pulls away from more stable surroundings. The eastern edge of the unloaded portion has raised relative to the western slide mass, making the western portion of the slide appear to rotate with respect to the eastern portion. Most likely the relative rotation of the slide masses expresses the change in the equilibrium between the eastern and western portion of the slide from the unloading.

Figure 35. Relative movement of the landslide.

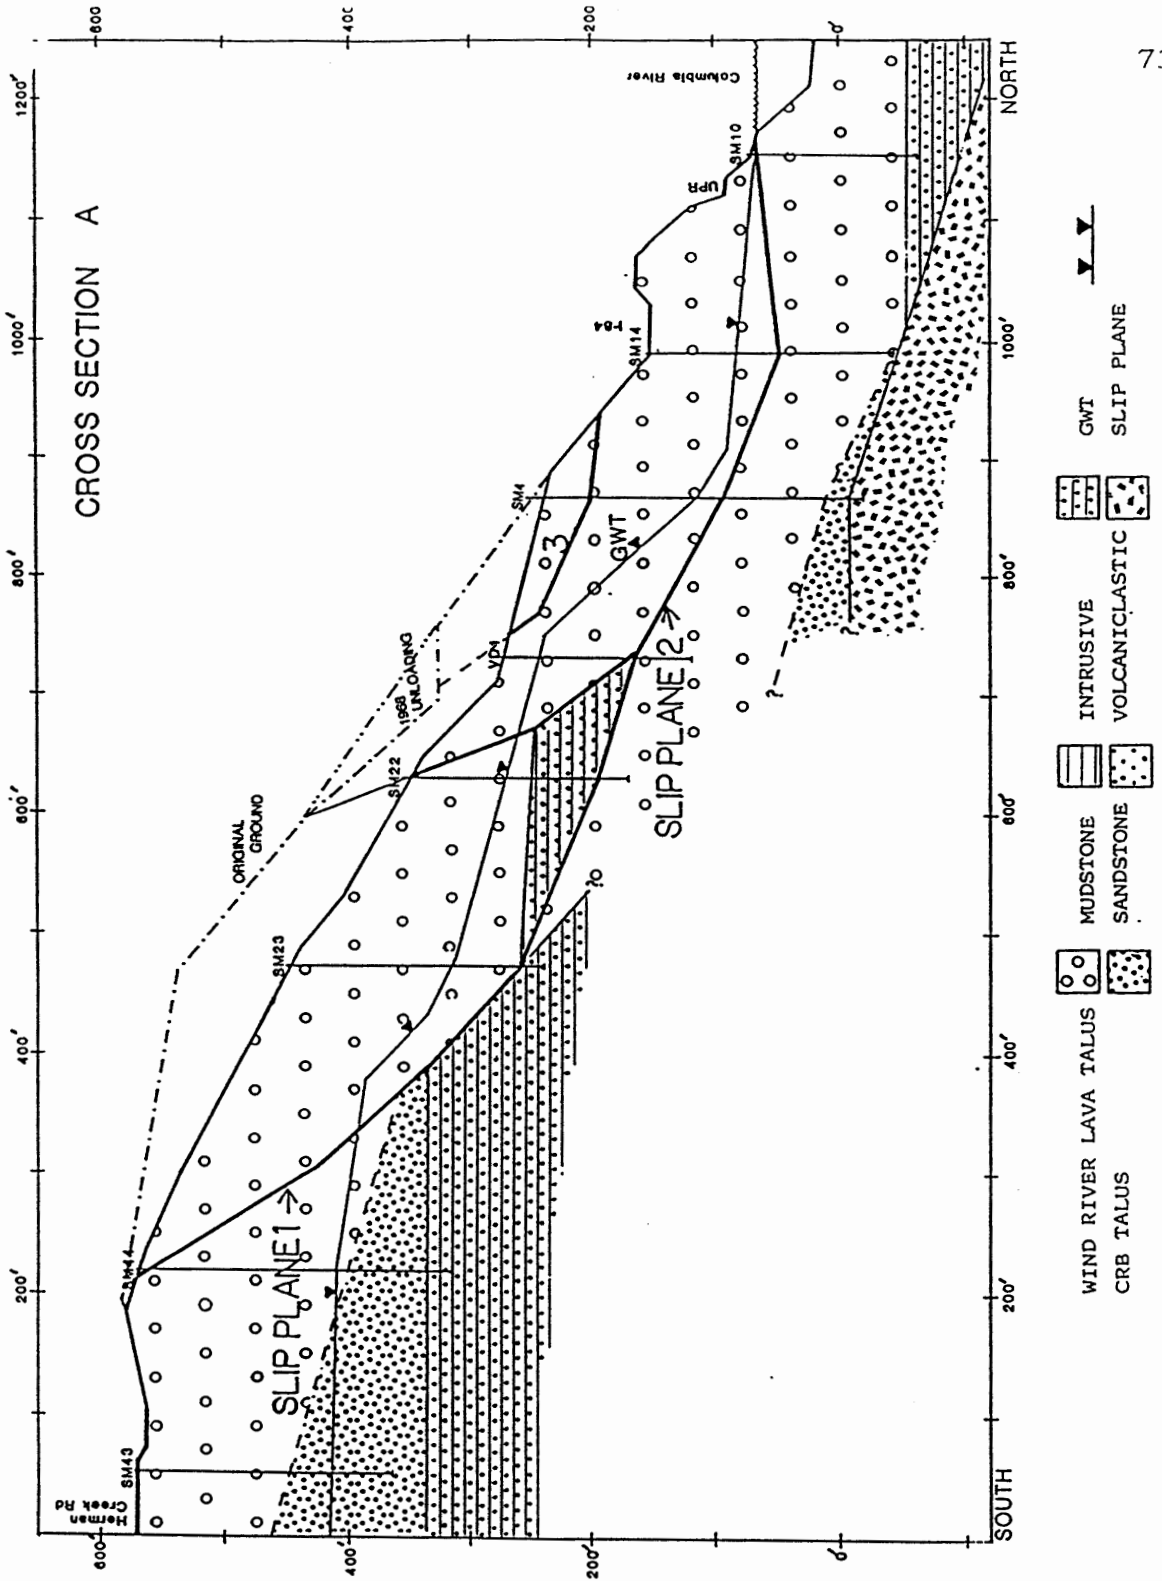
Figure 36A. Cross section A. For location see Plate 1.

Figure 36A shows the cross section through the unloaded portion of the landslide. Two major slip planes are seen in this cross section. The upper slip plane (1) is truncated at the toe by the lower slip plane (2). A smaller surface slide is marked by the slip plane number (3). The ground water table is perched over the volcanoclastic unit near the toe of slip plane (1). The slide mass is almost entirely Wind River Lava and Columbia River Basalt Group talus with silts and sand filling the voids. The two slip planes are confined to a 0.6 to 1.8 meter (2 to 6 foot) rocky mudstone layer. A sample of this material from core SM36 is shown in Figure 37.

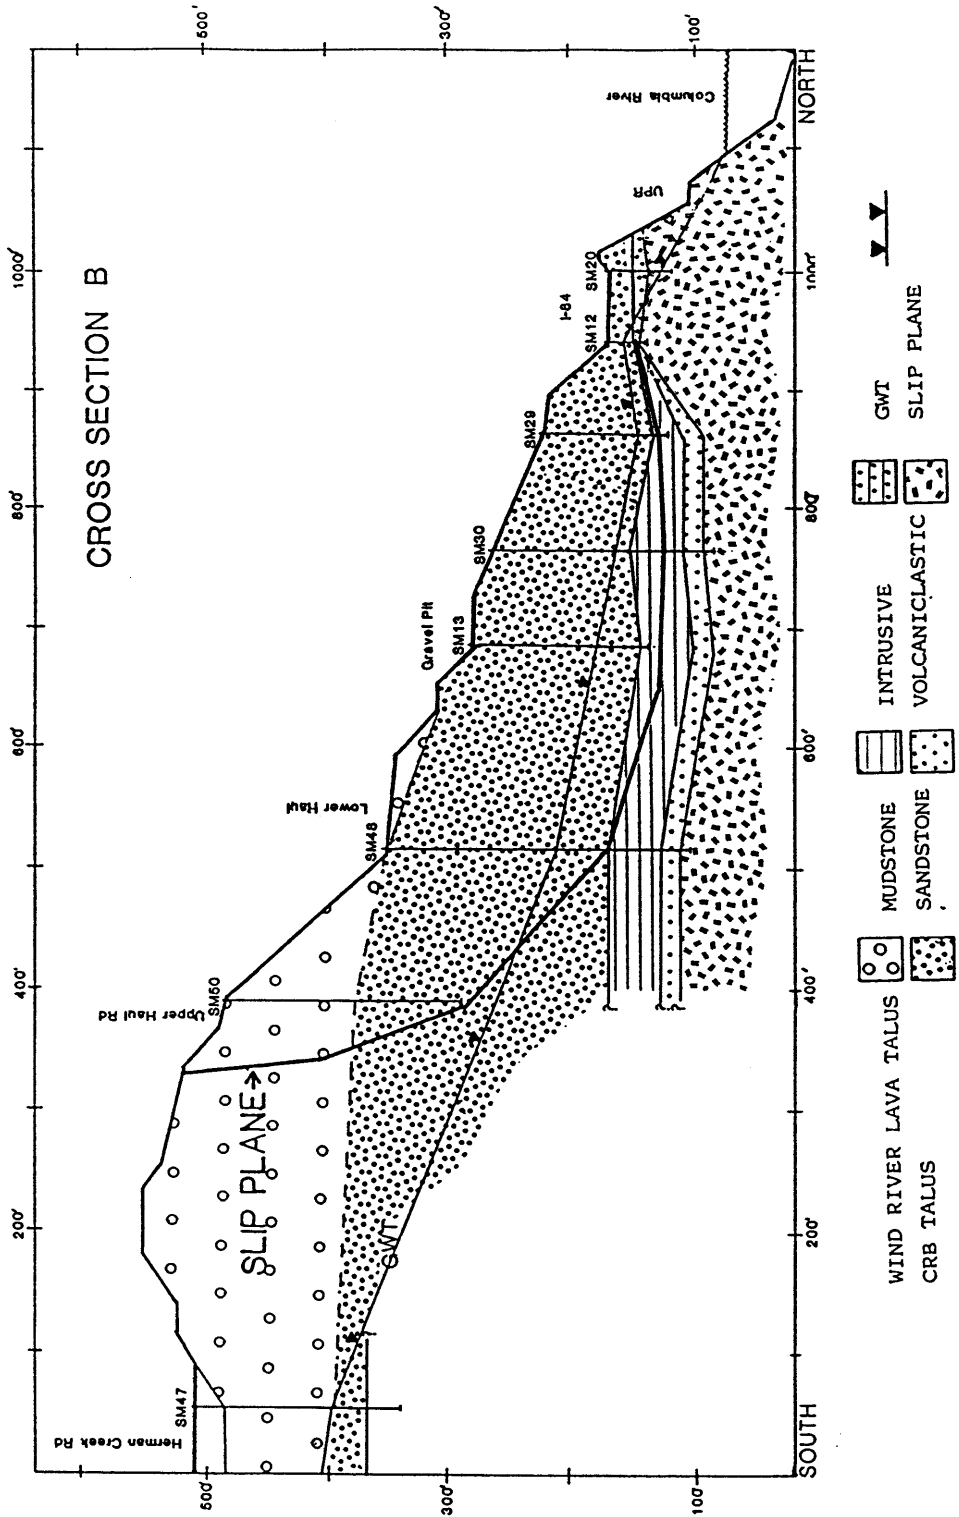
Figure 36B. Cross section B. For location see Plate 1.

The elevation of the ground water table in Plate 1 is high in the western portion of the Fountain Landslide where it is elevated over either the volcanoclastic unit (Figure 36A) or the intrusive unit (Figure 36B). By comparison the eastern portion has a low ground water table. The

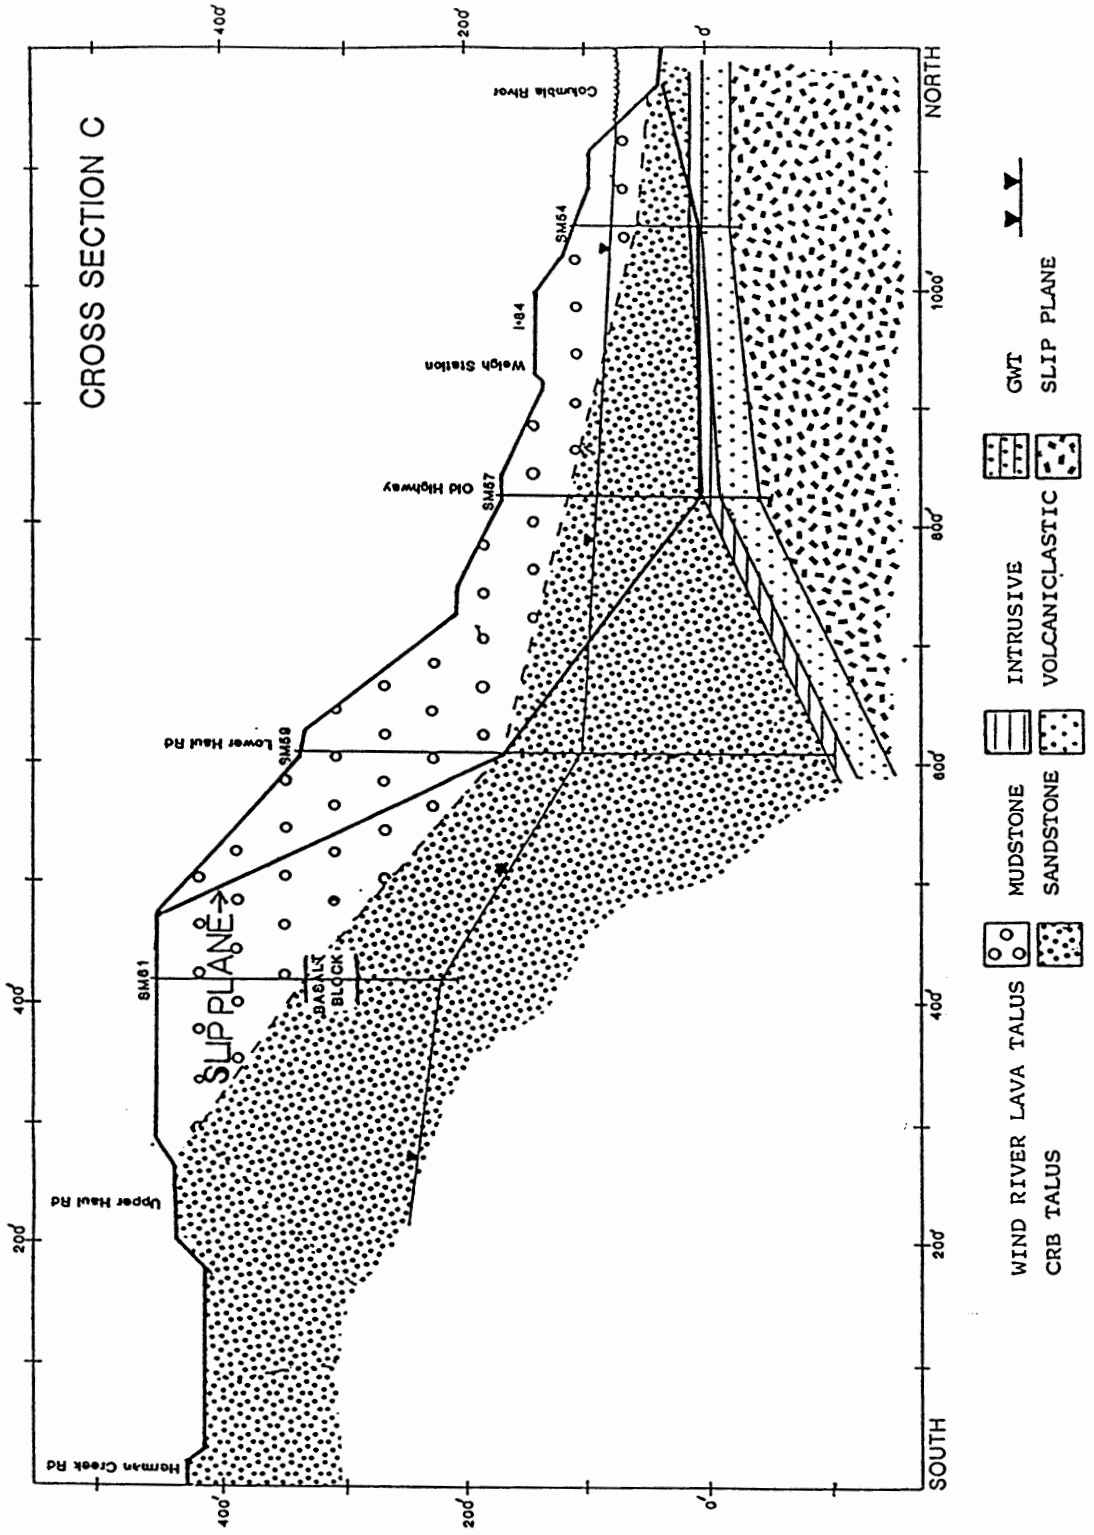
Figure 36C. Cross section C. For location see Plate 1.

are significant differences between the three cross sections which suggests the presence of two slide masses, the western portion and the eastern portion. The boundary between the two is approximately the eastern edge of the 1970 unloading. The differences are: 1) the western portion (Figure 36A) has two slip planes and the eastern portion has only one, 2) the western portion cuts through a talus slope and the eastern portion is mostly in the incompetent mudstone layer above the intrusive (basal failure). These differences indicate that the two portions have differing mechanics, stabilities, and behaviors.

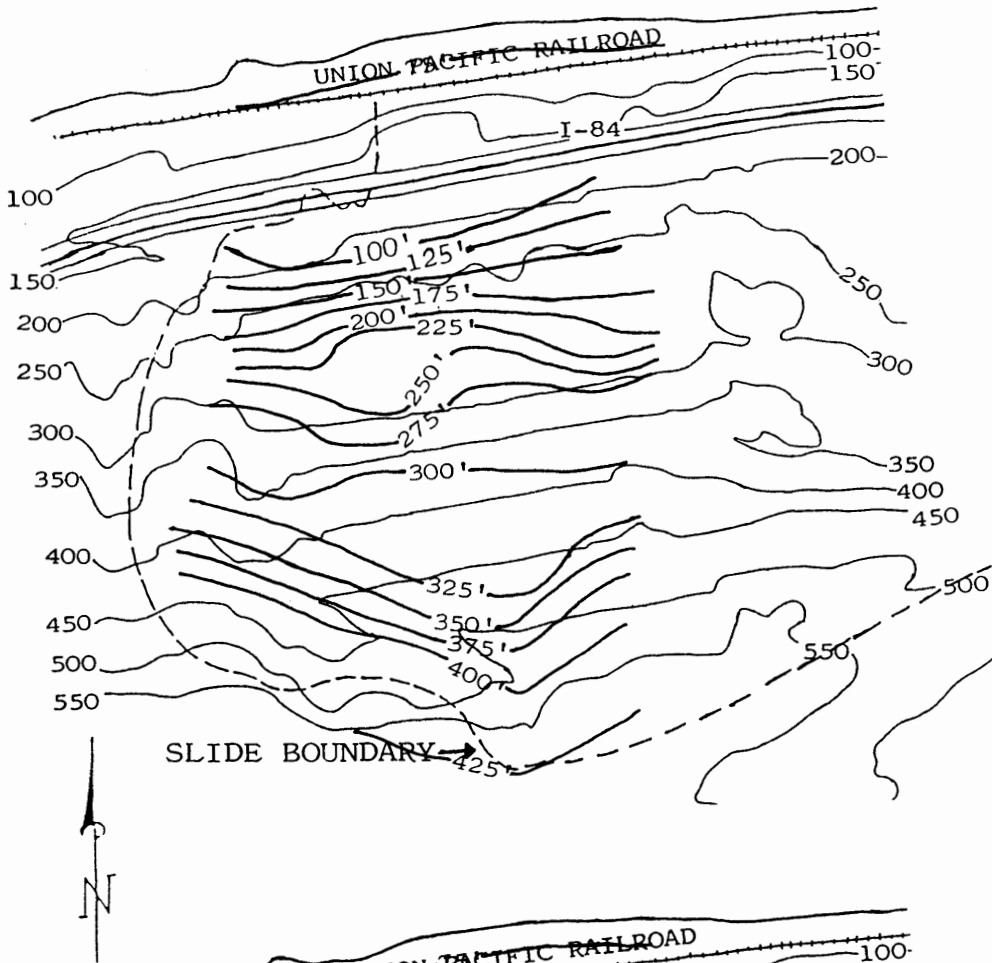
Figure 39. The elevation of the maximum measured ground water table, 1/21/72.

observations. The ground water table in Plate 1 corresponds to the January 11, 1972 measurement (Figure 39). The estimates were made by proportionally increasing the elevation according to the month it was taken. This has probably resulted in an underestimate of the water table for the eastern portion of the landslide.

The maximum measured ground water table (Figure 39 and Plate 1) probably does not represent the highest annual ground water table, since it is not near the surface and does not reflect the flowing springs. The high water pressures which occur seasonally at the spring at VD2E, most likely are the result of high seepage pressures from the steeply inclined ground water table in this area.

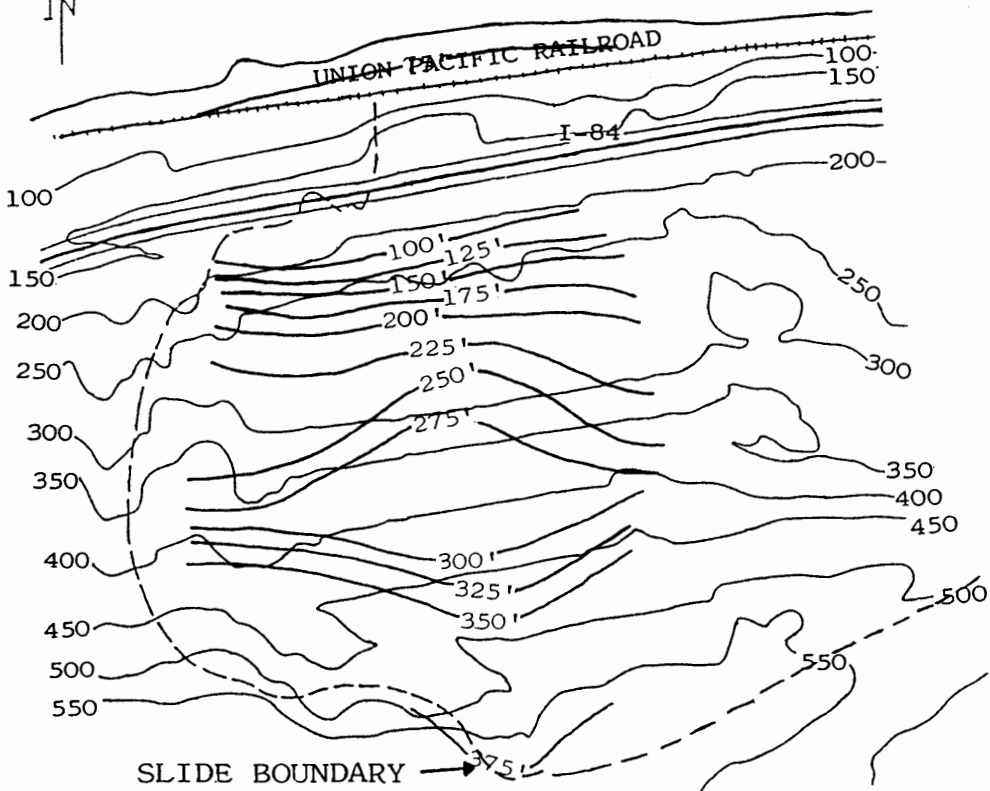
Figure 40. The elevation of the minimum measured ground water table, 10/11/71.

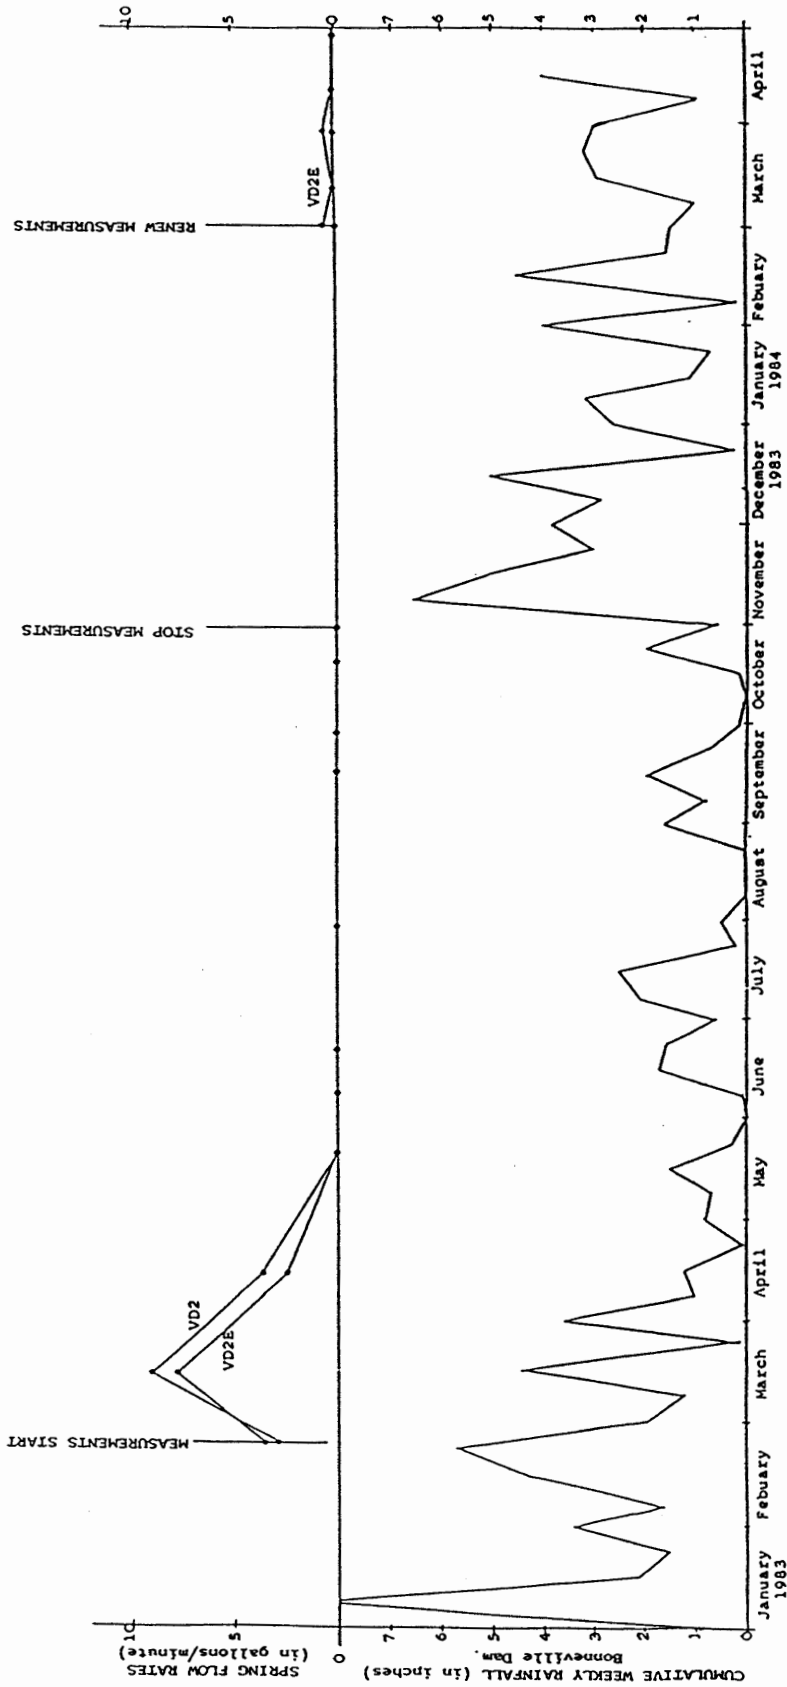
The flow rate for each spring and the cumulated weekly rainfall from records of the U.S. Department of Commerce, (1983-1984), NOAA, Climatological Data at Bonneville Dam are shown on Figure 41. The spring at VD2 had a maximum flow rate of 8.9 gallons/minute (34 liters/minute) and at VD2E it was 7.8 gallons/minute (29 liters/minute). The springs did not flow during the summer or winter months.

Figure 41. Spring flow rates and rainfall. See Plate 1 for spring locations. Rainfall data from US Dept. of Commerce, (1983-1984), NOAA, Climatological data for Bonneville Dam. Dots represent data points.

The flow rate data from January 1983 to April 1984 shows that flow rates were affected by high monthly, not weekly rainfall. High weekly rainfalls only had a small effect on the flow rates while the previous monthly rainfall had a greater effect on flow rates. As the monthly rainfall decreased the flow rates slowly receded to zero. This is a slower response than expected for talus, indicating that it has a relatively lower permeability than would be expected. Localized frost heave was observed during extended cold periods with ice crystals up to 3.5 centimeter (1.5 inches).

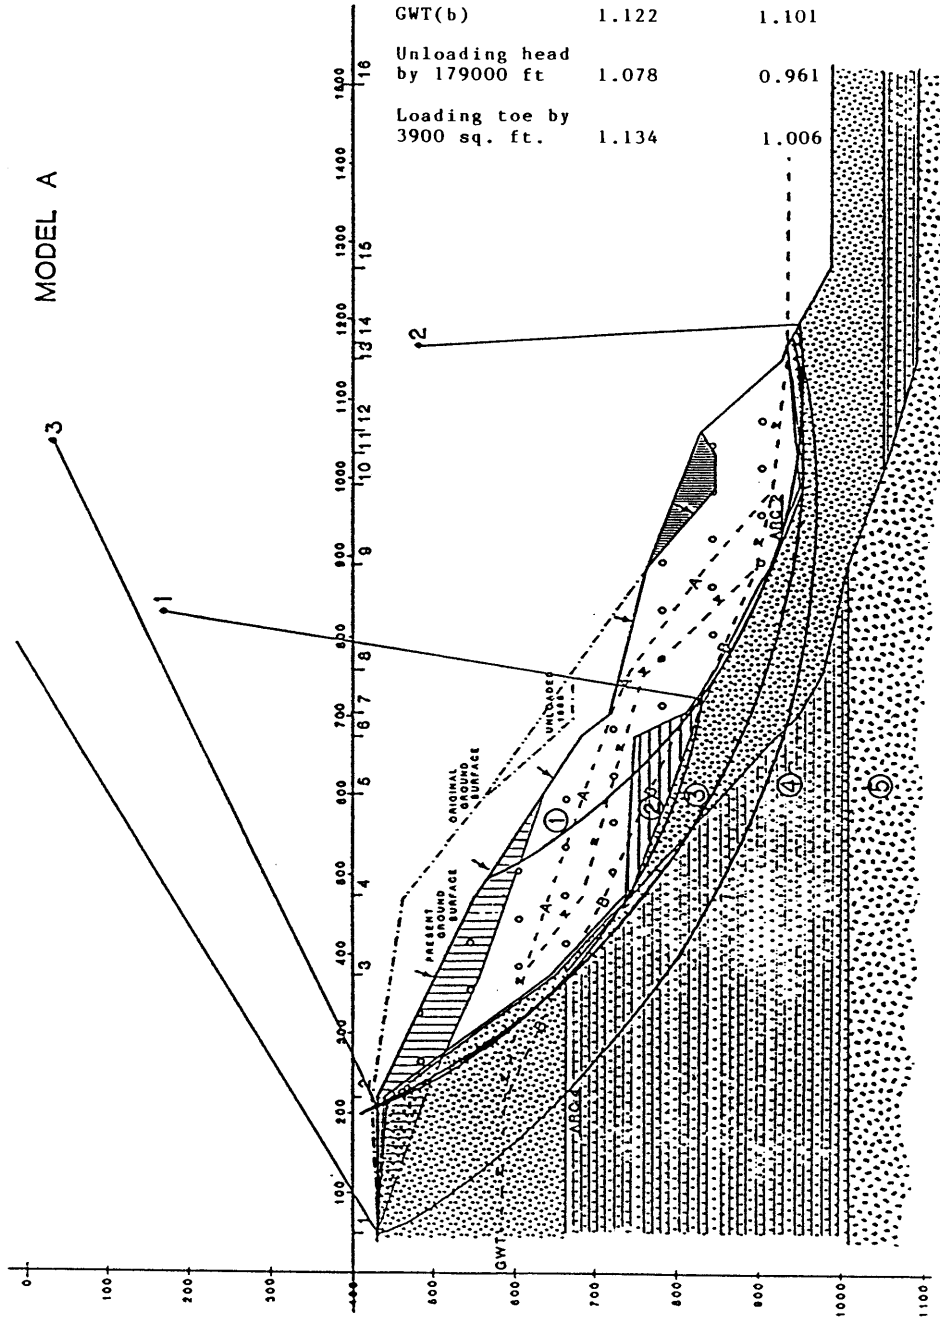
MODEL A

GWT(a)	0.982	0.899
GWT(b)	1.122	1.101
Unloading head by 179000 ft	1.078	0.961
Loading toe by 3900 sq. ft.	1.134	1.006

Figure 43A. Cross sectional model A. See Figure 36A for original cross section.

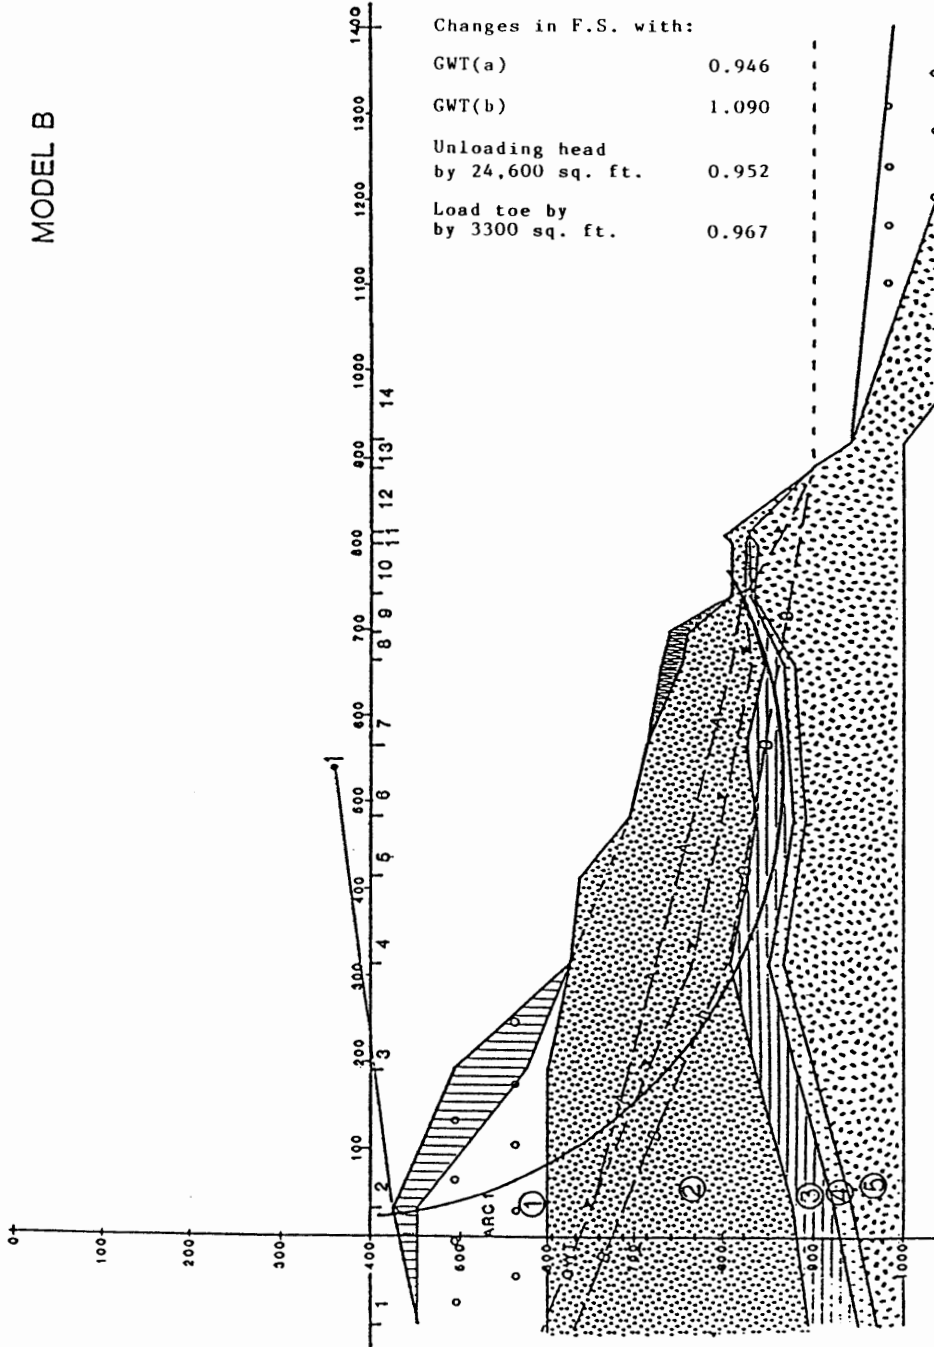
MODEL B

Figure 43B. Cross sectional model B. See Figure 36B for original cross section.
