# The Engineering Geology of the Fountain Landslide, Hood River County, Oregon

Susanne L. D'Agnese  
*Portland State University*

Title: The Engineering Geology of the Fountain Landslide  
Hood River County, Oregon.

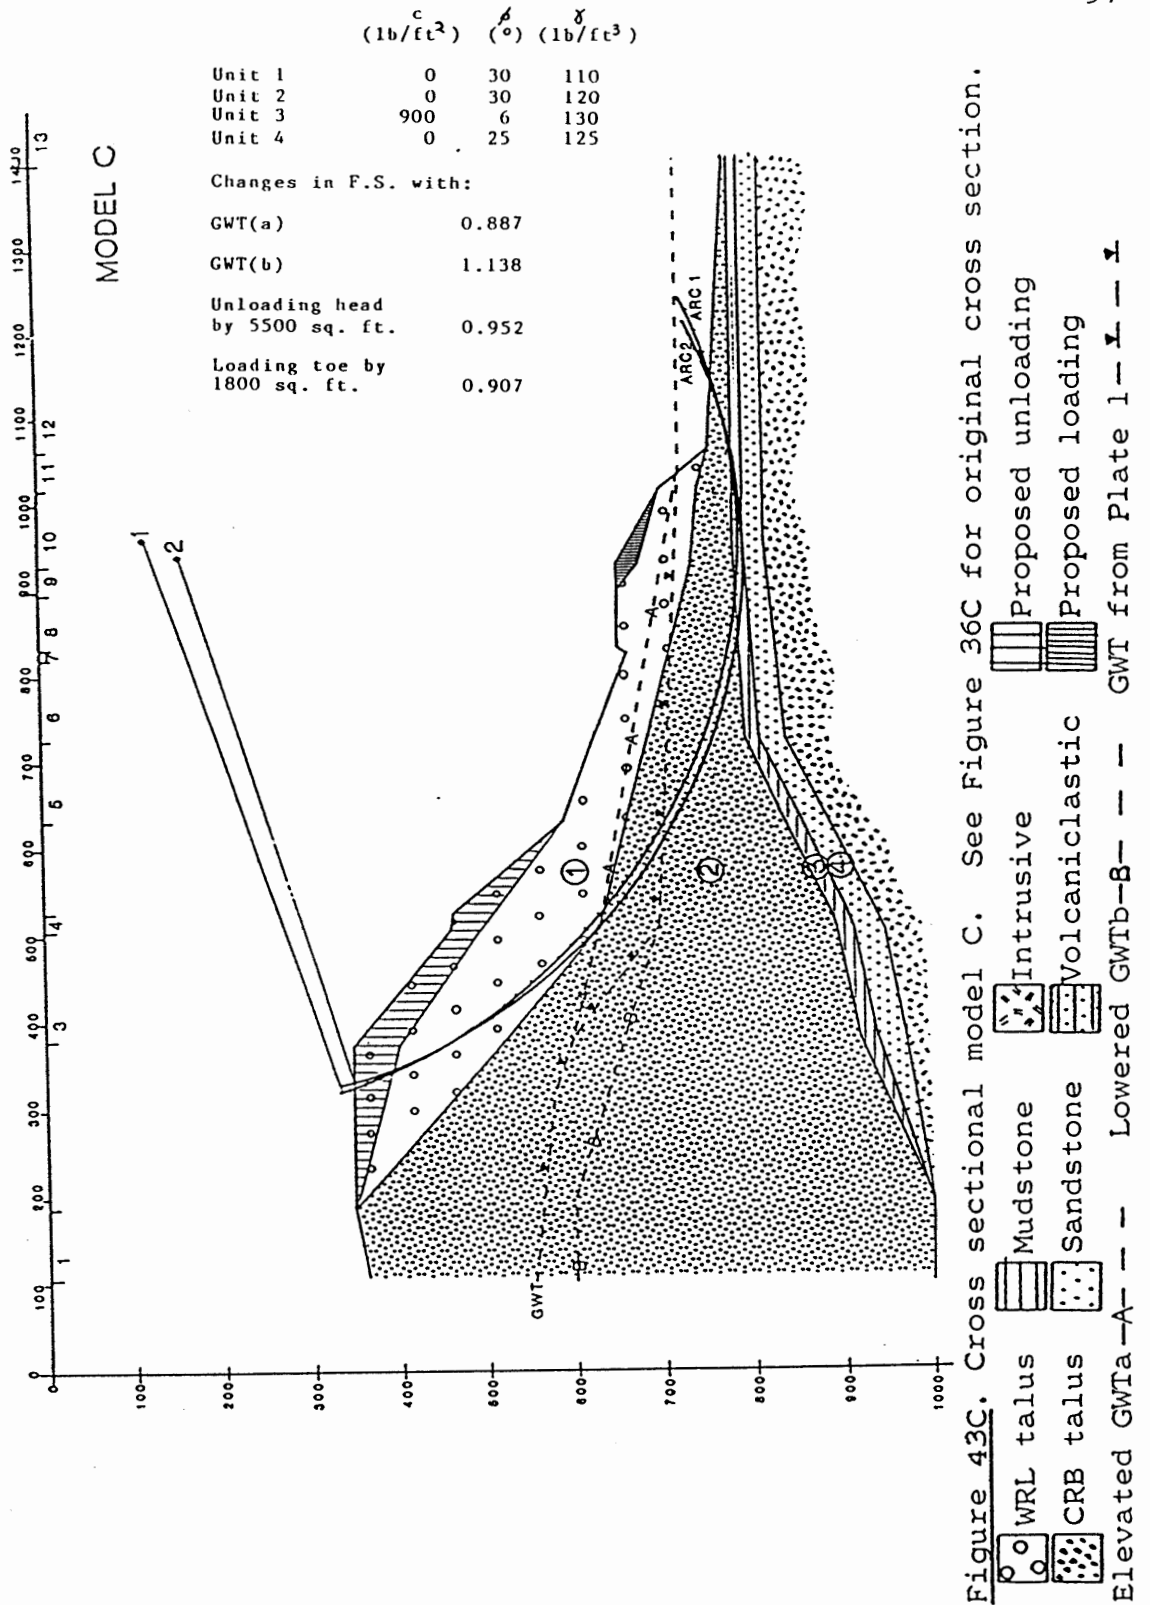
Figure 43C. Cross sectional model C. See Figure 36C for original cross section.

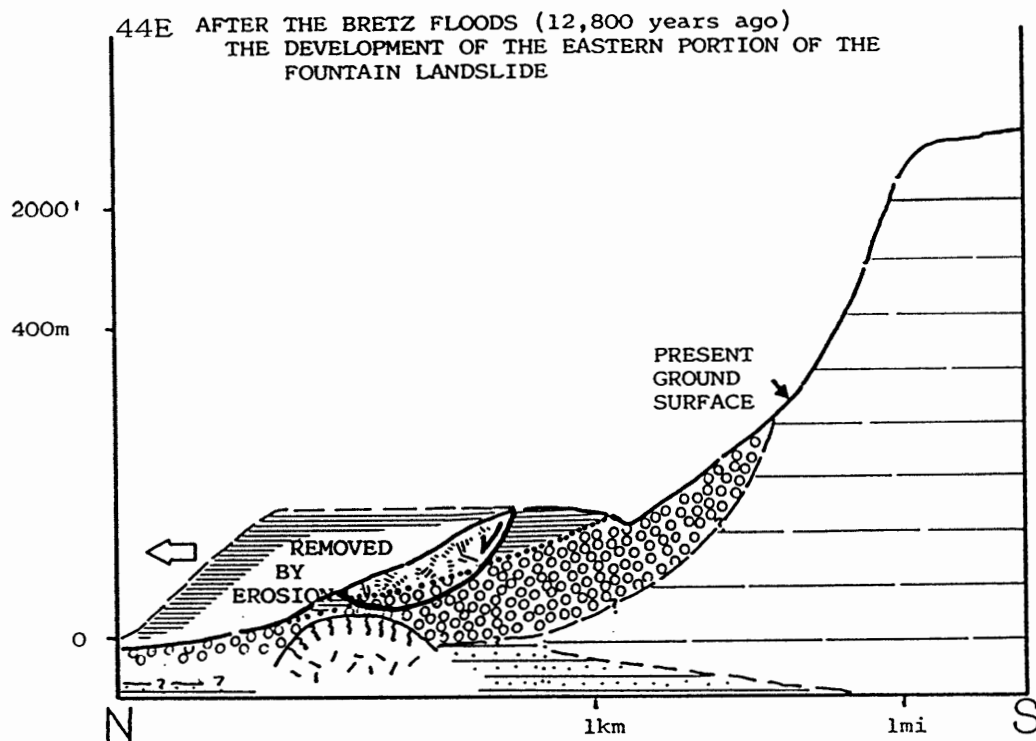
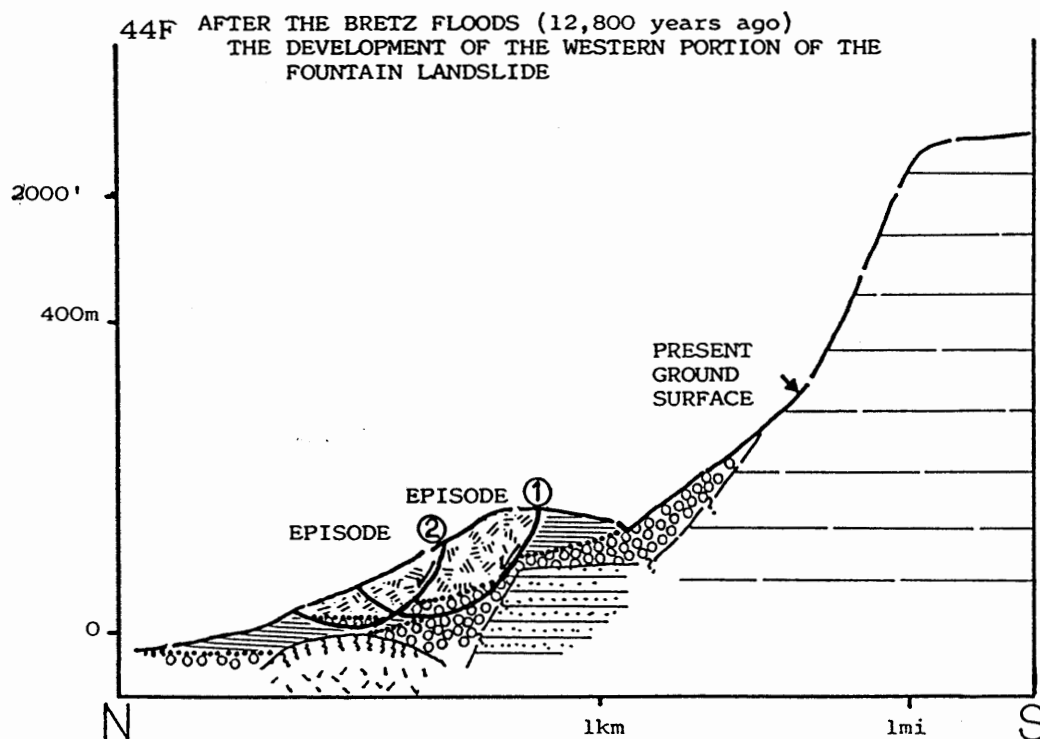
now lowest part of the dam. Erosion of the dam continued through the middle of the channel. As the lateral support for the heavy pile of WRL lava on the existing talus slope was removed the present sliding began (Figure 44E). The differences between the eastern and western portions appear to be the result of differing subsurface conditions prior to the deposition of the Wind River Lava (Figure 44F). There was a steeper depositional surface in the western portion, which created higher instabilities and resulted in more episodes of movement and more failure surfaces.

The instability of the present Fountain Landslide was examined in the engineering geology section of this report. There appears to be two independently moving slide masses, the eastern and western portions. This is probably due to the intrusion confining the base of the slip plane in the central portion of the slide (see cross section B in Figure 36). Both appear to be rotational slides with a nearly circular slip surfaces. Although the two masses move independently, the 1970 unloading showed that any reduction or increase in the stability of one portion of the landslide effects the remaining portion. Movement presently occurs in the western portion when the ground water table is high. By modeling the slope stability it was shown that the cut into the toe for freeway construction severely reduced the stability of the slope. The modeling also suggests that theoretically, it would be

Figures 44E and 44F. The geologic history of the development of the Fountain Landslide.

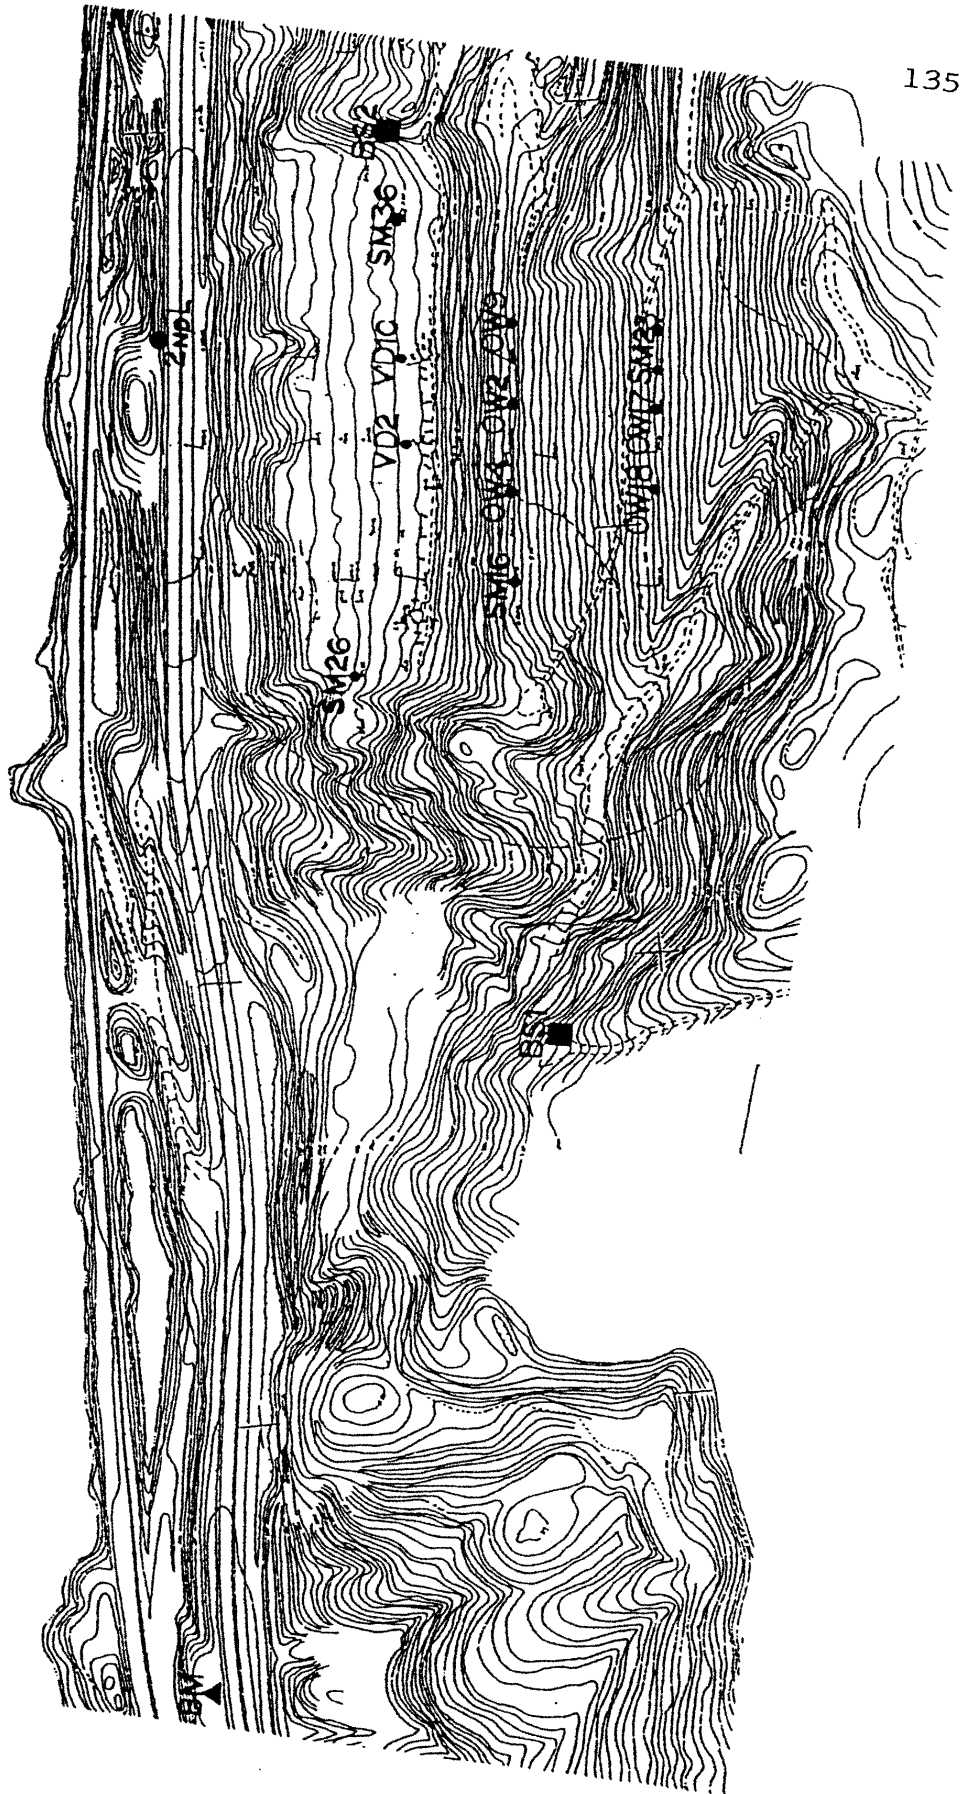
Figure 45.

Location of survey stations.  
Bench Mark ▲  
Base Stations ■  
Other stations ●

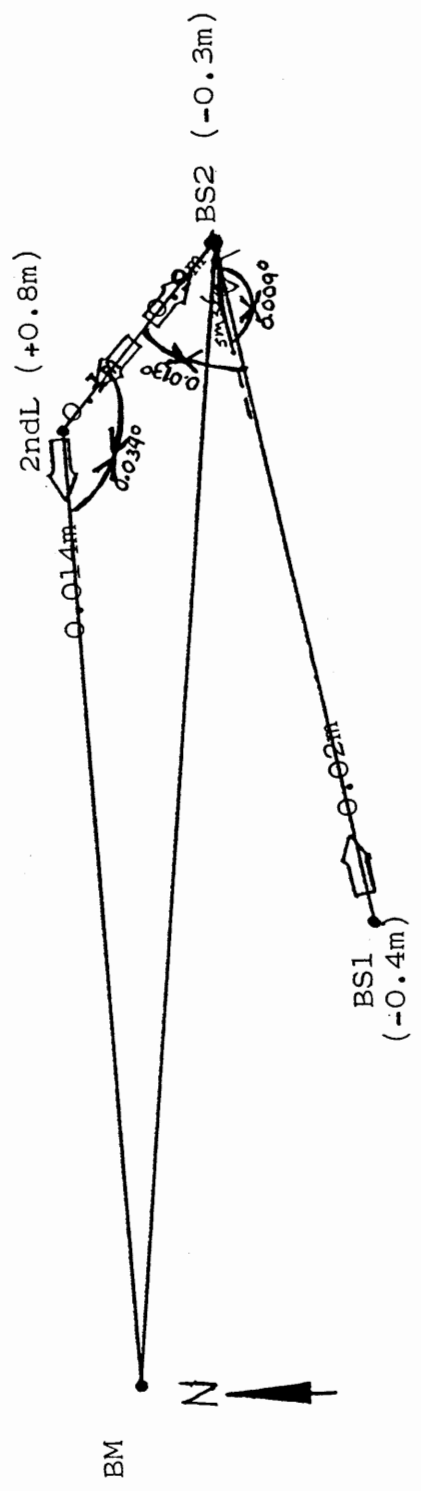
A summary of the known movements could be determined from the limited data and the assumptions, and is shown in Figure 46. They are: 1) station 2ndL (Figure 46) rose approximately 0.8 meters and moved approximately 0.014 meters closer to the BM, 2) BS2 has dropped approximately 0.3 meters and moved either 0.9 meters further from or 0.01

Figure 46. Movement direction of four survey stations. Arrows indicate direction of movement. (+) or (-) indicate relative change in elevations.

meters closer to the 2ndL, 3) BS1 has dropped approximately 0.4 meters and has apparently move closer to BS2 approximately 0.02 meters, and 4) SM36 has dropped approximately 0.4 meters. The differences in the horizontal angles measured are given in Figure 46.

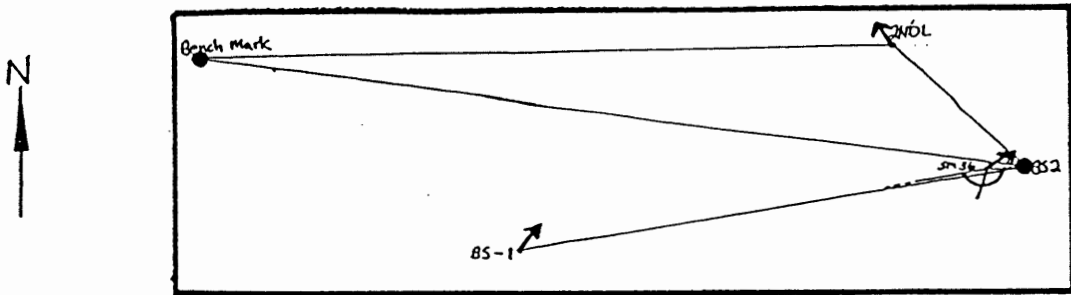
47A. BS2 stable (2ndL moves  $\sim 0.107\text{m}$  NW)

Figure 47. Possible interpretation of movement, condition 1. Arrows indicate directions of movement not magnitude. Slashes mark where errors must exist. Dots (●) indicate stable stations

Which of these possible interpretation best describe the movement of the Fountain Landslide is found by first eliminating the possibilities which are not reasonable. For example, the possibility that BS2 remains stationary (Figures 47A and 48A) appears to be inconsistent with all measurements which indicate that BS2 has dropped in elevation and if it is stable there are considerable and systematic errors in several horizontal angle measurements. Therefore, 47A and 48A can be eliminated. Which direction BS2 has moved will be explored further, but first some other interpretations can be eliminated.

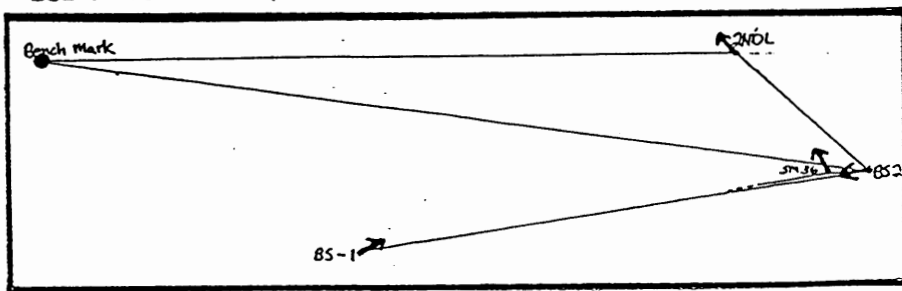
47B. BS2 moves west (2ndL moves more than  $0.107\text{m}$ )

This then leaves alternatives 47B, 47C, along with 48B. Both 47B and 47C can be substantiated trigonometrically so neither can be eliminated. Which one of these best describes the movement on the Fountain Landslide? Each show the expected northward movement. The cross sections and stress features would also support any and all of these alternatives. It was found that the precise determination of the movement of the Fountain Landslide using a survey grid is limited due to the instability of the base stations. The survey grid does shows that movement still occurs in the western portion of the Fountain Landslide and consists of heaving at the toe and a general northward movement of all the station survey.

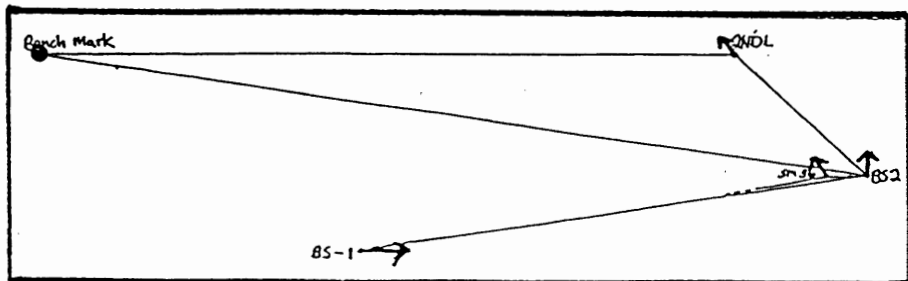
47D. BS2 moves north (2ndL moves much more than  $0.107\text{m}$ )

If BS2 is not stable, it is unlikely that the nearby SM36 has remained stable. This is supported by the lack of surface evidence of differential movement between the two stations such as new cracks or scarps. No cracks or scarps exist between the two (see Plate 1) therefore, differential movement has not occurred between BS2 and SM36 this eliminates the possibility 47D.

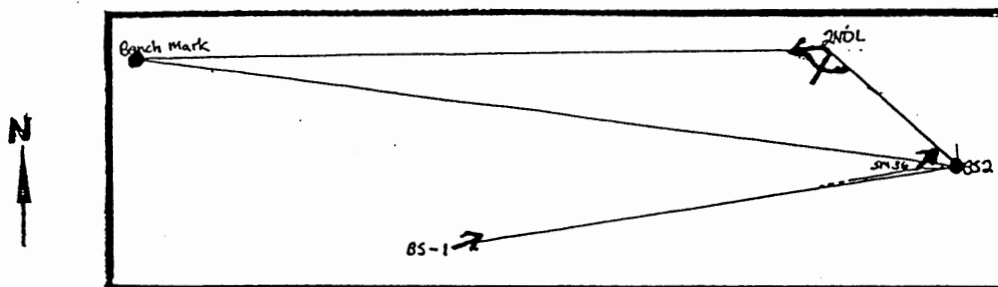
48A. BS2 stable (0.009° error in horz. angle)

Figure 48. Possible interpretation of movement, condition 2. Arrows indicate directions of movement not magnitude. Slashes mark where errors must exist. Dots (●) indicate stable stations.

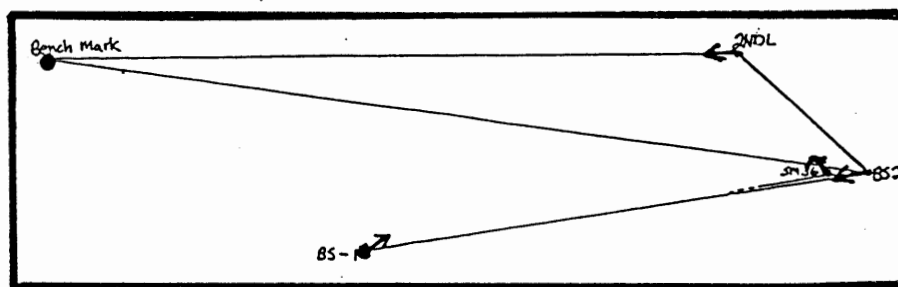
48B. BS2 moves west (0.1m error in distance)

measured from BS2 to 2ndL in 1985 (Appendix C), where it is 0.10 meters shorter than when it was measured from 2ndL. Assuming the horizontal angle measurements are accurate, BS2 must have moved 0.10 meters closer to the Bench Mark. The effect of this on the distance between the 2ndL and BS2 was a decrease of 0.10 meters or the distance equalled 239.647 meters, the exact distance measured from BS2 to 2ndL. This indicates that alternative 48B can not be eliminated.
