10-17-1994

Landslide Inventory and Susceptibility Mapping of the Upper Canyon Creek Basin, Cascade Range, Skamania County, Washington

Lawrence P. Growney
Portland State University

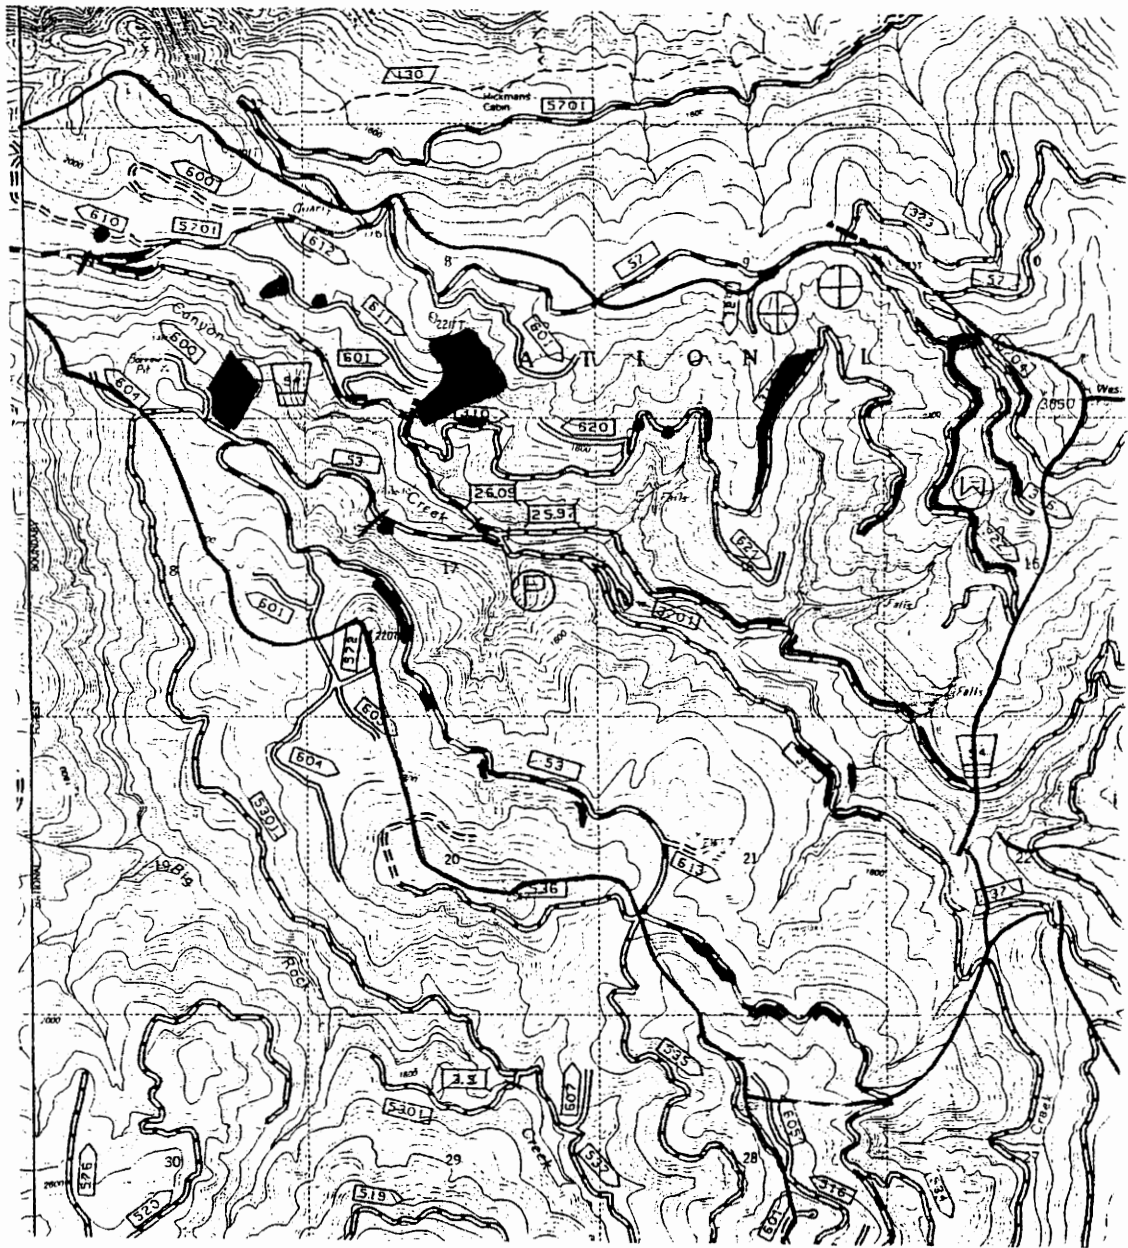
Rockfall, in terms of number of locations, is the most important type of mass wasting mechanism in this subdrainage; however, in terms of volume, rock avalanche deposits predominate. Seventeen locations of appreciable (> 0.1 hectare) rockfall occur over a minimum total of 4.8 ha. Of this number, all were a result of road building or quarrying operations; none were natural (Table 5). Three locations comprised of rock avalanche deposits occur covering a total of 10.6 ha (Table 6). Rock avalanche deposits are always the result of natural processes in this subdrainage. Failures due to other types of mass wasting mechanisms are volumetrically minor. Slumps occupy 2.4 ha of the subdrainage and debris slips 0.4 ha (Table 7).

A direct comparison between natural versus induced failures reveals that out of a minimum total mass wasting area of 18.2 ha in this subdrainage, 4.8 ha (26%) are the direct result of road building activity.

Figure 9. Lower Canyon Creek Subdrainage
 Failure locations are shown in black and identified in Tables 5,6 and 7

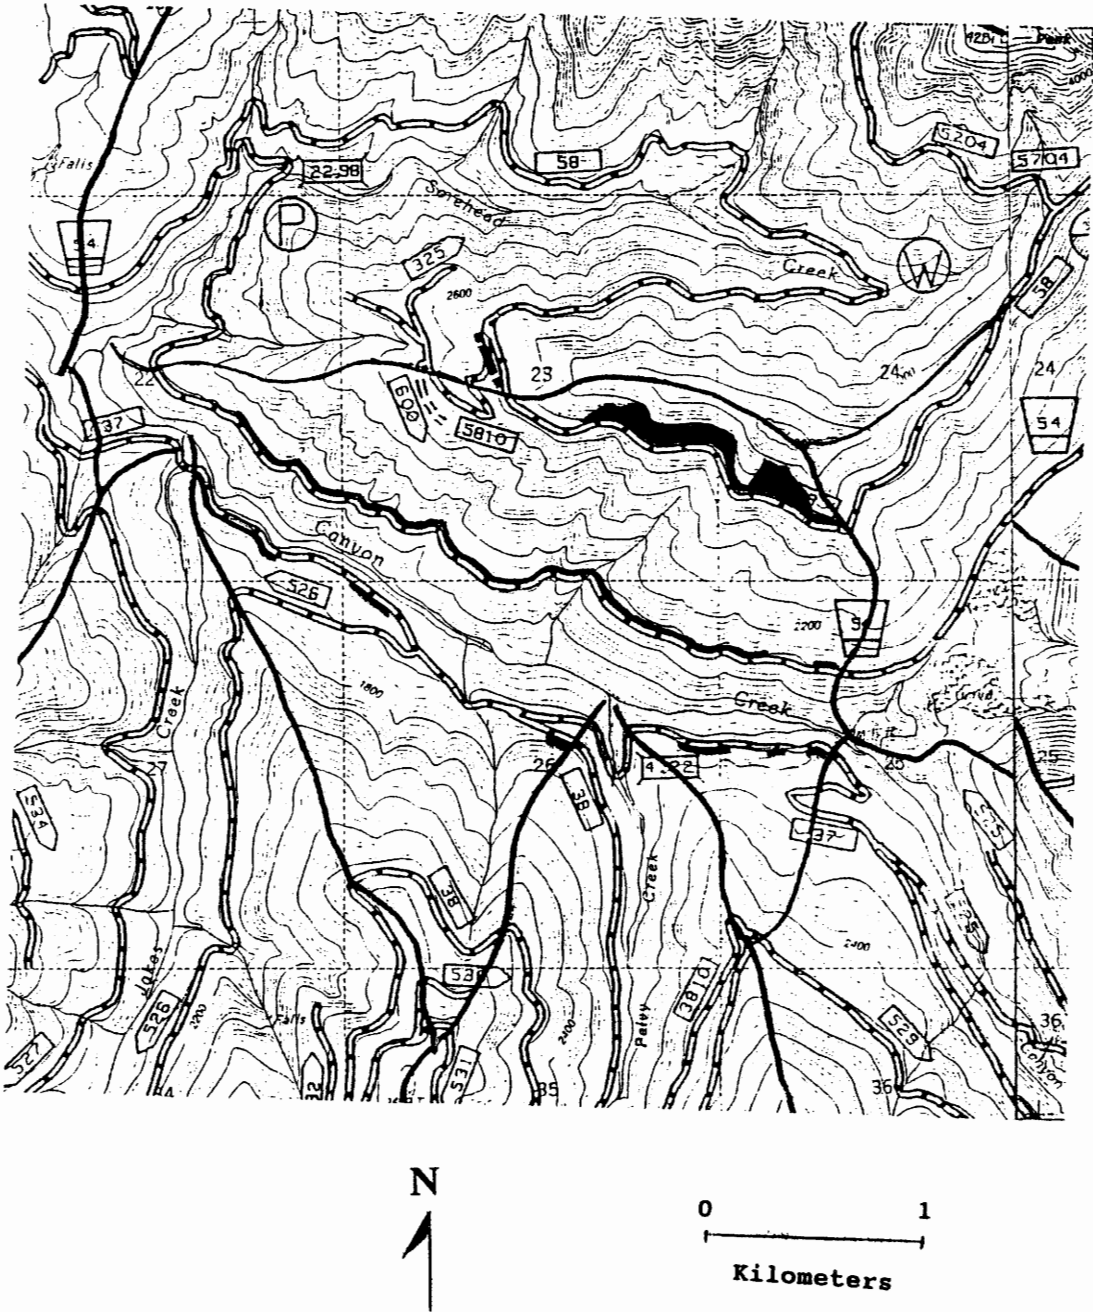
Rockfall appears to be the only type of mass wasting mechanism active in this subdrainage. All ten of the rockfall locations identified are the result of road building activity; however, three of the locations also have a component of natural degradation. The minimum total of 10.6 ha reflects both sources (Table 8). Rock avalanche deposits and failures due to other types of mass wasting mechanisms were not observed. Stream erosion of the till along Canyon Creek is occurring. A total streambank-area degradation value of seven hectares is based on qualitative factors such as bank height, type of material, stream energy, bank morphology and presence of groundwater.

A direct comparison between natural versus induced failures reveals that out of a minimum total mass wasting area of 10.6 ha in this subdrainage, 10.0 ha (94%) are the direct result of road building activity.

Figure 10. Middle Canyon Creek Subdrainage
 Failure locations are shown in black and identified in Table 8

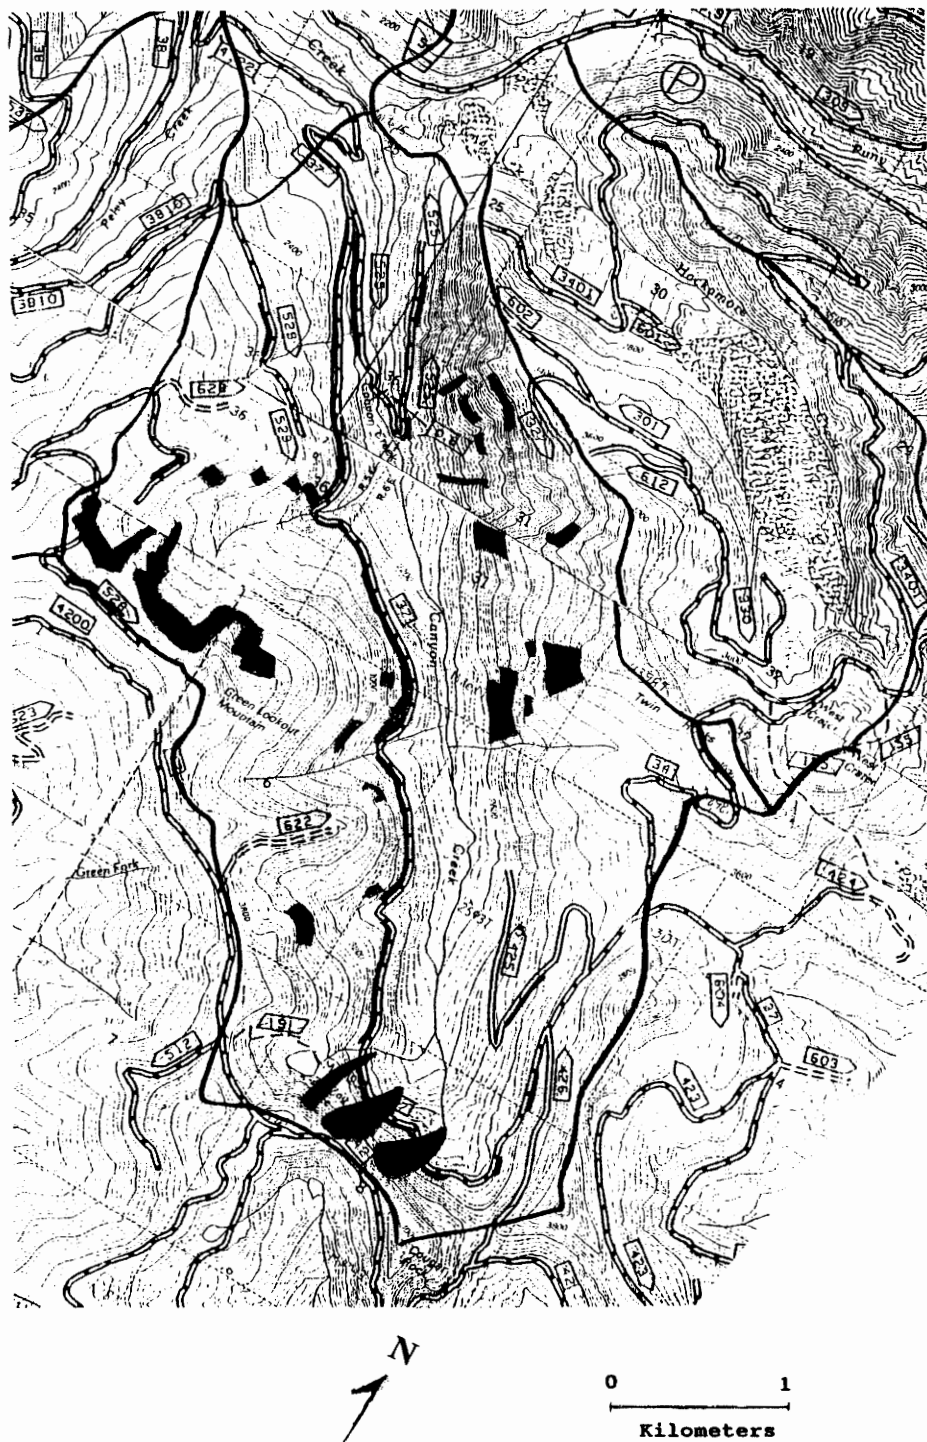
Rockfall, in terms of number of locations and volume of material, clearly outdistances all other types of mass wasting mechanisms in this subdrainage. Eighteen locations of appreciable (> 0.1 hectare) rockfall occur for a minimum total of 24.3 ha. Of this number, twelve were a result of road building or quarrying operations, three were natural and three were a combination natural and anthropogenic (Table 9). One rock avalanche deposit was observed covering 5.3 ha (Table 10). This rock avalanche deposit was a consequence of natural oversteepening. Failure of material above and along snow avalanche chutes is common on the north, east and south sides of Cougar Rock. While Table 11 shows that the amount of material associated with these features has a limited areal extent (2.5 ha) compared to the quantity of the other deposits in this subdrainage, their road-blocking potential is dramatic.

A direct comparison between natural versus induced failures reveals that out of a minimum total mass wasting area of 32.1 ha in this subdrainage, 3.8 ha (12%) are the direct result of road building activity.

Figure 11. Upper Canyon Creek Subdrainage
 Failure locations are shown in black and identified in Tables 9, 10 and 11.

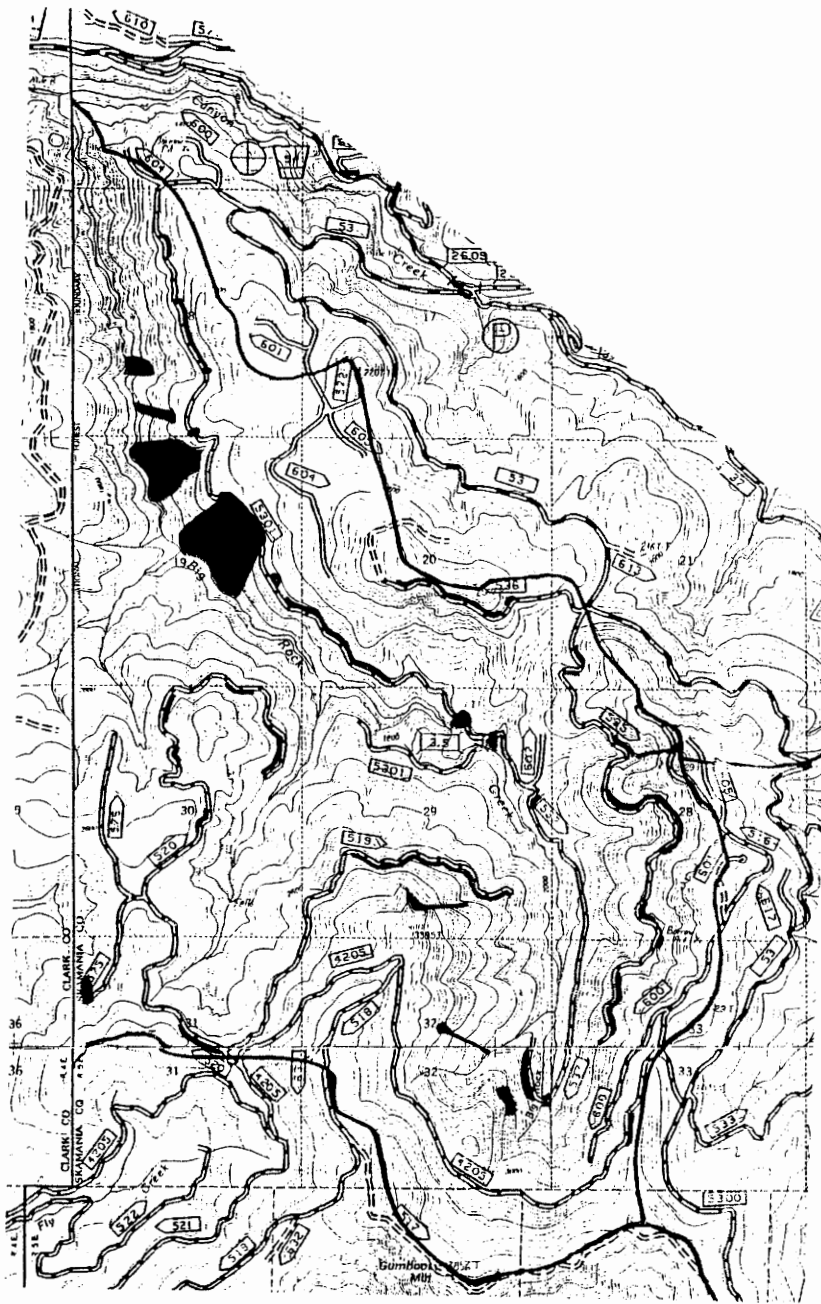
Rockfall, in terms of number of locations, clearly outdistances all other types of mass wasting mechanisms in this subdrainage; however, in terms of surface area, translational slide complexes located along lower Big Rock Creek predominate. Twenty-one locations of appreciable (> 0.1 hectare) rockfall occur for a minimum total of 17.9 ha. Of this number, four were natural covering 11 ha (Table 12). One rock avalanche location covers a total of 1.2 ha (Table 13). Failures due to other types of mass wasting mechanisms occupy the majority of failure deposits in this subdrainage. Slumps occupy at least 25.6 ha and debris flows 1.3 ha (Table 14).

A direct comparison between natural versus induced failures reveals that out of a minimum total mass wasting area of 46.0 ha in this subdrainage, 6.7 ha (14%) are the direct result of road building activity.

Figure 12. Big Rock Creek Subdrainage
 Failure locations are shown in black and identified in Tables 12, 3 and 14.

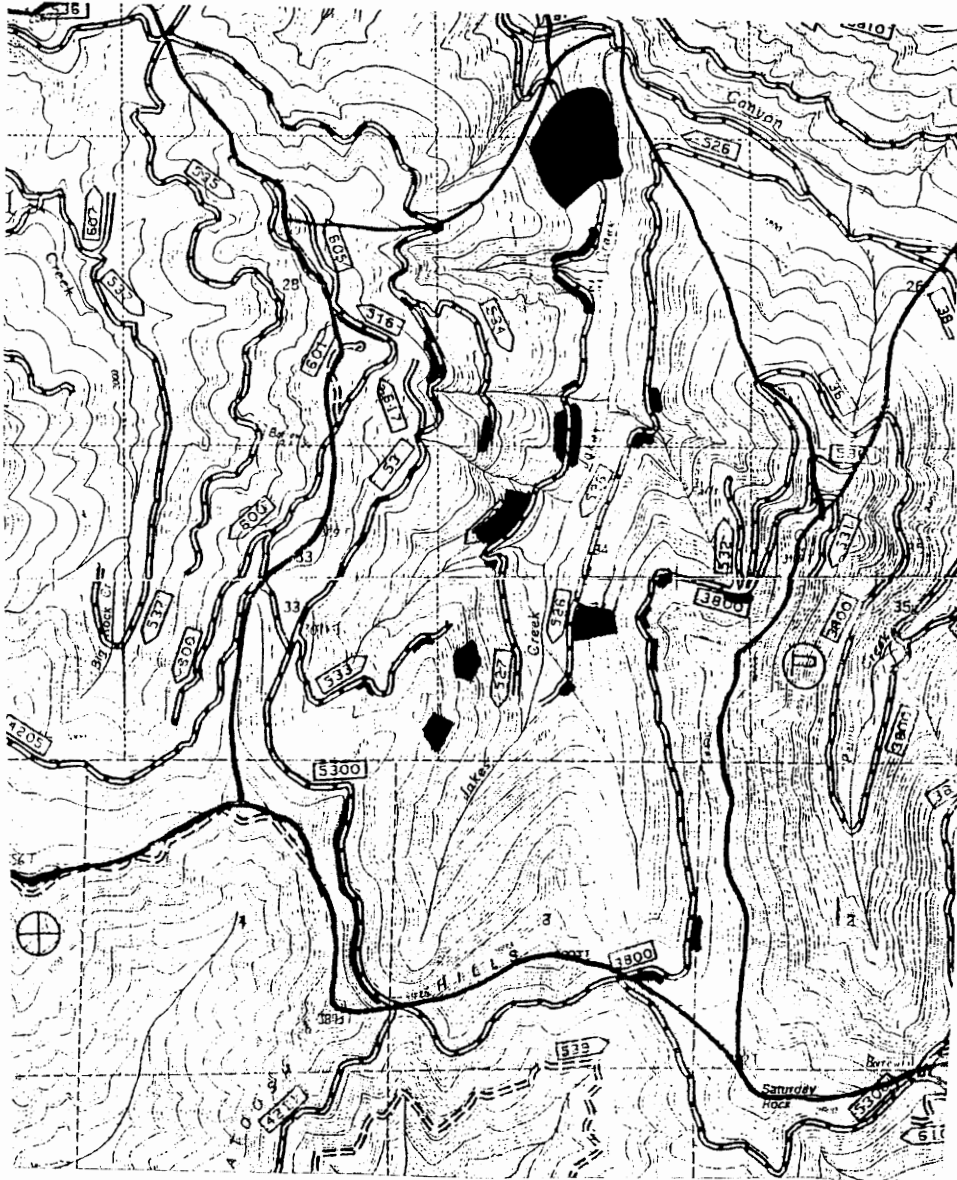
Rockfall, in terms of number of locations, clearly outdistances all other types of mass wasting mechanisms in this subdrainage; however, in terms of surface area, rock avalanche deposits predominate. Seventeen locations of appreciable (> 0.1 hectare) rockfall occur for a minimum total of 3.8 ha (Table 15). Of this number, only one is natural but accounts for nearly half the area covered by rockfall in the subdrainage (1.8 ha). Three locations comprised of rock avalanche deposits occur covering a total of 18.6 ha (Table 16). Failures due to other types of mass wasting mechanisms are volumetrically minor. Only one slump covering 0.7 ha was observed (Table 17).

A direct comparison between natural versus induced failures reveals that out of a minimum total mass wasting area of 23.1 ha in this subdrainage, 2.0 ha (9%) are the direct result of road building activity.

Figure 13. Jake's Creek Subdrainage
 Failure locations are shown in black and identified in Tables 15, 16 and 17.

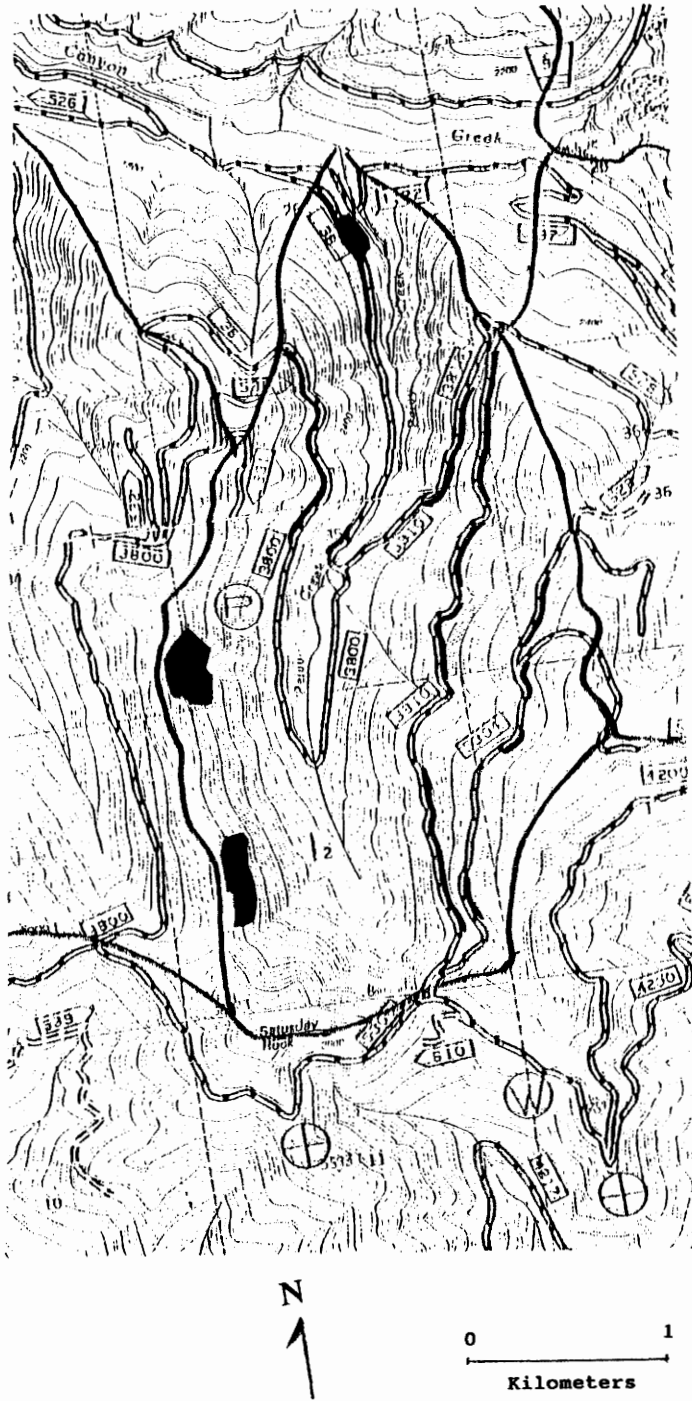
Rockfall, in terms of number of locations, is greater than all other types of mass wasting mechanisms in this subdrainage; however, in terms of surface area, rock avalanche deposits predominate. Thirteen locations of appreciable (> 0.1 hectare) rockfall occur for a minimum total of 2.6 ha (Table 18). Of this number, only one location is natural. Two locations comprised of rock avalanche deposits occur covering a total of 14.6 ha (Table 19). Failures due to other types of mass wasting mechanisms include only one slump covering 1.7 ha (Table 20).

A direct comparison between natural versus induced failures reveals that out of a minimum total mass wasting area of 18.9 ha in this subdrainage, 2.5 ha (13%) are the direct result of road building activity.

Figure 14. Pelvy Creek Subdrainage
 Failure locations are shown in black and identified in Tables 18, 19 and 20.

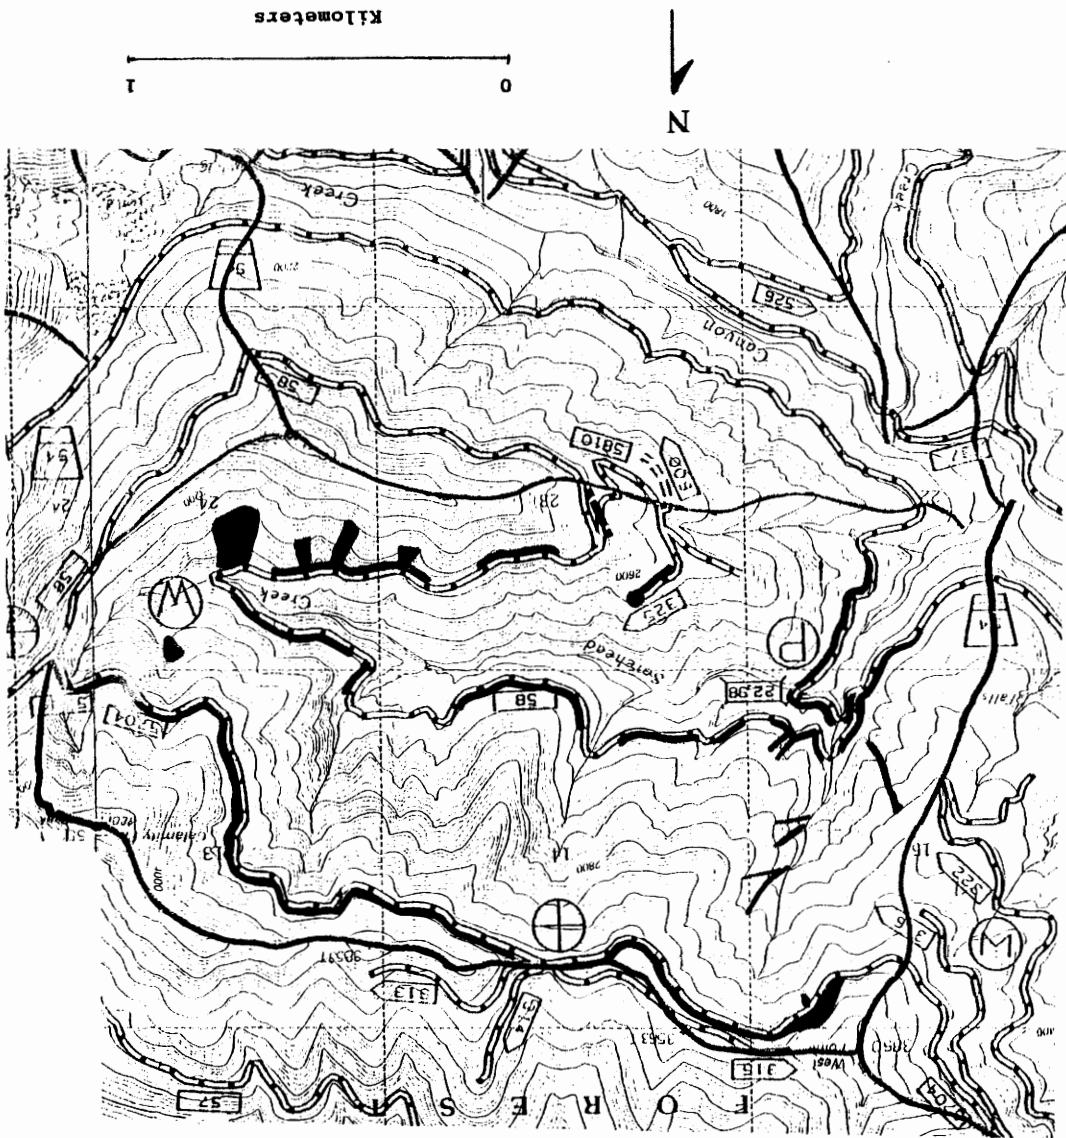
A direct comparison between natural versus induced failures reveals that out of a minimum total mass wasting area of 33.9 ha in this subdrainage, 19.0 ha (56%) are the direct result of road building activity.

Figure 15. Sorehead Creek Subdrainage
Failure locations are shown in black and identified in Tables 21 and 22.

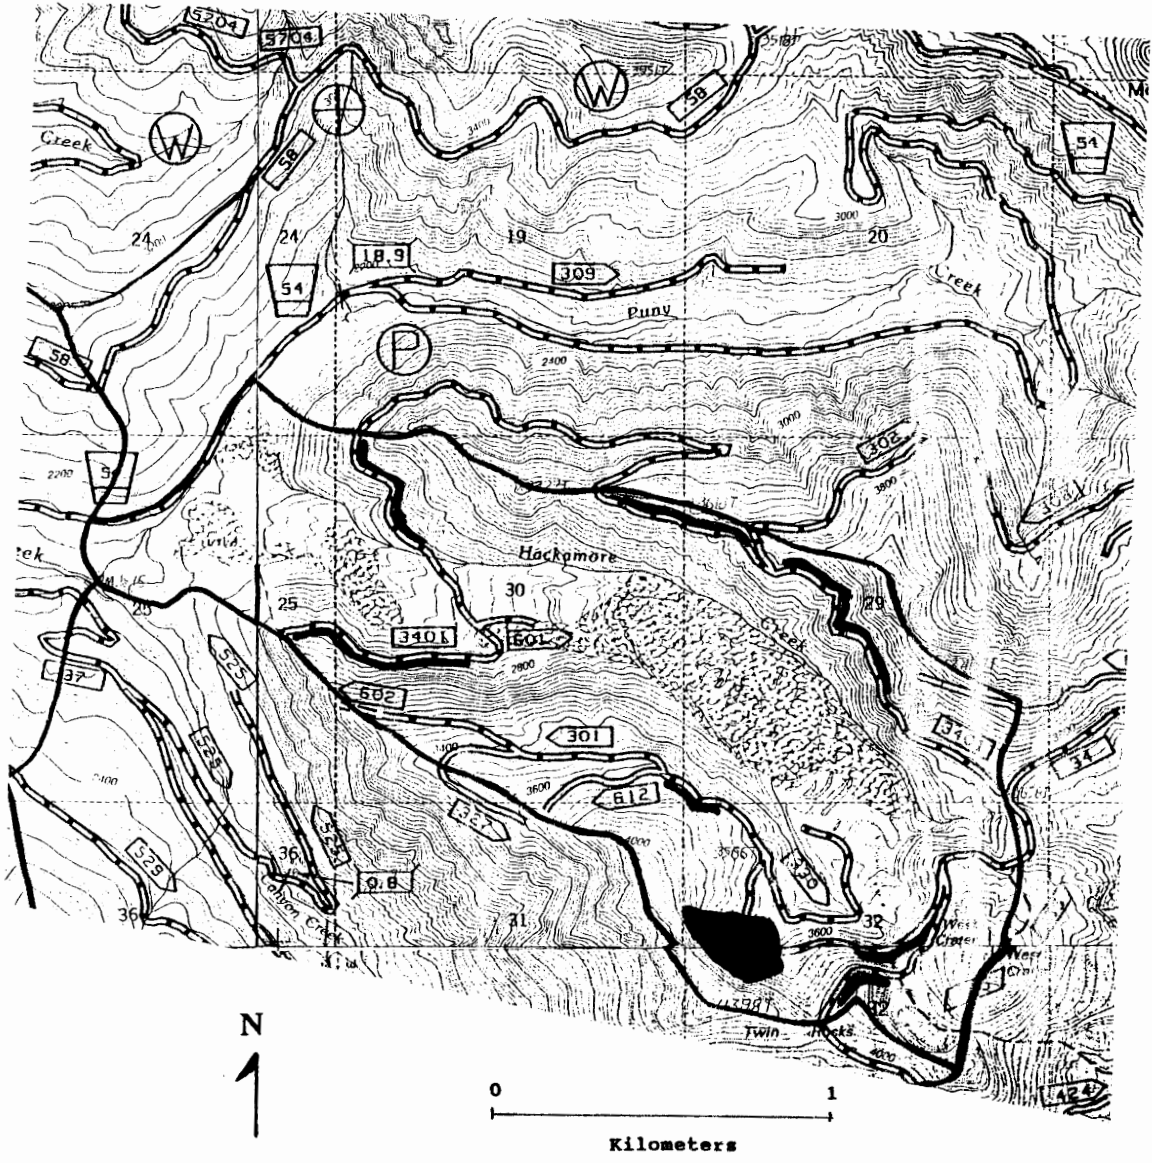
Rockfall is the predominant mass wasting mechanisms in this subdrainage. Ten locations of appreciable (> 0.1 hectare) rockfall occur for a minimum total of 8.8 ha (Table 23). Of this number, only one location is natural but accounts for 63% of the total volume (5.6 ha). Degradation of weathering tuff exposed in a roadcut along FS Road 301 is resulting in both rockfall and debris slips of sufficient quantity to block the road. No rock avalanche deposits occur. Failures due to other types of mass wasting mechanisms do not occur.

A direct comparison between natural versus induced failures reveals that out of a minimum total mass wasting area of 8.8 ha in this subdrainage, 3.2 ha (37%) are the direct result of road building activity.

Figure 16. Hackamore Creek Subdrainage
Failure locations are shown in black and identified in Table 23.

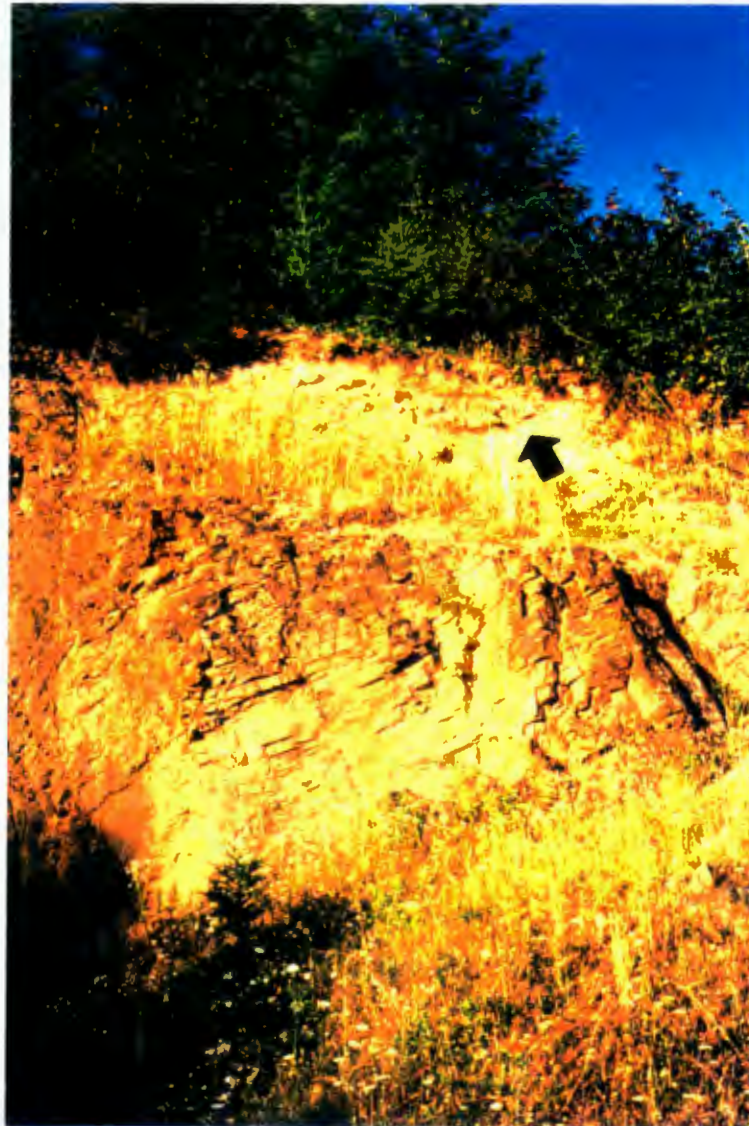
Figure 27. Scour surface contact with glacial overburden - FS Rd. 310, NE 1/4 sec. 19, T5 N. R.5 E. Scoured, dipping basaltic andesite bedrock overlain by cobbly fine-grained diamicton and also a small patch of cobble/boulder till (arrow). This clearly shows the impact of glaciation on the bedrock and suggests one reason for the dearth of weak or highly weathered surface material in the upper Canyon Creek basin.

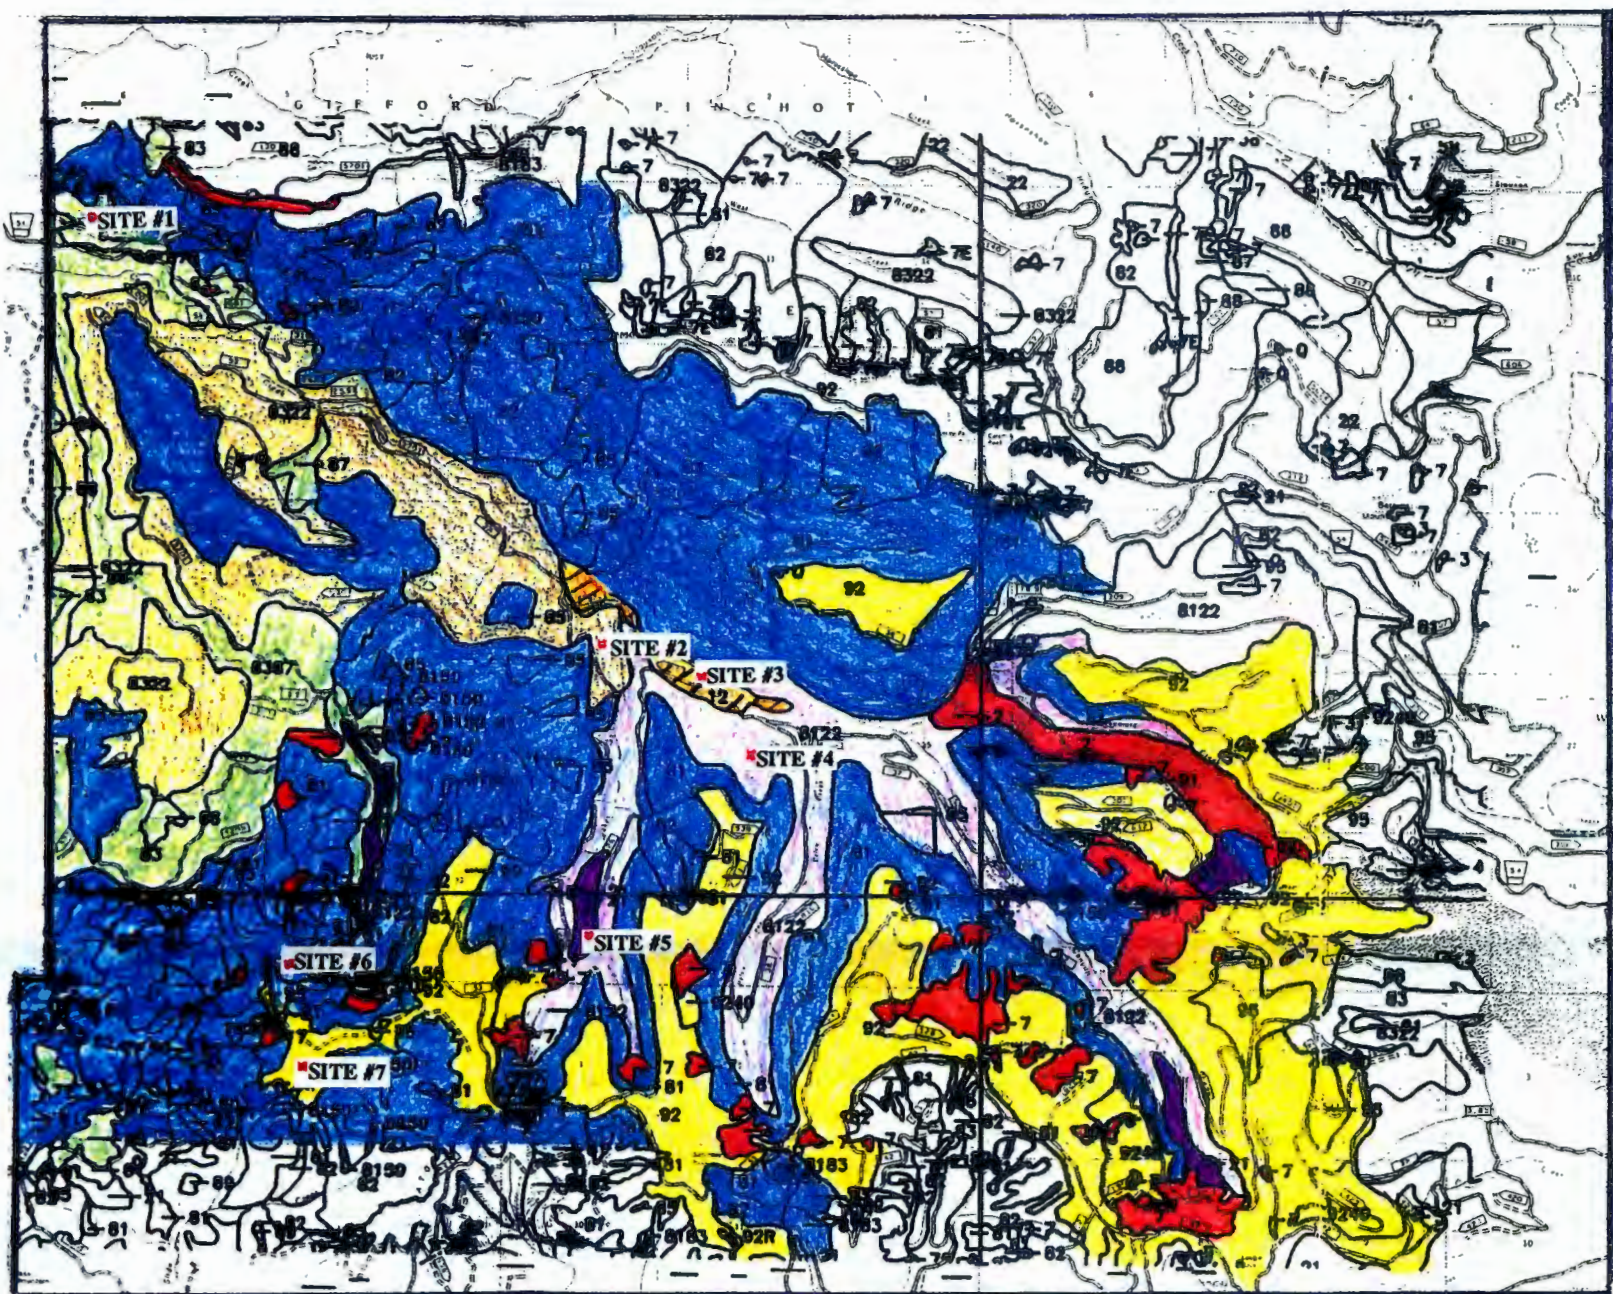
The soil types in areas 1 and 2 are identified in the Forest Service Soil Resource Inventory (SRI) (Wade, 1992) as being more clayey than the other soil types in the basin. These areas are underlain primarily by fragmental igneous bedrock (80%), whereas, the ratio associated with areas 3 - 6 is closer to 50/50. Soils associated with area 7 are underlain by >80% compact igneous bedrock.

Figure 29. Distribution of soil types found in the upper Canyon Creek study area. Areas 1 and 2 are identified in the Forest Service Soil Resource Inventory (Wade and others, 1992) as containing the most clay-rich material within the study area. This study has found that these areas are experiencing the greatest number of translational and rotational failures.
