# Crack Detection in an Aluminium Oxide Grinding Wheel by Impact Hammer Tests

Lee, Y.; Turcic, D.; Danks, D.; Wern, C. Crack Detection in an Aluminium Oxide Grinding Wheel by Impact Hammer Tests. *Computation* 2023, 11, 47. <https://doi.org/10.3390/computation11030047>

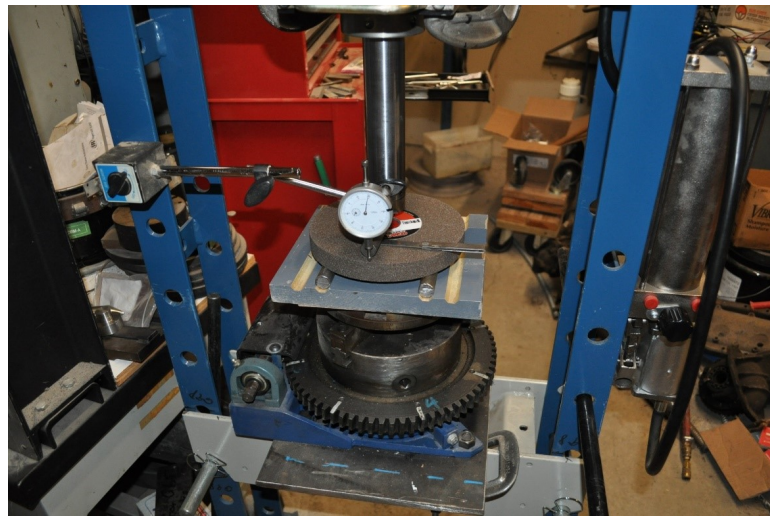
The grinding wheels were cracked, as shown in Figure 2, using a three-point bend fixture in a 20 ton hydraulic load frame.

The load and deflection were monitored with a pressure gauge on the load frame hydraulic cylinder and a dial indicator on the wheel directly adjacent to the loading point. The loading points were 203 mm long by 19 mm diameter steel bars. The outer load points were 178 mm apart and the centre loading point was midway, 89 mm, between the two outer bars. The cracked wheels were glued either with 25 mm of glue radially or glued completely, as shown in Figure 3, so that we could determine the effect of the amount of glued surface in the vibrational response of the grinding wheel during impact hammer testing. In this study, a water-curing single part glue was used to bond the grinding wheel segments since it can bond the vitrified grinding wheels. After applying the glue, mechanical steel clamps were used to hold the wheels until the glue was set.

**Figure 2.** Three-point bending fixture to crack the grinding wheels.
