Environmental Geology of the Marquam Hill Area

Roger Alan Redfern
Portland State University

ENVIRONMENTAL GEOLOGY
OF THE
MARQUAM HILL AREA

by
ROGER ALAN REDFERN

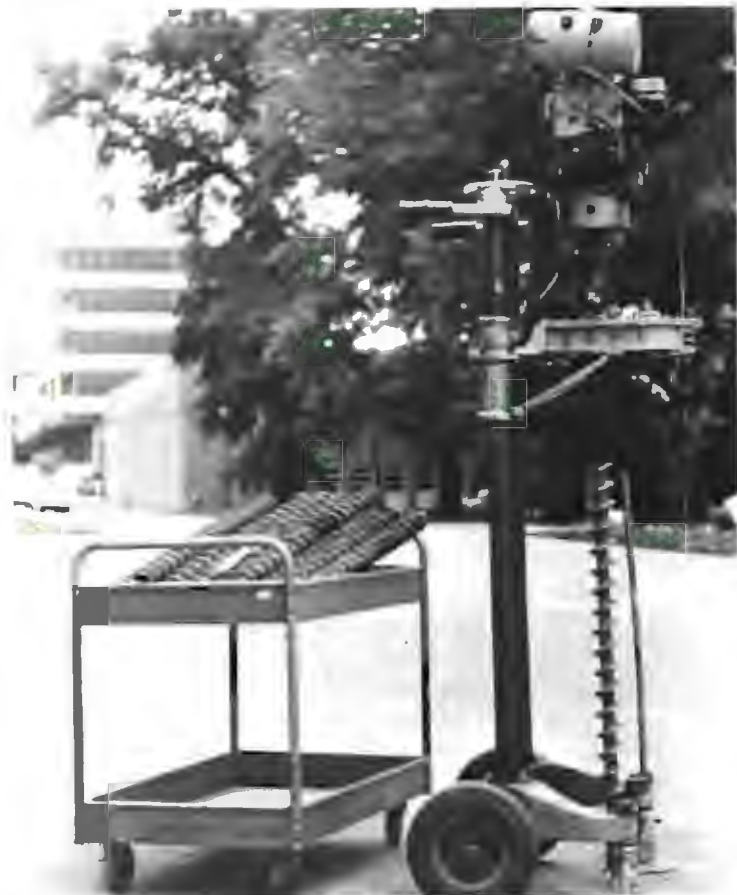
Figure 2. Highly portable power auger used for soil exploration to depths as much as 40 feet; supplied by Oregon Department of Geology and Mineral Industries.

Soil and rock exposures as shown on map 2 were classified and were examined for structure, relative stability, degree of weathering, and thickness. Unconsolidated sediments and soils were studied by field classification and laboratory analysis. Samples were obtained with the aid of hand and portable power augers (figure 2). Seismic surveys with a portable seismic timer (Soiltest Model MD-3) supplemented the identifications.

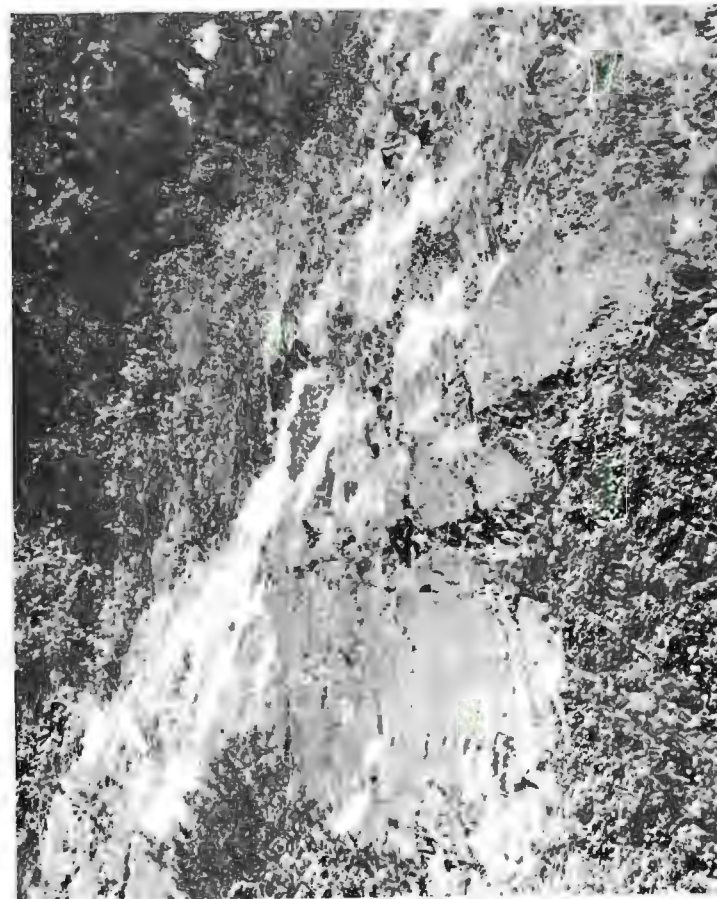
Figure 3. Columnar (bottom) and closely spaced (top) jointing in basalt have different stability and excavational characteristics.

Consistent variations within individual lava flows, however, are quite well known and have an important effect upon the way the land will respond to excavation, grading, and slope stability. An individual flow may contain the following layers (see figure 3): (1) an underlying soil, (2) a basal columnar jointed basalt, (3) a zone of closely spaced jointing with open cavities (vesicles), (4) an upper columnar jointed basalt, and (5) an overlying soil.)

Columnar jointed basalt is created by cooling of the hot molten lava forming columns approximately perpendicular to the top and bottom of the flow. The basalt columns range from several inches to several feet in diameter. Massive columns may form cliffs from which rockfalls occur. Large columns form stable foundations but are commonly difficult to excavate.

Basalt with closely spaced jointing and open cavities (vesicles) is generally more easily excavated. Where such basalts are weathered, unstable and failing ground can be expected on slopes steeper than 15 percent (figure 4).

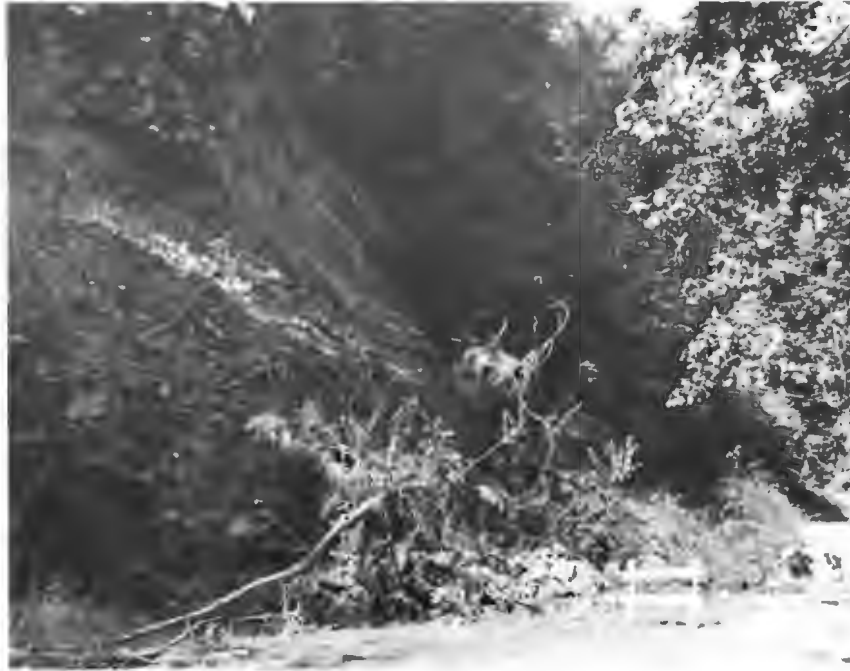
Figure 4. Landslide in moderately weathered basalt on Northwood Avenue, an unimproved and undeveloped street.

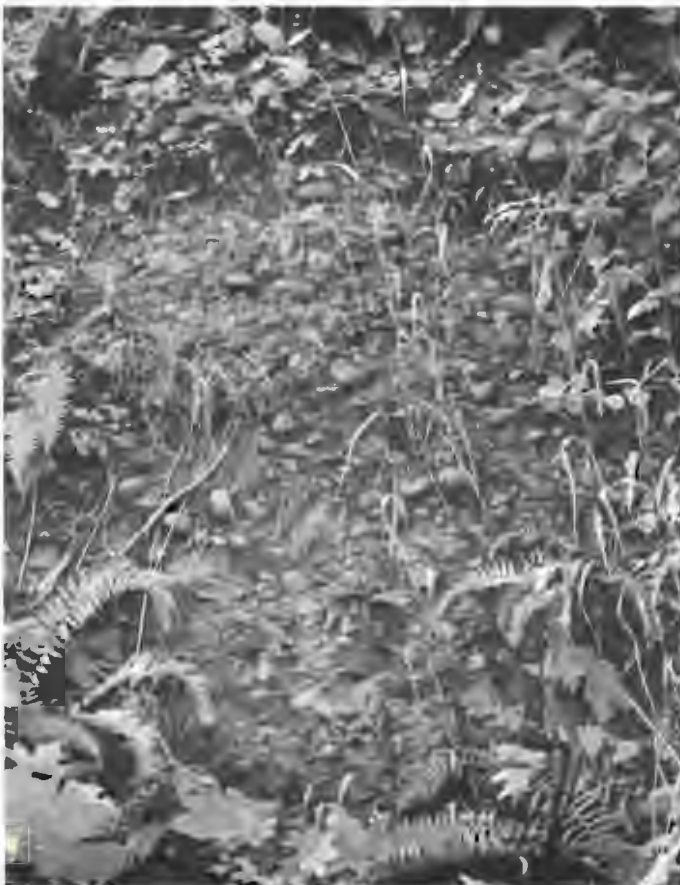
Figure 5. An unusual occurrence of quartzite-free conglomerate on S.W. Fairmount Boulevard at an elevation above 900 feet near the crest of the Portland Hills.

Two widely separated deposits of moderately well-cemented sands and gravels (conglomerate) were found, one of which was mapped by Treasher (1942) as Troutdale Formation (Figure 5). These deposits do not resemble the Troutdale in all respects, but stratigraphically* and within the objectives of this study the gravels can be considered equivalent to the Troutdale. The extent of the gravels is probably greater than shown on the map but is masked by soil cover.

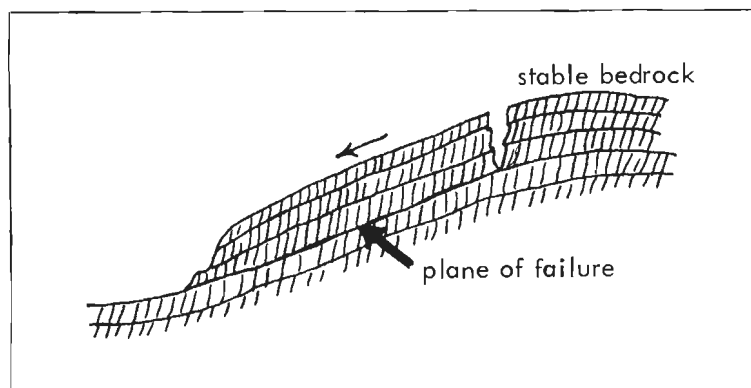
Figure 6. Diagrammatic cross section of a block glide failure in which inclined layers of bedrock break away from stable areas and move downslope under the force of gravity. Similar in concept to the "West Linn landslide" in the southern Portland Hills.

Columbia River Basalt flows over 700 feet thick have been folded into a broad arch (anticline*) that trends about 40 to 50 degrees west of north (N 40-50° W) and have probably been faulted at the base of both the northeast and southwest flanks (Schlicker and Deacon, 1967; Balsillie and Benson, 1971). There is a need for analysis of bedrock structure based on the premise that active faults do exist in the area and may be a hazard to development. Inclined layers of bedrock exposed by natural erosion, faulting, and/or by man's excavational activities, may result in block glide failures (Figure 6). Bedrock structure in the Marquam Hill is shown on map 3.

Structural conditions similar to these at West Linn exist in the Marquam Hill area. The Columbia River Basalt flows in the study area dip northeasterly at angles up to 15 degrees. Toes of several flows have been exposed by natural erosion and possibly by faulting, as shown in the cross section. Although no direct observations of interflow sediments were made in the study area, samples of clayey soils similar to those at West Linn were obtained in three power auger test drill holes. Therefore, the possibility of this type of failure must not be overlooked in the Marquam Hill area.

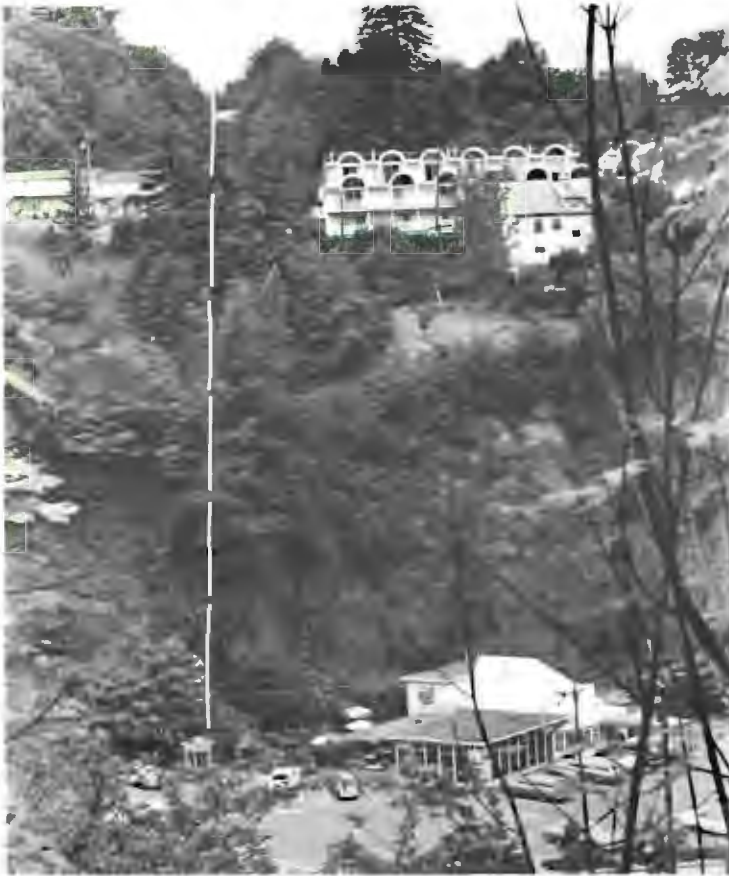
Figure 7. A nearly vertical, north-trending fault (indicated by dashed line) with minor displacement near Duniway Park.

Four fault zones were positively identified in the study area (map 3). Two faults near Duniway Park trend approximately due north with nearly vertical fault planes. One of these fault zones is shown in figure 7. A third north-trending fault was identified near Council Crest but no dip measurements on the fault plane were possible. The fourth fault zone trends approximately west and dips approximately 55 degrees to the north. Figure 8 shows an exposure of this last fault zone with three distinct fault planes separating areas of highly fractured basalt. Displacements on the first two faults are on the order of a few feet. The last two faults may have displacements of a few tens of feet at most. Comparison of these fault trends with the mapped lineations on map 3 indicates that there may be more faults in the area approximately parallel (en echelon) to the known faults.

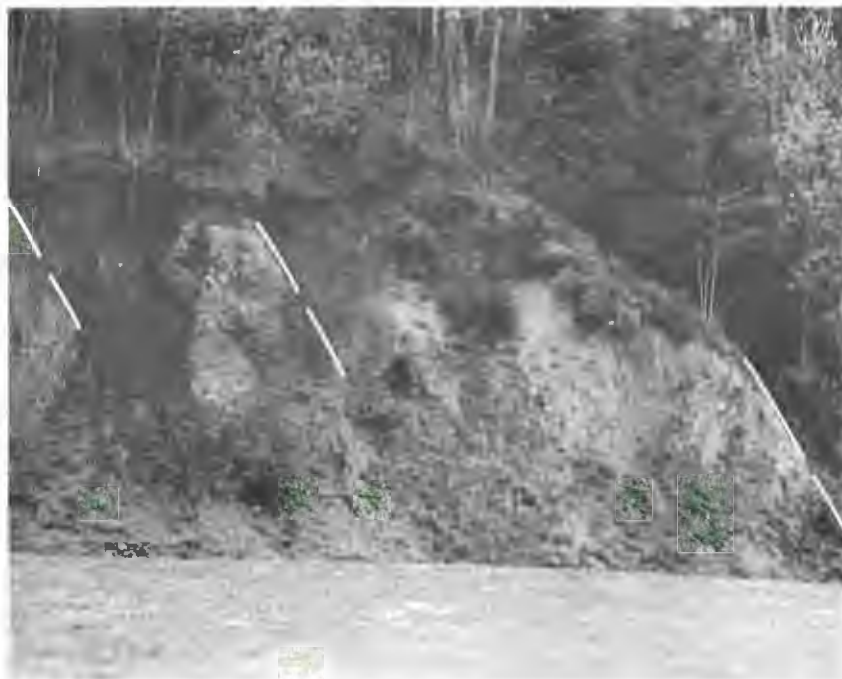
Figure 8. Part of a wide, west-trending, zone of normal faulting in a road cut on S.W. Terwilliger Boulevard. Note the three distinct fault planes separating highly fractured and weathered basalt.

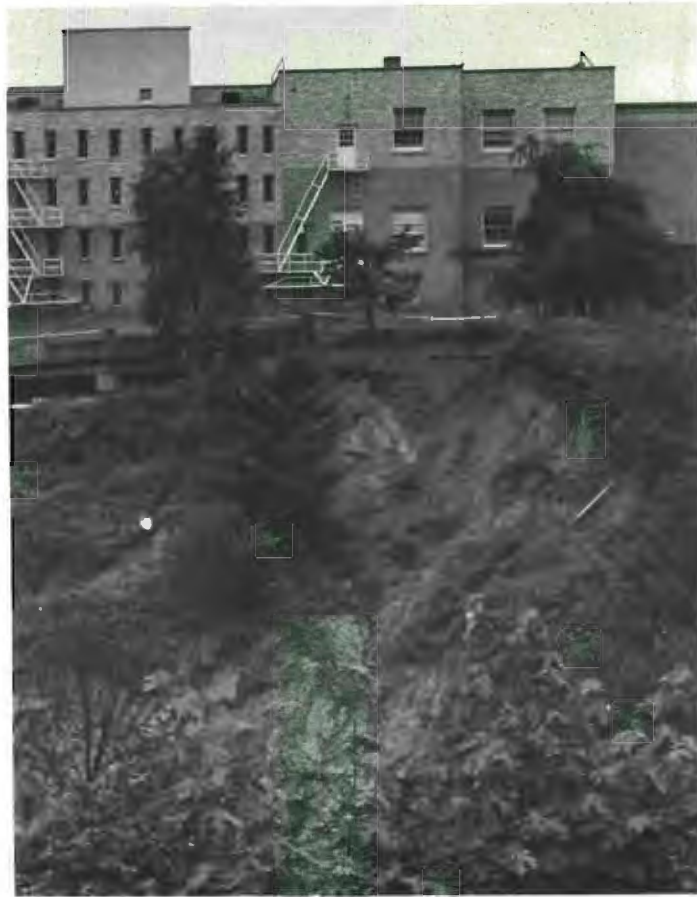
Figure 10. A landslide in Portland Hills Silt near the University of Oregon Medical School.

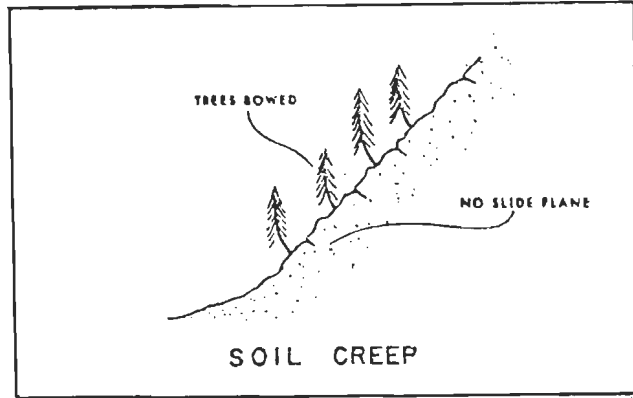
Figure 11. Diagram of soil creep shows the effect of this movement on the growth of trees. (Schlicker, 1956)

Curved tree trunks are usually caused by the downslope movement of the top portion of a soil mass (mass wasting or soil creep). The tree is moved downslope a short distance and leans somewhat downslope from vertical. If the movement and resultant root damage is not fatal to the tree, it will usually begin to grow in a vertical direction and acquire a bend in the lower trunk (see Figures 11 and 12).

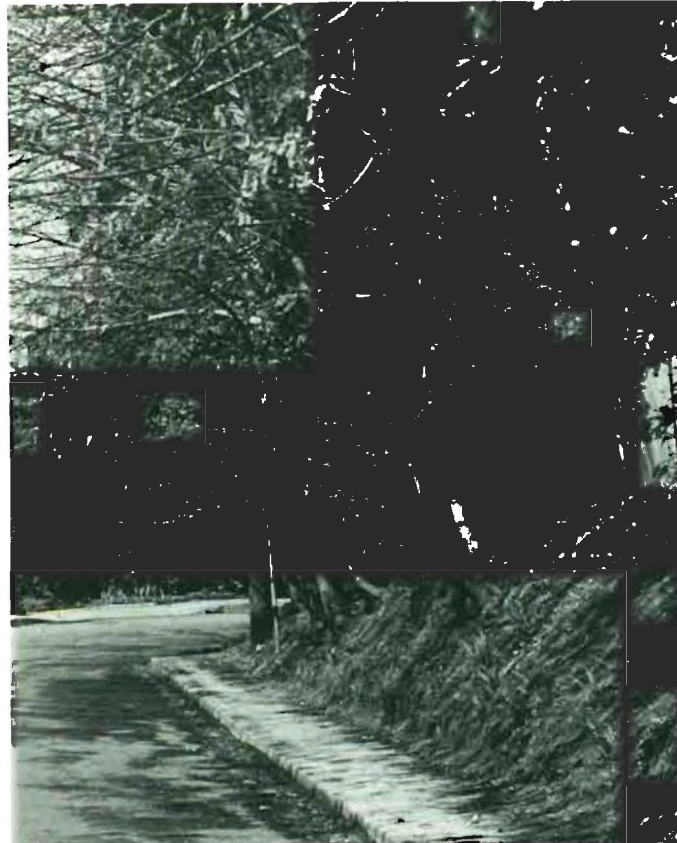
Figure 12. Bowed trees on a soil creep slope. Note also the diminished width of sidewalk.

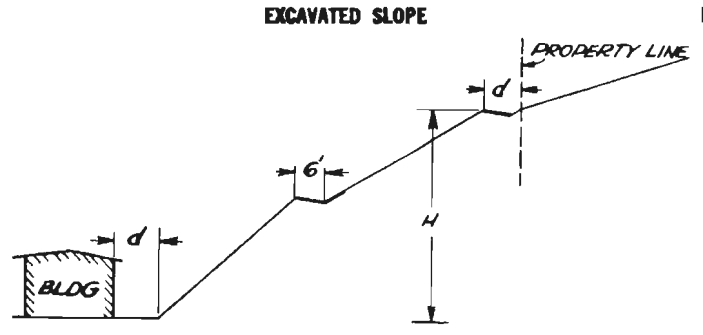
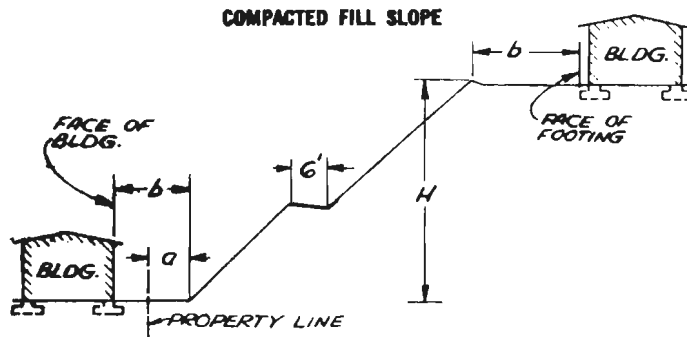
FIGURE NO. 1—REQUIRED SETBACKS

REQUIRED SETBACKS			
H FEET	FILL SLOPES		CUT SLOPES
	a	b	d
0-15	1'8"	3'	3'
15-50	H/10	H/5	H/5
Over 50	H/10	H/5	10'

Sec. 7013. Cuts and fills shall be set back from property lines and buildings shall be set back from cut or fill slopes in accordance with Figure No. 1. Retaining walls may be used to reduce the required setback when approved by the Building Official.

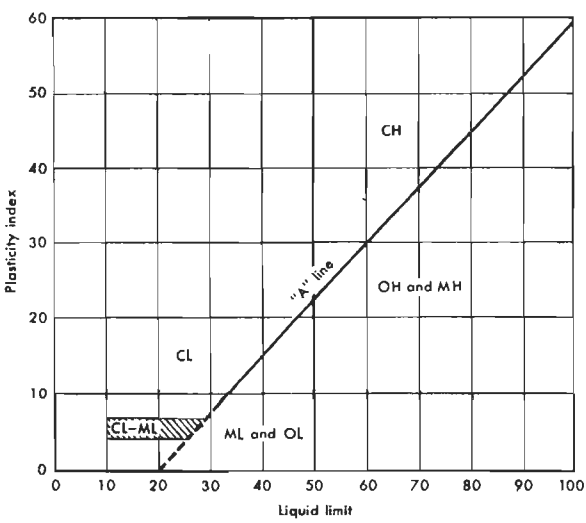
<p style="text-align: center;">Plasticity Chart</p>

CL	Inorganic clays of low to medium plasticity, gravelly clays, sandy clays, silty clays, lean clays				
		OL	Organic silts and organic silty clays of low plasticity				
	Silts and clays (Liquid limit greater than 50)	MH	Inorganic silts, micaceous or diatomaceous fine sandy or silty soils, elastic silts				
		CH	Inorganic clays of high plasticity, fat clays				
		OH	Organic clays of medium to high plasticity, organic silts				
	Highly organic soils	PI	Peat and other highly organic soils

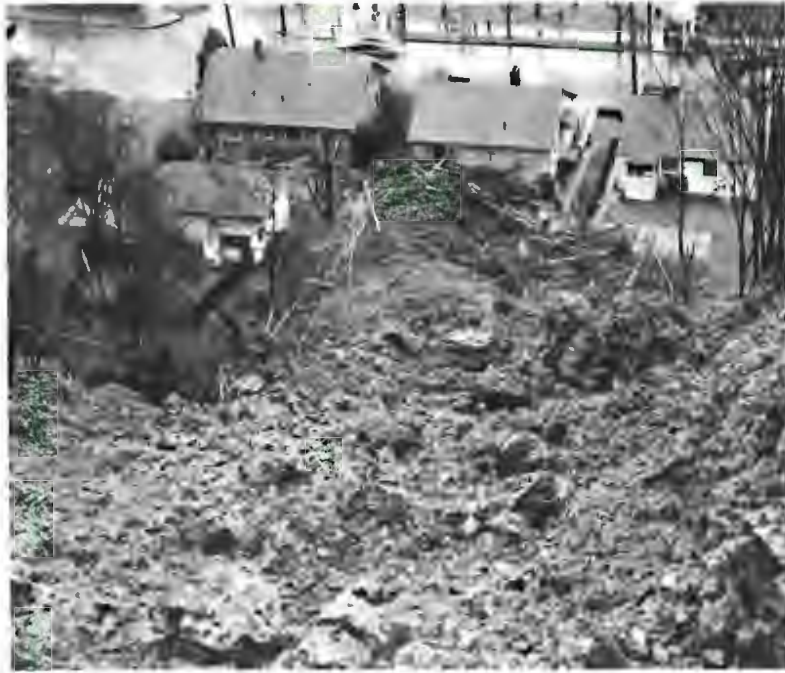
Figure 1. Photo of landslide near Marquam Hill area.

Visual perception of land instability was tested by first showing a photograph of a landslide (Figure 1) and asking "does this type of thing happen in the Portland Hills?" In the second visual test the respondent was asked to arrange five photographs of varying hazards into order of least (no. 1) to most (no. 5) hazardous as a building site (Figures 2, 3, 4, 5, 6). The photographs were taken within or very near the study area. They show the following conditions:

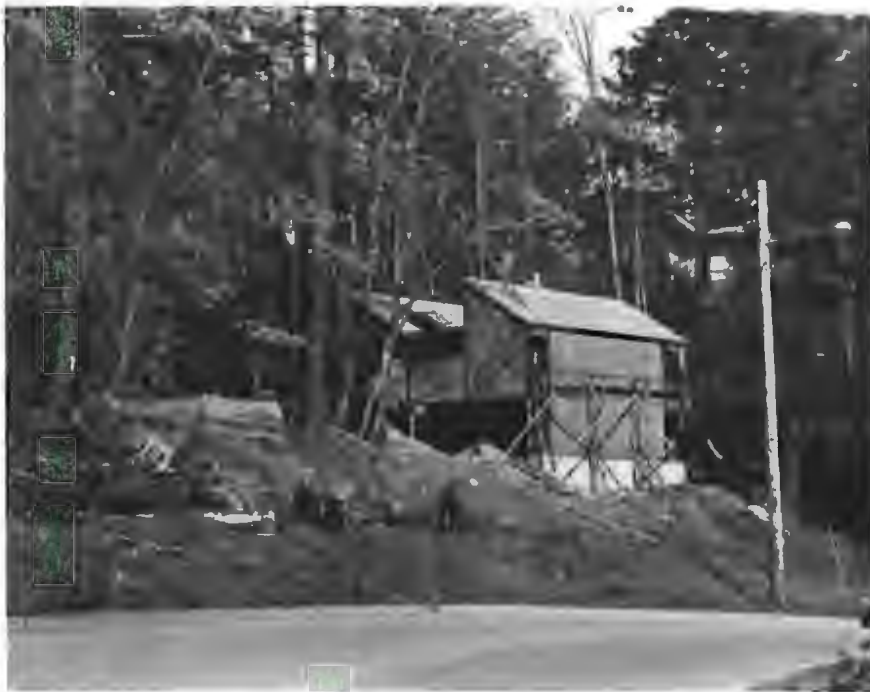
Figure 2. Photo of safe site; fairly level, no major signs of instability.

1. Safest site, fairly level, no major signs of instability (Figure 2).
2. A more secure site; we were curious if residents knew that the rock cliff was safer than a soil cliff (Figure 3).
3. Bent lower tree trunks showing soil creep (Figure 4).
4. Steep slope, a drainage course, and lack of older permanent vegetation (Figure 5).
5. Obvious landslide scarp (Figure 6).

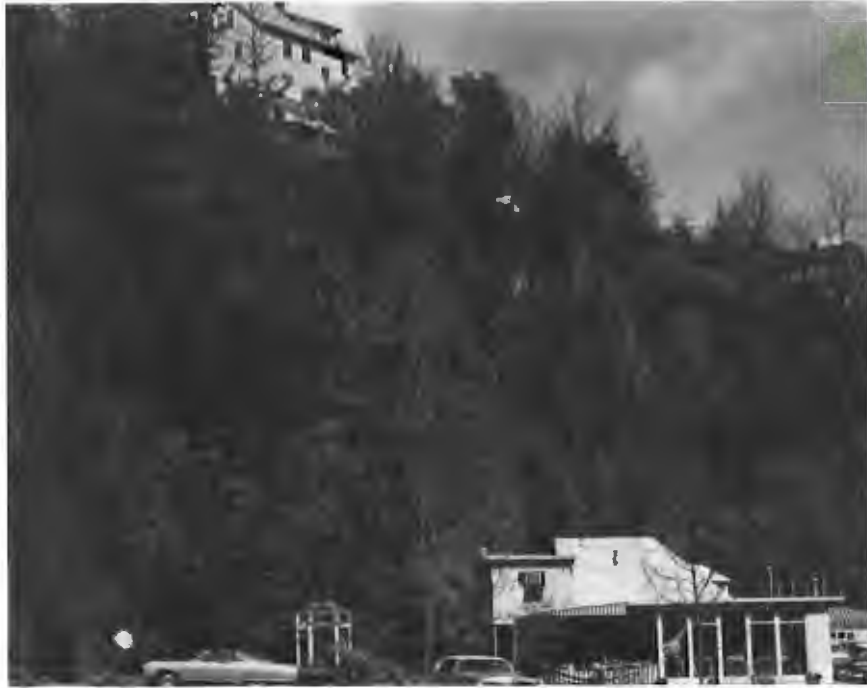
Figure 3. Photo of fairly secure site; cliff is bedrock rather than soil.

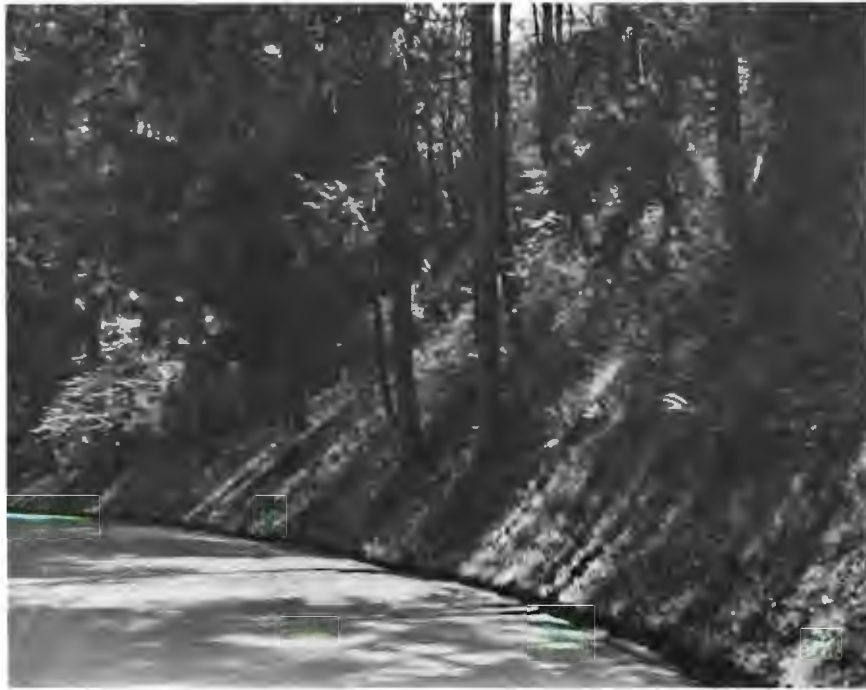
Figure 4. Photo of potentially unstable site; bent tree trunks indicate area of soil creep.

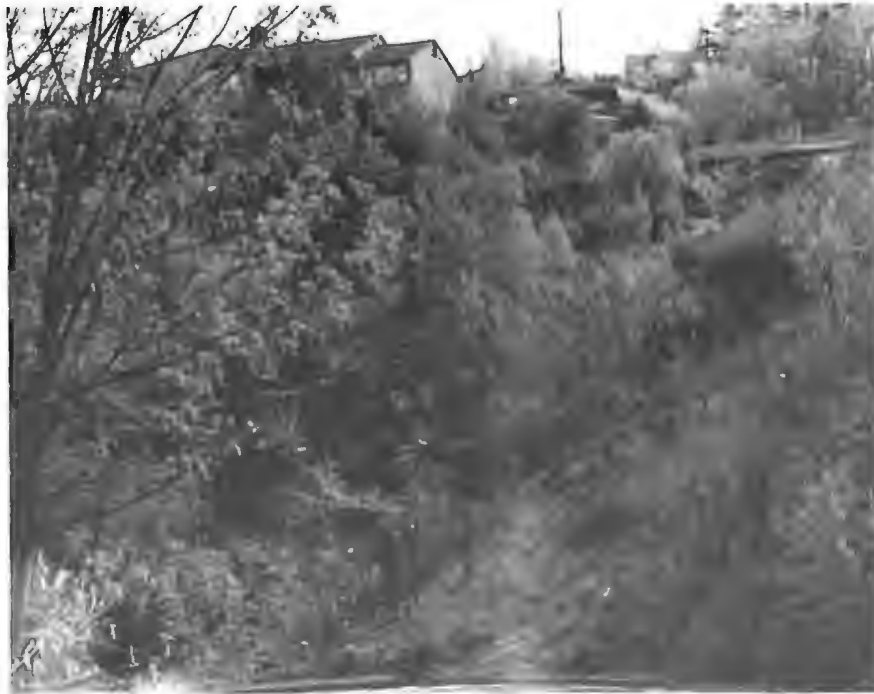
Figure 5. Photo of a poor building site; steep slope, lack of older permanent vegetation, and drainage course.

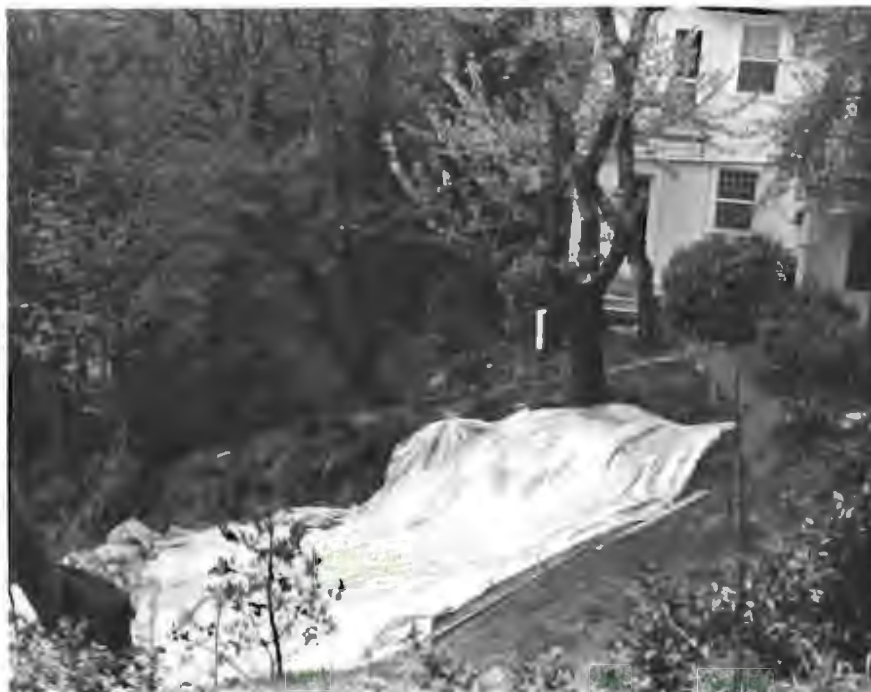
Figure 6. Photo of hazardous building site; a landslide scarp.

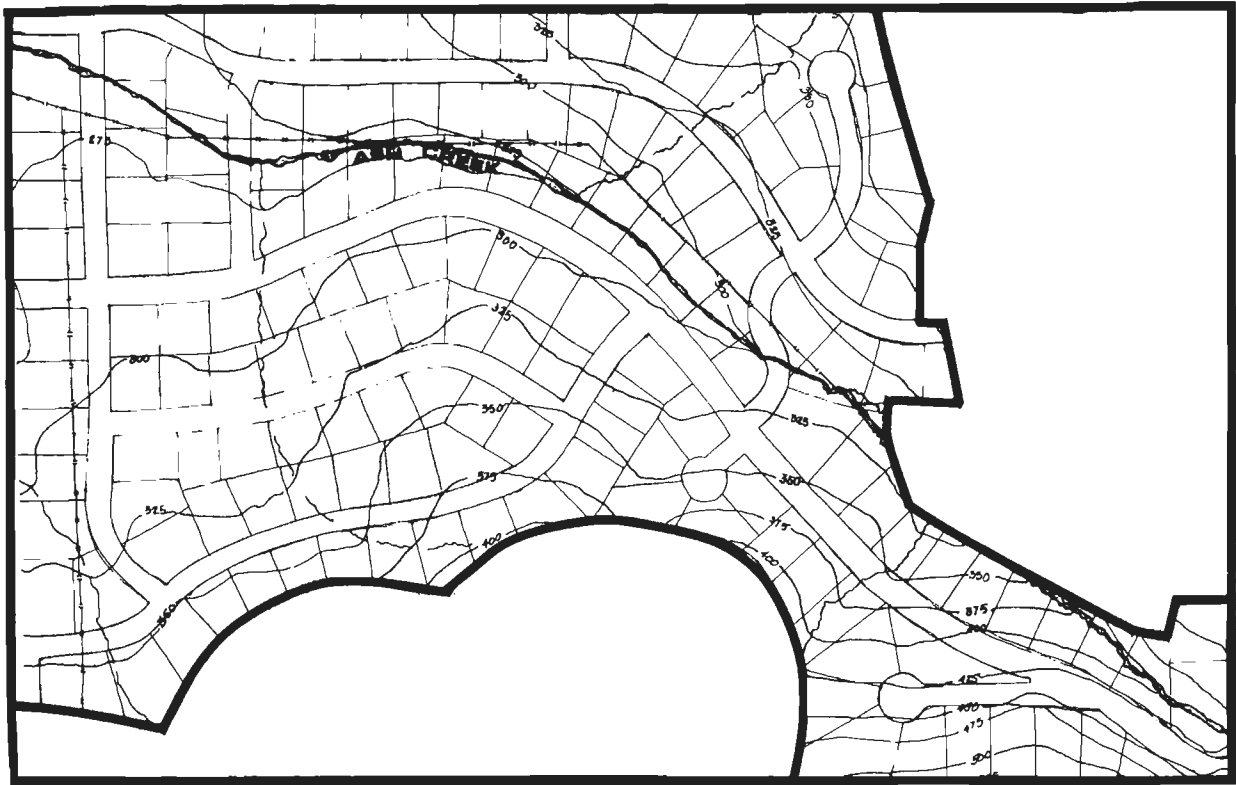
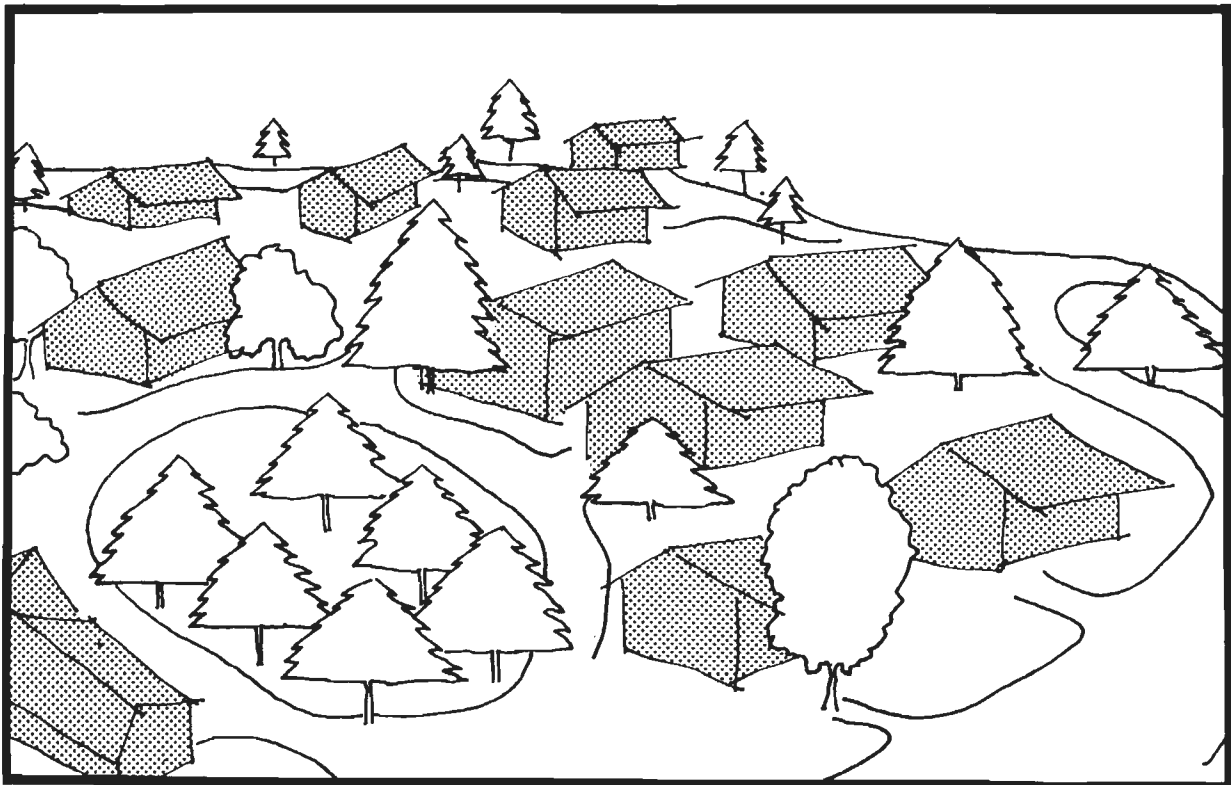
FIGURE 7

Standard Subdivision

SINGLE-FAMILY RESIDENCES ON ZONED LOTS

Visual perception of and preference for development type was tested by asking the respondent to indicate a preference for one of three development types, shown by diagram and sketch, for possible use in neighboring undeveloped hillside areas (Figures 7, 8, 9).

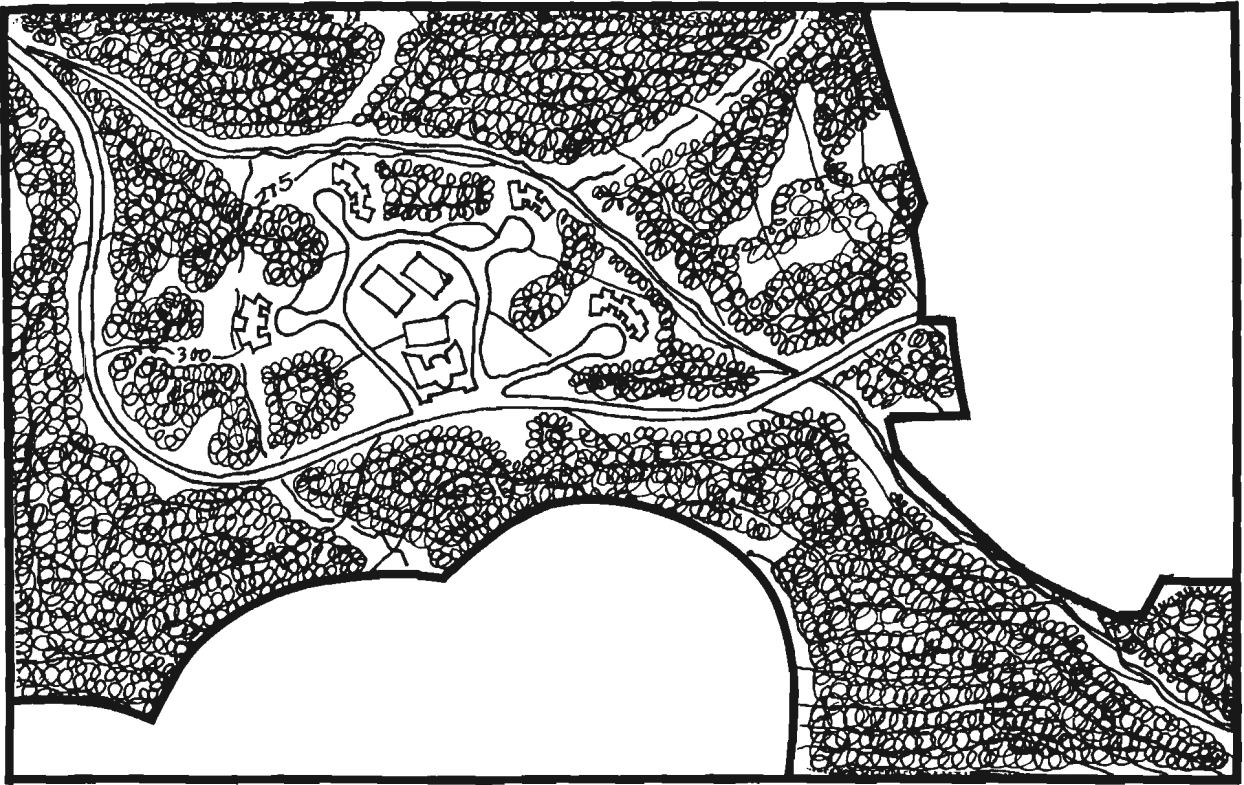
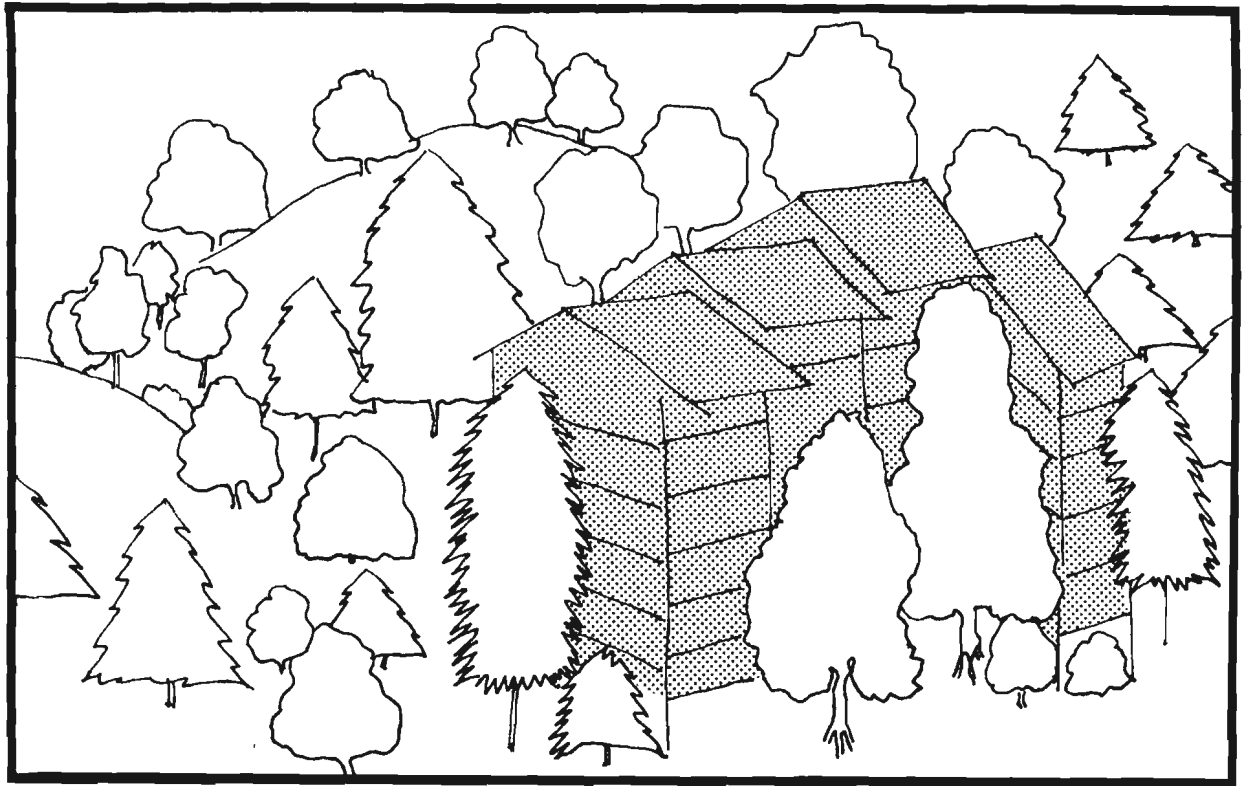
FIGURE 8

Open Space Medium Rise

CONDOMINIUM MEDIUM-RISE (8 STORIES) FAMILY RESIDENCE,
ASSOCIATED WITH A COMMONLY OWNED OPEN AREA

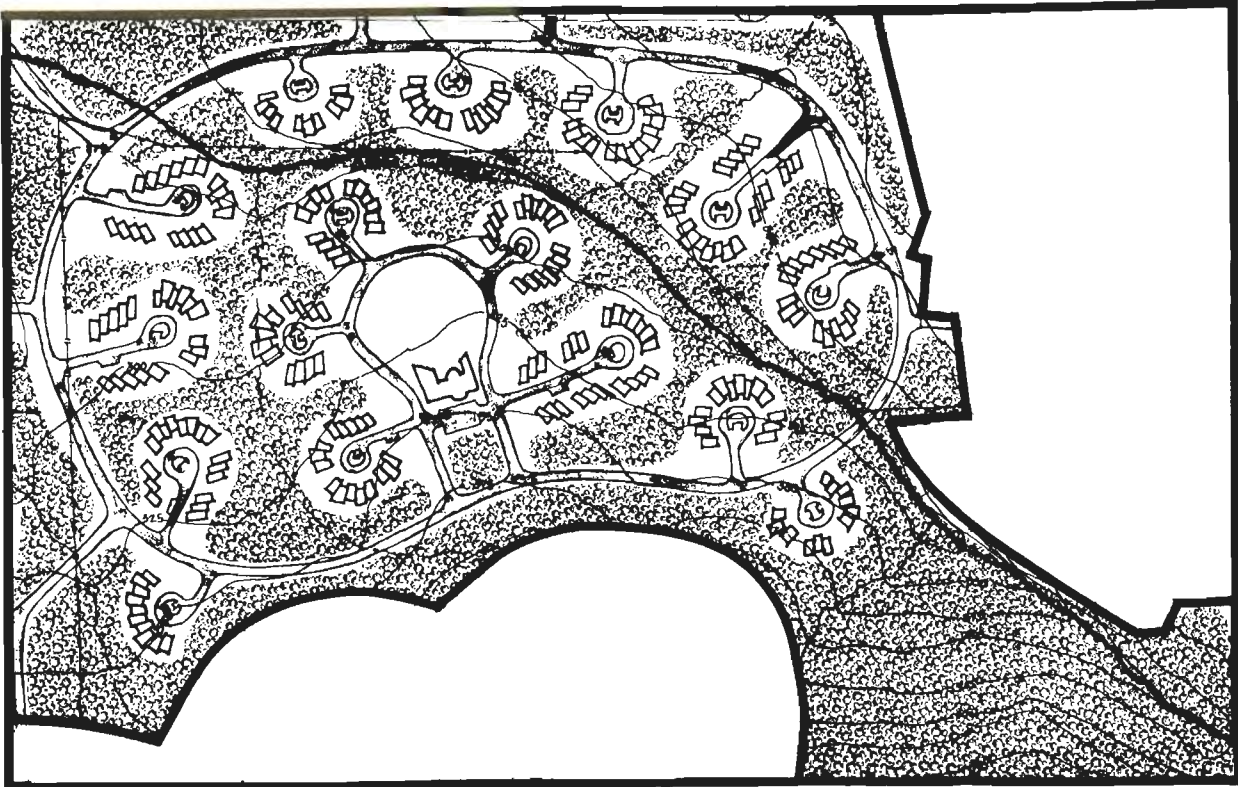
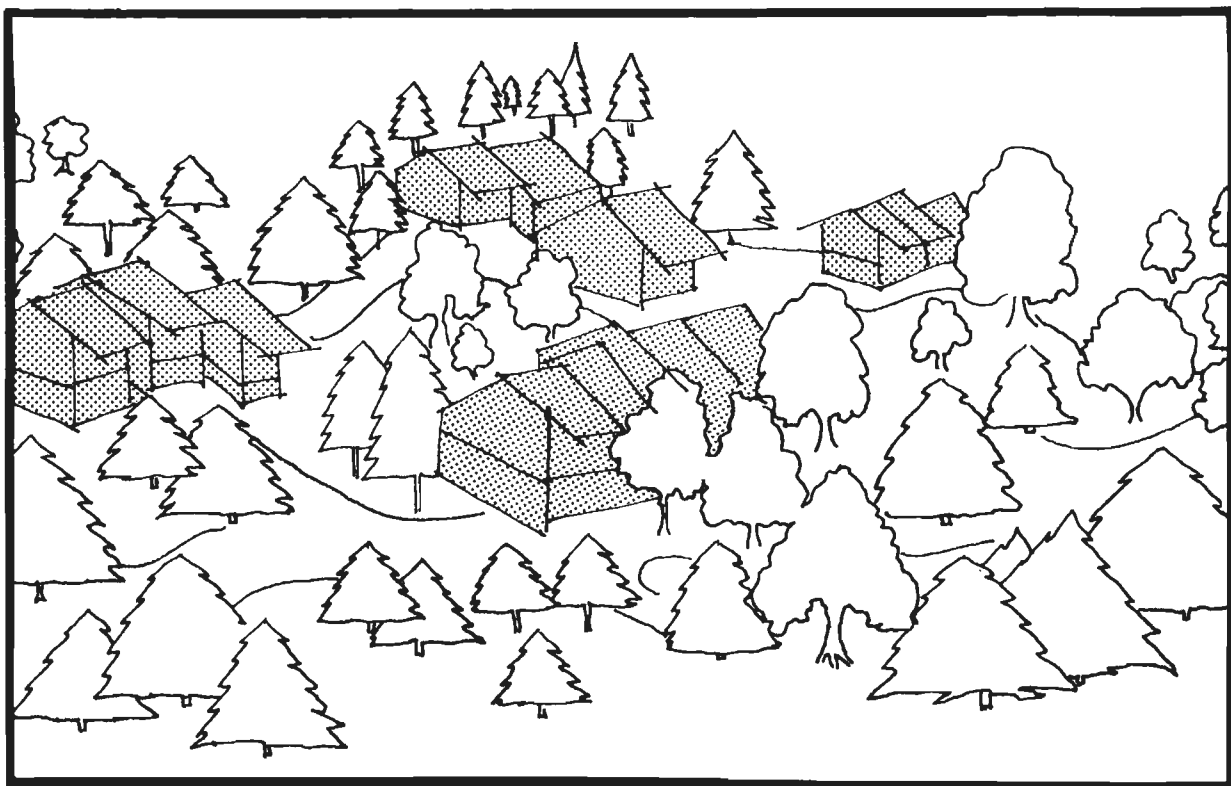
Open Space Cluster Housing

GROUPED SINGLE-FAMILY RESIDENCES,
ASSOCIATED WITH COMMONLY OWNED OPEN AREA
