Wall Assembly and Material Analysis

We researched the thought process and reasoning behind the design of wall assemblies from start to finish. We explored the specific reasoning for placement and use of every material in the wall and brought to light where the reasoning came from. The wall assemblies in question are those of an academic building currently under construction on Portland Community College, Cascade Campus designed by Thomas Hacker Associates Architecture (THA).

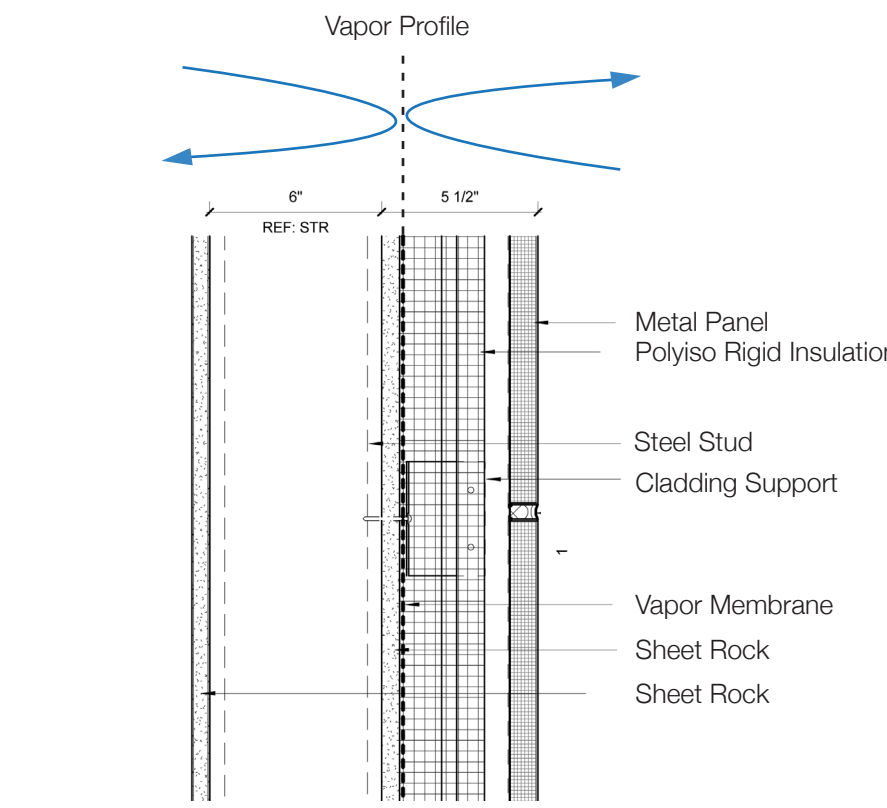
Figure 1: Exterior Wall Section with Metal Panel Facade

THA decided upon their air gap thicknesses based on the code minimum and aesthetic appearance. Since there is no conclusive data on the insulation value of air in the air gap decisions were made predominantly on facade appearances. The brick extends out the most at 3 3/4", Resysta at 3" and then the metal panel at 5 1/2". The intention behind this is to show the academic brick the most, the warmth of Resysta and then metal. The minimum air gap for metal panels as stated by the CWOT is 1", since Resysta is a rebated joint, the NHBC recommends at least 1 1/2", and brick is a minimum of 2" (Williams, 2008). The air gap for Brick, as shown by the drawings is 1 5/8" the air gap of the Resysta assembly is 3 3/8" and the air gap for metal paneling is 7/8".

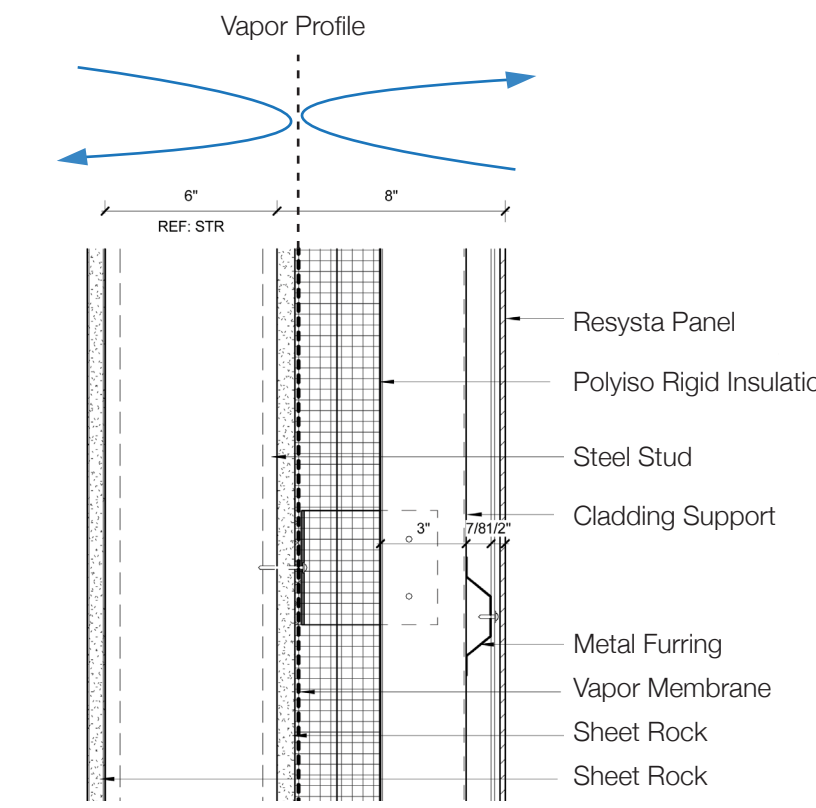
Figure 2: Exterior Wall Section with Resysta Facade

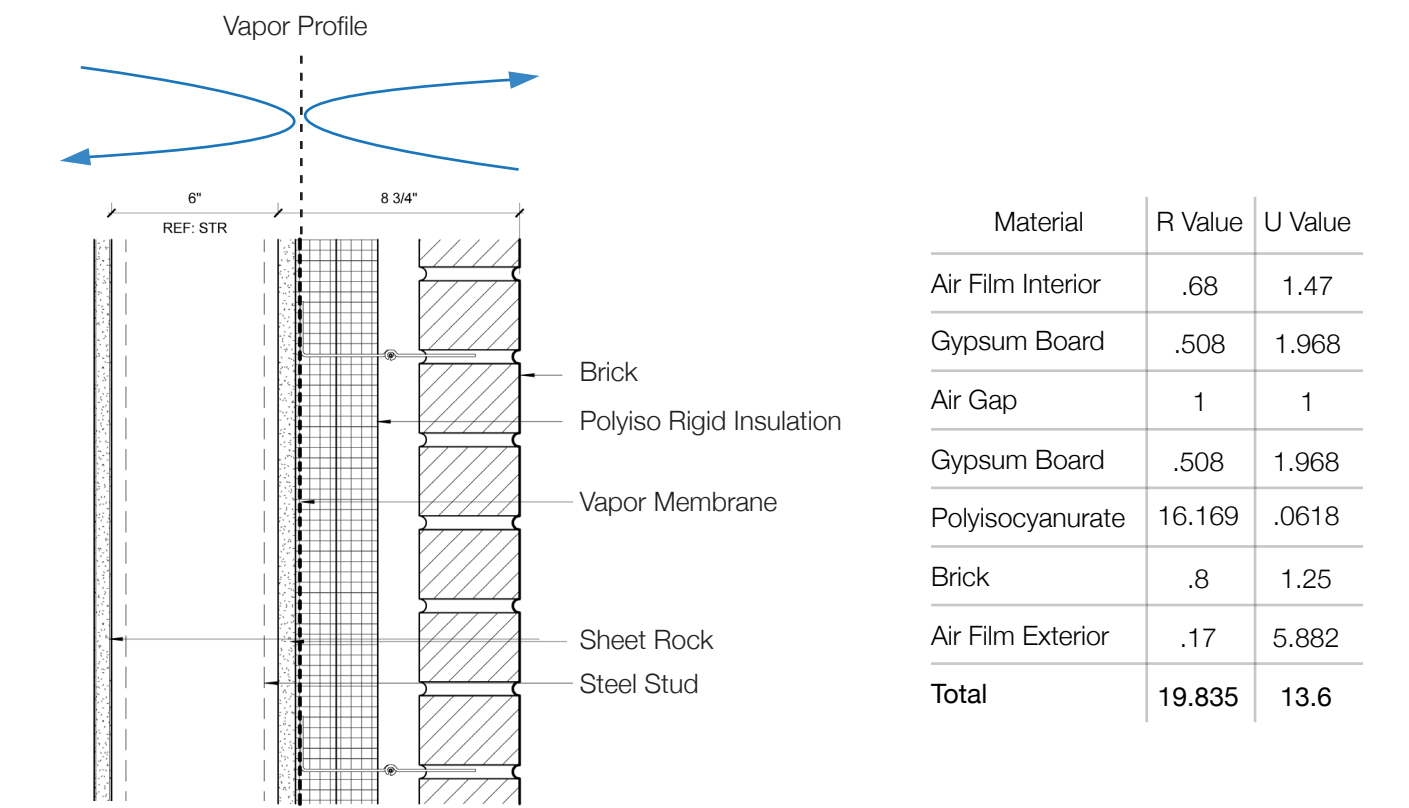
Figure 3: Exterior Wall Section with Brick Facade

There is little research pertaining to the air gap of a rain screen. Code requires a minimum gap of 1" for panel cladding material and 2" for brick to ease construction and allow some spillage of the mortar. The rain screen drains liquid equally if there is a gap of a 1/4" and a gap of 4". Since the air gap is pressure equalized from vents at the top and bottom, there is no barrier from outside environmental conditions. Pressure equalization is used to vent out the moisture accumulating in the wall. While this air gap performs well for ventilation, its thermal properties are unclear, and the air gap width is often arbitrary. There are theories about heat behaving differently depending on gap thickness. If the air gap is too thin conduction can adversely affect the temperature of the air gap and the insulation. If the air gap is too wide convection can adversely affect the insulating properties of the air gap (Al-Houmoud, 2005). Since the air gap is "open" to the exterior air in a rain screen application it does not provide insulation value.

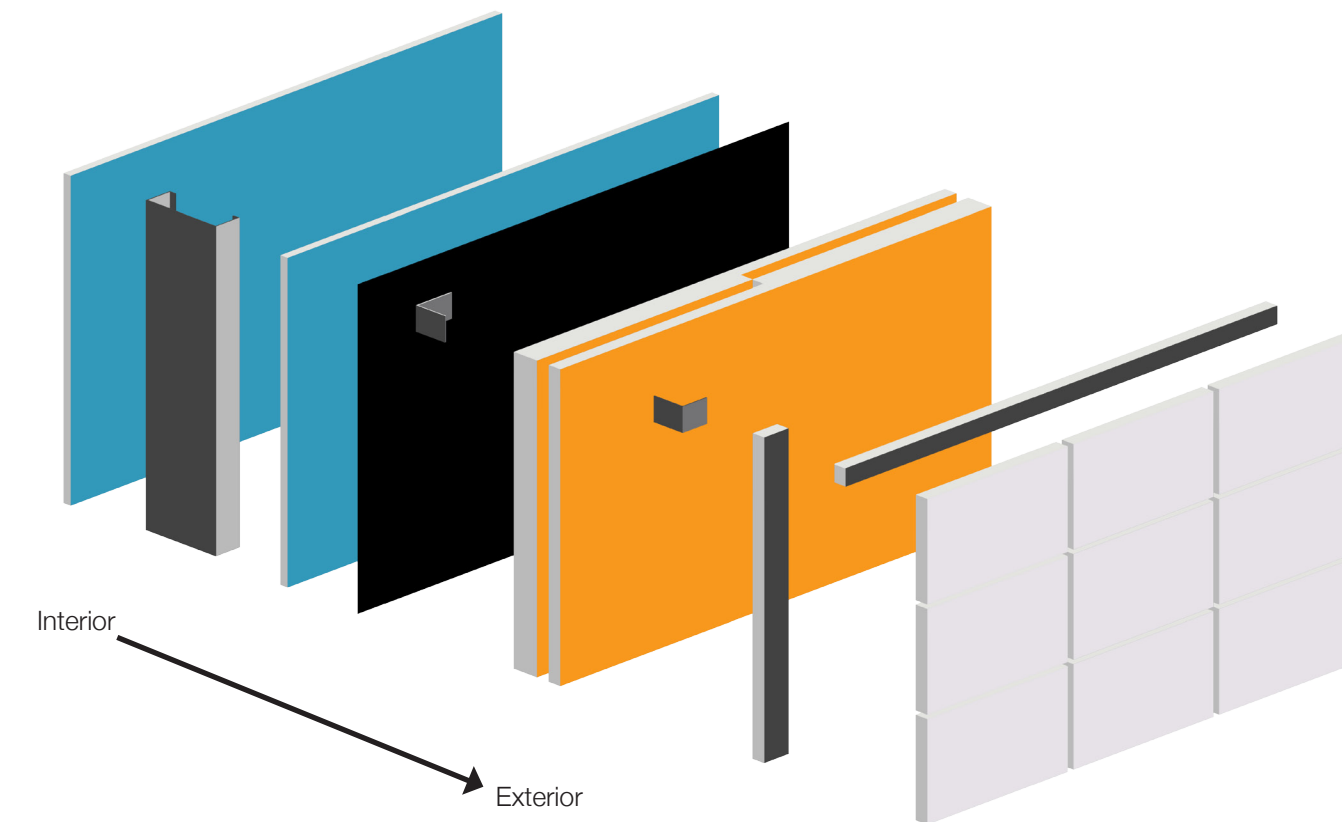
Figure 4: Exploded Isometric of Metal Panel Wall System

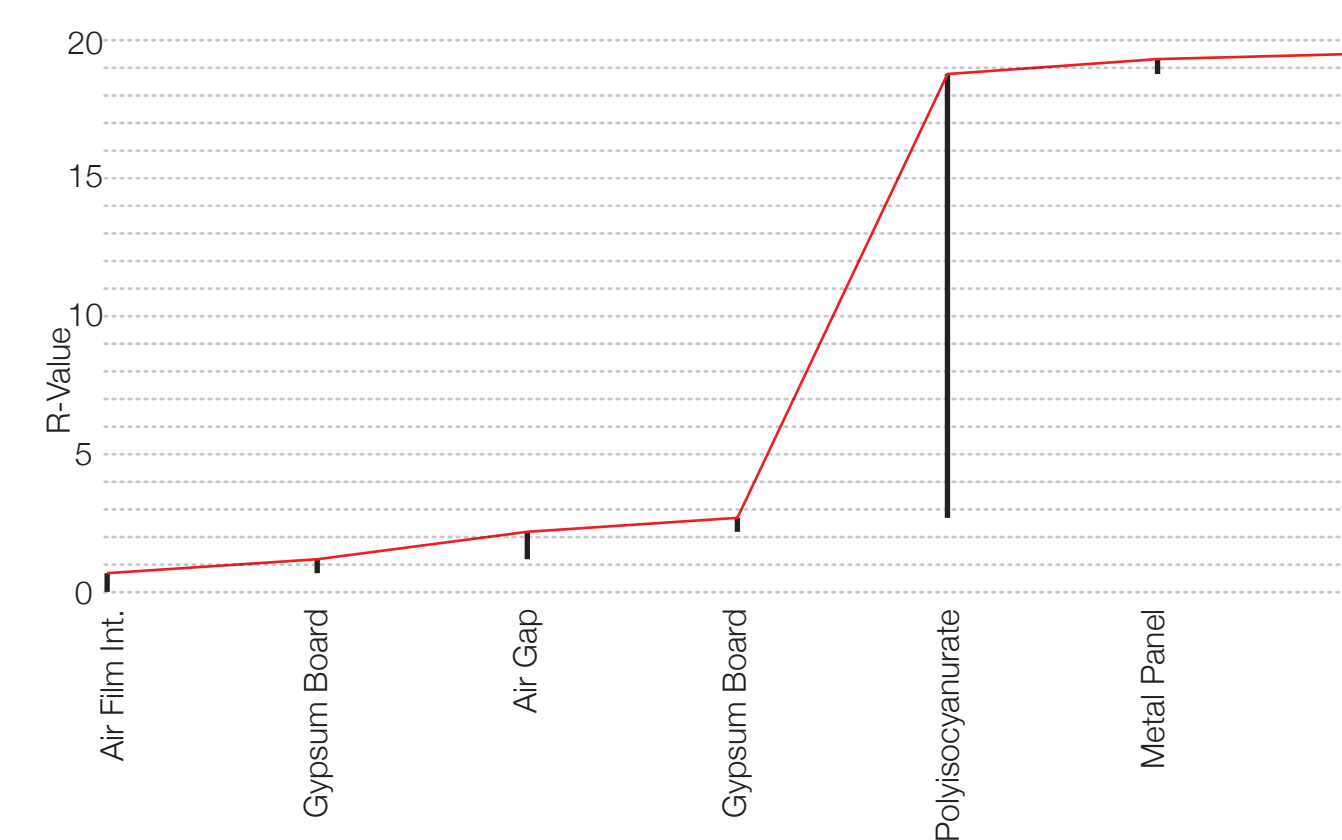
Figure 7: Metal Panel Wall System Material and Total R Value

From the R-values collected we totaled the overall R-value of the wall. From this data we have also calculated how variances in material thickness can change the total R-value. We found that the material that had the most effect on the overall R-value is the polyiso insulation but there comes a point of diminishing returns and the added insulation becomes uneconomical. By adding one inch to the insulation the R-value would increase from 19 to 24. At an R-value of 19 the wall is 94% efficient in reducing heat flow; at an R-value of 24, efficiency increases slightly to 96%. By increasing the cost of insulation by about 30% there would only be a 2% improvement rating in the efficiency of the overall wall assemblies. However, even with a total wall assembly R-value of 1000, the overall envelope performance would be ineffective due to heat loss through glazing.

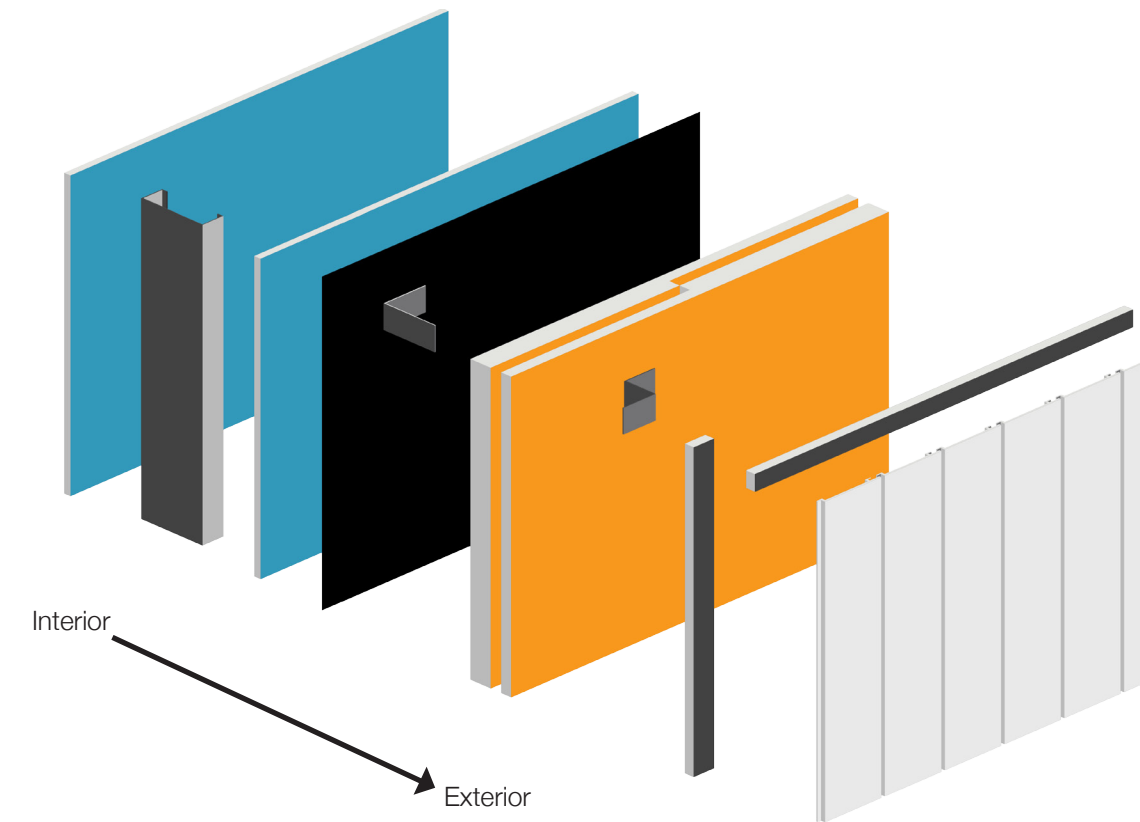
Figure 5: Exploded Isometric of Resysta Wall System (Interior to Exterior)

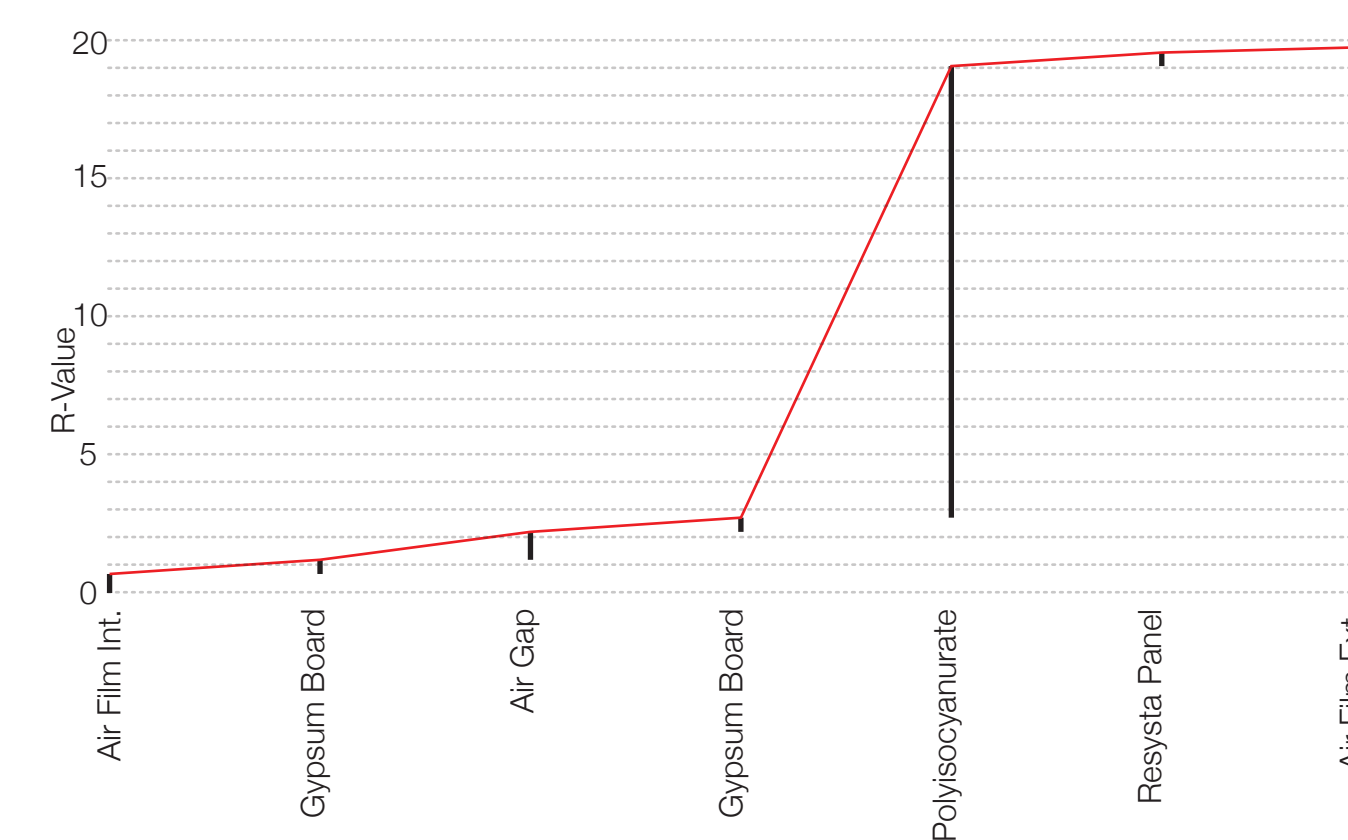
Figure 8: Resysta Wall System Material and Total R Value

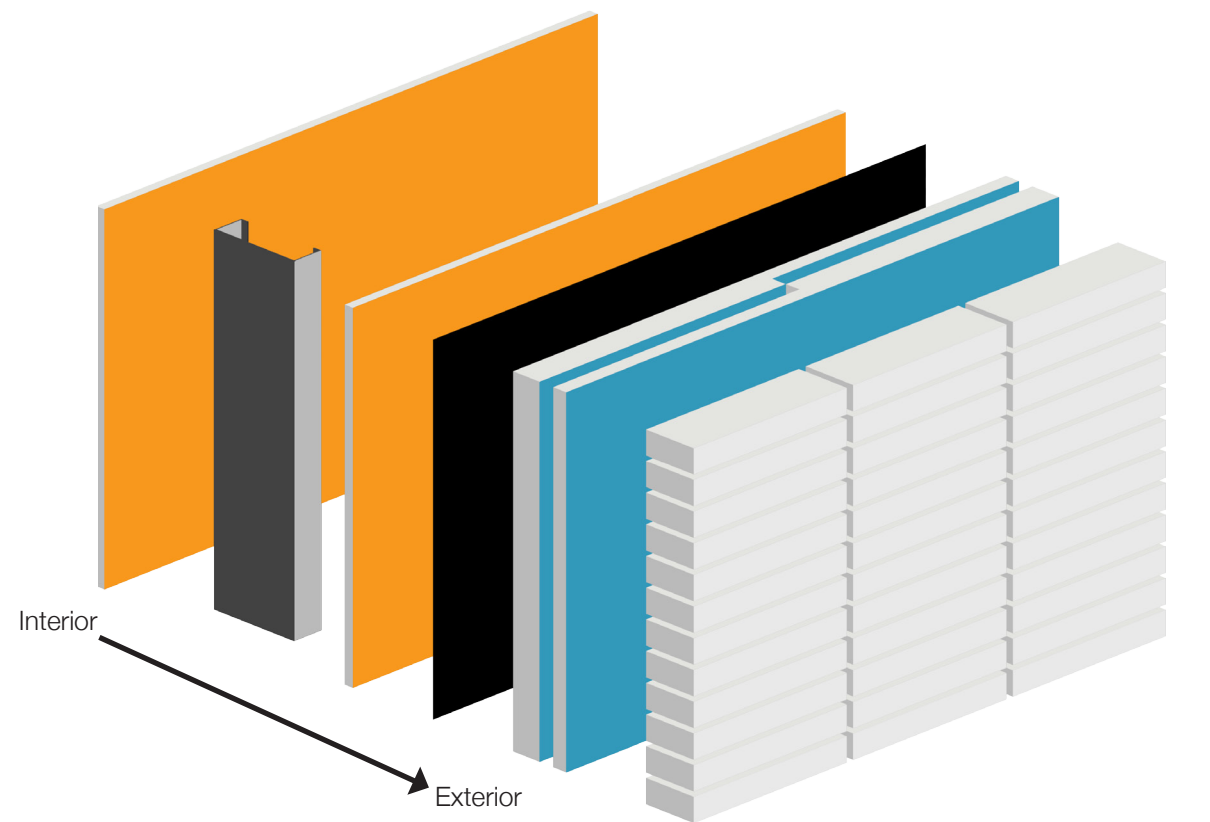
Figure 6: Exploded Isometric of Brick Wall System (Interior to Exterior)

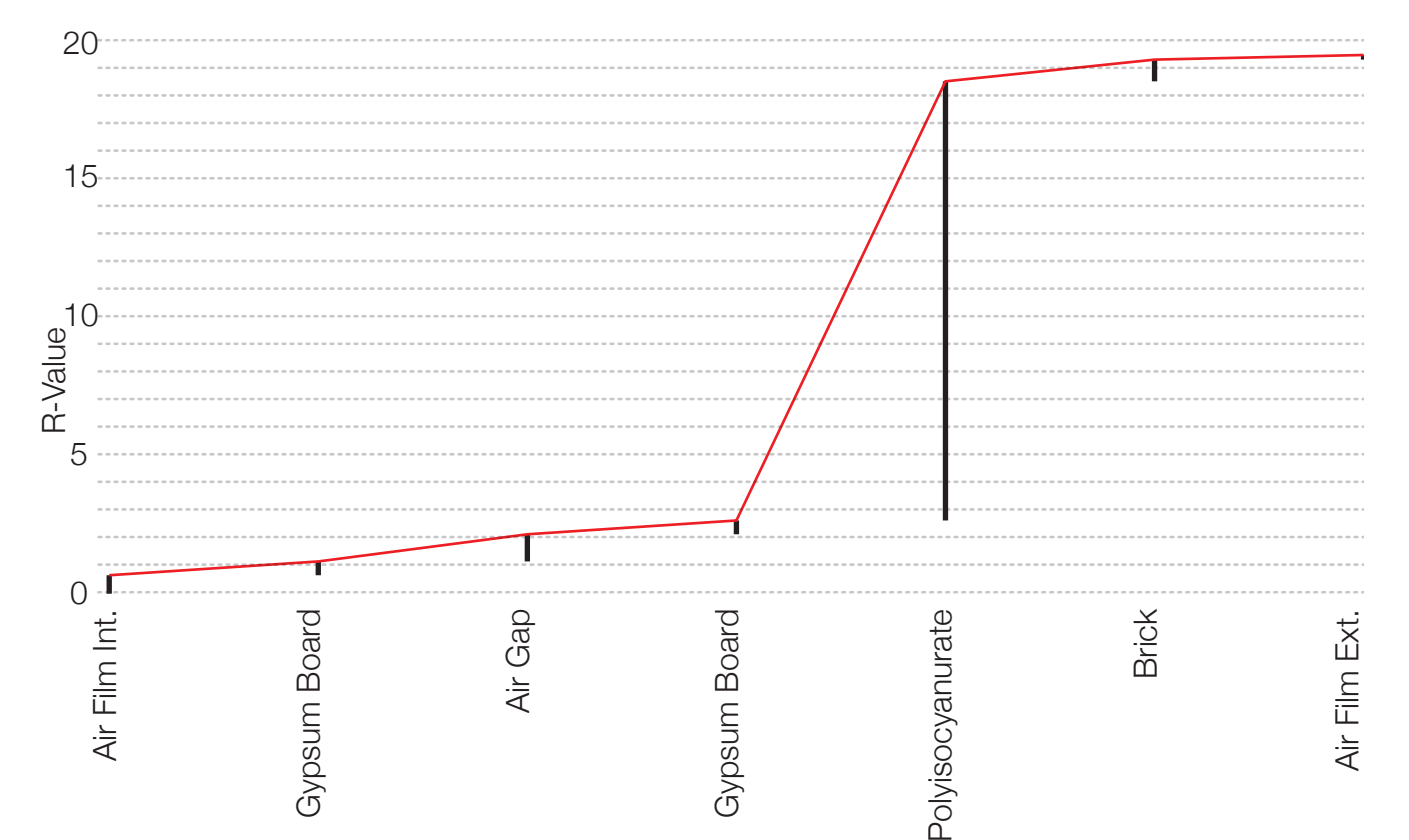
Figure 9: Brick Wall System Material and Total R Value

We examined and compared variations in material thickness to test the overall R-values. We tested the thermal properties of six different materials: metal panel, Resysta, polysocyanurate (polyiso) insulation, sheet rock, vapor barrier and brick (no usable results obtained from the brick assembly, so we used previous data).

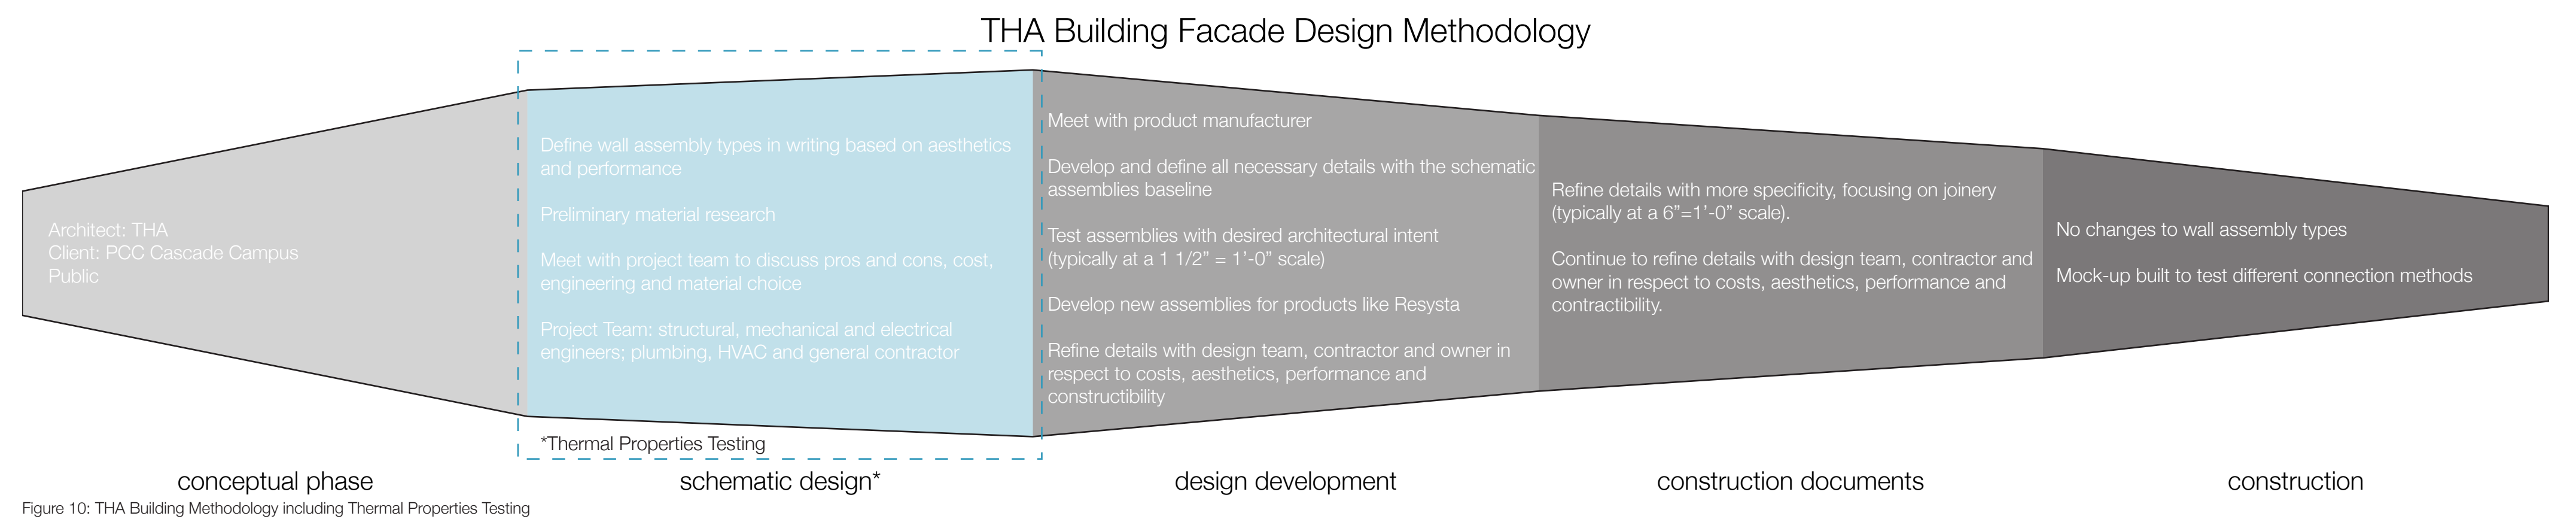
Figure 10: THA Building Methodology including Thermal Properties Testing

In the Green Building Research Lab on the PSU Campus we tested the thermal properties of the aforementioned materials in the FOX 314 Thermal Properties Analyzer. In the test, the environment of one side of the material was 20 degrees Celsius and the other side was 40 degrees Celsius. A material's conductivity was then calculated based on the time required for the material to reach temperature equilibrium. From these tests we found the thermal conductivity in BTU/hour*R (R - Rankine, the thermodynamic absolute temperature scale), which we then applied the specific material's depth to calculate the resistance value (R-value).
