Pacific Spaceflight **Research Brief #2013-1**

Hypobaric Chamber Test of Pacific Spaceflight Pressure Garment Mark I at Copenhagen University Hospital

Cameron M. Smith, PhD

25 Nov 2013

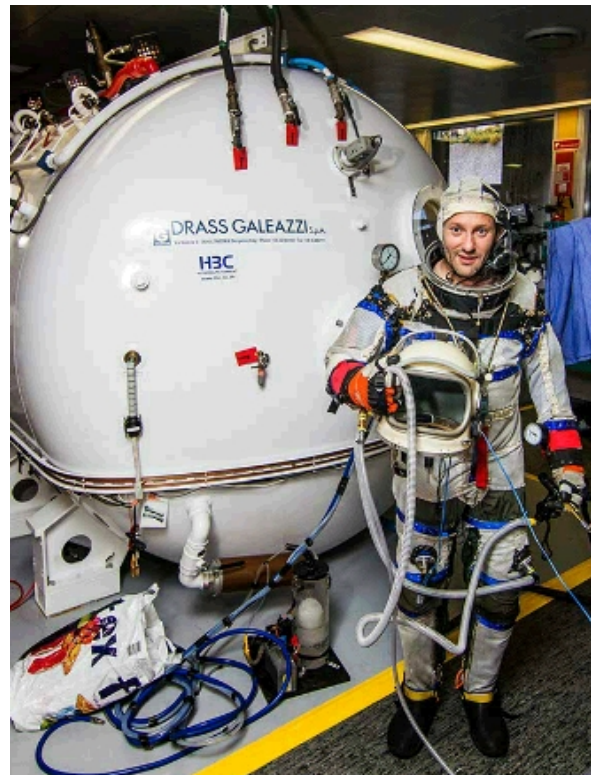
FIGURE 1. (A) Test Subject Standing Before the Trykkammer Wearing the Mark I (*Gagarin*) Pressure Garment. The flight coverall was not worn in this test; visible is the pressure restraint garment that covers the gas retention layer. (B) Test Subject (L) and Pressure Garment Operator (R) During Depressurization Test. Photos courtesy of Jev Olsen, Copenhagen Suborbitals.

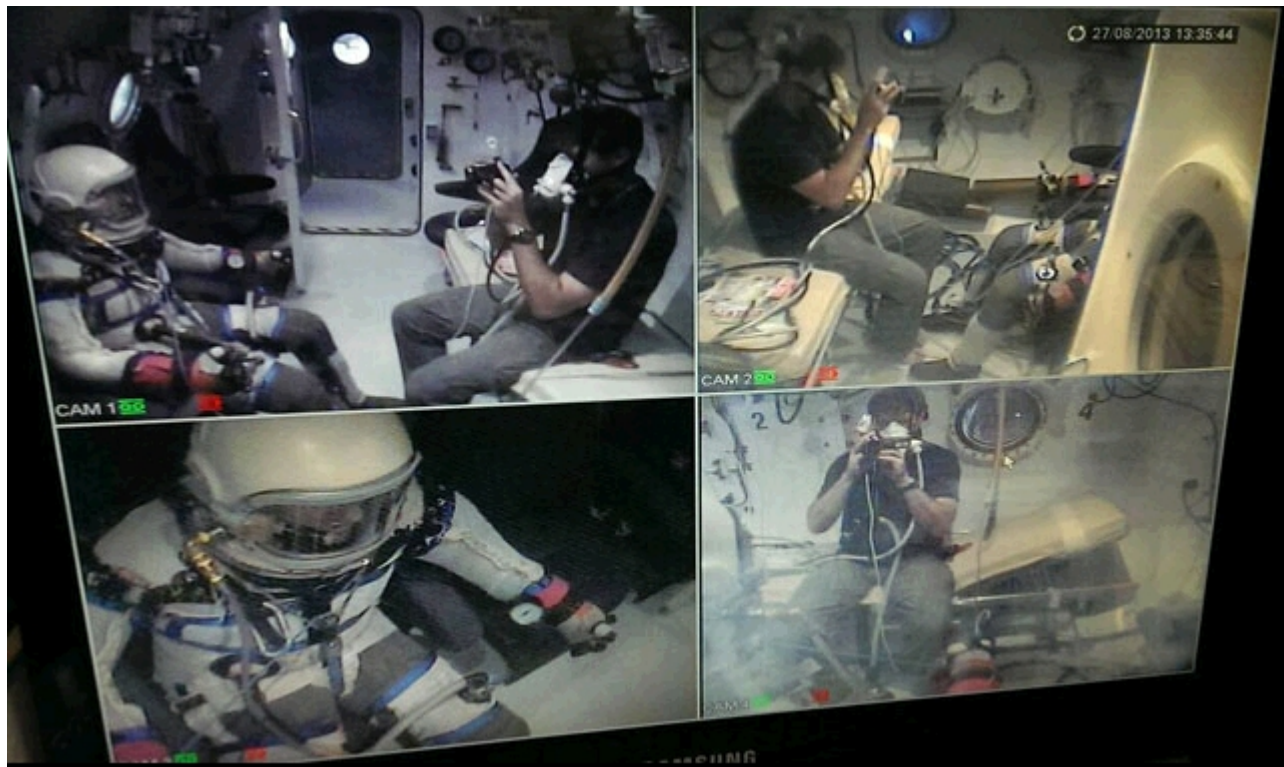
FIGURE 2. Pressure Garment Operator Test Subject in Trykkammer, Monitored by Closed-Circuit Video During Depressurization Test. Photo courtesy of Kristian von Bengtson, Copenhagen Suborbitals.

During the test the subject was supplied with normal air (c.20% oxygen, c.80% nitrogen and other gasses) via an external-to-chamber supply set to deliver 28 liters per minute (c. 1 cubic foot). The pressure suit operator was supplied with 50% oxygen via an oral-nasal mask at the same setting (Figure 2). Neither breathing
