Applying a Mt. Mazama Volcanic Ash Treatment as a Trail Accessibility Improvement

Final Report

NITC-TT-1529

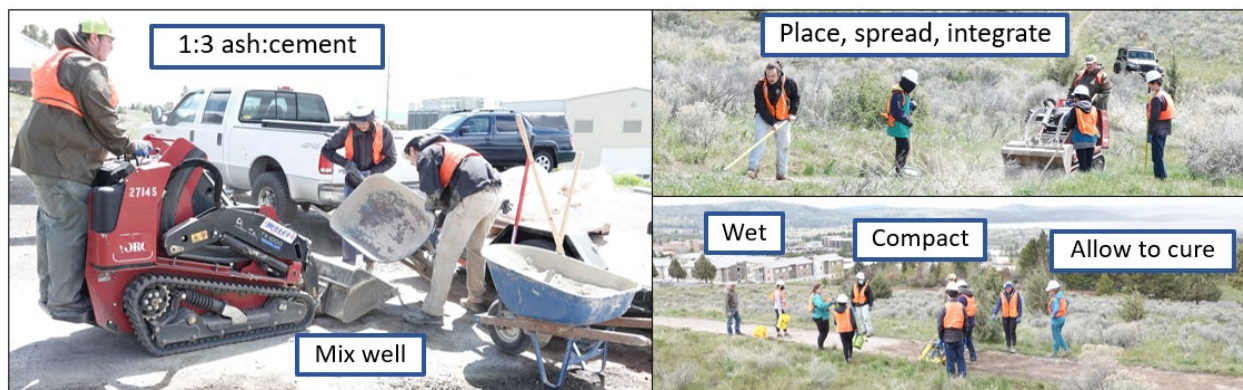
Figure 3.3: Process for applying Mt. Mazama ash treatment to trail surface.

Surface application took place in five distinct phases: (1) material mixing, (2) material placement, (3) wetting, (4) compacting, and (5) curing. Each of these steps is indicated in Figure 3.3. A staging area was set up at the beginning of the stretch of trail and used to stockpile and prepare materials. Materials were transported from the staging area to various locations on the trail such that these construction phases could take place in parallel with one another.

First, dry Mt. Mazama volcanic ash was mixed with Portland cement in an ash:cement volumetric ratio of 1:3. For ease of procedure, volumes were not determined precisely; uniform shovels were used to obtain material quantities and visual observation was used to ensure that scoops remained similar in size. Material was added directly to the trough of a narrow track loader and then mixed in an attempt to distribute particles throughout the mixture as evenly as possible.

Next, the narrow track loader was used to transport dry materials to the far end of the trail for application. Material was unloaded directly onto the trail by the loader and then manually spread along the trail surface with rakes. Care was taken to apply the surface evenly and to integrate the ash/cement mixture with the existing trail surface aggregate and soil to a depth determined by the depth of easily loosened material.

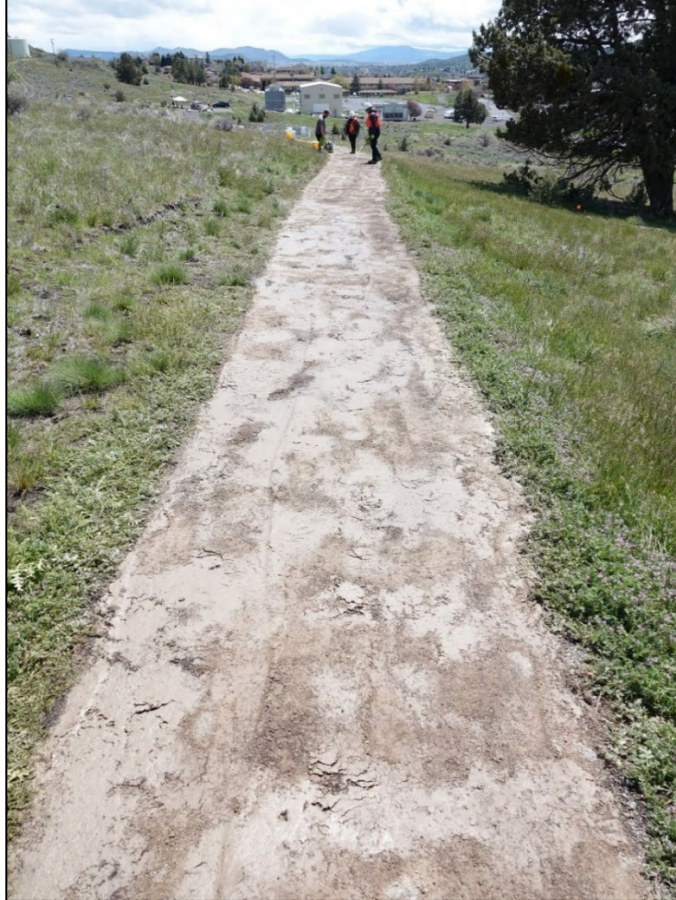
Figure 3.4: Completed trail surface.

After the surface was sufficiently moistened, a plate compactor was used to compact the surface. A uniform number of passes was taken with the plate compactor across the surface to compact materials as evenly as possible, and water was added to areas that appeared overly dry. The completed trail surface is shown in Figure 3.4.

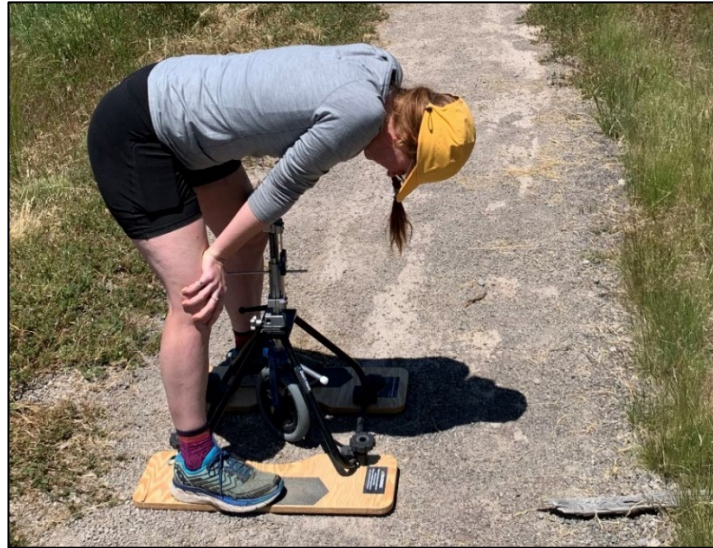
Figure 3.5: Testing with the Beneficial Designs rotational penetrometer.

A rotational penetrometer produced by Beneficial Designs was used in prior research to quantify the firmness and stability of the trail surface as a way of measuring improvement. The prior research had shown minor improvements in firmness and stability in treated surfaces (Sleep and Matzen, 2020). The prior research used a slurry approach rather than the dry mixing, wetting, and compacting of the current work. The latter approach allowed for more thorough mixing with existing trail material and a treatment that could be tailored to looser or more compacted material as it was encountered. Because the treated surface varied considerably, firmness and stability were tested in multiple locations where the surface was either smooth, inconsistent, or still loose with less apparent binding of the topmost material. The testing process is

depicted in Figure 3.5, photographs of the different surfaces in Figure 3.6, and the results of the testing in Figure 3.7. While the firmness of each surface tested falls within the bounds to be considered firm, it is clear that stability is substantially improved when surface material is more effectively bound with an ash-cement binder.

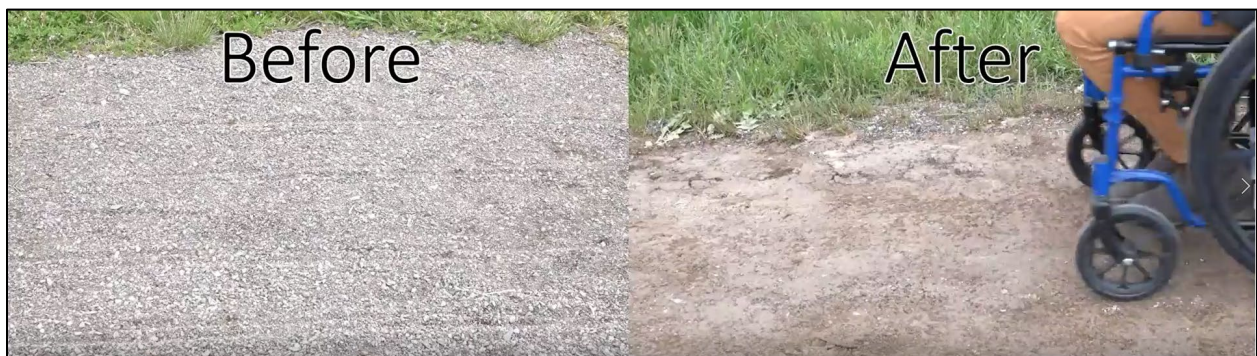
Figure 3.8: Wheelchair rutting performance on the untreated and treated surfaces.

The qualitative performance of pushing an occupied wheelchair across both the untreated and treated surfaces is significantly improved. The team considered ways of quantifying this improvement. While firmness, stability, and roughness are all relevant and quantifiable characteristics, they do not quite capture the experience of pushing a wheelchair. The best measure of this change is the effort required to push the wheelchair and the significance of rutting left after the wheelchair has passed. Figure 3.8 demonstrates the rutting that occurs in the unbound aggregate of the untreated trail surface. No such rutting is experienced on any of the treated surfaces, whether smooth, inconsistent or rough.

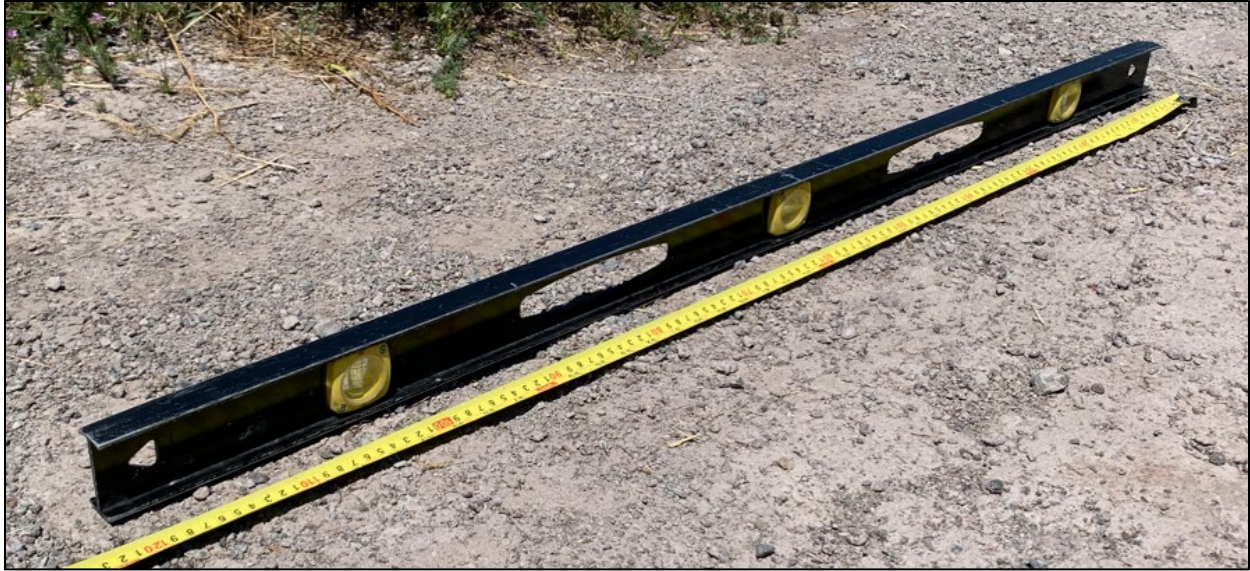
Figure 7.1: Roughness profile measurement setup: vertical distances between the level and the ground were measured at 10 cm increments.

Profile measurements were taken manually in an attempt to approximate the WPRI. The results of these measurements are listed in Appendix A: Surface Roughness measurements. Figure 7.1 shows the data collection setup, Figure 7.2 shows the results in graphical format, and Table 7.1 provides the raw data. These measurements indicated that the untreated surface is already relatively smooth but, because it is also softer, the experience of moving a small-wheeled vehicle across the surface is more challenging. The treated surface has the potential to be smoother depending primarily on the wetness of the material during compaction, but roughness can also be exacerbated if care is not taken in finishing the surface or if the material is overly dry and inconsistent.
