## Hypobaric Chamber Test of Pacific Spaceflight Pressure Garment Mark I at Copenhagen University Hospital

# Pacific Spaceflight **Research Brief #2013-1**

25 Nov 2013

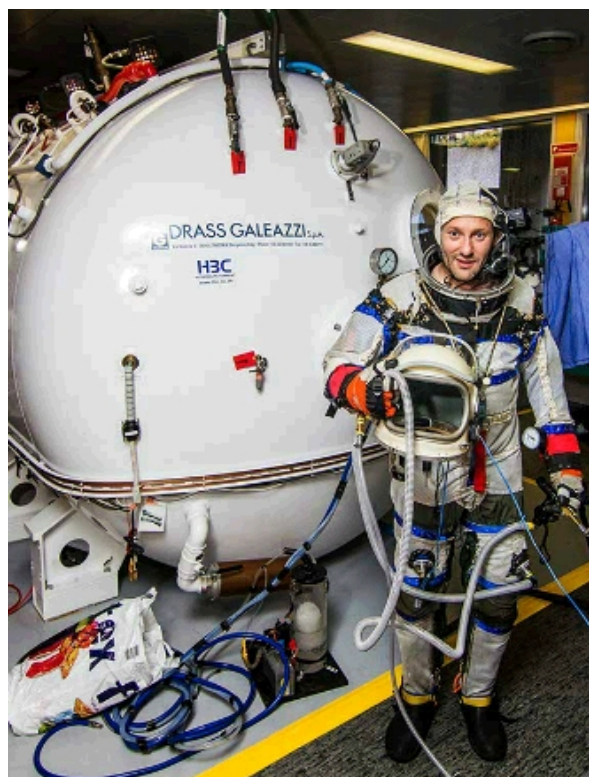
**FIGURE 1. (A) Test Subject Standing Before the Trykkammer Wearing the Mark I (*Gagarin*) Pressure Garment. The flight coverall was not worn in this test; visible is the pressure restraint garment that covers the gas retention layer. (B) Test Subject (L) and Pressure Garment Operator (R) During Depressurization Test. Photos courtesy of Jev Olsen, Copenhagen Suborbitals.**

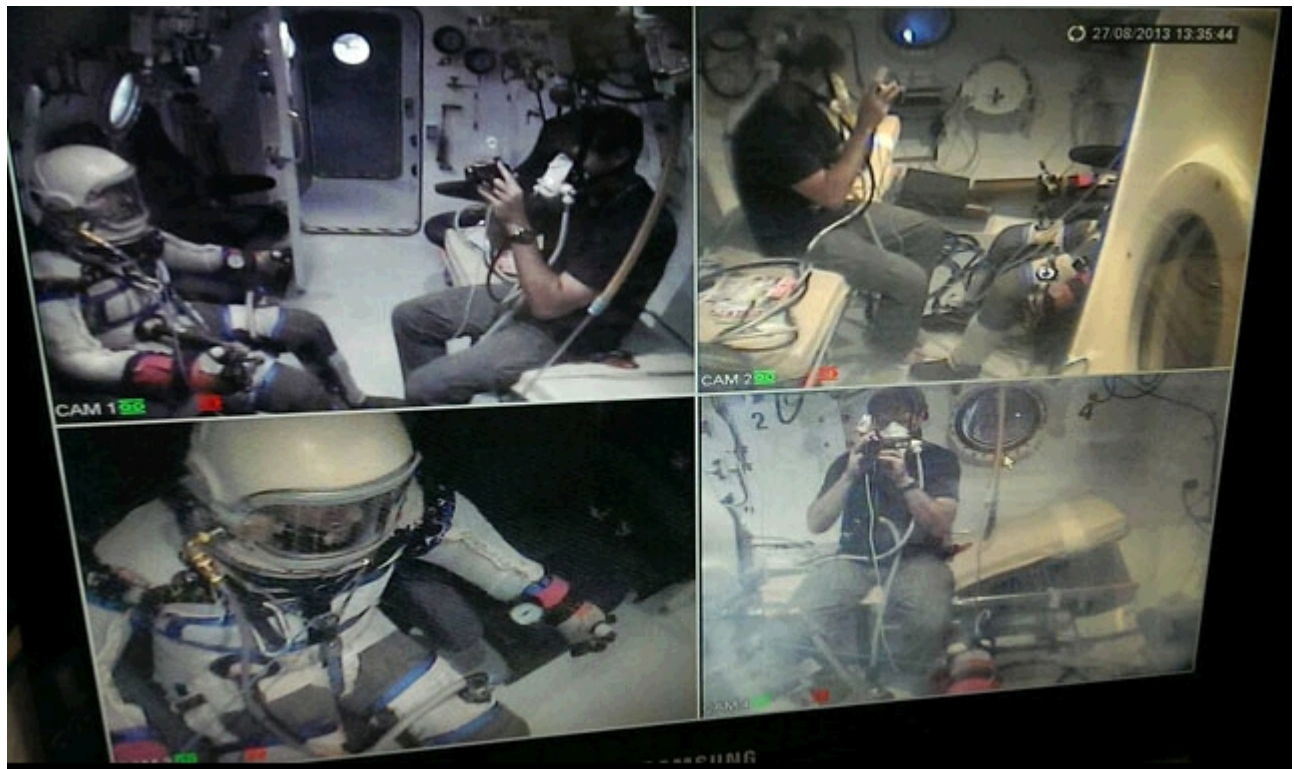
**FIGURE 2. Pressure Garment Operator Test Subject in Trykkammer, Monitored by Closed-Circuit Video During Depressurization Test. Photo courtesy of Kristian von Bengtson, Copenhagen Suborbitals.**

During the test the subject was supplied with normal air (c.20% oxygen, c.80% nitrogen and other gasses) via an external-to-chamber supply set to deliver 28 liters per minute (c. 1 cubic foot). The pressure suit operator was supplied with 50% oxygen via an oral-nasal mask at the same setting (Figure 2). Neither breathing

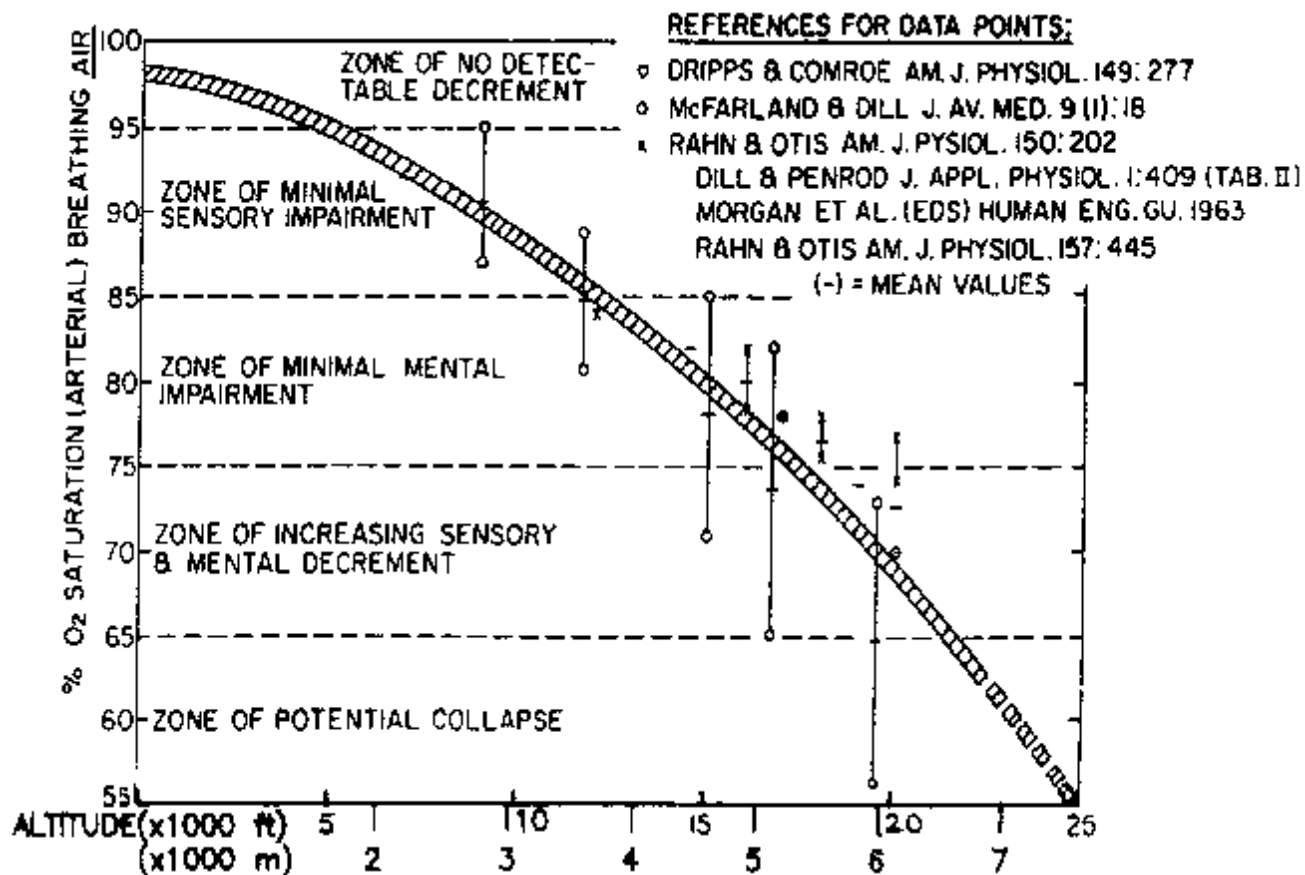
FIGURE 3. Aviation Blood Oxygenation Disassociation Curve.

The aviator's Blood Oxygenation Disassociation Curve (Figure 3) [2] indicates that normal (sea level) blood oxygenation is 96%-98%, whereas at 4,000m (13,123ft or .62atm) it is normally 82%-83%. At 4,000m simulated (when suit pressure {1.8psi/.122atm} + chamber pressure {8.8psi/.598atm} yielded a perceived pressure of 10.6psi/.72 atm within the pressure garment) the test subject's blood oxygenation figure was 90%. This is expected at 2,590m (8,497 ft) or .72atm.

Specifically, the pressure garment kept the test subject within in first half of the blood oxygenation range of 'Minimal Sensory Impairment' rather than in the first quarter of the range of 'Minimal Mental Impairment', where it would have been without the pressurized garment (Figure 3).
